Building and Timber Pest Inspection Report

Inspection Date: Fri, 6 Feb 2026

Property Address: 6/47 West St, Hurstville NSW 2220,
Australia

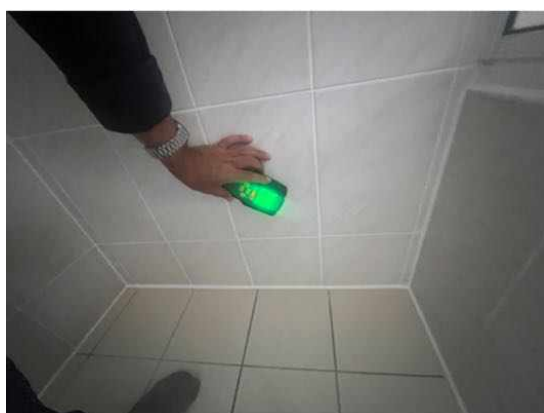
Building: Main Building
Location: Bathroom
Finding: Cracked Shower Tiles & Elevated Moisture – Bathroom (Also refer to defect 3.1)
Information: Cracked tiles were noted within the shower area, and moisture readings returned elevated levels above typical thresholds. This defect may be contributing to concealed water penetration due to cracked tiling on the floor and could lead to further damage if not remediated.

Recommend investigation by a licensed plumber and waterproofing contractor to access further followed by a licensed tiler.

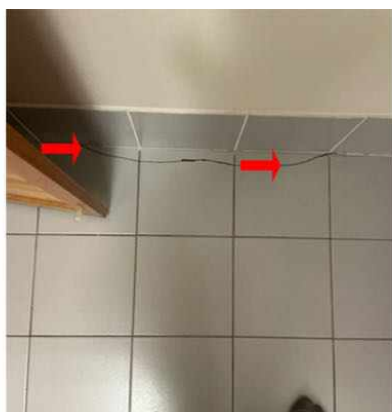
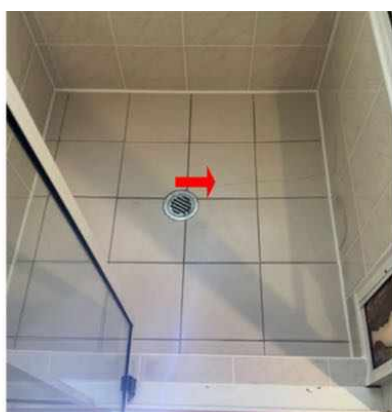
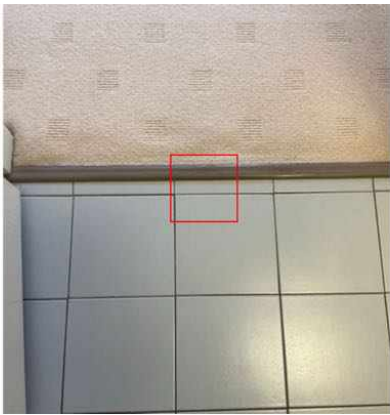
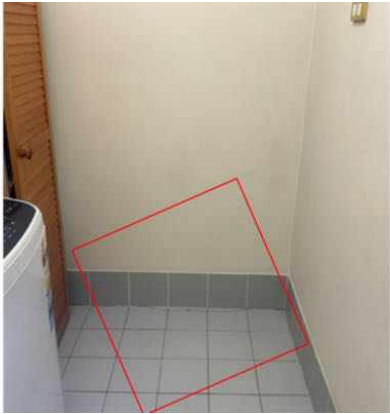
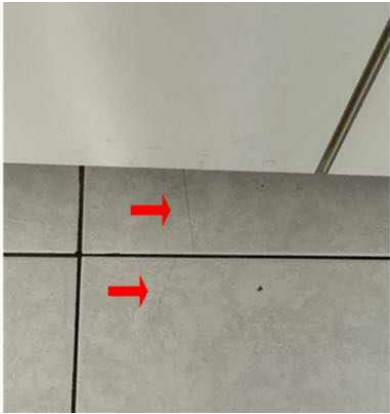
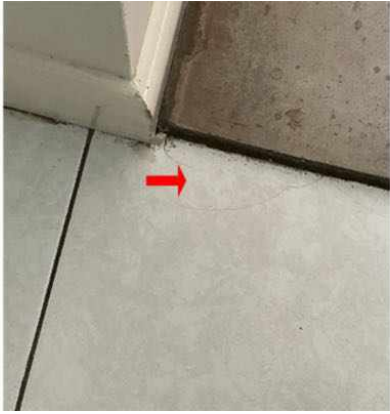
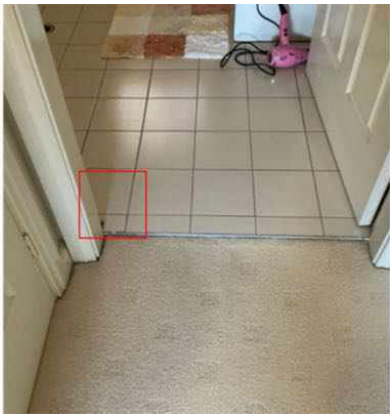
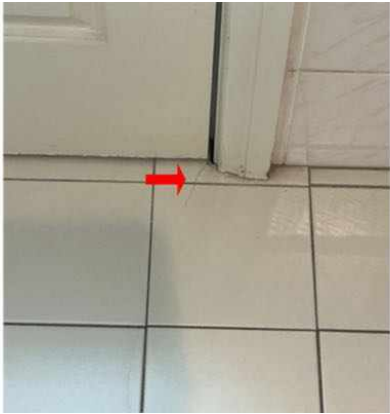
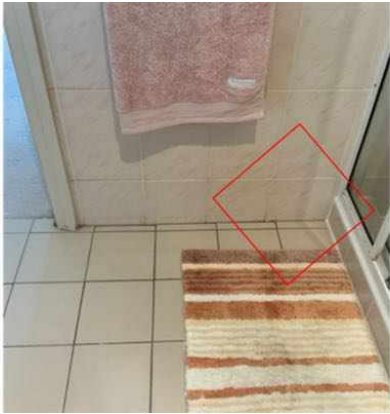
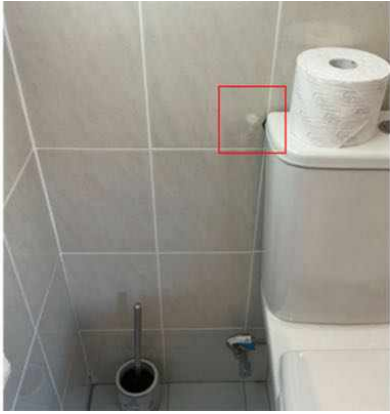
Finding 3.01

Building: Main Building
Location: All Internal Areas - Toilet, laundry, kitchen, main bathroom
Finding: Tiles - Cracked or damaged
Information: Cracking was evident to the tiling in this area at the time of inspection. While the cracking appears to be minor, this area is frequently exposed to water, allowing potential for water penetration into adjoining sections of walls or flooring. (shower area, laundry)

If left unmanaged, water penetration to these areas may lead to subsequent water damage, which is likely necessitate repair work to affected building elements.

A tiling contractor should be appointed to ensure that no further water damage occurs. The re-application of silicone and grouting throughout remaining tile work is also advised, to further protect the area against water penetration.

Where water penetration has led to water damage, appointment of a relevant tradesperson may be required to repair damaged building elements.

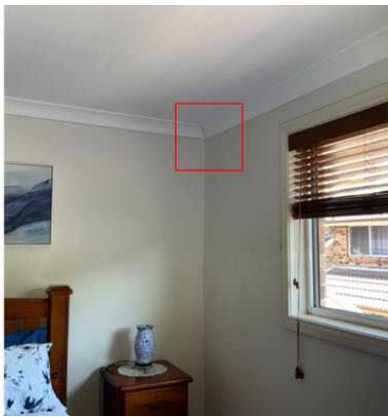
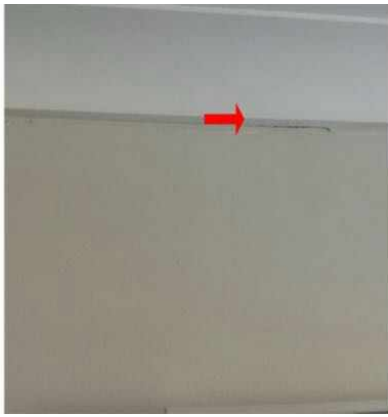
Finding 3.02

Building: Main Building
Location: Bedroom - Master
Finding: Moisture Damage and Minor Mould at Ceiling–Wall Junction
Information: Moisture staining, plaster deterioration and localised separation were observed at the ceiling–wall junction, with very minor possible mould present beneath the cornice. The condition is not consistent with normal settlement alone and indicates past or intermittent moisture ingress, potentially from roof leakage, flashing or gutter issues, or condensation within the ceiling space. While the visible mould is limited, the presence of staining and material breakdown suggests the area has been subjected to prolonged damp conditions. Further investigation is recommended to identify and rectify the moisture source before cosmetic repairs are undertaken, with ongoing monitoring to confirm no recurrence, in accordance with the intent of AS 4349.1.

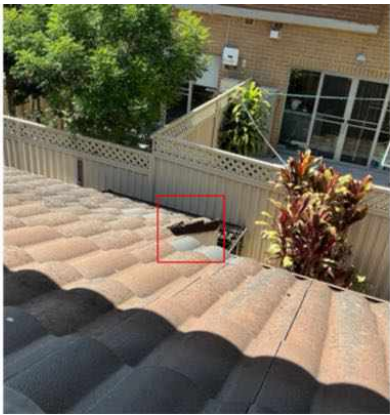
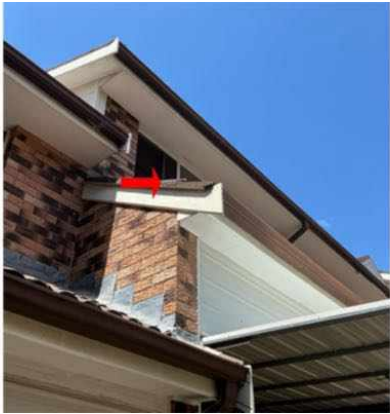
Finding 3.03

Finding: Mortar - Deterioration (Possible moisture ingress)

Information: Mortar, or 'bedding', is the material which fills joints and intersections between tiles and other building elements on the exterior roof covering, such as gable ends, hip capping and valleys. Upon inspection of the exterior roof, it was noted that sections of the mortar show varying levels of deterioration.

Mortar generally deteriorates as a result of frequent exposure to weather conditions over a prolonged period of time. Mortar that is deteriorating may allow water ingress into the roof void, putting associated building elements and roofing structures at risk of

water damage. Deteriorated mortar also detracts from the functionality of roof tiles and other roofing elements, potentially decreasing weather tightness and roof drainage.

Mortar deterioration can be attended to by a handy person where areas of deterioration are localised and easily accessible. Otherwise, consultation with a roofing contractor is advised where greater works are required.

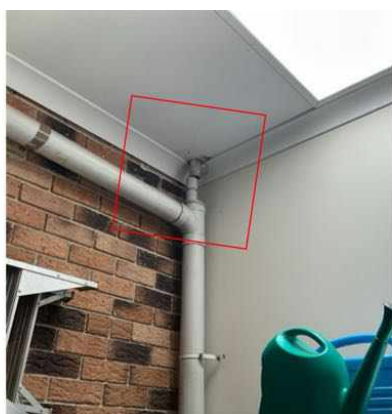
Finding 3.04

Building: Main Building
 Location: Garage
 Finding: Ceiling - Water damaged
 Information: Water damage to the ceiling lining is generally an indication of excessive moisture being present in the roof void, usually via a leak to the roof covering.

Where water damage is evident to the ceiling, the primary requirement is to identify and rectify the source of the leak. A roofing plumber should be appointed as soon as possible to identify the leak and perform rectification works as necessary, ensuring the water damage is restricted.

Once the leak is repaired, consultation with relevant tradespeople, including plasterers and painters, is advised. Rectification works may include replacement of ceiling lining or minor repainting, depending on the extent of the damage.

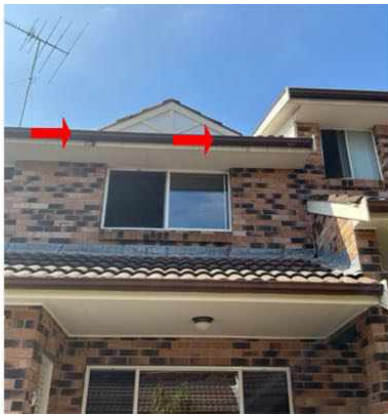
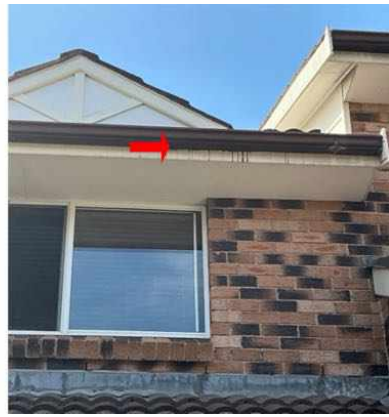
Finding 3.06

Building:	Main Building
Location:	All External Areas
Finding:	Moisture Staining to Eaves / Soffit /Fascia
Information:	Moisture staining was observed to the external eaves/soffit lining/Fascia consistent with past or ongoing water runoff from the gutter line above. This condition is commonly associated with overflowing or leaking gutters, inadequate falls, blocked downpipes, or deteriorated gutter joints, allowing water to track back onto the fascia and soffit. While no significant deformation is visible, continued moisture exposure can lead to deterioration/wood rot of the fascia, soffit lining, fixings, and concealed framing over time. Further inspection of the guttering system is recommended, with cleaning, repair or adjustment as required, and monitoring after rectification in accordance with the intent of AS 4349.1.

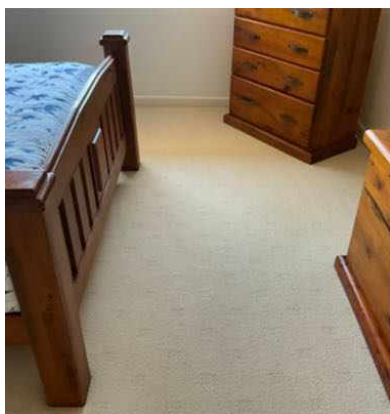
Bouncy floors generally indicate that the floorboards or the subfloor structures are coming loose from the joists that they are installed on. Bouncy flooring may also be the result of gaps between flooring and stumps or joist structures, which require packing.

The client is advised to seek quotations for required repairs from a Registered Builder specialising in re-stumping. The potential resolution may range from packing gaps in subfloor structures through to replacement of subfloors stumps and refixing of flooring.

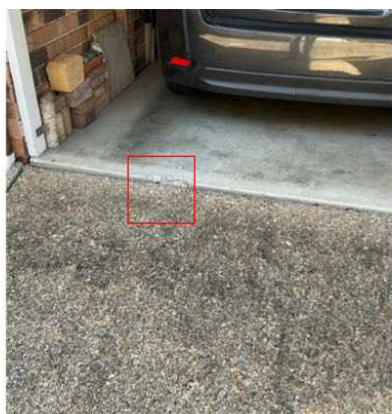
Finding 3.09

Building:	Main Building
Location:	All External Areas
Finding:	Building element - Damaged - Concrete damage
Information:	Breakage occurs generally when the building materials have either aged and decayed, or as a result of damage (accidental or deliberate).

Repair and/or replacement of broken elements is advised to ensure that additional secondary defects do not arise as a consequence. Such works are necessary, as all building elements play a key role in the operation and function of the overall structure and its performance.

A relevant tradesperson should be appointed to repair or replace the affected building element prior to any subsequent damage being caused.

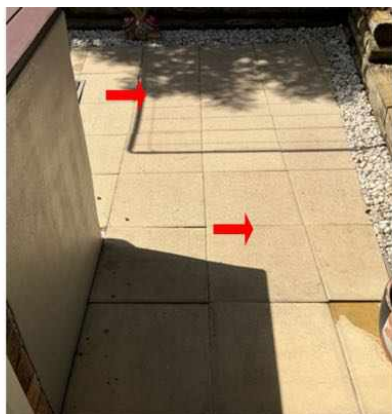
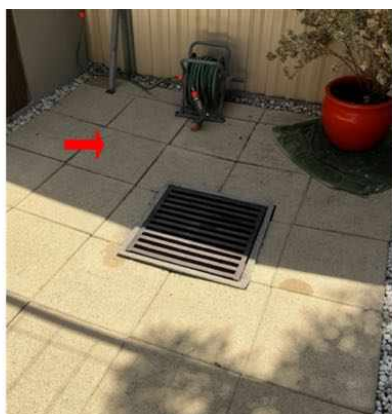
Finding 3.10

Building:	Main Building
Location:	All External Areas - Rear
Finding:	Paving - Uneven
Information:	Sections of the external paved area are uneven, creating a potential trip hazard. It appears as though the area has been subject to rough installation, or that paving

sections have lifted due to movements in the foundation of the property.

Where paving creates a trip hazard, personal injury may ensue if due caution is not taken by all persons within this area.

Re-paving of the area is required as soon as possible to remedy this situation. Further consultation with a specialist concreter is advised.

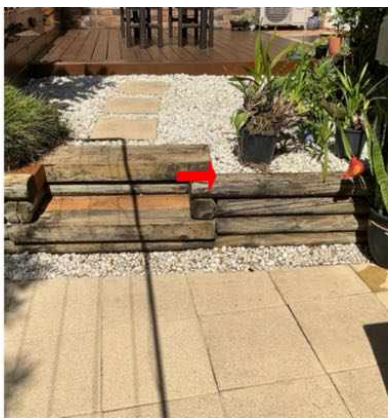
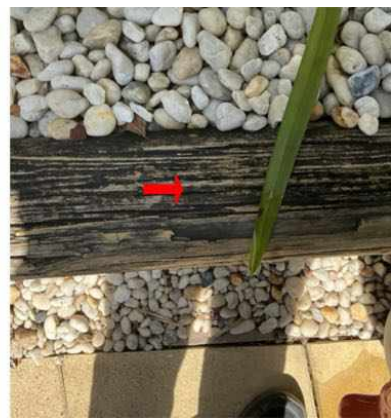
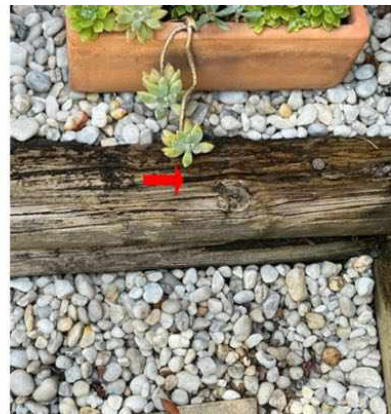
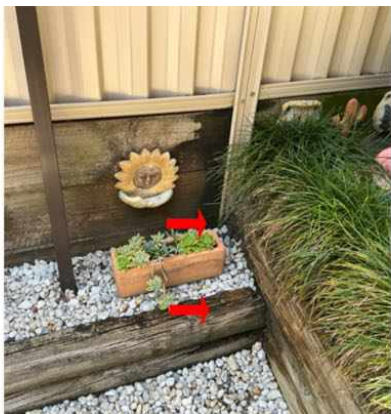
Finding 3.11

Building:	Main Building
Location:	All External Areas - Retaining wall
Finding:	Wood rot to some areas
Information:	This building element shows evidence of wood rot. Wood rot, also known as Fungal Decay, occurs when timbers and other cellulose building materials are exposed to damp conditions on an ongoing basis. This could be the result of exposure to weathering over a prolonged period of time, or the attraction of excessive moisture from other abutting building materials. Contributing factors also include poor air ventilation in the area.

Wood rot is often associated with general damp problems and is evidenced by a 'musty' smell or mould and mildew occurring on surfaces. If left unmanaged, damp conditions can lead to further health problems and the decay of timbers will continue.

Early intervention and regular maintenance, particularly of exterior timbers, will prolong the useful life of these building elements. Prior to any works being performed, the cause of the moisture that has created the visible wood rot should be identified and addressed in a suitable manner. Replacement of affected timbers may then be a necessary step in protecting surrounding building elements from such deterioration.

A qualified plumber may be appointed to assess the cause of excessive moisture and to provide advice on any remedial works as required. A qualified carpenter or registered builder may also be required to replace affected building materials.

Even though Liverpool termite activity was not visible. A further invasive inspection by a licensed termite technician its also highly recommended to eliminate possibility of potential termite activity.

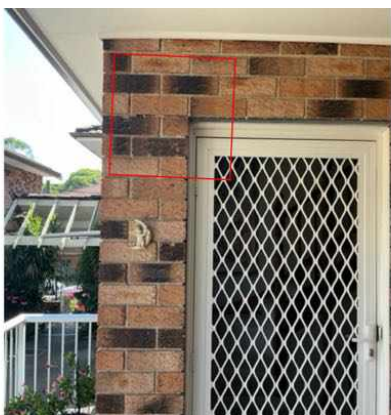
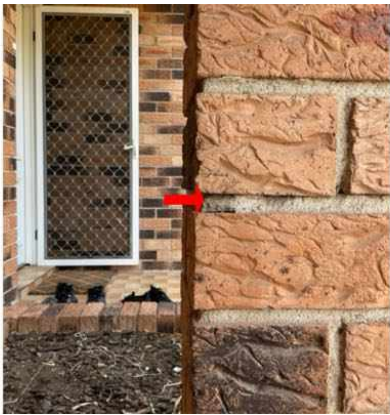
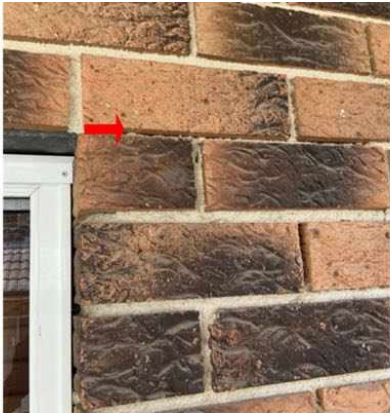
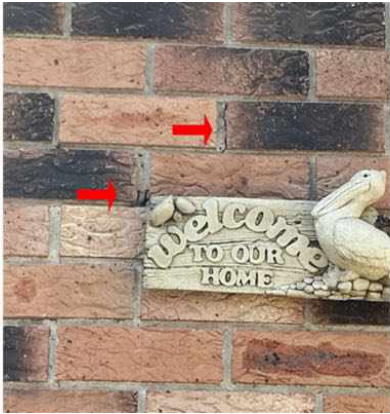
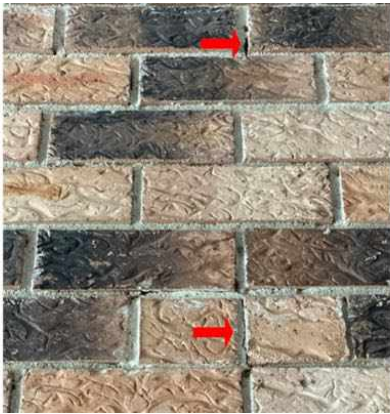
Finding 3.12

Building: Main Building
 Location: All External Areas
 Finding: Brickwork - Deteriorated mortar to some areas
 Information: Mortar, or 'bedding', is the material which fills joins and intersections between bricks in masonry walls and structures. Sections of mortar in this brickwork were identified as having deteriorated, which is generally expected for a property of this age and condition.

Mortar may deteriorate as a result of age of building materials, minor movement of bricks, or frequent exposure to weathering. Mortar should be replaced to ensure that bricks remain in their intended location and to prevent gaps, which would allow water or moisture ingress and secondary damage as a result.

Mortar deterioration can be addressed by a bricklayer where areas of deterioration are localised and easily accessible. Alternatively, appointment of a registered builder is advised, to repoint large areas of decaying mortar. Where secondary structural defects have become evident, consultation with a structural engineer may be required.

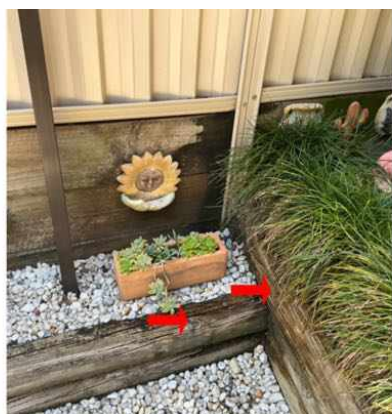
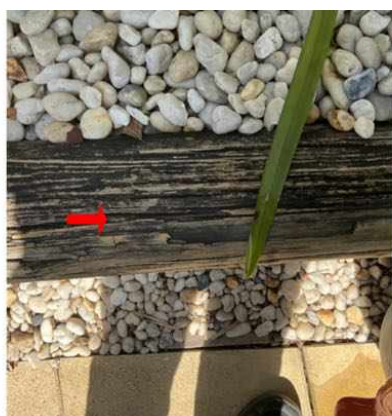
Finding 3.13

Building:	Main Building
Location:	All External Areas - Rear
Finding:	Retaining wall - Defective (Wood rot and splitting timber) to some areas
Information:	The retaining wall in this area was found to be defective at the time of inspection. Generally, defective retaining walls are caused by poor original design or material use. However, deteriorated retaining walls may also be a result of substandard construction, poor site drainage or unmanaged stormwater flows.

If left unmanaged, the retaining wall may become a safety hazard if it continues to destabilise. Where retaining walls further rot and decay, an environment is created that is conducive to termite and pest infestation.

Significant repair and replacement should be expected. Where retaining walls are considered structural walls, a structural engineer / surveyor should be consulted regarding required remedial works. Otherwise, a landscaper or retaining wall installer may be appointed to repair or replace the wall, at the discretion of the client.

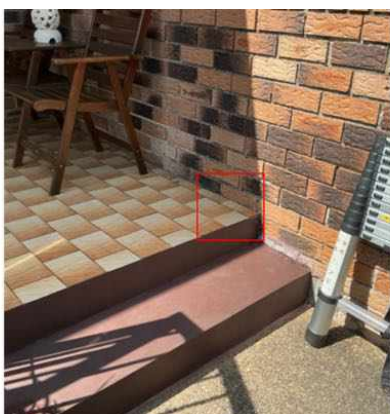
Finding 3.14

Building:	Main Building
Location:	All External Areas - Front
Finding:	Tiles - Cracked or damaged
Information:	Cracking was evident to the tiling in this area at the time of inspection. While the

cracking appears to be minor, this area is frequently exposed to water, allowing potential for water penetration into adjoining sections of walls or flooring.

If left unmanaged, water penetration to these areas may lead to subsequent water damage, which is likely necessitate repair work to affected building elements.

A tiling contractor should be appointed to ensure that no further water damage occurs. The re-application of silicone and grouting throughout remaining tile work is also advised, to further protect the area against water penetration.

Where water penetration has led to water damage, appointment of a relevant tradesperson may be required to repair damaged building elements.

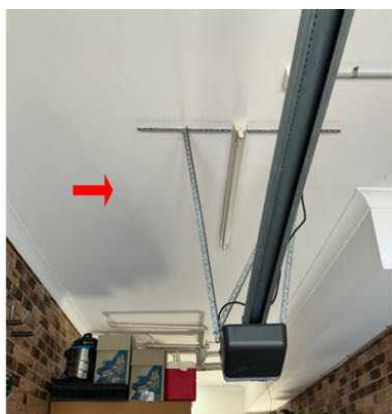
Finding 3.17

Building:	Main Building
Location:	All External Areas
Finding:	Cracking - Damage Category 1 - Fine (up to 1mm)
Information:	Although fine cracks are quite noticeable, they are often only considered to be an appearance defect, and usually do not indicate any structural damage. Generally, the cause of a fine crack is indicative of a separation between building materials and finishes (e.g. paint, plaster, etc.) along joins.

Cracking of this nature can generally be repaired with minor sanding, filling and/or repainting. Such works should be performed by a qualified painter or a general handyman.

Monitoring of all cracking should be conducted frequently. Always contact a building inspector should cracks widen, lengthen, or become more numerous.

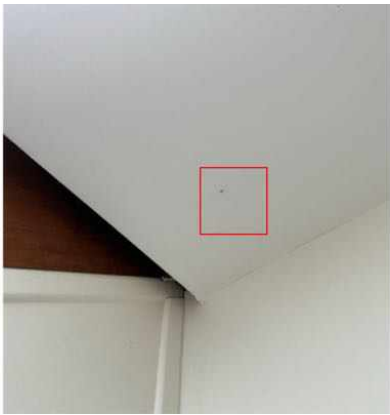
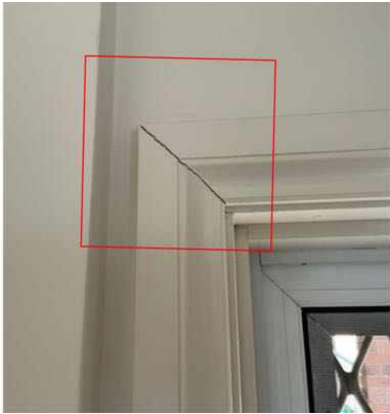
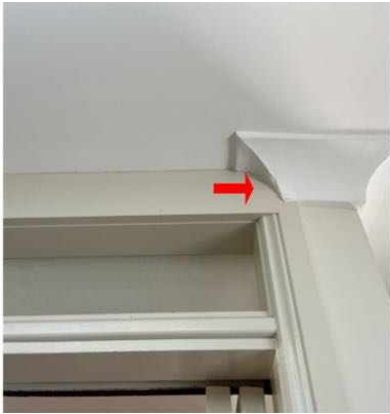
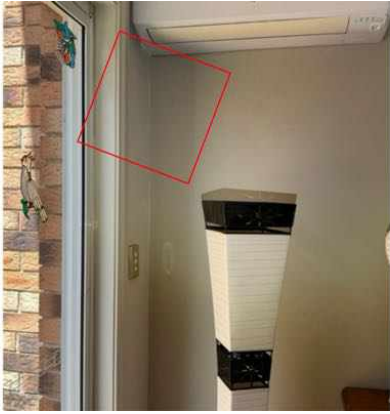
Finding 3.18

Building:	Main Building
Location:	All Internal Areas
Finding:	Paint Finish & Hairline Cracking - To some areas
Information:	The paint finish in this area was identified as being incomplete or substandard at the time of inspection including some hairline minor cracking/separation. Monitoring is recommended where cracking and separation is evident.

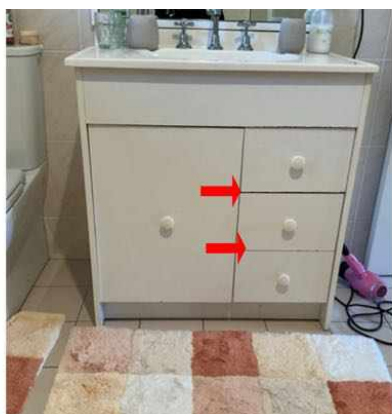
Finding 3.21

Building:	Main Building
Location:	Bathroom
Finding:	Building element - Damaged - vanity moisture damage
Information:	Breakage occurs generally when the building materials have either aged and decayed, or as a result of damage (accidental or deliberate).

A relevant tradesperson should be appointed to repair or replace the affected building element prior to any subsequent damage being caused.

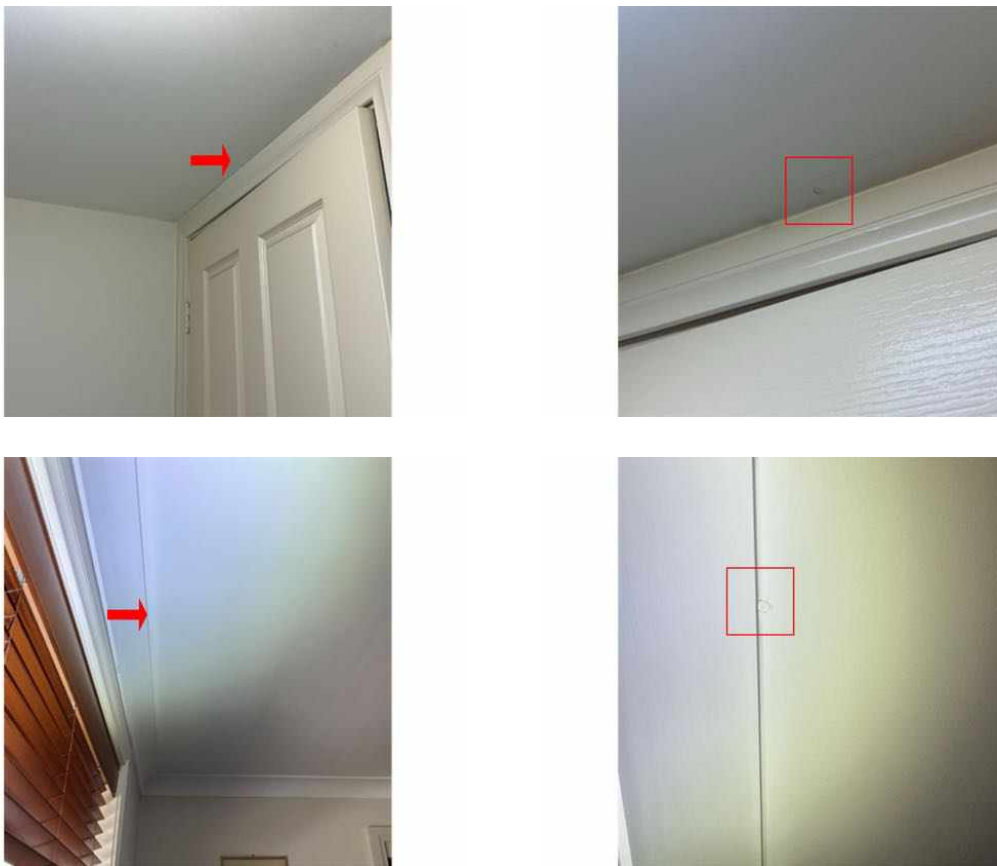
Finding 3.22

Building:	Main Building
Location:	All Internal Areas - toilet, bedroom
Finding:	Ceiling nails - Popping To some areas
Information:	Numerous popped nails were identified in the internal ceiling at the time of inspection. Nails and screws hold simply by the friction between them and the surface they are

Re-fastening of popped nails will help to maintain the stability of the internal ceiling and associated building elements. Such minor works will also help to improve the appearance of the affected area and secure the ceiling sheets, so as to prevent the onset of ceiling sagging. These works should be performed by a qualified carpenter or plasterer at client discretion.

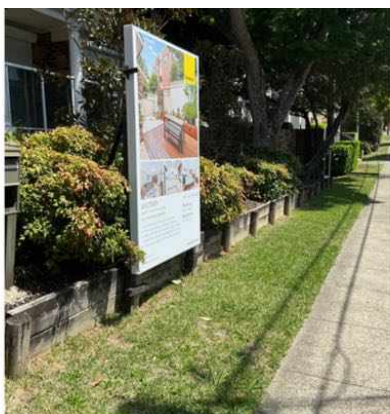
Finding 6.02

Building:	Main Building
Location:	All External Areas
Finding:	Trees within 50m
Information:	Trees within 50m of the property can be conducive to termite activity. It is recommended an invasive inspection of all trees with 50m to the property be carried out by a qualified pest control expert.

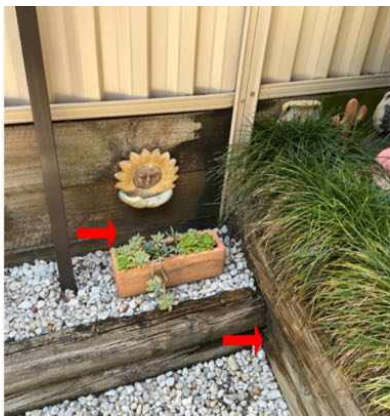
Finding 6.03

Building:	Main Building
Location:	All External Areas
Finding:	In ground contact - Timber - to some areas
Information:	Any timbers in direct ground contact provide opportunity for concealed termite entry and are likely to be subject to premature rot and decay as the soil retains moisture or damp conditions against the timbers.

Remove untreated timber that is in direct contact with external grounds. Consider replacement with more durable materials i.e. treated timber or non timber elements. Frequent pest inspections are advised to readily identify any termite activity in these areas.

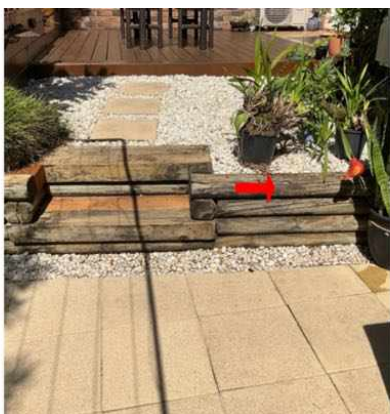
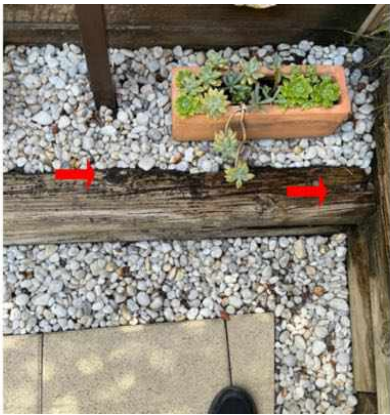
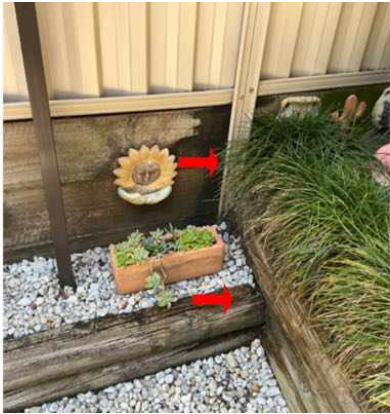
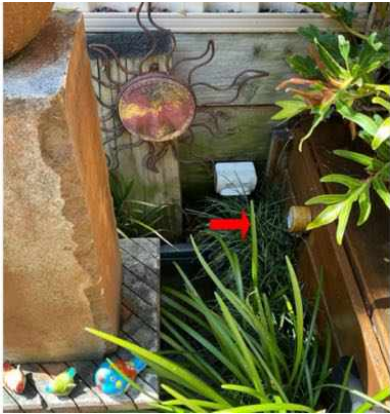
Finding 7.01

In this case although the affected timber element is in a decaying state the extent of any visible damage appears to be localised to a specific area and is yet to spread to other parts of the building element or affect adjoining structures. The fungal decay is therefore likely to be of a relatively superficial nature with minimal impact on the structural integrity or tensile strength of the timber element.
