Building and Timber Pest Inspection Report

Inspection Date: Wed, 18 Feb 2026

Property Address: 7/547 Chapel Rd, Bankstown NSW 2200,
Australia

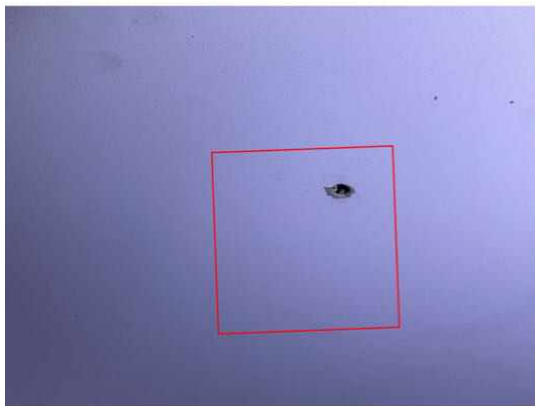
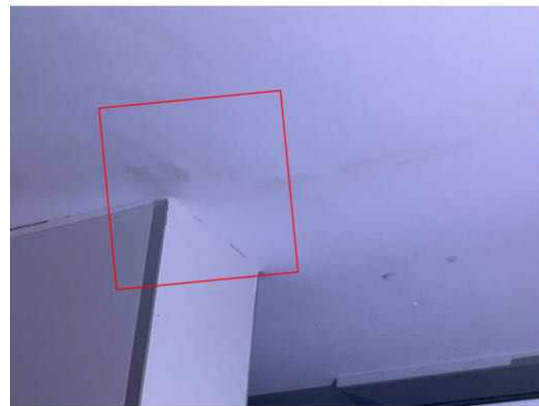
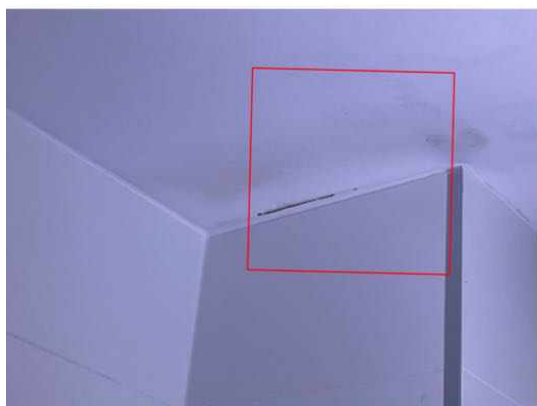
Building: Main Building
Location: Bathroom > Level 1
Finding: Ceiling - Water damaged
Information: Water damage to the ceiling lining is generally an indication of excessive moisture being present in the roof void, usually via a leak to the roof covering.

Where water damage is evident to the ceiling, the primary requirement is to identify and rectify the source of the leak. A roofing plumber should be appointed as soon as possible to identify the leak and perform rectification works as necessary, ensuring the water damage is restricted.

Once the leak is repaired, consultation with relevant tradespeople, including plasterers and painters, is advised. Rectification works may include replacement of ceiling lining or minor repainting, depending on the extent of the damage.

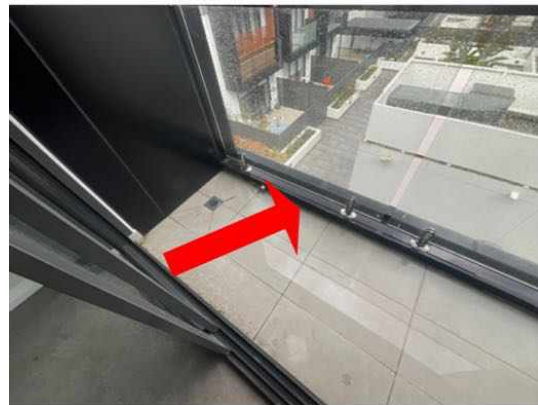
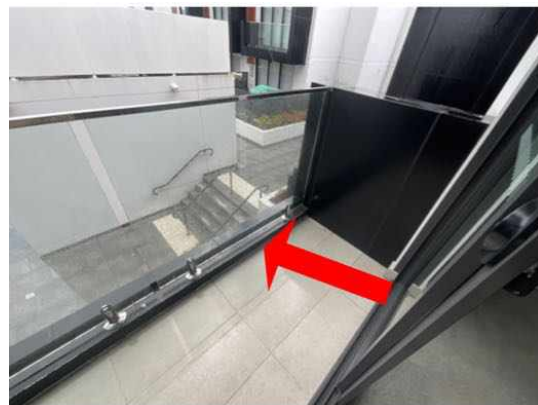
Finding 2.02

Building: Main Building
 Location: Balcony
 Finding: Poor Quality Sealant Application
 Information: Sealant around internal wall and junctions has been applied in a poor and inconsistent manner. The finish is uneven, with gaps, rough edges, and visible defects. The sealant does not provide a neat or durable finish.

- NCC 2022 – Volume Two, Part 2.1.2 (Amenity and Durability): Internal finishes must be installed to ensure adequate performance and durability.
- AS 3740:2021 – Waterproofing of domestic wet areas: Sealant must be applied correctly at junctions in wet areas to ensure waterproofing integrity.
- Guide to Standards and Tolerances 2017 (Section 12.10 – Sealant Finish): Sealant is defective if it is not applied in a neat, consistent manner or if it does not provide a watertight seal.

Recommendation:

The builder is to remove the defective sealant and reapply in a professional and

consistent manner, ensuring compliance with AS 3740 and manufacturer's installation instructions. Sealant must be tooled smooth, continuous, and provide an effective watertight joint.

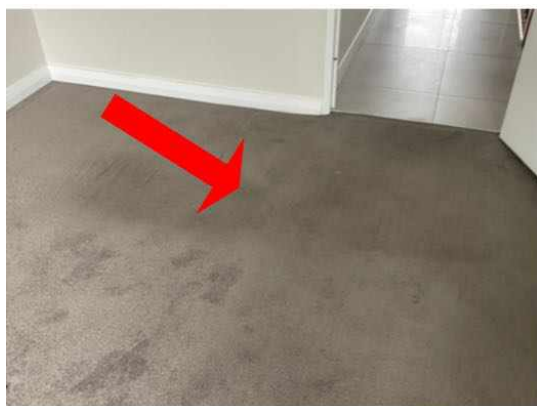
Finding 3.02

Building:	Main Building
Location:	All Internal Areas
Finding:	Carpet - damaged / deteriorated
Information:	Static Damage

Static is created through friction and as a result, the carpet snaps, crackles and pop as you walk across. Due to the dry weather and low humidity, static charges are formed within the carpet thus resulting to static damage. Although new types of carpets have anti-static agents like conductive agents and fine metal wires that protects the carpet.

The color differences between carpet areas caused by every day deterioration through physical contact and resulting random differences in pile lay direction; usually referred as shading.

If two adjacent areas have different identical tension during the manufacturing, unevenness and rippling will develop. Ripples can also be caused by dragging heavy furniture across the carpet which creates friction between the two objects.

Carpets are dyed to achieve the desired color and design. Sunlight exposure can deteriorate the color of your carpet but there are also several factors to consider when it comes to sunlight damage namely location, length of exposure to sunlight and the dye used for the carpet.

Replacement of the affected carpet is required as a matter of urgency to ensure the safety of the area. Where required, remedial works should be undertaken to any associated walls and flooring showing evidence of mould.

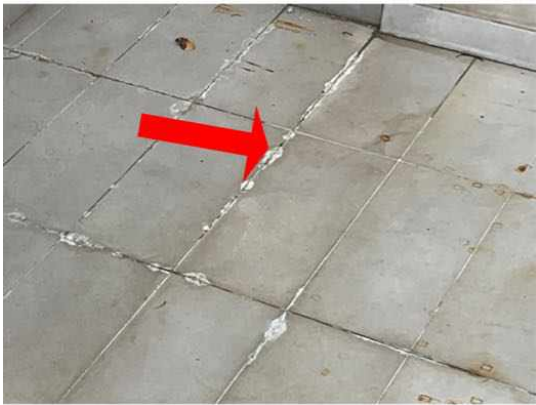
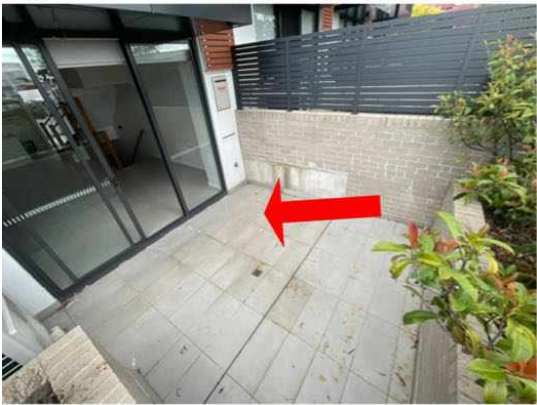
Finding 3.03

Building:	Main Building
Location:	Yard - Back
Finding:	Courtyard– Tiling & Wall (Evidence of Moisture Ingress)
Information:	Evidence of moisture-related deterioration was observed to the courtyard area. Tile adhesive is lifting through grout joints, tiles show signs of debonding, and cracking is visible to the adjoining concrete wall. Water staining and efflorescence were noted to the base of the external brick wall.

The conditions observed are consistent with possible waterproofing failure and/or inadequate drainage to the balcony. Ongoing moisture ingress may result in further deterioration of tiling, substrate damage, and structural cracking over time.

An invasive inspection by a qualified waterproofing specialist is recommended to:

- Lift tiles as required
- Assess condition of waterproof membrane and substrate
- Check falls toward drainage point
- Rectify waterproofing and drainage defects as necessary

Monitoring is recommended to determine whether moisture intrusion is active.

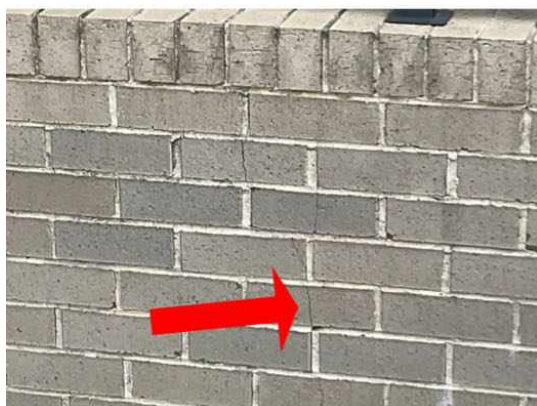
Finding 3.04

Building: Main Building
Location: Yard - Back
Finding: Brickwork / Concrete - damaged
Information: At the time of inspection, damaged bricks / concrete were identified. Significant deterioration is apparent in both the brick and concrete surfaces, with areas showing signs of erosion, crumbling, and loss of material, likely due to environmental exposure or aging or building structure moving.

Evidence of structural instability is present in both the brickwork and concrete, with sections showing signs of leaning, bulging, or displacement, posing safety hazards and requiring immediate attention

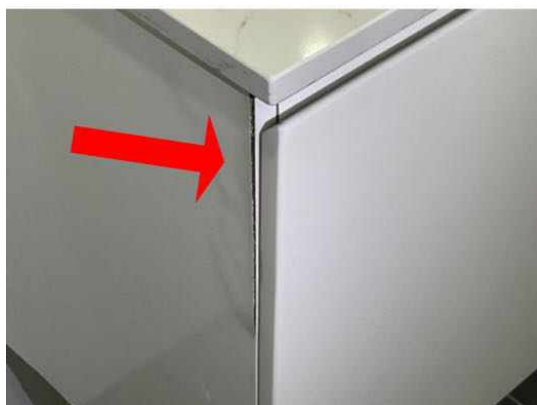
Finding 3.05

Building:	Main Building
Location:	Bathroom
Finding:	Delamination of timbers
Information:	Delamination is one means by which composite materials (e.g. layered timber composites) may fail over time. In laminated materials, repeated cyclic stresses may lead to the formation of mini-structures of separate layers, with significant loss of mechanical toughness. Water penetration or the presence of excessive moisture also generally contributes to delamination.

Where building materials have become delaminated, they lose their structural strength, and are likely to have a variety of appearance and serviceability defects as a result.

Delamination of timbers may be repaired where the area affected is minor and/or easily accessible, by gluing and screwing layers back together. However, this is an interim repair, and where delamination has occurred, the client should plan for the replacement of affected timbers sooner than would otherwise be expected.

All timber structures affected by delamination should be replaced as soon as possible to avoid any further damage. Repair and replacement estimates should be sought from a registered builder or qualified carpenter.

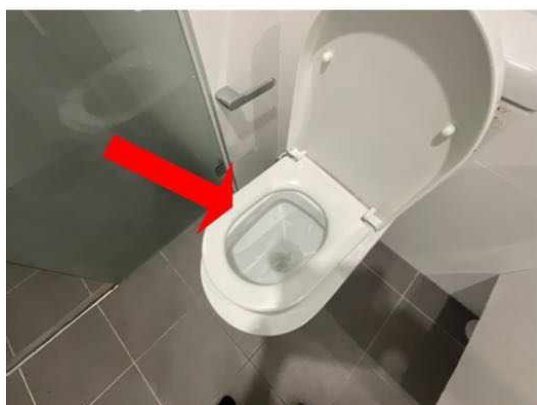
Finding 3.06

Finding: Toilet pan - Loose

Information: The toilet pan was found to be loose and relatively unstable at the time of inspection. It is suspected that this defect has developed due to general aging of the toilet pan and associated materials. However, the loose fixing may also be a result of impact damage.

If left unmanaged, the toilet pan could deteriorate further, leading to greater destabilisation and the potential for water leaks to surrounding building elements.

It is recommended that the pan be refixed to the floor with concrete or silicone by a licensed plumbing contractor.

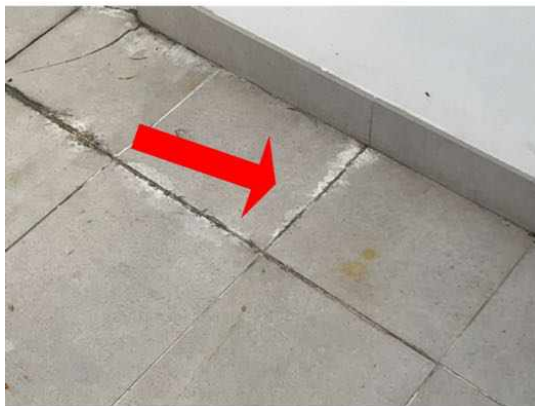
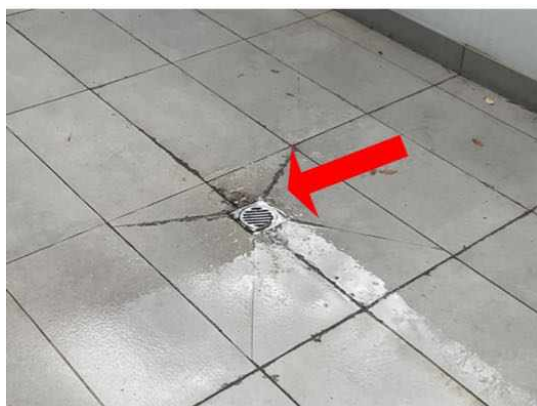
Finding 3.07

Finding: Balcony - Water Ingress and Staining

Information: Water staining, mould/mildew discolouration, and algae growth were observed beneath the balcony slab and along the external edges. This indicates ongoing water

Prolonged moisture ingress in such areas can lead to:

- Concrete degradation or spalling
- Structural weakening of the balcony slab
- Internal water ingress
- Mould growth, posing health risks

It is strongly recommended that:

- A qualified waterproofing or remedial specialist be engaged to assess the integrity of the balcony above.
- The balcony be tested for waterproof membrane failure or inadequate falls to drainage.
- Repairs or re-waterproofing be carried out as needed.
- Damaged or stained soffit areas be cleaned, treated, and sealed after cause rectification.

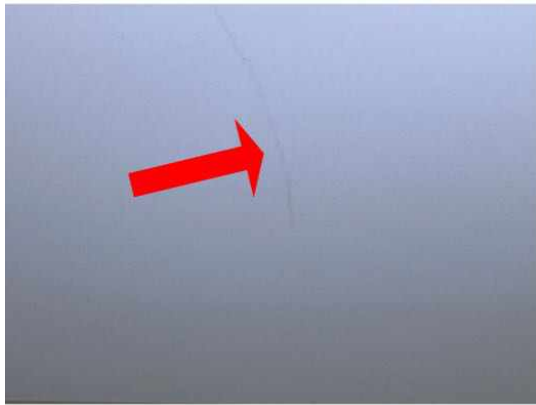
Finding 3.08

Building:	Main Building
Location:	All Internal Areas
Finding:	Paint finish - Substandard, Wear and Tear
Information:	The paint finish in this area was found to have been completed to a substandard level or wear and tear as the normal deterioration of a property from ordinary, everyday use. Exposure to the elements, time, as well as day to day living can cause fair wear and tear.

If this applies, further areas of poor and incomplete finishes could develop over time. Furthermore, substandard, wear and tear paint finishes in areas exposed to moisture, e.g. external areas or wet areas, could lead to deterioration of underlying building materials.

Substandard, wear and tear paint finishes should be sanded back, filled, leveled and repainted, as applicable. Where inadequate paint protection has led to the deterioration of the associated building element, repair and/or replacement of this building element may be required.

A painting contractor should be appointed as soon as possible to perform necessary works to aid the appearance of the affected area and to ensure that the area is protected against further deterioration. Alternatively, the homeowner following manufacturer instructions may be able to provide this service.

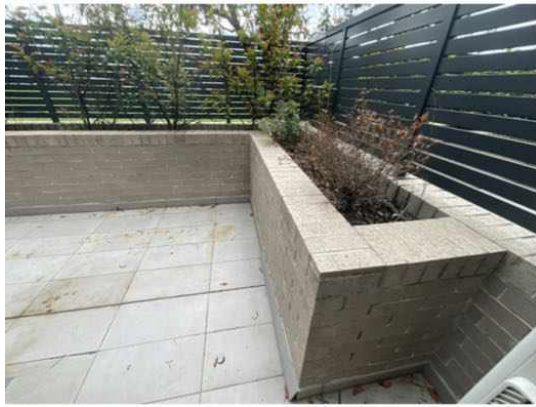
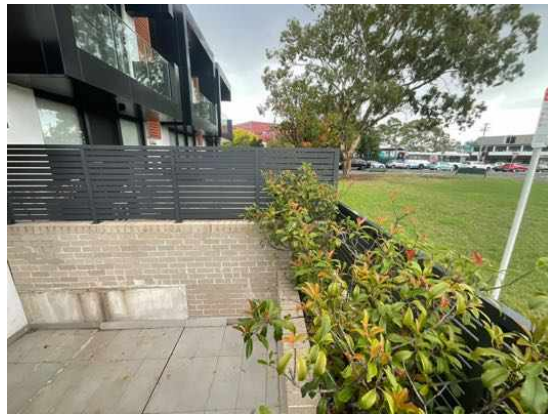
Finding 6.01

Building:	Main Building
Location:	All Areas
Finding:	Garden Beds - Conditions Conducive to Termites
Information:	Garden beds were found to be evident in the garden area. These garden beds can include untreated timber, and with a combination of moisture from watering hosing can make conditions conducive to termite activity and termite ingress.

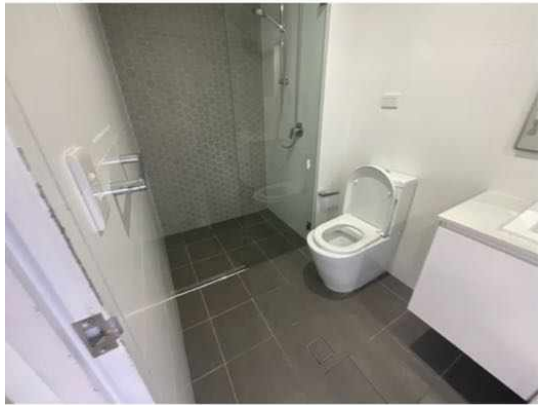
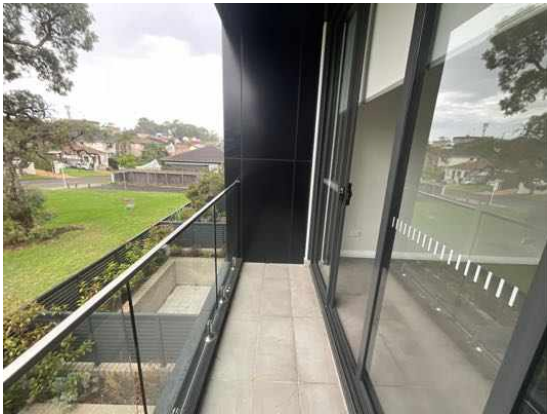
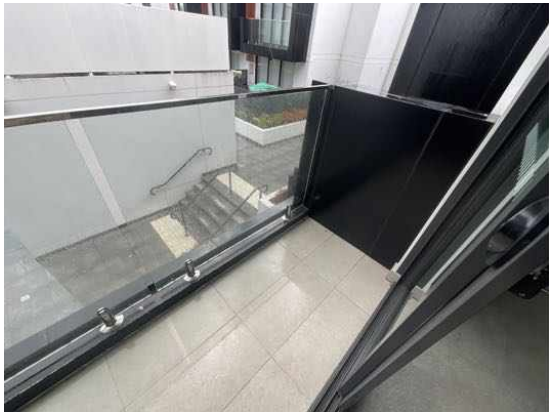
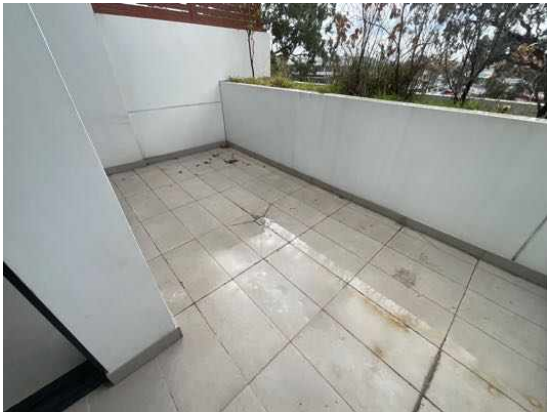
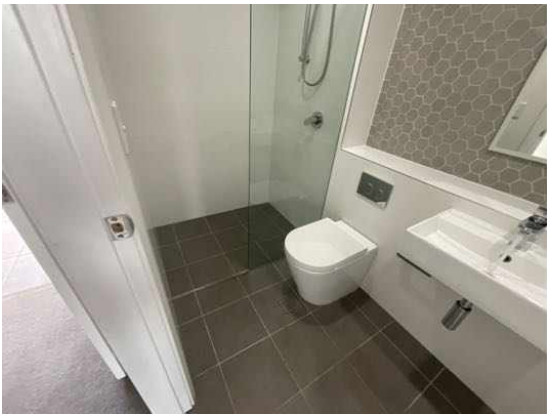
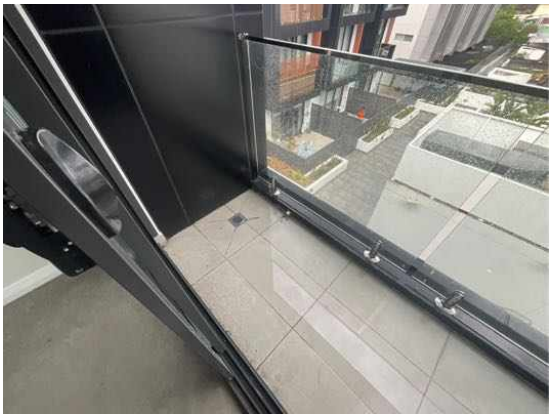
Building: Main Building
Location: All Areas
Finding: Water Proofing Membranes - Information Only
Information: Internal Water Proofing Membranes, are crucial in preventing water ingress into the property is important to know that the Membrane System used is to Australian Standards and has been installed correctly. Please refer to the original Building Documents or Maintenance Schedule for the relevant information including; - Membrane used and Manufacturers Specifications. - The Installer and Installation Certification. Especially with older property's where this information is unavailable, all wet areas should be monitored. Generally new waterproofing with a certificate may only have a guarantee of 8yrs. If any leaks, water staining, peeling or bubbling of the paint become evident to any adjacent walls or ceilings below a licensed builder or waterproofing specialist is recommended to investigate further.
