# Building and Timber Pest Inspection Report

Inspection Date: Thu, 6 Nov 2025

Property Address: 29 Cambridge Ave, Vaucluse NSW 2030, Australia

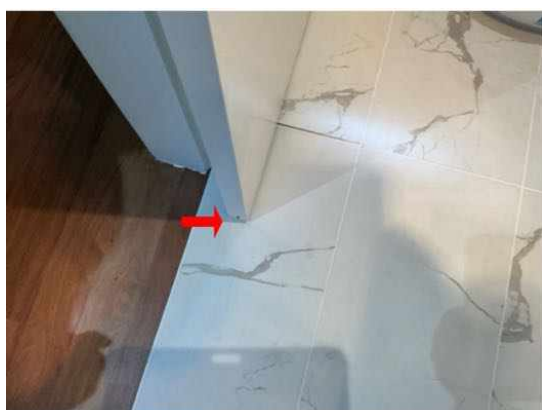
| Finding: | Loose Sliding Door Due to Missing Bottom Fixing Bracket |
| Information: | During the inspection, it was noted that the sliding door is missing a bottom fixing bracket, which causes the door to wobble when operated. It is recommended to have a door or window technician install or replace the missing fixing bracket to ensure smooth and stable operation. |

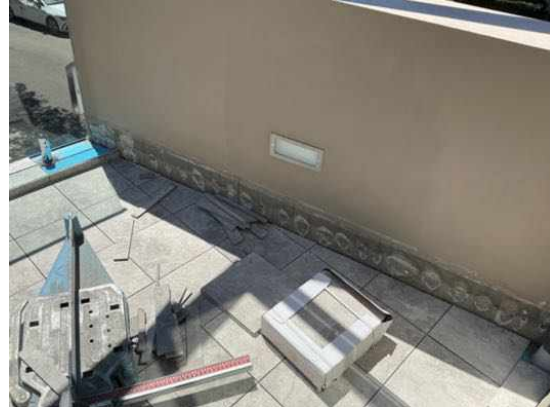
#### Finding 3.02

Works that have not been completed to a satisfactory level create potential for the development of building defects and may impede on the safety and integrity of the overall structure.

It is highly recommended that the relevant trades be appointed to complete these works and ensure the safety of the area and the longevity of all associated building elements.

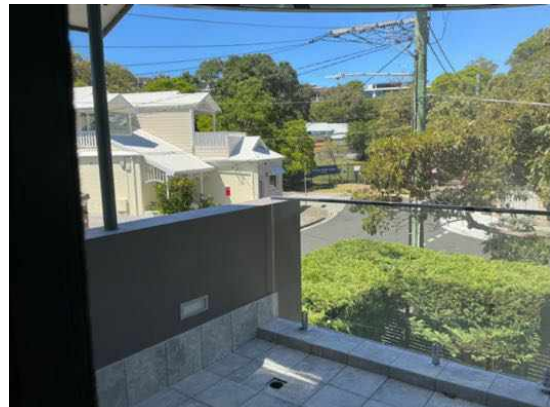
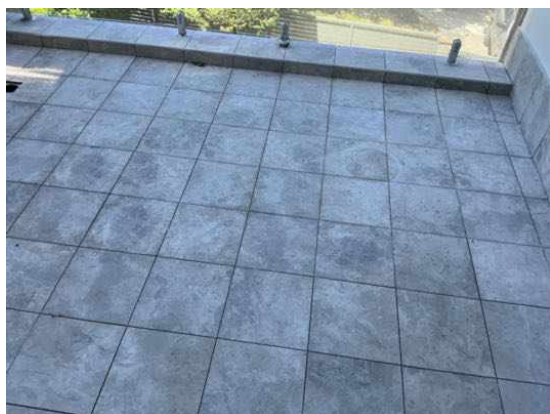
### Finding 3.03

| Finding: | Grout - Missing |
| Information: | Grout is missing in this area. Grout is used to protect gaps and crevices in building materials to ensure that they are water-tight and prevent water penetration to the associated structures. |

Where grout is missing, a tiling contractor should be appointed immediately to apply grout and re-apply any silicone where necessary. Failure to do so is likely to lead to water damage to the surrounding area.

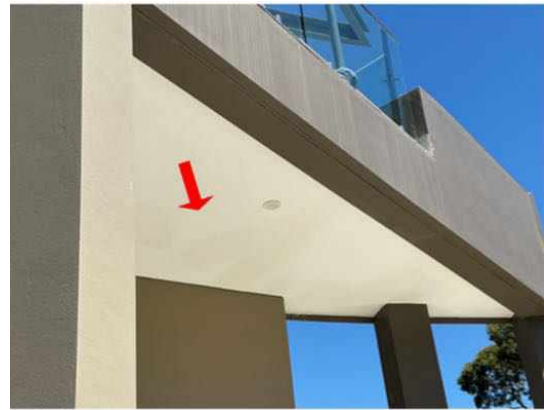
Building: Main Building  
Location: Entry  
Finding: Paint finish - Substandard  
Information: The paint finish in this area was found to have been completed to a substandard level. Substandard painting is generally classified as an appearance defect. However, the substandard appearance may also be indicative of poor surface preparation and substandard workmanship.

If this applies, further areas of poor and incomplete finishes could develop over time. Furthermore, substandard paint finishes in areas exposed to moisture, e.g. external

areas or wet areas, could lead to deterioration of underlying building materials.

Substandard paint finishes should be sanded back, filled, leveled and repainted, as applicable. Where inadequate paint protection has led to the deterioration of the associated building element, repair and/or replacement of this building element may be required.

A painting contractor should be appointed as soon as possible to perform necessary works to aid the appearance of the affected area and to ensure that the area is protected against further deterioration. Alternatively, the homeowner following manufacturer instructions may be able to provide this service.

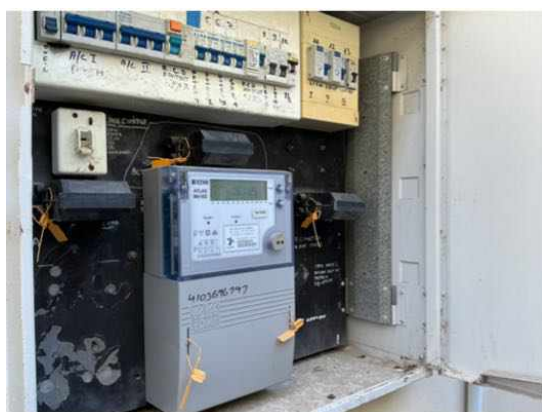
Location: Meter Box  
 Finding: Termite Management System - no evidence of a chemical installation  
 Information: The application of a post-construction chemical termite barrier is highly recommended for all properties, particularly if live termite activity has been found on the site previously. Such barriers are highly effective in preventing termite attack on any timber building elements throughout the property.

A durable notice should be placed in the switchboard unit to indicate current termite barriers. At the time of inspection, it appeared as though no termite management system has been installed, with no evidence to suggest preventative works taking place.

The client may consider gaining further advice from a pest controller as to the costs and procedures involved with this application. It is recommended that obtaining such advice be a short-term priority.

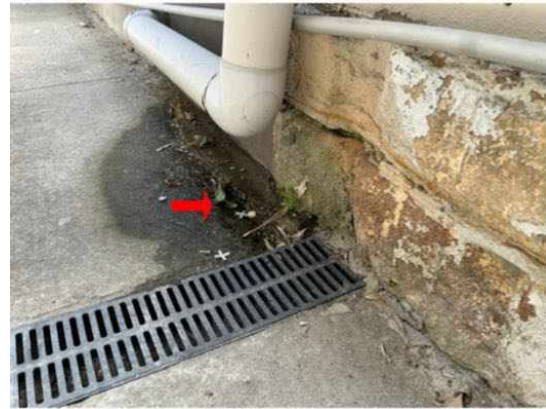
## Finding 6.02

Building: Main Building  
 Location: Exterior walls - left side  
 Finding: Excessive moisture - identified  
 Information: Excessive moisture can attract termites and produce conditions that promote fungal growth and wood decay.

Excessive moisture is generally caused by deteriorated, inadequate or missing roof drainage, leaking plumbing pipes or fixtures, poorly plumbed HWS overflows or condenser units and poor site drainage.

Prior to any remedial works being performed a qualified plumber should be appointed to further inspect the property and to identify the cause of the excessive moisture. Works to remove affected building elements may then be necessary and should be

performed by an appropriate tradesperson.

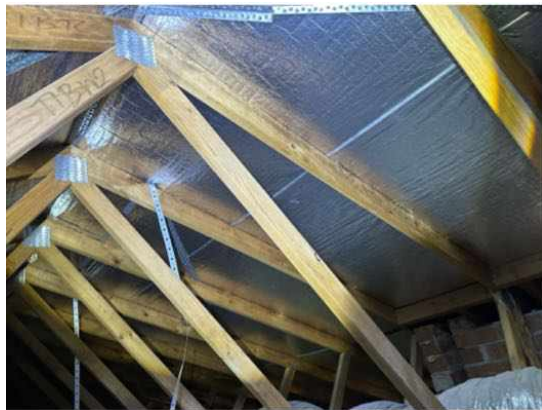
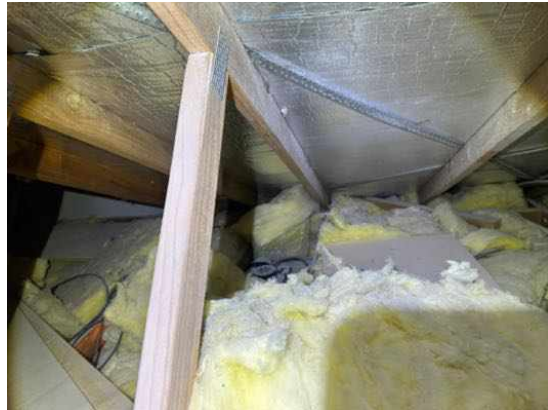
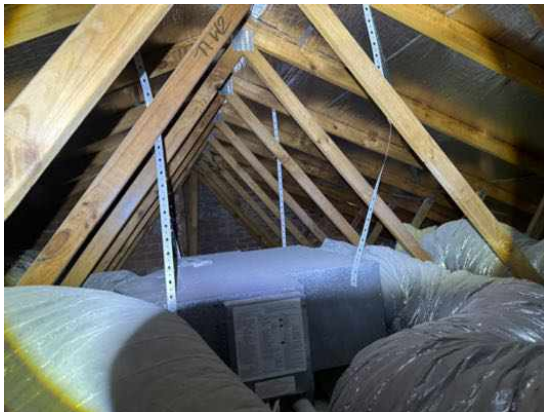
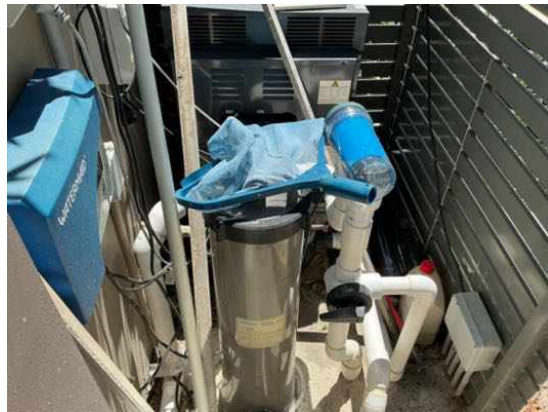
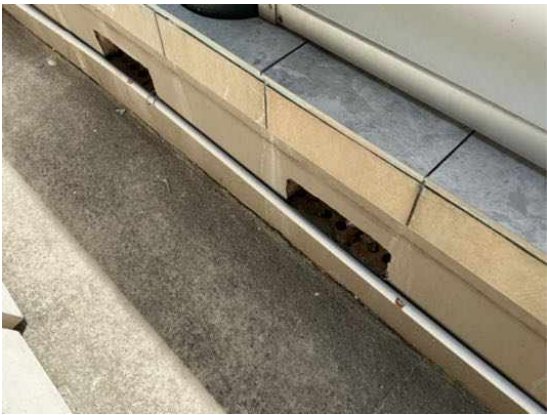
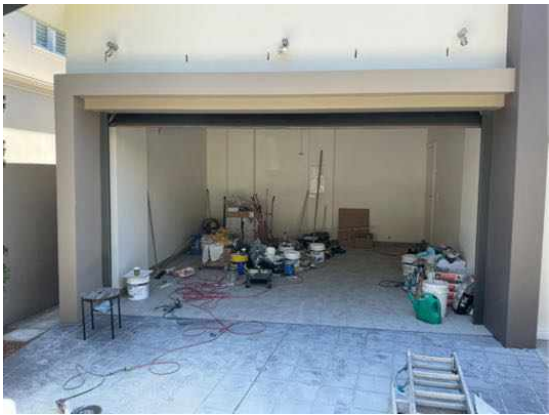
Finding: Additional Photos - Obstructions and Limitations

Information: These photographs are an indication of the obstructions and limitations which impeded full inspection of the property at the time of inspection. These obstructions can hide an array of defects and should be removed to allow full inspection to be carried out. A re-inspection is recommended once the areas are made accessible.
