# Building and Timber Pest Inspection Report

Inspection Date: Tue, 27 Jan 2026

Property Address: 7 Capstone Terrace, Glenmore Park NSW  
2745

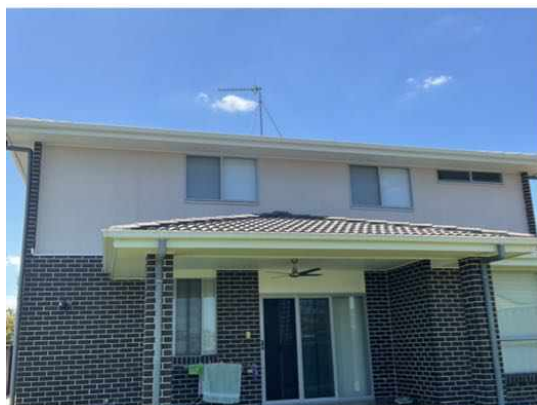
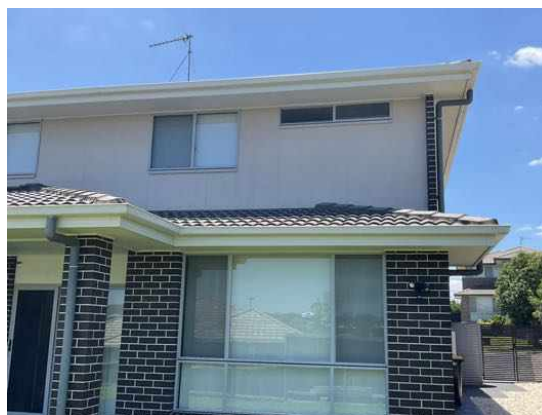
Building: Main Building  
 Location: Roof Exterior  
 Finding: Roof Tiles – External Inspection.  
 Information: Condition Overview:

Upon inspection of the exterior roofing, the majority of roof tiles were found to be in good condition. The mortar to the capping tiles appeared sound, with no significant signs of deterioration. General weathering of the roof tiles is consistent with the age and type of the property and does not raise immediate concern.

The second-storey roof and other areas not safely accessible from a 3.6m ladder were excluded from this inspection due to access limitations. These areas could not be assessed in detail, and it is therefore recommended that a qualified roofing specialist be engaged to inspect these sections and confirm the overall condition of the roofing system.

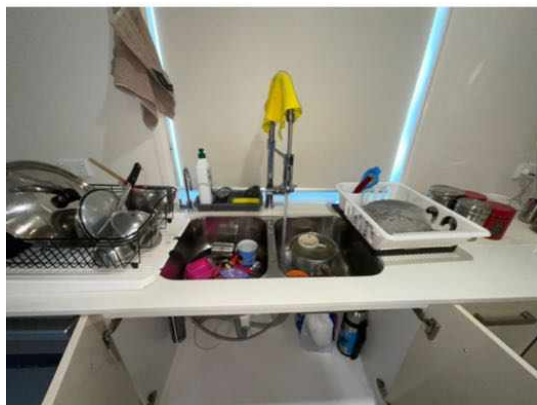
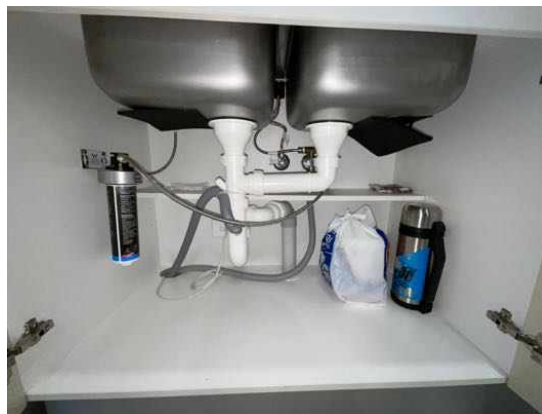
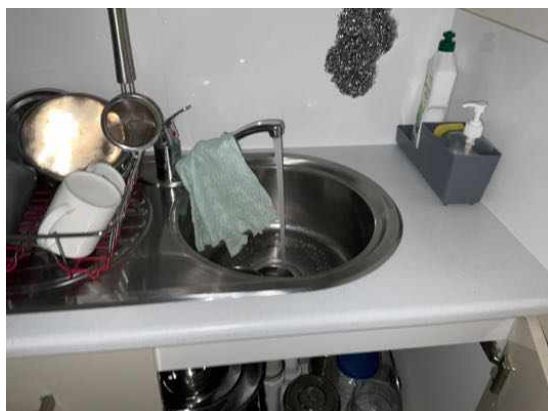
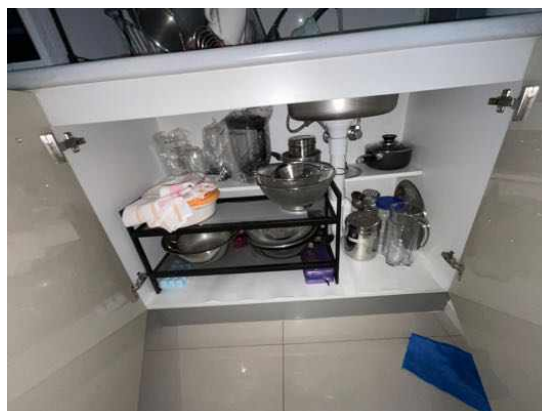
Building: Main Building  
 Location: Kitchen  
 Finding: Kitchen Sink – Overall Condition & Recommendations.  
 Information: Observations:

- The kitchen sink tap(s) were water tested at the time of inspection, with no evidence of leaks or blockages observed in the visible plumbing or drainage.
- No significant water damage was observed to the cabinetry/unit.
- Stored items under the sink obstructed access, limiting a full inspection of the plumbing and internal cabinetry.

- Further monitoring and testing are recommended once the tap(s) are in constant use, to identify any drainage issues or signs of slow leaks not evident during the limited inspection.
- For long-term property care, it is advised that sealant and grouting in water-exposed areas be regularly inspected and maintained.
- It is recommended that the stored items beneath the sink be removed to allow for a full re-inspection of the plumbing and cabinetry, ensuring no concealed defects are present.

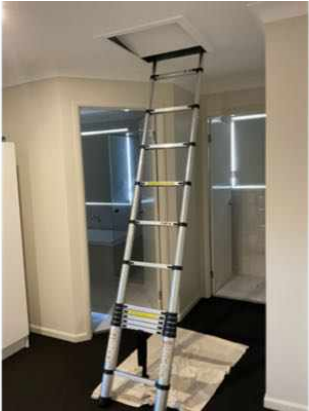
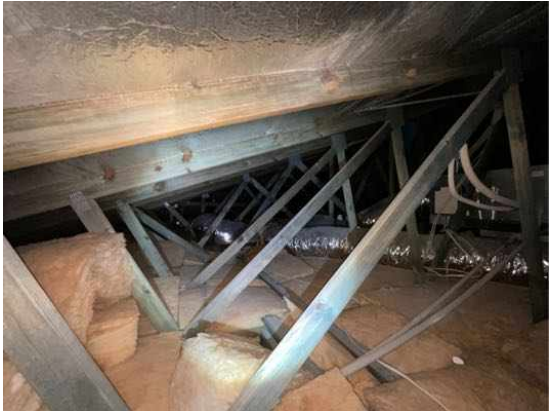
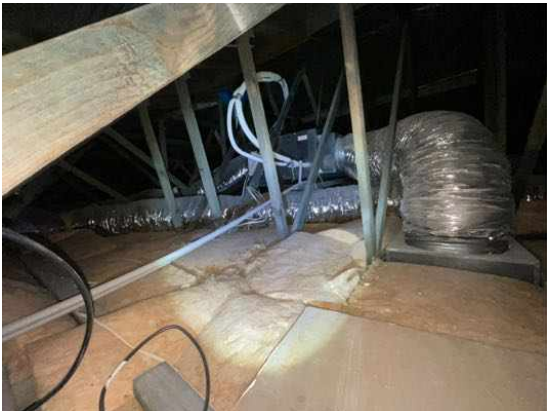
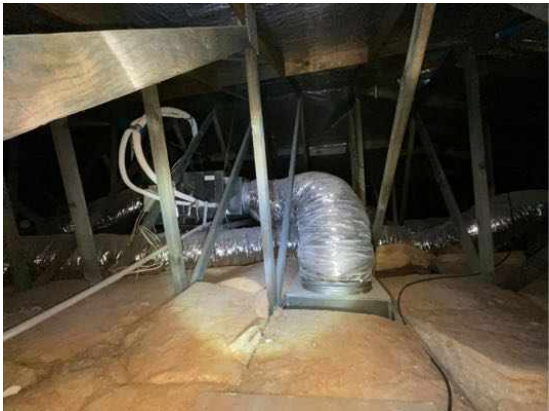
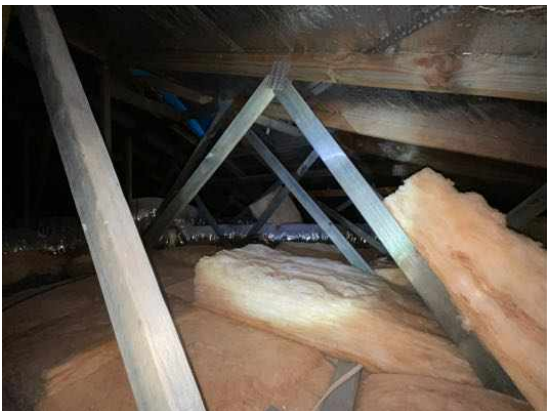
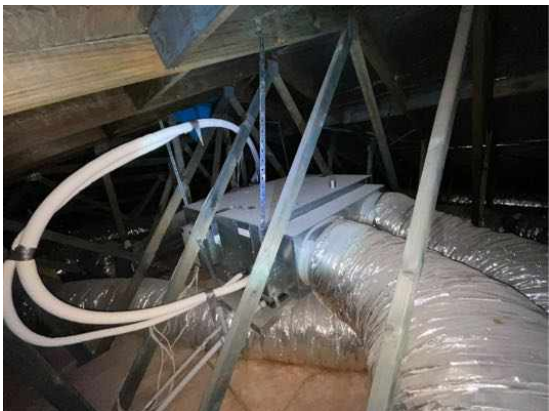
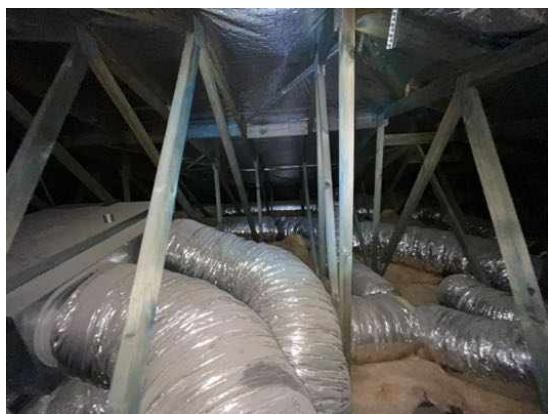
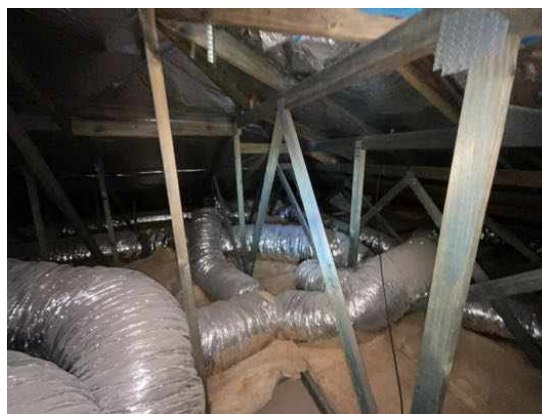
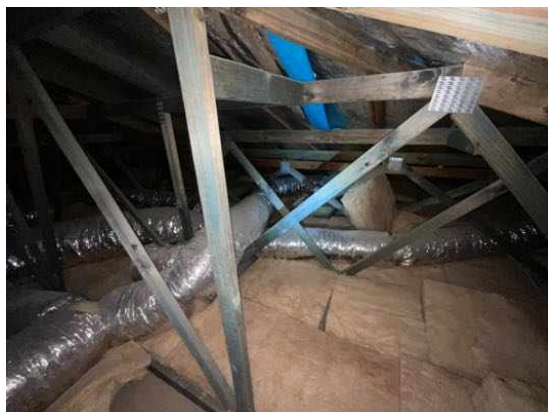
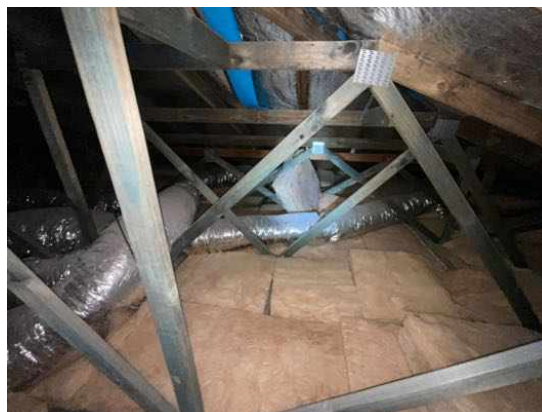
Building: Main Building  
 Location: Roof Void  
 Finding: Roof Void – Limited Accessibility..  
 Information: Observation:

insulation and restricted access points—are removed, and full, safe access is provided. Termite activity or timber pest damage may go undetected in concealed or inaccessible areas.

Installation of an additional manhole is recommended to facilitate a re-inspection and enable a more thorough assessment of the roof void in the future. This will help ensure that all structural elements and concealed areas are properly evaluated.

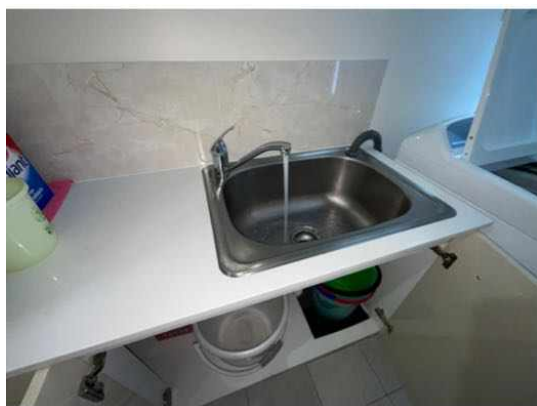
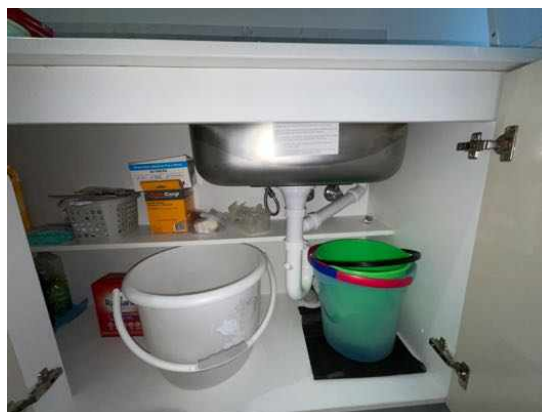
Building: Main Building  
 Location: Laundry  
 Finding: Laundry - Taps/Plumbing/Drainage.  
 Information: Observation: Laundry Tub – Taps, Plumbing, and Cabinetry

- The taps to the laundry tub were water tested and inspected, with no evidence of plumbing or drainage leaks observed at the time of inspection.
- No visible signs of water damage, rust, or corrosion were noted to the cabinetry or surrounding unit during the inspection.

- Further monitoring or testing is recommended once the taps are placed into regular use, to ensure no leaks develop over time and that the drainage system continues to perform adequately.
- Sealant and grouting in wet areas should be maintained as part of the long-term care and upkeep of the property.

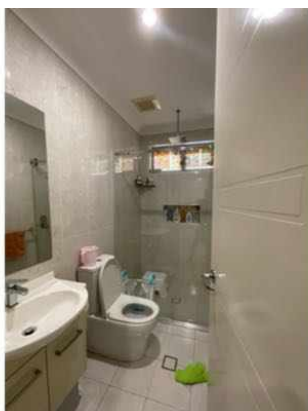
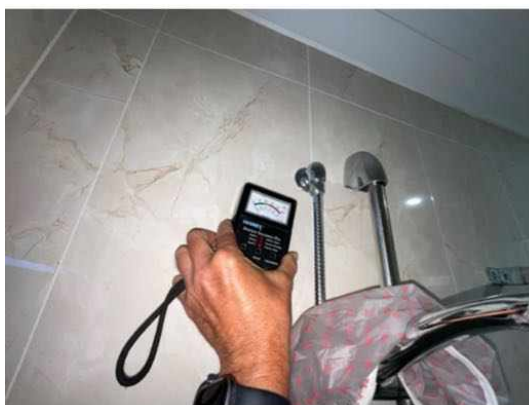
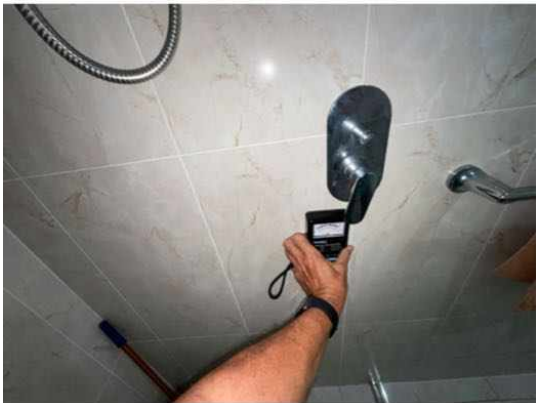
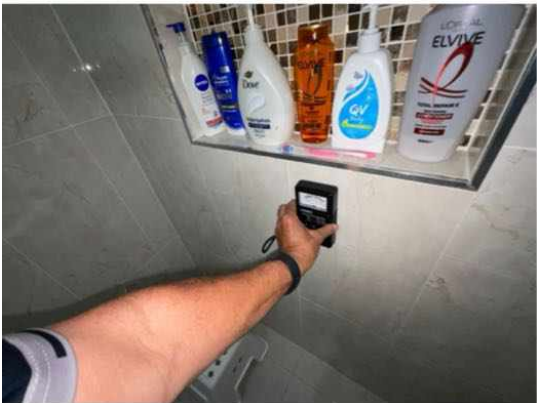
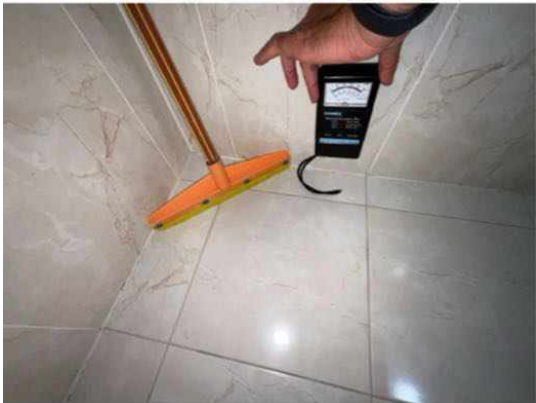
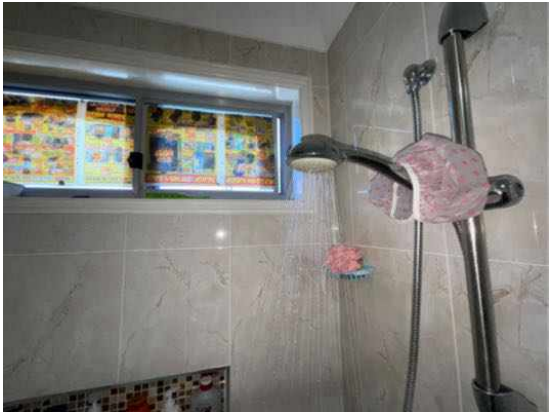
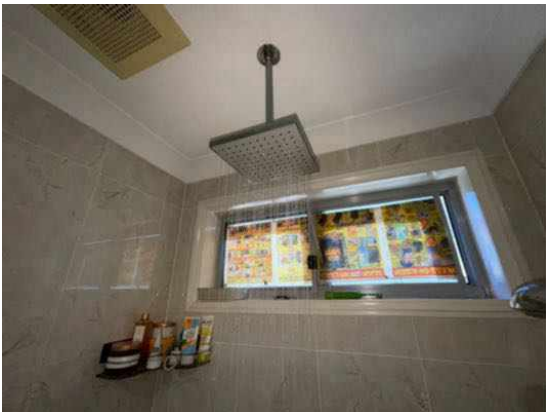
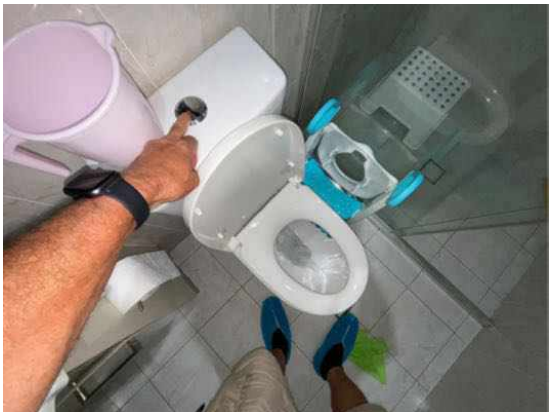
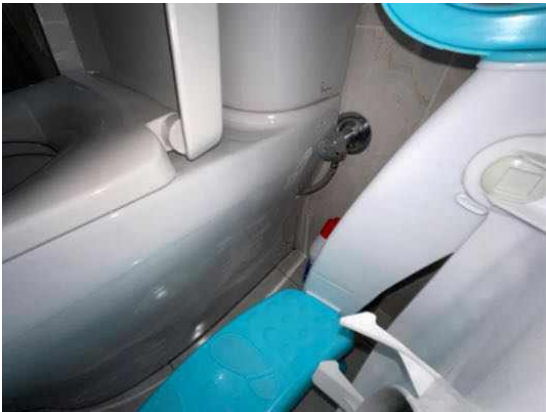
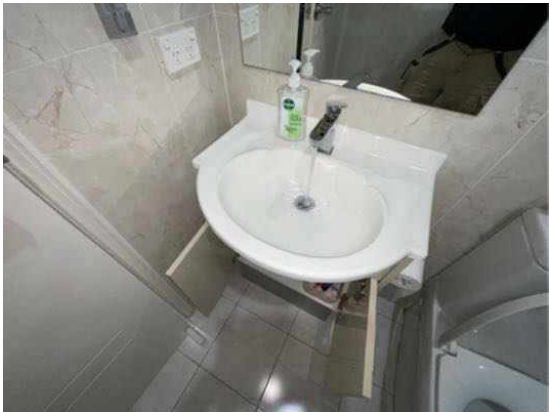
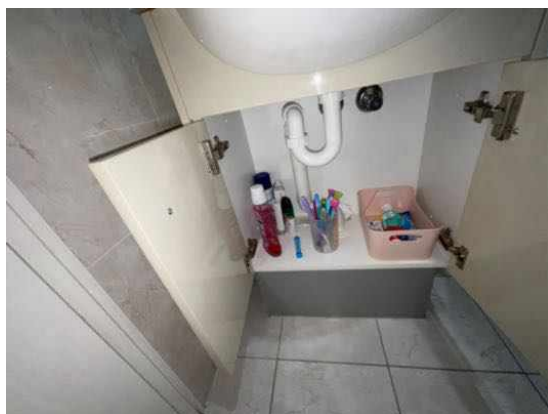
Building: Main Building  
 Location: Bathroom > Ground Level  
 Finding: Wet Areas - Bathroom(s) - Overall Condition & Recommendations.  
 Information: Overall Condition & Recommendations

- Floor waste was found to be clear and free of blockages at the time of inspection. Further monitoring is advised after consistent use to identify any drainage issues or buildup requiring cleaning.

- No elevated moisture readings were detected around the tap fittings or behind the shower walls (as viewed from adjacent rooms), suggesting no active plumbing leaks at the time of inspection.

- Sealing of grout and tiles is recommended to prevent moisture buildup and mould growth in damp areas such as showers.
- The condition of grout and sealant appeared to be good.

- Flood testing of the shower recess is recommended. This may reveal inadequacies in the waterproofing or shower screens, which could lead to water damage in surrounding areas.

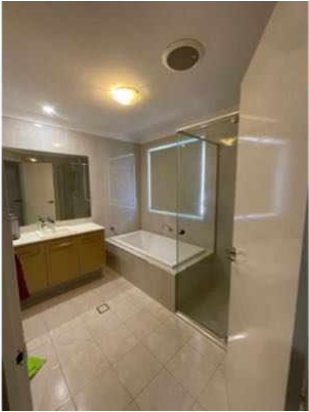
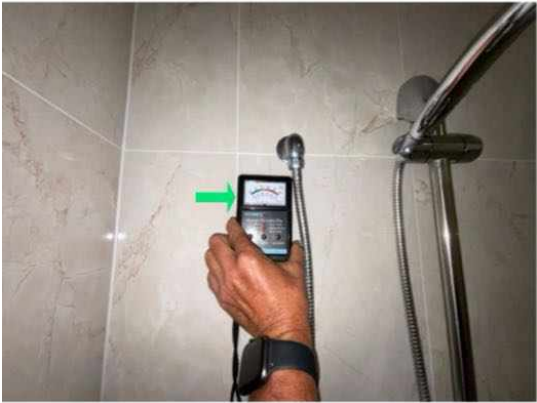
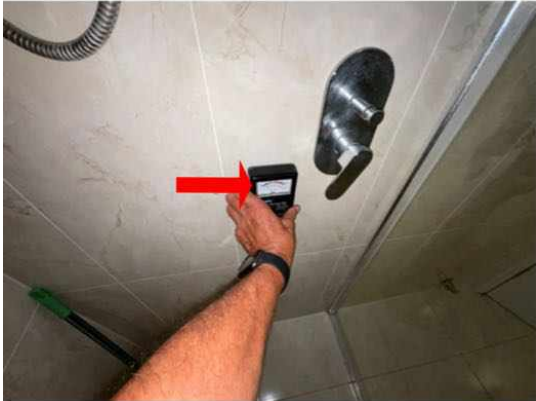
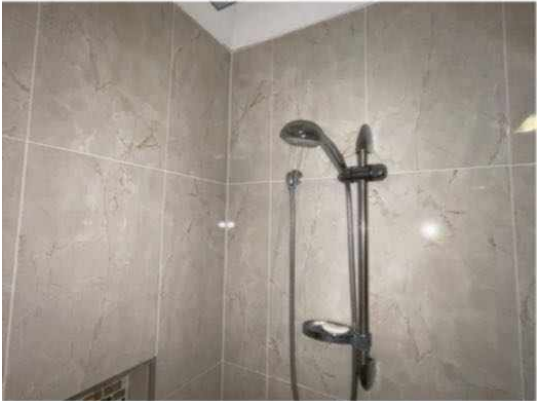
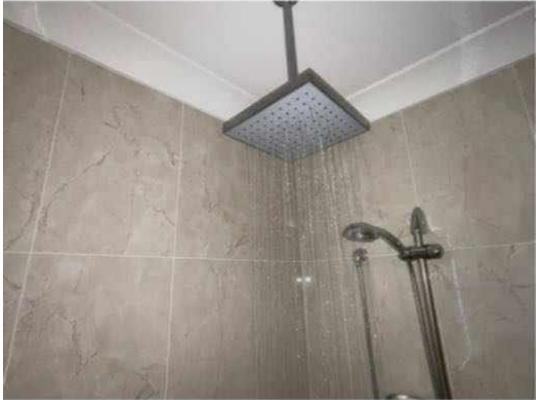
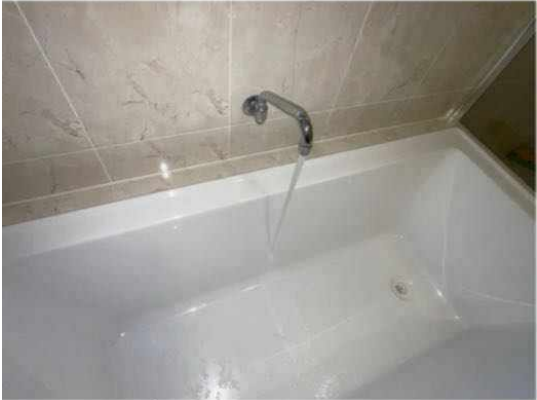
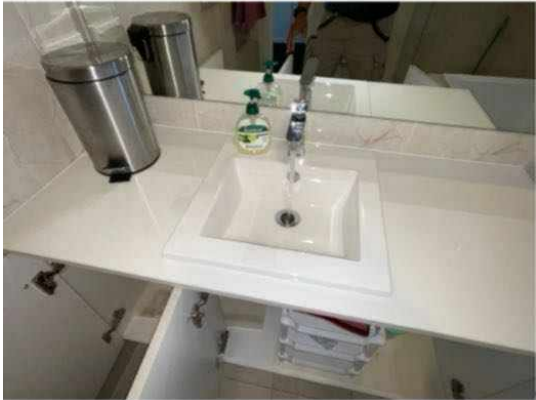
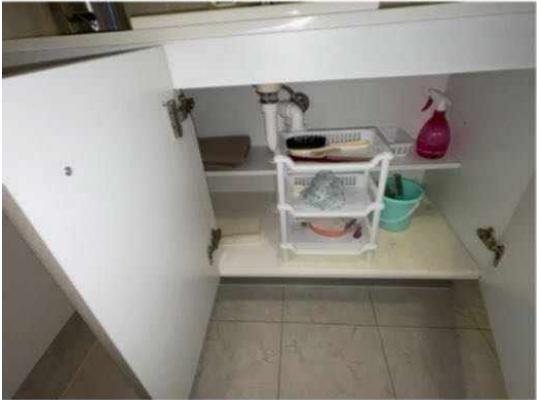
Building: Main Building  
 Location: Bathroom > Upstairs  
 Finding: Wet Areas - Bathroom(s) - Overall Condition & Recommendations.  
 Information: Overall Condition & Recommendations

- Minor elevated moisture readings were detected below the tap fittings, no elevated moisture readings were found behind the shower walls (as viewed from adjacent rooms), suggesting no active plumbing leaks at the time of inspection. Recommend sealing around tap fixtures and monitoring the tap fitting for any leaks that may become apparent.

- Elevated moisture readings were found in the lower shower walls, which is a common occurrence with certain tile types that naturally absorb more moisture. This should be monitored over time and issues arise contact a plumber.

- The condition of grout and sealant appeared to be good.
- There is a window which supports moisture control in the bathroom.

- Flood testing of the shower recess is recommended. This may reveal inadequacies in the waterproofing or shower screens, which could lead to water damage in surrounding areas.

- Sealing of grout and tiles is recommended to prevent moisture buildup and mould growth in damp areas such as showers.

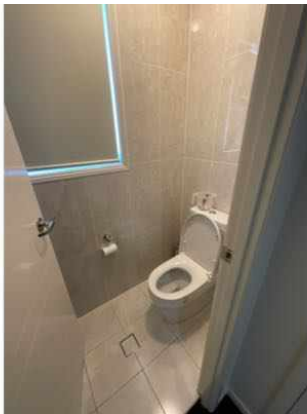
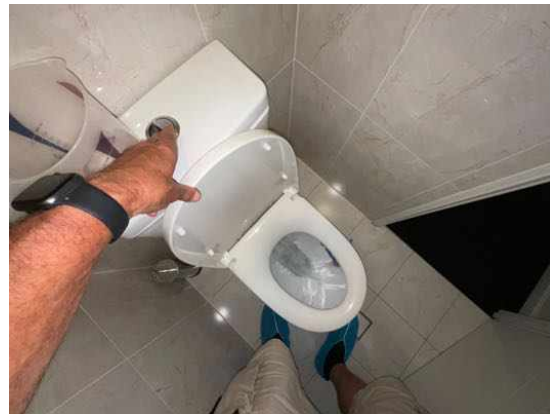
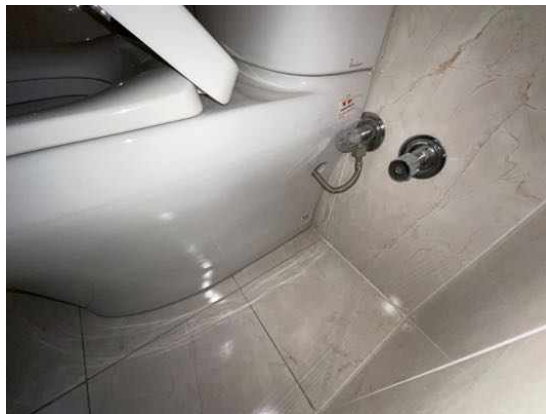
Building: Main Building  
Location: Toilet (WC)  
Finding: Overall Condition: Toilet.  
Information: TOILET ASSESSMENT

- No leaks were observed during the flushing process.
- The toilet operated normally with no signs of malfunction or abnormal water flow.
- The toilet pan was securely fixed to the floor at the time of inspection.

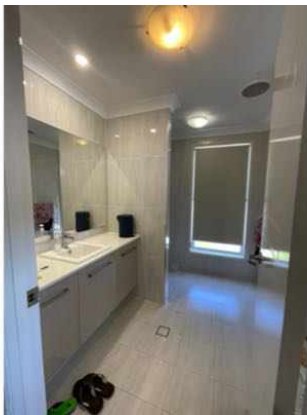
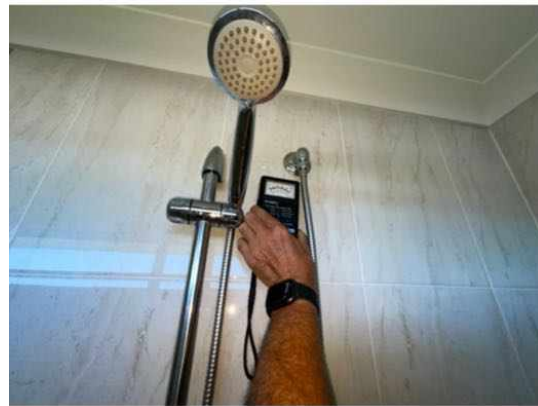
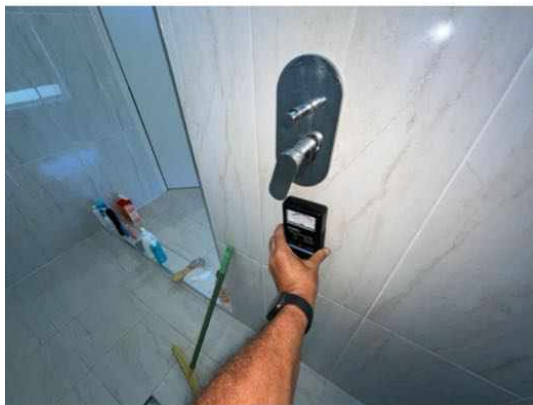
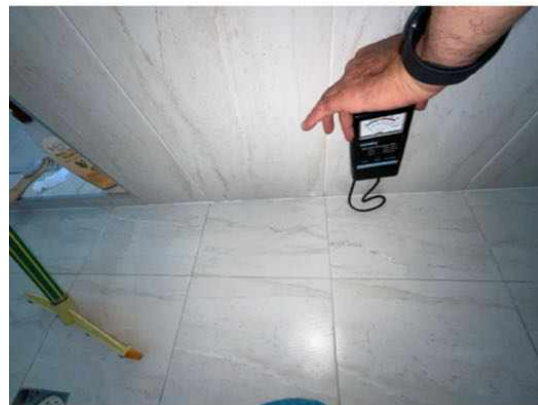
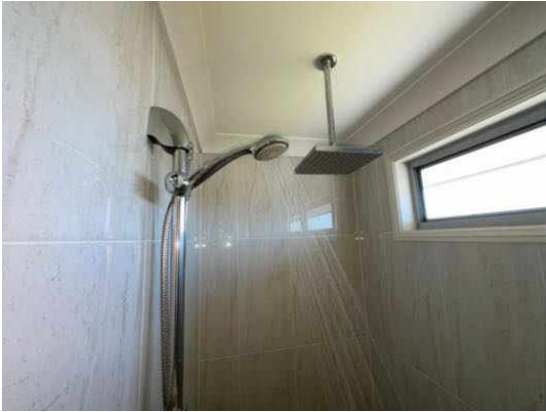
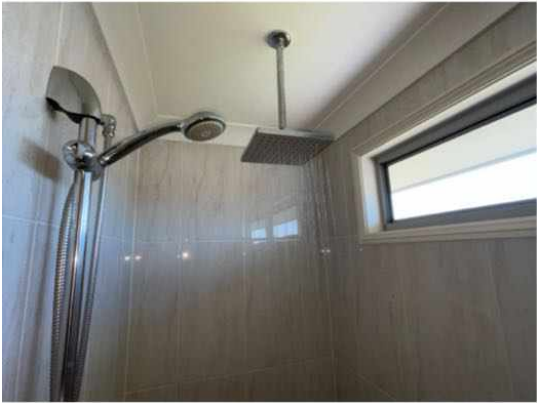
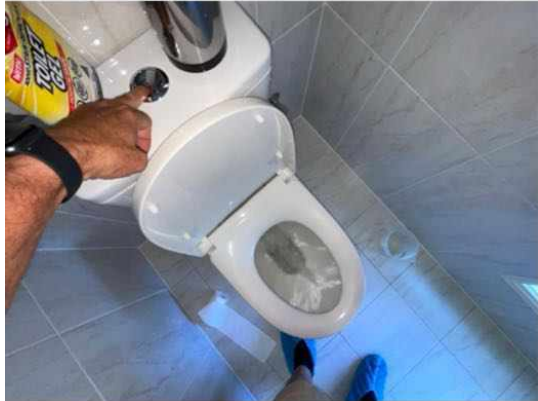
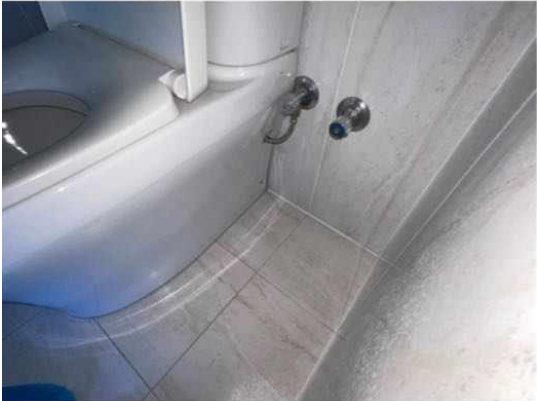
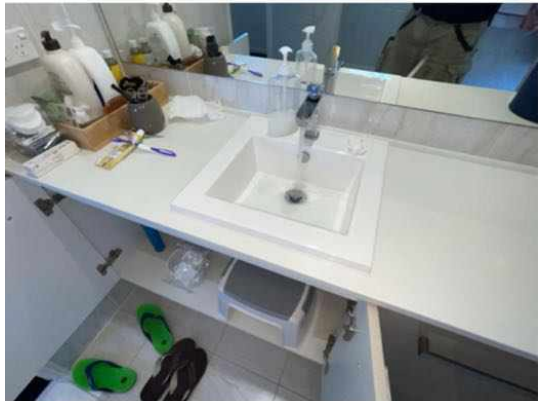
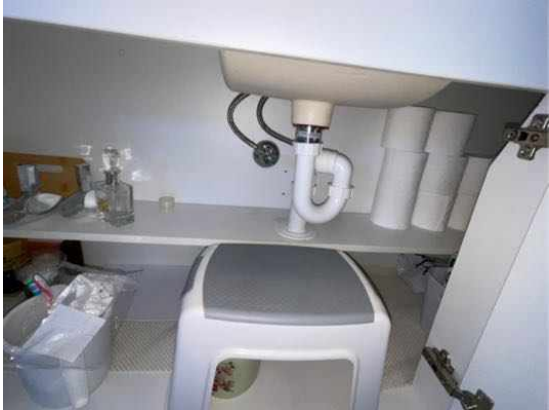
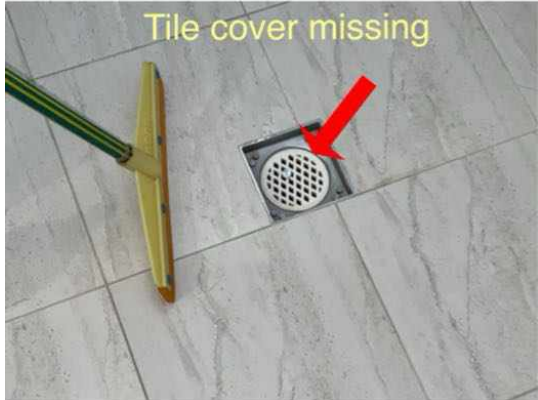
Building: Main Building  
Location: Ensuite  
Finding: Wet Areas - Bathroom(s) - Overall Condition & Recommendations.  
Information: Overall Condition & Recommendations

- No elevated moisture readings were detected around the tap fittings or behind the shower walls (as viewed from adjacent rooms), suggesting no active plumbing leaks at the time of inspection.

- The floor waste tile insert is missing! Replacement is recommended.
- Sealing of grout and tiles is recommended to prevent moisture buildup and mould growth in damp areas such as showers.

- Flood testing of the shower recess is recommended. This may reveal inadequacies in the waterproofing or shower screens, which could lead to water damage in surrounding areas.

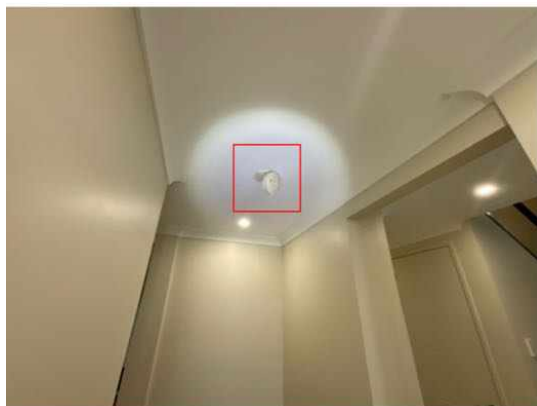
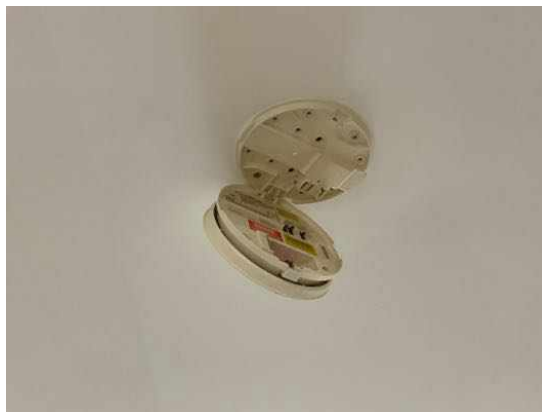
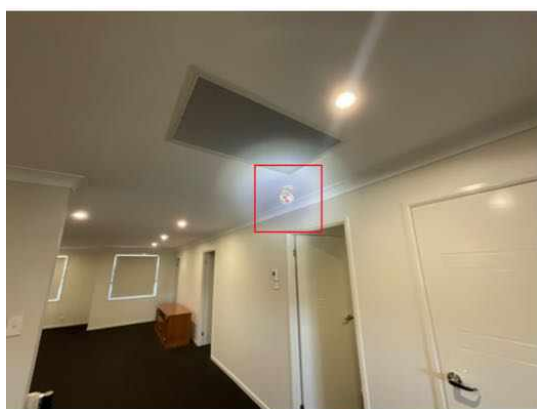
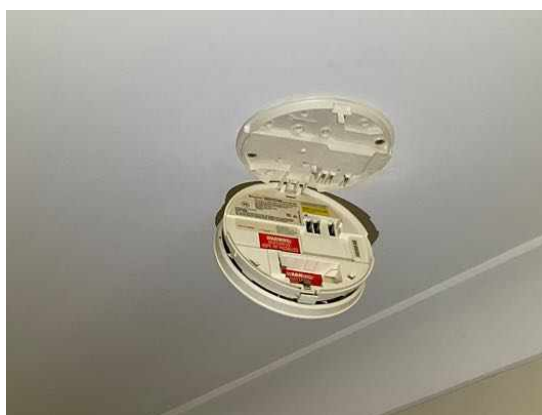
Building:	Main Building
Location:	All Areas
Finding:	Smoke Detectors / Alarms.
Information:	Reporting on the presence, type, location, or compliance of smoke detectors or alarms, including hard-wired smoke detection systems and their legislative requirements, is outside the scope of this inspection report.

- All smoke detectors be tested monthly by the homeowner.
- All systems comply with the requirements of AS 3786 and any applicable state-based legislation.
