Building and Timber Pest Inspection Report

Inspection Date: Mon, 9 Mar 2026

Property Address: 28 Rose Ave, Albion Park Rail NSW 2527, Australia

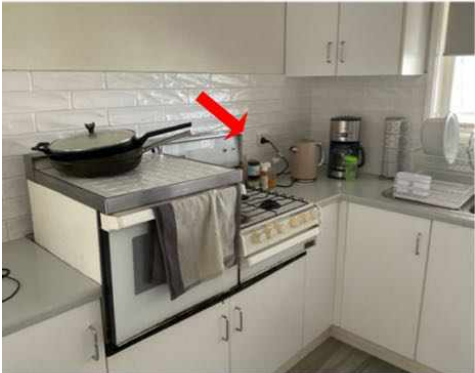
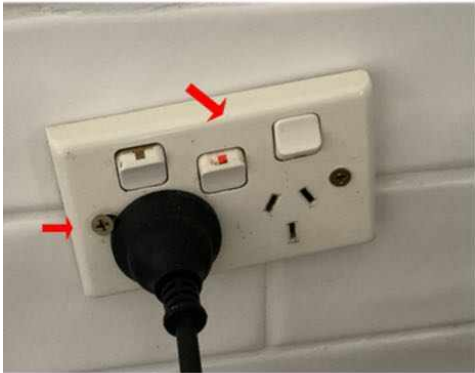
Building:	Building 1
Location:	Kitchen
Finding:	Electrical power point loose.
Information:	The electrical fitting in this kitchen area was found to be loose at the time of inspection. Loose fitting may damage electrical works, and may create a safety hazard if there is potential contact with persons in the area.

A Licensed electrician should be appointed to rectify these areas immediately.

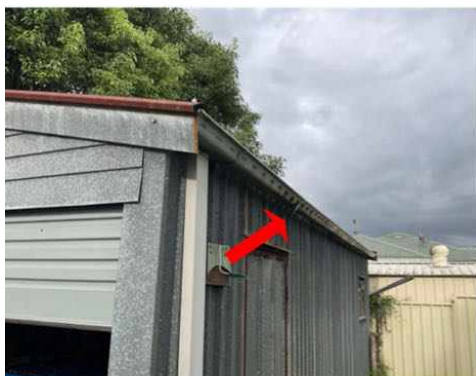
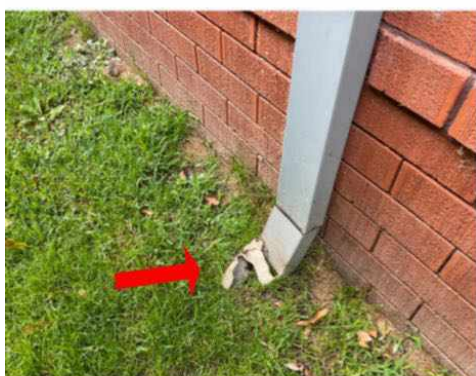
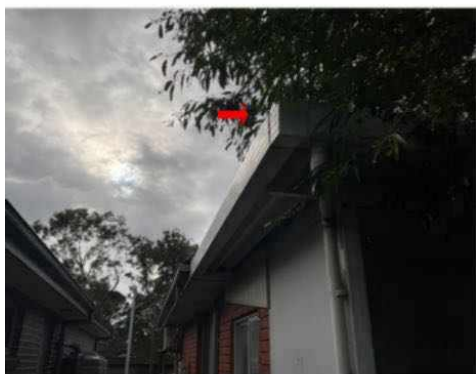
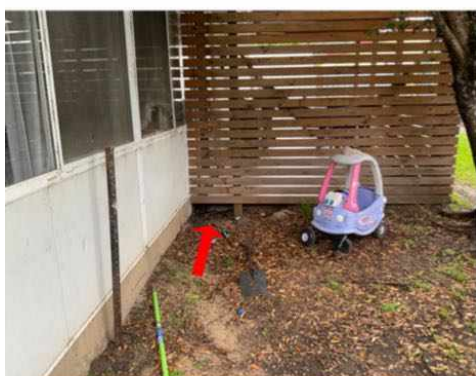
Building: Building 1
Location: Walls
Finding: Site drainage - Inadequate
Information: The site drainage in these areas was found to be inadequate at the time of inspection, creating potential for subsequent water damage to associated building elements.

pooling Major defect)

2. The garage gutters are sagging and most downpipe boots on the property have cracked.
3. The pergola has no gutters.
4. Two areas of the right rear gutter are leaking.
5. One overflow pipe runs onto the right rear wall.

It is important that water does not lie against the base of walls; surrounding paths and ground levels should be sloped to drain water away from walls. Downpipes should not discharge stormwater onto lower walls or plinths. Stormwater should be carried away by large, regularly cleaned drains. Ground levels may need to be lowered to expose a buried DPC.

Where site drainage is inadequate, installation of an Agricultural (Aggie) Drain may be required. A qualified plumber should be appointed before purchase to further inspect the property and perform any remedial works as necessary. Secondary defects are likely to occur if left unmanaged.

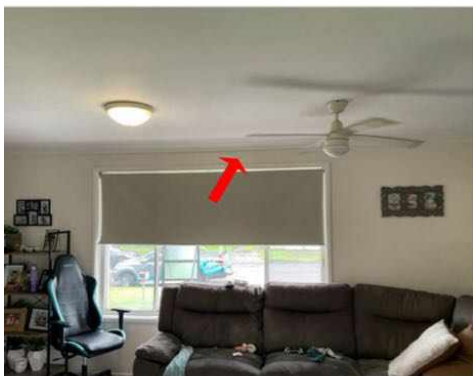
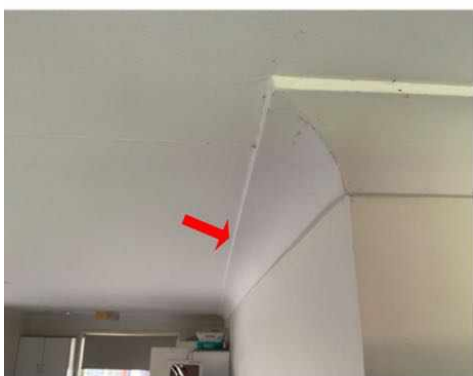
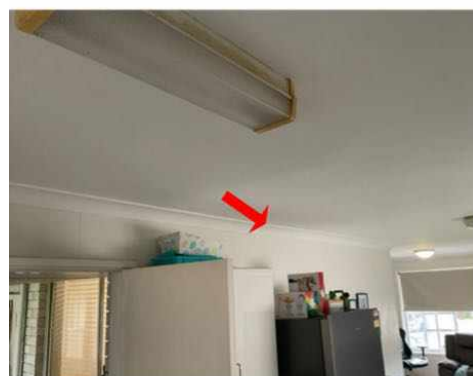
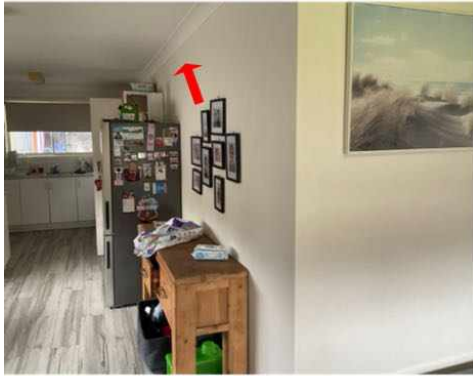
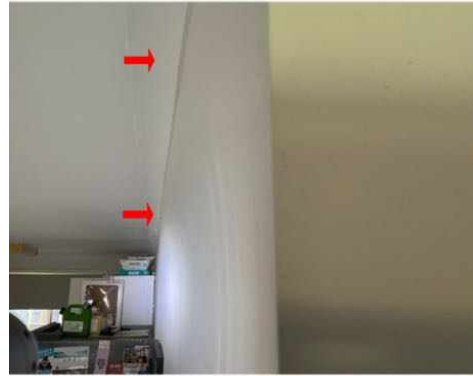
Building:	Building 1
Location:	Pictured lounge/kitchen areas
Finding:	Ceilings - Sagging/deflection evident and wall bowed
Information:	The ceiling cornice in the lounge/dining areas were found to have a minor deflection at the time of inspection. Deflection to the fixed ceiling structure may indicate that the building materials have swollen, due to contact with water, or that fixings (e.g. nails or

glue) have become loose and require reattachment. However it may also be just minor sagging of timbers over time.

In some cases, sagging ceiling linings may also indicate that there are structural issues, causing surfaces to warp, twist or sag, or that structural timber elements have been weakened from termite activity. Where sagging appears to be major, appointment of a structural engineer is advised to further inspect the property and identify the cause of the damage and determine the rectification works required.

Where minor sagging is evident, comparatively minor works, such as re-gluing of ceiling sheets, may be required. Such works may be performed by relevant tradespeople, such as plasterers and painters. Where excessive moisture has caused the roofing structure to swell and sag, the source of the water leak should primarily be identified prior to any remedial works being performed.

The appropriate action should be taken by the client as soon as possible to ensure that any potential further damage is limited.

An invasive inspection is required to remove roof tiles or plaster to check this area for the cause.

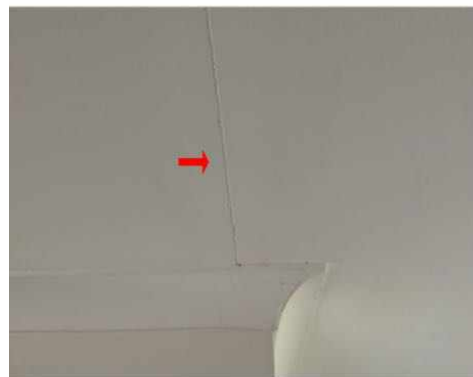
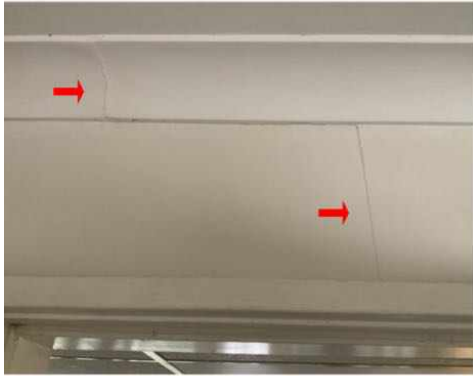
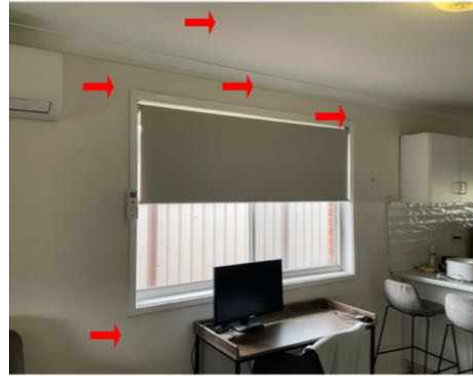
Finding 3.05

Building:	Building 1
Location:	Loungeroom/kitchen
Finding:	Cracking - Damage Category 1 - Fine (up to 1mm)
Information:	Although these numerous cracks are quite noticeable, they are usually only considered to be an appearance defect, and usually do not indicate any structural damage. Generally, the cause of a fine crack is indicative of a separation between building materials and finishes (e.g. paint, plaster, etc.) along joins.

Monitoring of all cracking should be conducted frequently. It is not clear if these cracks are related to the very high moisture in the subfloor areas.

Cracking of this nature can generally be repaired with minor sanding, filling and/or repainting. Such works should be performed by a qualified painter or a general handyman.

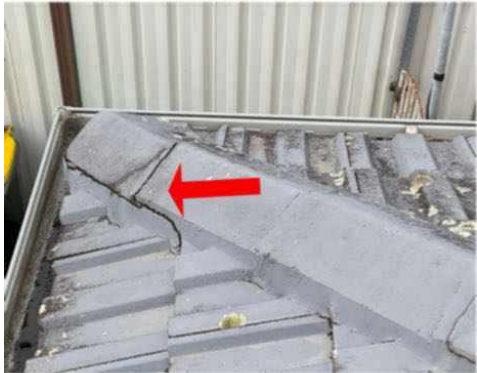
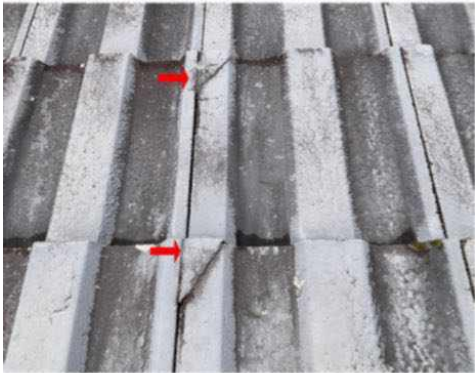
Finding 3.06

Building:	Building 1
Location:	All External Areas
Finding:	Roofing areas - Weathered
Information:	Upon inspection of the exterior roofing, the majority of the tiled roof areas were considered to be in a good condition. The garage roof is in poor condition. Many areas of the garage and pergola roof could not be seen due to overhanging trees and accumulated leaf debris. While weathering of these pictured areas is consistent with the age of the property, maintenance works are required.

Re-sealing and replacing small areas of gaps, damage or rust the may be considered as an interim solution by the client to help preserve and extend the life span of these roofing areas. Where left unmanaged, deteriorating roofing materials are likely to lead to a number of secondary defects, including minor water leaks and weather exposure to internal roofing structures.

Remedial works are likely to increase the longevity of the exterior roofing structure.

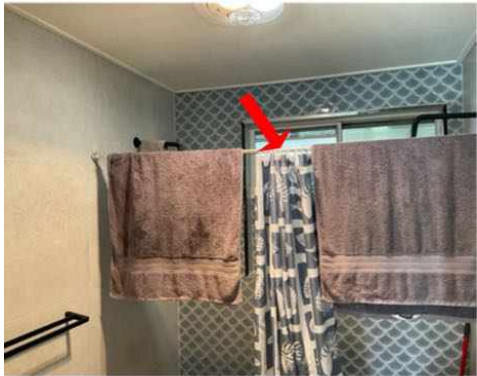
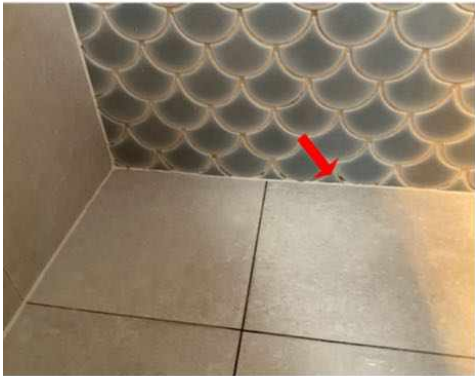
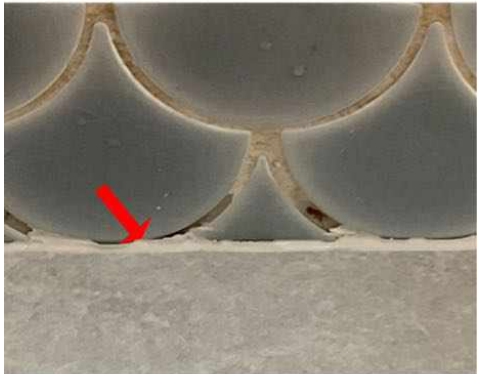
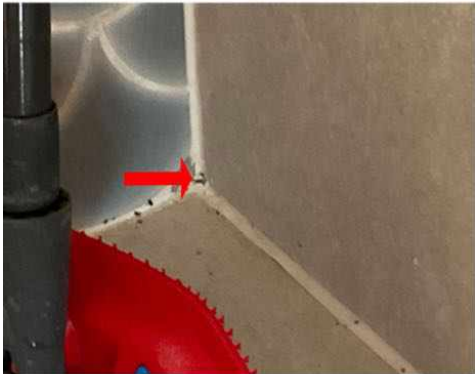
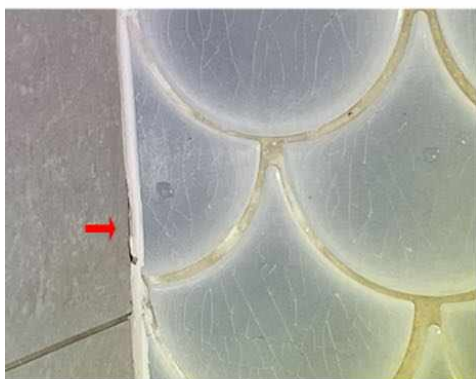
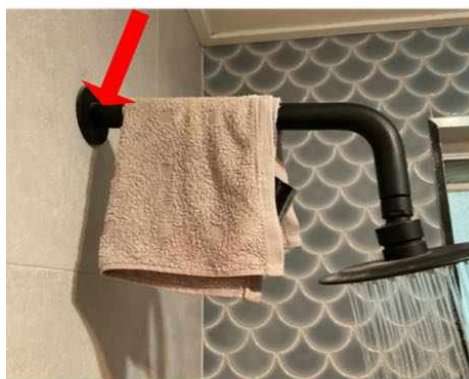
Finding 3.07

Building: Building 1
Location: Bathroom
Finding: Shower screen missing with temporary fixture only, spout loose, paint damaged
Information: Defects found in the bathroom include a missing shower screen, damaged sealant, a very loose shower spout and damaged paint to aluminium edges (see also tile crazing defect).

The appointment of a plumber and sealant expert is required to repair or replace these above mentioned defects. Such works should be performed as soon as possible to ensure that no further damage occurs.

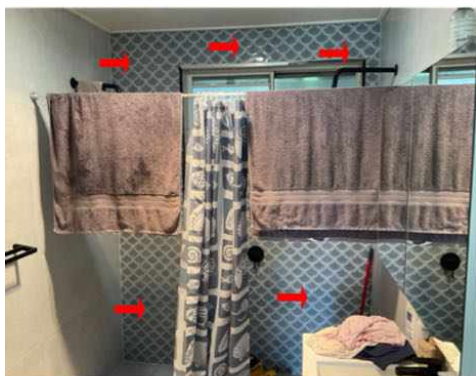
Finding 3.08

Information: Most fish scale tiles in the bathroom have suffered crazing. Crazing is internal fracturing without a change of the surface texture. It might be seen when light transmits through transparent or translucent material and it can also exist in opaque plastics. Crazing can be a precursor to cracking if it extends to the surface, but even if it stops short of the surface, crazing still decreases the strength of the material.

These tiles may need replacement in the future and can be undertaken by a tiling contractor.

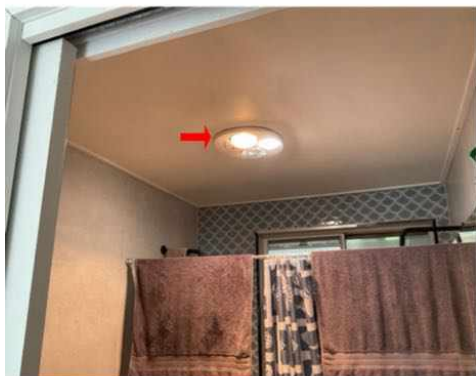
Building:	Building 1
Location:	Bathroom
Finding:	Exhaust fan - Not operating
Information:	The exhaust fan in this area appears to be damaged or blocked and is not operating as intended. If left unmanaged, a lack of general maintenance is likely to lead to the development of more significant defects, such as water damage to surrounding building materials from inadequate ventilation. If left unattended for a prolonged period of time, poor ventilation in this area may also be conducive to the development of mould.

Where no secondary damage has developed, the Homeowner may undertake minor cleaning of the area and consider replacement of the exhaust fan. Alternatively, consultation with a Licensed Electrician is required to check for any secondary or concealed damage and consider repair or replacement.

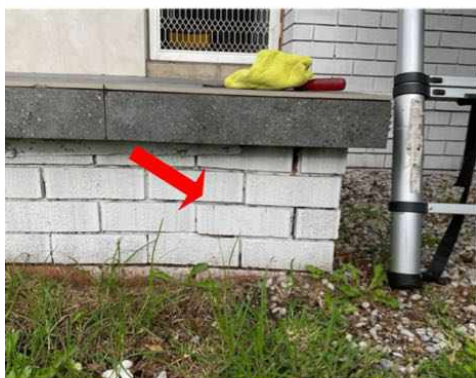
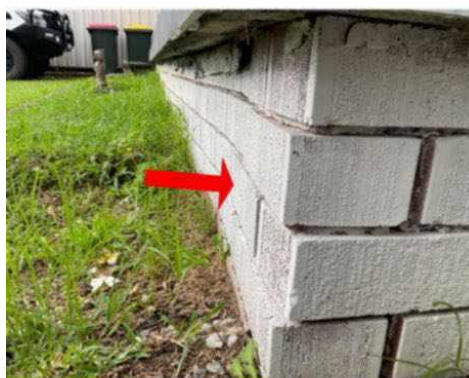
Finding 3.11

Building: Building 1
 Location: Exterior wall
 Finding: Step cracking to brickwork and tree damage
 Information: Step cracking and damage was identified to the brickwork in this area at the time of inspection. This is thought to be from a previous yukka tree which has pushed the brickwork toward the front door.

Step cracking is a relatively common defect. Mortar failure in the gaps between affected bricks indicates the stresses and tensions affecting the wall.

A bricklayer can repair this area.

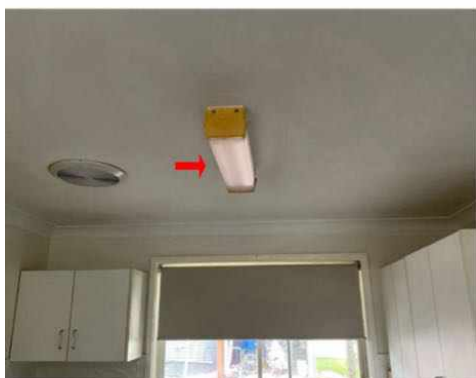
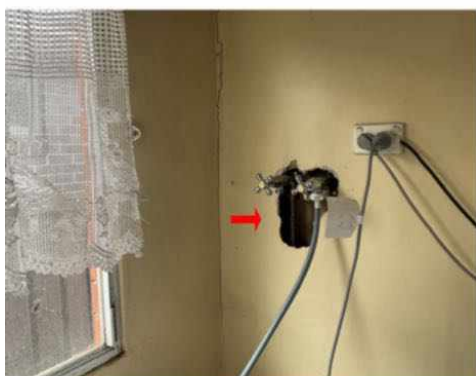
Finding 3.12

Building: Building 1
 Location: Pictured external areas
 Finding: Building elements - Damaged
 Information: Evidence of minor missing or damaged areas was identified at the time of the inspection. These include -

2. Many flyscreens are dog damaged.
3. The laundry wall has a large hole requiring repair and possibly made of asbestos .
4. The master bedroom ceiling fan would not work - possibly flat remote battery,

A carpenter and electrician would be the trades responsible for rectification of these areas when convenient.

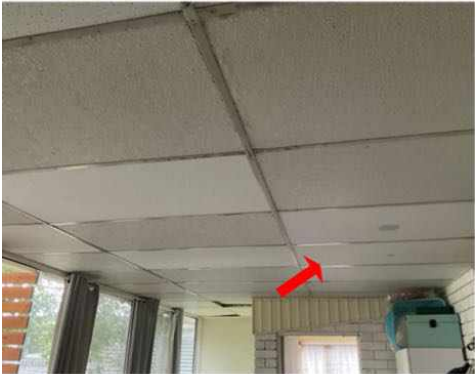
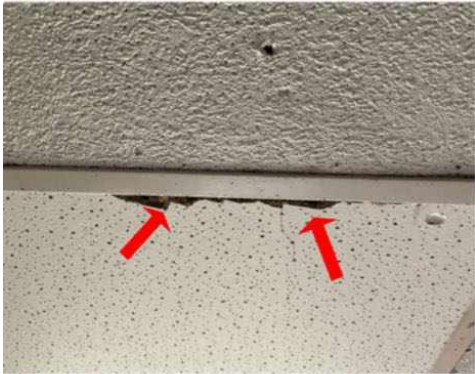
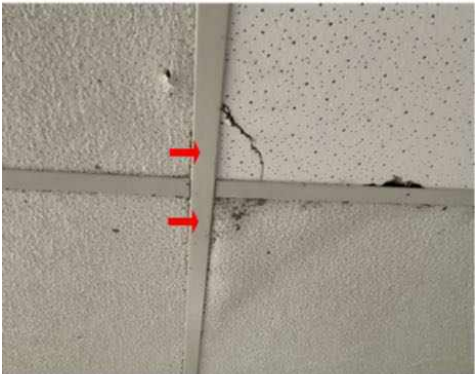
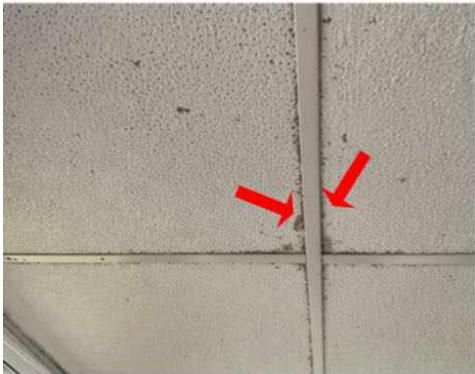
Finding 3.13

Building:	Building 1
Location:	Rear sunroom ceiling tiles
Finding:	Ceiling - Water stained, loose, minor mould
Information:	Water staining and minor mould in ceiling linings in this area was evident at the time of inspection. Water staining indicates that surfaces have been exposed to excessive moisture over time. The minerals and other elements in the water lead to staining, which may graduate to corrosion and deterioration if left unmanaged.

While mostly an appearance defect, water staining can be indicative of more serious defects, which may be currently concealed by interior ceilings.

Where water staining is active, a licensed plumber must be consulted to identify the cause of the staining and to provide advice on any reparation works that may be

required. Replacement of any damaged structures is advised.

Conversely, where water staining is old and inactive, affected building materials may be repaired or replaced at client discretion.

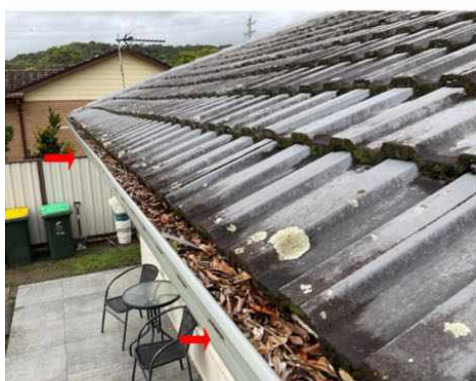
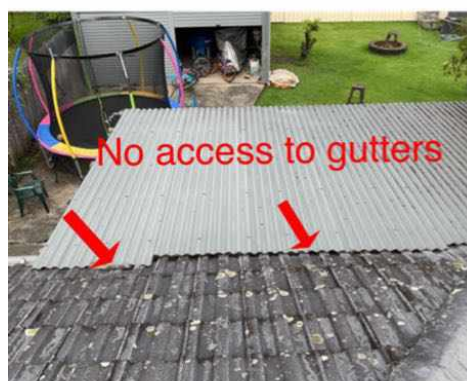
Finding 3.14

Building: Building 1
Location: Roof exterior
Finding: Gutters - Full and blocked
Information: The guttering on around the roof was found to be blocked at the time of the inspection. Roof plumbing structures, such as guttering and downpipes, should be

Blocked gutters are likely to lead to high levels of moisture in the affected areas which can cause rust and decay of the gutters and downpipes and wood rot to adjoining timber areas. Blockages in gutters should therefore be removed immediately to ensure dry conditions are maintained.

It is highly advised that gutters be cleaned by the homeowner or a general handyman as a matter of urgency.

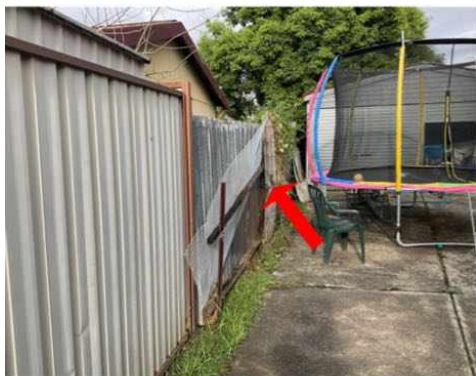
Finding 3.15

Building:	Building 1
Location:	Pictured left fence
Finding:	Fence damaged - leaning
Information:	Evidence of damage to the pictured fence was identified at the time of the inspection. The likely cause of this fence leaning is not enough concrete used in the post footings.

If left unmanaged this fence may deteriorate further. It is suggest a fencing contractor be engaged for rectification when convenient.

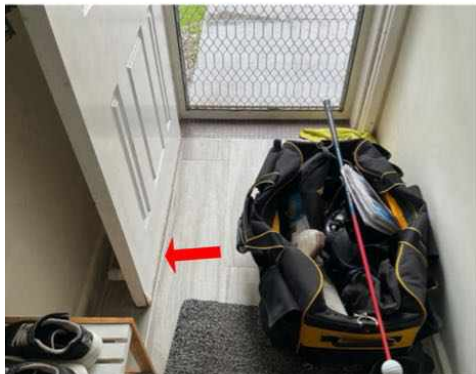
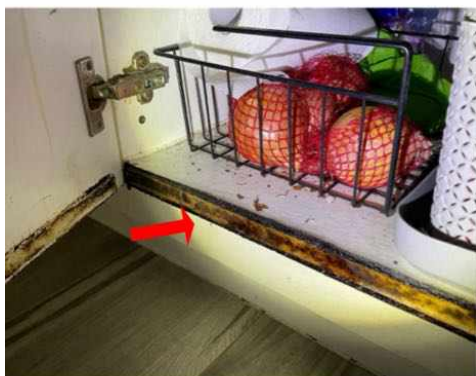
lead to the development of secondary damage to any associated building elements, which may necessitate major reparation works if prolonged.

Repair and/or replacement of swollen building elements should be conducted as a matter of urgency by a registered builder or qualified carpenter.

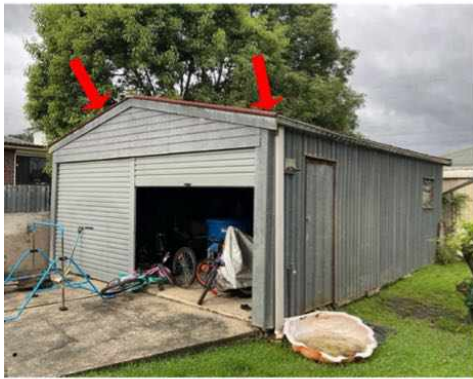
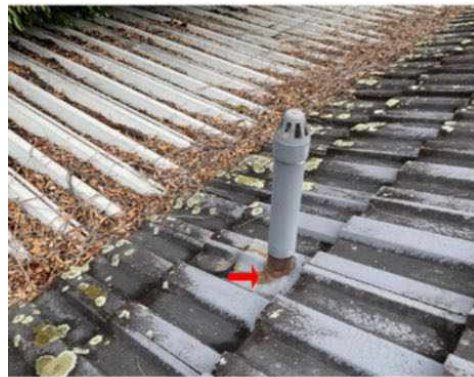
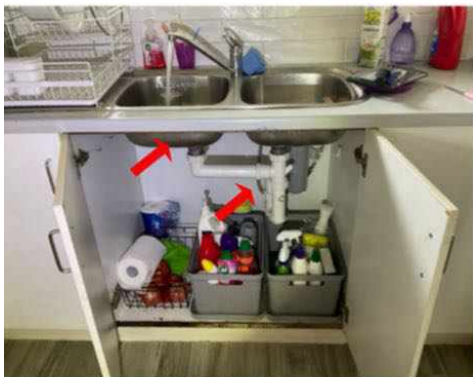
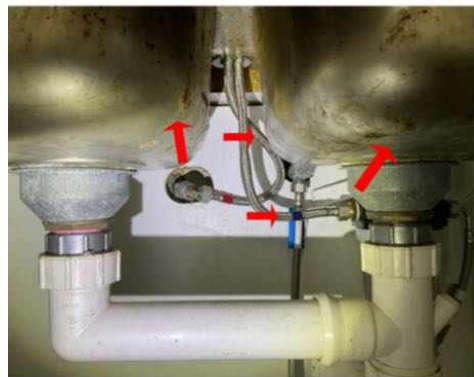
Finding 3.18

Building:	Building 1
Location:	External garage and other areas
Finding:	Building element - Rusted or corroded
Information:	These areas show evidence of rusting and corrosion, which is likely to have developed

as a result of excessive exposure to moisture and or inadequate coatings.

Rusting and corrosion should be managed by ideally removing or limiting the affected surface from exposure to moisture. A registered builder may be appointed to replace any building elements that have been severely affected by rust or water damage.

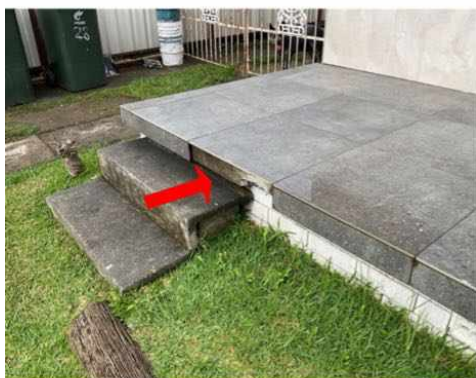
Finding 3.19

Building:	Building 1
Location:	Verandah
Finding:	Tiles loose/ chipped/ cracked or loose
Information:	Damaged and missing tiles were evident in these pictured verandah areas at the time of inspection. It is suspected that this cracking has occurred as a result of impact damage. Missing tiles throughout the household detract from the overall appearance of the affected areas.

Replacement of cracked tiles is recommended as soon as possible. A tiling contractor may be appointed to perform these works. Where cracks become more numerous, contact a licensed building inspector for further investigation.

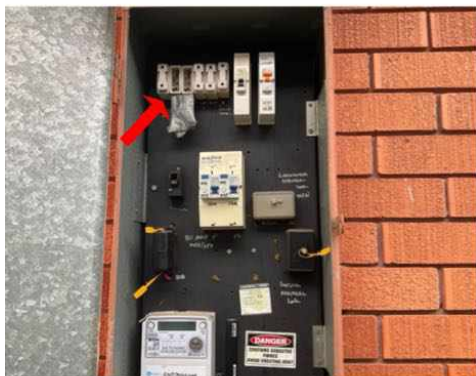
Building:	Building 1
Location:	Meter Box
Finding:	Electrical switchboard - Old ceramic fuses
Information:	The electrical switchboard while appearing to have adequate safety switches installed has old ceramic fuses in place.

While this on its own on is not considered a defect it is noted for the clients consideration that a switchboard upgrade may be required in the short to mid term to improve the functionality of the electrical system. A licensed electrician could be appointed to provide quotation for the works at the client's discretion which may in turn expose other required works to bring the system up to a compliant state.
