Building and Timber Pest Inspection Report

Inspection Date: Wed, 18 Mar 2026

Property Address: 229 Goomalibee Rd, Benalla VIC 3672,
Australia

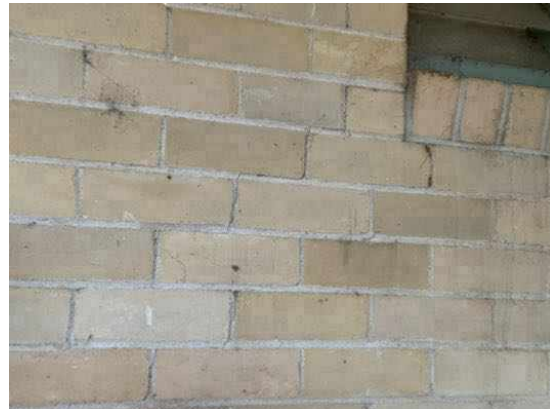
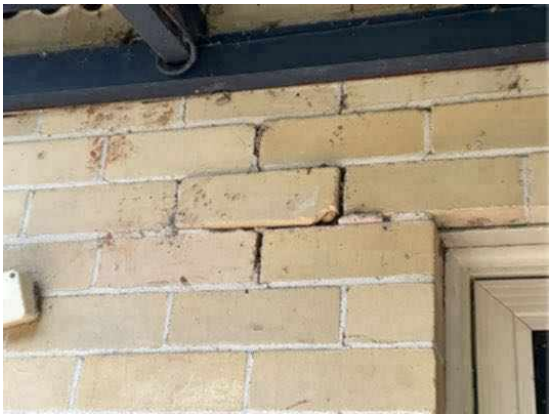
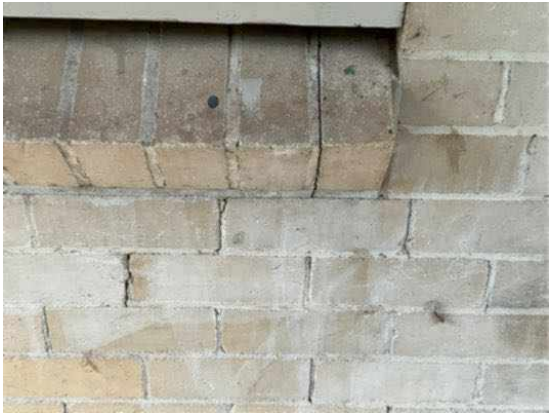
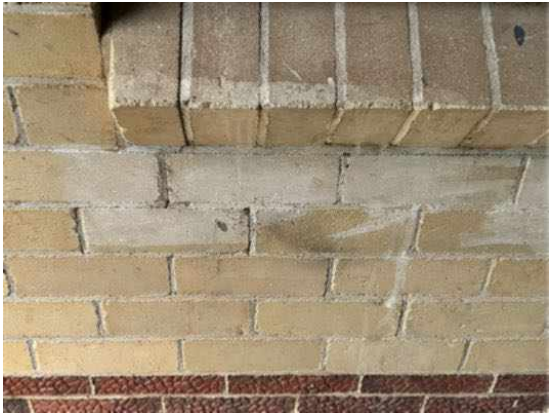
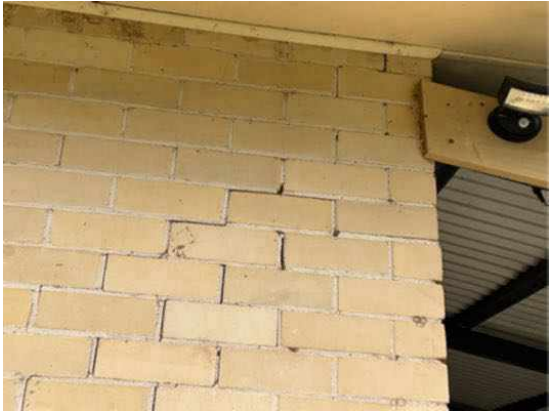
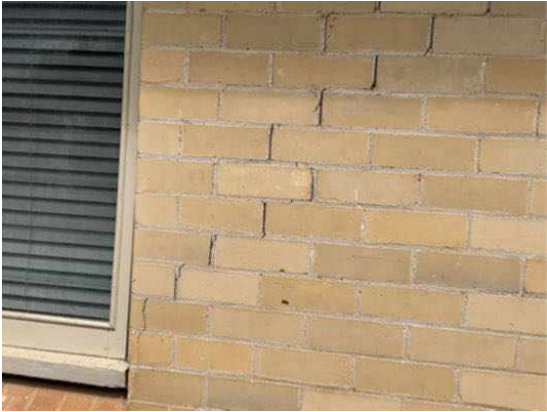
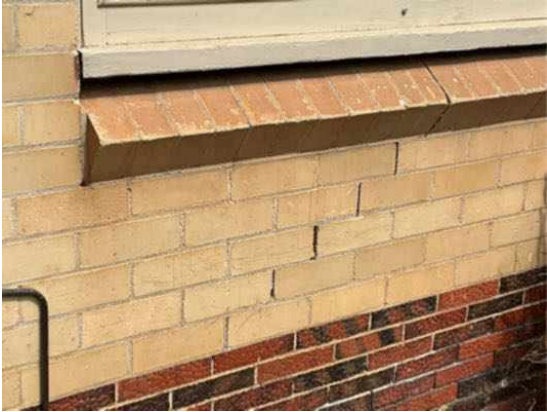
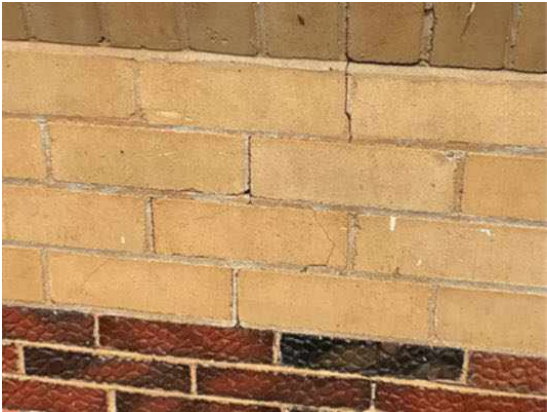
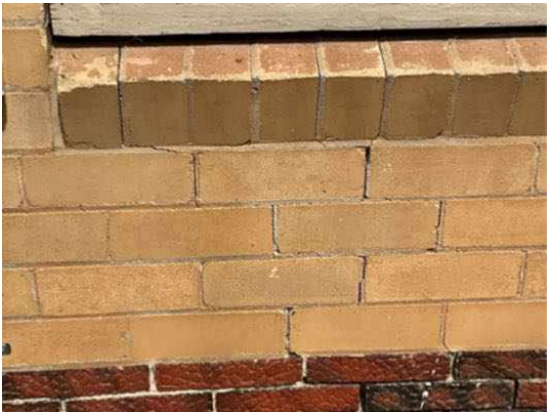
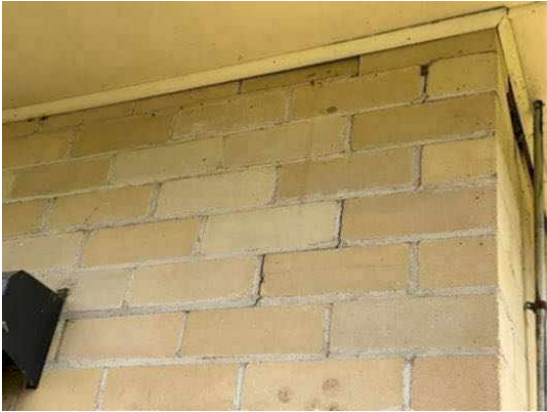
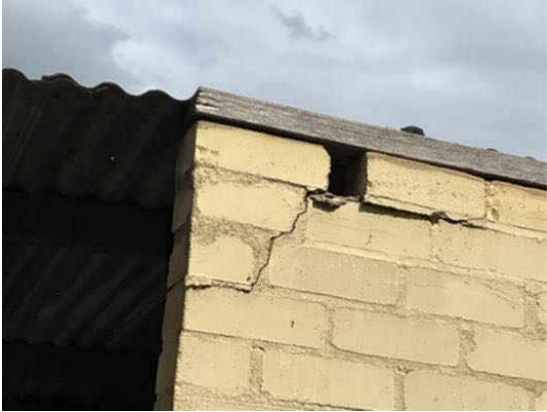
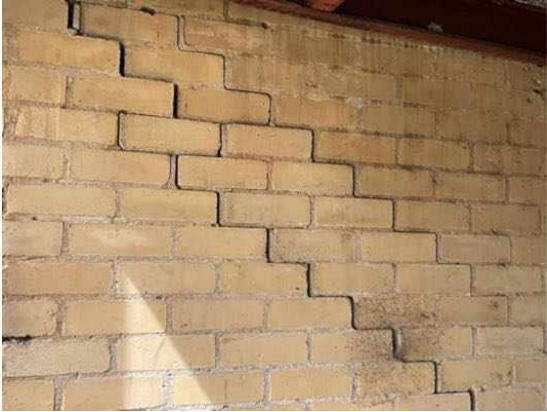
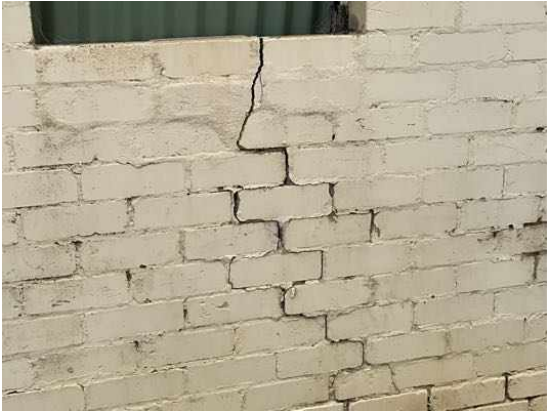
Building: Building 1
Location: Alfresco, laundry area, back verandah area, equipment shed
Finding: Brickwork - Step cracking
Information: Step cracking was identified to the brickwork in this area at the time of inspection. Step cracking, which is similar to other forms of cracking, has a variety of possible causes. However, the most common is the subsidence of adjacent footings.

Step cracking is a relatively common defect, and is most likely to occur adjacent to windows, doors and other openings. Mortar failure in the gaps between affected bricks indicates the stresses and tensions affecting the wall.

A major defect is noted. Cracking can be seen in several areas of the house walls. Any one area could be considered a minor defect, but when taken as a whole the cracking must be considered a major defect. This is major defect, in that repair probably should be considered in the near future to prevent further deterioration. A registered builder or bricklayer should be contacted soon to restore these areas and prevent further deterioration.

Where step cracking is extensive or severe, the client is advised to consult a structural engineer. Minor step cracking can be used as a warning sign to address factors causing stress to the wall, which can include the effect of surrounding trees, water leaks, soil erosion, or even the presence of reactive soils in the surrounding area.

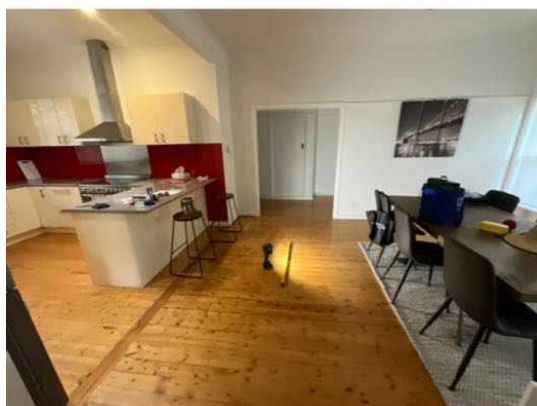
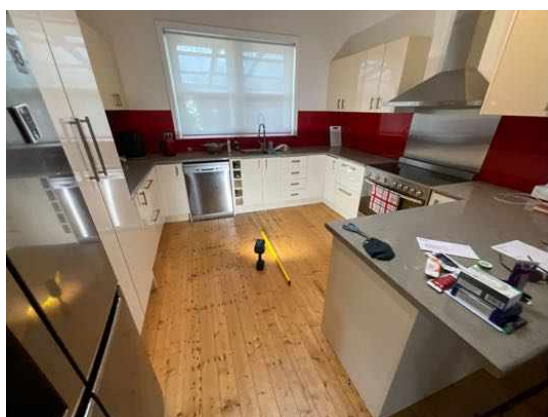
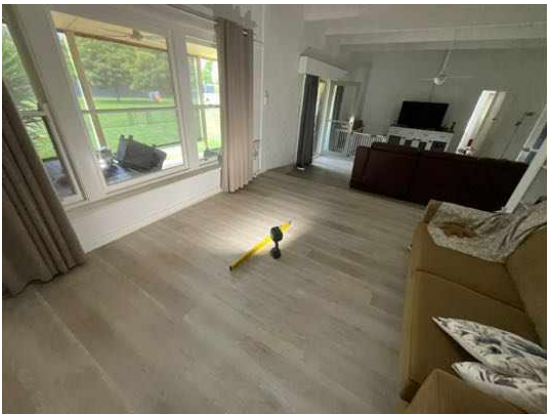
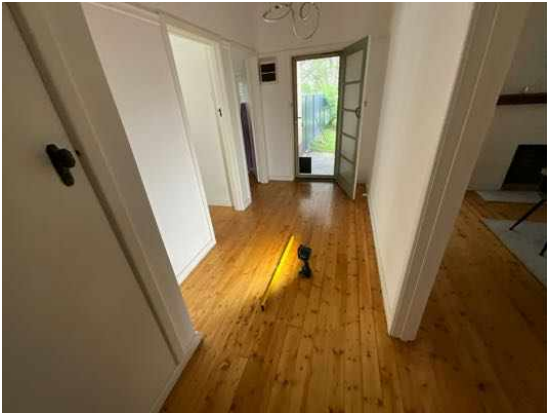
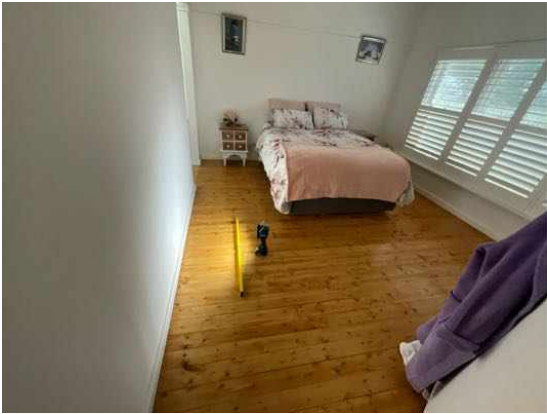
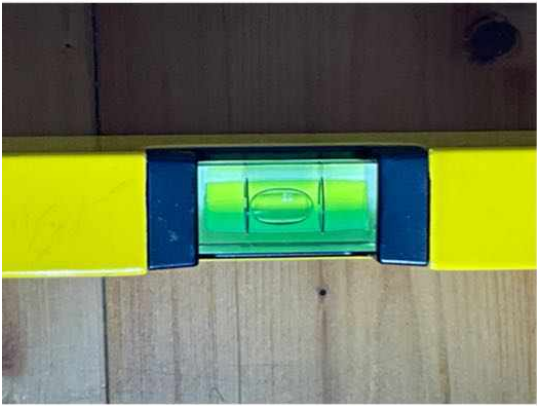
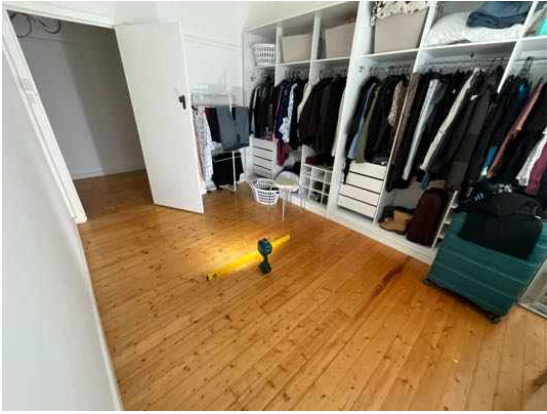
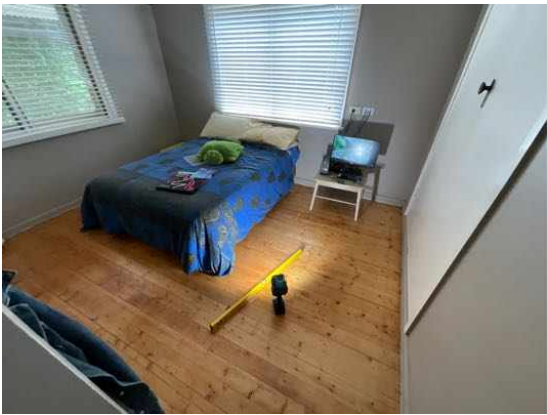
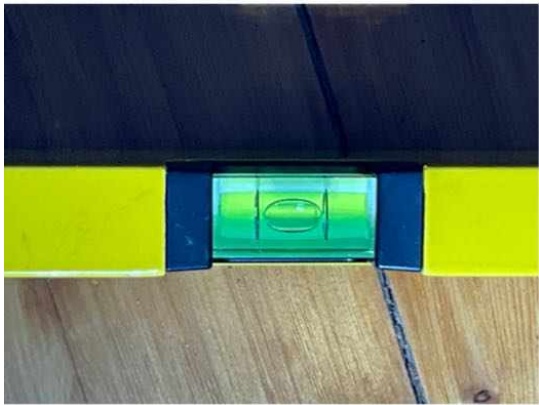
Finding 3.01

Building:	Building 1
Location:	All Internal Areas in original house
Finding:	Flooring - Uneven
Information:	The internal flooring in this area is out of level and uneven. Uneven flooring is likely to indicate minor defects such as expected movement of the foundations of the property, but may also indicate subsidence of the associated subfloor stumps.

It is advised that the flooring be closely monitored to identify any further movement. Where flooring remains relatively unchanged for an extended period of time (i.e. several months), it is likely that this defect has been caused by expected movement of the foundations of the property.

However, where flooring is uneven further, potentially invasive inspection of the subfloor structures and stumps in this area is required. In this case, works to repair are likely to be required, and would be carried out by a registered builder specialising in re-stumping.

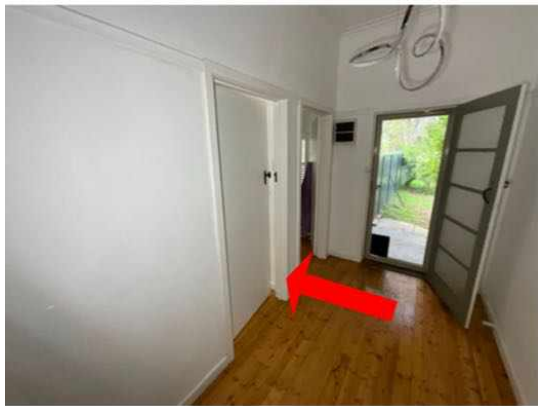
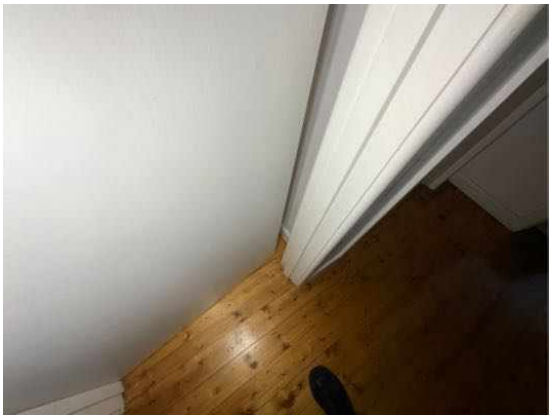
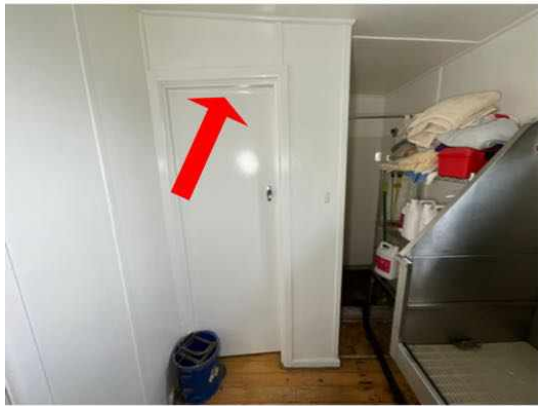
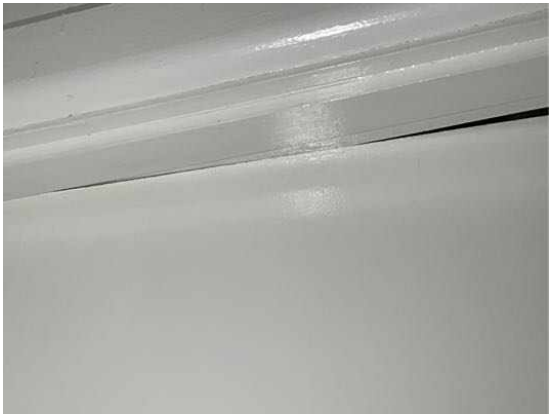
Finding 3.02

Building: Building 1
Location: Bedroom 2, studio
Finding: Door- Binding/jamming
Information: Binding and/or jamming of this door is evident during standard operation. This defect inhibits the functionality of the affected door as well as creating potential for secondary defects to associated building elements, such as damage to the floor covering.

A qualified carpenter or general handyperson should be appointed to perform minor rectification works at client discretion.

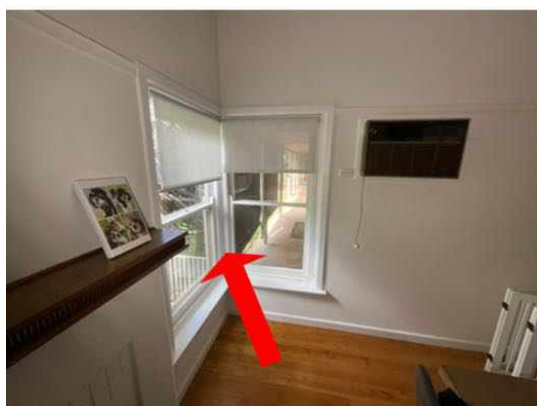
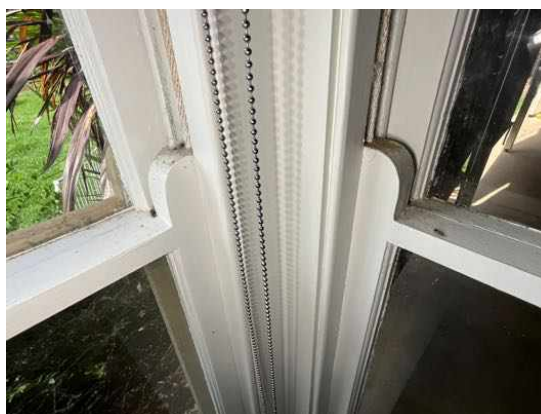
Finding 3.03

Building:	Building 1
Location:	Dining Room
Finding:	Windows - Sash painted shut
Information:	Where window sashes have been painted shut, it is generally indicative of poor, rushed workmanship. The window is difficult if not impossible to open and close until remedial works have been undertaken.

Windows provide ventilation to the adjoining area and should be at a fully operational level to ensure user comfort. Restricted function of the window may also pose as a potential safety hazard if required for emergency egress from the building.

Where windows have been painted shut the seal of the paint needs to be broken. This is generally done by breaking the seal of the paint and then maintaining the sash tracks clearing and lubricating them with silicone. Remedial paint work will likely be required and can be completed along with the rest of the remedial works necessary by a general handyman.

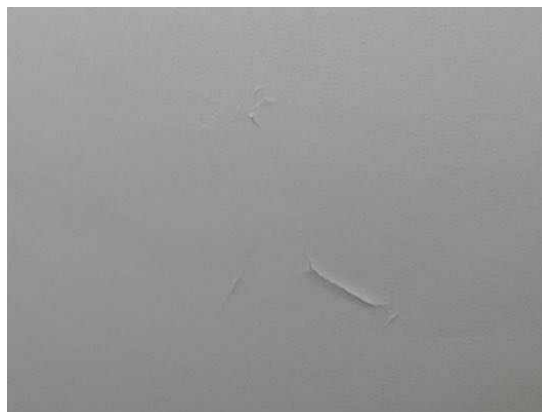
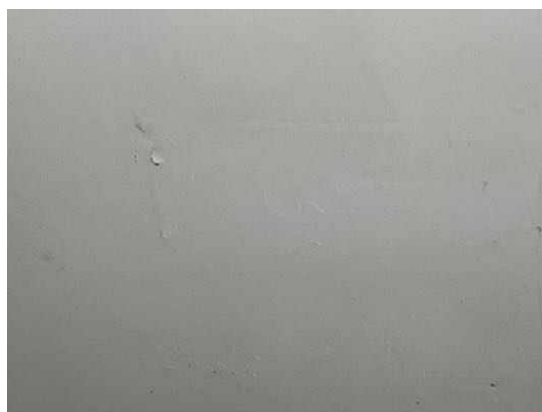
Finding 3.04

Building:	Building 1
Location:	Bedroom 2,3
Finding:	Paint- Flaking
Information:	Sections of paint in this area was found to have deteriorated. Paint flaking is generally an indication of excessive moisture in the area, that is currently hidden by the painted surface.

The presence of excessive moisture can have major implications on associated building elements if left unattended. While only seemingly minor at this stage, the damage cannot be determined due to the paint obstructing any further inspection of the damage.

A qualified Painter should be contacted at the Owner's discretion to re-paint the area.

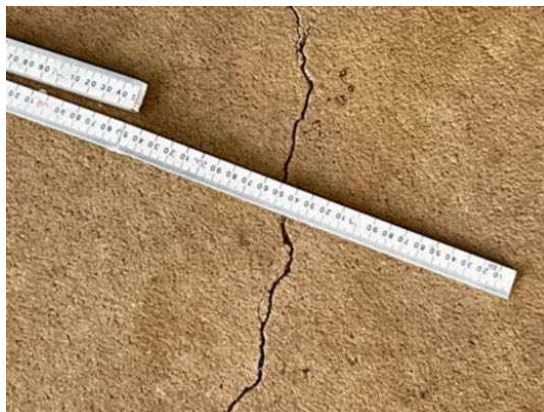
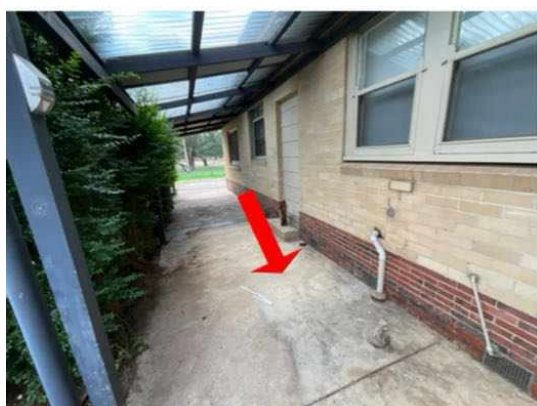
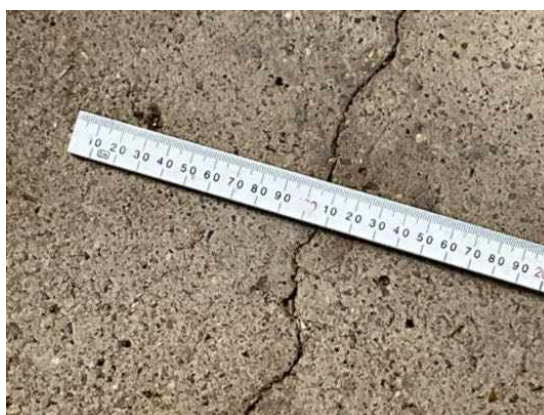
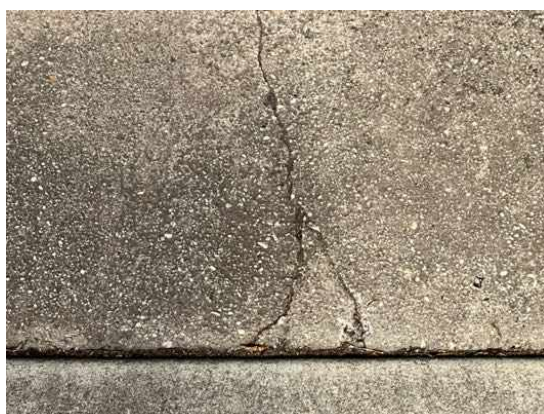
Finding 3.05

Building:	Building 1
Location:	Verandah, back and front
Finding:	Cracking - External Concrete Paving Damage Category 3 - Wide Cracks (2mm - 4mm)
Information:	Wide cracks were identified in external concrete paving. Wide cracks are significant and are likely to lead to the development of safety hazards and secondary defects if left unmanaged.

General age and expected deterioration of the paved areas is a common cause of this type of cracking. However, expansion and contraction of the slab may also have occurred due to environmental factors. Such factors include variable moisture and weather conditions, the presence of trees and their roots having a settling or lifting affect on the soil, or the effect of load bearing, e.g. heavy vehicles over a sustained period of time.

Cracking to this degree may also be due to poor original installation of the concrete. Factors such as poor compaction of the sub surface and/or inadequate reinforcing of the slab may create cracking and other secondary defects. Wide cracks may also have a more significant structural cause, such as subsidence of soils.

Where the crack is located adjacent to structural elements of the building, the advice

of a Structural Engineer is advisable before undertaking repairs. Significant repair and likely replacement of the concrete paving is probable.

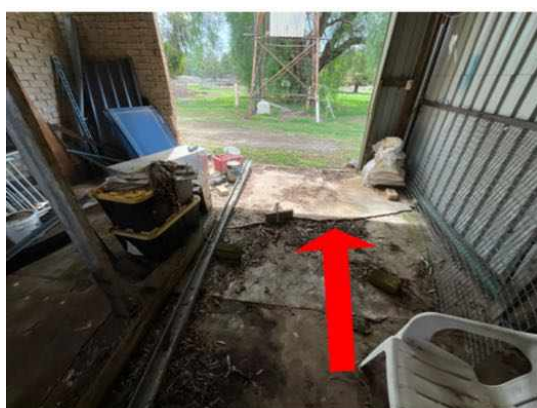
Finding 3.06

Building:	Building 1
Location:	Equipment shed
Finding:	Cracking - External Concrete Paving Damage Category 4 - Gaps in Slab (4mm - 10mm +)
Information:	Gaps in the slab were identified in external concrete paving. Gaps in the slab are significant and are likely to lead to the development of safety hazards and secondary defects if left unmanaged, such as the creation of a trip hazard.

General age and expected deterioration of the paved areas is a common cause of this type of cracking. However, expansion and contraction of the slab may also have occurred due to environmental factors. Such factors include variable moisture and weather conditions, the presence of trees and their roots having a settling or lifting affect on the soil, or the effect of load bearing, e.g. heavy vehicles over a sustained period of time.

Cracking to this degree may also be due to poor original installation of the concrete. Factors such as poor compaction of the sub surface and/or inadequate reinforcing of the slab may create cracking and other secondary defects. Gaps in the concrete paving may also have a more significant structural cause, such as subsidence of soils.

Where gaps in the concrete paving are adjacent to structural elements of the building, the advice of a Structural Engineer is advisable before undertaking repairs. Significant repair and likely replacement of the concrete paving is probable.

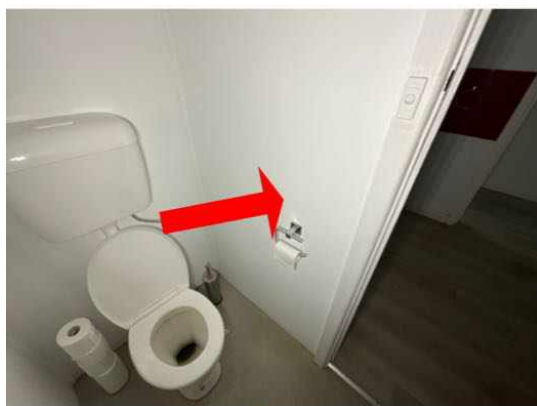
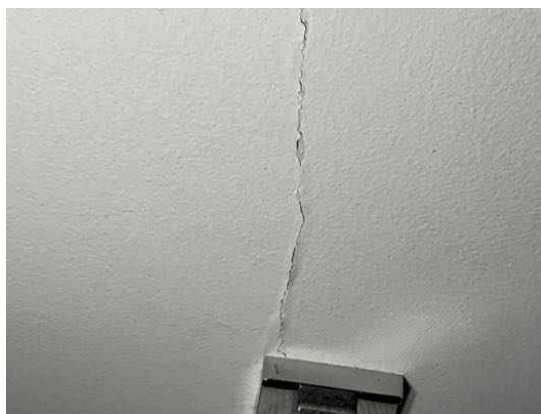
Finding 3.07

Building:	Building 1
Location:	Toilet (WC)
Finding:	Cracking - Damage Category 1 - Fine (up to 1mm)
Information:	Although fine cracks are quite noticeable, they are often only considered to be an appearance defect, and usually do not indicate any structural damage. Generally, the cause of a fine crack is indicative of a separation between building materials and finishes (e.g. paint, plaster, etc.) along joins.

Cracking of this nature can generally be repaired with minor sanding, filling and/or repainting. Such works should be performed by a qualified painter or a general handyman.

Monitoring of all cracking should be conducted frequently. Always contact a building inspector should cracks widen, lengthen, or become more numerous.

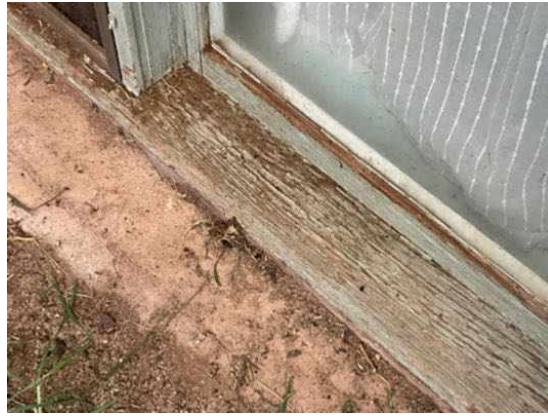
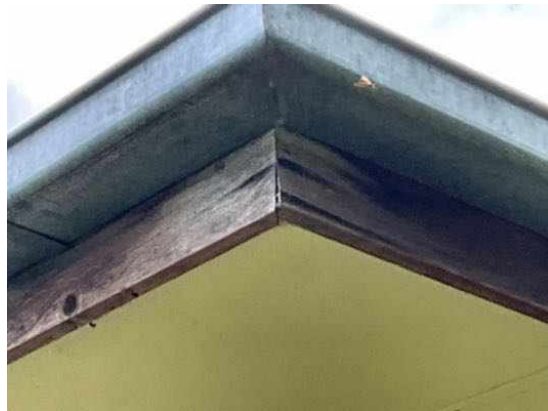
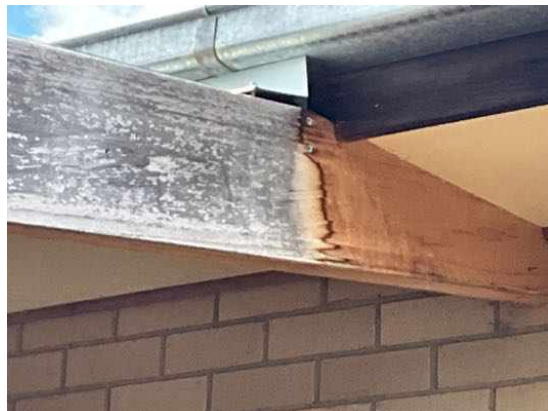
Building:	Building 1
Location:	External timber
Finding:	External painting deteriorated
Information:	Much of the external paintwork including but not limited to windows, fascias, guttering, veranda and other external fitments have been neglected and require attention to prepare and re-paint.

Whilst incomplete or missing paint finish is generally an appearance defect, it can also lead to the development of secondary building defects over time. Incomplete areas of paint finish expose the area to moisture, potentially accelerating the deterioration of underlying building materials.

Degraded paint finishes should be sanded back, filled, leveled and painted, as applicable. Where inadequate or missing paint protection has led to the deterioration of the associated building element, repair and/or replacement of this building element may be required.

A painting contractor should be appointed as soon as possible to perform necessary works to aid the appearance of the affected area and to ensure the area is protected against further deterioration. Alternatively, the homeowner following manufacturer instructions may perform these works.

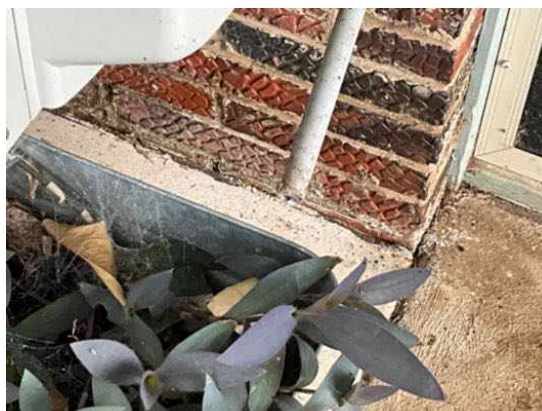
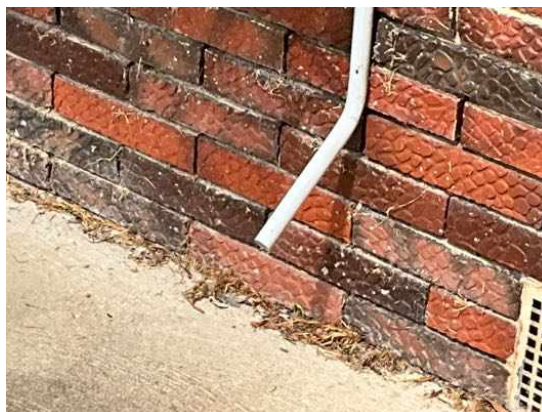
Finding 6.02

Building: Building 1
 Location: Yard - Side, driveway
 Finding: Air conditioner - Disconnected overflow
 Information: The Air Conditioner (A/C) overflow was found to be disconnected from storm water drainage and is creating excessive moisture in the surrounding area.

Such leaking creates an environment which is conducive to an array of defects, including water damage to associated building elements and the attraction of termite or timber pest infestation.

It is highly recommended that a licensed plumber be appointed to connect the A/C overflow in order to prevent such an environment from being created. These minor works should be carried out as soon as possible.

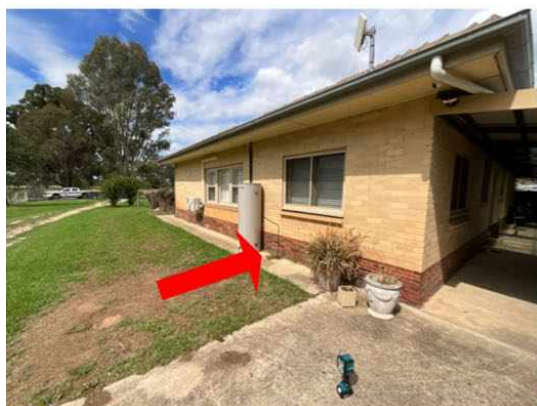
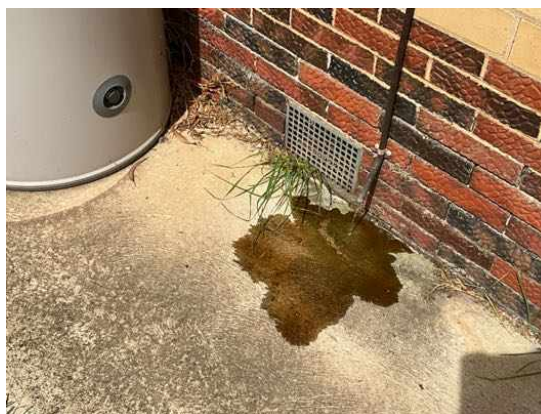
Finding 6.03

Building:	Building 1
Location:	Driveway
Finding:	HWS Overflow - Not Connected
Information:	The Hot Water System (HWS) overflow was found to be disconnected from storm water drainage and is creating excessive moisture in the surrounding area.

These damp conditions can lead to secondary defects such as rot, rust or corrosion of associated building elements, the formation of fungal decay, or even the creation of potential slip hazards. When coupled with poor site drainage, pooling of water may also attract termite activity to this area.

It is highly recommended that a licensed plumber be appointed to connect the HWS overflow in order to prevent such an environment from being created. These minor works should be carried out as soon as possible.

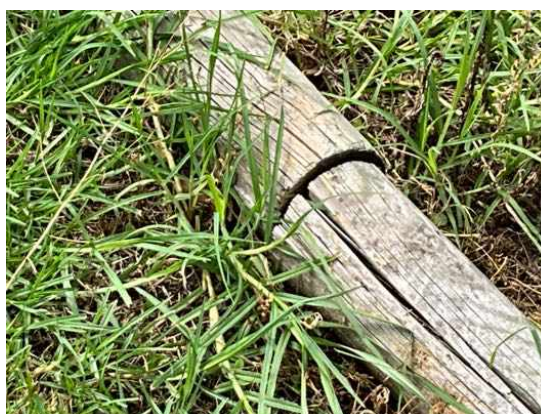
Finding 6.04

Building:	Building 1
Location:	Yard - Side
Finding:	Untreated or non-durable timbers in a hazardous environment
Information:	To reduce the risk of timber pest attack it is essential that timber used in a hazardous environment (e.g. in direct contact with the ground or frequently exposed to damp conditions) is of sufficient durability and/or is adequately preservative treated.

Untreated timbers in direct contact with the ground are likely to develop severe wood rot and/or fungal decay if left unattended creating attraction for subterranean termites to infest the timbers from surrounding areas.

If untreated or non-durable timbers are found to be in a hazardous environment it is highly advised that replacement of these building elements be performed as soon as possible to aid the protection of the property against termite / timber pest attack.

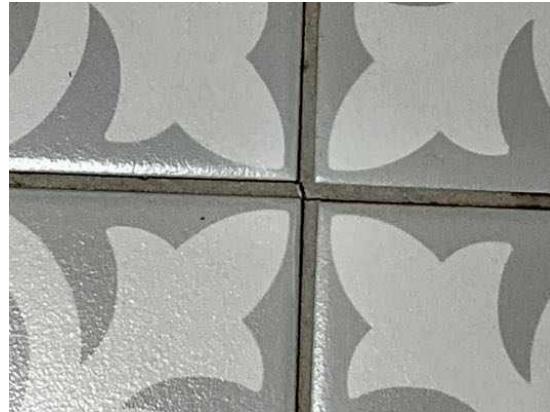
Finding 6.05

Building:	Building 1
Location:	Bathroom
Finding:	Inadequate sealant or Grout
Information:	This area has a lack of effective Sealant or Grout. This is allowing the ingress of water

The presence of water encourages Termite attack, Mould and Fungal Decay.

A Tiler or General Handy person must be contacted as soon as possible to effect repairs and prevent further deterioration.

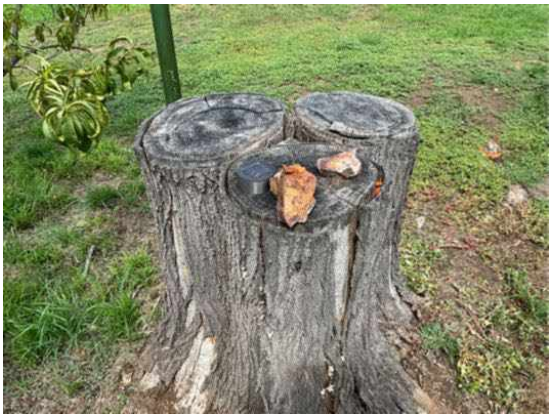
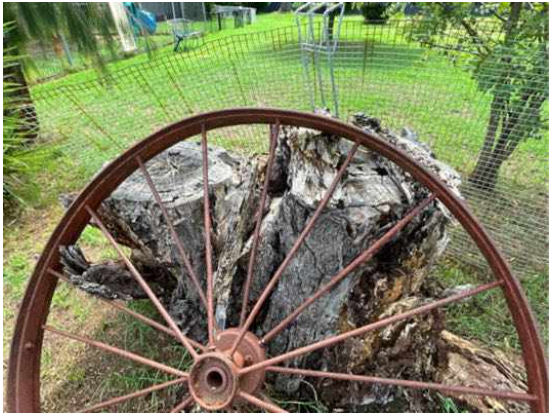
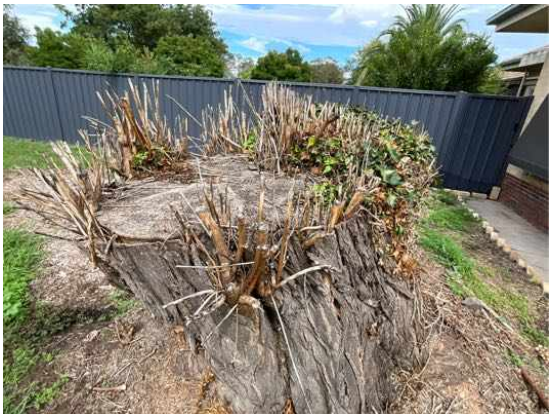
Finding 6.06

Building:	Building 1
Location:	Yard - Back, driveway
Finding:	Tree Stump in Ground
Information:	Any tree stumps in the yard not removed during the tree removal process provides the opportunity for Termite infestation and is likely to be subject to decay from damp conditions against the stump.

Services for tree stump removal should be contacted as soon as possible to reduce the risk of timber pest attack.

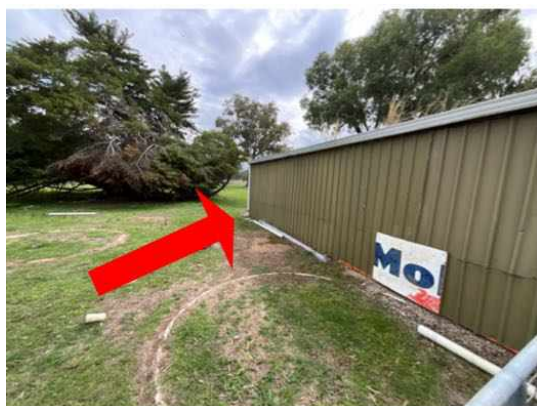
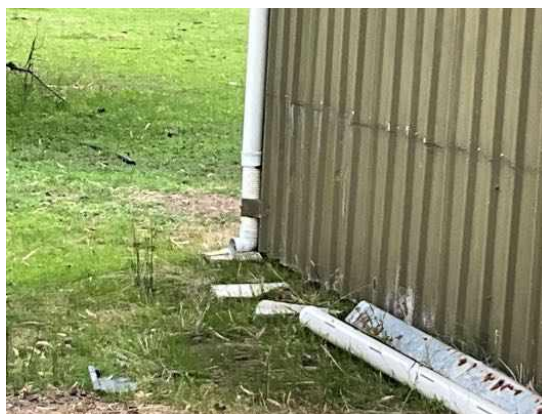
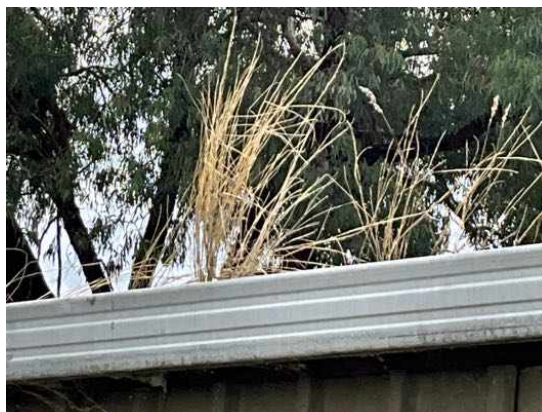
Where roof plumbing doesn't drain adequately, the area at the base perimeter can become excessively damp, potentially creating an environment that is susceptible to rust and corrosion of surrounding building elements, as well as attracting termites and other pests.

It is highly recommended that a plumber be appointed to further inspect the area and to install adequate drainage equipment where necessary.

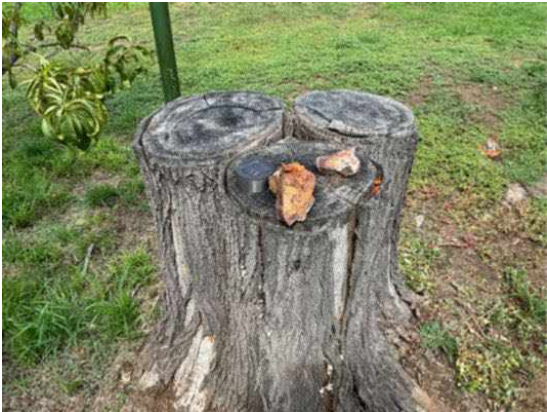
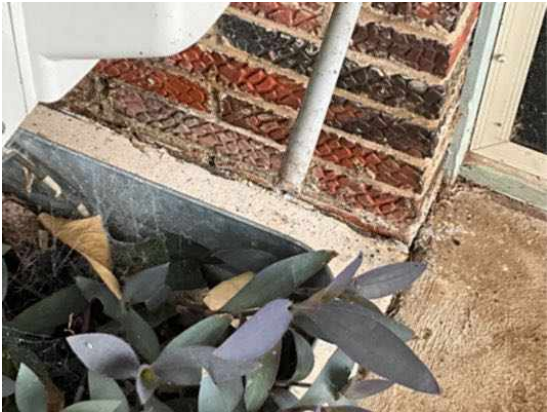
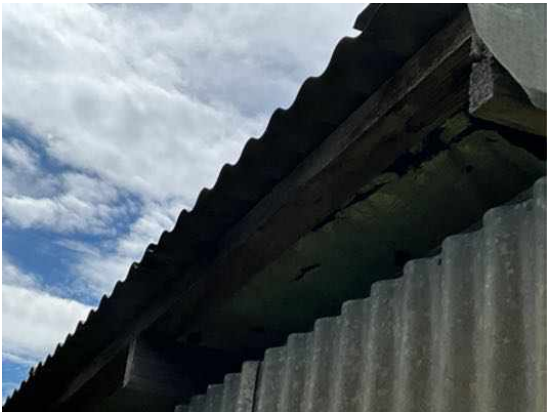
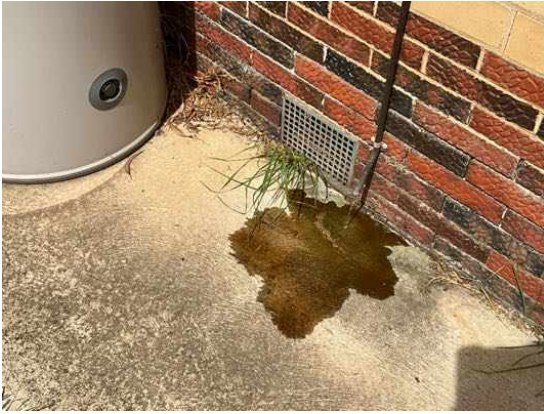
Finding 6.09

Building:	Building 1
Location:	All External Areas
Finding:	Termite Management System - no evidence of a chemical installation
Information:	The application of a post-construction chemical termite barrier is highly recommended for all properties, particularly if live termite activity has been found on the site previously. Such barriers are highly effective in preventing termite attack on any timber building elements throughout the property.

A durable notice should be placed in the switchboard unit to indicate current termite barriers. At the time of inspection, it appeared as though no termite management system has been installed, with no evidence to suggest preventative works taking place.

There is no evidence of previous Termite Management services. The property has factors that are Conducive to Termite attack. A Licensed Pest controller should be contacted soon to advise on a Termite Management Plan and avoid potentially costly repairs.

The client may consider gaining further advice from a pest controller as to the costs and procedures involved with this application. It is recommended that obtaining such advice be a short-term priority.

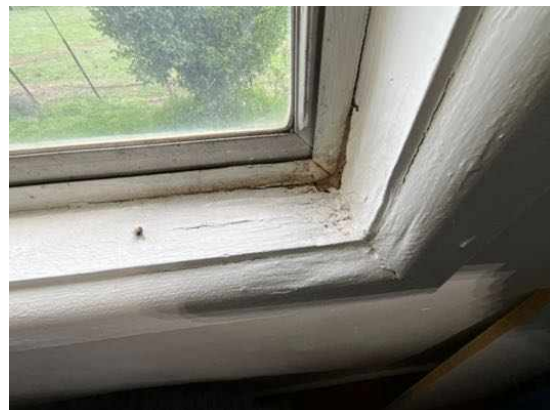
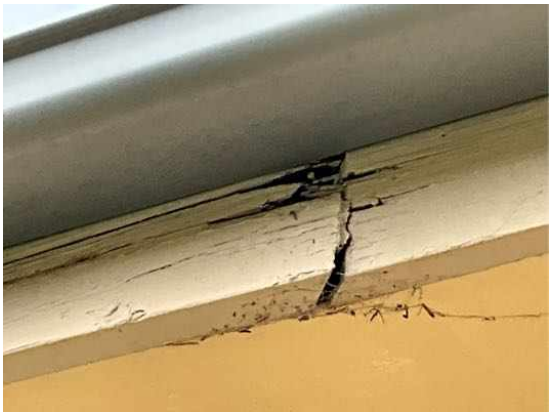
Finding 7.01

Building:	Building 1
Location:	Studio, eaves
Finding:	Fungal decay - present (localised)
Information:	Fungal decay also known as wood decay or wood rot generally refers to the deterioration of timber elements when in contact with excessive levels of moisture for a prolonged period of time.

The development of fungal decay is accelerated by temperatures in the range of 5degreeC to 40degreeC as well as the presence of oxygen. Generally fungal decay develops on timber elements that are in use in an external environment which are exposed to rain penetration.

In this case although the affected timber element is in a decaying state the extent of any visible damage appears to be localised to a specific area and is yet to spread to other parts of the building element or affect adjoining structures. The fungal decay is therefore likely to be of a relatively superficial nature with minimal impact on the structural integrity or tensile strength of the timber element.

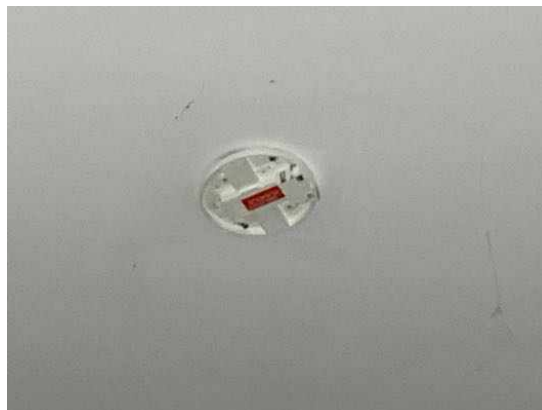
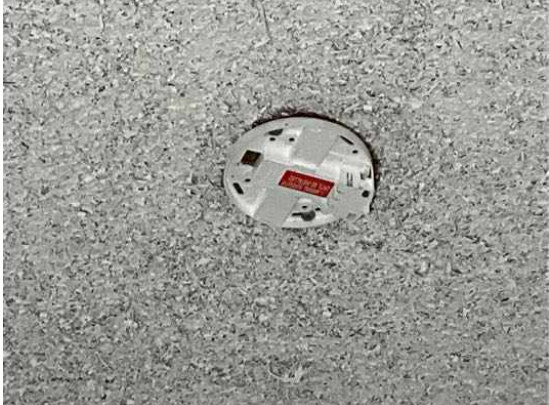
Please note that this defect is highlighted as a caution only. We suspect, based on our experience in the building industry, that the absence of smoke detectors, or their poor condition, should be addressed as a matter of urgency to improve occupant safety.

Always ensure sufficient working and suitable smoke detectors are installed prior to occupying any building. Additionally, it is advised that all smoke detectors be tested by the homeowner on a monthly basis.
