Building and Timber Pest Inspection Report

Inspection Date: Wed, 21 Jan 2026

Property Address: 5 Pinetree Ave, Cranebrook NSW 2749,
Australia

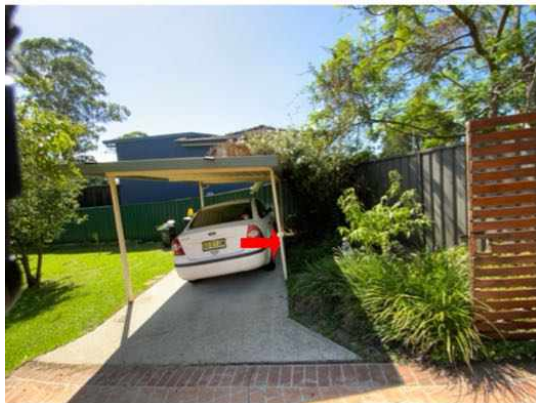
Finding 1.01

Building: Main Building
Location: Carport
Finding: Carport wobbly
Information: It was noted that the carport is lopsided and wobbly due to the substandard workmanship ,which can be a safety hazard.

A qualified carpenter should be contacted to assess and make good

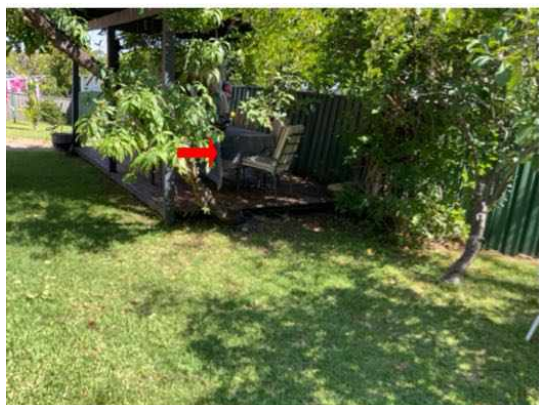
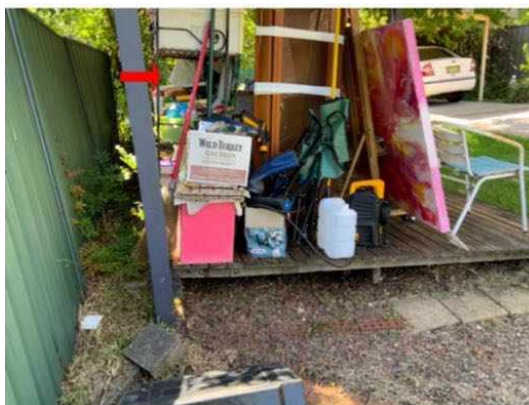
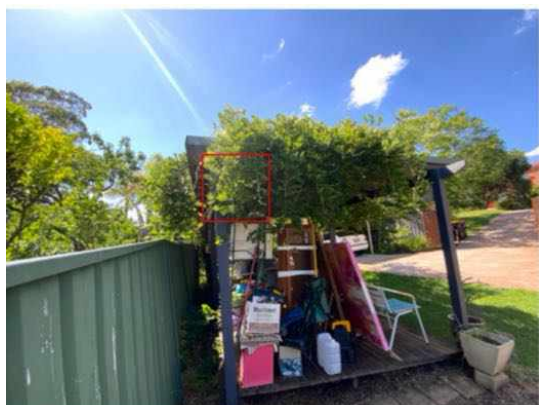
Finding 1.02

Building: Main Building
Location: Pergola
Finding: Structure - Old and non-compliant
Information: This structure, whilst appearing to provide adequate structural support, does not comply with contemporary building practices and current Australian Standards.

Although this is not a requirement in older homes, the client should be aware of the age and non-compliance of the structure when planning any repairs or remodelling.

It is advised that this structure be inspected by a registered builder or structural engineer on a relatively frequent basis to ensure that the structural integrity does not falter over time.

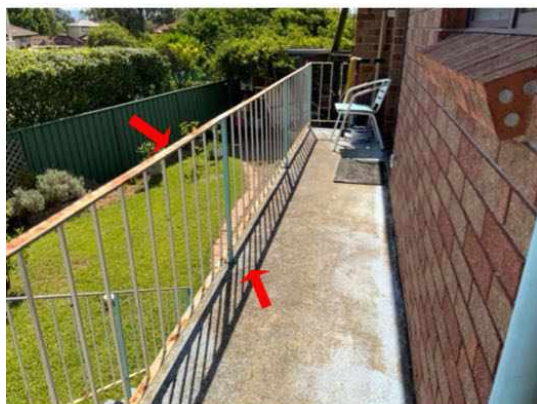
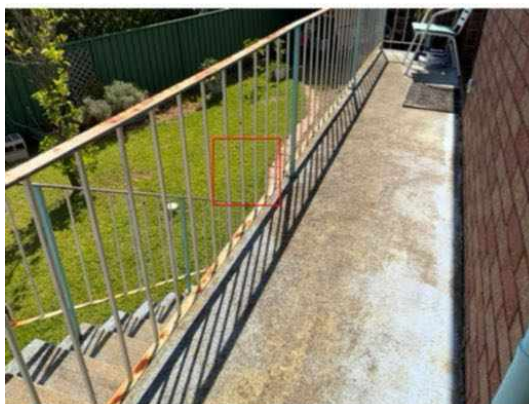
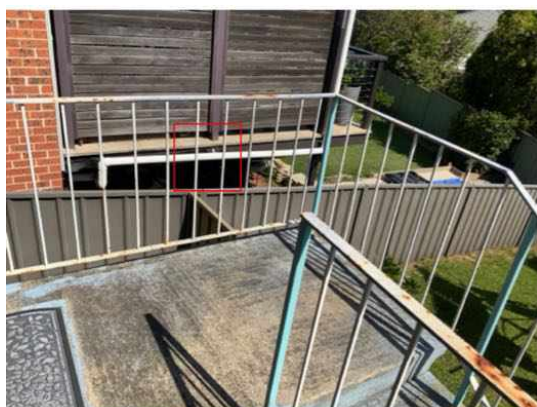
Finding 1.03

Building:	Main Building
Location:	Exterior walls - rear
Finding:	Balustrade - Suspected Non-Compliance
Information:	The balustrade was measured and found to be less than the present building regulation requirement of 1000mm high. Additionally the gaps between the balustrade cladding were found to be greater than the present building regulation requirement of 125mm.

This defect creates a potential safety hazard and should be rectified as soon as

possible to ensure the safety of the area and to meet present building standards and regulations.

A registered builder should be contacted to discuss possible rectification solutions.

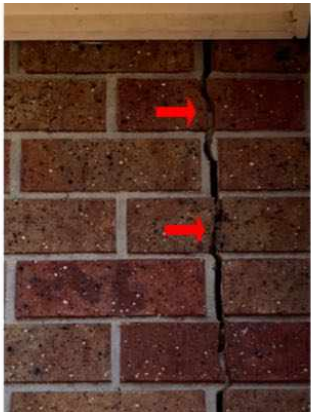
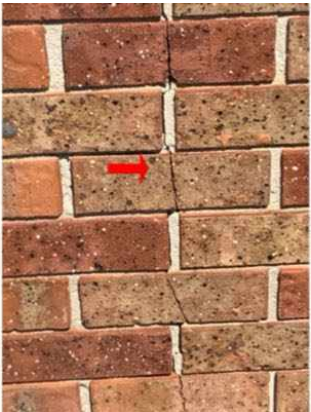
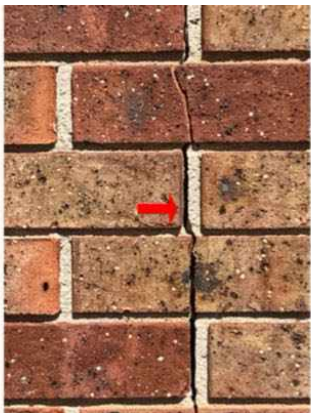
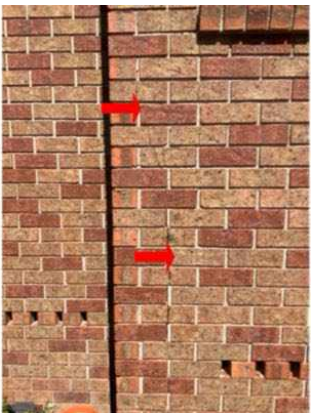
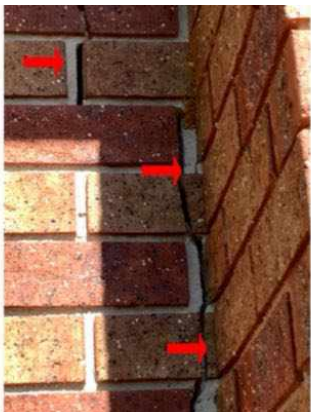
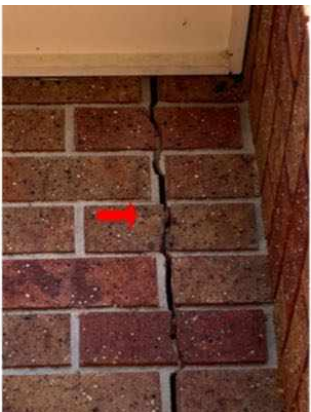
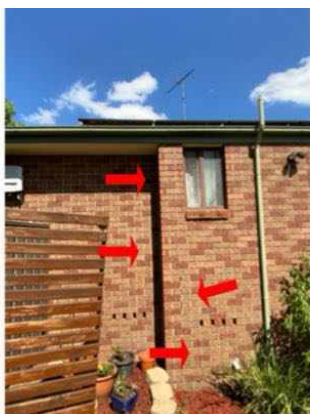
Finding 2.01

Building:	Main Building
Location:	Exterior walls - right side
Finding:	Brickwork - Cracking [Repair required]
Information:	Major cracking was identified to the brickwork in this area. Cracks of this type are likely to have been caused by minor expected movement of building elements, but may also have a structural cause that is more significant.

Please note that the owner told me that there was a rainwater tank along the wall and was leaking .

A qualified bricklayer should be contacted immediately to estimate and perform repair and restoration works. Consultation with a structural engineer may be required where structural instability is found to be the underlying cause of the cracking.

Always contact a building inspector should cracks widen, lengthen, or become more numerous.

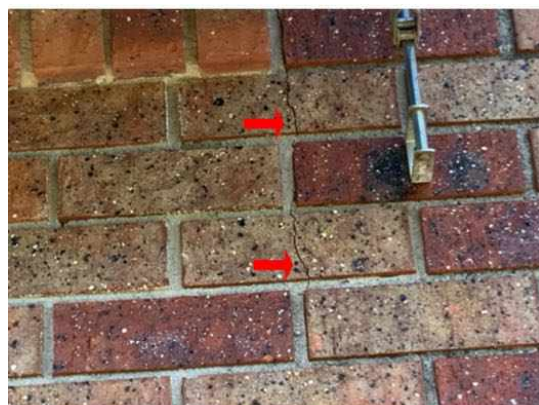
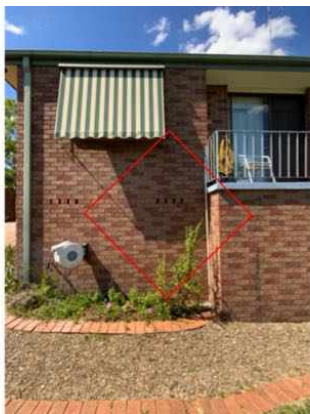
Finding 2.02

Building:	Main Building
Location:	Exterior walls - rear
Finding:	Subsidence
Information:	It appears that the wall structure has been affected by movement of the foundations, often referred to as sinking or subsidence. Whilst a degree of movement is expected in subfloors over time, especially as environmental conditions change and buildings 'settle' after construction, this degree of subfloor movement requires attention.

General subsidence is usually initiated by changes in soil moisture content. The most critical factor is identifying the specific causes, and identifying if this is a recurring or ongoing problem, or one that has been resolved by previous works in the past.

Subsidence can have complex and varying causes, which will influence the required remedial works. It is advised to begin by consulting a structural engineer to determine the required scope of works. This generally includes some form of underpinning, as well as addressing the underlying cause. Consultation with a geotechnical engineer may also be necessary where changes to soil moisture content is apparent.

A Registered Builder specialising in re-stumping would then generally carry out works as advised by an Engineer.

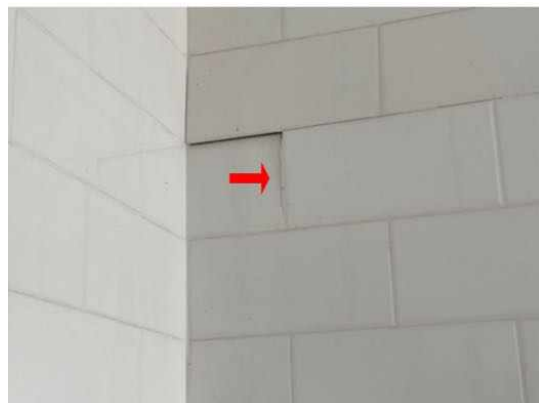
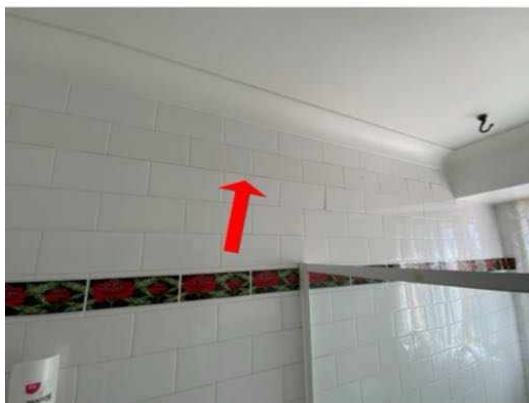
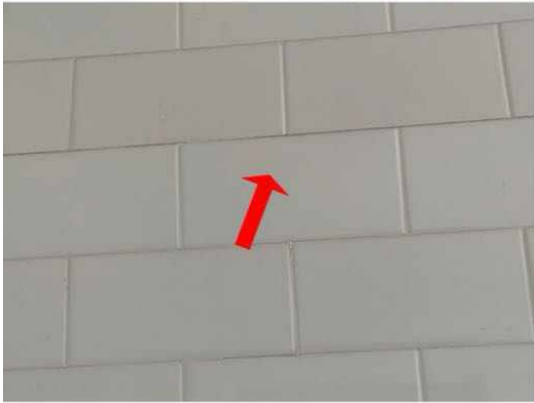
Finding 2.03

Building:	Main Building
Location:	Bathroom
Finding:	Tiles - Drummy
Information:	Drummy tiled areas were identified at the time of inspection. The term 'drummy' refers to tiles that have become detached from their fixing, despite otherwise being in relatively good condition. Such defects are generally caused by physical or moisture damage to the area. Drummy tiled areas may also be a direct result of poor workmanship during the construction process.

Tiled areas may swell and shrink with changes in air humidity if the area has sustained moisture damage. Any exposure to moisture is capable of causing tiled areas to become drummy and/or cracked over a prolonged period of time. Drummy tiled areas generally require removal and replacement of affected tiles, with adequate sealant and grouting.

Specialist trades are available for these types of services. A registered builder may be required to undertake works if damage is extensive or if secondary building defects have resulted. Otherwise, it is advised that a tiling contractor be appointed to perform works as necessary. Immediate action is recommended to ensure that no further damage is sustained in the affected area.

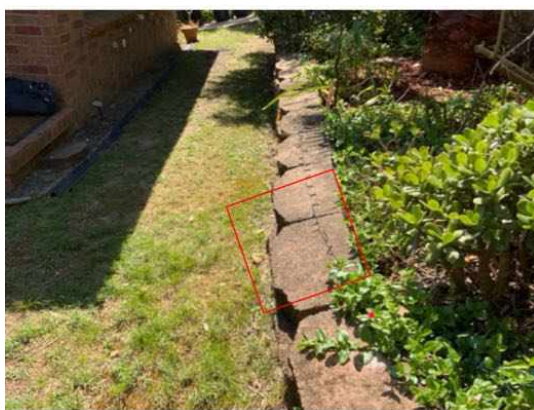
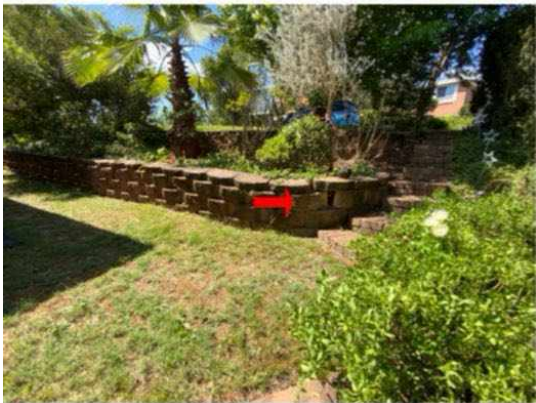
Finding 3.01

Building: Main Building
 Location: Exterior walls - front
 Finding: Retaining wall - Defective
 Information:

The retaining wall in this area was found to be defective at the time of inspection. Generally, defective retaining walls are caused by poor original design or material use. However, deteriorated retaining walls may also be a result of substandard construction, poor site drainage or unmanaged stormwater flows.

Significant repair and replacement should be expected. Where retaining walls are considered structural walls, a structural engineer / surveyor should be consulted regarding required remedial works. Otherwise, a landscaper or retaining wall installer may be appointed to repair or replace the wall, at the discretion of the client.

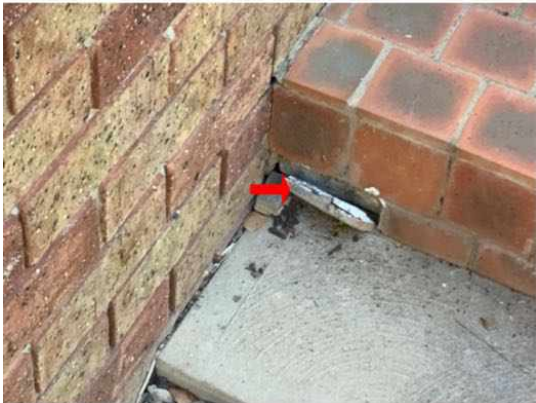
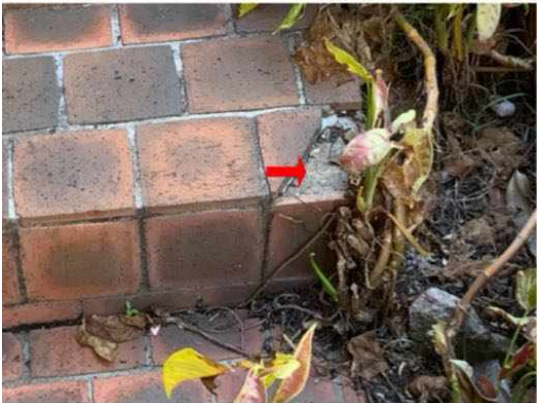
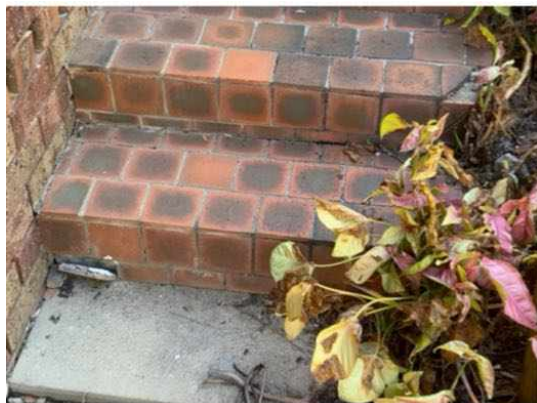
Finding 3.02

Building: Main Building
Location: Exterior walls - front
Finding: Cracked floor tiles
Information: Cracking in the floor tiles was evident in this area at the time of inspection. It is suspected that this cracking has occurred as a result of minor accidental damage .

Cracked tiles throughout the household detract from the overall appearance of the affected areas however it is unlikely to create or lead to any secondary defects.

While not considered a matter of urgency, replacement of cracked floor tiles is recommended at the clients discretion. A tiling contractor may be appointed to perform these works. Where cracks become more numerous, contact a licensed building inspector for further investigation.

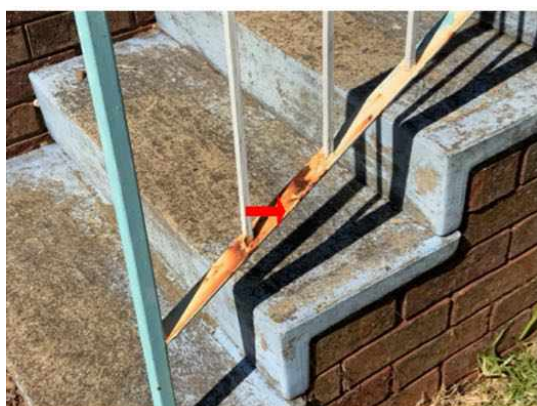
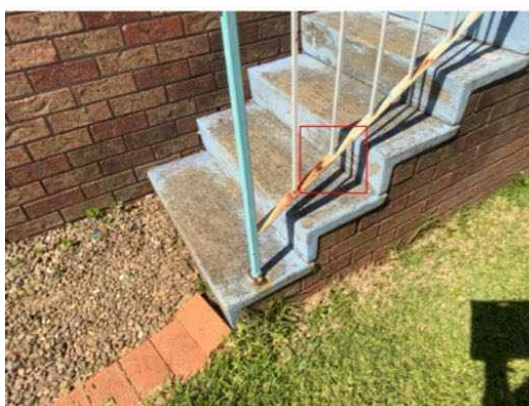
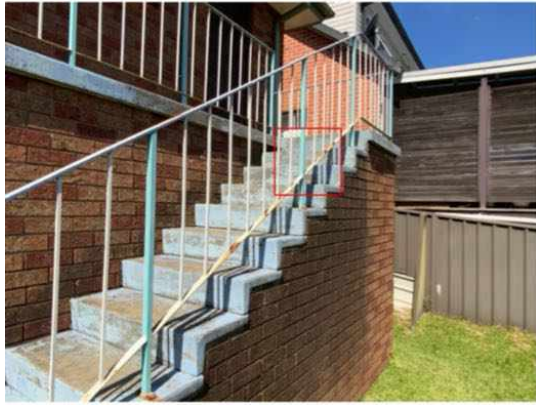
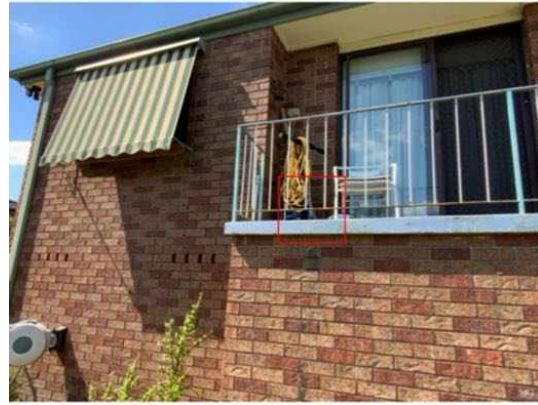
Finding 3.03

Building:	Main Building
Location:	Exterior walls - rear
Finding:	Building element - Rusted or corroded
Information:	The handrail shows evidence of rusting and corrosion, which is likely to have developed as a result of excessive exposure to moisture and or inadequate coatings.

As surface rust provides no protection to the underlying iron, the deteriorating condition is likely to worsen if not addressed in the short-term future.

Where possible, the use of galvanized (treated) metals or aluminium coated metals aid in rust prevention, as does regular general maintenance. Rust formation can be controlled with coatings, such as paint, that isolate the iron from the environment.

Rusting and corrosion should be managed by ideally removing or limiting the affected surface from exposure to moisture. A registered builder may be appointed to replace any building elements that have been severely affected by rust or water damage.

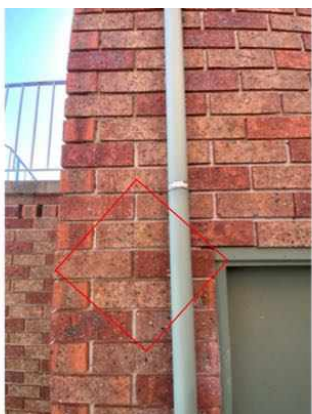
Finding 3.04

Finding: Brickwork - Cracking [Fine]

Information: Although fine cracks are quite noticeable, they are often only considered to be an appearance defect and usually do not indicate any structural damage. Generally, the cause of a fine crack is indicative of a separation between brickwork and mortar throughout the structure, but single bricks may also show cracks of this nature.

Cracking of this nature can generally be repaired with minor filling and should be conducted by a qualified bricklayer.

Always contact a building inspector should cracks widen lengthen or become more numerous.

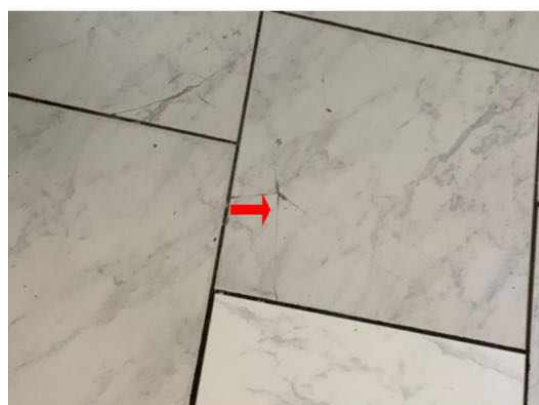
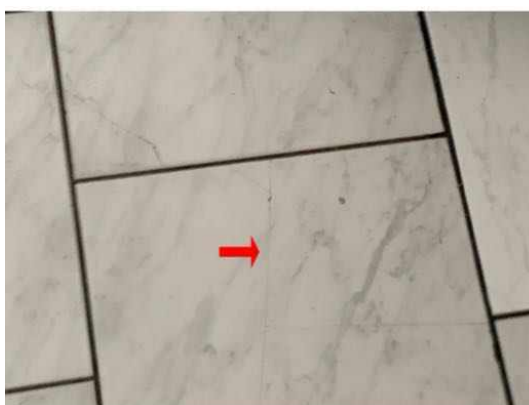
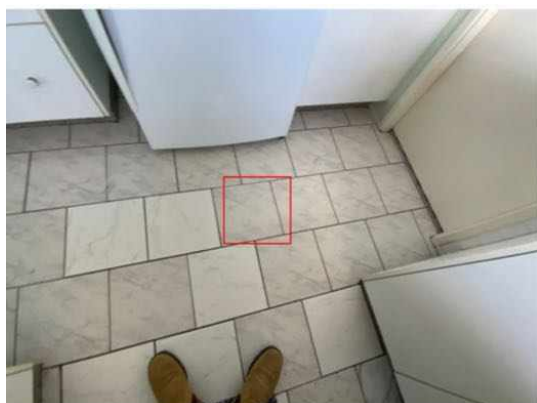
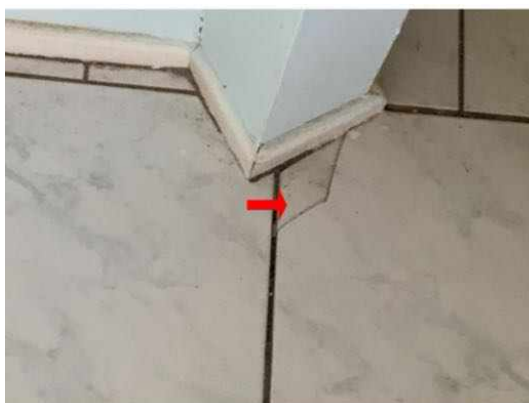
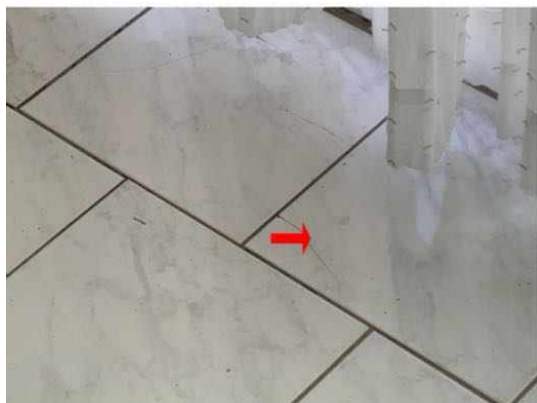
Finding 3.05

Building:	Main Building
Location:	Kitchen/hallway
Finding:	Floor tiles - Cracked
Information:	Cracking in the floor tiles was evident in this area at the time of inspection. It is suspected that this cracking has occurred as a result of the floor being uneven and lacking a solid or suitable foundation for the tiles to be laid on. Settlement in the floor foundations may also have caused movement and resulted in the cracking of tiles in this area.

Cracked tiles throughout the household detract from the overall appearance of the affected areas, as well as creating potential for water penetration to adjoining building elements. If left unmanaged, water damage may occur as a result of constant water penetration over a prolonged period of time.

While not considered a matter of urgency, replacement of cracked floor tiles is advised as a solution. A tiling contractor or general handyperson may be appointed to perform these works at client discretion. Where cracks become more numerous, consultation with a registered builder specialising in re-stumping may be required.

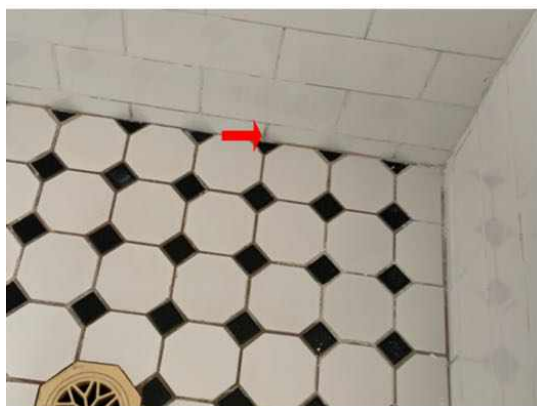
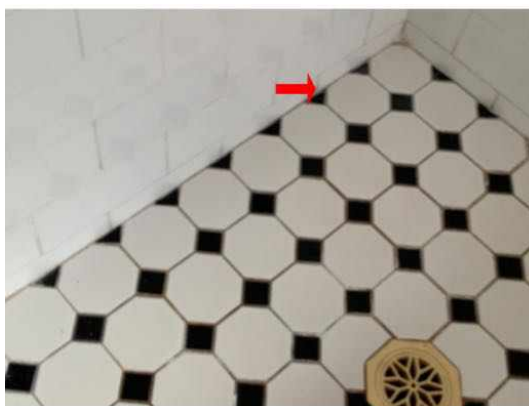
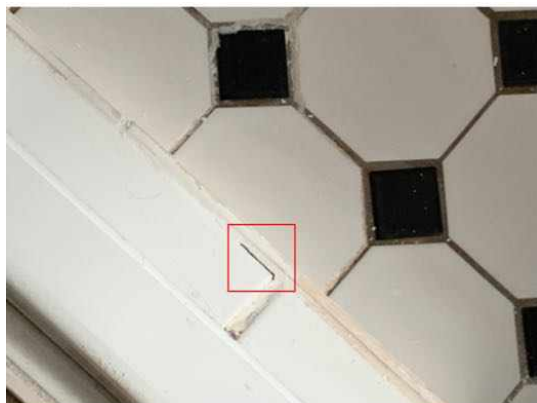
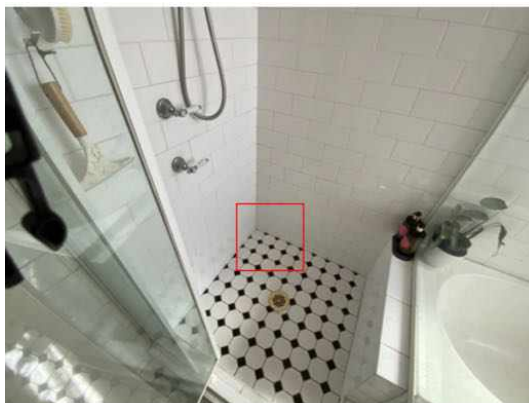
Finding 3.06

Building:	Main Building
Location:	Bathroom
Finding:	Sealant and grouting - Missing or damaged
Information:	It was noted on inspection that sealant or grout is degraded to the tiled shower alcove and or other areas of the bathroom.

Different materials and floor areas move at different rates, generally causing cracking to grout or sealant at this point. A flexible sealant is required to allow for expected expansion and contraction, while keeping the joint water tight and protective of all associated building materials.

Flexible and mould resistant materials should be applied to affected areas to prevent any subsequent water damage that is likely to occur. Regular maintenance and replacement of damage or missing or damaged sealant and grout is highly recommended to the wet areas, as this is a regular wear and tear defect. Sealant and grouting in areas that come into regular contact with water should be maintained for the long term care of your property.

A sealant specialist or tiling contractor should be appointed to complete these works as soon as possible

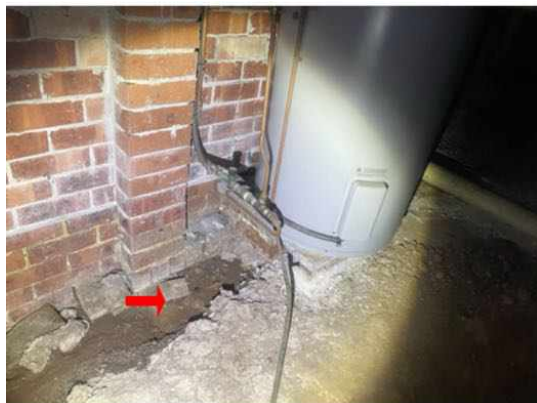
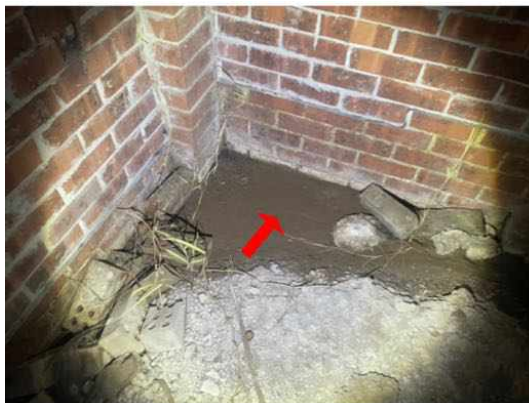
Finding 3.07

Building:	Main Building
Location:	Subfloor
Finding:	subfloor drainage poorly drained
Information:	Poor drainage leads to excessive moisture, entering the subfloor area and being retained in the soil, which overtime can destabilise the foundations and promote timber pest activity such as fungal decay and termite.

Note: The effect of poor drainage on foundations is often dependent on the soil type. Establishing soil type is beyond the scope of the standard prepurchase inspections. Also, timber pest activity, including termites, and fungal decay, commonly associated with poor drainage.

Generally, to ensure that water drains away from the footings, the profile of the ground adjacent to the building should slope away from the base of the exterior walls, and all stormwater drainage should be maintained in good condition and free from blockage.

If the ground level of the subfloor area is fully or partly below, the surrounding ground level, then well designed retaining walls with appropriate drainage are required to prevent water entering the subfloor area.

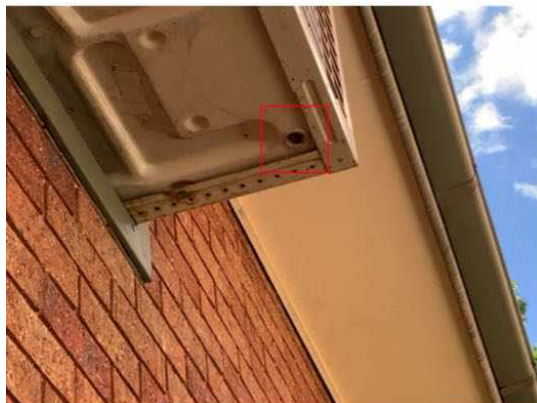
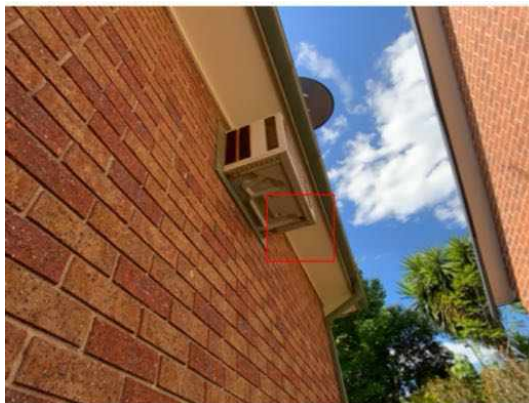
Building:	Main Building
Location:	Exterior walls - right side
Finding:	Air conditioner - Disconnected overflow
Information:	The Air Conditioner (A/C) overflow was found to be disconnected from storm water drainage and is creating excessive moisture in the surrounding area.

Such leaking creates an environment which is conducive to an array of defects, including water damage to associated building elements and the attraction of termite or timber pest infestation.

It is highly recommended that a licensed plumber be appointed to connect the A/C overflow in order to prevent such an environment from being created. These minor works should be carried out as soon as possible.

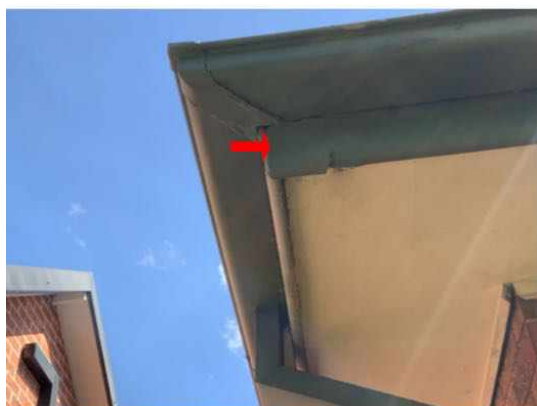
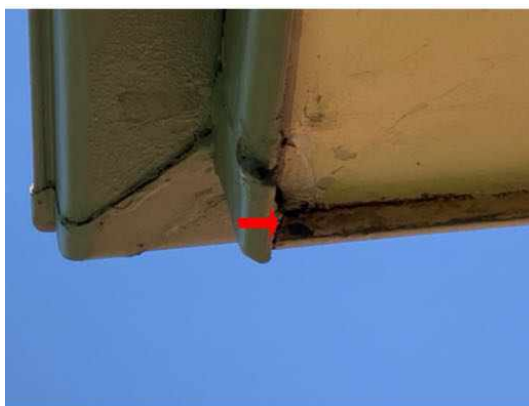
Finding 7.01

Building:	Main Building
Location:	Exterior walls - front
Finding:	Fascias - Wood rot
Information:	Wood rot was found to be affecting fascias and barges in this area, evidenced by the presence of mould on the surface in some areas. Wood rot, also known as Fungal Decay, occurs when timbers and other cellulose building materials are exposed to damp conditions on an ongoing basis.

It is likely that this wood rot has developed as a result of faults in the roof plumbing, creating excessive moisture in this areas. Frequent exposure to rain and other weather conditions also make fascias and barges susceptible to accelerated deterioration.

Early intervention and regular maintenance will prolong the useful life of these building elements. Prior to any works being performed, the cause of the moisture that has created the visible wood rot should be identified and addressed in a suitable manner.

It is advised that a roof plumber be appointed to inspect all roof plumbing and subsequently identify the cause of the wood rot. Replacement of affected fascias and barges may then be a necessary step in protecting surrounding building elements from such deterioration.

A qualified plumber may be appointed to assess the cause of excessive moisture and to provide advice on any remedial works as required. A qualified carpenter or registered builder may also be required to replace affected building materials.

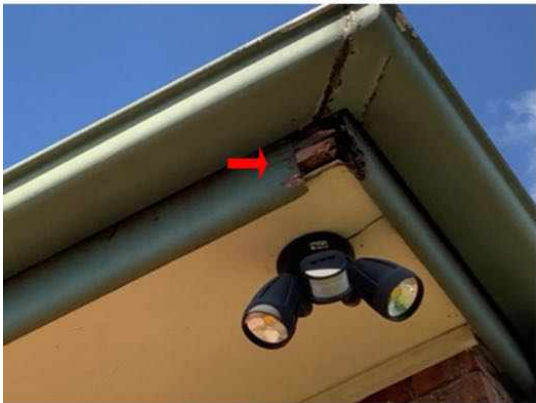
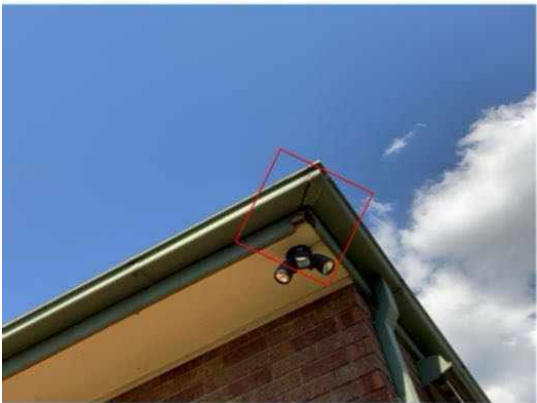
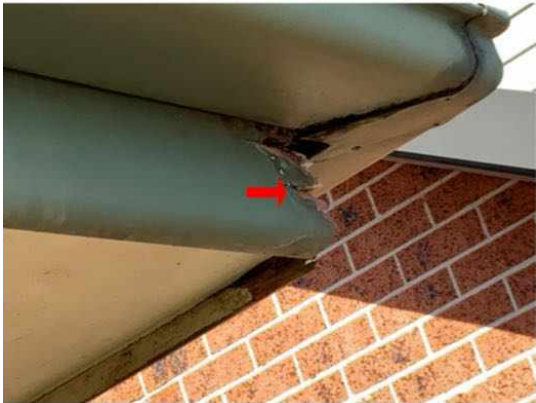
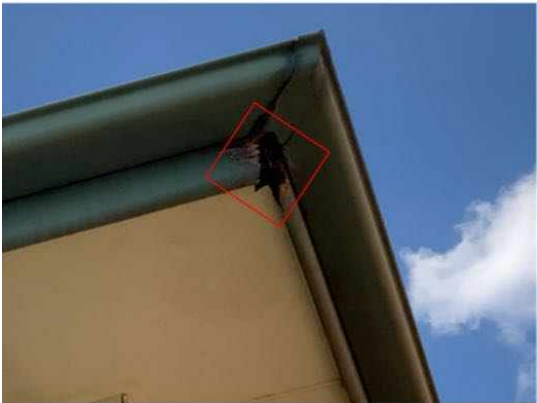
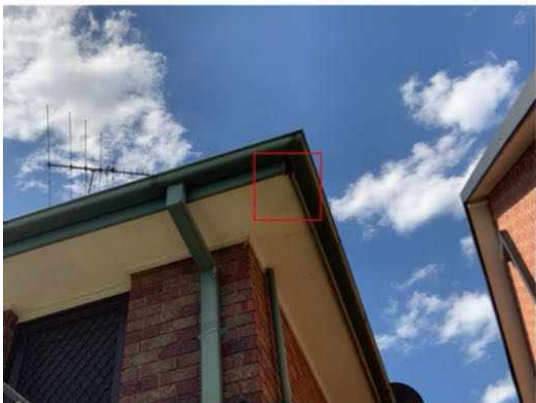
Finding 7.02

Building:	Main Building
Location:	Exterior walls - rear
Finding:	Fascias - Wood rot
Information:	Wood rot was found to be affecting fascias and barges in this area, evidenced by the presence of mould on the surface in some areas. Wood rot, also known as Fungal Decay, occurs when timbers and other cellulose building materials are exposed to damp conditions on an ongoing basis.

It is likely that this wood rot has developed as a result of faults in the roof plumbing, creating excessive moisture in this areas. Frequent exposure to rain and other weather conditions also make fascias and barges susceptible to accelerated deterioration.

Early intervention and regular maintenance will prolong the useful life of these building elements. Prior to any works being performed, the cause of the moisture that has created the visible wood rot should be identified and addressed in a suitable manner.

It is advised that a roof plumber be appointed to inspect all roof plumbing and subsequently identify the cause of the wood rot. Replacement of affected fascias and barges may then be a necessary step in protecting surrounding building elements from such deterioration.

A qualified plumber may be appointed to assess the cause of excessive moisture and to provide advice on any remedial works as required. A qualified carpenter or registered builder may also be required to replace affected building materials.

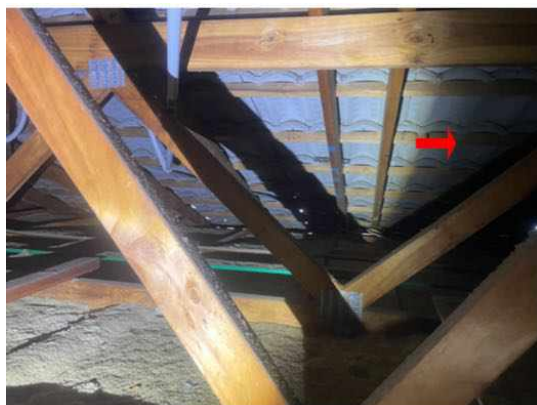
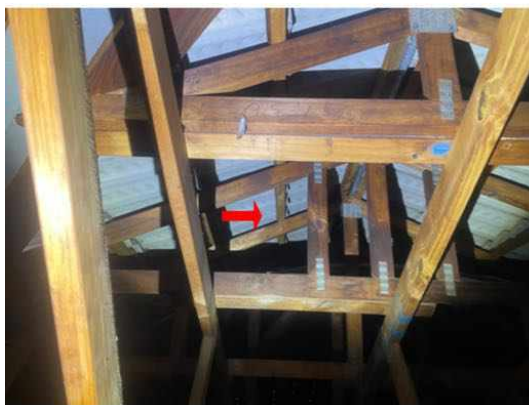
Building: Main Building
Location: Roof Void
Finding: Sarking - Missing
Information: Sarking is missing under the roof sheeting. Sarking acts as an insulator that helps with noise reduction and protects against water penetration. Sarking plays a key role in the operation and function of the overall roofing structure and its performance.

Although not a requirement at the time of construction, replacement of any missing building element is advisable (although this can be quite expensive to do after the time of construction). Where sarking is missing, regular inspections of the roof tiles for cracking and potential moisture penetration is required.

Sarking may be retrospectively fitted by a registered builder at the discretion of the client.
