Building and Timber Pest Inspection Report

Inspection Date: Thu, 12 Mar 2026

Property Address: 5 Skilton Ave, Tatura VIC 3616, Australia

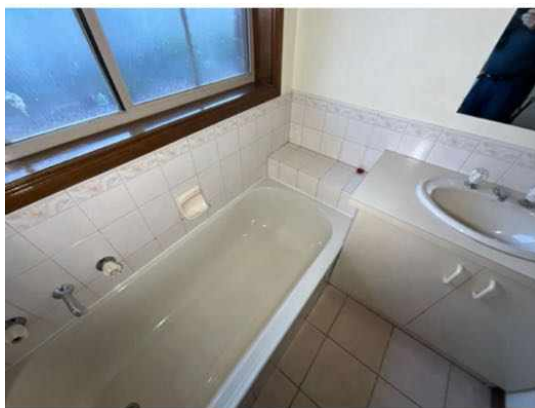
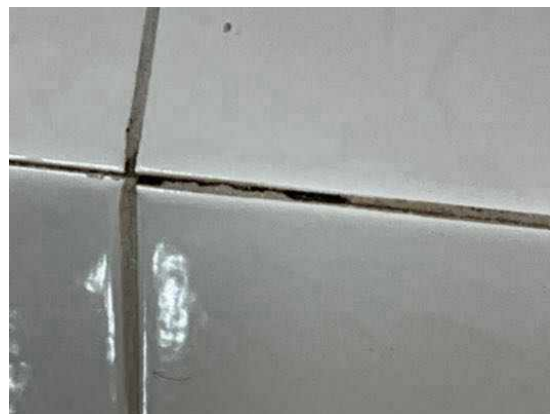
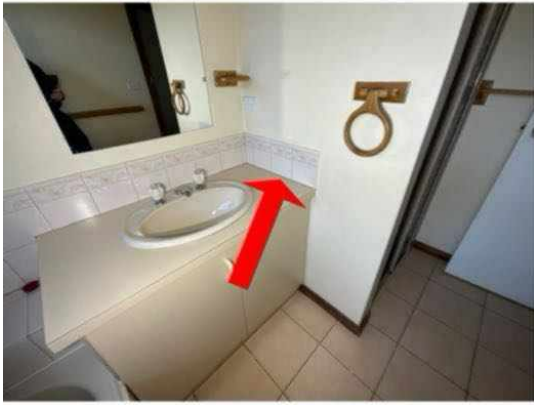
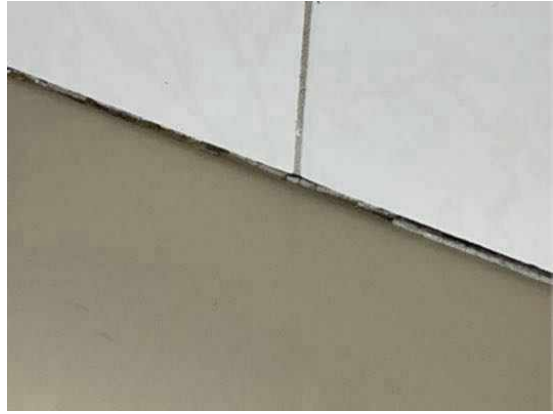
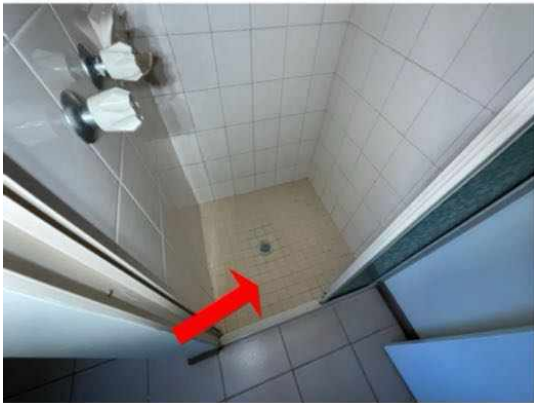
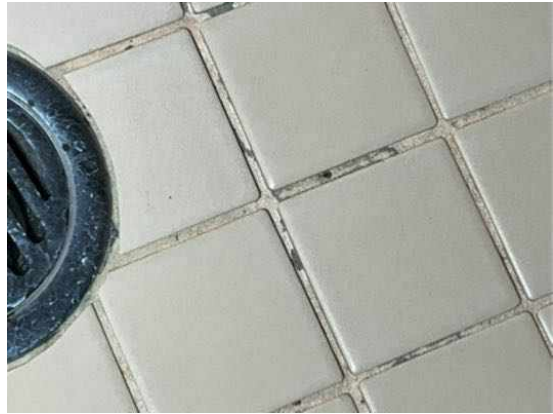
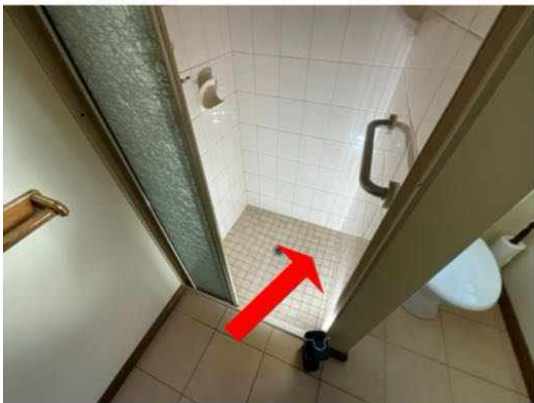
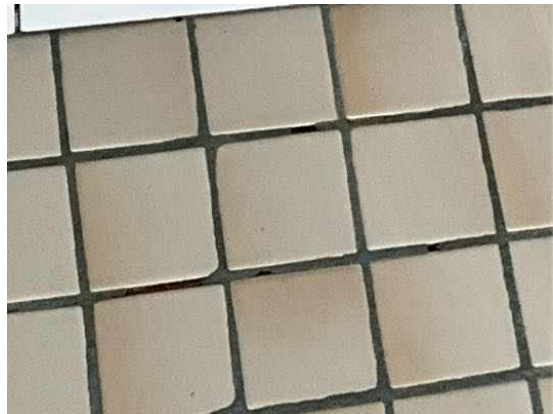
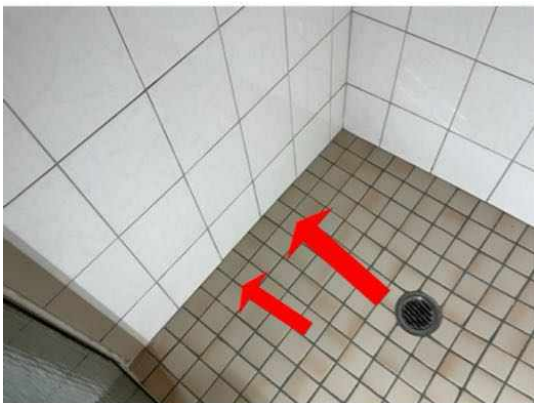
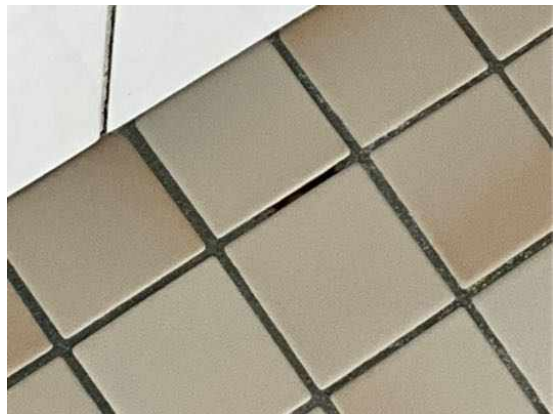
Finding 3.01

Building: Building 1
Location: Bathroom, ensuite
Finding: Inadequate sealant or Grout
Information: This area has a lack of effective Sealant or Grout. This is allowing the ingress of water to the structure inside the wall.

The presence of water encourages Termite attack, Mould and Fungal Decay.

A Tiler or General Handy person must be contacted as soon as possible to effect repairs and prevent further deterioration.

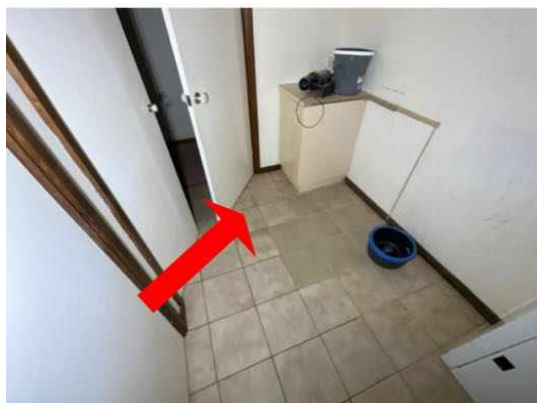
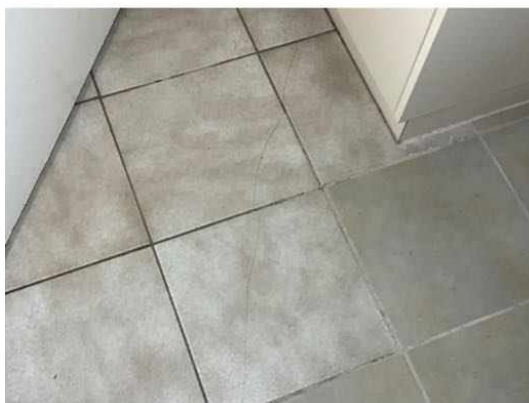
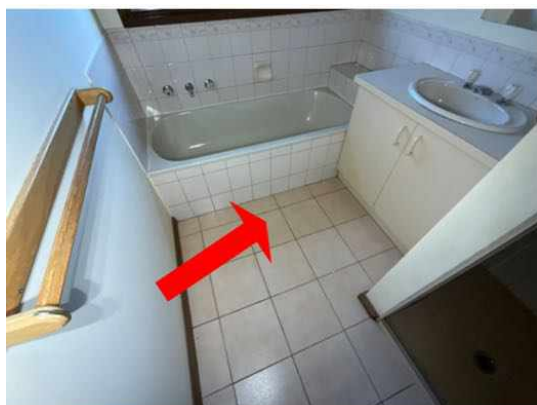
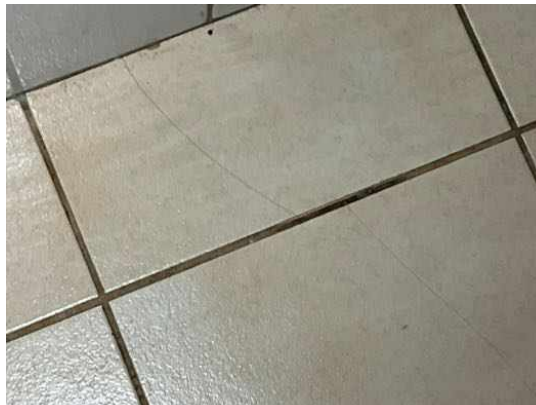
Finding 3.02

Building: Building 1
 Location: Laundry, bathroom
 Finding: Cracked floor tiles
 Information: Cracking in the floor tiles was evident in this area at the time of inspection. It is suspected that this cracking has occurred as a result of minor settlement or impact damage.

Cracked tiles throughout the household detract from the overall appearance of the affected areas however it is unlikely to create or lead to any secondary defects.

While not considered a matter of urgency, replacement of cracked floor tiles is recommended at the clients discretion. A tiling contractor may be appointed to perform these works. Where cracks become more numerous, contact a licensed building inspector for further investigation.

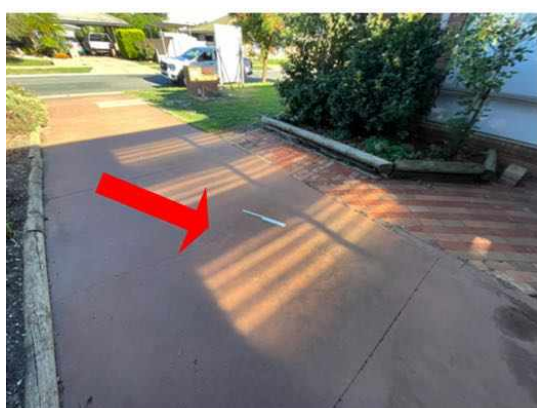
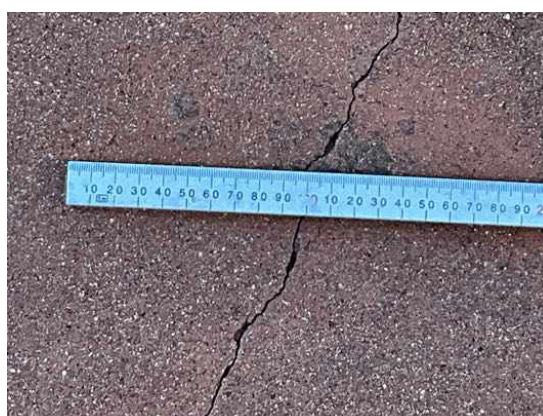
Finding 3.03

Building: Building 1
 Location: Driveway
 Finding: Cracking - External Concrete Paving Damage Category 1 - Fine (less than 2mm)
 Information: Fine cracks were identified in external concrete paving. Although fine cracks are quite noticeable, they are often only considered to be an appearance defect, and usually do not indicate any structural damage. To be considered a Category 1 or fine crack, the

crack is found to be less than 2mm in width.

Generally the cause of a hairline crack in existing concrete paving such as driveways and pathways is indicative of the expansion and contraction of the concrete. Such causes are generally due to environmental factors, such as moisture levels, weather conditions, root systems of nearby trees or the soil types on which they are laid.

Fine cracks may also be due to poor original installation of the concrete. Factors such as poor compaction of the sub surface and/or inadequate reinforcing of the slab may create cracking and other secondary defects.

Monitoring of all cracking should be conducted frequently. Always contact a building inspector should cracks widen, lengthen, or become more numerous.

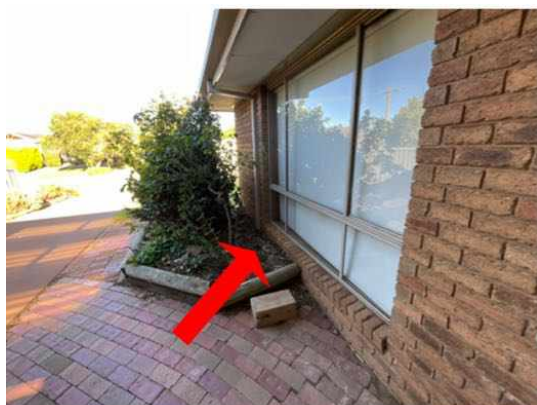
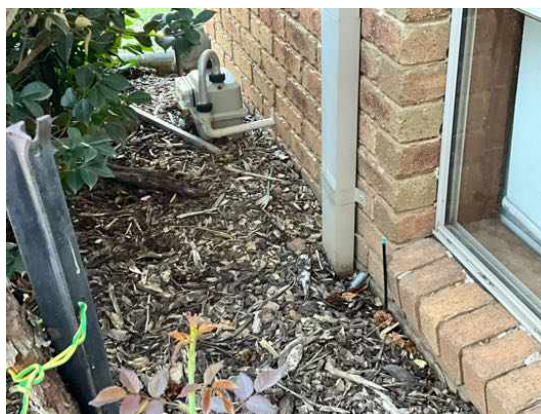
Finding 6.01

Building:	Building 1
Location:	Yard - Front
Finding:	Weep holes - Blocked
Information:	It was noted during the time of inspection that some of the weep holes to the brickwork were blocked. Weep holes are designed to allow water from leaks or seepages in brickwork to be directed to the external environment, prior to entering the wall cavity or associated building materials. Weep holes should therefore be kept clean

and free of debris or blockages.

Blocked weep holes are likely to result in the presence of excessive moisture within the brickwork and associated structures, creating potential for water damage and moisture problems.

Removal or lowering of the Garden bed will uncover the weep holes. Preventative works are necessary in ensuring the structural integrity of the affected brickwork and should be performed as soon as possible.

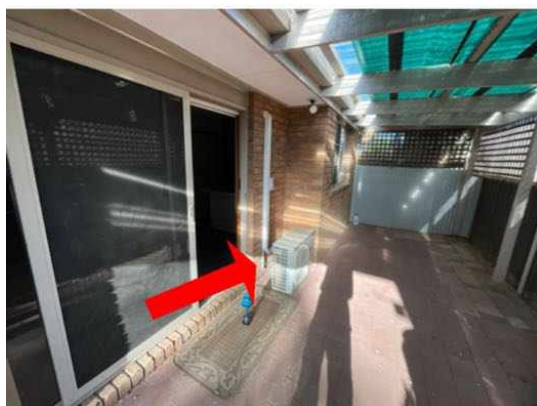
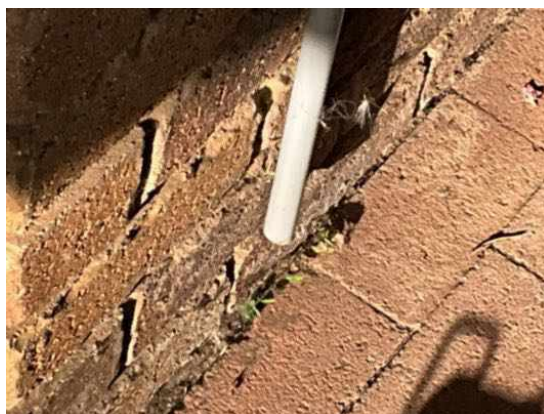
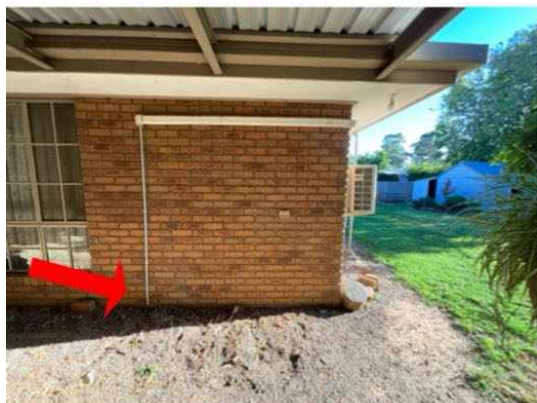
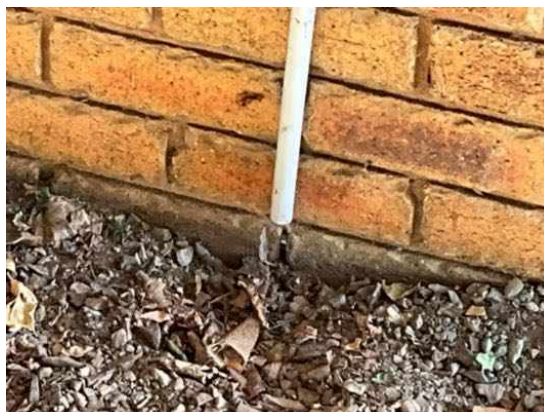
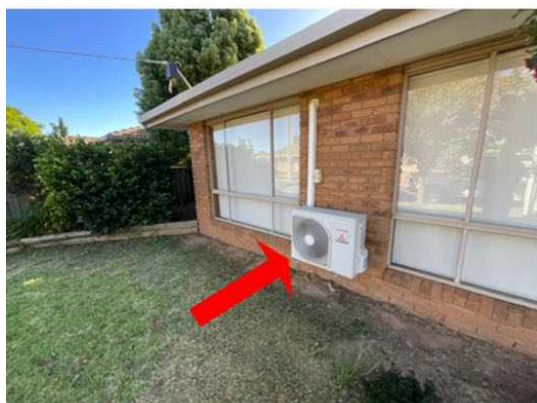
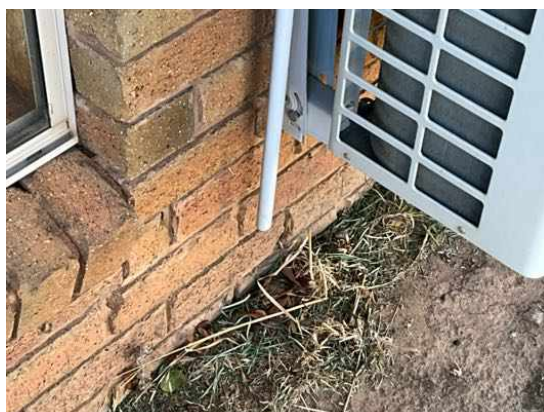
Finding 6.02

Building:	Building 1
Location:	Alfresco, carport, front yard
Finding:	Air conditioner - Disconnected overflow
Information:	The Air Conditioner (A/C) overflow was found to be disconnected from storm water drainage and is creating excessive moisture in the surrounding area.

Such leaking creates an environment which is conducive to an array of defects, including water damage to associated building elements and the attraction of termite or timber pest infestation.

It is highly recommended that a licensed plumber be appointed to connect the A/C overflow in order to prevent such an environment from being created. These minor works should be carried out as soon as possible.

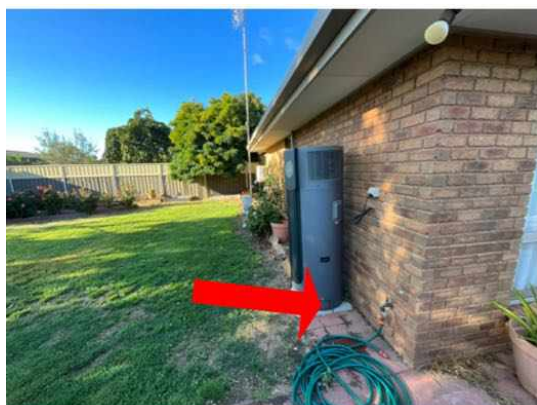
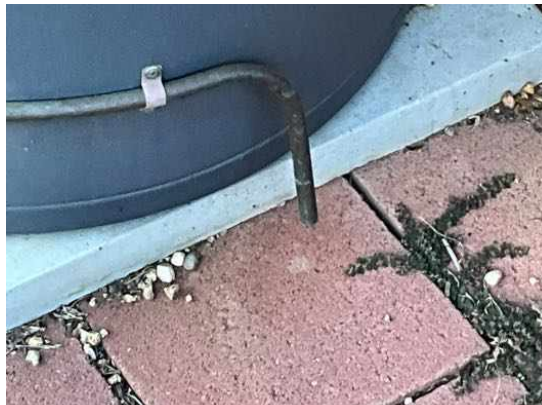
Finding 6.03

Building: Building 1
 Location: Yard - Back
 Finding: HWS Overflow - Not Connected
 Information: The Hot Water System (HWS) overflow was found to be disconnected from storm water drainage and is creating excessive moisture in the surrounding area.

These damp conditions can lead to secondary defects such as rot, rust or corrosion of associated building elements, the formation of fungal decay, or even the creation of potential slip hazards. When coupled with poor site drainage, pooling of water may also attract termite activity to this area.

It is highly recommended that a licensed plumber be appointed to connect the HWS overflow in order to prevent such an environment from being created. These minor works should be carried out as soon as possible.

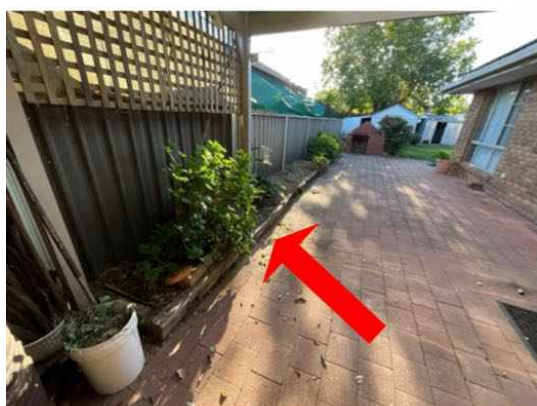
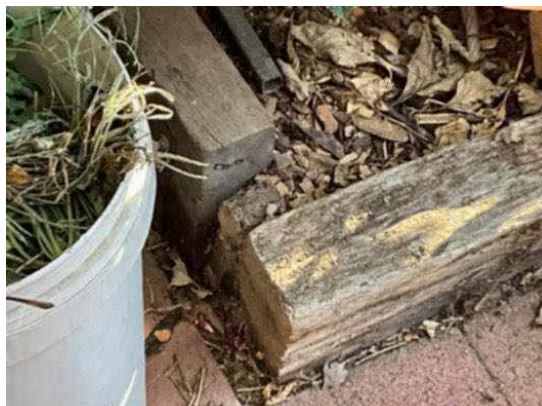
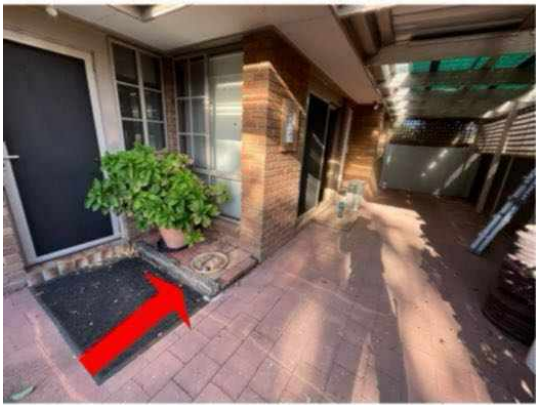
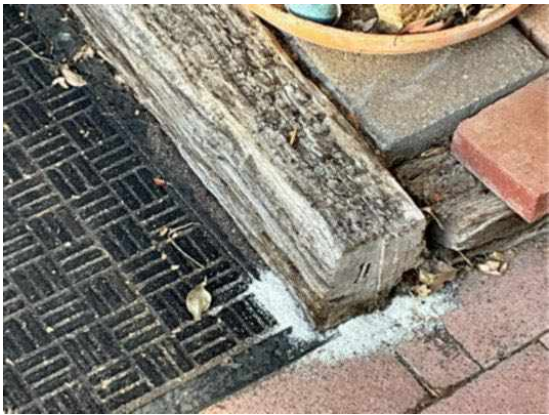
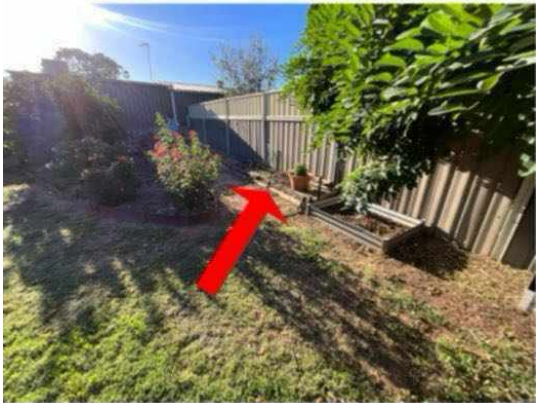
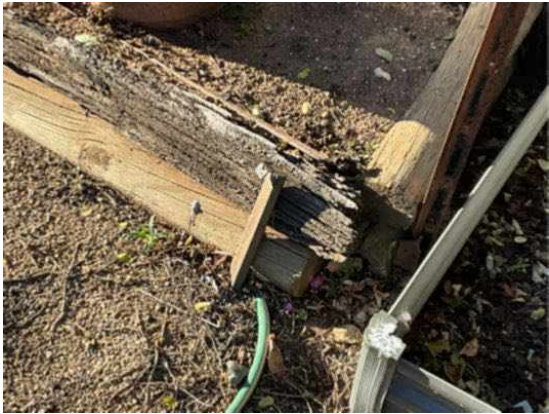
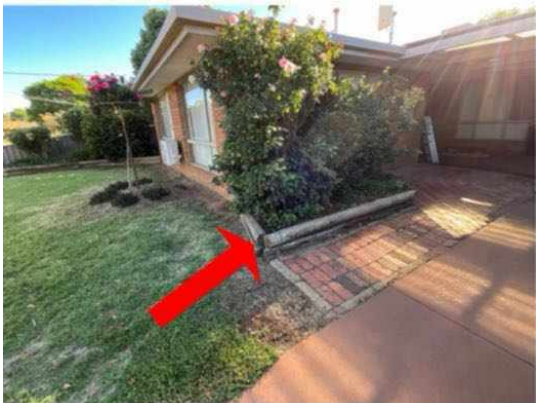
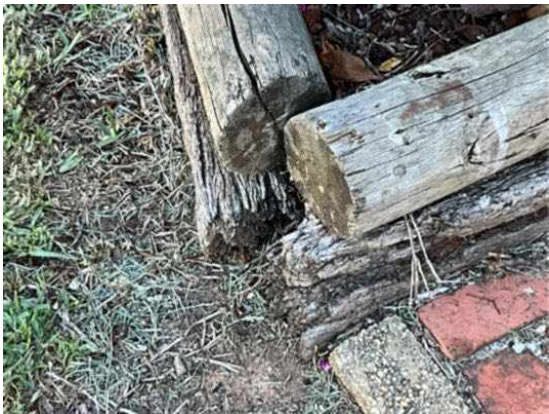
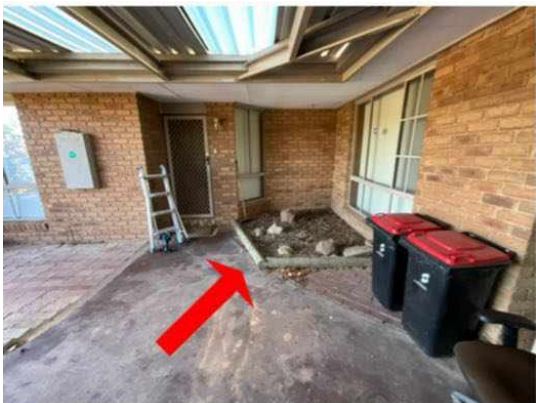
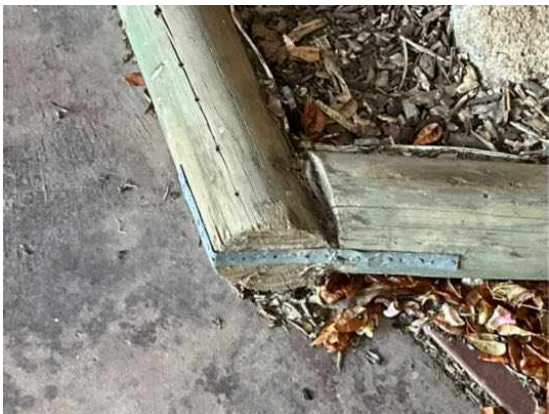
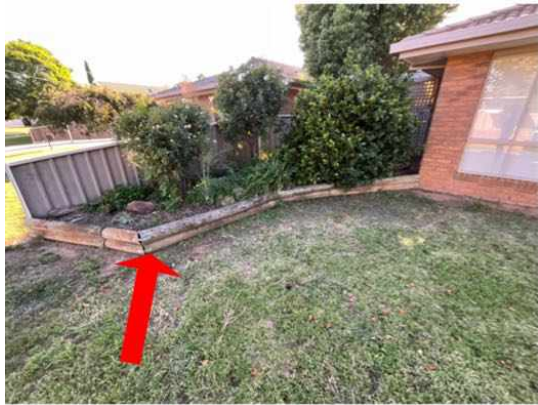
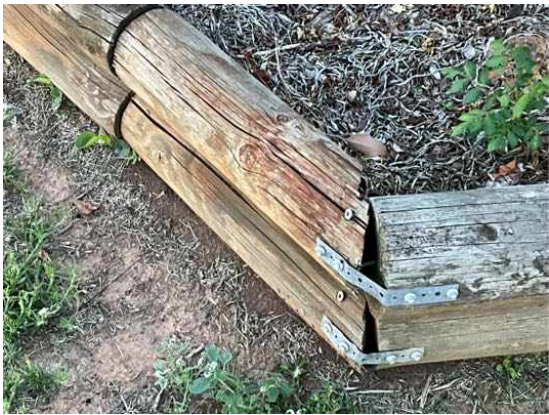
Finding 6.04

Building:	Building 1
Location:	Yard - Back, front
Finding:	Untreated or non-durable timbers in a hazardous environment
Information:	To reduce the risk of timber pest attack it is essential that timber used in a hazardous environment (e.g. in direct contact with the ground or frequently exposed to damp conditions) is of sufficient durability and/or is adequately preservative treated.

Untreated timbers in direct contact with the ground are likely to develop severe wood rot and/or fungal decay if left unattended creating attraction for subterranean termites to infest the timbers from surrounding areas.

If untreated or non-durable timbers are found to be in a hazardous environment it is highly advised that replacement of these building elements be performed as soon as possible to aid the protection of the property against termite / timber pest attack.

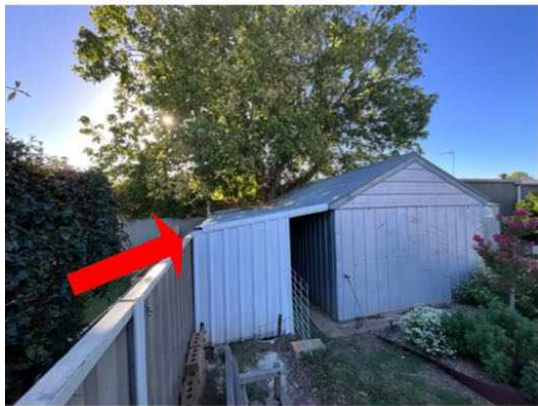
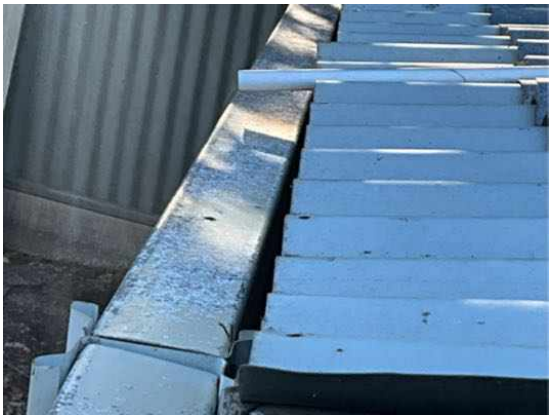
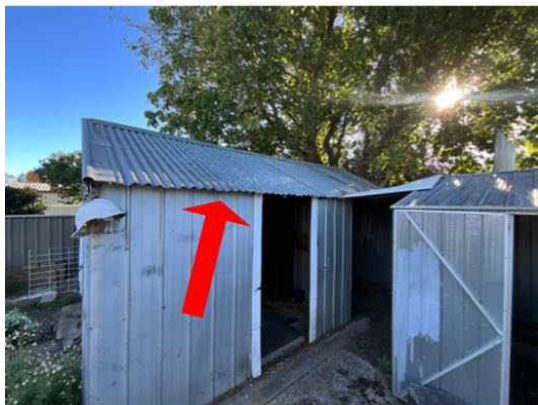
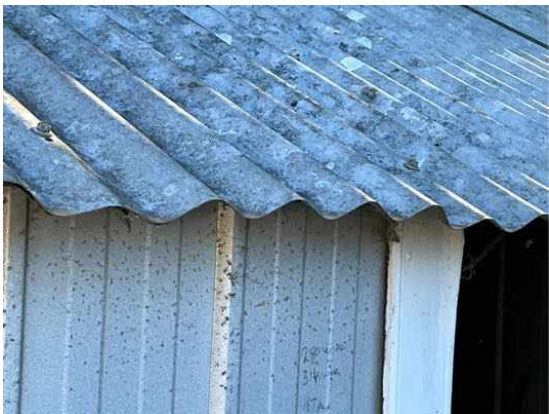
Finding 6.05

Building: Building 1

Location: Shed

Finding: Guttering Missing

Information: The Guttering in this area was missing at the time of inspection. Guttering, Downpipes and Stormwater drainage are vital to protect the integrity of the structure and to prevent an environment conducive to Timber Pest attack.

A Plumber should be contacted as soon as possible to replace and connect to drainage the missing Guttering.

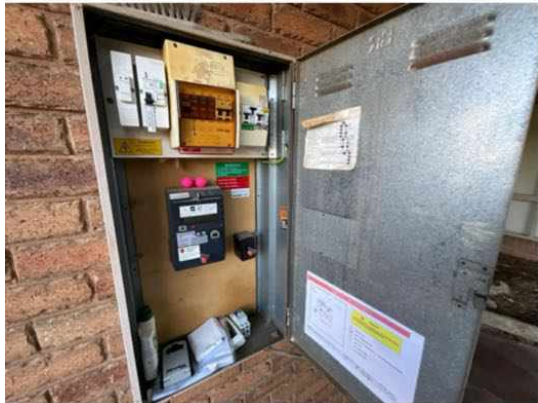
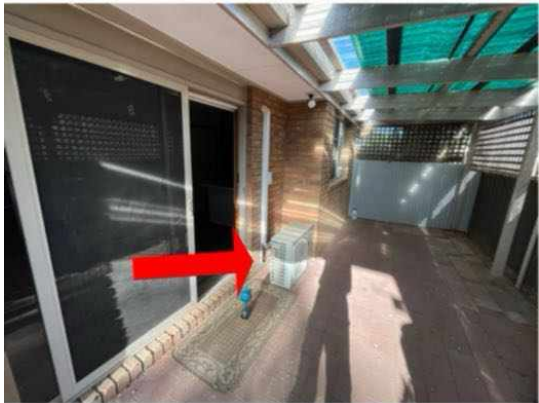
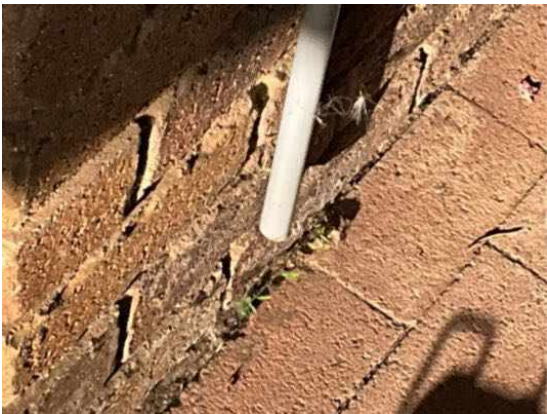
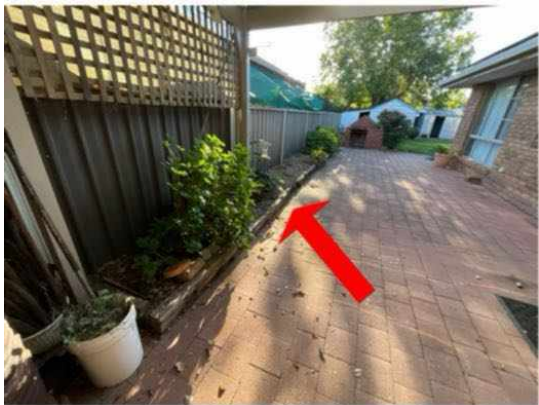
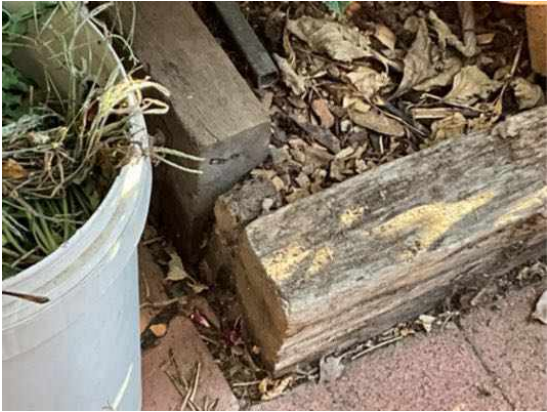
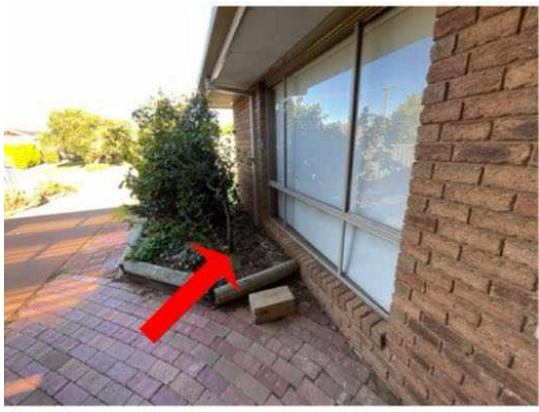
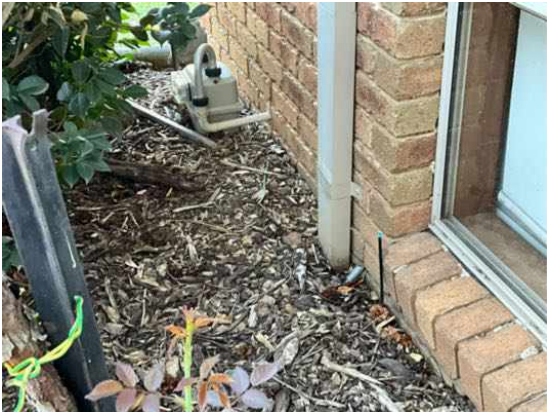
Finding 6.06

Building: Building 1
Location: All External Areas
Finding: Termite Management System - no evidence of a chemical installation
Information: The application of a post-construction chemical termite barrier is highly recommended for all properties, particularly if live termite activity has been found on the site previously. Such barriers are highly effective in preventing termite attack on any timber building elements throughout the property.

A durable notice should be placed in the switchboard unit to indicate current termite barriers. At the time of inspection, it appeared as though no termite management system has been installed, with no evidence to suggest preventative works taking place.

The client may consider gaining further advice from a pest controller as to the costs and procedures involved with this application. It is recommended that obtaining such advice be a short-term priority.

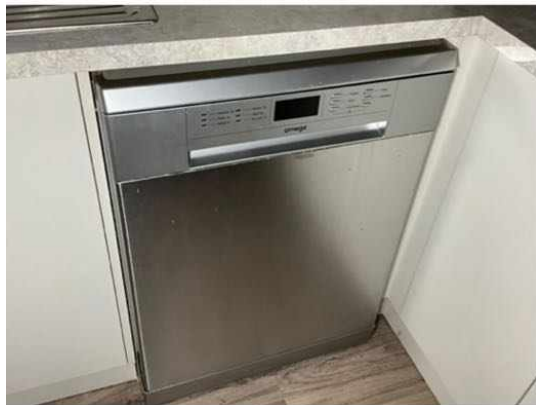
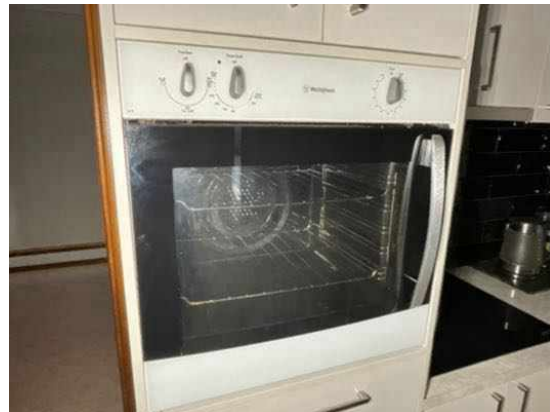
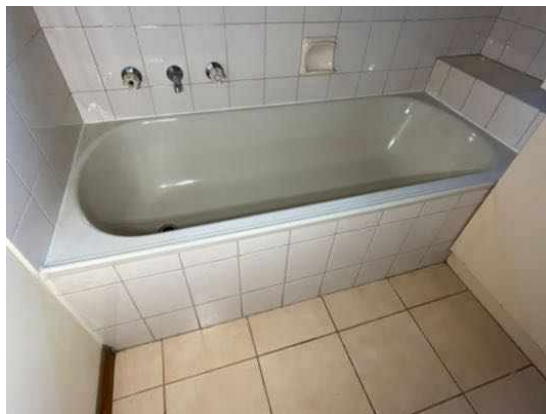
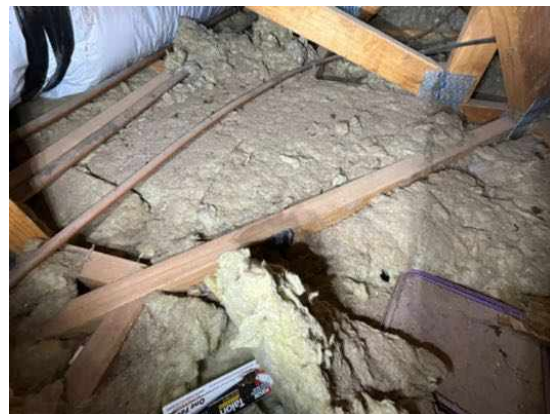
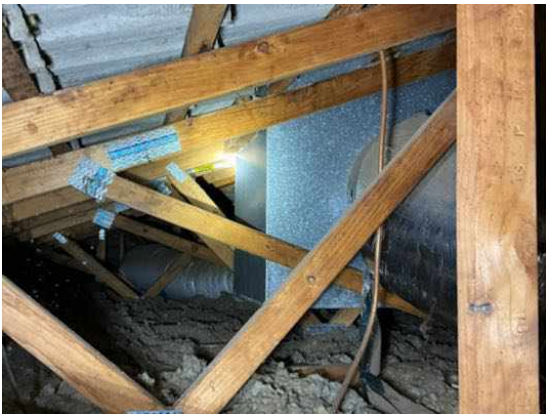
Noted Item

Building: Building 1
Location: All Areas
Finding: Additional Photos - Obstructions and Limitations
Information: These photographs are an indication of the obstructions and limitations which impeded full inspection of the property at the time of inspection. These obstructions can hide an array of defects and should be removed to allow full inspection to be carried out. A re-inspection is recommended once the areas are made accessible.
