## Building Inspection Report

Inspection Date: Mon, 16 Feb 2026

Property Address: 85 Clifford St, Warragul VIC 3820, Australia

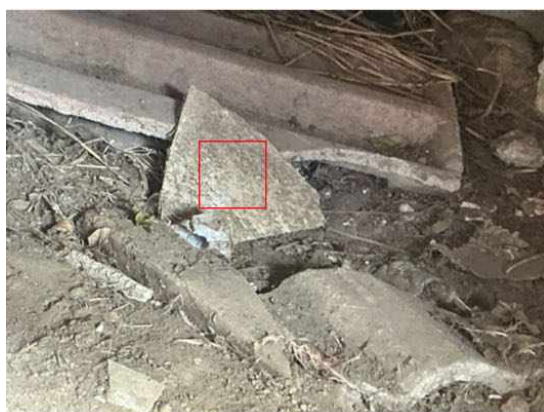
#### Defects 1.01

The existence of suspected asbestos debris presents a potential health and safety risk and should not be disturbed. Its presence limits visibility and may conceal additional defects that could not be assessed during this inspection.

It is recommended that a licensed asbestos removal contractor be engaged immediately to undertake a formal assessment, including sampling if required, and to remove all asbestos-containing debris in accordance with relevant health and safety regulations. Once the area has been professionally cleared and deemed safe, a follow-up subfloor inspection should be conducted to assess previously inaccessible areas.

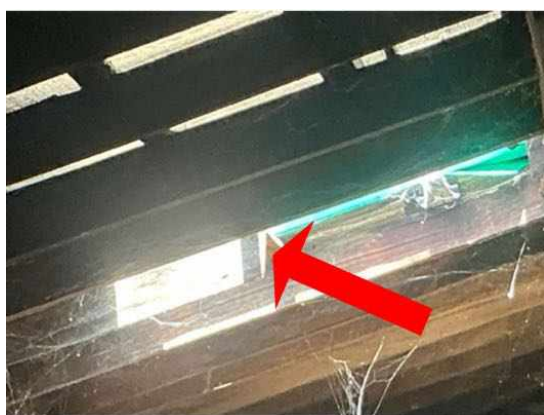
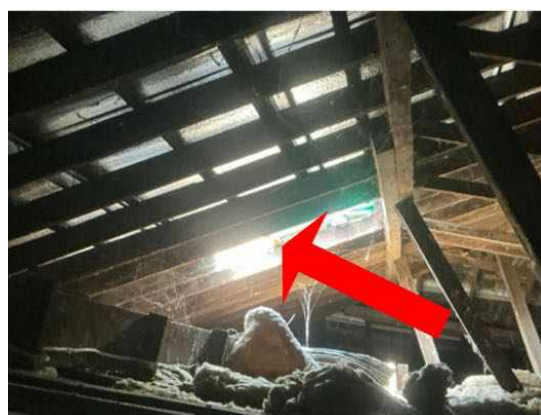
#### Defects 2.01

A compromised rafter may reduce the load-carrying capacity of the roof, increasing the risk of deflection, sagging, or failure under load. Over time, this can lead to roof instability, structural damage, and potential safety hazards.

It is recommended that a registered structural engineer and a qualified carpenter or registered builder assess the roof structure. The cut rafter should be replaced with a properly sized and installed rafter to fully restore structural integrity, ensuring compliance with relevant building standards and safety requirements.

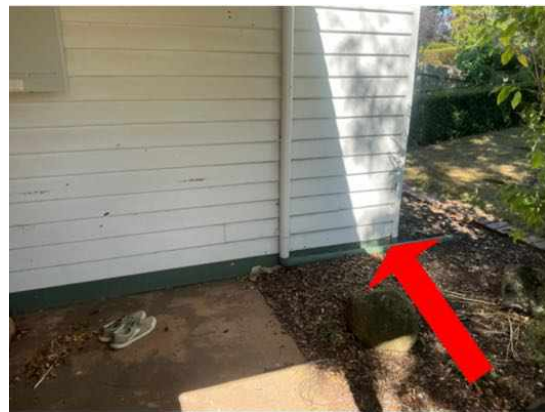
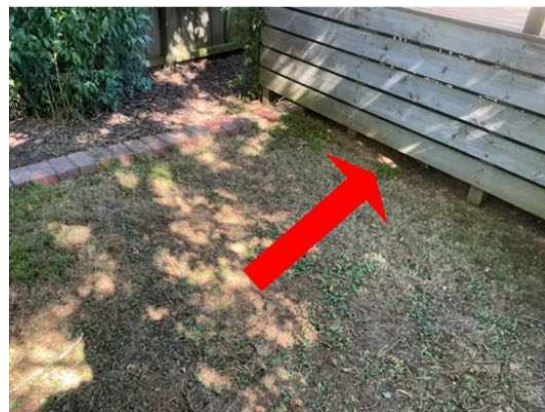
### Defects 3.01

Building:	Main Building
Location:	All External Areas
Finding:	Site drainage - Inadequate
Information:	The site drainage in all yards was found to be inadequate at the time of inspection, creating potential for subsequent water damage to associated building elements.

It is important that water does not lie against the base of walls; surrounding paths and ground levels should be sloped to drain water away from walls. Downpipes should not discharge stormwater onto lower walls or plinths. Stormwater should be carried away by large, regularly cleaned drains. Ground levels may need to be lowered to expose a buried DPC.

Where site drainage is inadequate, installation of an Agricultural (Aggie) Drain may be required. A qualified plumber should be appointed to further inspect the property and perform any remedial works as necessary. Water damage and secondary defects are likely to occur if left unmanaged.

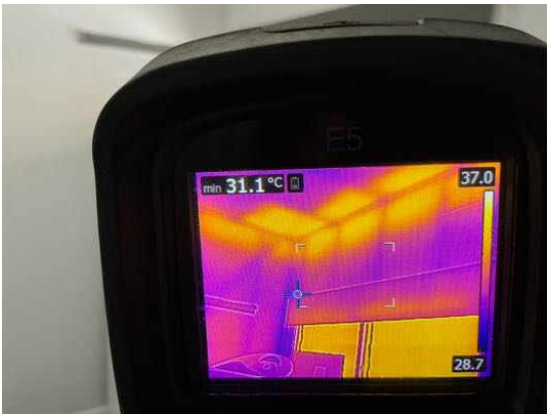
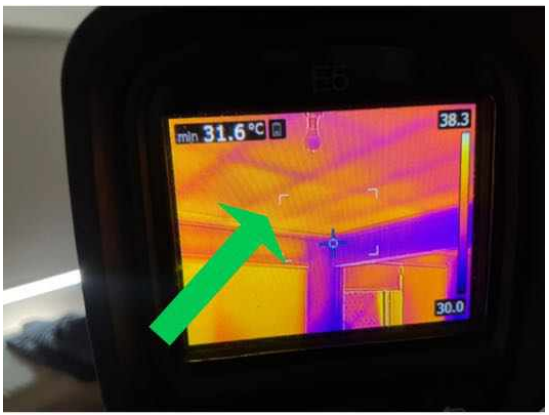
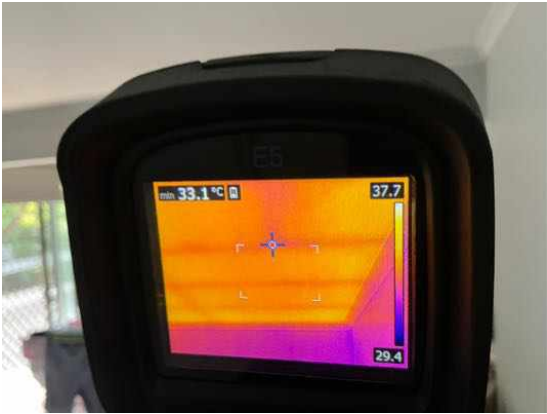
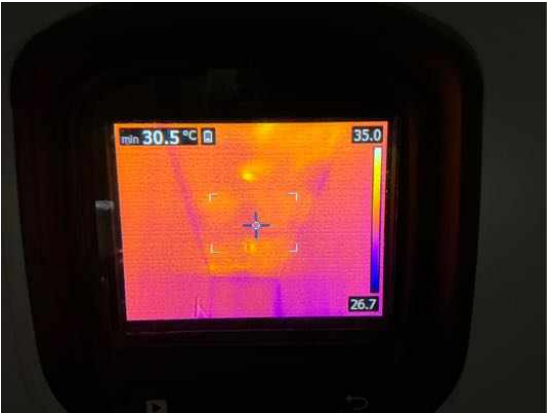
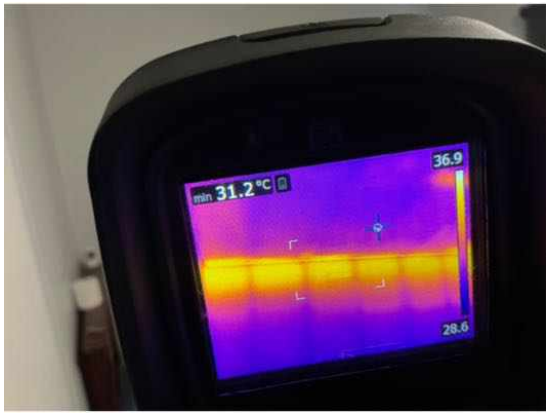
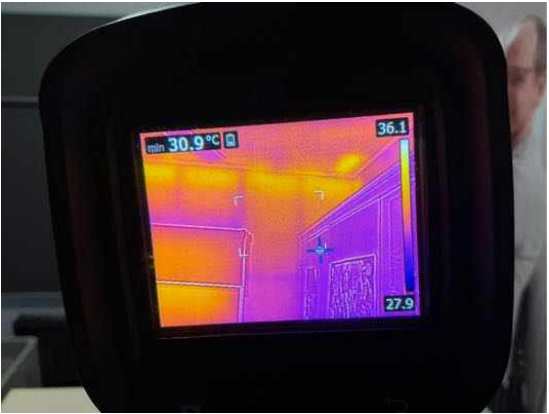
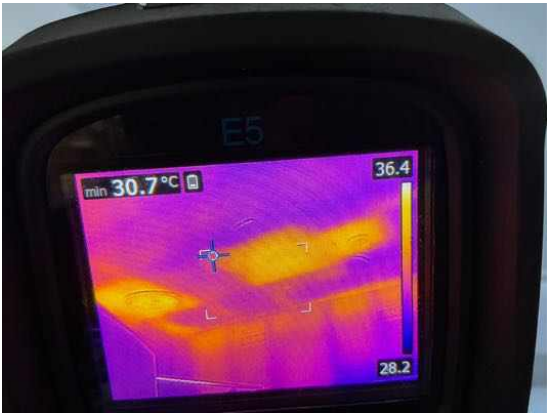
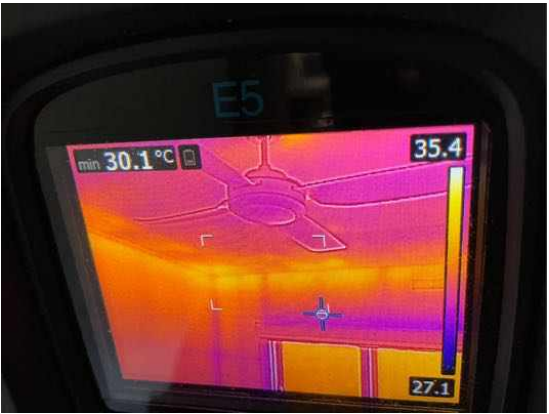
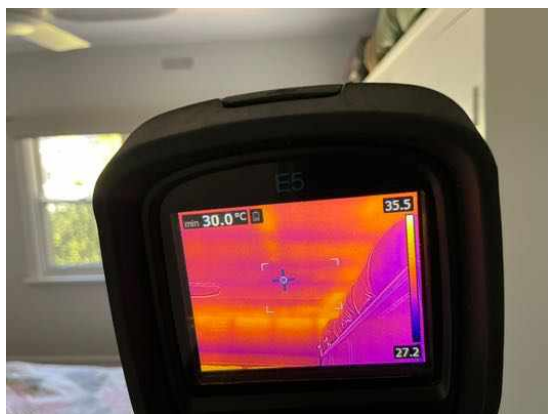
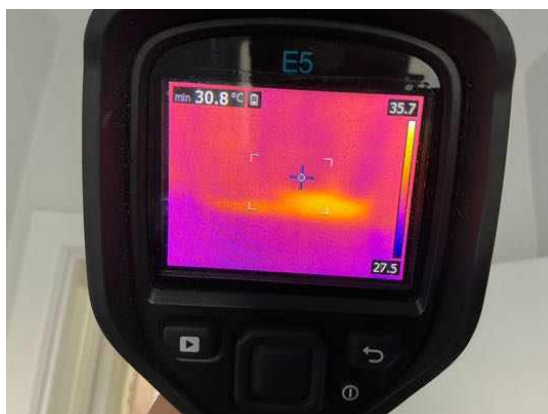
### Defects 3.02

Building:	Main Building
Location:	All Internal Areas
Finding:	Inconsistent Thermal Performance to Ceiling Areas – Suspected Insulation Deficiencies
Information:	Thermal imaging conducted to internal ceiling areas at the time of inspection identified inconsistent heat patterns, which are indicative of variations in thermal performance across the roof space. These patterns are commonly associated with areas of missing, displaced, or insufficient insulation above the ceiling linings.

Inadequate or uneven insulation coverage can reduce the energy efficiency of the

dwelling, contribute to heat loss in cooler periods and heat gain in warmer conditions, and may result in reduced occupant comfort and increased heating and cooling costs. Due to the non-invasive nature of the inspection, the exact extent and condition of insulation could not be confirmed visually in all affected areas.

It is recommended that a qualified insulation contractor inspect the roof space, assess insulation coverage and condition, and top up or reinstate insulation where required to achieve consistent thermal performance throughout the property.

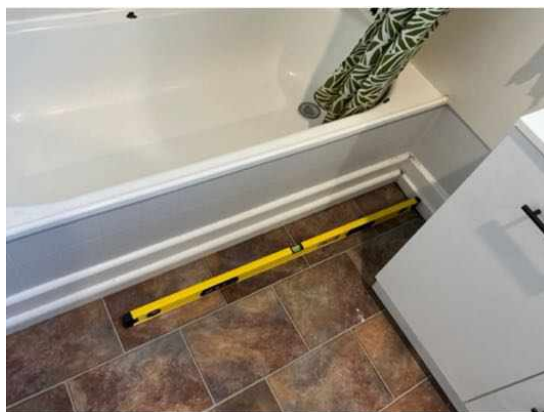
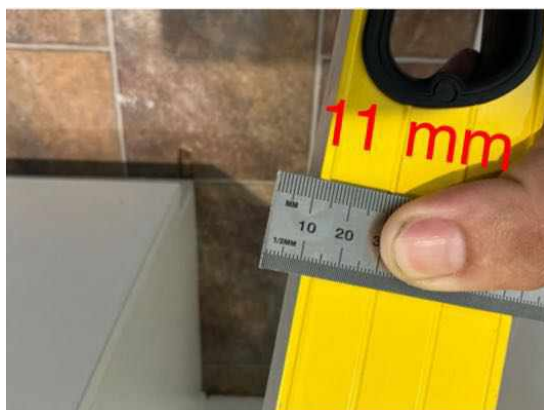
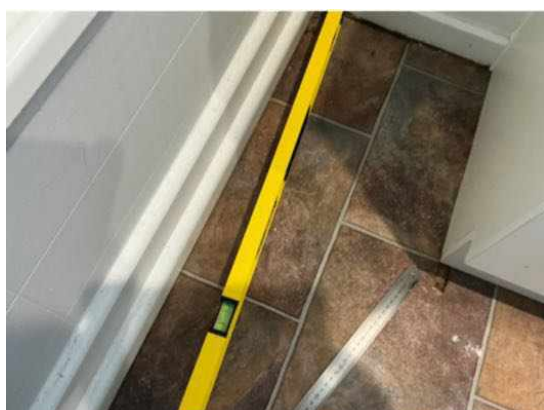
### Defects 3.03

Building: Main Building  
 Location: Bathroom  
 Finding: Uneven Flooring and Localised Floor Level Drop  
 Information:

The timber flooring throughout the dwelling was observed to be uneven, with noticeable undulations and variations in level. Of particular concern, the bathroom floor exhibited a measurable fall of approximately 11 mm over a 1-metre span when checked with a spirit level. This degree of deviation indicates localised settlement beyond normal surface irregularity.

The differential movement is consistent with possible subsidence or settlement of the supporting concrete stumps beneath the subfloor structure. Ongoing stump movement may result in further floor distortion, misalignment of wall and door frames, cracking to finishes, and potential impact on wet area performance if not addressed.

It is recommended that a qualified restumping contractor or registered builder experienced in subfloor rectification be engaged to assess the condition, bearing capacity, and vertical alignment of the existing stumps. Re-levelling, packing, or replacement of affected stumps may be required to restore acceptable floor levels and provide adequate structural support.

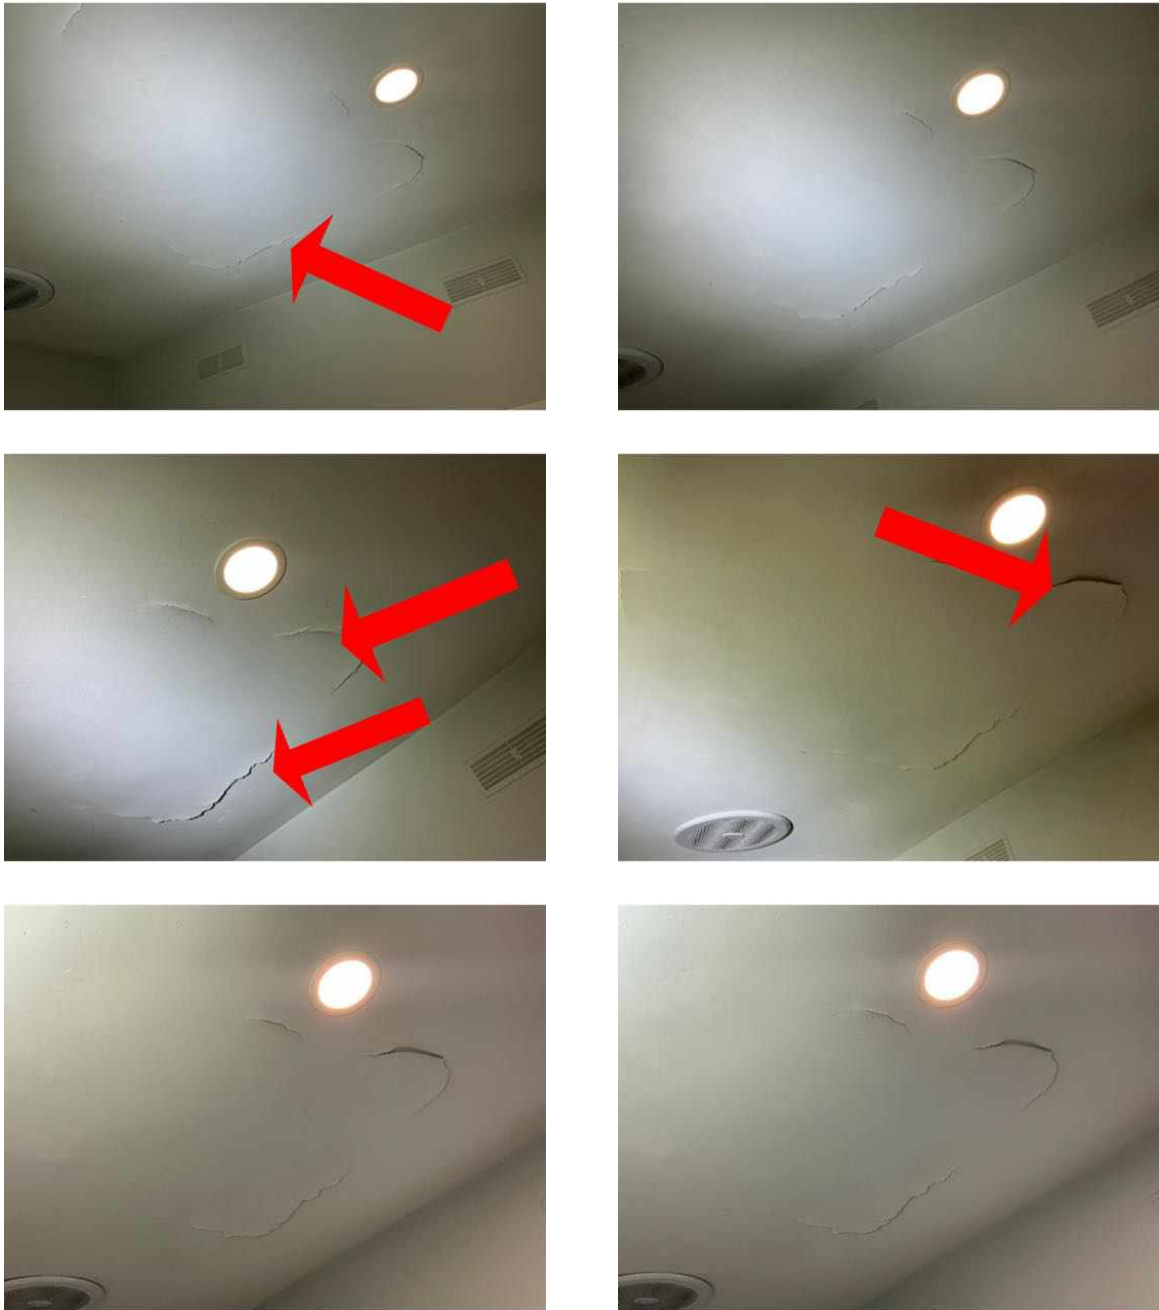
### Defects 3.04

Building: Main Building  
 Location: Bathroom  
 Finding: Bathroom Ceiling Paint Deterioration Due to Moisture  
 Information:

Peeling and flaking paint was observed to the bathroom ceiling. The condition is consistent with prolonged exposure to elevated moisture and condensation levels generated during shower use over time. No active water ingress was evident at the time of inspection; however, the deterioration appears attributable to internal humidity and inadequate ventilation.

mould growth, and gradual deterioration of the ceiling substrate if not addressed. Wet areas are particularly susceptible to moisture-related surface failure where ventilation is insufficient.

It is recommended that the affected ceiling areas be prepared by scraping and sanding back all loose and deteriorated paint, followed by application of a suitable moisture-resistant primer and repainting with appropriate bathroom-grade paint. In addition, a licensed electrician or suitably qualified contractor should assess and improve the bathroom ventilation system (e.g., installation or upgrade of an exhaust fan vented to the exterior) to reduce condensation and prevent recurrence.

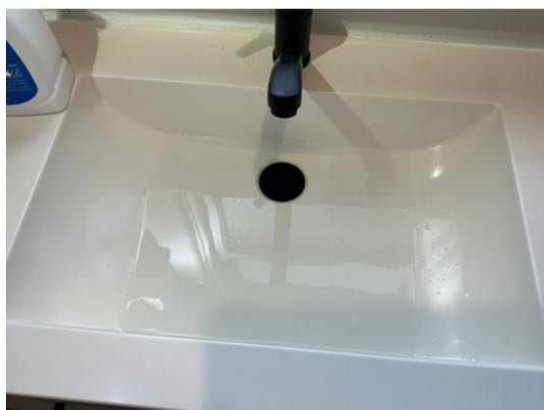
Defects 3.05

Building: Main Building  
Location: Bathroom  
Finding: Slow Drainage at Bathroom Vanity sink  
Information:

The bathroom vanity sink was observed to drain slowly at the time of inspection. Water discharge from the sink was delayed, with minor pooling remaining in the bowl before gradually clearing. This condition is typically indicative of a partial blockage or build-up within the waste pipe or trap assembly.

Restricted drainage may worsen over time and can lead to complete blockage, unpleasant odours, or potential overflow if left unaddressed. Accumulation of hair, soap residue, and general debris within the trap or downstream pipework is a common cause.

It is recommended that a licensed plumber be engaged to inspect and clear the basin waste line, including removal and cleaning of the trap and, if required, mechanical clearing of the associated pipework to restore normal drainage performance.

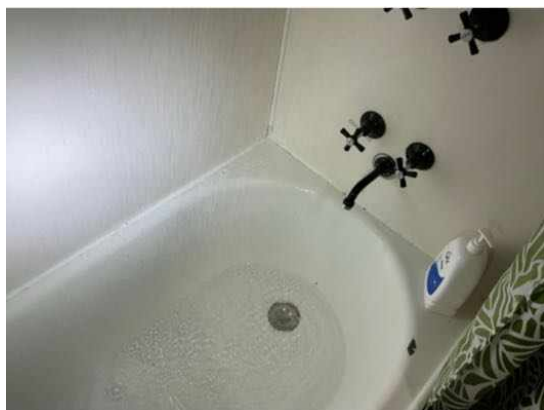
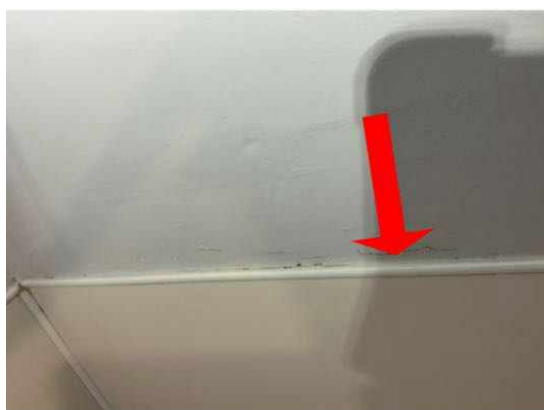
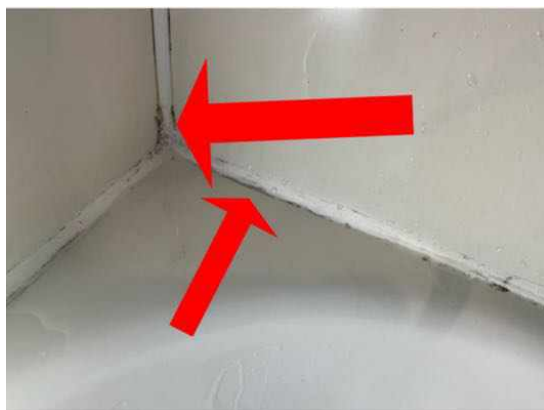
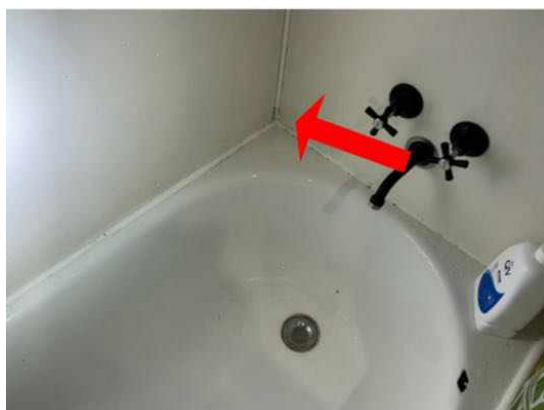
### Defects 3.06

Building: Main Building  
Location: Bathroom  
Finding: Deteriorated and Inconsistent Shower Sealant

The sealant to the internal junctions of the shower recess, including wall-to-wall and wall-to-bathtub corners, was observed to be deteriorated, inconsistently applied, and locally debonded. Minor gaps were noted in sections of the sealant line, and mould growth was visible to some corner areas. The condition is consistent with age-related wear and prolonged exposure to moisture within this older bathroom.

Defective or deteriorated sealant may allow water to penetrate behind wall and floor finishes, potentially affecting the underlying substrate and concealed framing over time. If not rectified, moisture ingress may contribute to concealed damage, mould development within cavities, and deterioration of waterproofing performance.

It is recommended that a licensed plumber or suitably qualified bathroom renovation specialist remove all existing sealant to the shower recess junctions, thoroughly clean and treat affected areas for mould, allow surfaces to dry, and reapply a continuous bead of sanitary-grade mould-resistant silicone sealant in accordance with manufacturer guidelines. Ongoing maintenance of sealant lines should be undertaken to minimise the risk of water ingress into wall and floor cavities.

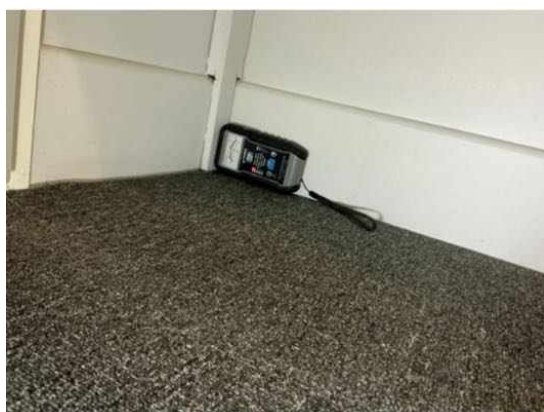
### Defects 3.07

Building:	Main Building
Location:	Bathroom / bedroom 2
Finding:	Elevated Moisture Readings – Wall Behind Shower (Cabinetry Side)
Information:

Following operation of the shower for approximately 30 minutes, moisture testing was undertaken to the wall surface and skirting board located directly behind the shower, accessible from within the adjoining cabinetry/storage area. Slightly elevated moisture readings were detected in this section of wall. The readings were not excessive at the time of inspection; however, they were above typical background levels expected in dry internal areas.

The precise source of the elevated moisture could not be confirmed during this visual and non-invasive inspection. A possible contributing factor may be minor water migration through shower junctions or sealant lines; however, this remains unconfirmed. No finishes were removed and no invasive investigation was carried out, therefore concealed conditions within the wall cavity, including framing and lining materials, could not be assessed.

It is recommended that a licensed plumber undertake further assessment, which may include controlled invasive inspection and testing of the shower recess and associated plumbing to determine whether active leakage or historic moisture ingress is present. Any identified defects to plumbing, sealant, or waterproofing systems should be

rectified accordingly to prevent potential concealed damage.

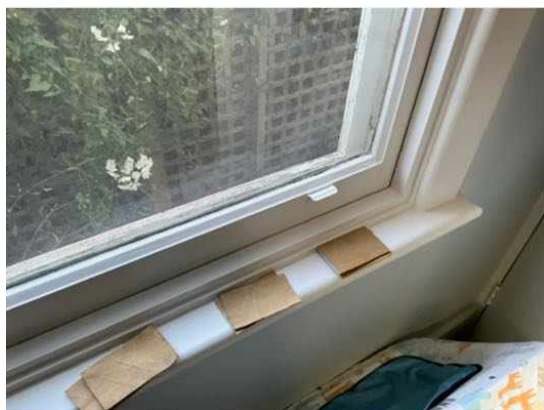
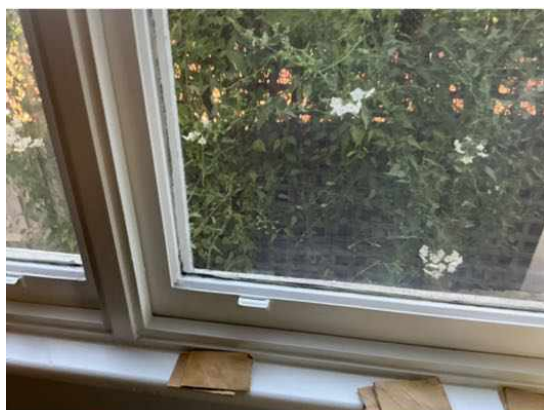
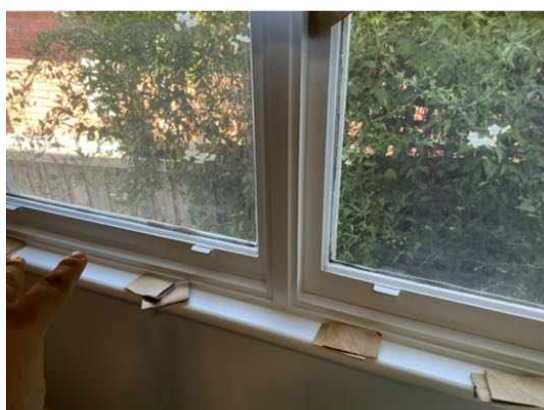
### Defects 3.08

Building: Main Building  
 Location: All Internal Areas  
 Finding: Stiff Window Operation and Inadequate Weather Sealing  
 Information:

Several windows throughout the dwelling were noted to be stiff during operation, requiring additional pressure to open and close. While some windows operated satisfactorily, others did not move freely within their tracks. The condition may be associated with minor frame distortion, settlement, hardware wear, or lack of maintenance.

In addition, a number of windows were observed to be inadequately weather-sealed. Visible gaps were present between the sash and frame in certain locations. The tenant has reportedly inserted cardboard and paper materials into these gaps in an attempt to reduce draughts. This is considered a temporary and unsuitable measure and does not provide an effective or compliant weather seal.

Poorly sealed or difficult-to-operate windows may contribute to air leakage, moisture ingress during adverse weather, and reduced energy efficiency. It is recommended that a qualified carpenter or window specialist inspect the affected windows to assess frame alignment, hardware condition, and sealing components. Adjustment of hardware, planing or re-alignment of sashes, and installation or replacement of appropriate weather seals may be required to restore proper function and weather tightness.

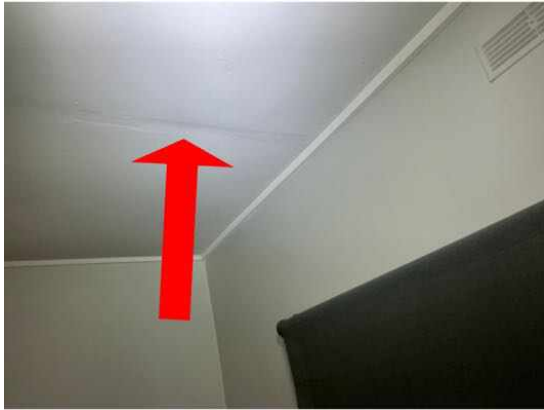
### Defects 3.09

Information: Sections of the ceiling in bedroom 2 were found to be sagging at the time of inspection. Sagging to the fixed ceiling structure generally indicates that the building materials have swollen, due to contact with water, or that fixings (e.g. nails or glue) have become loose and require reattachment.

Where minor sagging is evident, comparatively minor works, such as re-gluing of ceiling sheets, may be required. Such works may be performed by relevant tradespeople, such as plasterers and painters. Where excessive moisture has caused

the roofing structure to swell and sag, the source of the water leak should primarily be identified prior to any remedial works being performed.

The appropriate action should be taken by the client as soon as possible to ensure that any potential further damage is limited.

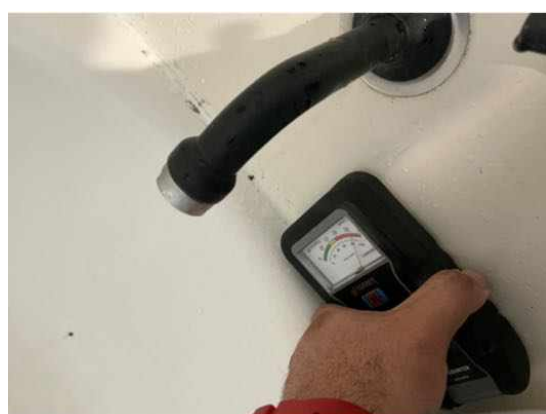
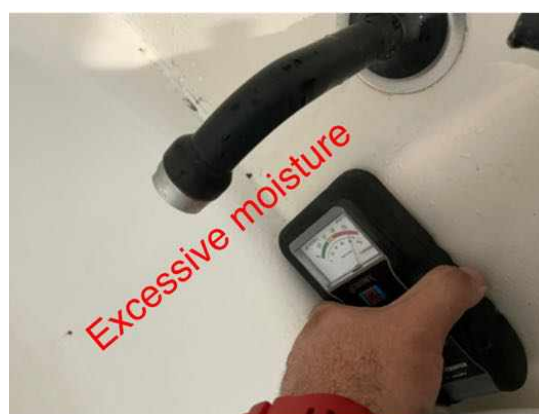
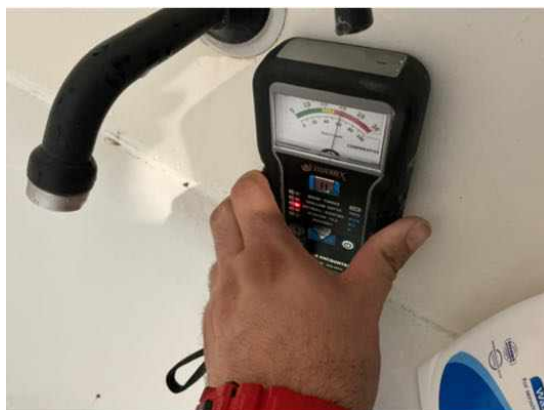
**Defects 3.10**

Building:	Main Building
Location:	Bathroom
Finding:	Shower - Damp
Information:	Damp is evident to the lower 300mm of wall to the shower alcove. This defect is quite common, and is suspected to have been caused by moisture permeating through the grouting in this area, which shows evidence of deterioration. Leaking pipes within the adjoining wall is also a possible cause.

Damp (or structural damp) refers to the presence of unwanted moisture in the structure of a building, either as the result of intrusion from outside, or condensation from within the structure. In the shower area, internal water leaks or other sources of excessive moisture are generally the cause of damp.

Unmanaged damp in the shower recess is likely to facilitate the formation and development of mould and fungi growth, decaying associated building materials and compromising their structural integrity. It is important to address damp conditions, as the World Health Organisation notes that excess moisture leads - on almost all indoor materials - to growth of microbes such as moulds, fungi and bacteria, which subsequently emit spores and other matter into the indoor air. Exposure to these contaminants is associated with a wide range of respiratory and other health-related problems.

Consultation with a qualified plumber or bathroom specialist is advised immediately to identify the cause of damp and to perform remedial works as required. Where excessive mould growth is present, further inspection by a specialist environmental health inspector should also be considered.

Always ensure that sealant and grout is in good condition to prevent any moisture issues occurring in the future.

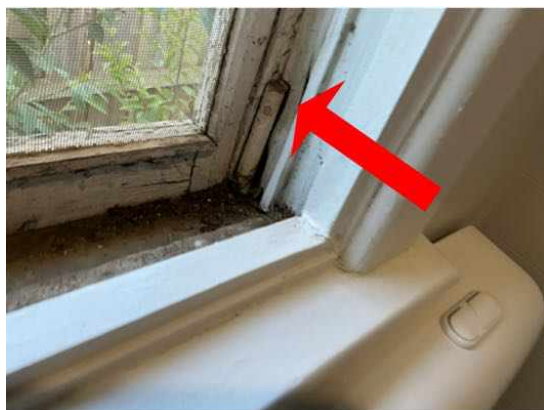
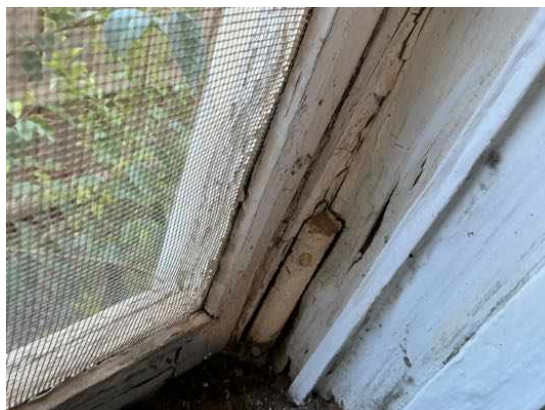
### Defects 3.11

Building:	Main Building
Location:	Bathroom
Finding:	Window - Wood rot
Information:	Wood rot was found to be affecting the bathroom window. Wood rot, also known as Fungal Decay, occurs when timbers and other cellulose building materials are exposed to damp conditions on an ongoing basis.

It is likely that this wood rot has developed as a result of frequent exposure to rain and other weather conditions. It is suspected that failure to maintain the window frames over a prolonged period has resulted in them deteriorating at an accelerated rate, increasing their susceptibility to the development of wood rot. Leaks in roof plumbing or associated pipework may have also contributed to the formation of the wood rot in this area.

Early intervention and regular maintenance will prolong the useful life of these building elements. Prior to any works being performed, any associated pipework or roof plumbing should be inspected by a licensed plumber for faults or leaks.

Repair and/or replacement of affected window frames may be a necessary step in protecting surrounding building elements from such deterioration. Remedial works should be performed by a qualified carpenter or registered builder as soon as possible to prevent any further damage.

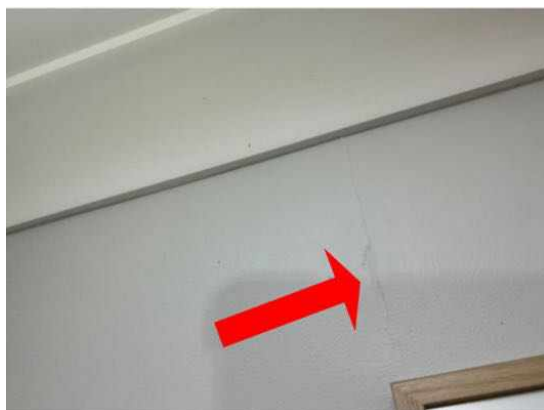
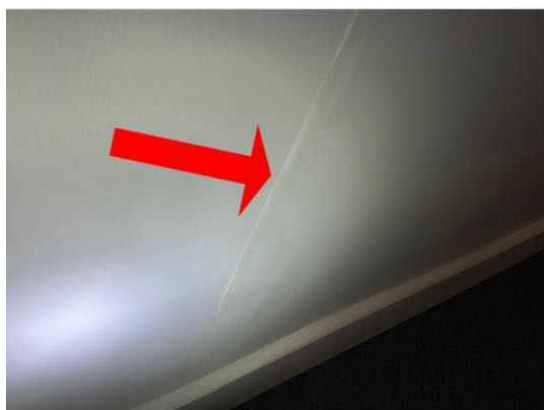
### Defects 3.12

Building:	Main Building
Location:	All Internal Areas
Finding:	Minor Internal Wall Cracking – Movement Related
Information:

Minor cracking was observed to internal wall linings in the hallway and several bedrooms. The cracks were predominantly vertical and horizontal in orientation, with some horizontal cracking occurring along plasterboard joints where slight separation has developed. The cracking observed is considered minor in width and typical of movement-related stress within the structure.

The pattern and location of cracking are consistent with general building movement and possible differential settlement of the supporting stump system. Where subfloor stumps experience minor subsidence or seasonal movement, stress can transfer to wall linings, resulting in joint separation and fine cracking. While the cracks are presently cosmetic in nature, ongoing movement may lead to recurrence if the underlying cause is not addressed.

of affected plaster areas, may be undertaken once the structural movement has been assessed and stabilised.

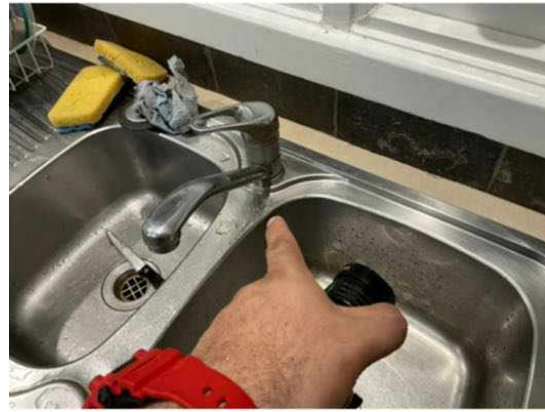
### Defects 3.13

Building:	Main Building
Location:	Kitchen
Finding:	Tap - Water hammer
Information:	The kitchen sink tap shows evidence of water hammer being present. Water hammer, a pressure surge resulting when a fluid is forced to suddenly change direction, is a common defect in plumbing fittings, particularly those that are aged and not frequently maintained. Water hammer is generally caused by factors that create high water pressure in the affected plumbing fixture, usually evidenced by a faint banging noise during operation of the affected tap.

A licensed plumber should be appointed as soon as possible to replace any affected tap hardware and perform any remedial works as necessary. Please be advised that the appointment of a cabinet maker or qualified carpenter may be necessary if water damage to associated building elements has occurred.

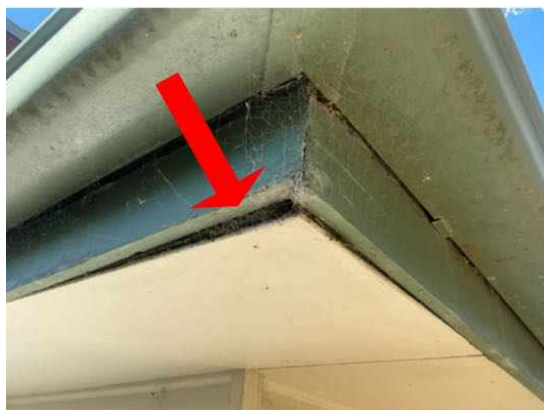
### Defects 3.20

Building:	Main Building
Location:	All External Areas
Finding:	Loose and Partially Detached Eaves – Front Elevation
Information:

It is recommended that a qualified carpenter resecure the affected eaves lining, replace any damaged fixings or framing as required, and ensure the eaves are properly aligned and firmly fixed to prevent further movement.

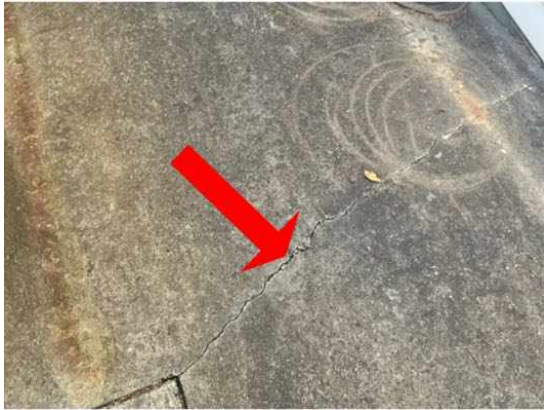
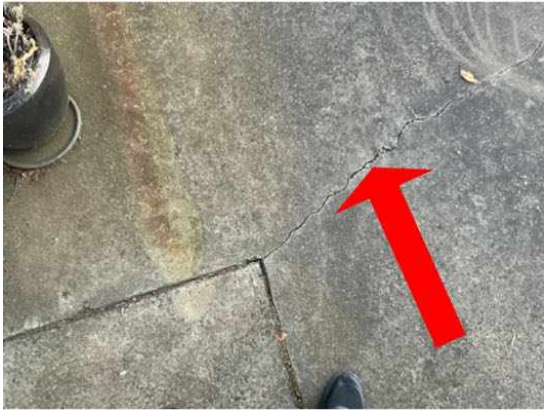
### Defects 3.21

Building:	Main Building
Location:	All External Areas
Finding:	Cracking - External Concrete Paving Damage Category 2 - Distinct (less than 3mm)
Information:	Distinct cracks were identified in external concrete paving. Distinct cracks are generally found in older concrete paving, and may also present as a trip hazard as consequence of an uneven or curved surface.

Repairs are likely to be required to prevent further cracking and to reduce hazards associated with cracking, such as tripping. Monitoring of all cracking should be conducted frequently. Always contact a building inspector should cracks widen, lengthen, or become more numerous.

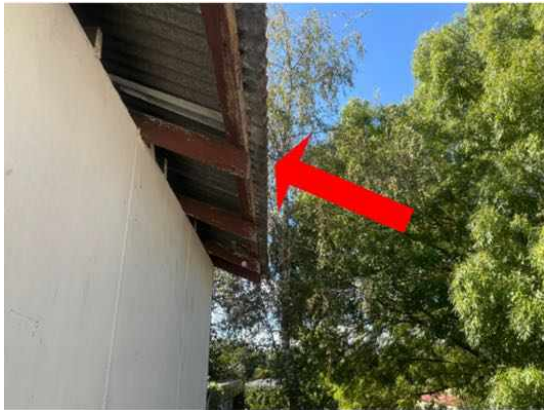
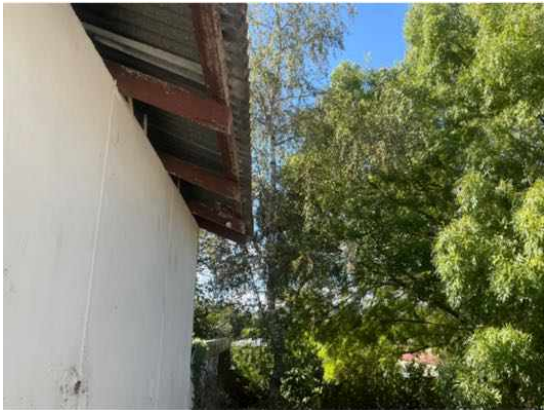
**Defects 3.22**

Building: Main Building  
Location: Shed  
Finding: No gutters installed to the shed  
Information: No gutters were installed to the shed. Recommend engaging a plumber to install gutters and down pipes to reduce the risk of footing movement and other moisture related issues as soon as possible.

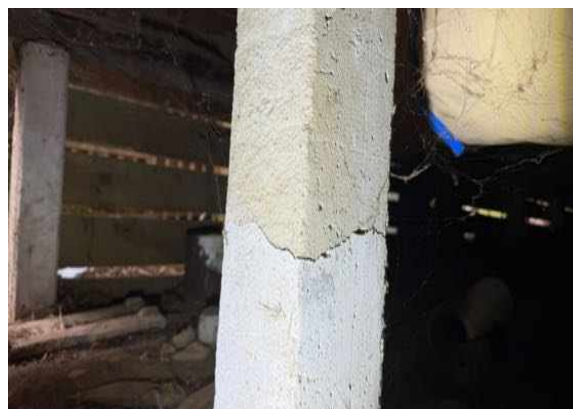
**Defects 3.26**

Building: Main Building  
Location: Subfloor  
Finding: Surface Deterioration to Subfloor Concrete Stump  
Information:

It is recommended that the affected stump be cleaned, prepared, and recoated with a suitable masonry-grade protective coating. Subfloor moisture levels and ventilation should also be reviewed to minimise ongoing exposure to damp conditions.

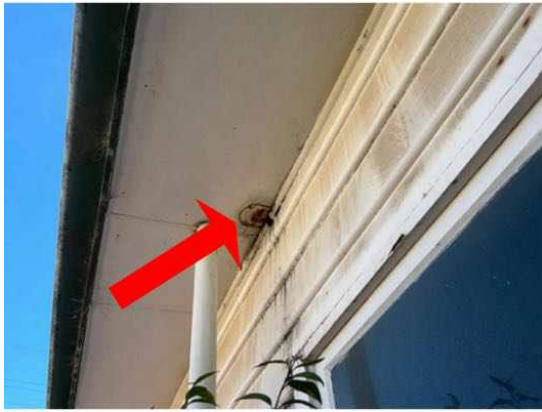
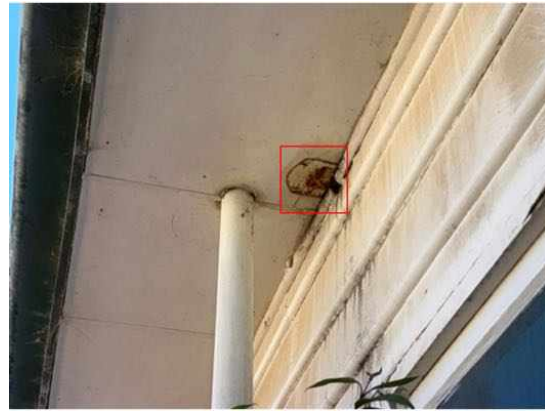
### Defects 3.27

Building:	Main Building
Location:	All External Areas
Finding:	Moisture Staining to Eaves
Information:

A licensed roof plumber should inspect the gutter, downpipe connection and penetration detailing, and rectify as required (e.g., reseal joints, replace defective sections, ensure correct falls, and ensure watertight connections). Once the moisture source is rectified and the area is dry, a qualified painter/carpenter should repair any affected substrate (if required) and repaint/recoat the soffit and cladding to restore weather protection and appearance.

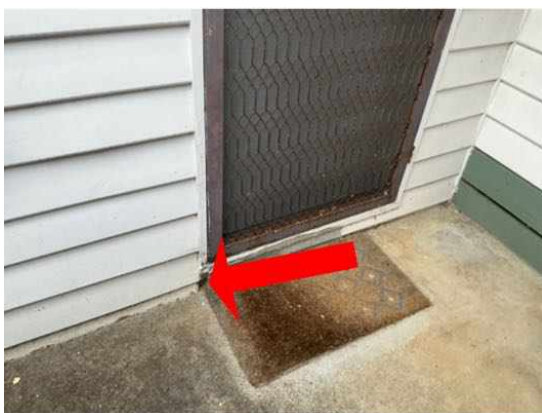
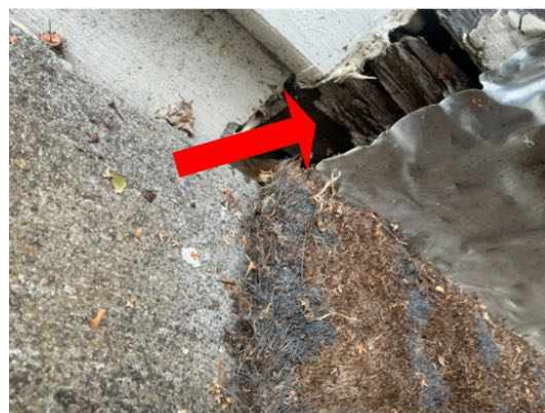
### Defects 3.28

Building:	Main Building
Location:	Family Room
Finding:	Timber Decay – External Door Framing (Family Room to Backyard)
Information:

As this inspection was non-invasive, the full extent of decay could not be determined. It is recommended that a qualified carpenter or registered builder undertake an invasive inspection to assess the extent of deterioration to the framing and adjacent structural elements. All decayed timbers should be removed and replaced, and the underlying source of moisture ingress rectified to prevent recurrence.

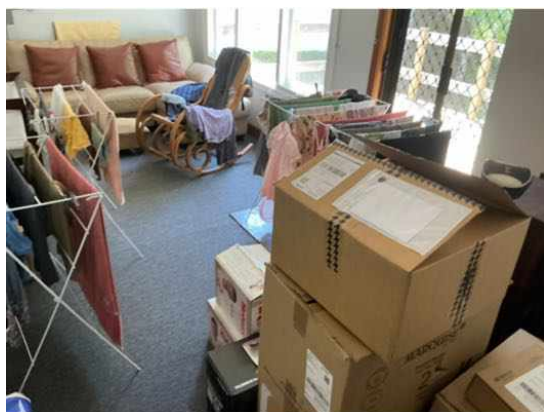
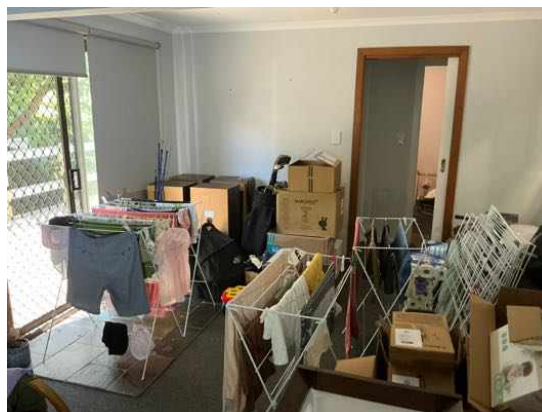
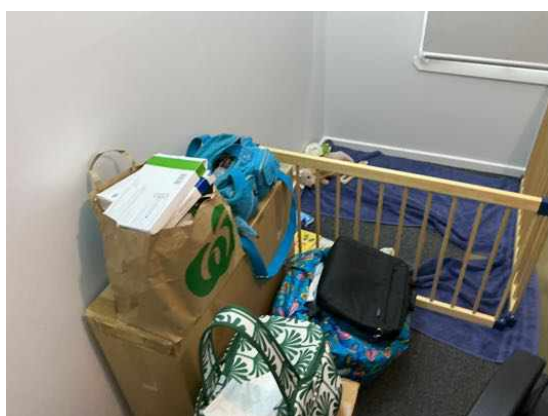
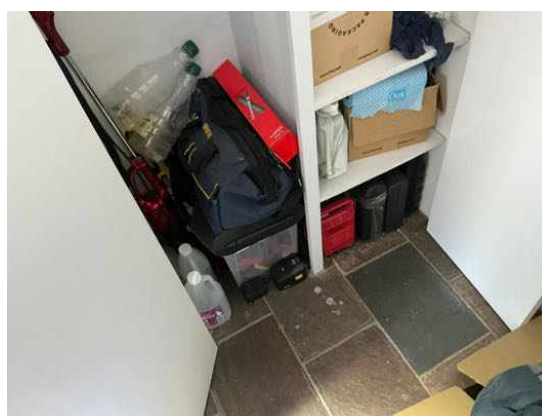
Building: Main Building  
 Location: All Internal Areas  
 Finding: Obstructions and Limitations - Interior  
 Information: These photographs are an indication of the obstructions and limitations which impeded the inspection of the internal areas of the property at the time of inspection. These obstructions can hide an array of defects and should be removed to allow full inspection to be carried out. A re-inspection is recommended once the areas are made accessible.

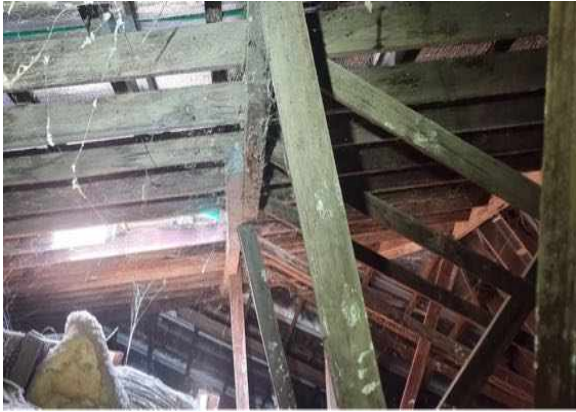
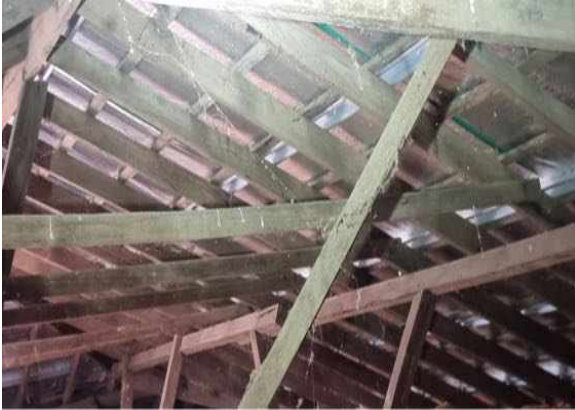
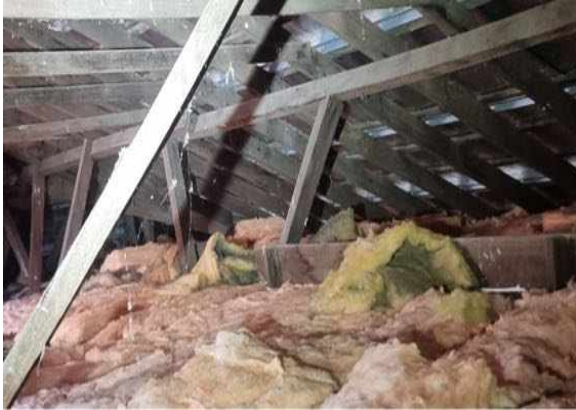
Building: Main Building  
 Location: Roof Void  
 Finding: Obstructions and Limitations - roof cavity  
 Information: photographs illustrate the obstructions and limitations that impeded the inspection of the roof cavity area of the property at the time of inspection. The access hole was particularly small, measuring approximately 35cm, which is below the minimum size required by Australian Standard AS4349.1. Such obstructions can conceal a range of defects and should be removed to allow a full inspection to be carried out. A re-inspection is recommended once the areas are made accessible.

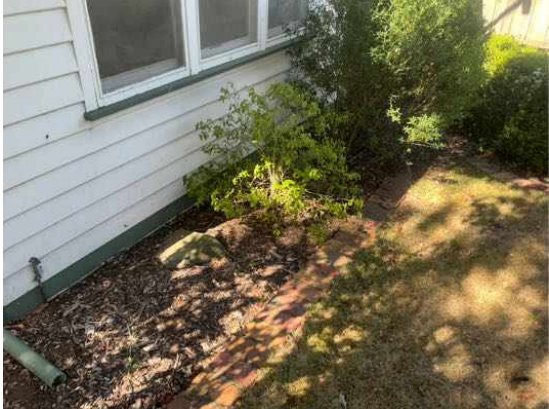
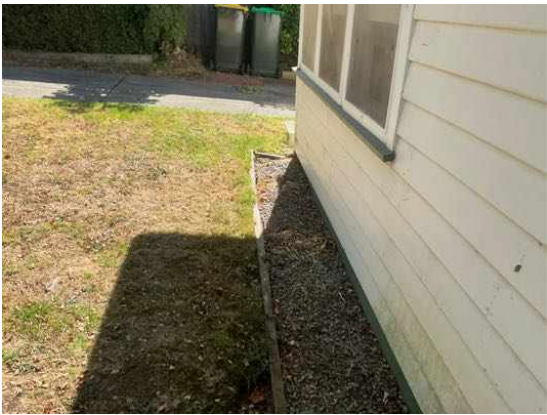
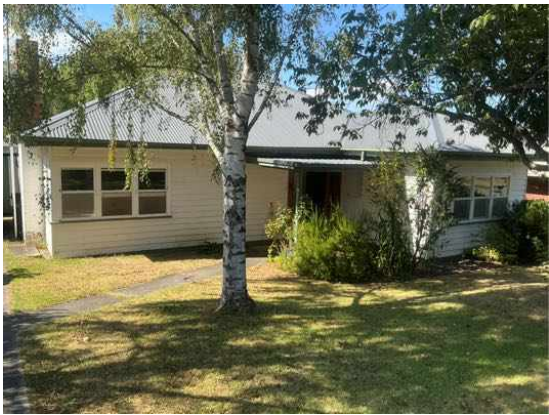
Building: Main Building  
Location: All External Areas  
Finding: Obstructions and Limitations - Exterior  
Information: These photographs are an indication of the obstructions and limitations which impeded the inspection of the external areas of the property at the time of inspection. These obstructions can hide an array of defects and should be removed to allow full inspection to be carried out. A re-inspection is recommended once the areas are made accessible.

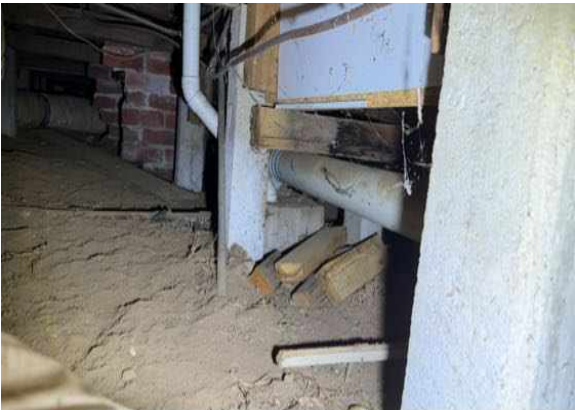
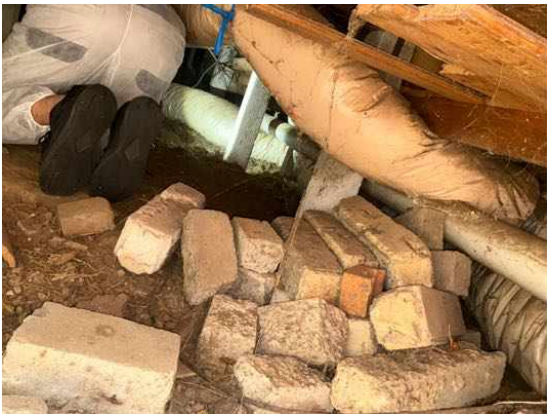
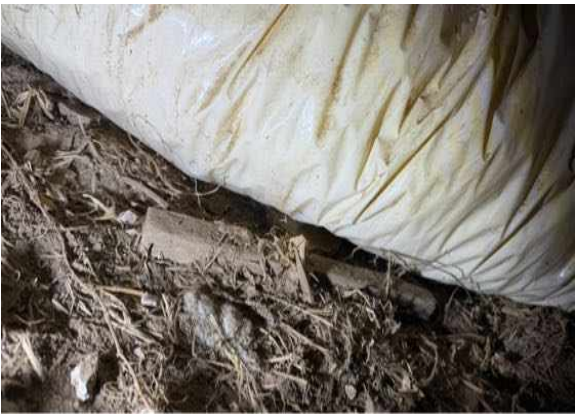
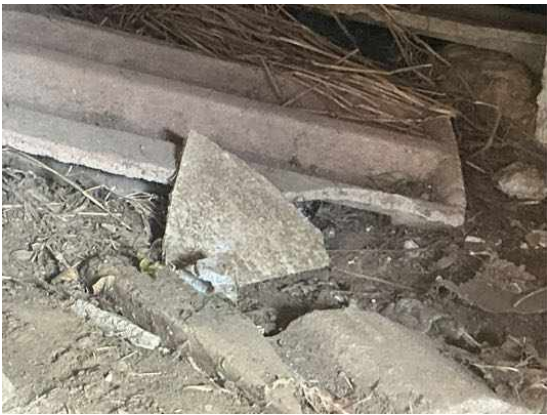
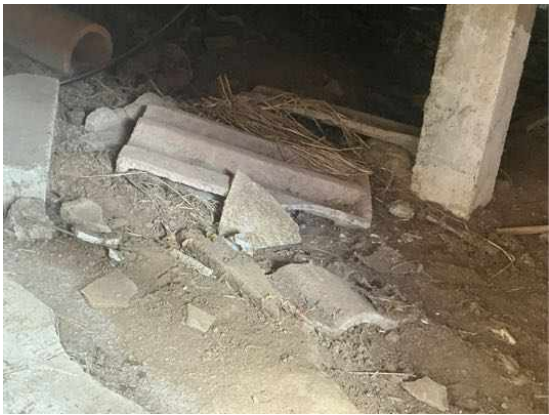
Building: Main Building  
Location: All Areas  
Finding: Obstructions and Limitations - subfloor  
Information: These photographs are an indication of the obstructions and limitations which impeded the inspection of the subfloor area of the property at the time of inspection. These obstructions can hide an array of defects and should be removed to allow full inspection to be carried out. A re-inspection is recommended once the areas are made accessible.
