# Building and Timber Pest Inspection Report

Inspection Date: Tue, 24 Feb 2026

Property Address: 2/2 Baxter Ct, Moe VIC 3825, Australia

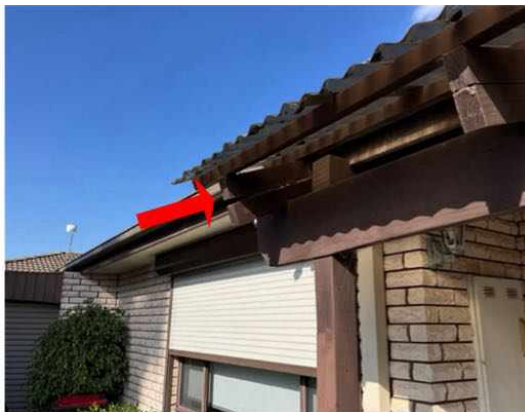
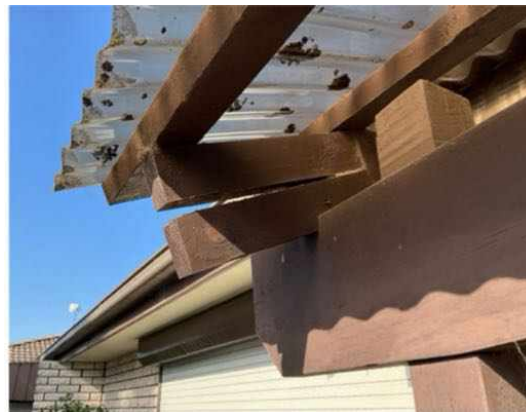
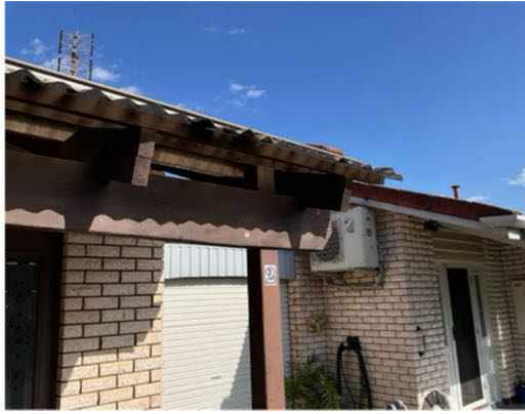
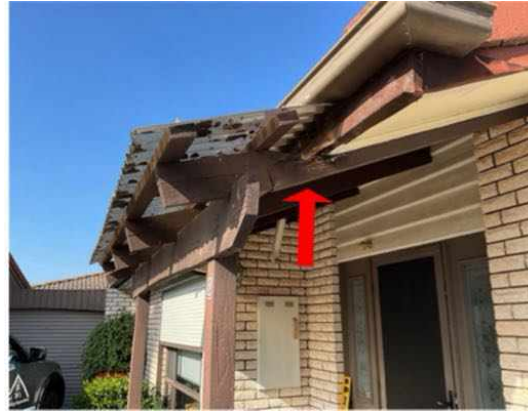
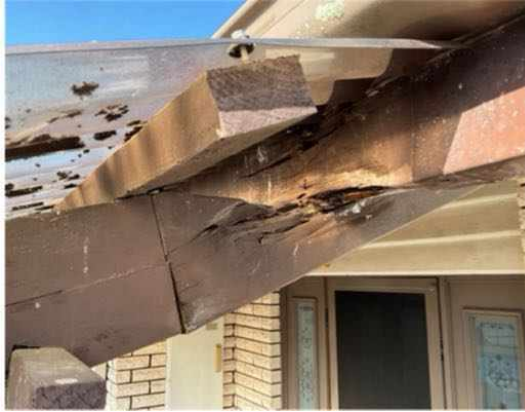
Building: Main Building  
Location: Porch  
Finding: Deteriorated Structural Timber – Porch Area  
Information: Deterioration was observed to the structural timber elements within the porch area at the time of inspection. Visible signs of wood rot were noted, indicating prolonged exposure to moisture and possible inadequate weather protection. The assessment was based on a visual, non-invasive inspection only, and concealed sections of timber framing could not be fully assessed.

Timber decay can compromise the structural integrity of the affected members, potentially reducing their load-bearing capacity. If left unaddressed, deterioration may progress, leading to further structural weakening and increasing the risk of failure, particularly in exposed external areas subject to weather conditions.

It is recommended that a registered builder or qualified carpenter be engaged to further assess the extent of the decay and undertake necessary repair or replacement of the affected structural timber. Any contributing moisture sources should also be identified and rectified to prevent recurrence.

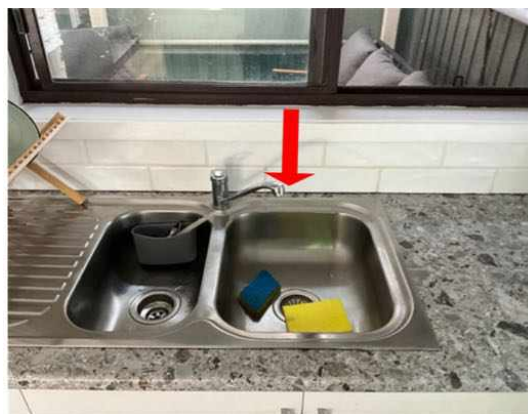
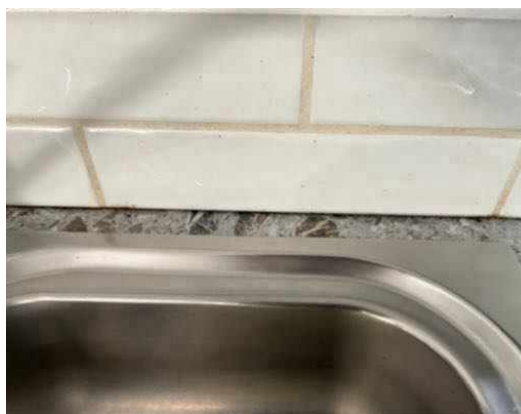
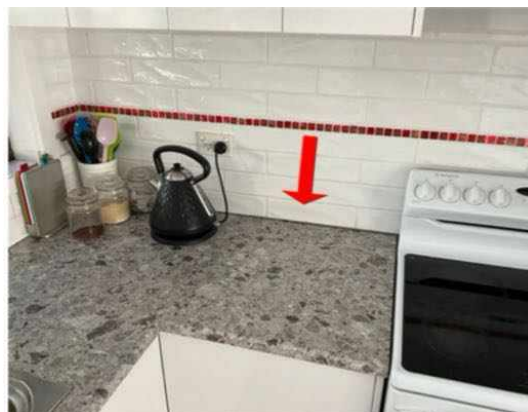
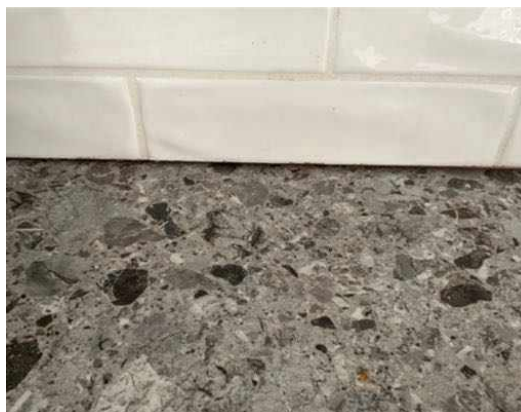
### Finding 3.02

Finding: Deteriorated Grouting – Kitchen Wall Tiles

Information: Deterioration to the grouting between the kitchen wall tiles was observed at the time of inspection. The grout appears cracked and worn in sections, which may be attributed to age, general wear and tear, or minor movement of the tiled substrate. This assessment was based on a visual, non-invasive inspection only.

Deteriorated grout can allow moisture to penetrate behind the tiled surface, potentially leading to damage of the underlying wall lining or substrate over time. Continued moisture ingress may result in tile loosening, mould growth, or concealed deterioration to adjacent materials.

It is recommended that the affected grout be removed and re-grouted by a qualified tiler to restore the integrity of the tiled surface and reduce the risk of moisture penetration. Ongoing monitoring is advised to ensure no further deterioration occurs.

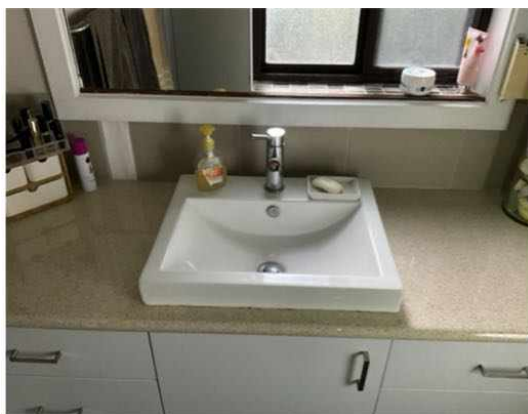
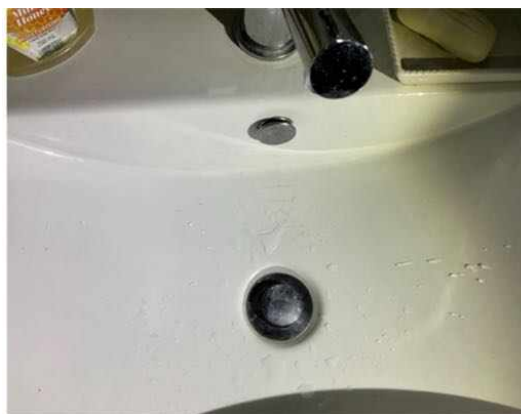
### Finding 3.03

Finding: Basin Cracking

Information: Cracking was observed on the surface of the basin during the inspection. Cracking typically appears as fine hairline cracks in the glazed finish and commonly occurs due to age, thermal stress, manufacturing defects, or prolonged use of harsh cleaning products.

While crazing is generally a cosmetic defect, it can trap dirt and moisture within the cracks, making the surface difficult to clean and potentially leading to staining or hygiene concerns over time. In some cases, continued deterioration may eventually compromise the glazed surface.

No immediate action is required if the basin remains functional and watertight. However, it is recommended that the basin be monitored for any signs of cracking progression or leakage. Replacement of the basin may be considered if the crazing worsens or if hygiene or aesthetic concerns become unacceptable.

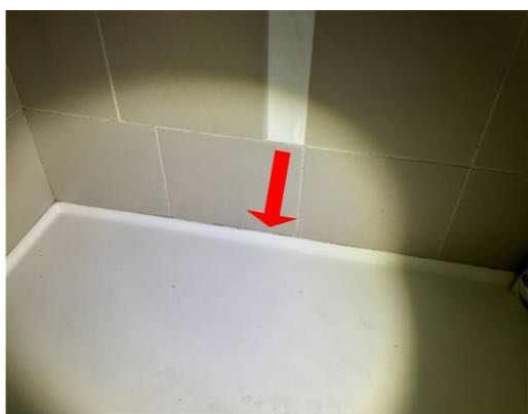
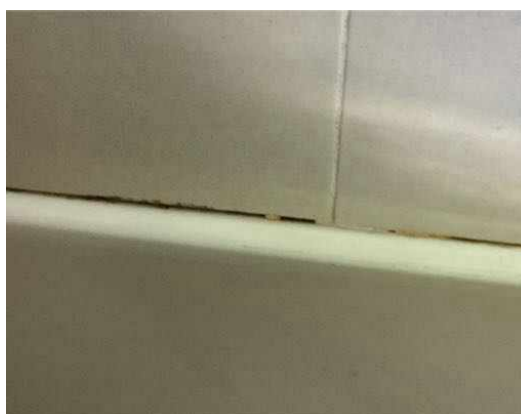
### Finding 3.04

Building:	Main Building
Location:	Bathroom
Finding:	Deteriorated Grouting – Shower Wall Base
Information:	Deterioration to the wall tile grout was observed at the base of the shower area during the inspection. The grout appears worn and degraded in sections, likely due to prolonged exposure to moisture and regular use. This assessment was based on a visual, non-invasive inspection only, and concealed substrate conditions could not be confirmed.

Deteriorated grout at the base of shower walls can allow water to penetrate behind the tiles and into the wall lining or framing. If left unaddressed, this may result in elevated moisture levels, mould growth, timber decay, or damage to adjacent building elements.

It is recommended that a qualified tiler remove and replace the affected grout to restore the waterproof integrity of the shower area. Further assessment should be undertaken if signs of underlying moisture damage are identified during rectification works.

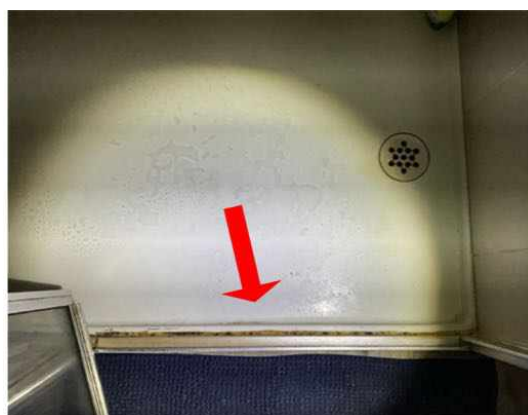
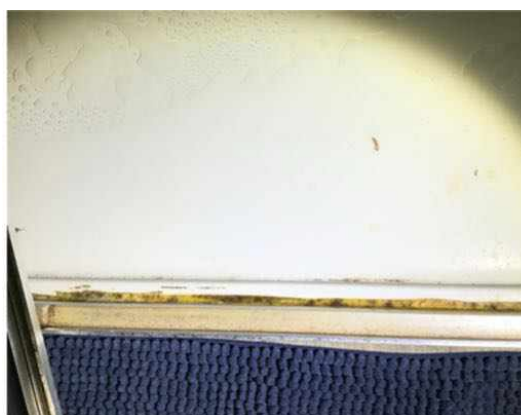
### Finding 3.05

Information: Suspected mould growth was noted in the shower area during the inspection. This is likely the result of excessive moisture and humidity commonly associated with wet areas, combined with inadequate ventilation or poor drainage. The persistent presence of water and damp conditions creates an environment conducive to mould development, especially if regular cleaning and drying practices are not maintained.

If left unmanaged, suspected mould growth can lead to several issues. Mould has the potential to impact indoor air quality and pose health risks, particularly for individuals with respiratory conditions, allergies, or sensitivities. Additionally, prolonged exposure to moisture can damage surrounding materials, such as grout, tiles, and underlying structures, leading to deterioration and costly repairs. In severe cases, mould growth may spread beyond the immediate area, affecting other parts of the building.

To address the issue, a qualified environmental health inspector or mould specialist should confirm the presence of mould and assess its extent. Minor mould growth can typically be cleaned using appropriate cleaning agents by the homeowner or a professional cleaning contractor. If materials are severely affected, a licensed builder or carpenter may be required to replace damaged elements. It is recommended to address this issue promptly and ensure proper ventilation and moisture control in the shower area to prevent recurrence.

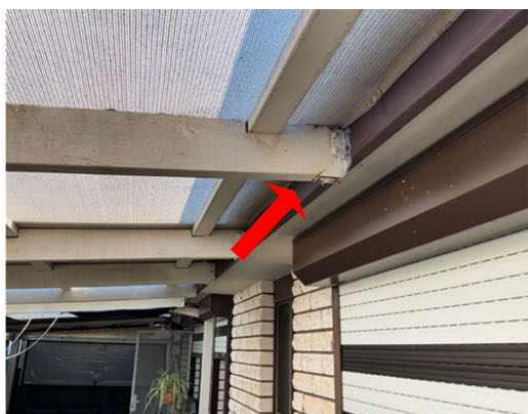
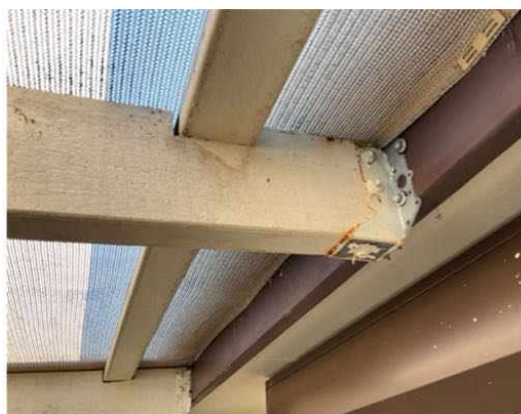
### Finding 3.06

Finding: Corrosion to Steel Connection Bracket – Pergola

Information: Corrosion was observed to the steel connection bracket and associated fixings at the pergola beam junction during the inspection. Surface rusting is visible around bolt heads and along the edges of the bracket, likely due to prolonged exposure to weather conditions and possible breakdown of protective coatings. This assessment was based on a visual, non-invasive inspection only.

Corrosion to structural steel components can progressively reduce the cross-sectional thickness and strength of the affected elements. If left unaddressed, continued deterioration may compromise the integrity of the connection and potentially affect the structural performance of the supported members.

It is recommended that a registered builder or qualified structural contractor assess the extent of the corrosion. Remedial works may include removal of surface rust, application of appropriate rust-inhibiting treatment, recoating, or replacement of severely affected brackets and fixings as required. Regular maintenance and protective coating should be implemented to prevent recurrence.

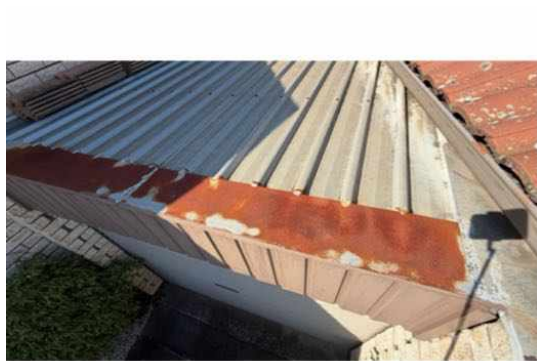
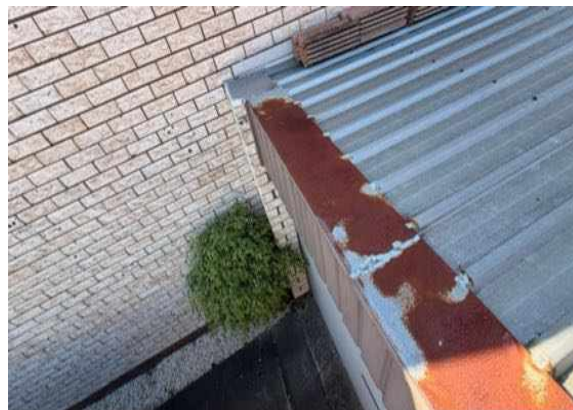
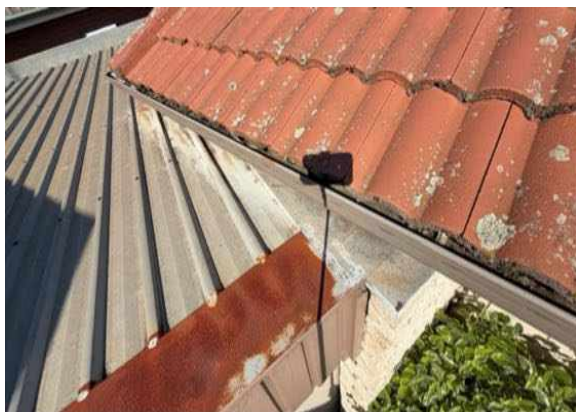
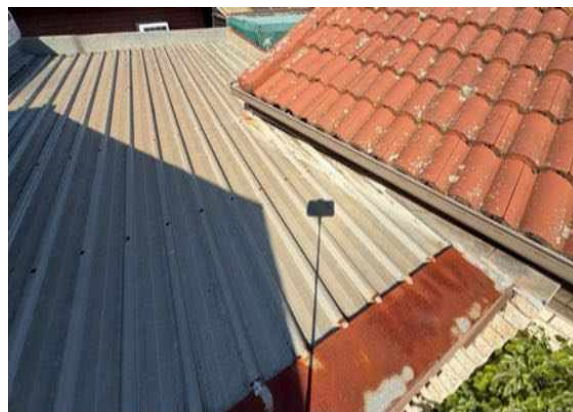
### Finding 3.07

Building:	Main Building
Location:	Roof Exterior
Finding:	Rusted Metal Flashing – Garage Roof
Information:	Rusting was observed to the metal roof flashing in the garage area at the time of inspection. The corrosion appears to have developed due to prolonged exposure to weather conditions and possible deterioration of the protective coating. This assessment was based on a visual, non-invasive inspection only.

Corroded flashing can compromise the roof's weatherproofing performance, increasing the risk of water ingress into the garage structure. If left unaddressed, ongoing corrosion may lead to perforation of the metal, leakage, and subsequent damage to adjacent structural elements.

It is recommended that a licensed roofing contractor assess the extent of the corrosion and undertake necessary remedial works. This may include cleaning, treating, and recoating the affected areas or replacing the flashing if deterioration is advanced. Prompt attention will assist in maintaining the roof's integrity and preventing moisture-related damage.

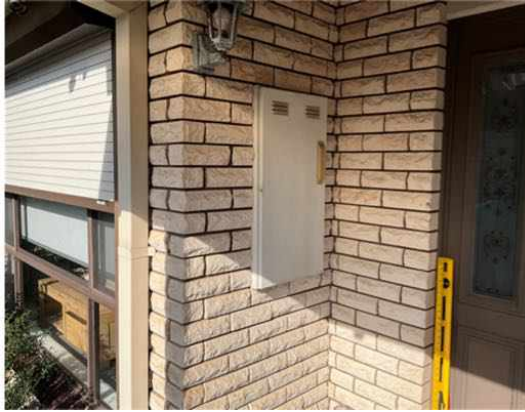
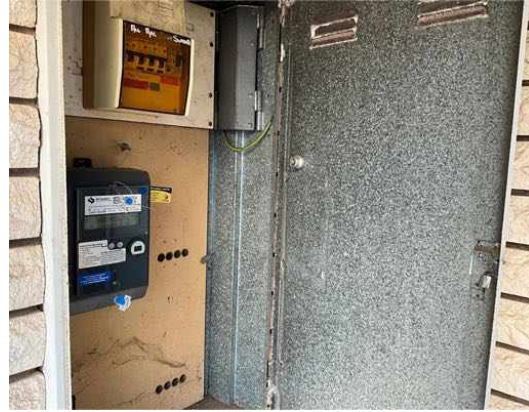
Building:	Main Building
Location:	Meter Box
Finding:	Termite Management System - no evidence of a chemical installation
Information:	The application of a post-construction chemical termite barrier is highly recommended for all properties, particularly if live termite activity has been found on the site previously. Such barriers are highly effective in preventing termite attack on any timber building elements throughout the property.

system has been installed, with no evidence to suggest preventative works taking place.

The client may consider gaining further advice from a pest controller as to the costs and procedures involved with this application. It is recommended that obtaining such advice be a short-term priority.

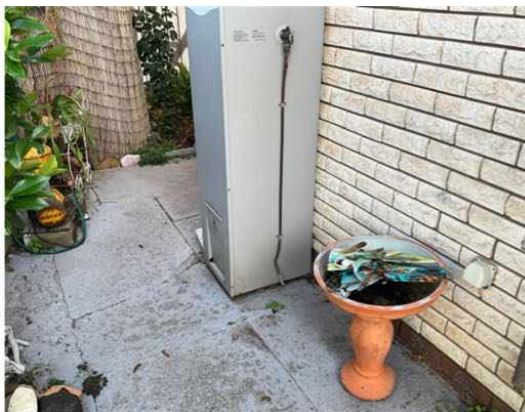
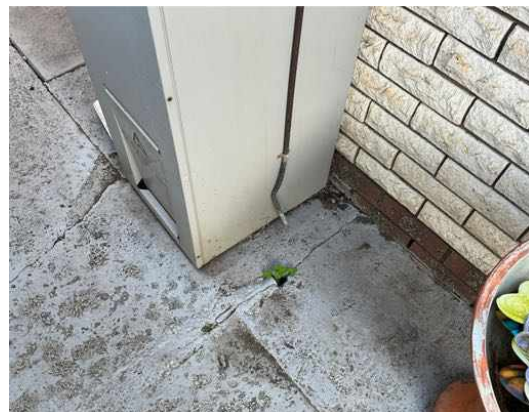
## Finding 6.02

Building:	Main Building
Location:	All External Areas
Finding:	HWS Overflow - Not Connected
Information:	The Hot Water System (HWS) overflow was found to be disconnected from storm water drainage and is creating excessive moisture in the surrounding area.

These damp conditions can lead to secondary defects such as rot, rust or corrosion of associated building elements, the formation of fungal decay, or even the creation of potential slip hazards. When coupled with poor site drainage, pooling of water may also attract termite activity to this area.

It is highly recommended that a licensed plumber be appointed to connect the HWS overflow in order to prevent such an environment from being created. These minor works should be carried out as soon as possible.

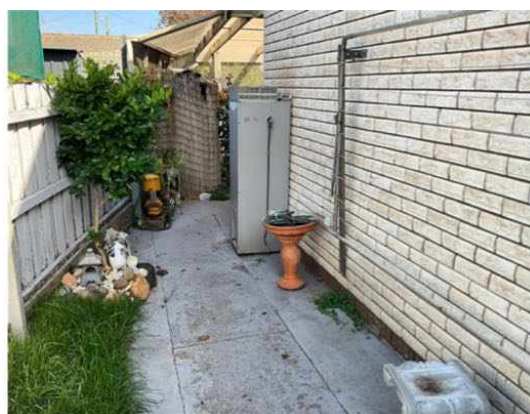
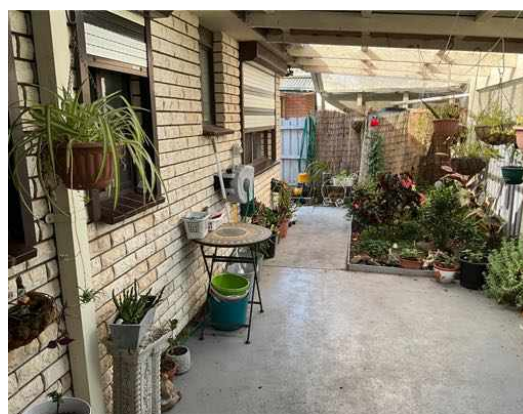
### Finding 6.03

Building:	Main Building
Location:	All External Areas
Finding:	Bridging - Attachments to Buildings
Information:	Bridging occurs when items against a building provide a concealed entry point for termites into the building or by passing around a termite management system.

Where any part of an attachment to a building is not isolated and is not provided with a clear gap of not less than 25mm from the building, bridging occurs. Attachments to buildings such as hot water services, downpipes, verandahs, decks, steps, fences, service conduits are the like provide the opportunity for concealed entry.

Building attachments of this nature need to be frequently inspected for termite activity by a qualified inspector.

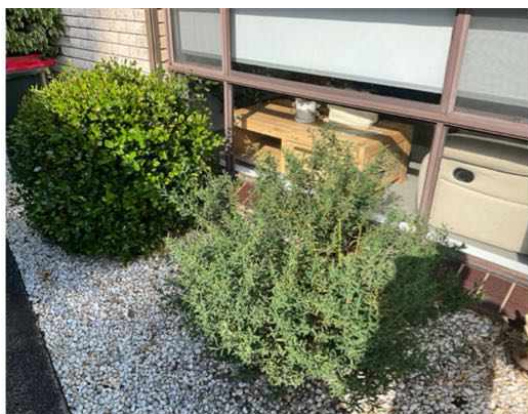
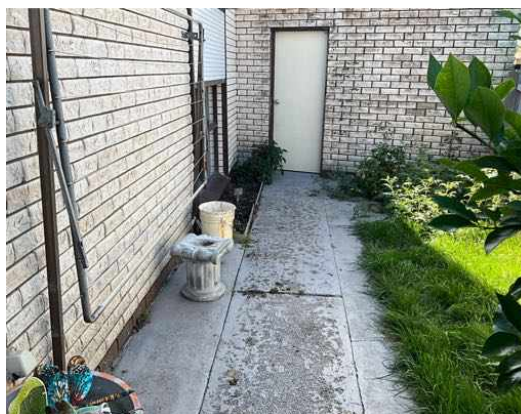
### Finding 6.04

Building:	Main Building
Location:	All External Areas
Finding:	Garden Beds - Conditions Conducive to Termites
Information:	Garden beds were found to be evident in the garden area. These garden beds can include untreated timber, and with a combination of moisture from watering hosing can make conditions conducive to termite activity and termite ingress.

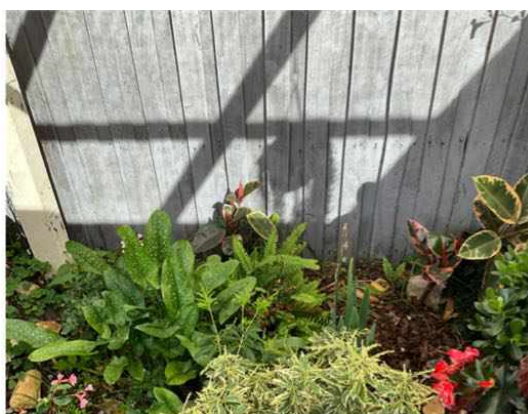
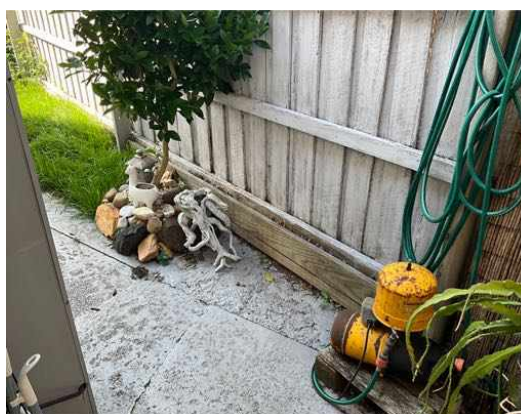
### Finding 6.05

Building:	Main Building
Location:	All External Areas
Finding:	Building materials in direct ground contact - conducive to termites
Information:	Where timber elements are in direct contact with the ground and consequently moisture or dampness they become conducive to termite activity. Whether timber is used as a building element part of a fencing structure or stored as an unused item they can provide an environment that is attractive to termite infestation.

When met with excessive moisture timber begins to decay and develop wood rot. Any timbers that are in direct contact with external grounds especially if left untreated or non-durable also provide ingress for subterranean termites into that particular element.

The removal of any such materials that may be conducive to termite activity should be removed as soon as possible to minimise the risk of termite attack.

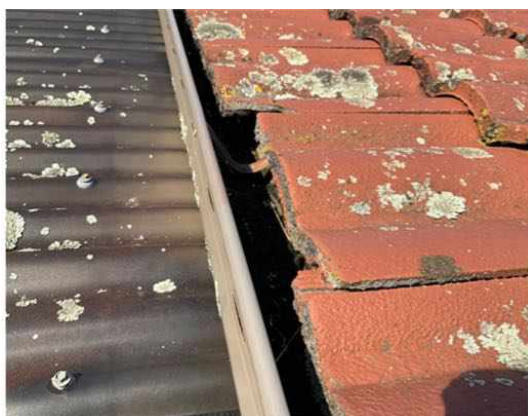
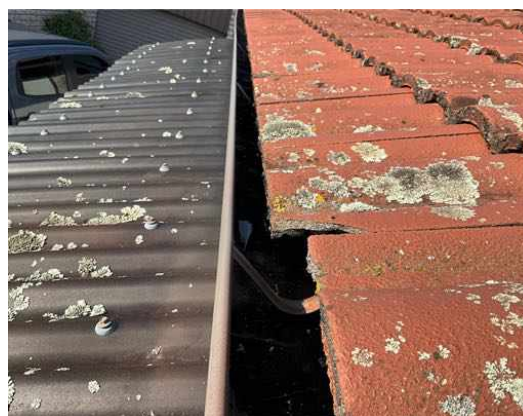
### Finding 6.06

Building:	Main Building
Location:	Roof Exterior
Finding:	Gutters - Partially Blocked - Timber Pest Risk
Information:	During the inspection, debris accumulation was noted in the guttering and downpipes.

Blocked gutters can cause water to pool and overflow, leading to excessive moisture around eaves, fascia boards, and exterior walls. Where gutter guards are installed, regular maintenance is essential to remove any debris that may settle on top or filter through. Prolonged exposure to moisture in these areas creates conditions conducive to timber decay and potential termite or timber pest activity.

Excess moisture resulting from blocked gutters can accelerate timber deterioration, increasing the risk of fungal decay and attracting timber pests such as termites. Moisture-damaged timber is highly susceptible to infestation, as pests are drawn to damp and softened wood. If left unaddressed, this issue can lead to structural weakening and costly remediation work.

It is strongly recommended that all blockages in the gutters and downpipes be cleared immediately to maintain dry conditions and reduce the risk of timber pest activity. Homeowners or a general handyperson can perform routine cleaning; however, a licensed plumber should be consulted for further assessment and any necessary remedial work. Ongoing gutter maintenance is crucial in preventing future moisture-related timber issues.

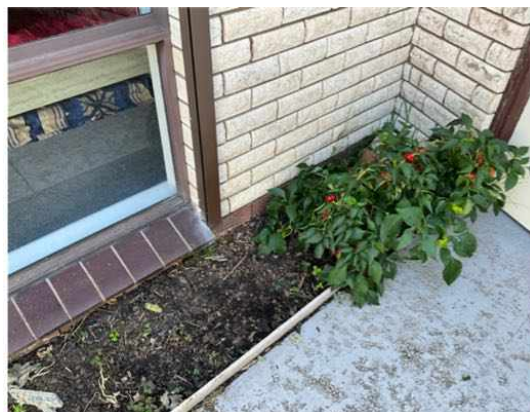
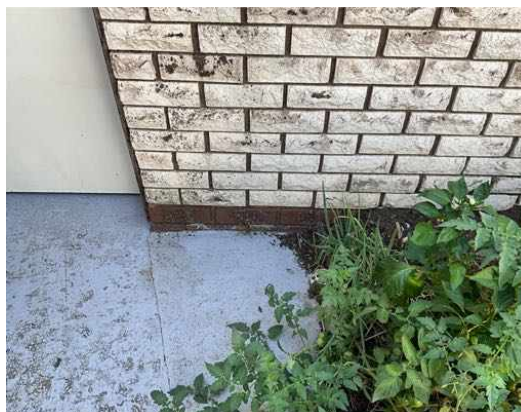
### Finding 6.07

Building:	Main Building
Location:	All External Areas
Finding:	Slab Edge - Exposure
Information:	An inspection zone of at least 75mm in relation to the exposed slab edge, between the bottom brick and the perimeter pavement, is required. This inspection zone should be maintained in order to force termites into the open where they can be detected more readily during regular inspections. The slab edge should not be concealed by anything that may prevent inspection of the area, including render, landscaping, soil, turf, paving, concrete cladding or other structures.

If the slab edge is not properly exposed there is a high risk of termite attack. Sometimes, in order to determine the type of slab, a suitably qualified person such as an architect or builder may be required to consult the construction plans.

Where the slab edge cannot be properly inspected, it is highly recommended that termite or timber pest inspections be carried out every 6-12 months to aid protection of the property against infestation.

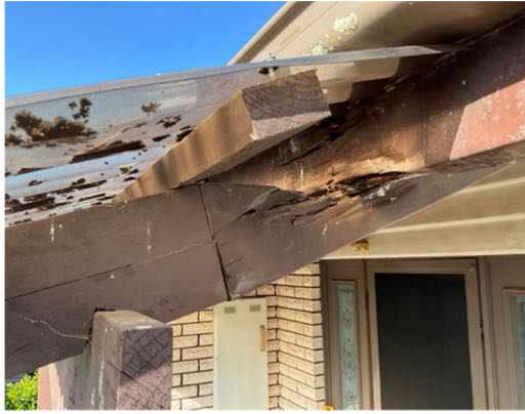
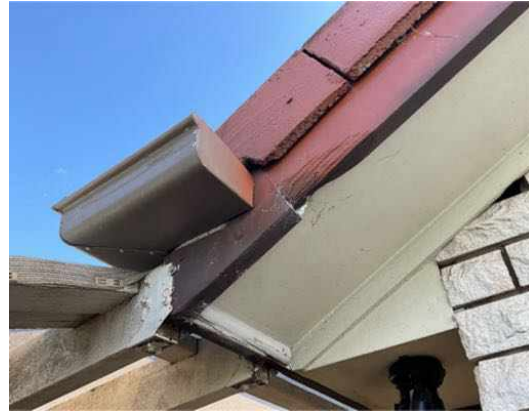
### Finding 7.01

Building:	Main Building
Location:	All Areas
Finding:	Wood rot
Information:	This building element shows evidence of wood rot. Wood rot, also known as Fungal Decay, occurs when timbers and other cellulose building materials are exposed to damp conditions on an ongoing basis. This could be the result of exposure to weathering over a prolonged period of time, or the attraction of excessive moisture from other abutting building materials. Contributing factors also include poor air ventilation in the area.

Wood rot is often associated with general damp problems and is evidenced by a 'musty' smell or mould and mildew occurring on surfaces. If left unmanaged, damp conditions can lead to further health problems and the decay of timbers will continue.

Early intervention and regular maintenance, particularly of exterior timbers, will prolong the useful life of these building elements. Prior to any works being performed, the cause of the moisture that has created the visible wood rot should be identified and addressed in a suitable manner. Replacement of affected timbers may then be a necessary step in protecting surrounding building elements from such deterioration.

A qualified plumber may be appointed to assess the cause of excessive moisture and to provide advice on any remedial works as required. A qualified carpenter or registered builder may also be required to replace affected building materials.

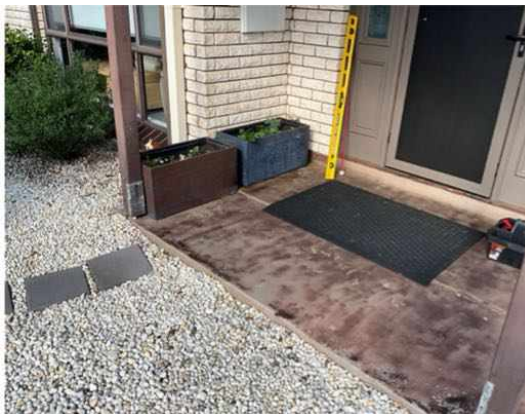
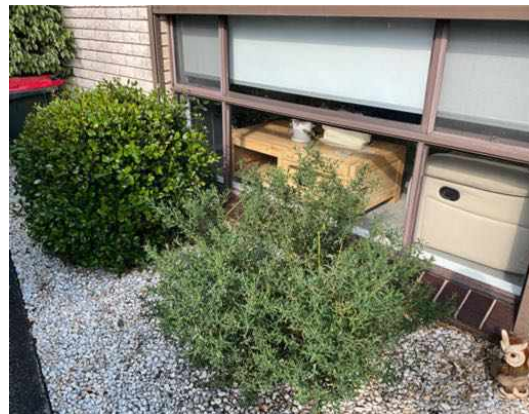
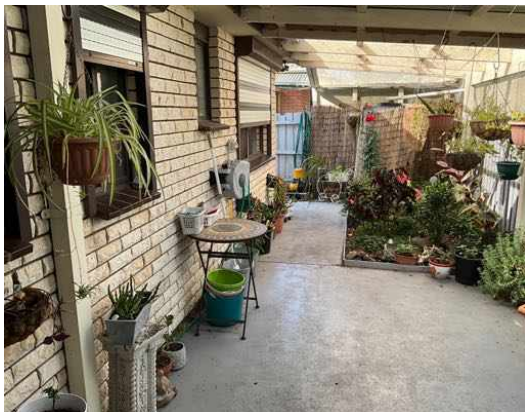
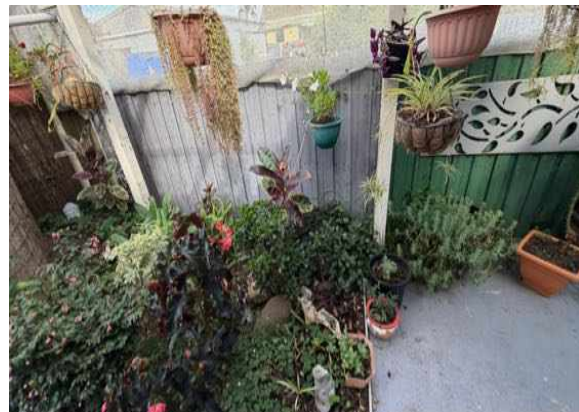
Building: Main Building  
 Location: All External Areas  
 Finding: Obstructions and Limitations - External areas  
 Information: These photographs are an indication of the obstructions and limitations which impeded full inspection of the external areas of the property at the time of inspection. These obstructions can hide an array of defects and should be removed to allow full inspection to be carried out. A re-inspection is recommended once the areas are made accessible.

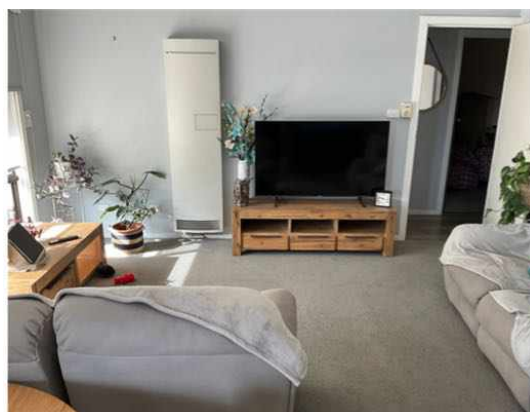
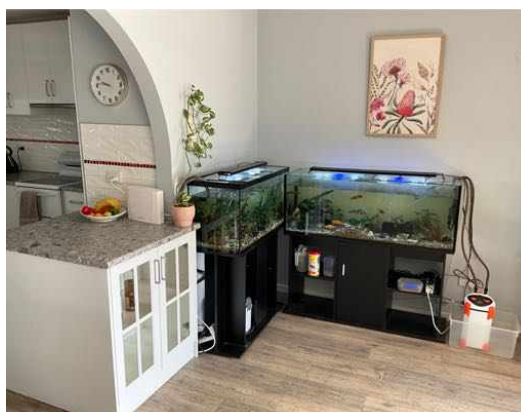
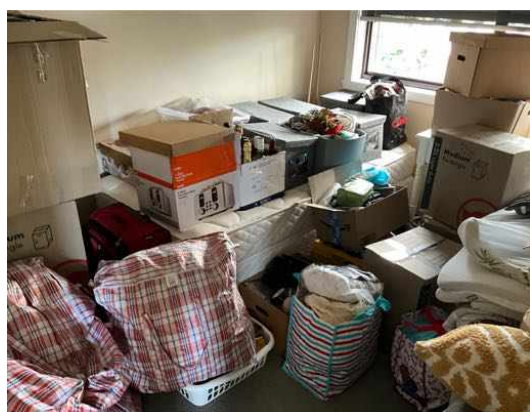
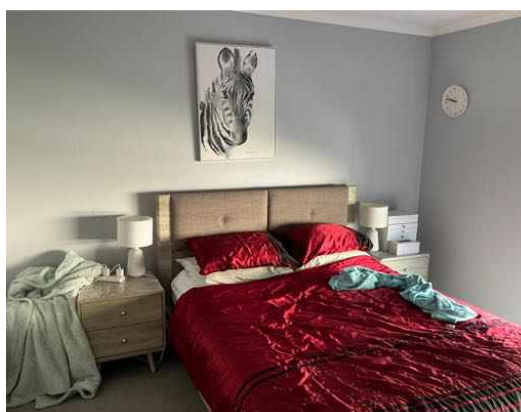
Building: Main Building  
 Location: All Internal Areas  
 Finding: Obstructions and Limitations - Internal areas  
 Information: These photographs are an indication of the obstructions and limitations which impeded full inspection of the internal areas of the property at the time of inspection.

These obstructions can hide an array of defects and should be removed to allow full inspection to be carried out. A re-inspection is recommended once the areas are made accessible.

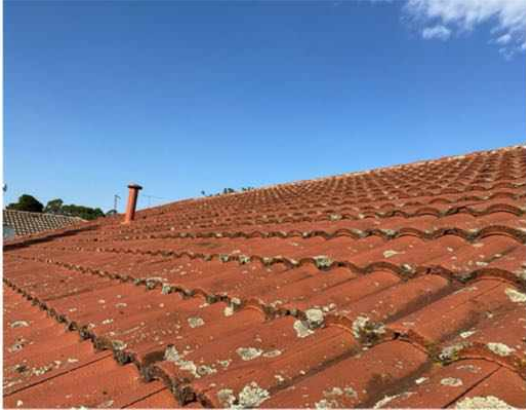
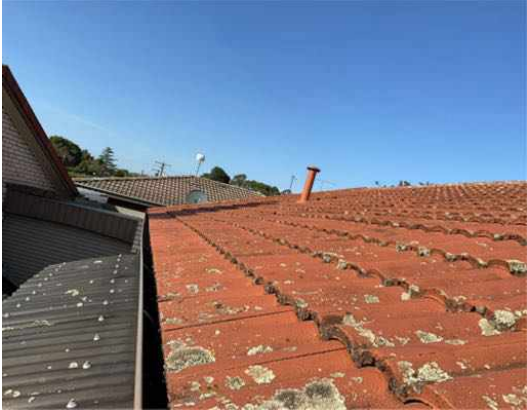
Building: Main Building  
 Location: Roof Exterior  
 Finding: Exterior roof tiles - condition  
 Information: Upon visual inspection, the roof tiles appear to be in fair condition, with minor wear consistent with the age of the building. Moss growth was also observed to sections of the roof surface. Moss accumulation can retain moisture against the tiles, which may accelerate surface deterioration and affect the long-term performance of the roofing material.

To maintain the roof's condition, regular inspections and maintenance by a licensed roofing contractor are recommended. Routine maintenance will assist in identifying any hidden or emerging issues, including tile displacement, mortar deterioration, or moisture-related concerns, allowing proactive rectification works to be undertaken.
