# Building and Timber Pest Inspection Report VR

Inspection Date: Sat, 14 Mar 2026

Property Address: 1 McMahon St, Fairy Meadow NSW 2519,  
Australia

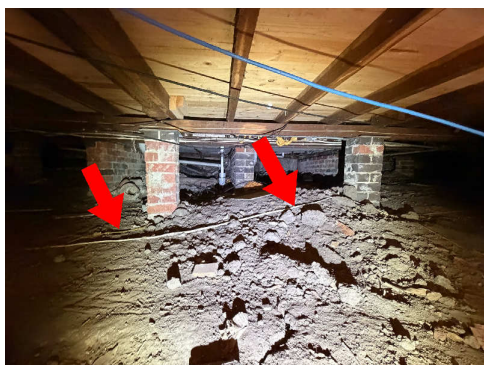
Information: Electrical wiring was observed running along the ground surface within the subfloor area at the time of inspection. This installation is considered substandard as cabling in subfloor areas should generally be adequately supported, protected, and secured clear of the ground to prevent damage from moisture, pests, or physical disturbance.

A licensed electrician should further assess the installation and rectify as required. Cabling should be properly supported and protected in accordance with applicable electrical standards to reduce the risk of damage and ensure safe operation.

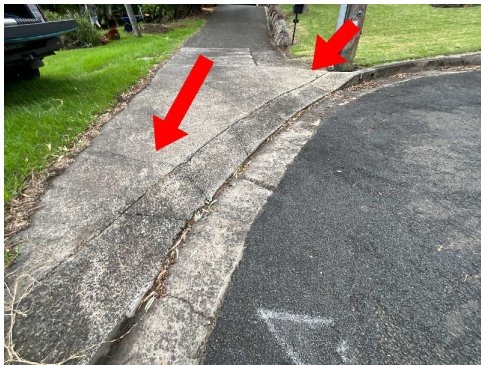
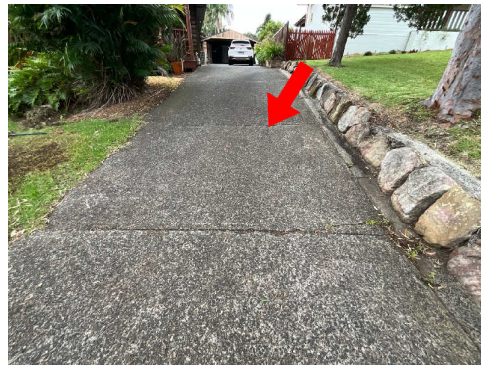
Finding: Crack in concrete slab - Category 0

Information: A crack coded as Category 0 was identified in the slab. A Category 0 crack is described as a hairline crack, representing insignificant movement of slab from level.

No rectification is required at this time. However, all cracking should be monitored over a 12 month period to identify any further damage in the area.

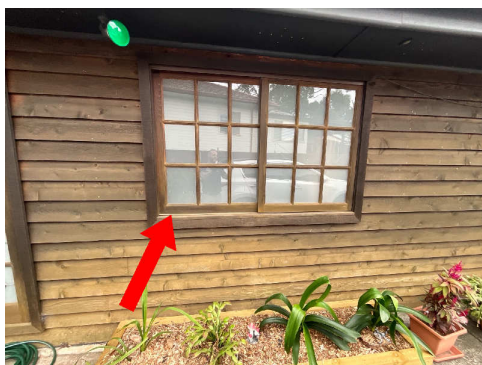
**Information:** The window rail to the cedar window was observed to have become disconnected from the windowsill. This has resulted in a separation between the rail and sill, which may allow moisture ingress and may affect the stability and operation of the window assembly if left unrectified.

Repairs are recommended to securely refix the window rail to the windowsill. Works should include sealing of any gaps and ensuring the window assembly is properly secured and weather-resistant. Any damaged timber should also be assessed and repaired as required.

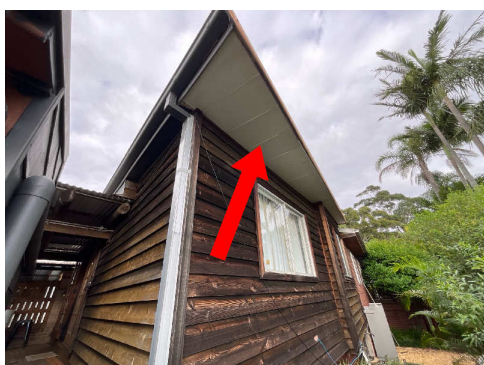
### Finding 3.04

Whilst incomplete or missing paint finish is generally an appearance defect, it can also lead to the development of secondary building defects over time. Incomplete areas of paint finish expose the area to moisture, potentially accelerating the deterioration of underlying building materials.

Incomplete paint finishes should be sanded back, filled, leveled and painted, as applicable. Where inadequate or missing paint protection has led to the deterioration of the associated building element, repair and/or replacement of this building element may be required.

A painting contractor should be appointed as soon as possible to perform necessary works to aid the appearance of the affected area and to ensure the area is protected against further deterioration. Alternatively, the homeowner following manufacturer instructions may perform these works.

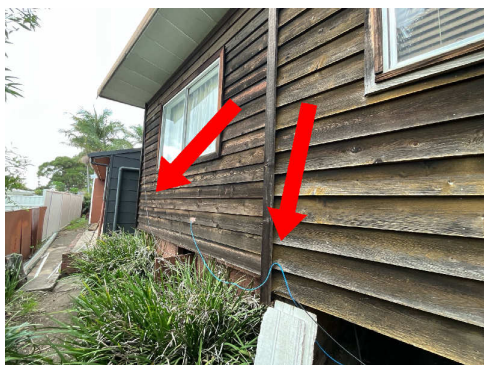
### Finding 3.06

Information: Substandard and incomplete installation of external data and Foxtel (coaxial) cabling was observed to the exterior of the building. The cabling appears to be poorly routed and not properly secured or terminated, resulting in an untidy installation that may leave the cables vulnerable to damage and weather exposure.

A licensed communications technician should inspect the installation and complete the routing and termination of the data and Foxtel cabling. Cabling should be properly secured, protected, and installed in accordance with industry standards to ensure durability and correct operation.

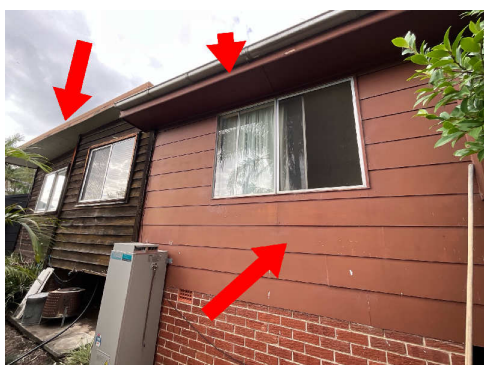
**Finding 3.07**

Building: Main Building  
Location: All External Areas  
Finding: External Painting Deteriorated

Whilst incomplete or missing paint finish is generally an appearance defect, it can also lead to the development of secondary building defects over time. Incomplete areas of paint finish expose the area to moisture, potentially accelerating the deterioration of underlying building materials.

Degraded paint finishes should be sanded back, filled, leveled and painted, as applicable. Where inadequate or missing paint protection has led to the deterioration of the associated building element, repair and/or replacement of this building element may be required.

A painting contractor should be appointed as soon as possible to perform necessary works to aid the appearance of the affected area and to ensure the area is protected against further deterioration. Alternatively, the homeowner following manufacturer instructions may perform these works.

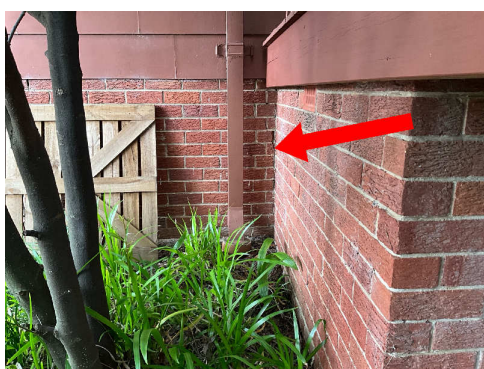
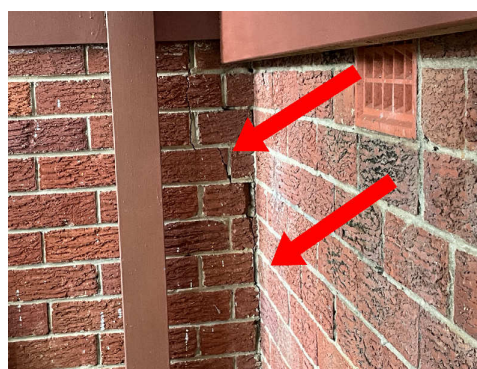
## Finding 3.08

Building:	Main Building
Location:	Exterior walls - left side
Finding:	Brickwork - Cracking [Fine]
Information:	<p>Although fine cracks are quite noticeable, they are often only considered to be an appearance defect and usually do not indicate any structural damage. Generally, the cause of a fine crack is indicative of a separation between brickwork and mortar throughout the structure, but single bricks may also show cracks of this nature.</p> <p>Cracking of this nature can generally be repaired with minor filling and should be conducted by a qualified bricklayer.</p> <p>Always contact a building inspector should cracks widen lengthen or become more numerous.</p>

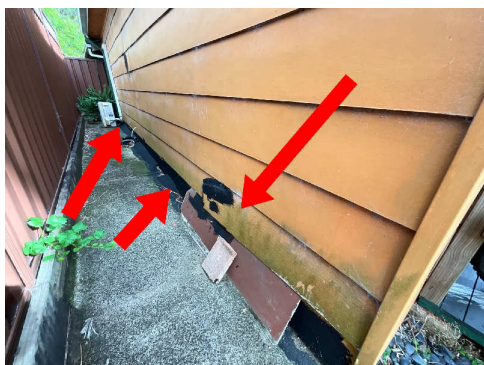
### Finding 3.09

Building:	Granny-Flat
Location:	Exterior walls - right side
Finding:	Incomplete / Substandard construction
Information:	<p>There are a number of Building elements that were identified as being incomplete or substandard works in this areas consisting of poor installation of cladding boards, sub standard repair to seal the cladding to the concrete, suspected previous water entry to granny flat.</p> <p>Sub standard and incomplete work are determined by identifying a failure to achieve the minimum requirement set out in the mandated Australian Standard as outlined in the Building Code of Australia and referenced by the Manufacturers Guideline.</p>

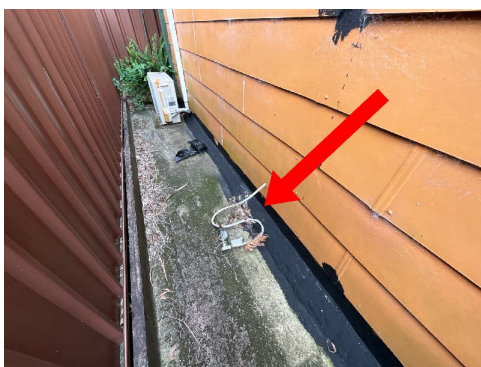
**Finding 3.10**

Building: Main Building  
Location: Garage  
Finding: Gas Regulators - Non-compliant

Unfinished and substandard building works are likely to degrade more quickly and may create potential for secondary defects to associated building elements, as well as a potential safety hazard in the case of gas service management.

The findings are that there appears to be no compliance plate and the bottle is not securely fastened. Where installation is substandard and/or incomplete, the client should contact the responsible trade (gas plumber) to undertake rectification.

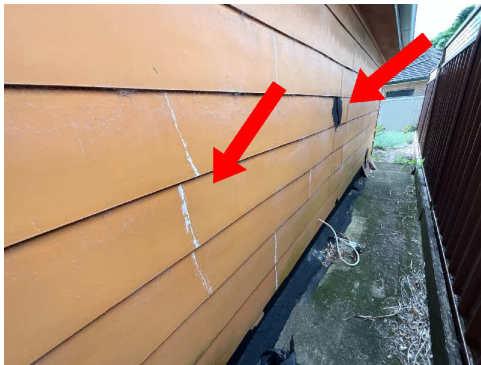
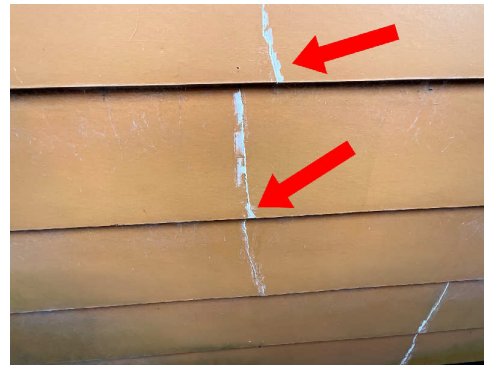
### Finding 3.11

**Finding:** Extensive Cracking to External Garage Cladding Boards – Patch Repairs Evident

**Information:** Extensive cracking was observed to the external cladding boards to the garage. Evidence of previous patch repairs was also noted; however, the cracking remains visible and indicates substandard finish and deterioration of the cladding material. The defects affect the overall appearance of the garage façade and may allow moisture ingress if the cladding continues to deteriorate.

Further assessment and rectification by a suitably qualified contractor is recommended. Damaged cladding boards may require proper repair or replacement, followed by appropriate preparation and repainting to restore the durability and finish of the external wall surface.

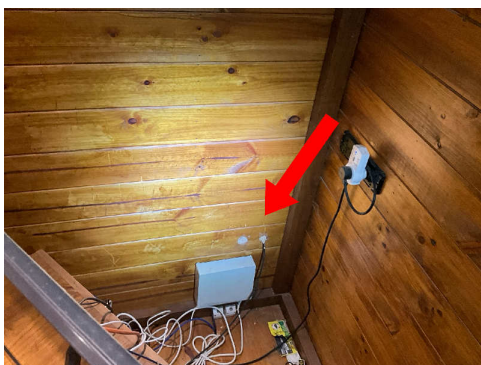
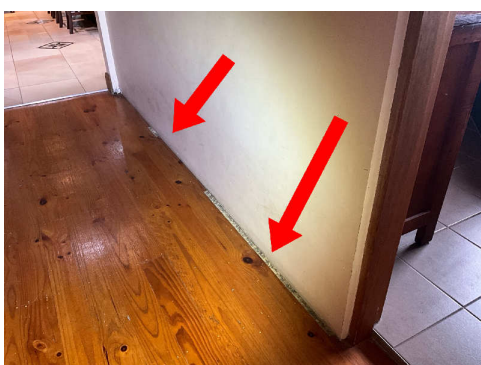
**Finding 3.12**

Building: Main Building  
Location: All Areas  
Finding: Incomplete / Substandard construction

- Missing Skirting
- Missing ceiling cornice
- Incomplete painting to wet area doors and bedroom walls
- Floor tiling repairs in progress

Sub standard and incomplete work are determined by identifying a failure to achieve the minimum requirement set out in the mandated Australian Standard as outlined in the Building Code of Australia and referenced by the Manufacturers Guideline.

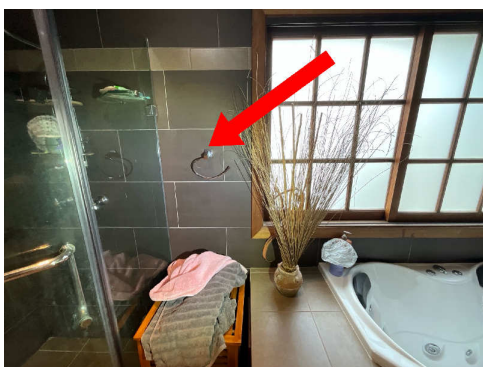
If left unmanaged, the fitting may further deteriorate, causing potential for the development of other minor secondary defects.

A relevant tradesperson should be appointed to perform these rectification works at discretion of the client.

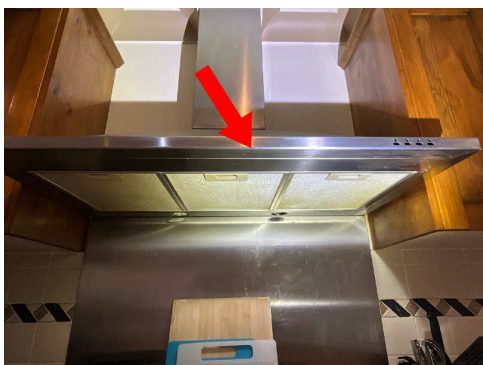
### Finding 3.18

Without a functional fan, a build-up of grease and evaporative moisture is likely to accelerate deterioration of the range hood and associated flue. This potential build up may also create a minor fire hazard, particularly if left uncleaned.

A licensed electrician should be appointed to replace the fan on the range hood to restore it to a fully operational state.

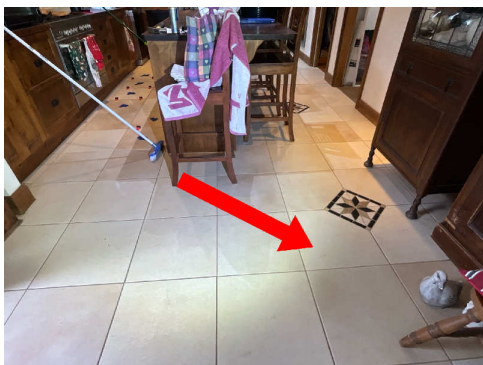
### Finding 3.19

Cracked tiles throughout the household detract from the overall appearance of the affected areas however it is unlikely to create or lead to any secondary defects, as water proof membrane failure.

While not considered a matter of urgency, replacement of cracked floor tiles is recommended at the clients discretion. A tiling contractor may be appointed to perform these works. Where cracks become more numerous, contact a licensed building inspector for further investigation.

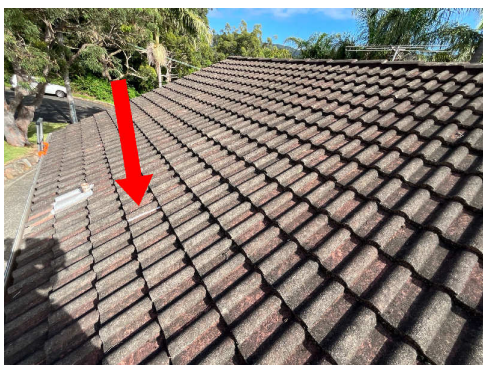
### Finding 3.20

If left to further deteriorate, broken and brittle roof tiles are likely to lead to water penetration via the roof into the ceiling space, causing secondary damage to ceiling linings, insulation and roof structures. Broken roof tiles are also likely to detract from the effectiveness of the roof drainage system, creating potential for secondary damage to the exterior roof covering and roof plumbing.

Replacement of broken tiles is required and should be performed by a roofing contractor as soon as possible.

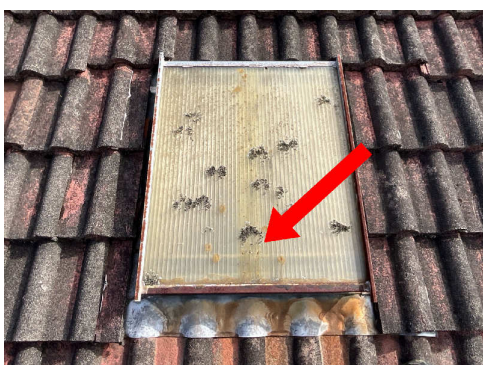
### Finding 3.21

Building: Main Building  
 Location: Yard - Back  
 Finding: Skylight - Damaged cover

However, repair or replacement of the skylight covering is recommended to prevent further deterioration or potential water damage to the surrounding areas. These works should be carried out as soon as possible by a qualified carpenter or general handyperson.

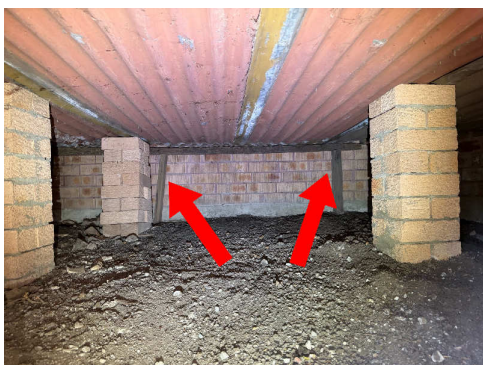
### Finding 6.06

Finding: Formwork timbers - left in situ

Information: Formwork timber appears to have been left on site and in situ after concrete construction. Formwork timber is used to support and shape the concrete while pouring during the construction process. Leaving formwork timbers in the subfloor space or around the exterior of the property increases the risk of termite activity being present. As they are likely to come into contact with weather conditions or excessive moisture wood rot is likely to develop on timbers that are not treated. It is highly recommended that any formwork timbers be immediately removed from areas in which they may attract any termite/timber pest attack. Minimisation of risk/prevention of termite attack is far more adequate than dealing with the presence of termite activity.

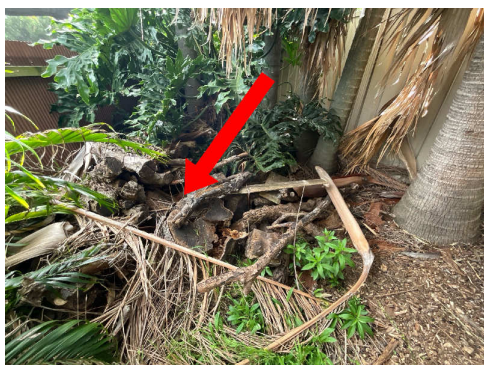
### Finding 6.09

Finding: Garden Beds - Conditions Conducive to Termites

Information: Garden beds were found to be evident in the garden area. These garden beds can include untreated timber, and with a combination of moisture from watering hosing can make conditions conducive to termite activity and termite ingress.
