Building Inspection Report

Inspection Date: Sat, 10 Jan 2026

Property Address: 9B Ashbourne Road, Woodend, VIC 3442

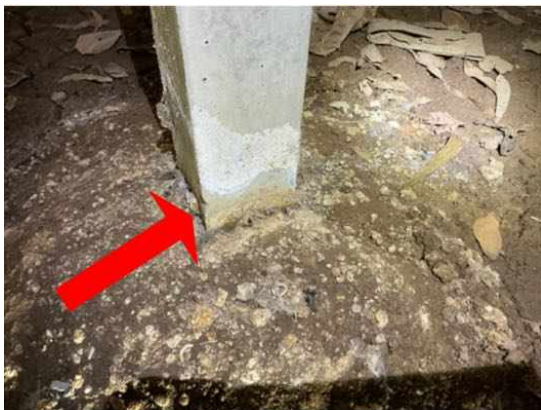
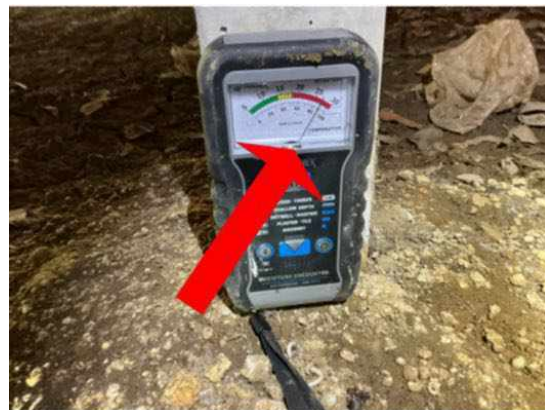
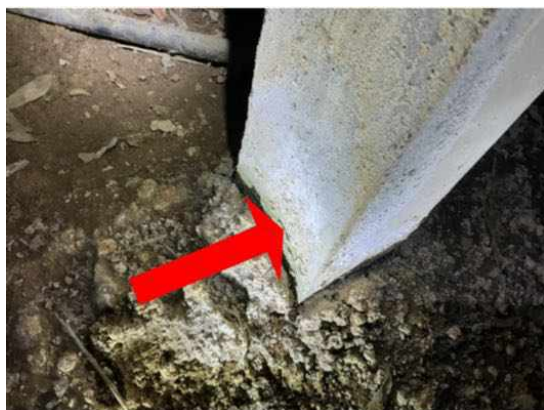
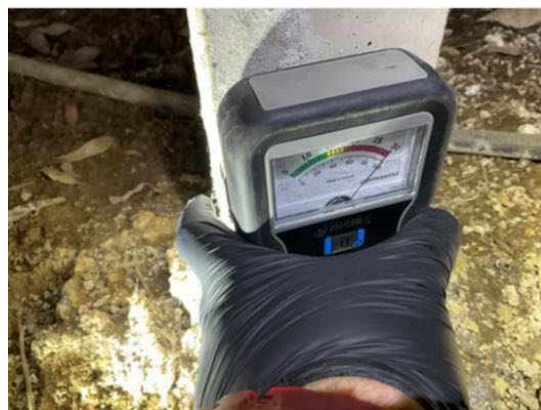
Defects 2.01

Building: Main Building
Location: Subfloor
Finding: Major Defect – Excessive Moisture Affecting Subfloor Stumps
Information:

High moisture readings were recorded to multiple subfloor stumps using a handheld moisture meter, with readings indicating excessively elevated moisture levels at the time of inspection. The affected stumps were also observed to be visibly damp. This condition is considered a major defect due to the potential impact on the structural performance and long-term durability of the subfloor support system.

Excessive and sustained moisture exposure to subfloor stumps may result in material deterioration, loss of bearing capacity, and progressive subfloor movement. This condition may be associated with factors such as poor site drainage, rising ground moisture, or inadequate subfloor ventilation. If left unaddressed, this issue has the potential to lead to structural instability, uneven flooring, and further damage to the building.

It is recommended that a registered builder specialising in restumping be engaged as a matter of priority to undertake a detailed assessment of the subfloor stumps and surrounding conditions. Remedial works may include improving site drainage, upgrading subfloor ventilation, and repairing or replacing affected stumps as required to restore the structural adequacy of the subfloor system.

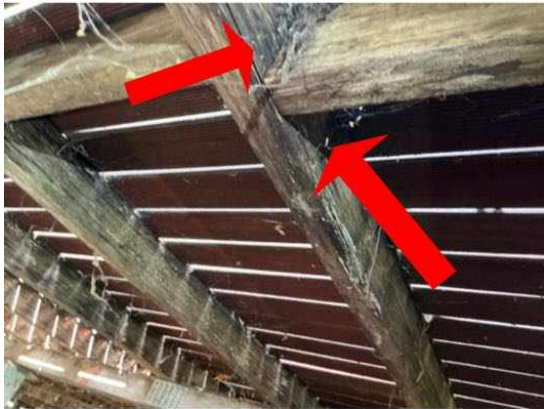
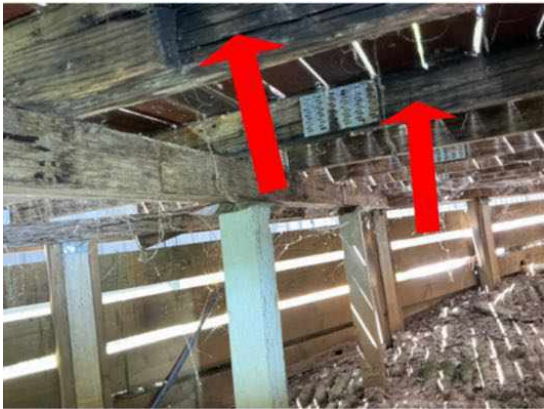
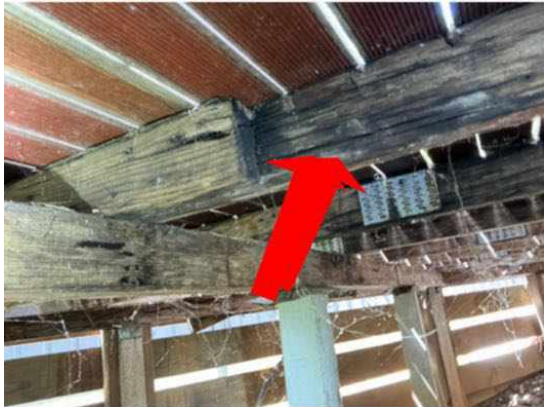
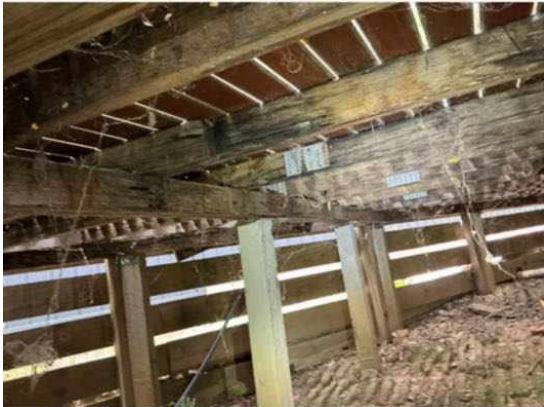
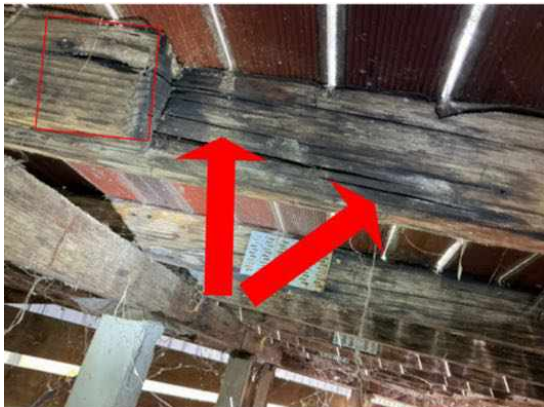
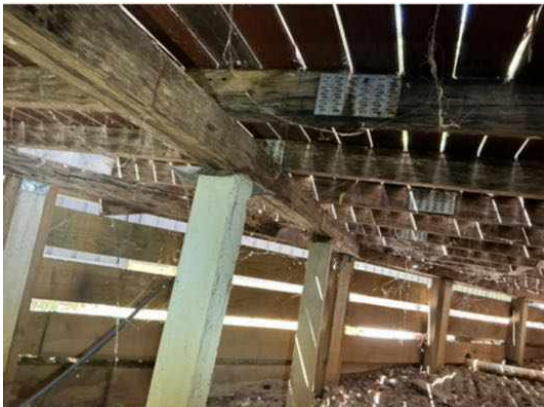
Defects 2.02

Building: Main Building
 Location: Subfloor
 Finding: Major Defect – Timber Deterioration and Fungal Decay to Subfloor Structure Beneath Decking

Information: The subfloor structural timbers located beneath the external decking were observed to be deteriorated, with visible signs consistent with timber decay and fungal rot. The affected timbers show evidence of prolonged moisture exposure and material breakdown at the time of inspection.

This condition is considered a major defect, as fungal decay reduces the strength and load-bearing capacity of timber members and may compromise the structural integrity of the decking and associated subfloor structures. The deterioration is suspected to have developed as a result of damp conditions beneath the deck, likely caused by water passing through the decking timber panels and insufficient drying or ventilation to the subfloor area.

It is recommended that a registered builder or suitably qualified carpenter experienced in structural timber repairs be engaged as a matter of urgency to further assess the extent of timber decay. Remedial works are likely to include removal and replacement of affected timbers, rectification of moisture entry through the decking, and improvements to drainage and ventilation beneath the deck to prevent recurrence of fungal decay.

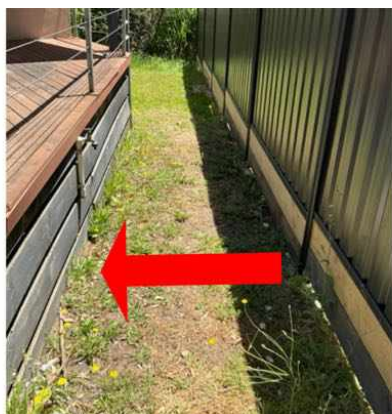
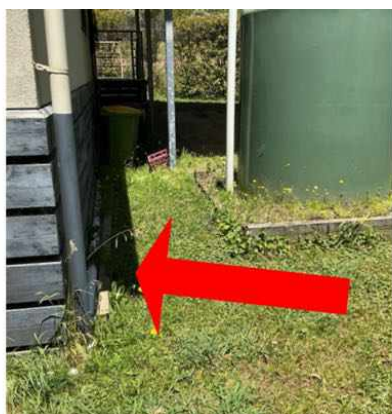
Defects 3.01

Building: Main Building
 Location: All External Areas
 Finding: Site drainage - Inadequate
 Information: The site drainage in all yards was found to be inadequate at the time of inspection, creating potential for subsequent water damage to associated building elements.

ground levels should be sloped to drain water away from walls. Downpipes should not discharge stormwater onto lower walls or plinths. Stormwater should be carried away by large, regularly cleaned drains. Ground levels may need to be lowered to expose a buried DPC.

Where site drainage is inadequate, installation of an Agricultural (Aggie) Drain may be required. A qualified plumber should be appointed to further inspect the property and perform any remedial works as necessary. Water damage and secondary defects are likely to occur if left unmanaged.

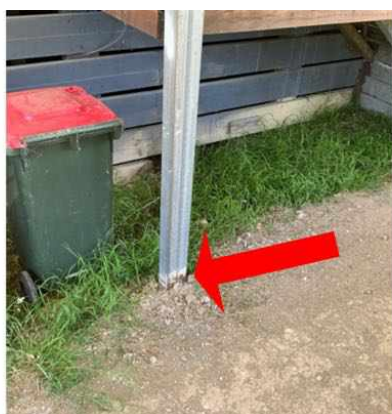
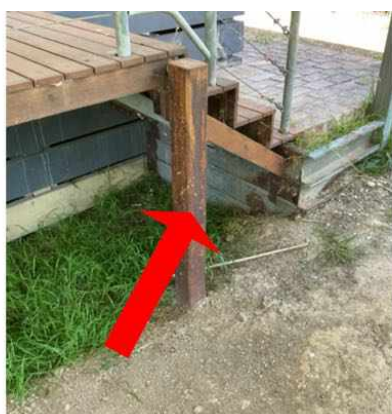
Defects 3.02

Building:	Main Building
Location:	Covered area
Finding:	Corrosion to Steel Posts and Beams – Rear Covered Area
Information:	Rust corrosion was observed to sections of the steel posts and steel beams supporting the rear covered area. The corrosion appears to be associated with the steel posts being in direct contact with the ground and exposed to ongoing weather conditions, including moisture and rainfall, which increases the risk of accelerated deterioration.

If left unaddressed, continued corrosion may compromise the protective coating and reduce the long-term durability of the steel elements. Progressive corrosion can also

lead to section loss over time, potentially affecting the structural performance and service life of the affected components.

It is recommended that a registered builder be engaged to assess the extent of corrosion and determine appropriate remedial works. Remedial measures may include removal of surface rust, application of suitable corrosion protection systems, and detailing works to isolate the steel posts from direct ground contact to prevent further deterioration.

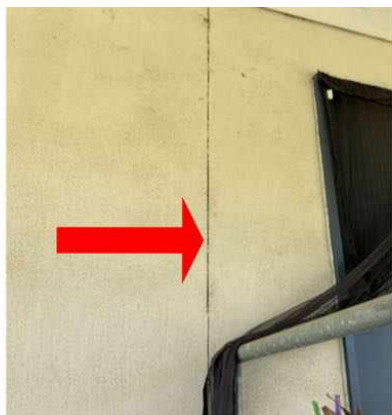
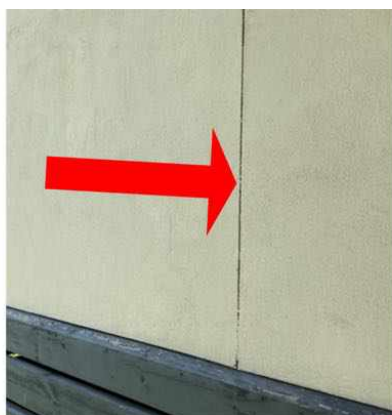
Defects 3.03

Building:	Main Building
Location:	All External Areas
Finding:	Inadequate Sealing to Expansion Joints – External Wall Cladding
Information:	The expansion joints between the external wall cladding panels on all elevations were observed to be exposed and inadequately sealed. The panel joints lack appropriate flexible sealant or compliant caulking to accommodate movement and provide effective weatherproofing.

Unsealed or poorly sealed expansion joints increase the risk of water ingress behind the cladding system, which may lead to moisture penetration, deterioration of wall framing, and potential mould growth. These openings may also provide entry points for pests and insects into the wall cavity.

It is recommended that a qualified renderer or caulking specialist be engaged to install suitable flexible sealant to all affected expansion joints in accordance with the cladding manufacturer's installation requirements. All works should ensure the joints remain flexible to accommodate thermal and structural movement while maintaining effective weatherproofing.

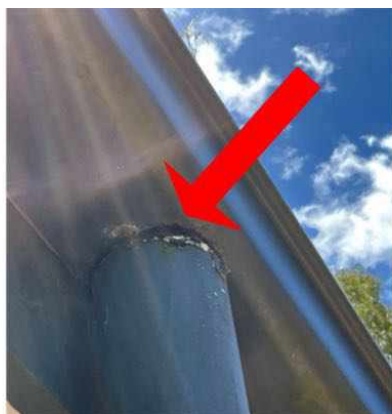
Defects 3.04

Building:	Main Building
Location:	All External Areas
Finding:	Non-Watertight Downpipe Connections
Information:	Multiple downpipes around the dwelling were observed to exhibit signs of previous water leakage, including staining and residue at joints. Several downpipe connections were noted to have small gaps, misalignments, or sections that are not fully sealed, indicating that the downpipe system is not consistently watertight. While no significant damage was evident at the time of inspection, these conditions suggest substandard jointing and/or previous movement of the downpipe components.

If left unaddressed, leaking or poorly sealed downpipes can result in uncontrolled discharge of stormwater adjacent to the building. This may contribute to moisture penetration, deterioration of external building elements, erosion at the base of walls, and increased risk of moisture-related defects over time, particularly during heavy rainfall events.

It is recommended that a licensed plumber be engaged to inspect all downpipes around the dwelling, reseal and refit defective joints, realign misaligned sections, and ensure all connections are properly secured and watertight. Any downpipes or components that cannot be adequately sealed should be repaired or replaced as required to ensure effective and compliant stormwater drainage.

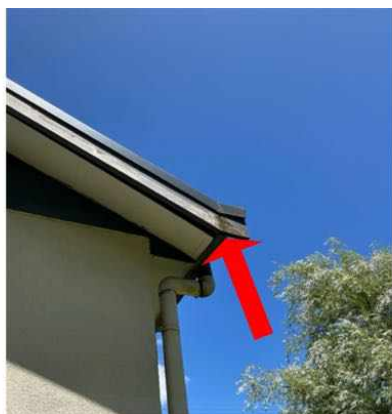
Defects 3.05

Building:	Main Building
Location:	All External Areas
Finding:	Fascias - Wood rot
Information:	Wood rot and timber deterioration was found to be affecting fascias and barges around the house, evidenced by the presence of mould on the surface in some areas. Wood rot, also known as Fungal Decay, occurs when timbers and other cellulose building materials are exposed to damp conditions on an ongoing basis.

It is likely that this wood rot has developed as a result of faults in the roof plumbing, creating excessive moisture in this areas. Frequent exposure to rain and other weather conditions also make fascias and barges susceptible to accelerated deterioration.

Early intervention and regular maintenance will prolong the useful life of these building elements. Prior to any works being performed, the cause of the moisture that has created the visible wood rot should be identified and addressed in a suitable manner.

It is advised that a roof plumber be appointed to inspect all roof plumbing and subsequently identify the cause of the wood rot. Replacement of affected fascias and barges may then be a necessary step in protecting surrounding building elements from such deterioration.

A qualified plumber may be appointed to assess the cause of excessive moisture and to provide advice on any remedial works as required. A qualified carpenter or registered builder may also be required to replace affected building materials.

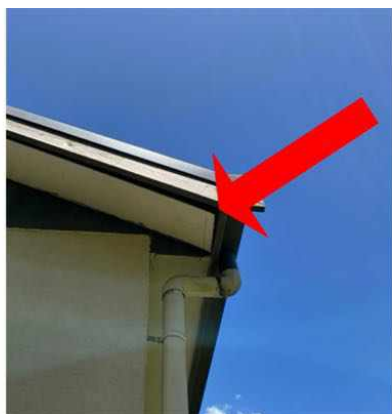
Defects 3.06

Building:	Main Building
Location:	Western/Northern elevation
Finding:	Detached and Sagging Eave Lining Sheet – Western Elevation
Information:

One eave lining sheet to the western elevation was observed to be slightly detached and sagging from its original position. The sheet appears to have loosened at its fixings, resulting in a visible deflection and an untidy finish to the eaves in this area.

If not rectified, a detached or sagging eave sheet may allow pest entry, moisture ingress, and further deterioration of the lining and associated fixings. Ongoing movement may also cause the sheet to drop further, increasing the extent of repair required and detracting from the overall presentation of the building.

It is recommended that a qualified carpenter or licensed builder be engaged to refix or replace the affected eave sheet, reinstate secure fixings, and ensure the eave lining is properly aligned and adequately supported to prevent future detachment.

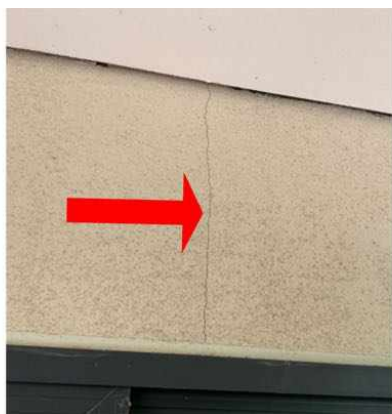
Defects 3.07

Building:	Main Building
Location:	All External Areas
Finding:	Deteriorated and Cracked Rendered External Wall Cladding
Information:

Multiple sections of the rendered external wall cladding around the dwelling were observed to be deteriorated, with cracking evident in various locations. The condition varies across the elevations, including minor hairline cracking, more pronounced cracking, and areas where cladding sheets have begun to separate, creating small gaps between panels. These defects indicate loss of continuity in the cladding system and compromise its intended performance as a weather-resistant external envelope.

Cracked or separated rendered cladding is not reliably watertight and may allow moisture ingress into the wall system. If moisture penetrates behind the cladding, it can lead to concealed damage to wall framing, insulation, and internal linings, as well as increased risk of mould growth and long-term material deterioration. Over time, unaddressed cracking may worsen due to thermal movement and weather exposure, increasing the extent and cost of repairs.

It is recommended that a qualified cladding specialist be engaged to assess all affected elevations and carry out appropriate repairs. All gaps between cladding sheets should be properly sealed using a suitable waterproof and flexible sealant, and all cracks should be professionally repaired and patched to reinstate the cladding's watertightness and improve overall appearance. Any sections of cladding that cannot be adequately repaired should be replaced as necessary to ensure ongoing durability and weather protection.

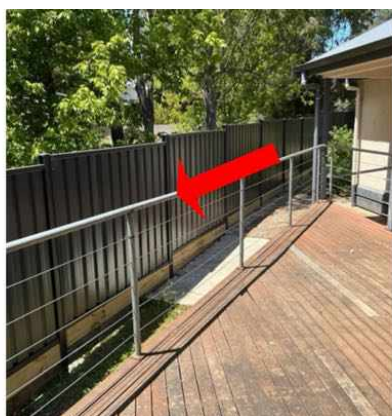
Defects 3.08

Building:	Main Building
Location:	Deck
Finding:	Unstable Deck Balustrade and Associated Subfloor Deterioration
Information:

The balustrade to the external decking area was observed to be unstable and flimsy at the time of inspection. Further inspection identified that several fixing screws to the balustrade were corroded, with some screws missing or no longer adequately secured. This has reduced the overall stability and effectiveness of the balustrade as a safety barrier.

The instability of the balustrade also appears to be contributed to by deterioration and timber decay to the subfloor structural elements beneath the decking. The compromised condition of the supporting subfloor timbers is likely reducing the capacity of the structure to adequately support the balustrade fixings, further affecting its stability.

It is recommended that a suitably qualified carpenter or registered builder be engaged to carry out a detailed assessment of the decking, balustrade, and supporting subfloor structure. Remedial works may include replacement of corroded or missing fixings, repair or replacement of deteriorated subfloor timbers, and strengthening or rebuilding sections of the balustrade as required to restore adequate stability and safety.

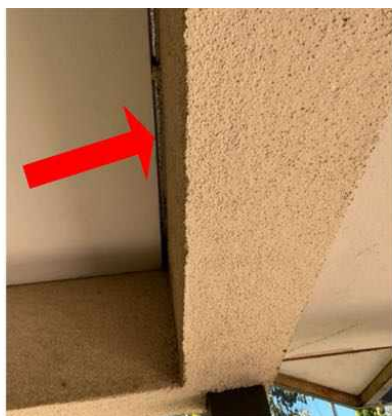
Defects 3.09

Building: Main Building
 Location: All External Areas
 Finding: Missing and Inadequate Sealant to External Junctions
 Information:

The property was observed to have inadequate and missing sealant in multiple areas around the exterior at the time of inspection. Affected areas include, but are not limited to, eaves junctions, edges, joints, and corners, where visible gaps were noted. These areas appear to have either insufficient sealant application or no sealant present at all.

Gaps and unsealed junctions reduce the weather-tightness of the building envelope and may allow wind-driven rain, moisture, dust, and pests to enter the building and roof space. Over time, this may contribute to moisture ingress, deterioration of building materials, and an increased risk of vermin or pest infestation within the roof void and wall cavities.

It is recommended that a suitably qualified caulking or sealing specialist be engaged to thoroughly inspect all external edges, joints, corners, and penetrations and to apply appropriate external-grade sealant where required. All sealing works should be completed to ensure the building envelope and roof space are made as watertight and well-sealed as reasonably practicable, reducing the risk of moisture ingress and pest entry.

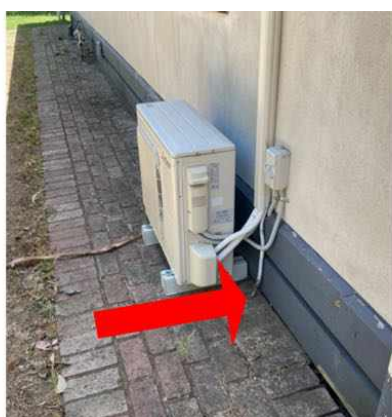
Defects 3.10

Building:	Main Building
Location:	Exterior walls - front
Finding:	AC Overflows - Not plumbed to suitable drainage
Information:	Upon inspection, it was found that the AC overflow is not plumbed or connected to suitable drainage. This could lead to the surrounding area becoming excessively damp, which in turn may cause secondary defects such as rot, rust, corrosion of associated building elements, and the formation of fungal decay. In addition, prolonged damp conditions could create potential slip hazards. Poor site drainage may exacerbate the issue, potentially attracting termite activity to the area.

We recommend that a licensed plumber be appointed to properly plumb the AC overflow and connect it to suitable drainage. This will help ensure that the area remains dry and free from secondary defects.

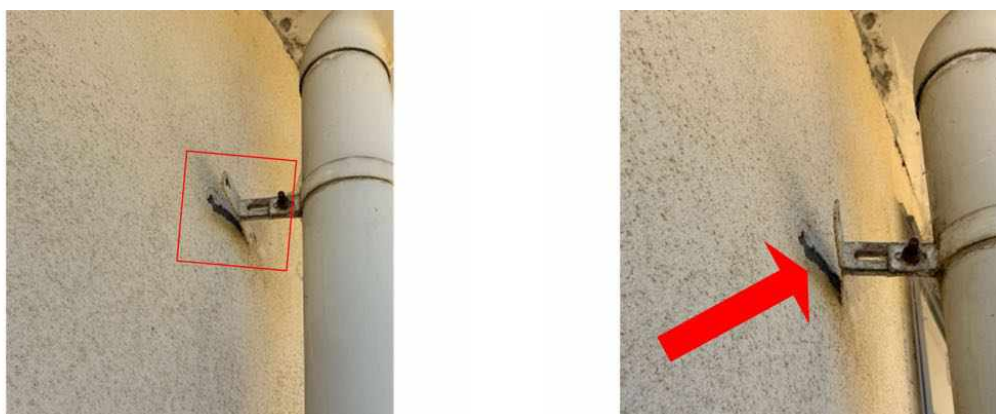
Defects 3.11

Building:	Main Building
Location:	Exterior walls - front
Finding:	Detached Downpipe Bracket
Information:	One of the downpipe brackets to the front external wall was observed to be detached at the time of inspection. As a result, the downpipe is inadequately supported and not

A detached or loose downpipe bracket can allow the downpipe to move during rainfall or wind, increasing the risk of joint separation, water leakage, and inefficient stormwater discharge. Over time, this may contribute to moisture penetration, staining, or deterioration of adjacent wall finishes and building elements.

It is recommended that a suitably qualified tradesperson re-secure the detached downpipe bracket to the wall substrate using appropriate fixings and ensure the downpipe is correctly aligned, firmly supported, and fully operational. All associated brackets should be checked and adjusted as necessary to maintain a secure and watertight installation.

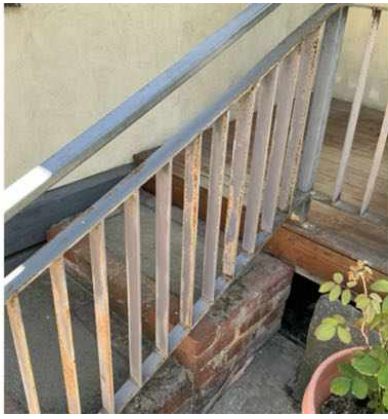
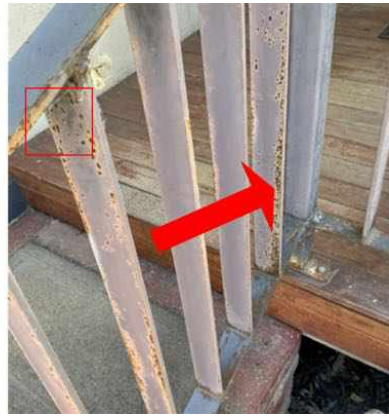
Defects 3.12

Building:	Main Building
Location:	Porch
Finding:	Minor Corrosion to Balustrade and Steel Elements – Porch Area
Information:

Minor signs of surface rust were observed to the balustrade at the entry of the porch area, as well as to some of the steel elements associated with the double lintels within the same area. At the time of inspection, the corrosion appeared to be superficial in nature, with no evidence of significant section loss or structural distress noted.

If left untreated, surface corrosion can progressively worsen, particularly when exposed to weather and moisture. Ongoing rusting may lead to deterioration of protective coatings, staining of adjacent finishes, and eventual reduction in the durability and service life of the affected steel components.

It is recommended that a suitably qualified tradesperson clean the affected areas, remove surface rust, and treat the steel with an appropriate rust-inhibiting primer followed by a suitable protective coating or paint system. Regular maintenance should be undertaken to prevent further corrosion and to maintain the condition and appearance of the affected elements.

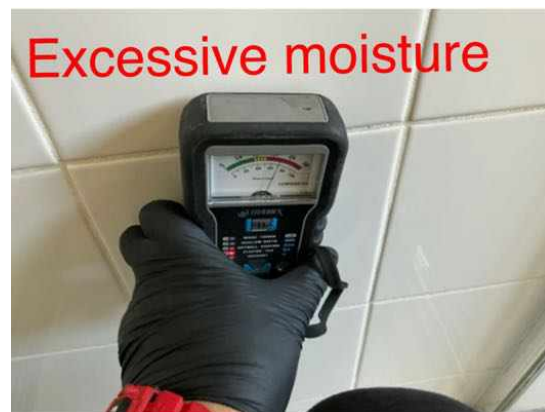
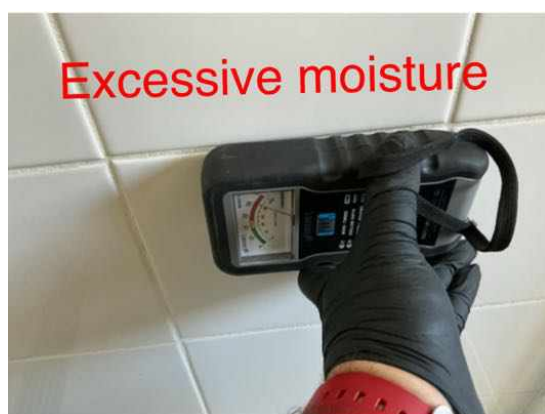
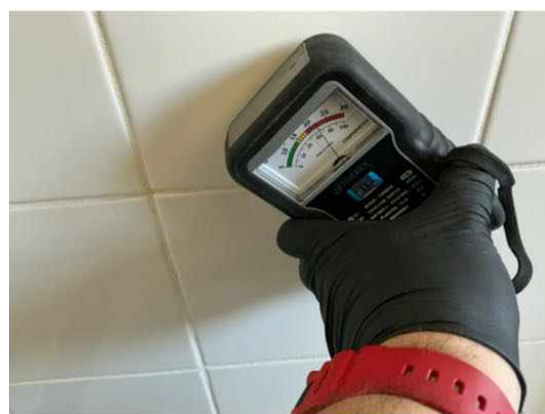
Defects 3.14

Information: Damp is evident to the lower 300mm of wall to the shower alcove. This defect is quite common, and is suspected to have been caused by moisture permeating through the grouting in this area, which shows evidence of deterioration. Leaking pipes within the adjoining wall is also a possible cause.

Damp (or structural damp) refers to the presence of unwanted moisture in the structure of a building, either as the result of intrusion from outside, or condensation from within the structure. In the shower area, internal water leaks or other sources of

excessive moisture are generally the cause of damp.

Unmanaged damp in the shower recess is likely to facilitate the formation and development of mould and fungi growth, decaying associated building materials and compromising their structural integrity. It is important to address damp conditions, as the World Health Organisation notes that excess moisture leads - on almost all indoor materials - to growth of microbes such as moulds, fungi and bacteria, which subsequently emit spores and other matter into the indoor air. Exposure to these contaminants is associated with a wide range of respiratory and other health-related problems.

Consultation with a qualified plumber or bathroom specialist is advised immediately to identify the cause of damp and to perform remedial works as required. Where excessive mould growth is present, further inspection by a specialist environmental health inspector should also be considered.

Always ensure that sealant and grout is in good condition to prevent any moisture issues occurring in the future.

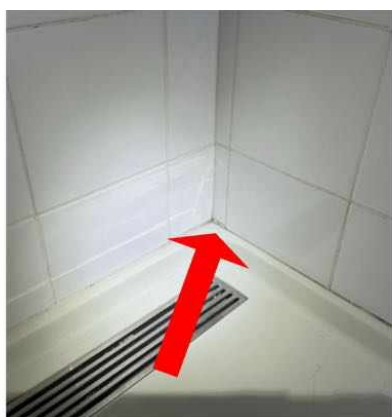
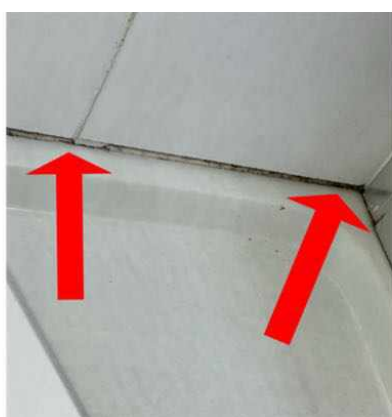
Defects 3.15

Building: Main Building
Location: Bathroom

A sealant specialist or tiling contractor should be appointed to complete these works as soon as possible

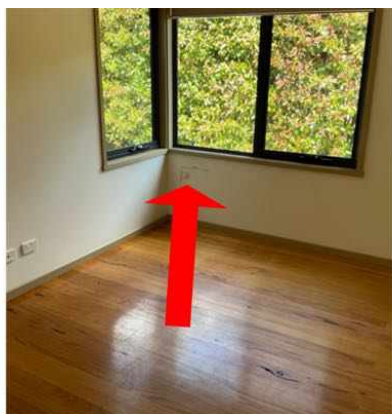
Defects 3.21

Building:	Main Building
Location:	Living Room
Finding:	Deteriorated Internal Paint Finish – Living Area Wall Below Window
Information:

flaking and damage to the underlying surface finish.

It is recommended that a suitably qualified painter or handyman prepare the affected wall surface by removing loose and flaking paint, lightly sanding and sealing the area as required, and repainting the wall using an appropriate internal paint system to restore an acceptable finish.

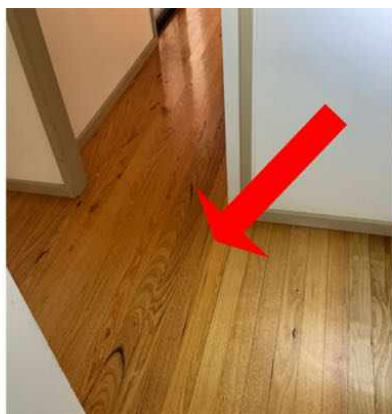
Defects 3.22

Building: Main Building
 Location: Hallway
 Finding: Squeaking Timber Flooring – Localised Areas
 Information:

If the squeaking is of concern to the occupants, a suitably qualified carpenter or flooring contractor may be engaged to investigate and carry out localised repairs, such as re-fixing or tightening affected boards. Otherwise, the condition may be monitored as part of normal building movement and wear over time.

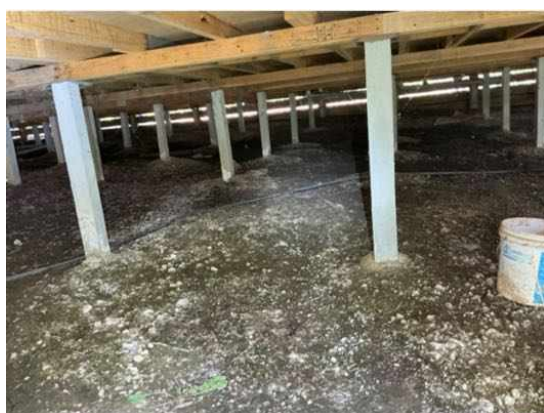
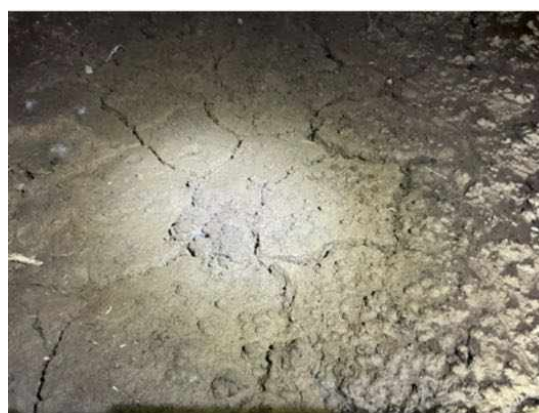
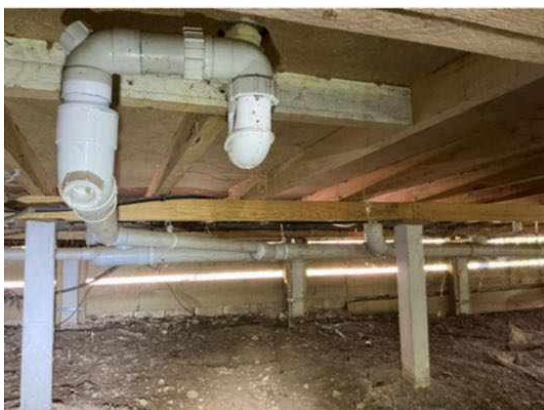
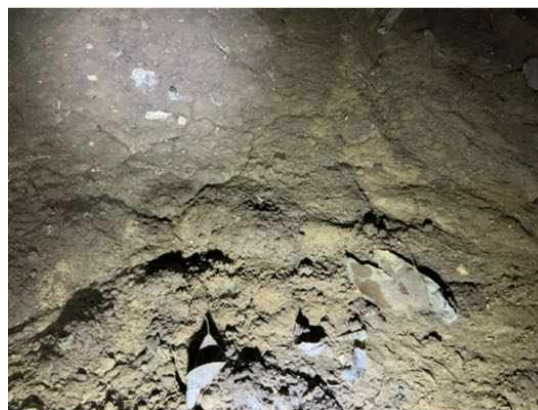
Defects 3.23

Building:	Main Building
Location:	Subfloor
Finding:	Subfloor - damp
Information:	The subfloor was found to be damp at the time of inspection. This excessive moisture could be the result plumbing leaks, and or water ingress from external sources. Prolonged dampness in the subfloor can lead to the degradation of structural elements such as stumps, causing them to weaken or rot over time.

It is recommended to engage a licensed plumber or registered builder as a matter of urgency to assess the source of the moisture and rectify any leaks or ventilation issues. In addition, the affected subfloor should be treated to address the moisture problem, and any damaged stumps should be replaced to ensure the stability and safety of the property.

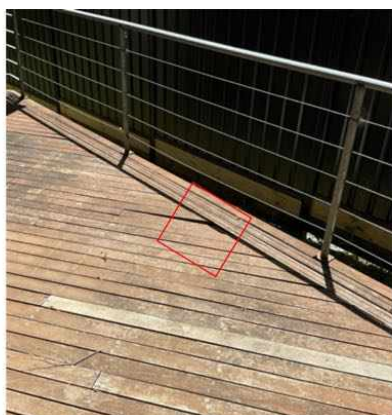
Defects 3.24

Building: Main Building
 Location: Deck
 Finding: Inadequate Support to Decking – Localised Bouncy Areas
 Information:

It is recommended that a suitably qualified carpenter or registered builder be engaged to assess the affected decking areas and the supporting substructure beneath. Rectification works may include strengthening or replacing supporting members and re-fixing the decking boards as required to restore adequate support and stability.

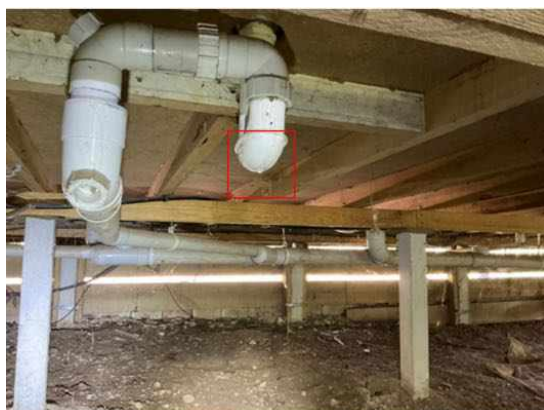
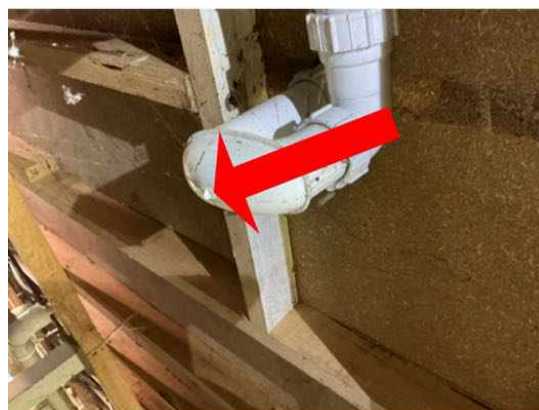
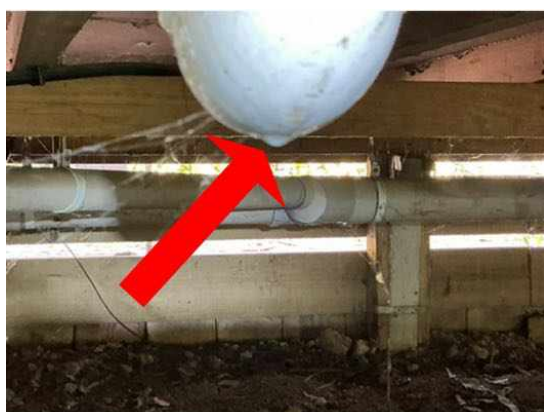
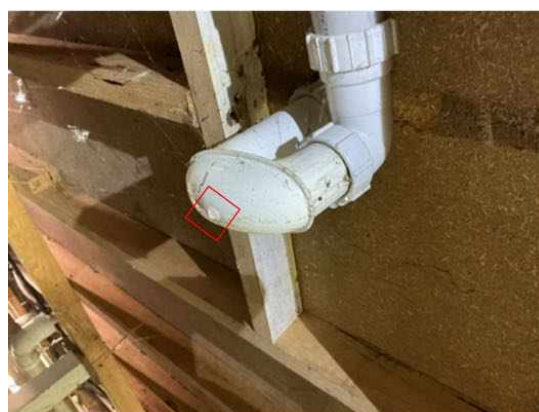
Defects 3.25

Building: Main Building
 Location: Subfloor
 Finding: Leaking Plumbing to Subfloor – Shower and Laundry Areas
 Information:

It is recommended that a licensed plumber be engaged as a matter of urgency to investigate the source of the leaks and carry out all necessary repairs to the plumbing pipework. Following rectification, the affected subfloor area should be allowed to dry and be re-assessed to confirm that no further moisture-related issues are present.

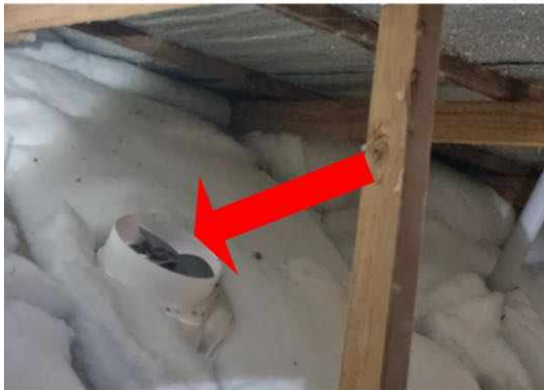
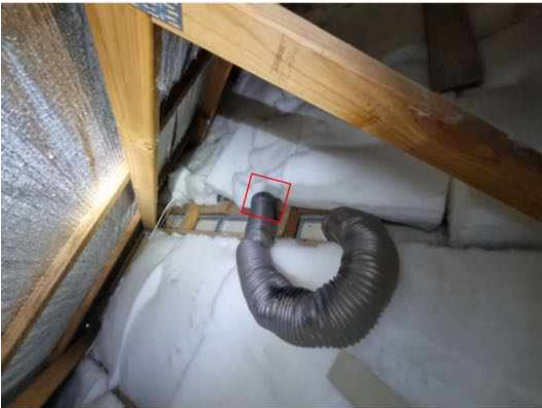
Defects 3.26

Building: Main Building

It is recommended that a licensed ventilation specialist or electrician be engaged to install compliant ducting that vents the exhaust air to the outside of the building, in accordance with current building regulations and ventilation standards.

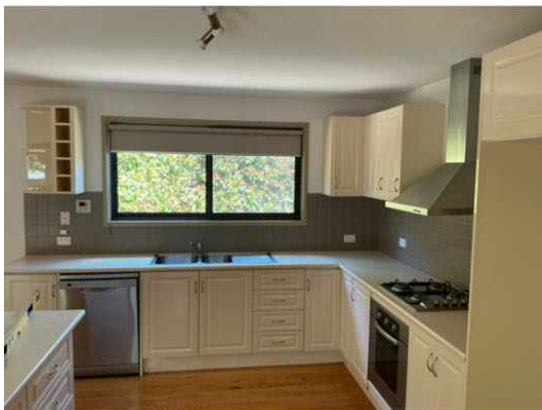
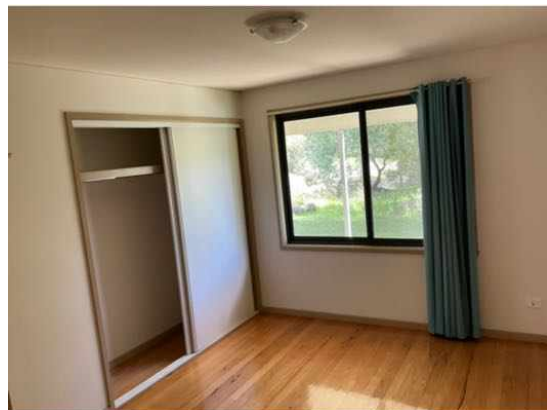
Building: Main Building
 Location: All Internal Areas
 Finding: Obstructions and Limitations - Interior
 Information: These photographs are an indication of the obstructions and limitations which impeded the inspection of the internal areas of the property at the time of inspection. These obstructions can hide an array of defects and should be removed to allow full inspection to be carried out. A re-inspection is recommended once the areas are made accessible.

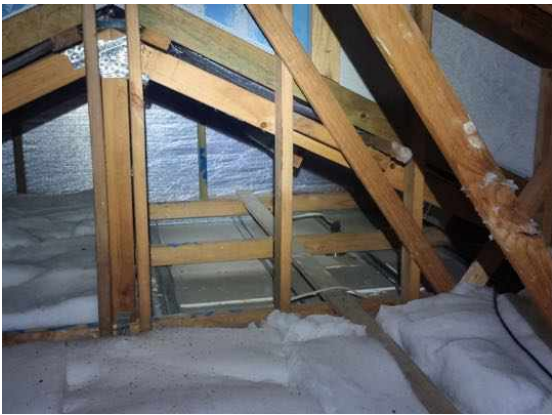
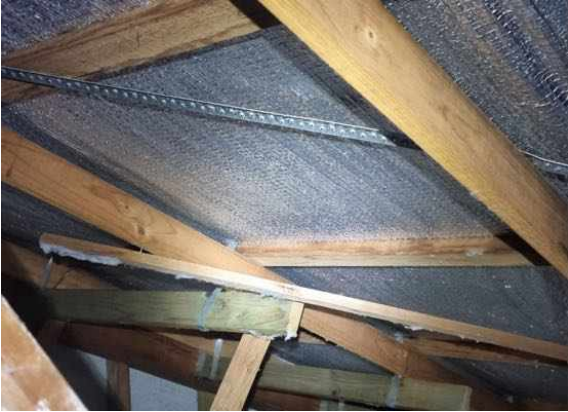
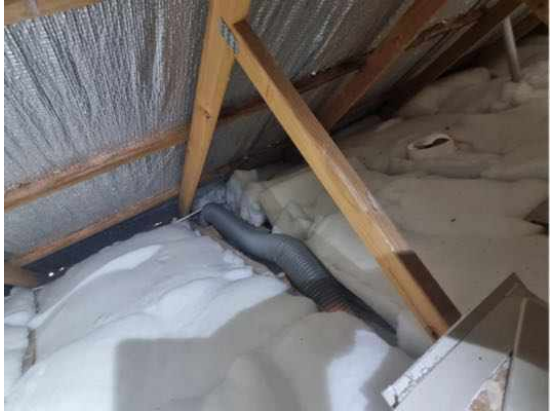
Building: Main Building
 Location: Roof Void
 Finding: Obstructions and Limitations - roof cavity
 Information: These photographs are an indication of the obstructions and limitations which impeded the inspection of the roof cavity area of the property at the time of inspection. These obstructions can hide an array of defects and should be removed to allow full inspection to be carried out. A re-inspection is recommended once the areas are made accessible.

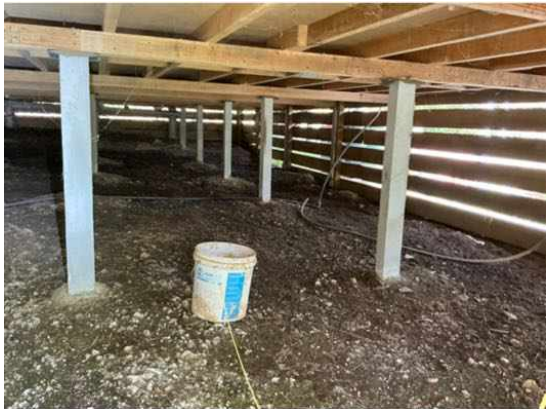
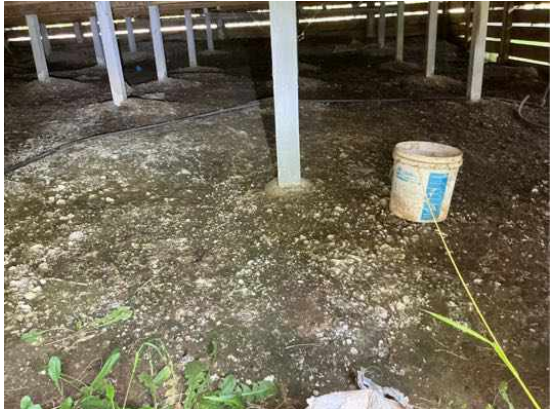
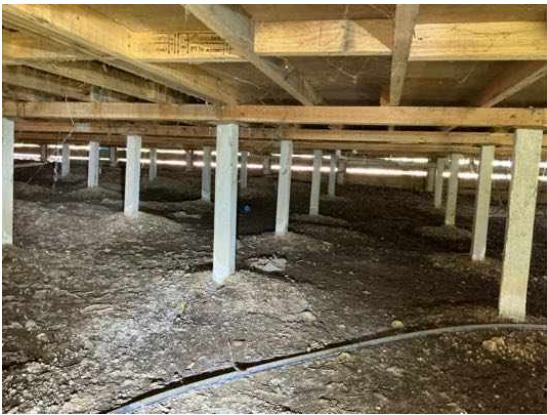
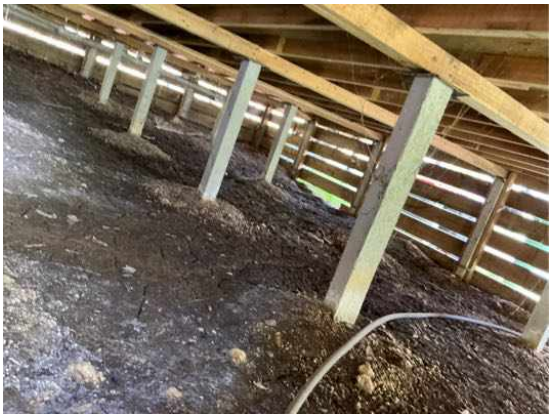
Building: Main Building
 Location: Subfloor
 Finding: Obstructions and Limitations - subfloor
 Information: These photographs are an indication of the obstructions and limitations which impeded the inspection of the subfloor area of the property at the time of inspection. These obstructions can hide an array of defects and should be removed to allow full inspection to be carried out. A re-inspection is recommended once the areas are made accessible.
