## Building Inspection Report

Inspection Date: Fri, 27 Feb 2026

Property Address: 20 Deoro Parade, Clyde North VIC 3978,  
Australia

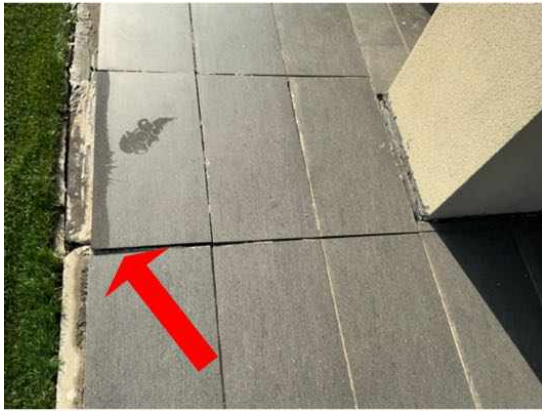
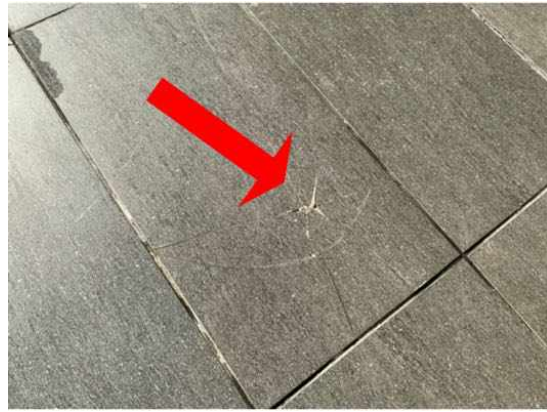
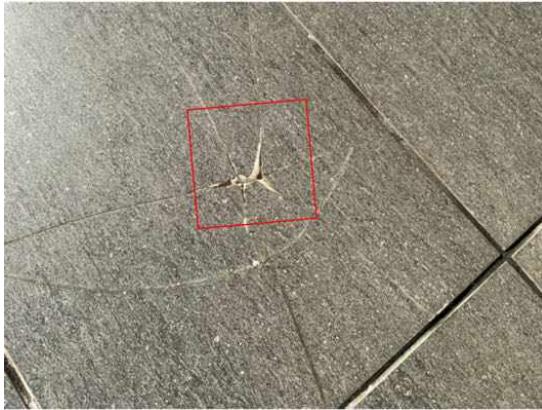
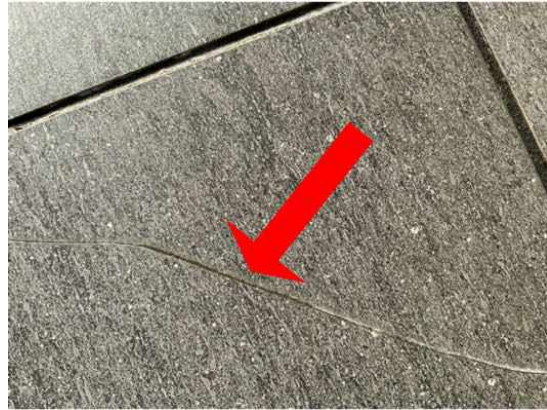
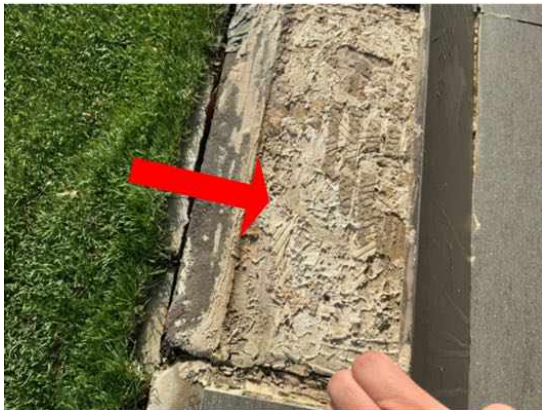
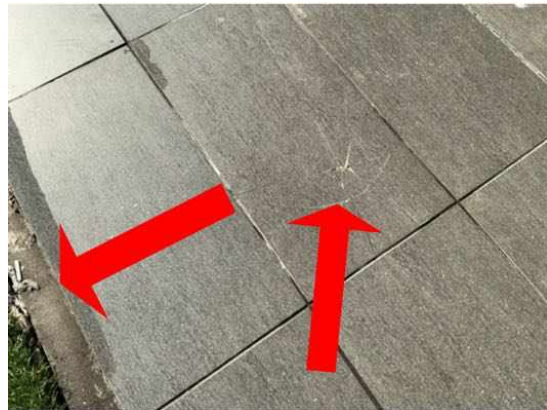
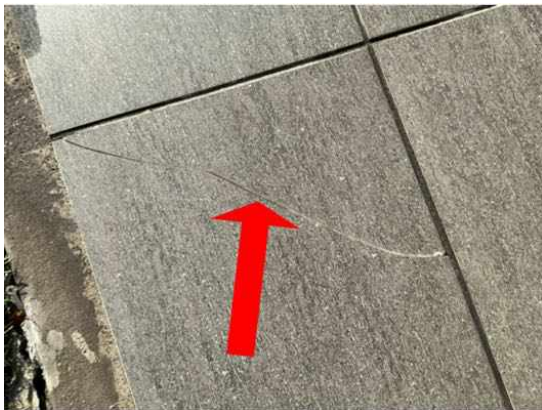
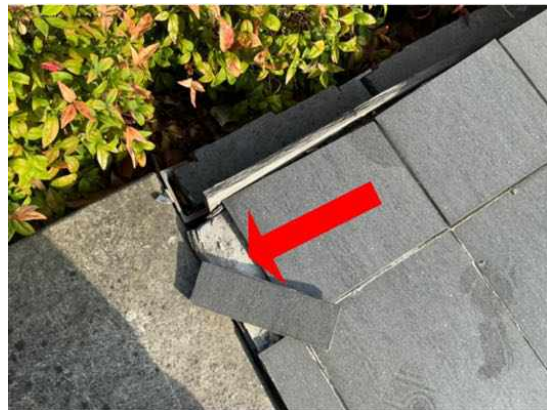
#### Defects 3.01

Building: Main Building  
Location: Front Elevation  
Finding: Front Porch Tiling – Cracked / Loose / Debonded Tiles  
Information:

At the time of inspection, the tiled porch area to the front elevation was observed to be in poor condition. A large number of tiles were cracked and/or broken, and multiple tiles were loose and debonded from the underlying concrete slab (i.e., tiles could be lifted/moved by hand), indicating failure of the bonding bed/adhesive and loss of effective adhesion.

This condition presents an increased risk of trip hazards and further progressive deterioration, and it may also allow water to enter beneath the tiles, which can contribute to ongoing debonding and deterioration of the bedding/screed and grout lines over time.

It is recommended that a suitably qualified tiler attend to assess the full extent of tile debonding and substrate condition, then undertake rectification which may include removing and reinstating affected tiles and re-bedding/re-grouting as required. Where widespread debonding is confirmed, full removal and re-tiling of the porch area may be necessary, including appropriate substrate preparation, waterproofing (if applicable), and installation to suitable standards.

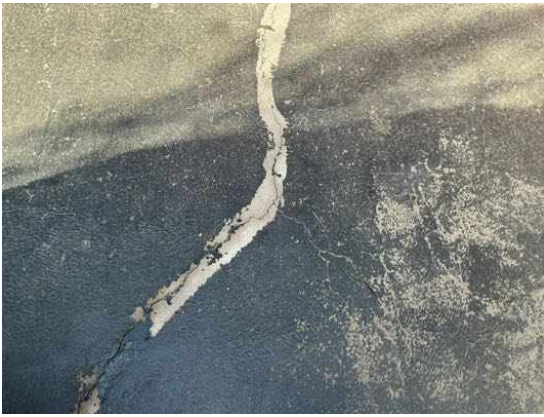
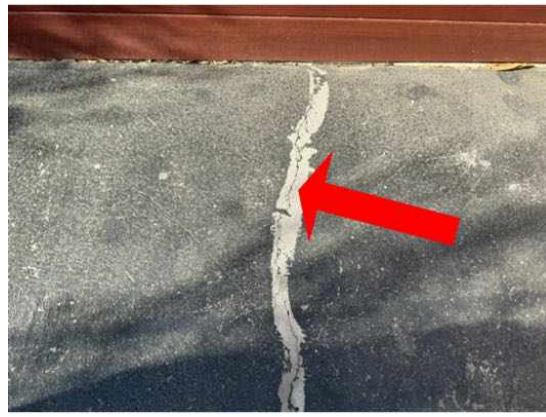
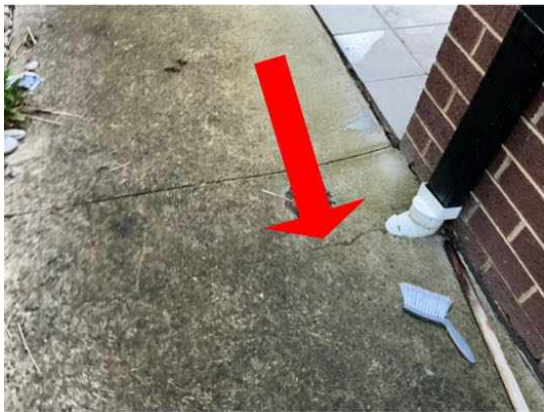
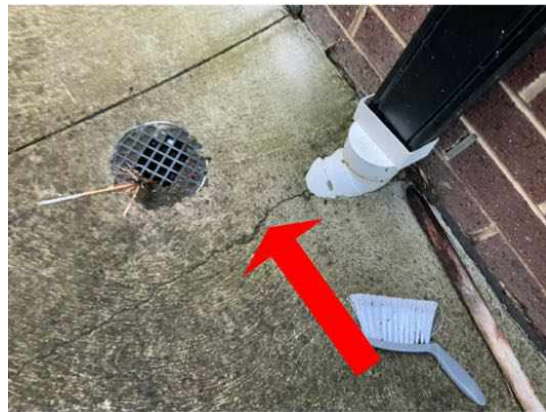
Defects 3.02

Building: Main Building  
Location: All External Areas  
Finding: Cracking - External Concrete Paving and Driveway Damage Category 2 - Distinct (less than 3mm)  
Information: Distinct cracks were identified in external concrete paving and driveway. Distinct cracks are generally found in older concrete paving, and may also present as a trip hazard as consequence of an uneven or curved surface.

General age and expected deterioration of the paved areas is a common cause of this type of cracking. However, expansion and contraction of the slab may also have occurred due to environmental factors. Such factors include variable moisture and weather conditions, the presence of trees and their roots having a settling or lifting affect on the soil, or the effect of load bearing, e.g. heavy vehicles over a sustained period of time.

Cracking to this degree may also be due to poor original installation of the concrete. Factors such as poor compaction of the sub surface and/or inadequate reinforcing of the slab may create cracking and other secondary defects.

Repairs are likely to be required to prevent further cracking and to reduce hazards associated with cracking, such as tripping. Monitoring of all cracking should be conducted frequently. Always contact a building inspector should cracks widen, lengthen, or become more numerous.

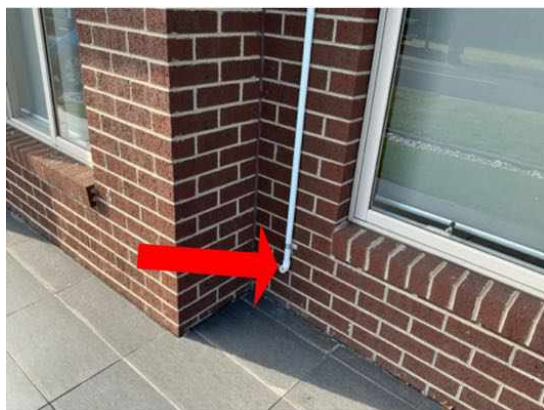
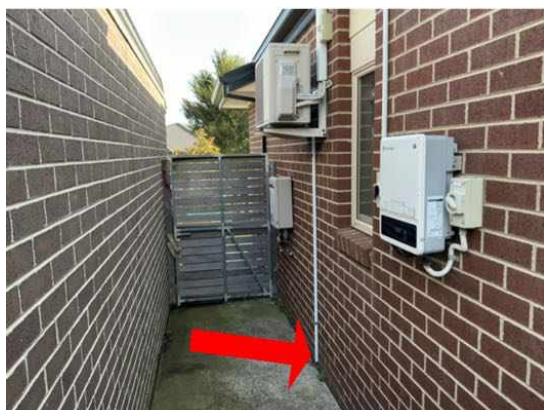
### Defects 3.03

Building:	Main Building
Location:	All External Areas
Finding:	AC Overflows - Not plumbed to suitable drainage
Information:	Upon inspection, it was found that the AC overflow is not plumbed or connected to suitable drainage. This could lead to the surrounding area becoming excessively damp, which in turn may cause secondary defects such as rot, rust, corrosion of associated building elements, and the formation of fungal decay. In addition, prolonged damp conditions could create potential slip hazards. Poor site drainage may exacerbate the issue, potentially attracting termite activity to the area.

We recommend that a licensed plumber be appointed to properly plumb the AC overflow and connect it to suitable drainage. This will help ensure that the area remains dry and free from secondary defects.

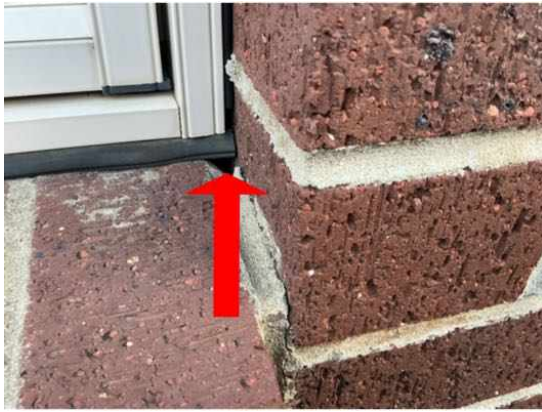
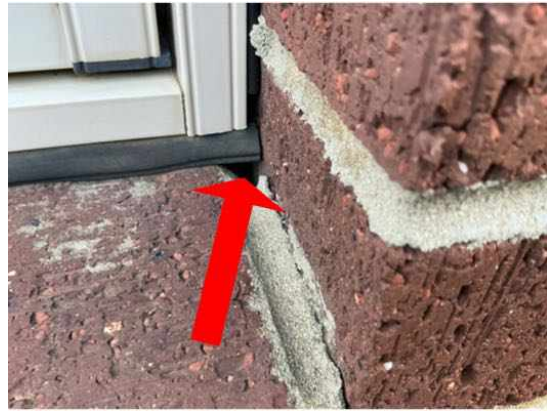
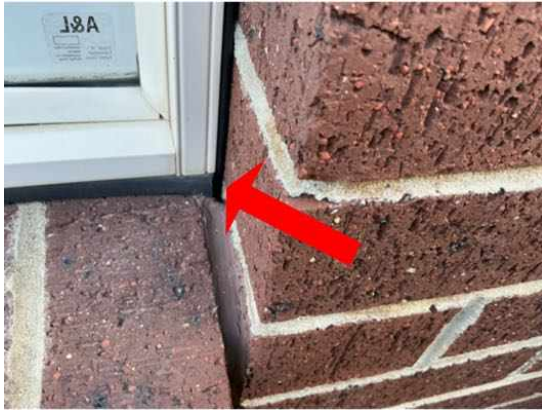
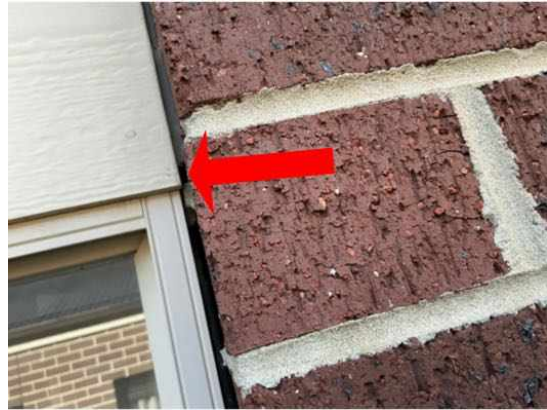
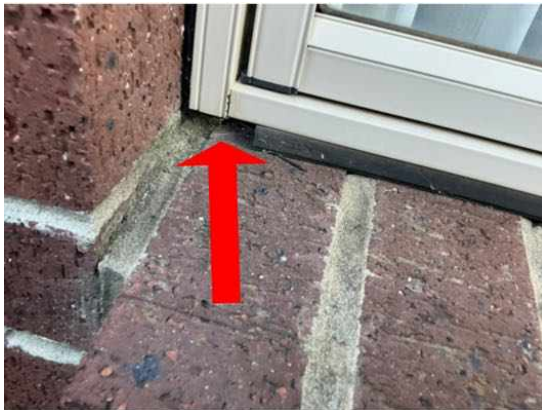
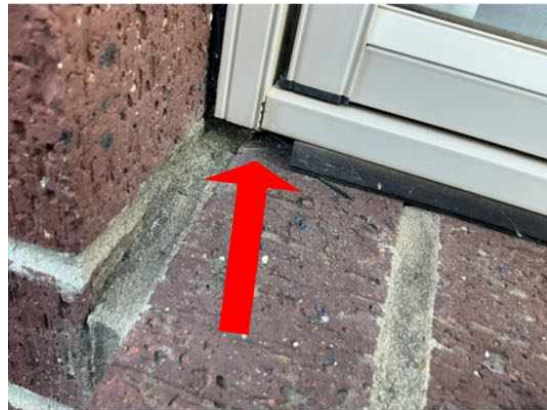
### Defects 3.04

Building:	Main Building
Location:	All External Areas
Finding:	Gaps Around External Window Frames
Information:	Multiple gaps were identified between the external window frames and the adjoining brickwork across several elevations. These gaps appear to be the result of either poor or inconsistent sealant application during installation, or deterioration of the original sealant over time.

Unsealed or poorly sealed gaps can allow moisture ingress, wind-driven rain, draughts, and provide potential entry points for pests. Ongoing exposure to moisture may also contribute to internal dampness and premature deterioration of surrounding building elements.

A qualified handyman or registered builder should apply a consistent, waterproof, flexible exterior-grade sealant around all affected windows to ensure adequate weatherproofing and protection against moisture and pest entry.

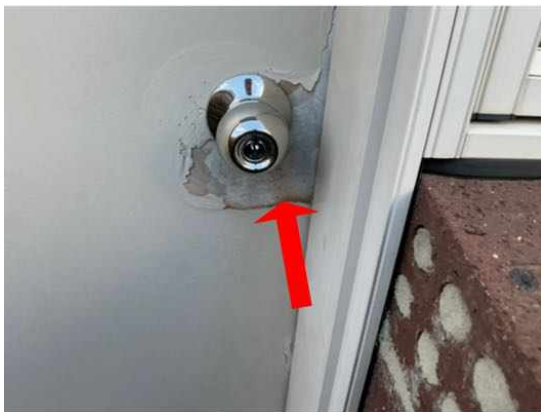
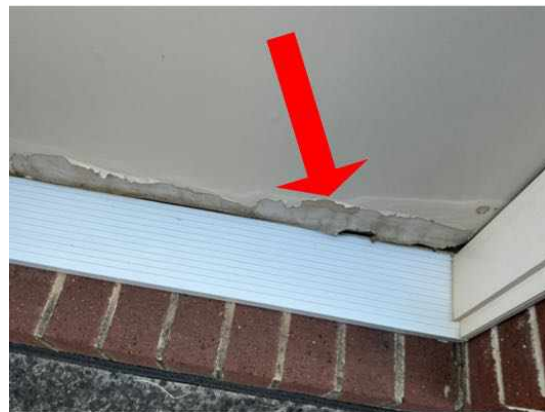
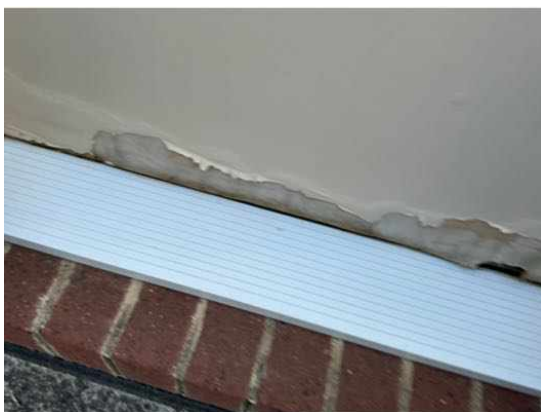
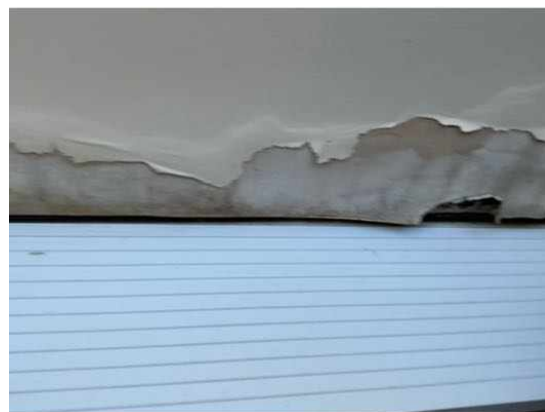
### Defects 3.05

Building: Main Building  
 Location: Laundry  
 Finding: Laundry Door – Deteriorated Door Skin and Moisture Damage  
 Information:

At the time of inspection, the lower section of the external laundry door was observed to be significantly deteriorated. The door skin and paint finish along the bottom edge and adjacent to the threshold were peeling, delaminating, and deteriorating, with visible moisture staining and substrate breakdown. The damage appears consistent with prolonged moisture exposure at the base of the door, likely due to weather exposure, inadequate sealing, or water ponding at the threshold area. Localised deterioration was also noted around the door hardware penetration.

This condition may allow ongoing moisture ingress into the door core, leading to further swelling, decay, and progressive material failure. If left unaddressed, deterioration may compromise the structural integrity and serviceability of the door and could result in the need for full door replacement. Continued moisture exposure may also affect adjacent framing components.

It is recommended that a qualified carpenter assess the door and determine whether repair is feasible. Rectification may include removal of the door, cutting back and sealing affected areas, re-skinning or repairing the lower section where possible, and properly sealing and repainting all exposed edges with suitable exterior-grade coatings. If deterioration is advanced or the core is compromised, full replacement of the external door with a suitable weather-resistant unit should be undertaken. Additionally, the threshold area should be checked to ensure appropriate drainage and sealing to prevent recurrence.

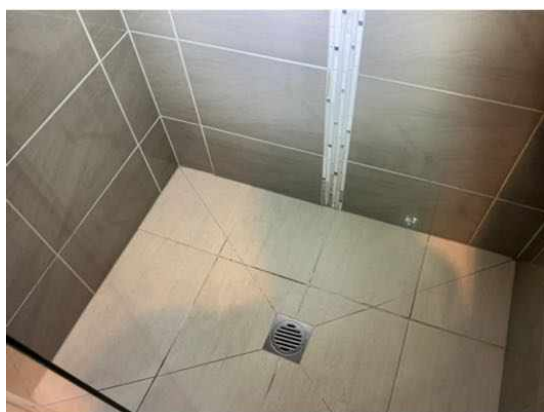
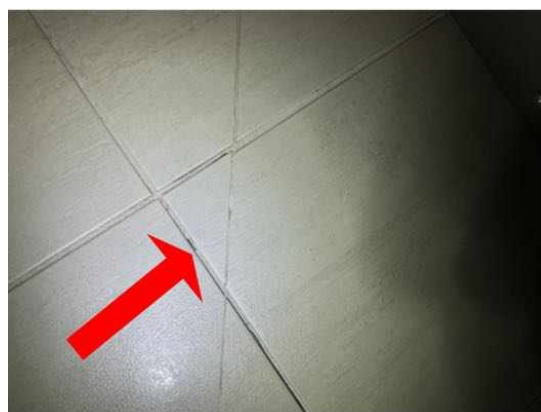
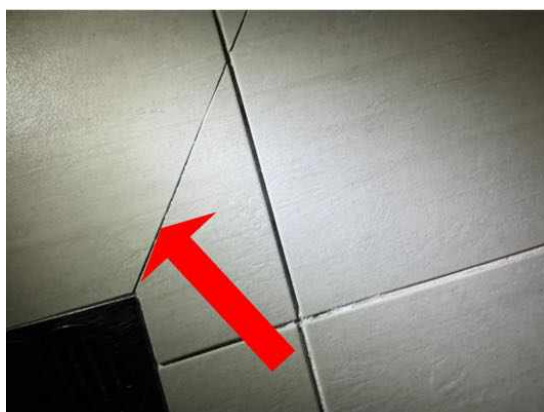
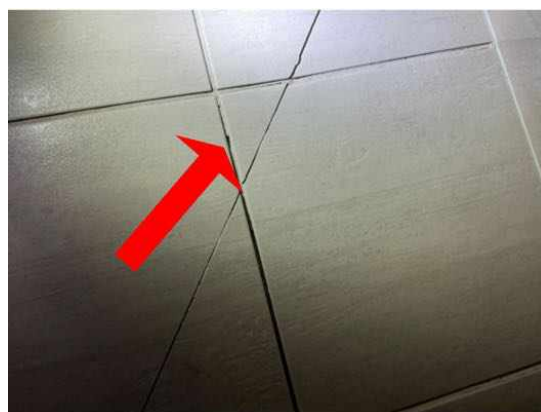
### Defects 3.06

Building:	Main Building
Location:	Ensuite - Master
Finding:	Sealant and grouting - Deteriorated
Information:	It was noted on inspection that sealant or grout is degraded to the tiled shower alcove and or other areas of the bathroom.

Different materials and floor areas move at different rates, generally causing cracking to grout or sealant at this point. A flexible sealant is required to allow for expected expansion and contraction, while keeping the joint water tight and protective of all associated building materials.

Flexible and mould resistant materials should be applied to affected areas to prevent any subsequent water damage that is likely to occur. Regular maintenance and replacement of damage or missing or damaged sealant and grout is highly recommended to the wet areas, as this is a regular wear and tear defect. Sealant and grouting in areas that come into regular contact with water should be maintained for the long term care of your property.

A sealant specialist or tiling contractor should be appointed to complete these works as soon as possible

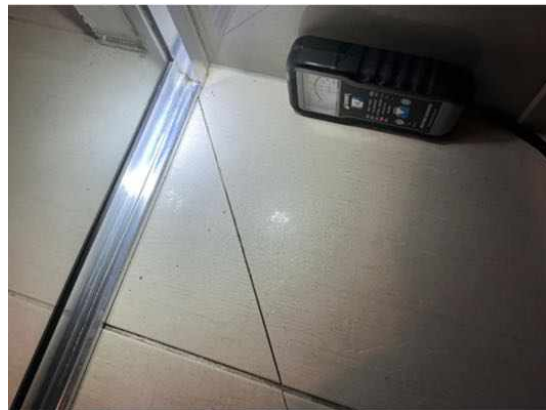
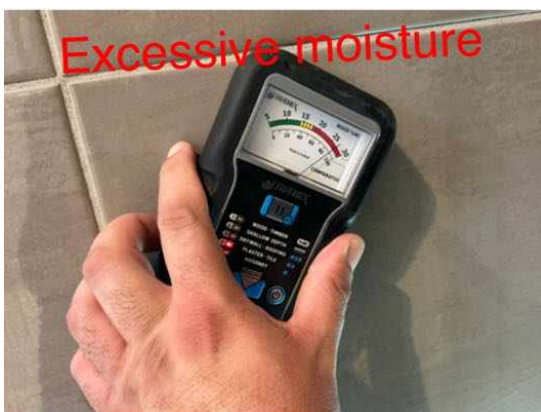
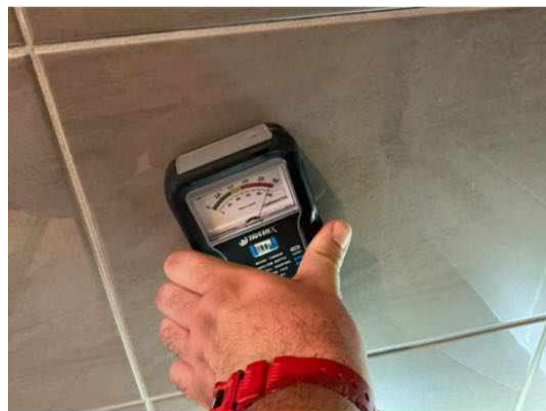
### Defects 3.07

Building:	Main Building
Location:	Ensuite - Master
Finding:	Shower - Damp
Information:	Damp is evident to the lower 300mm of wall to the shower alcove. This defect is quite common, and is suspected to have been caused by moisture permeating through the grouting in this area, which shows evidence of deterioration. Leaking pipes within the

adjoining wall is also a possible cause.

Damp (or structural damp) refers to the presence of unwanted moisture in the structure of a building, either as the result of intrusion from outside, or condensation from within the structure. In the shower area, internal water leaks or other sources of excessive moisture are generally the cause of damp.

Unmanaged damp in the shower recess is likely to facilitate the formation and development of mould and fungi growth, decaying associated building materials and compromising their structural integrity. It is important to address damp conditions, as the World Health Organisation notes that excess moisture leads - on almost all indoor materials - to growth of microbes such as moulds, fungi and bacteria, which subsequently emit spores and other matter into the indoor air. Exposure to these contaminants is associated with a wide range of respiratory and other health-related problems.

Consultation with a qualified plumber or bathroom specialist is advised immediately to identify the cause of damp and to perform remedial works as required. Where excessive mould growth is present, further inspection by a specialist environmental health inspector should also be considered.

Always ensure that sealant and grout is in good condition to prevent any moisture issues occurring in the future.

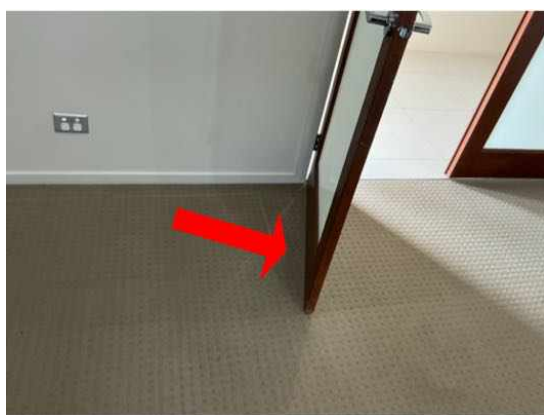
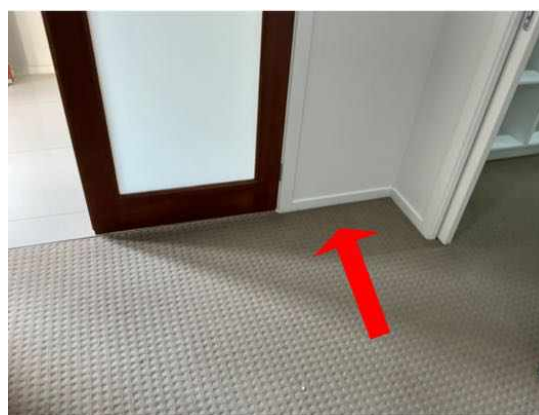
### Defects 3.08

Building:	Main Building
Location:	Bedroom - Master
Finding:	Door stop - Missing
Information:	The door stop is missing or is inadequate to stop the door handle from damaging the wall. Although some building elements may seem irrelevant or unnecessary, all building elements play a key role in the operation and function of the overall structure and its performance.

Re-installation or replacement of the door stop is advised as soon as possible to prevent any subsequent damage to the door or associated structures. A general handyman may be appointed to perform these works at client discretion.

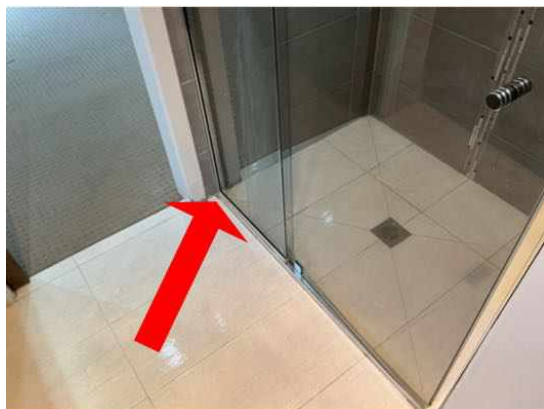
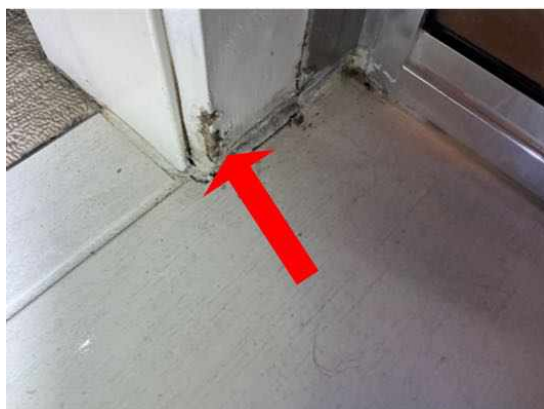
### Defects 3.09

Building:	Main Building
Location:	Ensuite - Master
Finding:	Shower screen - Leaking
Information:	Leaking was evident to the ensuite shower screen at the time of inspection. It is suspected that the leakage has occurred as a result of deteriorated and/or missing caulking to the shower screen junctions or general ageing and breakdown of sealing materials to the shower enclosure.

Leaking from the shower, if left unattended, is likely to lead to moisture ingress into adjoining flooring and wall components. Prolonged exposure to moisture can result in deterioration of building materials, swelling of timber elements, damage to finishes, and may necessitate extensive remedial works. Active moisture conditions may also create an environment conducive to mould growth.

In addition, the lower section of the adjacent door frame was observed to exhibit signs of previous moisture-related deterioration. The base of the frame appears to have sustained water damage, which is likely associated with ongoing or historical water escape from the shower screen area, or possible water ponding against the door

frame over time.

It is recommended that a qualified caulking contractor be engaged to remove and replace all deteriorated sealant to the shower screen and surrounding junctions to ensure proper waterproof sealing. These works should be undertaken without delay. Furthermore, a qualified carpenter should be consulted to assess the condition of the lower section of the door frame and undertake repairs as required, which may include cutting back damaged timber, repairing or replacing the affected section, followed by appropriate sealing and repainting to prevent recurrence.

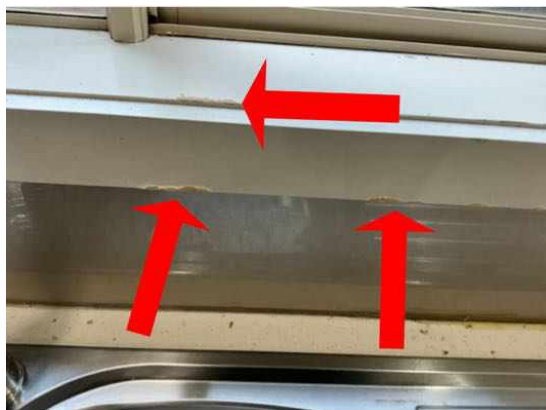
### Defects 3.10

Building: Main Building  
 Location: Kitchen  
 Finding: Kitchen Window Sill – Minor Timber Deterioration  
 Information:

At the time of inspection, minor deterioration to the timber window sill within the kitchen area was observed. The affected area appears to exhibit slight surface wear and localised finish breakdown, likely resulting from repeated water splash exposure from the adjacent kitchen sink over time.

While the deterioration is considered minor and primarily cosmetic in nature at this stage, continued moisture exposure may contribute to progressive timber degradation if not maintained.

It is recommended that the affected timber surface be lightly sanded, allowed to dry thoroughly, and refinished with an appropriate moisture-resistant primer and paint system. Ongoing care should be taken to minimise water splash onto the sill to prevent recurrence.

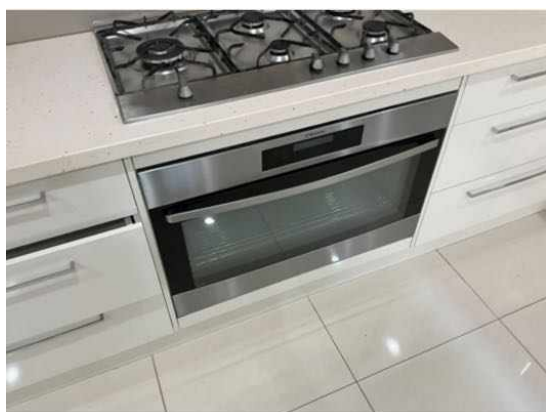
### Defects 3.11

Building: Main Building  
 Location: Kitchen  
 Finding: Oven – Inoperable at Time of Inspection  
 Information:

An inoperable oven may indicate an electrical supply issue, internal component fault, control failure, or general appliance malfunction. Without further diagnostic testing, the exact cause of the issue cannot be determined.

It is recommended that a qualified electrician or licensed appliance technician be engaged to investigate the fault, confirm the cause of non-operation, and undertake repairs or replacement as required.

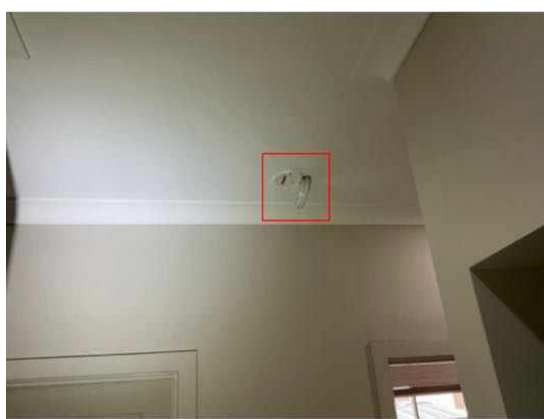
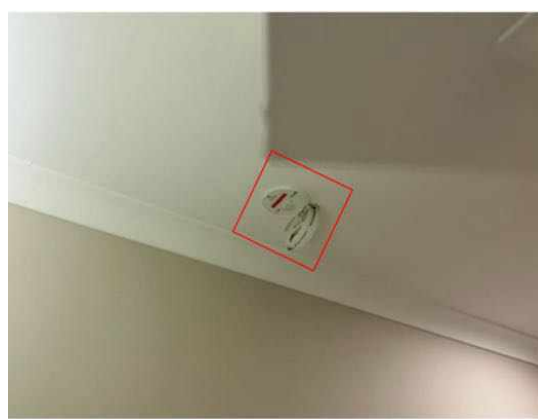
### Defects 3.12

Building:	Main Building
Location:	All Internal Areas
Finding:	Smoke Alarm Non-Operational
Information:	During inspection, the smoke alarm appeared to have been tampered with or opened and did not appear to be operational at the time of inspection. Smoke alarms are essential safety devices and must be fully functional in accordance with current building regulations and Australian Standards.

It is recommended that a licensed electrician inspect and test the smoke alarm, and carry out any necessary repairs or replacement to ensure it is fully operational.

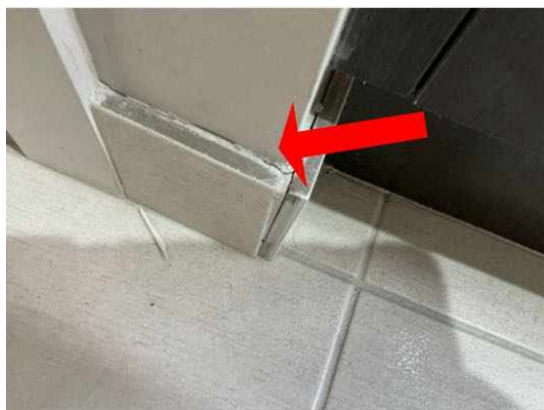
### Defects 3.13

Building:	Main Building
Location:	Laundry
Finding:	Laundry – Detached Skirting Tile
Information:

At the time of inspection, one skirting tile to the laundry floor perimeter was observed to have detached and come away from the wall. The tile was no longer bonded in position, indicating localised adhesive failure.

Although the defect is minor in extent, detached tiles can present a sharp edge hazard and may allow moisture to penetrate behind the wall lining if left unaddressed.

It is recommended that a qualified tiler be engaged to re-fix or replace the affected skirting tile, ensuring appropriate surface preparation and bonding to prevent recurrence.

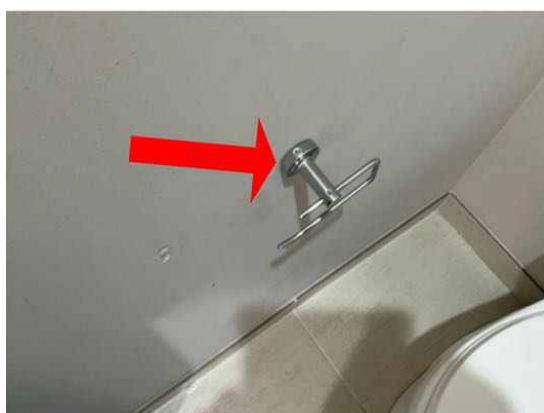
### Defects 3.14

Building:	Main Building
Location:	Toilet (WC)
Finding:	Toilet roll holder - Loose
Information:	The toilet roll holder was found to be loose at the time of inspection. While not a major operational defect, function can deteriorate if the problem is left unmanaged.

It is advised that the homeowner performs remedial works to re-attach the toilet roll holder to its original fixing. A general handyperson may be required to perform these works.

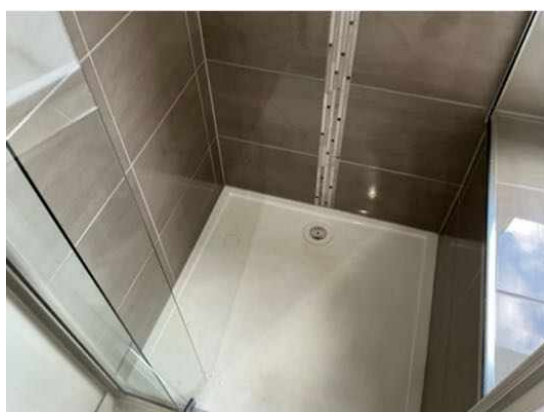
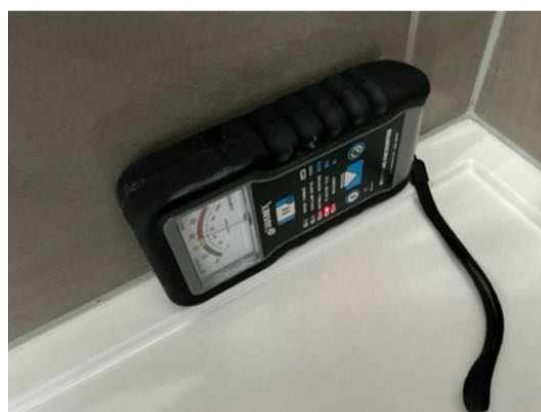
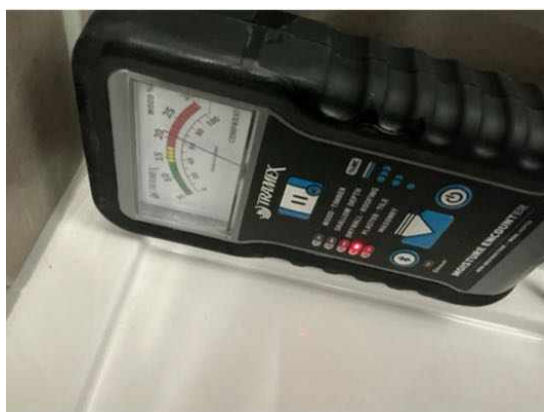
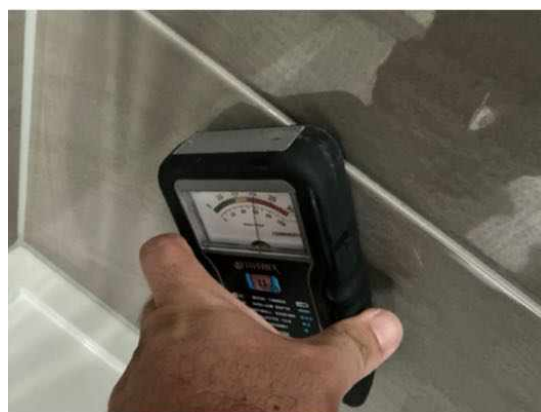
### Defects 3.15

Building:	Main Building
Location:	Bathroom 2
Finding:	Shower - Damp
Information:	Damp is evident to the lower 300mm of wall to the shower alcove. This defect is quite common, and is suspected to have been caused by moisture permeating through the grouting in this area, which shows evidence of deterioration. Leaking pipes within the adjoining wall is also a possible cause.

Damp (or structural damp) refers to the presence of unwanted moisture in the

structure of a building, either as the result of intrusion from outside, or condensation from within the structure. In the shower area, internal water leaks or other sources of excessive moisture are generally the cause of damp.

Unmanaged damp in the shower recess is likely to facilitate the formation and development of mould and fungi growth, decaying associated building materials and compromising their structural integrity. It is important to address damp conditions, as the World Health Organisation notes that excess moisture leads - on almost all indoor materials - to growth of microbes such as moulds, fungi and bacteria, which subsequently emit spores and other matter into the indoor air. Exposure to these contaminants is associated with a wide range of respiratory and other health-related problems.

Consultation with a qualified plumber or bathroom specialist is advised immediately to identify the cause of damp and to perform remedial works as required. Where excessive mould growth is present, further inspection by a specialist environmental health inspector should also be considered.

Always ensure that sealant and grout is in good condition to prevent any moisture issues occurring in the future.

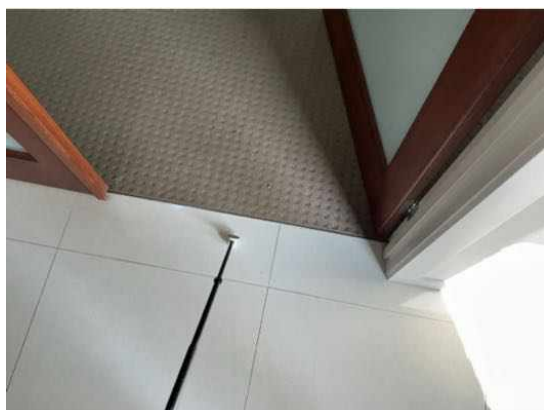
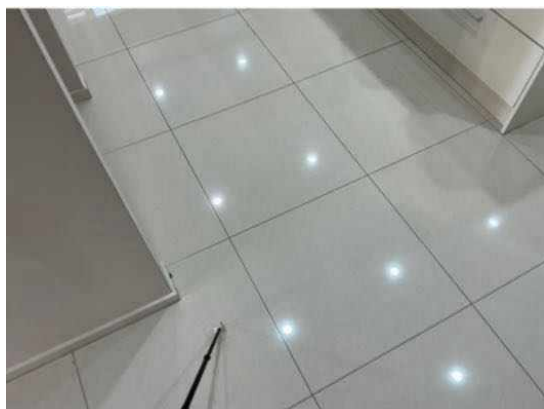
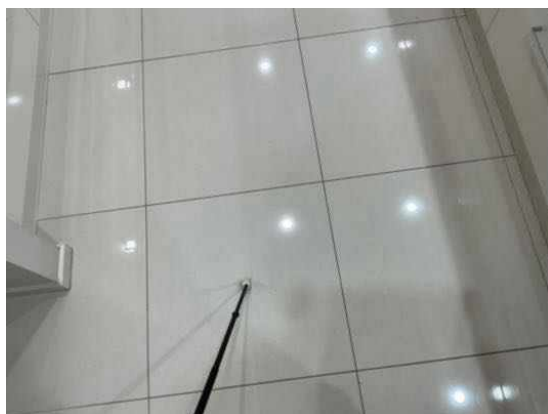
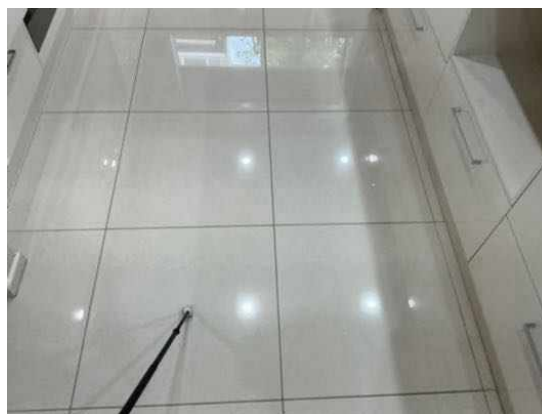
### Defects 3.16

Location: All Internal Areas  
Finding: Tiles - Drummy  
Information: Drummy tiled areas were identified at the time of inspection. The term 'drummy' refers to tiles that have become detached from their fixing, despite otherwise being in relatively good condition. Such defects are generally caused by physical or moisture damage to the area. Drummy tiled areas may also be a direct result of poor workmanship during the construction process.

Tiled areas may swell and shrink with changes in air humidity if the area has sustained moisture damage. Any exposure to moisture is capable of causing tiled areas to become drummy and/or cracked over a prolonged period of time. Drummy tiled areas generally require removal and replacement of affected tiles, with adequate sealant and grouting.

Specialist trades are available for these types of services. A registered builder may be required to undertake works if damage is extensive or if secondary building defects have resulted. Otherwise, it is advised that a tiling contractor be appointed to perform works as necessary. Immediate action is recommended to ensure that no further damage is sustained in the affected area.

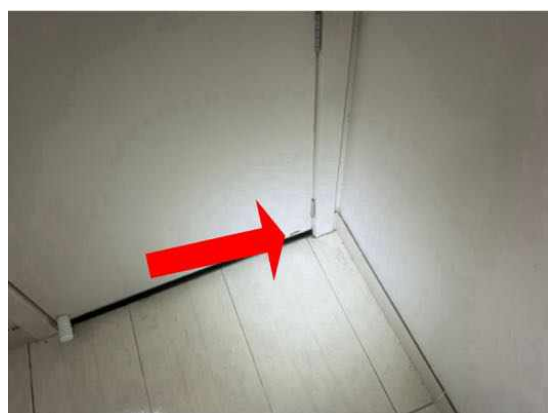
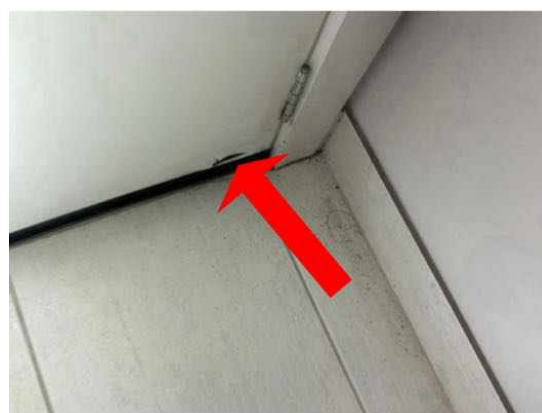
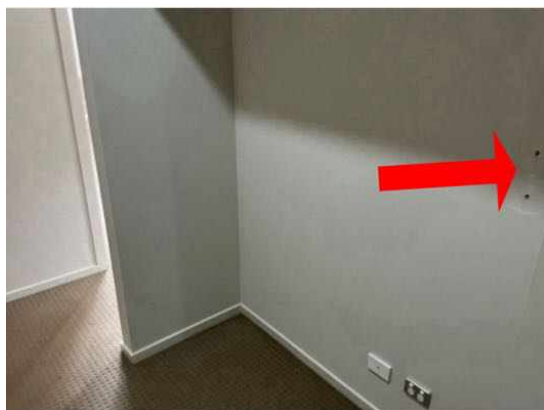
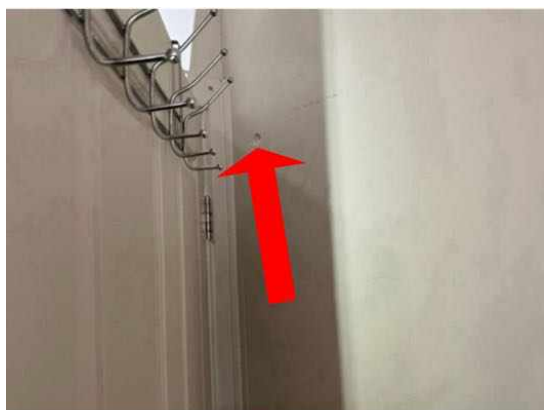
### Defects 3.17

Building: Main Building  
 Location: All Internal Areas  
 Finding: General Internal Wear and Tear – Minor Cosmetic Damage  
 Information:

During the inspection, various minor wear and tear items were observed throughout the dwelling. These included minor damage to an internal door, localised plaster damage to the second bedroom (including impact marks consistent with contact from a clothes hanger), and small holes to plasterboard walls within the master bedroom and hallway areas, likely associated with previous installation of TV brackets and wall-mounted fixtures.

These conditions are considered minor and cosmetic in nature and are consistent with general use and ageing of the property. They do not represent structural defects or significant building failures.

Rectification, if desired for presentation purposes, may include patching affected plaster areas, filling holes, sanding surfaces smooth, and repainting to match existing finishes. Such works are discretionary and may be undertaken as part of routine maintenance.

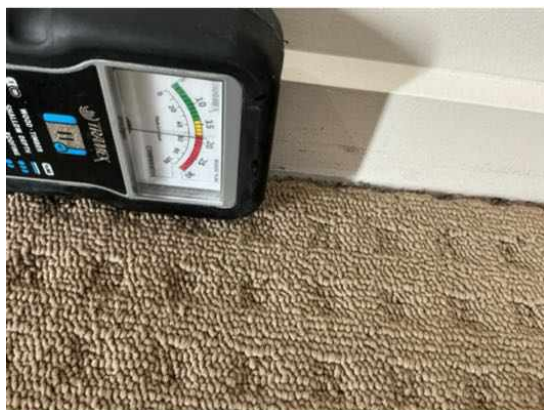
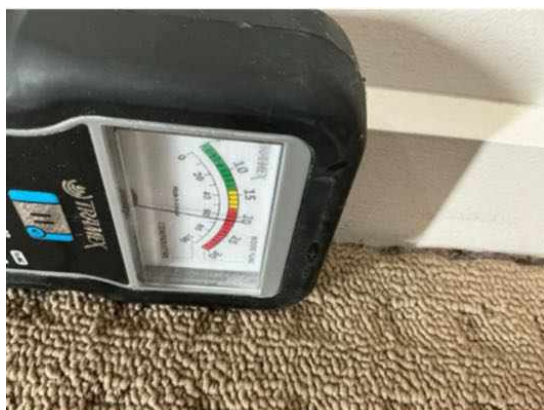
### Defects 3.18

Building:	Main Building
Location:	Bedroom - Master
Finding:	Master Ensuite – Elevated Moisture Readings to Skirting Board
Information:

At the time of inspection, elevated moisture readings were recorded to the skirting board located behind/adjacent to the shower area within the master ensuite using a non-invasive moisture meter. No invasive testing was undertaken. The elevated readings may be associated with water escape from the shower screen area, including previously noted leakage, or may be attributable to other concealed plumbing or waterproofing issues. The exact source of moisture could not be confirmed at the time of inspection.

Persistently elevated moisture levels within wall linings and skirting components may lead to deterioration of timber elements, swelling, material breakdown, and potential mould development if not rectified.

It is recommended that a licensed plumber be engaged to undertake further investigation, which may include invasive inspection as required, to determine the root cause of the moisture ingress. Following identification of the source, appropriate rectification works should be carried out to prevent further damage.

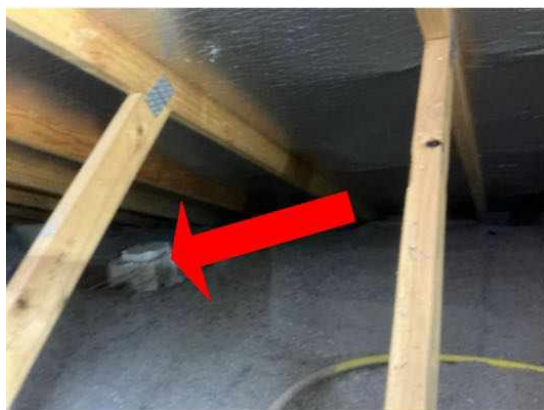
### Defects 3.19

Building:	Main Building
Location:	Roof Void
Finding:	Bathroom Exhaust Fans Not Ducted to External Atmosphere
Information:	The exhaust fans installed in the bathrooms were observed to be discharging directly into the roof cavity rather than being ducted to the external atmosphere. This configuration does not comply with best practice ventilation standards, as it allows moist air to accumulate within the roof space.

Prolonged moisture build-up in the roof cavity can lead to elevated humidity levels, which may contribute to mould growth, timber decay, and potential damage to insulation or other roof components over time.

It is recommended that a licensed ventilation specialist or electrician be engaged to install compliant ducting that vents the exhaust air to the outside of the building, in accordance with current building regulations and ventilation standards.

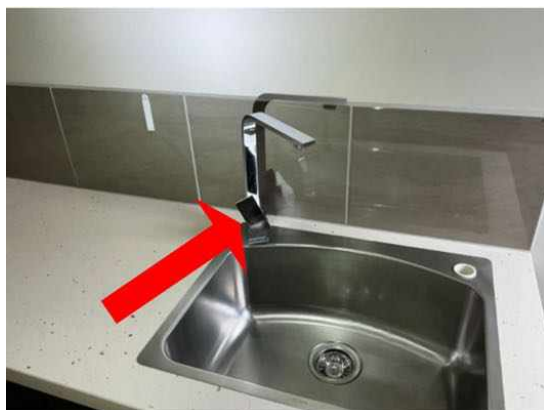
### Defects 3.21

At the time of inspection, the laundry tap was not operational and no water discharge was observed when tested. As a result, the serviceability and functionality of the tap could not be confirmed.

The lack of operation may be due to a localised plumbing fault, isolation valve being closed, internal tap failure, or other supply-related issue. Without further investigation, the exact cause could not be determined at the time of inspection.

It is recommended that a licensed plumber be engaged to investigate the cause of non-operation, restore proper water supply to the fixture, and undertake repairs or replacement as required.

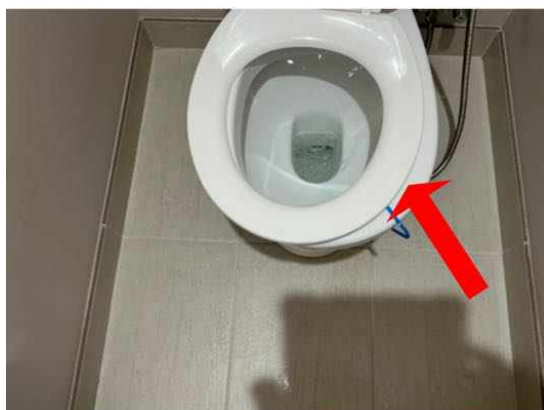
### Defects 3.22

Building:	Main Building
Location:	Toilet (WC)
Finding:	Toilet seat - loose
Information:	The toilet seat was found to be loose and shifting during use at the time of inspection. This defect likely developed due to wear and tear of the seat's fixing hardware. However, it may also be the result of improper installation or accidental impact.

If left unaddressed, the loose toilet seat could worsen, leading to potential damage to the mounting points or discomfort for users. In some cases, further instability may lead to minor injuries or increased wear on the toilet bowl.

It is recommended that the toilet seat be properly refastened or replaced by a licensed plumber to ensure safe and stable use.

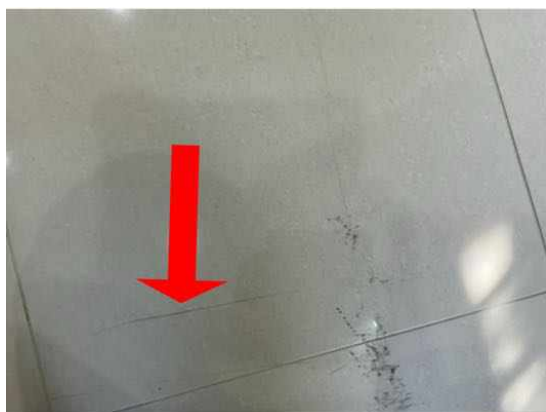
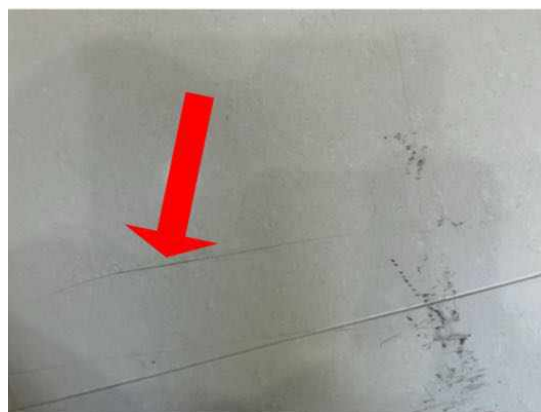
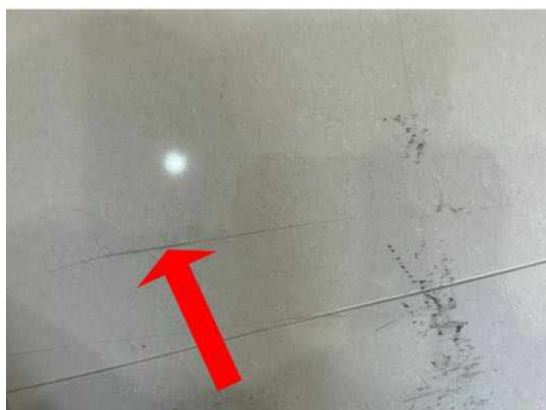
### Defects 3.23

Building:	Main Building
Location:	Hallway
Finding:	Hallway Floor Tile – Surface Scratch
Information:

Replacement of the affected tile may be undertaken at the client's discretion should the appearance be of concern. Otherwise, no immediate repair is considered necessary, and the tile may remain in its current condition.

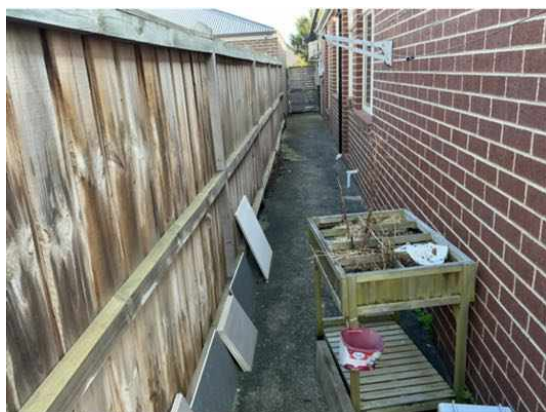
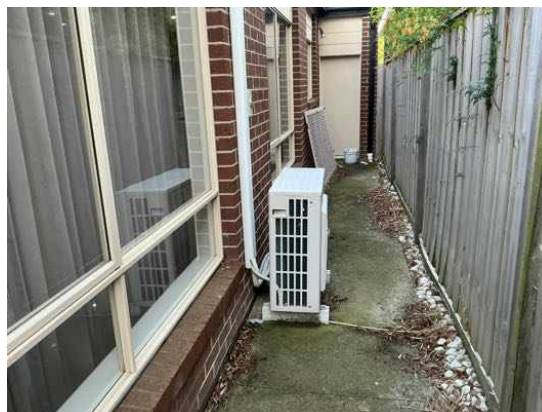
Building: Main Building  
Location: All External Areas  
Finding: Obstructions and Limitations - Exterior  
Information: These photographs are an indication of the obstructions and limitations which impeded the inspection of the external areas of the property at the time of inspection. These obstructions can hide an array of defects and should be removed to allow full inspection to be carried out. A re-inspection is recommended once the areas are made accessible.

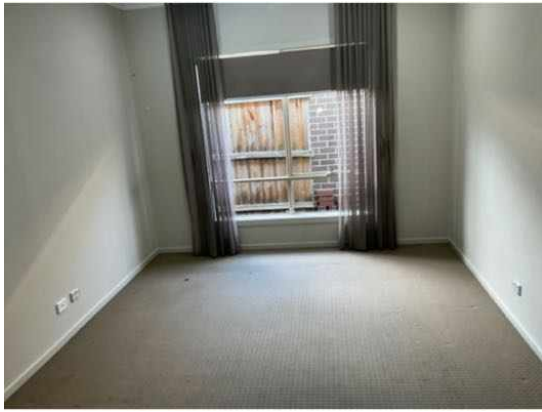
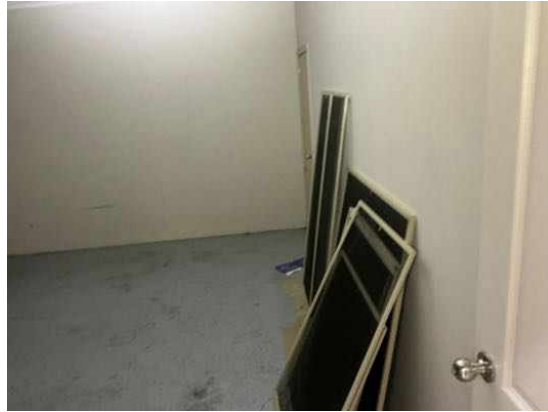
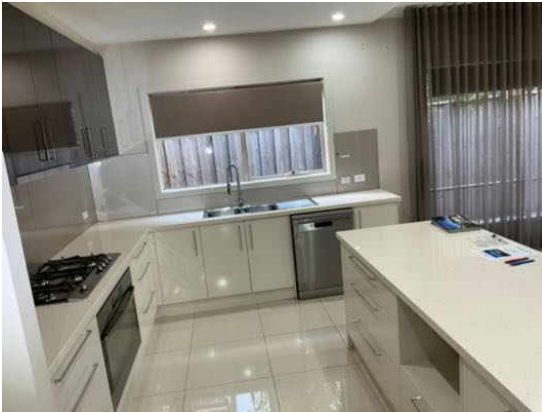
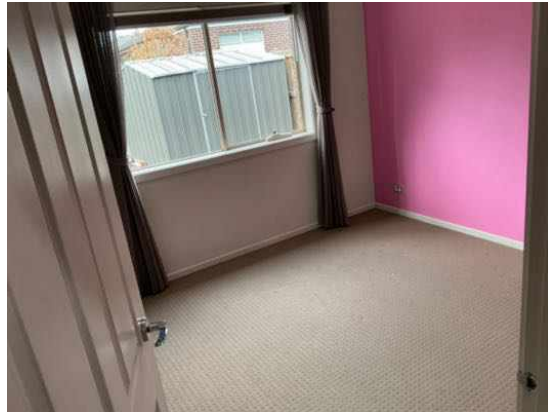
Building: Main Building  
Location: All Internal Areas  
Finding: Obstructions and Limitations - Interior  
Information: These photographs are an indication of the obstructions and limitations which impeded the inspection of the internal areas of the property at the time of inspection. These obstructions can hide an array of defects and should be removed to allow full inspection to be carried out. A re-inspection is recommended once the areas are made accessible.

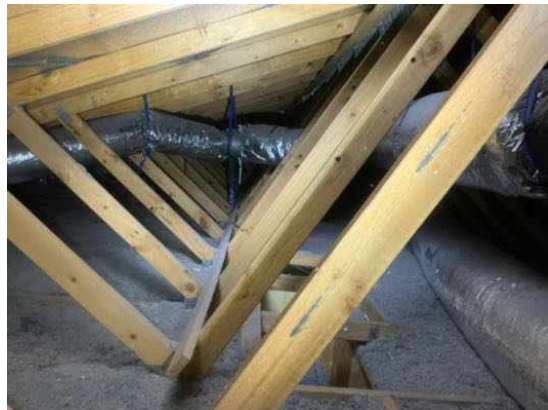
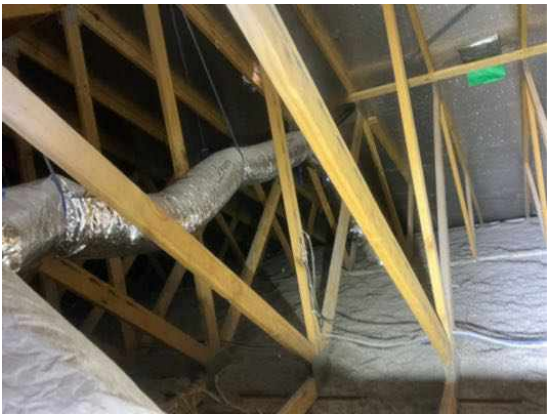
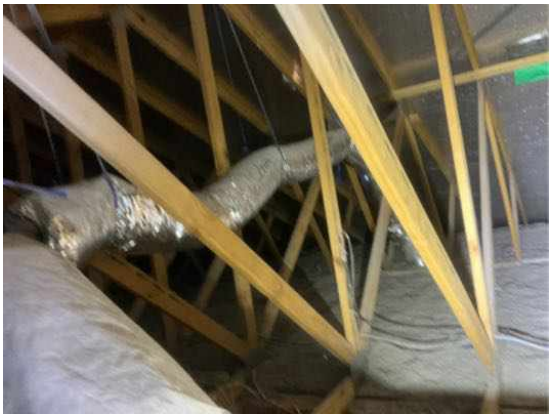
Building: Main Building  
 Location: Roof Void  
 Finding: Obstructions and Limitations - roof cavity  
 Information: These photographs are an indication of the obstructions and limitations which impeded the inspection of the roof cavity area of the property at the time of inspection. These obstructions can hide an array of defects and should be removed to allow full inspection to be carried out. A re-inspection is recommended once the areas are made accessible.
