Building Inspection Report

Inspection Date: Thu, 5 Mar 2026

Property Address: 4 Keane Ct, Old Reynella SA 5161, Australia

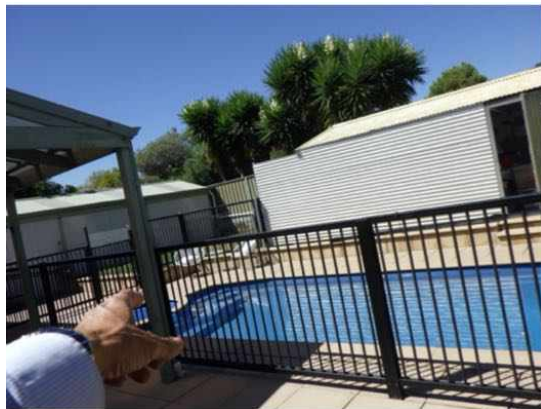
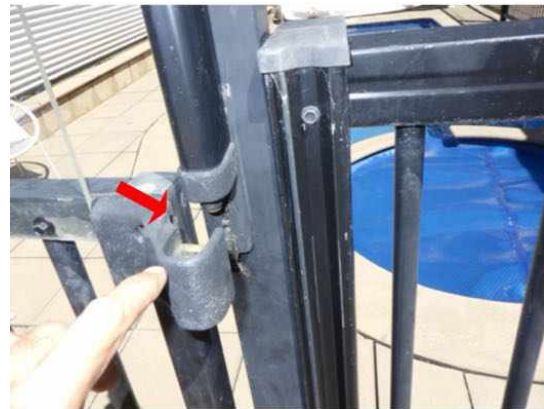
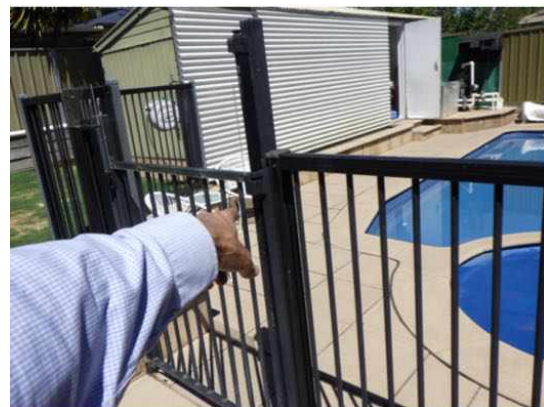
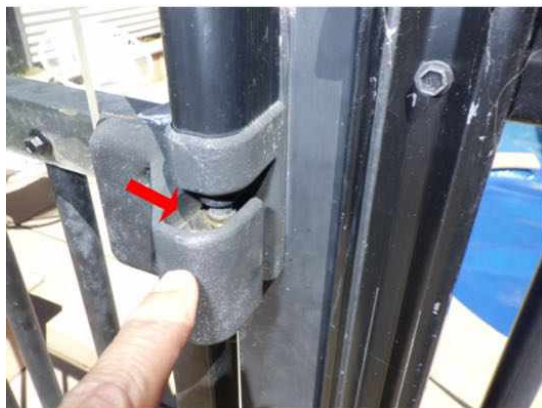
Defects 1.01

Building:	Building 1
Location:	All External Areas
Finding:	Pool fencing - Do not to comply with Australian Standards
Information:	It is suspected that areas of the pool fencing do not to comply with Australian Standards and do not appear to be safe. Assessment of the pool area is required.

Please note that this inspection does not cover pool fencing and other pool fittings and fixtures. It is highly advised that a specialist be appointed to inspect the pool and surrounding area and provide advice on rectification works that may be required.

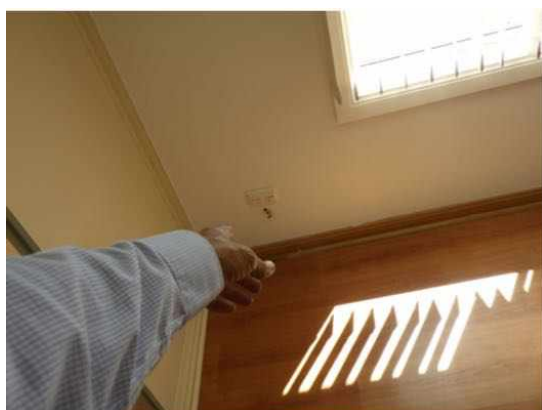
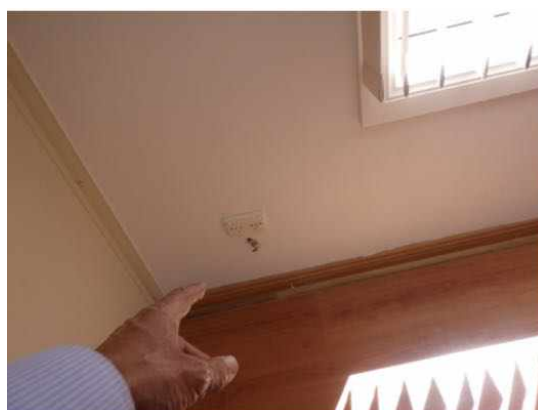
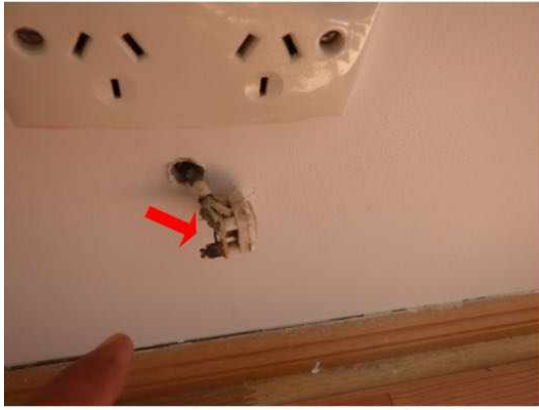
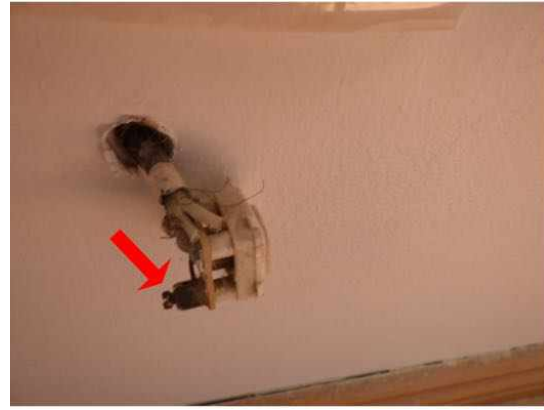
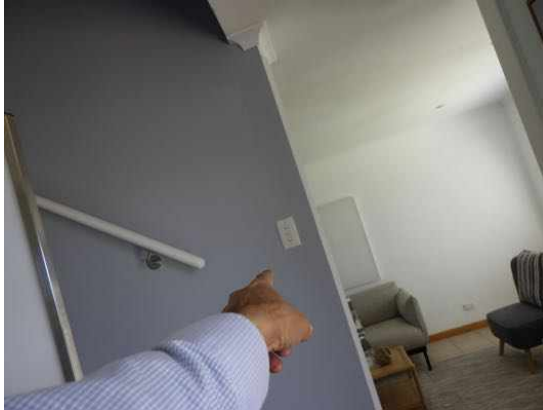
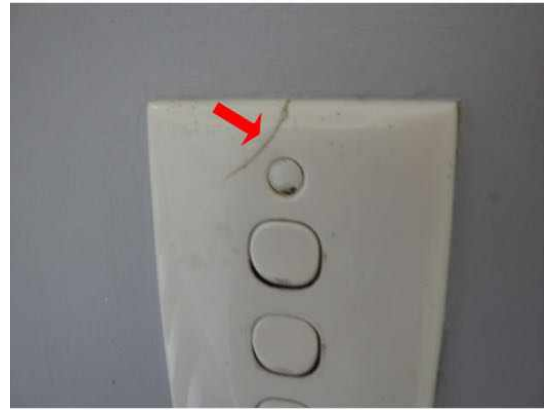
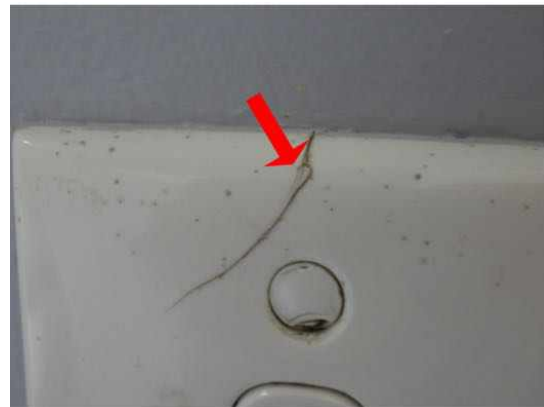
Defects 1.02

Building:	Building 1
Location:	All Internal Areas
Finding:	Electrical fitting - Broken
Information:	The electrical fitting in this ground floor and upper floor bedroom area was found to be broken at the time of inspection. Breakage occurs generally when the building materials have aged and decayed, but may also be indicative of impact damage to the building element (accidental or deliberate).

Left unmanaged, the fitting is unlikely to cause further damage to surrounding building elements. However, the broken fitting does expose electrical works, and may create a safety hazard if there is potential contact with persons in the area.

Repair and/or replacement of the broken fitting is advised. A Licensed electrician should be appointed to repair/replace the fitting immediately.

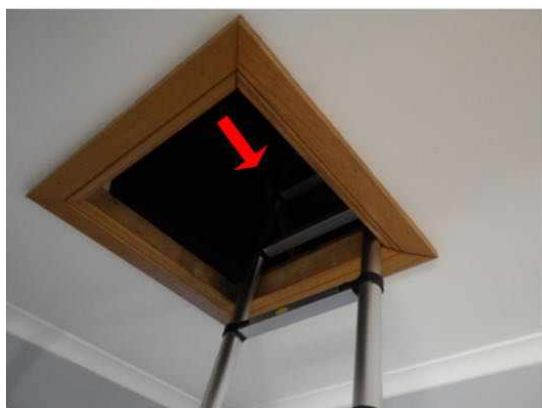
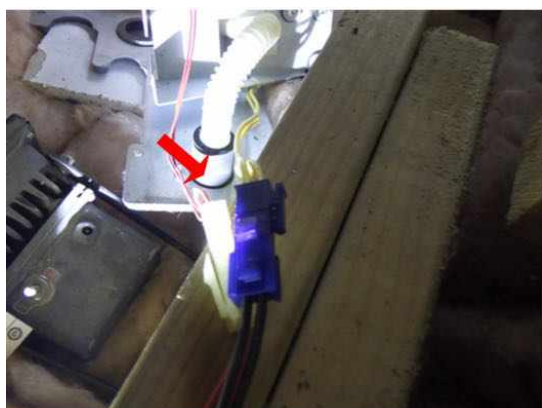
Defects 1.03

Building: Building 1
 Location: All Internal Areas
 Finding: Roof space area - Electrical wires exposed
 Information: At the time of inspection of this roof space area it was noticed that exposed electrical wiring was identified. Exposed electrical wiring represents a potential safety hazard including for fire and personal contact.

Contact a licensed electrician urgently for further inspection investigation and rectification.

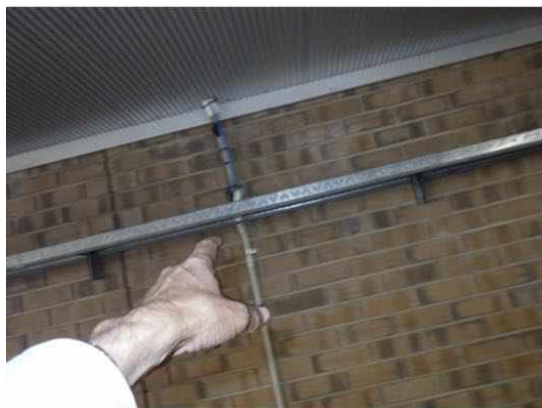
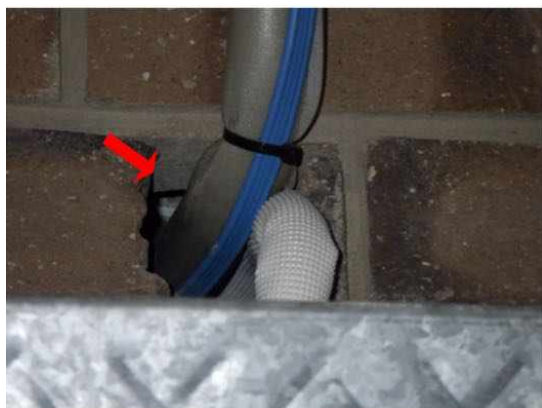
Defects 2.01

Gaps and holes around pipework makes the area susceptible to insect and vermin ingress, as well as allowing water penetration to the cavity wall. As such, associated building elements are likely to deteriorate at an accelerated rate, and major implications are expected if holes around the pipework are left unmanaged.

All excessive holes, gaps or cracks should be adequately filled by a suitable sealant or trimmings as soon as possible to prevent any further damage. Such works may be conducted by a general handyperson or licensed plumber.

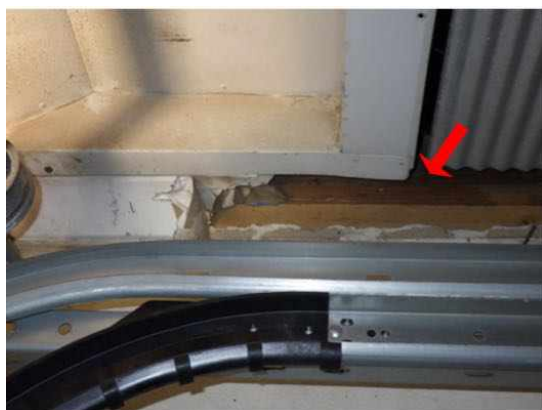
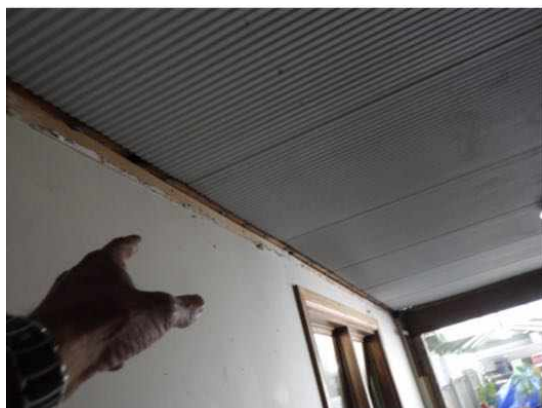
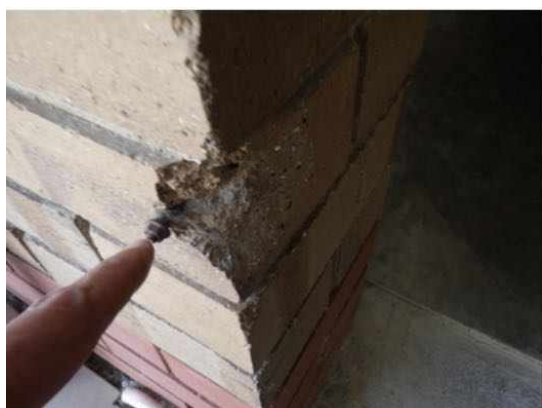
Defects 3.01

Building:	Building 1
Location:	All External Areas
Finding:	Building element - Damaged
Information:	At the time of inspection it was noticed few building elements are damaged / loose from its original fixing around the property.

Breakage occurs generally when the building materials have either aged and decayed, or as a result of damage (accidental or deliberate).

Repair and/or replacement of broken elements is advised to ensure that additional secondary defects do not arise as a consequence. Such works are necessary, as all building elements play a key role in the operation and function of the overall structure and its performance.

A relevant tradesperson should be appointed to repair or replace the affected building element prior to any subsequent damage being caused.

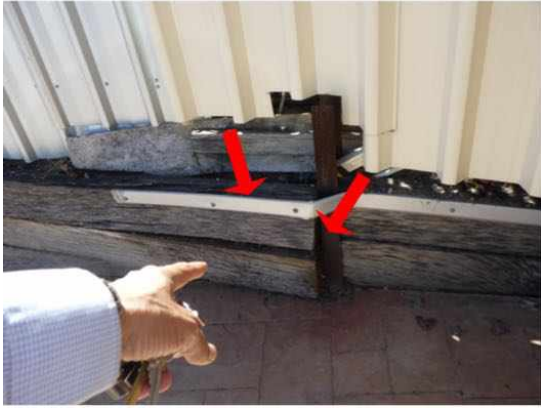
Defects 3.02

Building:	Building 1
Location:	All External Areas
Finding:	Retaining Walls – Timber Sleepers – Deterioration / Damaged
Information:	At the time of inspection, several sections of timber sleepers forming part of the retaining walls around the property were observed to be deteriorated and damaged. The deterioration appears consistent with ageing, decay, and/or possible impact damage.

Timber retaining wall elements that have decayed or broken may compromise the structural integrity and load-bearing capacity of the retaining wall system. If left unrectified, this condition may result in progressive movement, soil displacement, loss

of support, drainage issues, and potential structural failure of the retaining wall.

This condition is considered a defect and warrants further assessment.

It is recommended that a suitably qualified structural engineer be engaged to assess the retaining walls and provide advice regarding structural adequacy and required remedial measures. Following assessment, an appropriately licensed and experienced contractor should be appointed to repair or replace the affected timber sleepers in accordance with the engineer's recommendations and accepted building practices.

Rectification works should be undertaken in a timely manner to prevent further deterioration and the development of secondary defects.

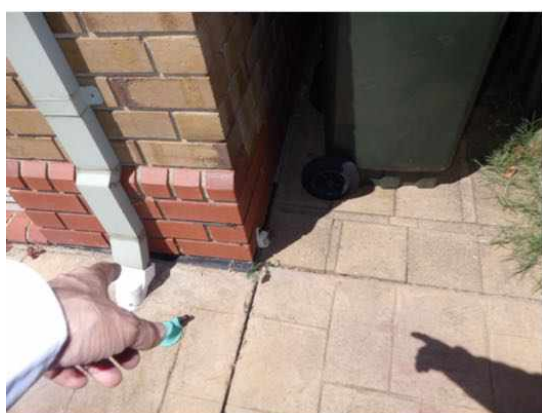
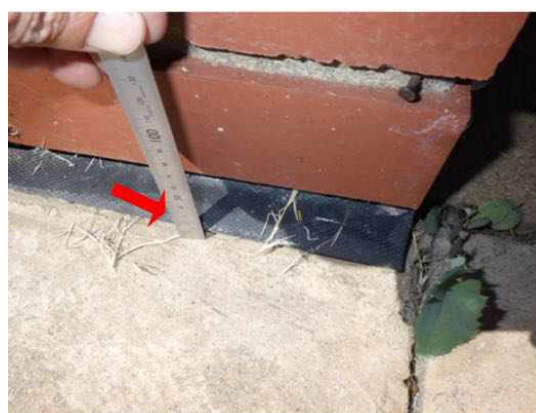
Defects 3.03

Building:	Building 1
Location:	All External Areas
Finding:	Slab Edge - Exposure Compromised
Information:	At the time of inspection it was noticed that slab edge exposure has been compromised in few sections around the property.

If the slab edge is not properly exposed there is a high risk of termite attack. Sometimes, in order to determine the type of slab, a suitably qualified person such as an architect or builder may be required to consult the construction plans.

Where the slab edge cannot be properly inspected, it is highly recommended that termite or timber pest inspections be carried out every 6-12 months to aid protection of the property against infestation.

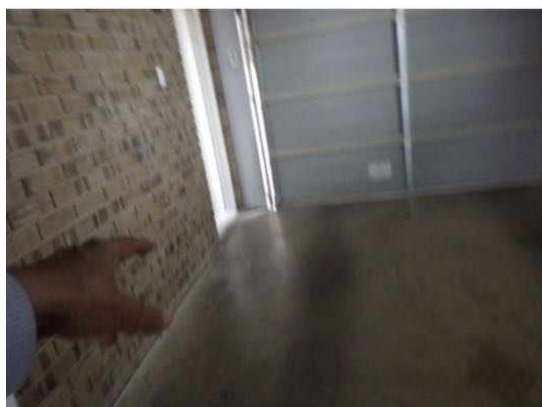
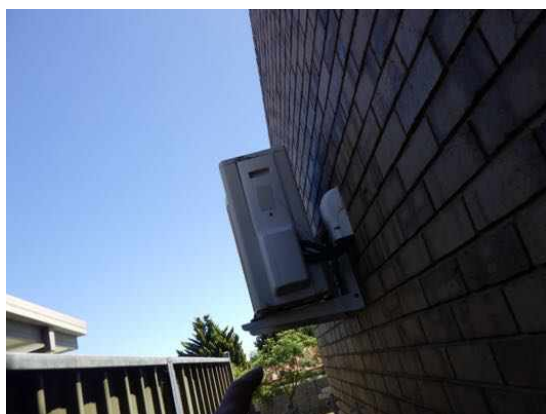
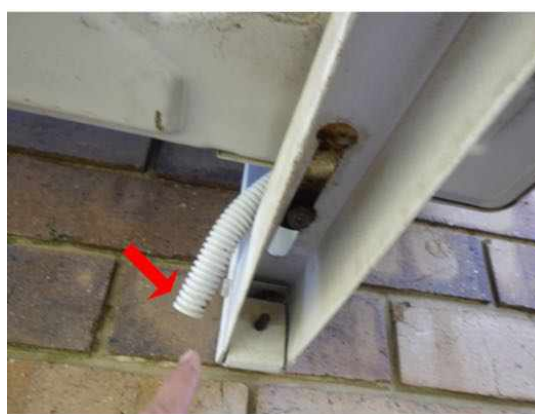
Defects 3.05

Building:	Building 1
Location:	All External Areas
Finding:	Air conditioner - Disconnected overflow
Information:	The Air Conditioner (A/C) overflow was found to be disconnected from storm water drainage and is creating excessive moisture in the surrounding area.

Such leaking creates an environment which is conducive to an array of defects, including water damage to associated building elements and the attraction of termite or timber pest infestation.

It is highly recommended that a licensed plumber be appointed to connect the A/C overflow in order to prevent such an environment from being created. These minor works should be carried out as soon as possible.

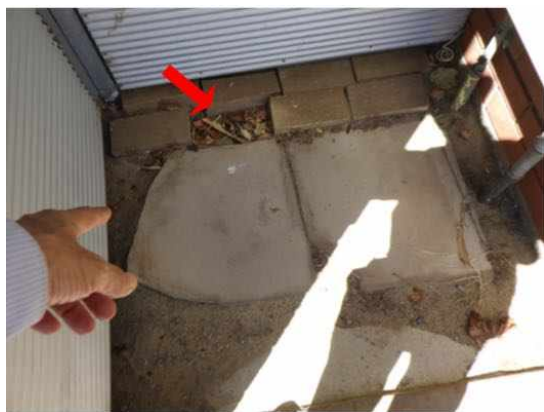
Defects 3.06

Building:	Building 1
Location:	All External Areas
Finding:	Paving - Uneven
Information:	Sections of the external paved area are uneven, creating a potential trip hazard. It appears as though the area has been subject to rough installation, or that paving

sections have lifted due to movements in the foundation of the property.

Where paving creates a trip hazard, personal injury may ensue if due caution is not taken by all persons within this area.

Re-paving of the area is required as soon as possible to remedy this situation. Further consultation with a specialist concreter is advised.

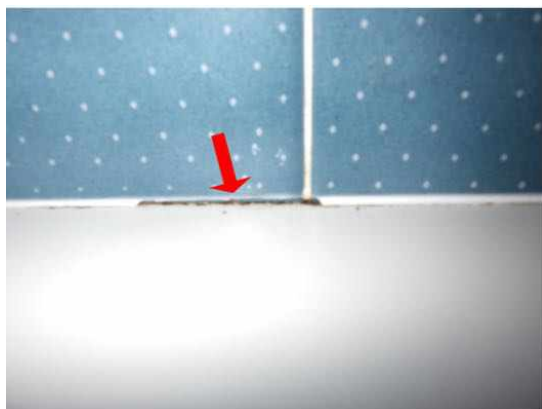
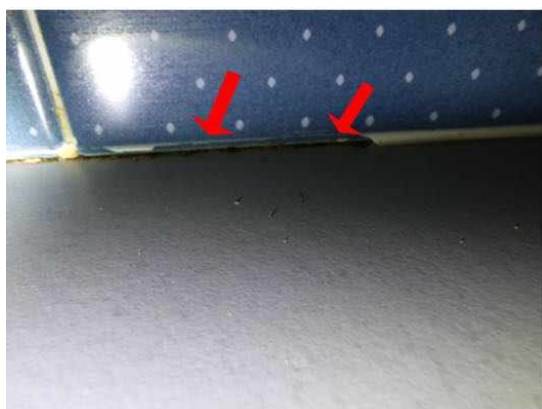
Defects 3.08

Building: Building 1
 Location: All Internal Areas
 Finding: Grout - Missing/ Deteriorated
 Information: Grout is missing/ deteriorated in this kitchen area. Grout is used to protect gaps and crevices in building materials to ensure that they are water-tight and prevent water penetration to the associated structures.

Where grout is missing, a tiling contractor should be appointed immediately to apply grout and re-apply any silicone where necessary. Failure to do so is likely to lead to water damage to the surrounding area.

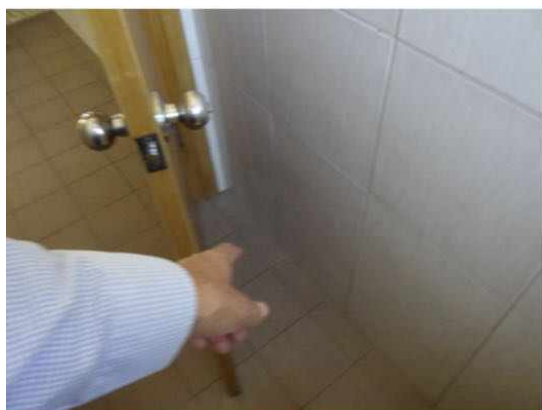
Defects 3.10

Building:	Building 1
Location:	All Internal Areas
Finding:	Door stop - Missing
Information:	The door stop is missing or is inadequate to stop the door handle from damaging the wall. Although some building elements may seem irrelevant or unnecessary, all building elements play a key role in the operation and function of the overall structure and its performance.

Re-installation or replacement of the door stop is advised as soon as possible to prevent any subsequent damage to the door or associated structures. A general handyman may be appointed to perform these works at client discretion.

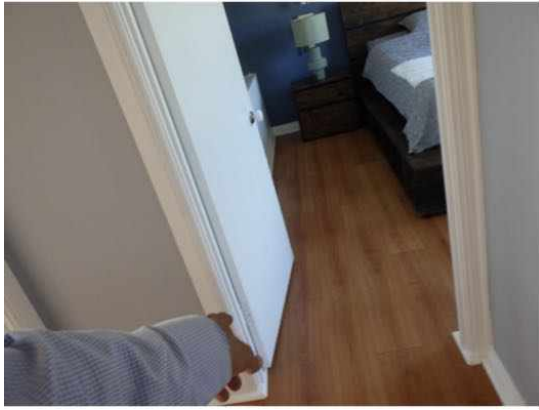
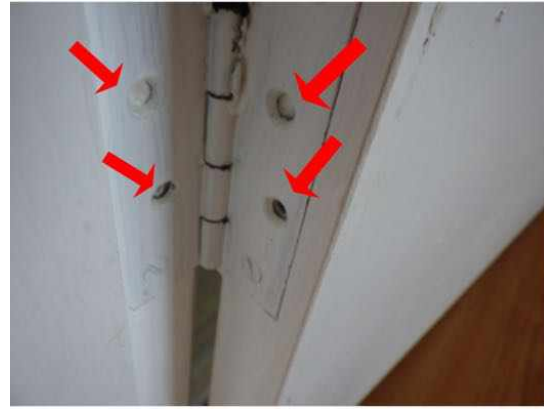
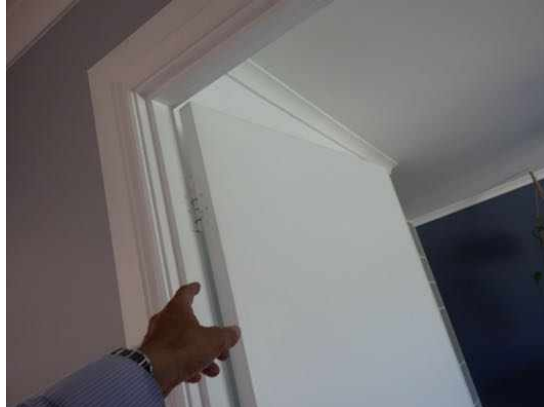
Defects 3.11

Building:	Building 1
Location:	All Internal Areas
Finding:	Door hinges - Screws - Missing
Information:	At the time of inspection it was noticed that few screws were missing from door hinges around the property.

Replacement of any missing building element should be conducted as soon as possible to ensure that no damage or functional issues occur to associated building materials.

The appropriate tradesperson should be appointed as soon as possible to replace the missing building element.

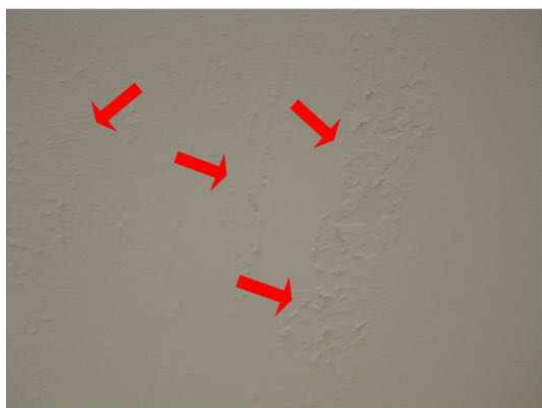
Defects 3.12

Building:	Building 1
Location:	Bathroom
Finding:	Ceilings - Scuffed
Information:	At the time of inspection it was noticed that evidence of ceilings scuffed in this bathroom area.

Scuffed surfaces, while detracting from the overall appearance of the affected building element, do not indicate any operational or structural damage. This degree of surface damage is consistent with general wear and tear and minor impact damage, normally accumulated over a number of years.

Marked surfaces may be left as is at the discretion of the client; no repairs or replacement are necessarily required, as this is an appearance defect. However, the client may wish to seek quotations for the cost to refurbish or replace the identified building element.

A general handyman or plasterer may be appointed to rectify marked surfaces if considered necessary by the client.

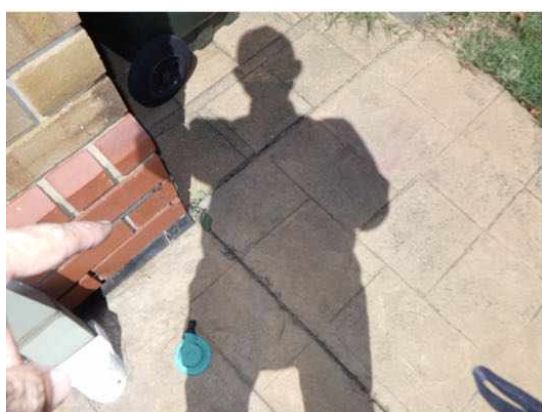
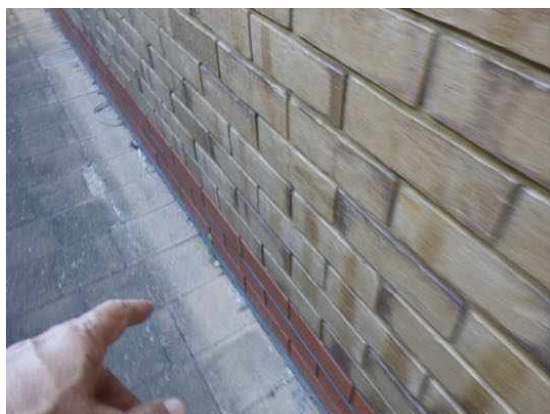
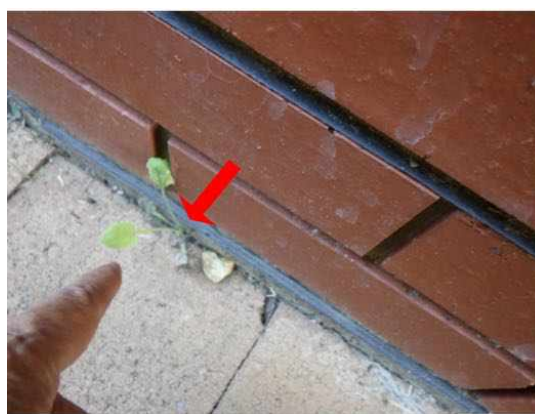
Defects 3.13

Building:	Building 1
Location:	All External Areas
Finding:	Bridging - Vegetation
Information:	Where vegetation obstructs inspection of building elements, also known as bridging as it provides a bridging point for the access of termites, full inspection can not be achieved. Consequently moisture or dampness may be present and the areas becomes conducive to termite activity. Plants against or very close to buildings provide cover, shade and can provide an environment that is attractive to termite infestation.

The removal and replanting of species that do not provide "cover" or cutting back of existing vegetation will assist greatly in preventing Bridging from occurring.

The removal of any such materials that may be conducive to termite activity should be carried out as soon as possible and arrange re inspection to minimize the risk of termite attack.

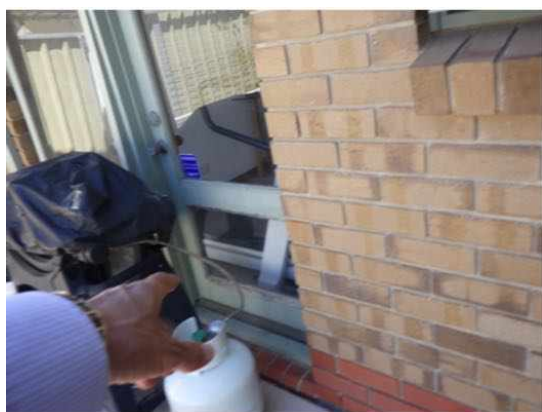
Defects 3.14

Building:	Building 1
Location:	All External Areas
Finding:	External painting deteriorated
Information:	Much of the external paintwork including but not limited to windows, fascias, guttering, veranda and other external fitments have been neglected and require attention to prepare and re-paint.

Whilst incomplete or missing paint finish is generally an appearance defect, it can also lead to the development of secondary building defects over time. Incomplete areas of paint finish expose the area to moisture, potentially accelerating the deterioration of underlying building materials.

Degraded paint finishes should be sanded back, filled, leveled and painted, as applicable. Where inadequate or missing paint protection has led to the deterioration of the associated building element, repair and/or replacement of this building element may be required.

A painting contractor should be appointed as soon as possible to perform necessary works to aid the appearance of the affected area and to ensure the area is protected against further deterioration. Alternatively, the homeowner following manufacturer instructions may perform these works.

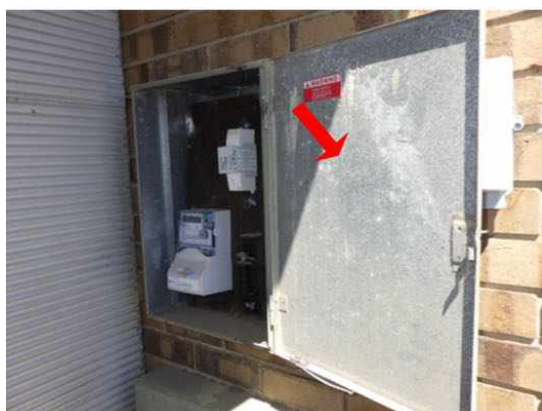
Building: Building 1
 Location: All External Areas >
 Finding: Termite Management System - No evidence of a chemical installation
 Information: The application of a post-construction chemical termite barrier is highly recommended for all properties, particularly if live termite activity has been found on the site previously. Such barriers are highly effective in preventing termite attack on any timber building elements throughout the property.

A durable notice should be placed in the switchboard unit to indicate current termite barriers. At the time of inspection, it appeared as though no termite management system has been installed, with no evidence to suggest preventative works taking place.

The client may consider gaining further advice from a pest controller as to the costs and procedures involved with this application. It is recommended that obtaining such advice be a short-term priority.

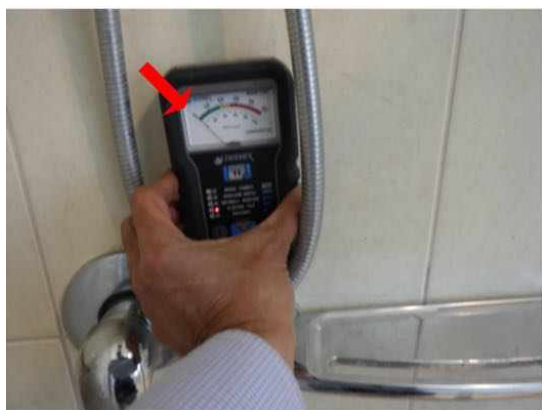
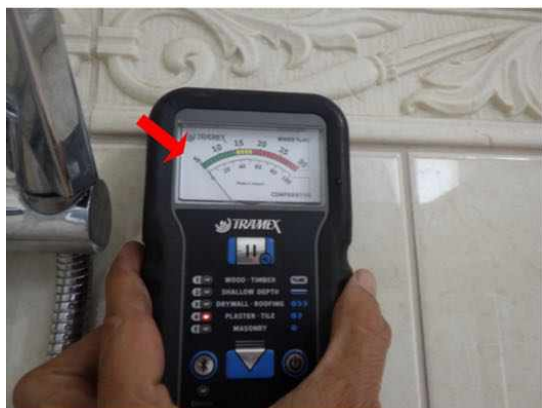
Building: Building 1
 Location: Bathroom
 Finding: Shower Alcove - No Damp
 Information: At the time of inspection it was noticed that damp is not evident to the shower alcove.

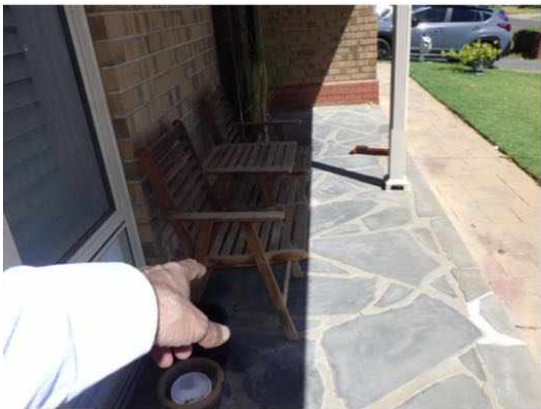
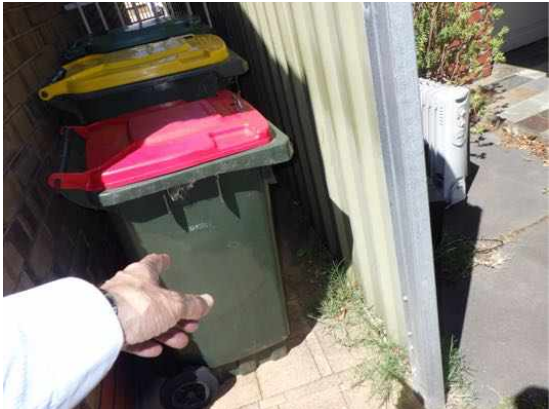
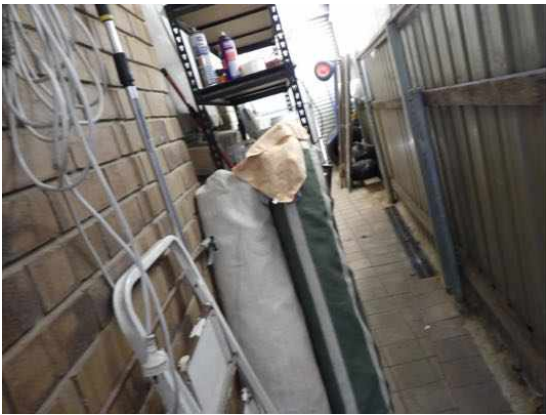
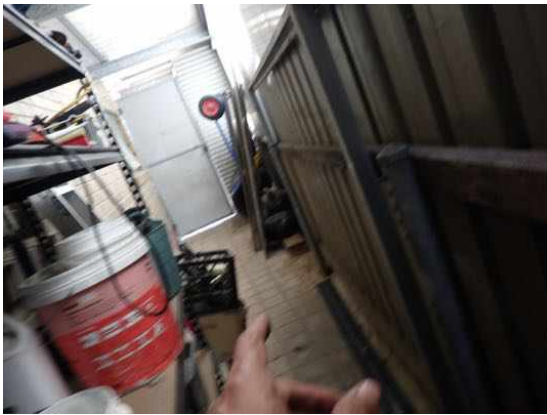
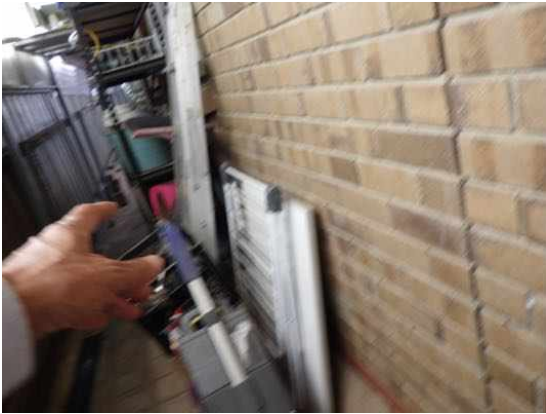
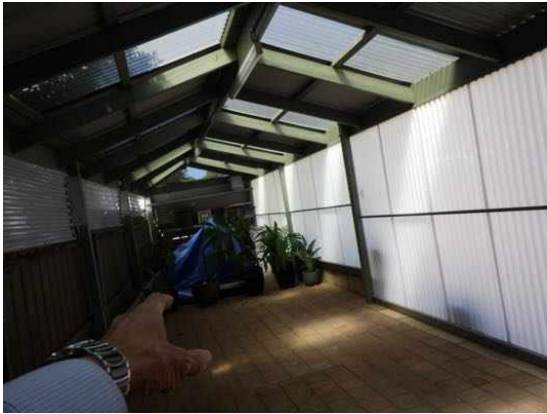
Building: Building 1
Location: All Areas
Finding: Additional Photos - Obstructions and Limitations
Information: These photographs are an indication of the obstructions and limitations which impeded full inspection of the property at the time of inspection. These obstructions can hide an array of defects and should be removed to allow full inspection to be carried out. A re-inspection is recommended once the areas are made accessible.
