Building and Timber Pest Inspection Report

Inspection Date: Mon, 09 Mar 2026

Property Address: 15 Pulley Dr, Ropes Crossing NSW 2760,
Australia

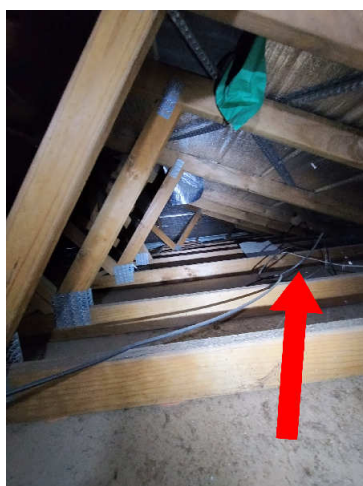
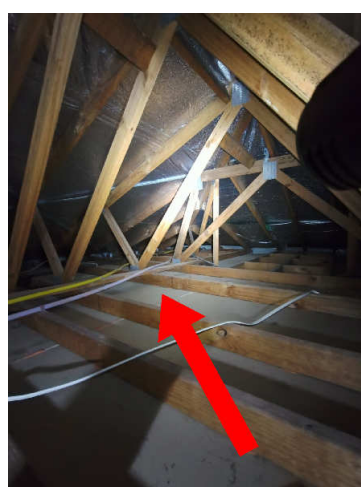
Not fixed electrical wiring at the entrance of this roof space represents a potential safety hazard to personal contact.

Contact a licensed electrician urgently for further inspection investigation and rectification.

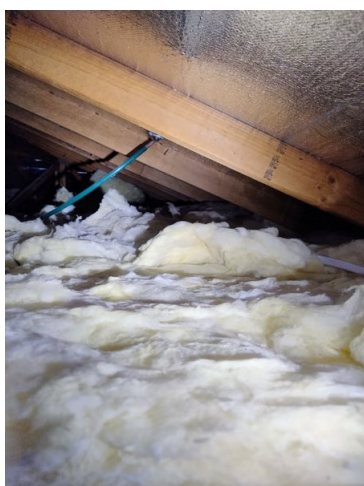
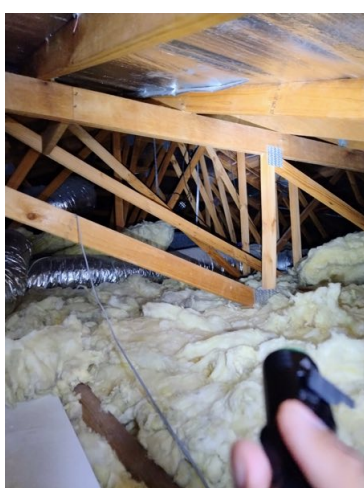
Finding 1.02

Information: Sections of insulation in the Ensuit roof void have been poorly installed or moved from their original position and are covering down light fittings at the time of inspection. While the down lights have been fitted with appropriate protective covers, the presence of this insulation creates a potential fire hazard.

Any insulation within the vicinity of down light fixtures should be moved and re-applied to more appropriate sections of the roof void, thus ensuring the area is fire-safe. An insulation contractor should be appointed as soon as possible to perform any necessary works as required.

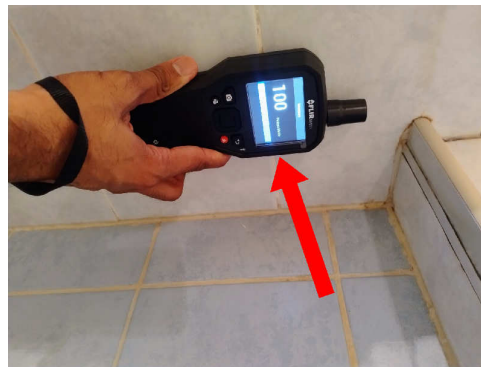
Finding: Evidence of Excessive moisture - identified - Major Defect

Information: Evidence of excessive moisture recorded by moisture meter in the shower wall of the bathroom and Ensuite.

Excessive moisture can attract termites and produce conditions that promote fungal growth and wood decay.

Excessive moisture is generally caused by deteriorated, inadequate or missing roof drainage, leaking plumbing pipes or fixtures, poorly plumbed HWS overflows or condenser units and poor site drainage.

Prior to any remedial works being performed a qualified plumber should be appointed to further inspect the property and to identify the cause of the excessive moisture. Works to remove affected building elements may then be necessary and should be performed by an appropriate tradesperson.

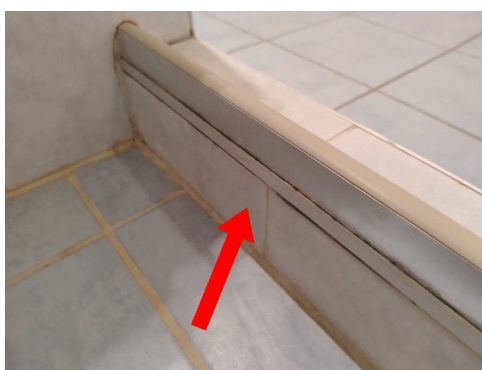
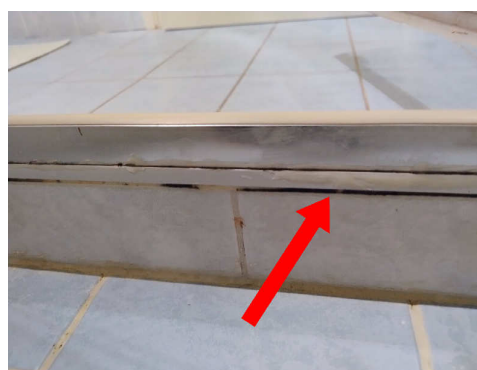
Finding 3.01

| Finding: | Sealant and Grouting - Damaged or Detoriorated |
| Information: | It was noted on inspection that sealant or grout is degraded to the tiled shower alcove and or other areas of the bathroom. |

There mould to the sealant and grout which will likely require scraping out and replacement.

This can lead to water ingress into the shower base and creates conducive condition to termite activity. If left unmanaged can cause further deterioration to building elements.

Flexible and mould resistant materials should be applied to affected areas to prevent any subsequent water damage that is likely to occur. Regular maintenance and replacement of damage or missing or damaged sealant and grout is highly recommended to the wet areas, as this is a regular wear and tear defect. Sealant and grouting in areas that come into regular contact with water should be maintained for the long term care of your property.

Qualified trade person or plumber must be appointed for rectification on priority.

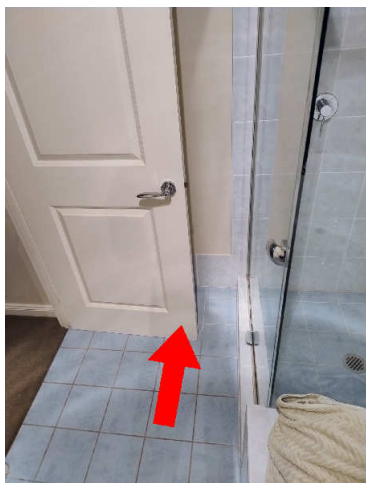
Finding 3.02

Finding: Door stop - Missing

Information: The door stop is missing and door is inadequate to stop the door handle from damaging the wall in Bathroom area. Although some building elements may seem irrelevant or unnecessary, all building elements play a key role in the operation and function of the overall structure and its performance.

Re-installation of the door stop is advised as soon as possible to prevent any subsequent damage to the door or associated structures. A general handyman may be appointed to perform these works at client discretion.

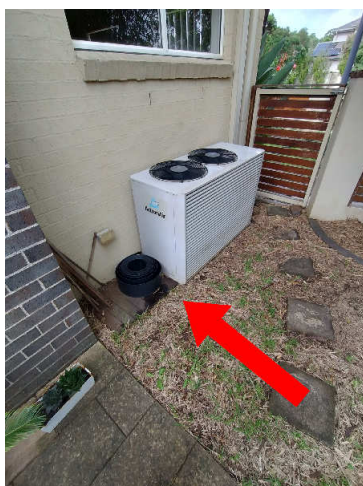
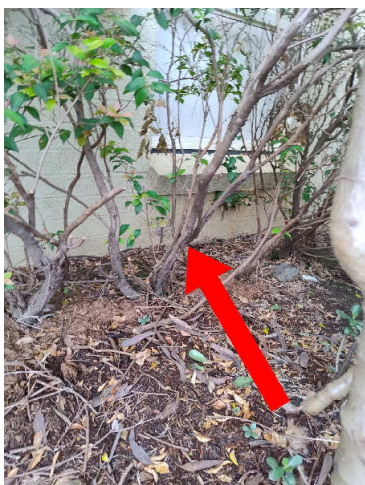
Finding: Site drainage - Inadequate

Information: The site drainage in all external area was found to be inadequate at the time of inspection, creating potential for subsequent water damage to associated building elements.

It is important that water does not lie against the base of walls; surrounding paths and ground levels should be sloped to drain water away from walls. Downpipes should not discharge stormwater onto lower walls or plinths. Stormwater should be carried away by large, regularly cleaned drains. Ground levels may need to be lowered to expose a buried DPC.

Where site drainage is inadequate, installation of an Agricultural (Aggie) Drain may be required. A qualified plumber should be appointed to further inspect the property and perform any remedial works as necessary. Water damage and secondary defects are likely to occur if left unmanaged.

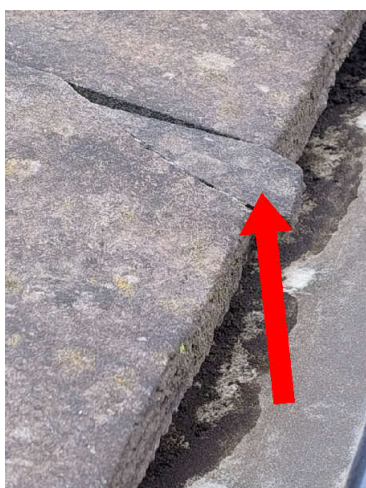
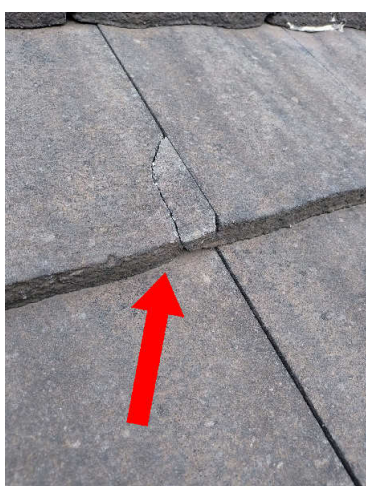
Finding 3.06

Finding: Roof tiles - Weathered and Cracking in sealant of roof structure

Upon inspection of the exterior roofing, the some of roof tiles were considered to be in a fair condition. While weathering of the tiles is consistent with the age of the property, maintenance works are required.

Isolated areas of mortar have come loose in the valleys and minor cracking is also present. Re-pointing and re-sealing the may be considered as an interim solution by the client to help preserve and extend the life span of the tiles.

Where left unmanaged, deteriorating roof tiles are likely to lead to a number of secondary defects, including minor water leaks and weather exposure to internal roofing structures.

Consultation with a roofing contractor is highly advised to gain advice on cost of remedial works that may be required in the short to medium term. Remedial works are likely to increase the longevity of the exterior roofing structure.

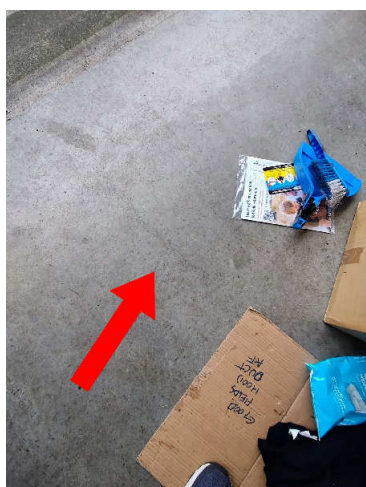
Finding 3.07

Finding: Crack in concrete slab - Category 1

Information: Cracks was observed in the garage slab at the time of inspection. A crack coded as Category 1 was identified in the slab. A Category 1 crack is described as a fine but noticeable crack, with the slab at an otherwise reasonable level.

To be considered Category 1, the approximate width of the crack is less than 1.0mm, or a less than 10mm change in offset when a 3m straight edge is placed over the defect.

Category 1 cracks should be monitored for a period of 12 months. At the end of the monitoring period, identified cracks that are rated greater than Category 2 are considered defects, and require rectification.

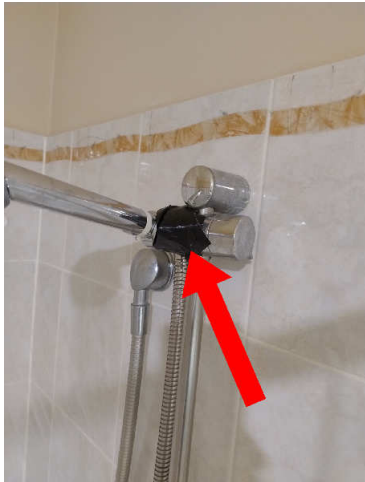
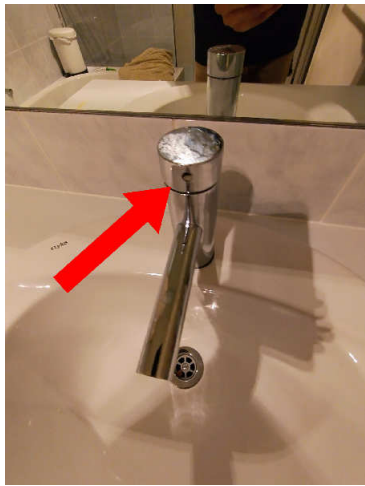
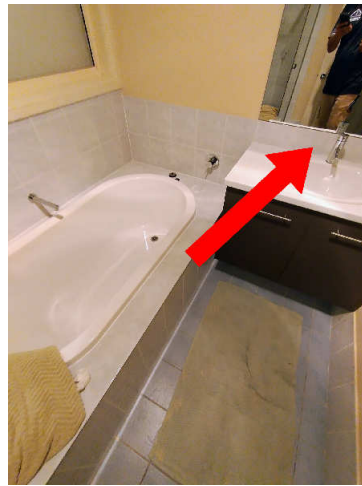
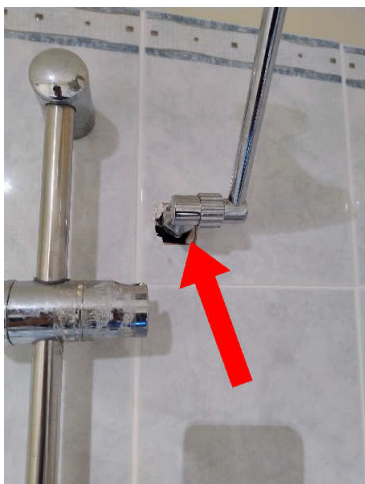
Finding 3.08

| Finding: | Building element - Damaged |
| Information: | Shower head in Ensuit, Water tap and tiles around shower head in bathroom is of substandard quality or damaged. |

Repair and/or replacement of broken elements is advised to ensure that additional secondary defects do not arise as a consequence. Such works are necessary, as all building elements play a key role in the operation and function of the overall structure and its performance.

A relevant tradesperson should be appointed to repair or replace the affected building element prior to any subsequent damage being caused.

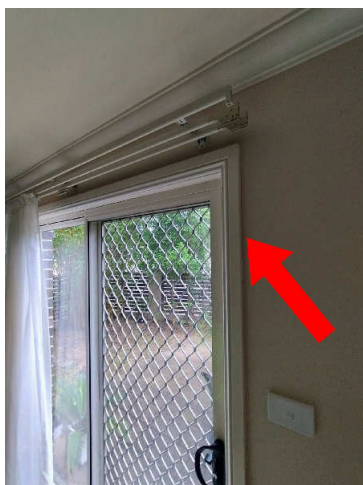
Finding 3.09

Finding: Cracking - Damage Category 2 - Noticeable (up to 5mm)

Information: Cracks were observed in the dining and family area between door framing and wall at the time of inspection. Noticeable cracks are a common occurrence as a result of many primary defects. Such causes may include age, general wear and tear, expected building movement, general expansion/contraction of building materials in different weather conditions, and/or minor failings in the installation or application of building materials.

Noticeable cracks may result in minor sticking or jamming of associated doors and windows, which require easement. However, noticeable cracks are easily filled and repaired. A plasterer can be consulted to install an expansion joint at this point to allow for this movement during different weather conditions.

Relevant tradespeople, such as carpenters, painters and plasterers, should be appointed to perform remedial works, as deemed necessary.

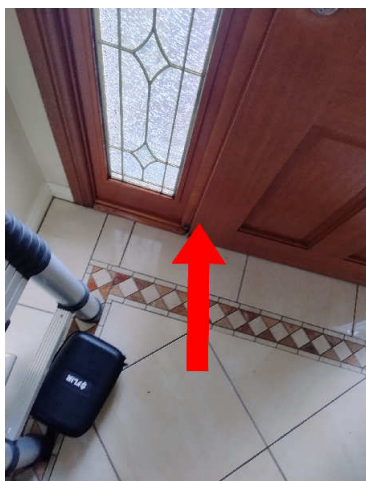
Finding 3.10

Information: Binding and/or jamming of Bedroom 2 door was evident during standard operation at the time of inspection. This defect inhibits the functionality of the affected door as well as creating potential for secondary defects to associated building elements, such as damage to the floor covering.

A door that binds to flooring or to the associated door frame may have several causes, ranging from minor defects, such as poor installation of the door or deteriorated hinges, through to major structural issues, such as damage to subfloor structures.

Where door binding/jamming appears to indicate major structural issues, a registered builder specialising in re-stumping should be appointed to provide an estimate on the cost of rectification.

For minor causes, a qualified carpenter or general handyperson should be appointed to perform minor rectification works at client discretion.

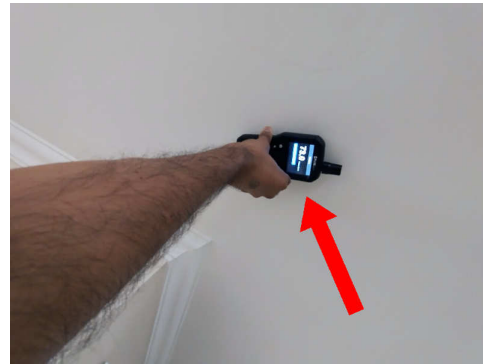
Finding 3.11

Information: Mould were observed at the time of inspection in ceiling of Family room area. Where evidence of mould growth was noted, there may be environmental, biological or health issues associated with the report. A specialist inspection by a suitably qualified environmental health inspector is warranted, where mould is extensive or where any queries regarding air quality spores or other related issues apply. Moisture reading were taken at the location of mould impression at the soffit of ceiling and high moisture reading was observed at concentrated location.

Generally, the client is advised to ensure that the general environment is free of moisture and humidity to aid in the prevention of mould formation and development. Any mould found during the inspection should be cleaned immediately by a cleaning contractor or the homeowner as applicable.

Please note that severely affected building elements may require replacement by a registered builder or qualified carpenter.

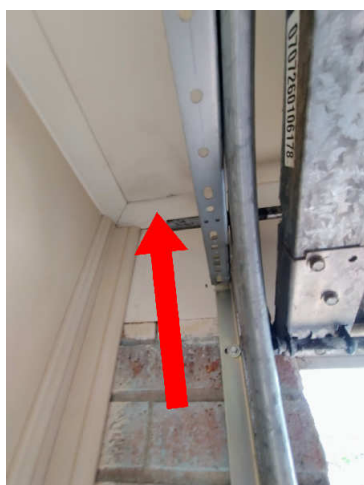
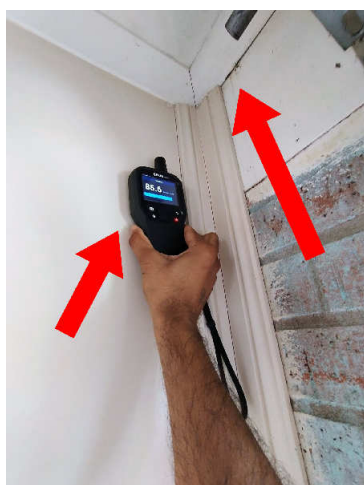
Finding 3.12

Finding: Evidence of Excessive moisture and Mould - identified

Prior to any remedial works being performed a qualified plumber should be appointed to further inspect the property and to identify the cause of the excessive moisture. Works to remove affected building elements may then be necessary and should be performed by an appropriate tradesperson.

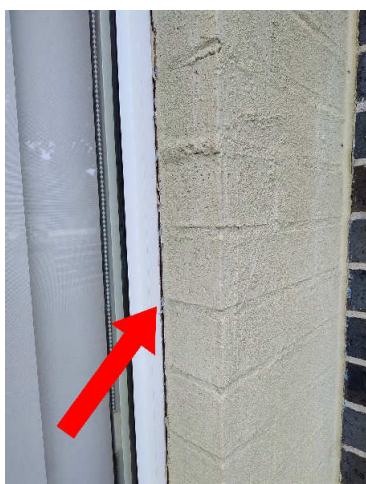
Finding 3.18

Any gaps to the exterior walls of the building that are larger than 3mm are deemed a defect and require filling, beading or replacement of brickwork to close or cover the gaps. Such gaps create potential for pest ingress, excessive moisture and structural issues, and should therefore be minimised prior to the development of secondary defects.

Such works should be carried out by the builder on site to prevent secondary defects and to comply with Australian Standards.

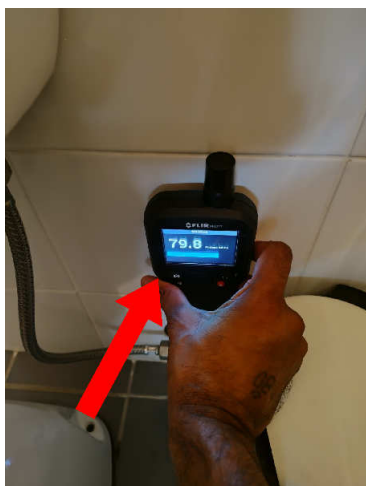
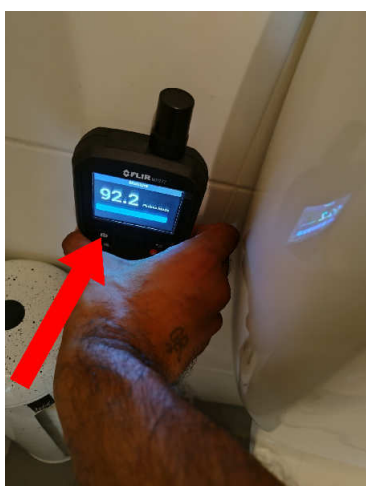
Finding 3.20

Excessive moisture was observed in the toilet area walls at ground floor at the time of inspection. Excessive moisture can attract termites and produce conditions that promote termite attack, fungal growth and wood decay. Excessive moisture is generally caused by deteriorated, inadequate or missing roof drainage, leaking plumbing pipes or fixtures, poorly plumbed HWS overflows or condenser units and poor site drainage. It is highly recommended that all plumbing and drainage fixtures and fittings be maintained regularly in order to prevent excessive moisture being present in the external / internal property.

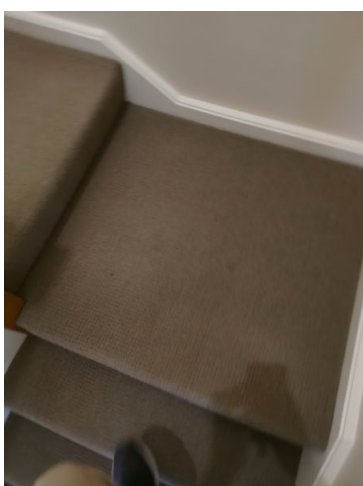
Information: All area of the carpet floor covering in upper floor area appeared to be deteriorated and old. Deteriorated carpet pose health hazards by trapping allergens like dust mites and pet dander, which can trigger asthma and allergies. They can also hold bacteria, mould and fungi, especially if damp, leading to respiratory problems and infections,

Replacement of the carpet is suggested as a matter to ensure the safety of the area at client discretion. Where required, remedial works should be undertaken to any associated walls and flooring showing evidence of mould.

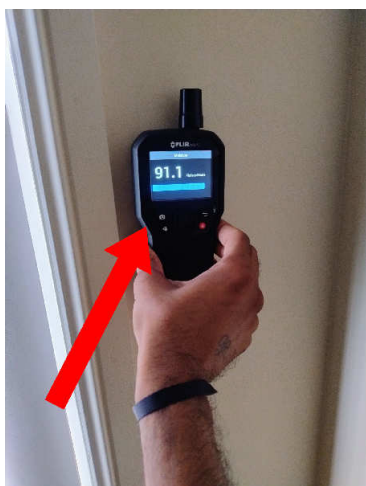
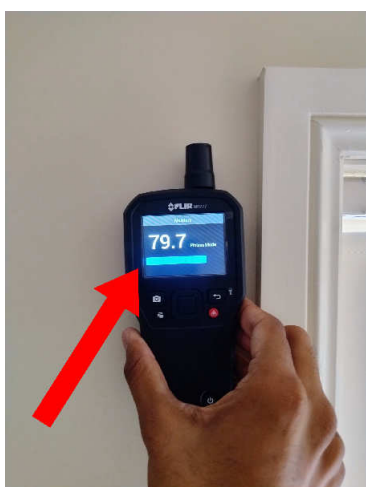
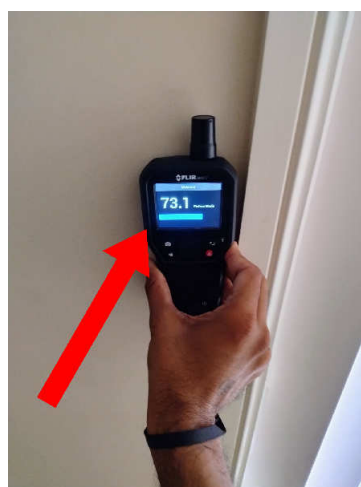
Finding 3.23

| Finding: | Excessive moisture - identified |
| Information: | <p>Excessive moisture was identified at sides of window frame in all areas of upper floor. Excessive moisture can attract termites and produce conditions that promote fungal growth and wood decay.</p> <p>Excessive moisture is generally caused by deteriorated, inadequate or missing roof drainage, leaking plumbing pipes or fixtures, poorly plumbed HWS overflows or condenser units and poor site drainage.</p> <p>If mould growth has been found there may be environmental biological or health issues involved. In these cases an appropriately qualified inspector should also be contacted.</p> <p>Prior to any remedial works being performed a qualified plumber should be appointed to further inspect the property and to identify the cause of the excessive moisture. Works to remove affected building elements may then be necessary and should be performed by an appropriate tradesperson.</p> |

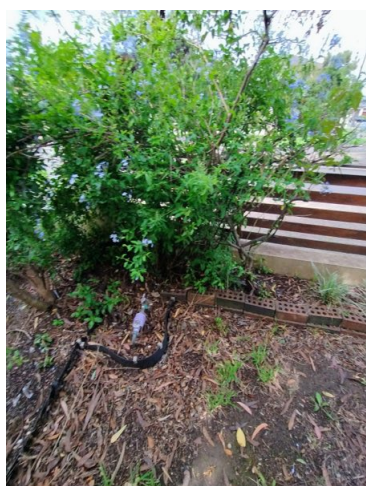
Finding 6.08

Finding: Garden Beds - Conditions Conducive to Termites

Information: Garden beds were found to be evident in the front area. These garden beds can include untreated timber, and with a combination of moisture from watering hosing can make conditions conducive to termite activity and termite ingress.
