Building and Timber Pest Inspection Report

Inspection Date: Tue, 7 Apr 2026

Property Address: 3/19 Lalor Rd, Quakers Hill NSW 2763,
Australia

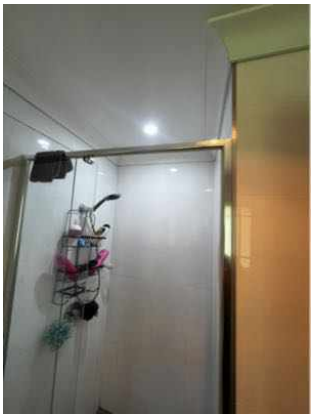
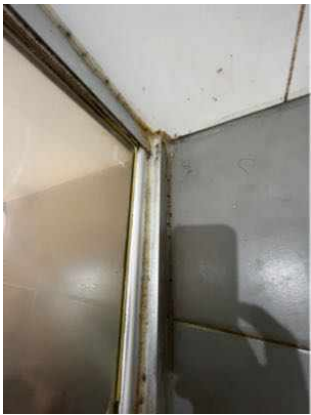
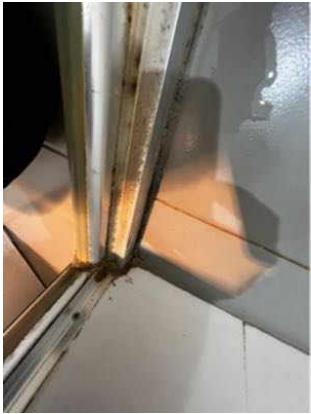
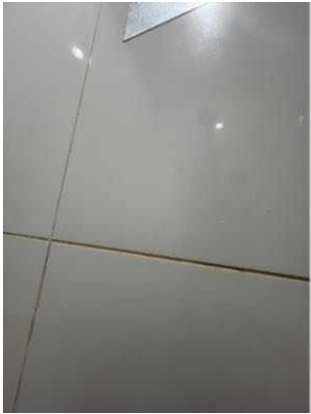
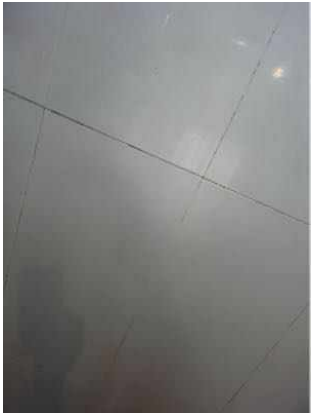
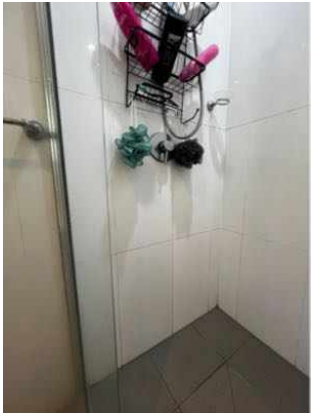
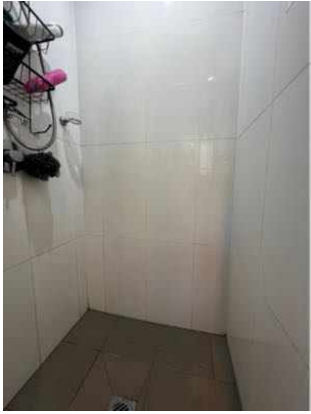
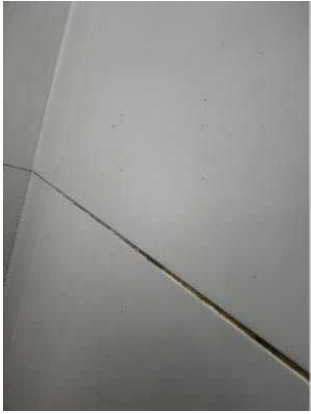
Building:	Main Building
Location:	Bathroom >
Finding:	Sealant and grouting - Missing or damaged
Information:	It was noted on inspection that sealant or grout is degraded to the tiled shower alcove and or other areas of the bathroom.

Different materials and floor areas move at different rates, generally causing cracking to grout or sealant at this point. A flexible sealant is required to allow for expected expansion and contraction, while keeping the joint water tight and protective of all associated building materials.

There appears to be excessive mould to the sealant and grout which will likely require scraping out and replacement.

Flexible and mould resistant materials should be applied to affected areas to prevent any subsequent water damage that is likely to occur. Regular maintenance and replacement of damage or missing or damaged sealant and grout is highly recommended to the wet areas, as this is a regular wear and tear defect. Sealant and grouting in areas that come into regular contact with water should be maintained for

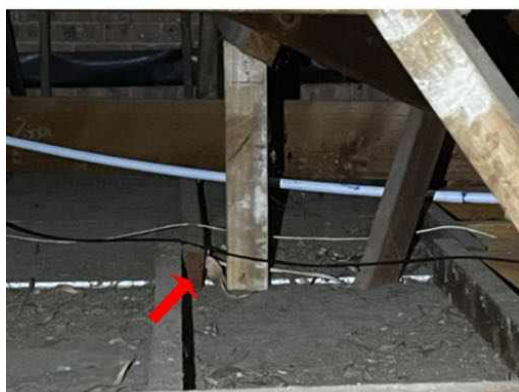
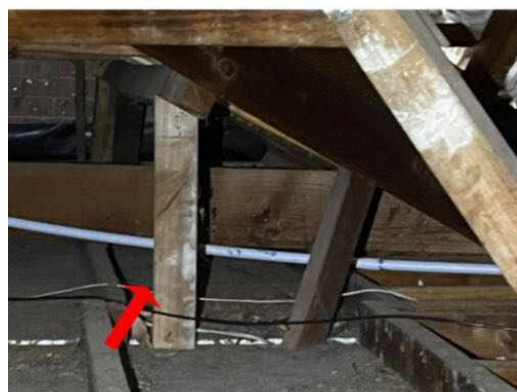
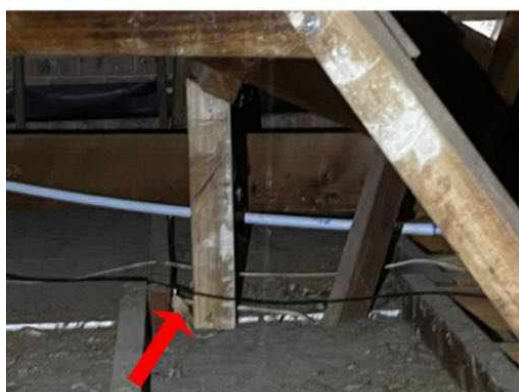
Finding 2.02

Building: Main Building
Location: Roof
Finding: Roof structure - Connections (Sagging)
Information: Upon inspection the ceiling was inspected for the visible crack and found that the roof structure was improperly supported.

The roofing structure was found to be sagging in certain sections at the time of inspection. Upon closer inspection within the ceiling void, it is suspected that the sagging is a direct result of inadequate connections, which appear to have deteriorated over a prolonged period of time.

It is critical to ensure that the fastenings holding important roof elements together remain structurally sound (i.e. not corroded) and tightly fastened. Any failure in fastenings can lead to movement of roof members, which is likely to result in an uneven or sagged appearance of the roof exterior. Improper nailing at the point where the ceiling joist connects to the bottom of the rafter may also cause sagging.

Remedial works are highly advised and should be performed by a registered builder or roofing contractor as soon as possible.

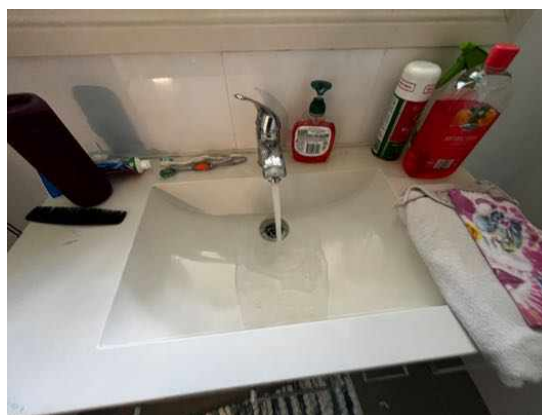
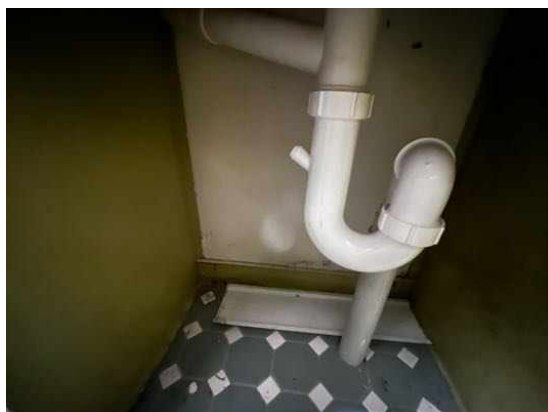
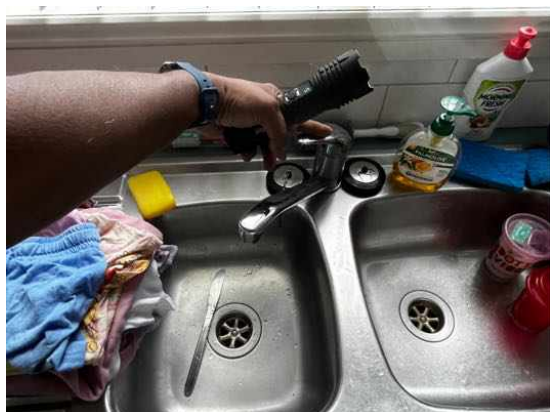
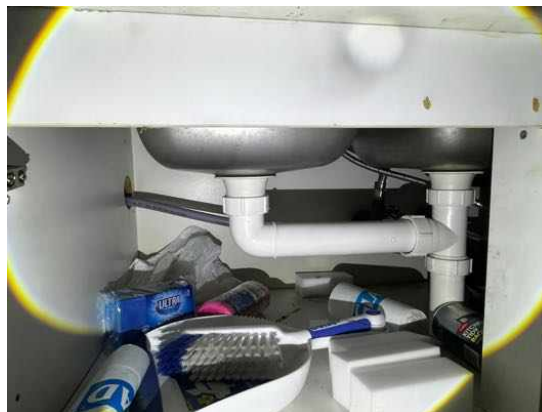
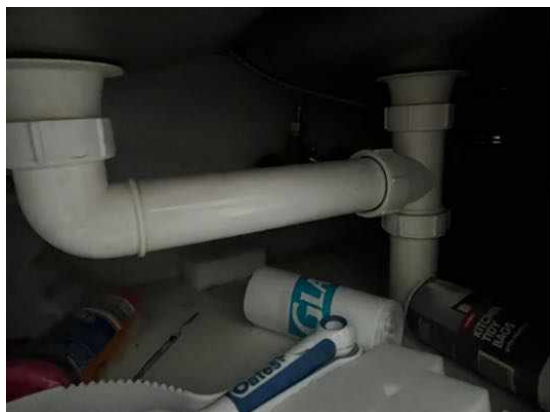
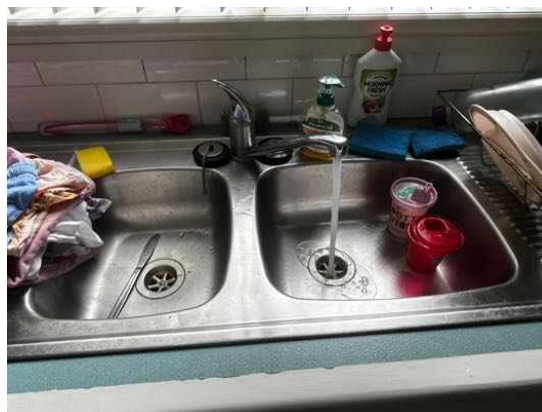
Finding 3.01

Building: Main Building
Location: Kitchen/ Laundry/ Bathroom
Finding: Cabinetry Plumbing - Kitchen/ Laundry/Ensuite
Information: All cupboards where sinks and basins with drainage plumbing were inspected and no evidence of leaks were present at the time of inspection.

Water hammer was found when taps turned on and off.

For your information only no remedial works are required at the time of inspection.

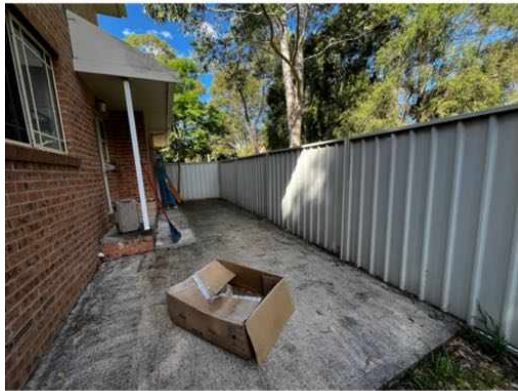
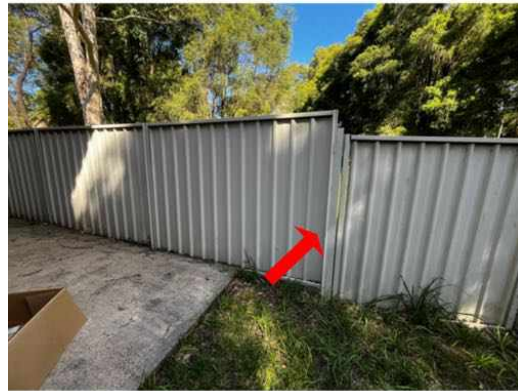
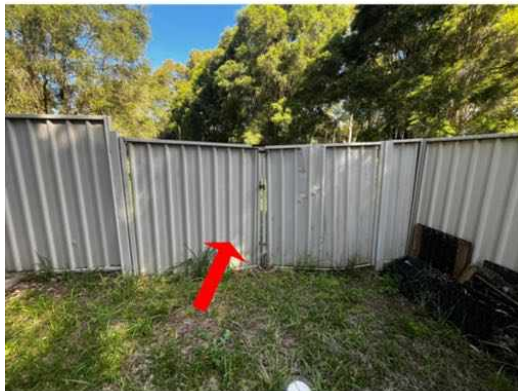
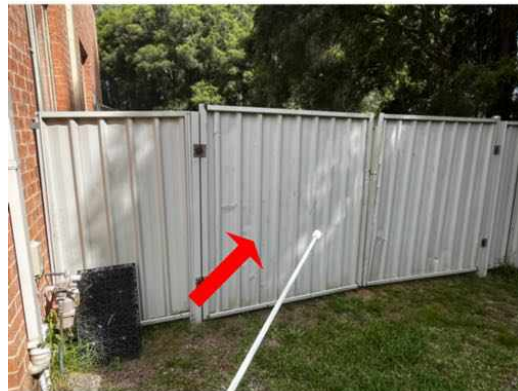
Finding 3.02

Building:	Main Building
Location:	Yard
Finding:	Perimeter Fencing - Deteriorated
Information:	For your information photos taken at the time of inspection.

Fencing was found deteriorated at many places of the yard area including the side access gate.

It was noted at the time of inspection that sections of the fencing throughout the property have deteriorated. Typically fencing deteriorates due to age and or wear, rot and or rust which is generally expected for a structure of this age, due to prolonged exposure to weather conditions. Sometimes inadequate installation or maintenance can be to blame.

If left unattended, it is likely that further damage will occur. It is suspected that repair of several elements of the fencing may be required however replacement may be a consideration of the client also.

A licensed fencing contractor should be appointed to provide further advice and perform rectification works as necessary.

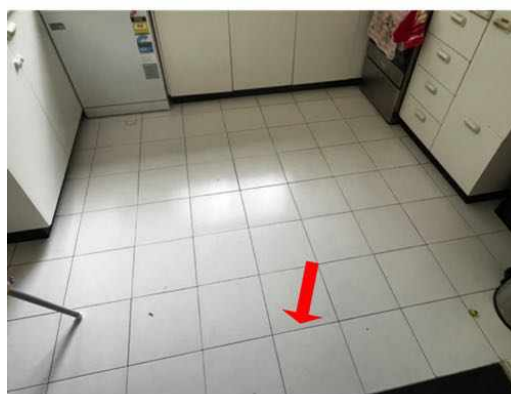
Finding 3.03

Finding: Cracked floor tiles

Information: Cracking in the floor tiles was evident in this area at the time of inspection. It is suspected that this cracking has occurred as a result of minor settlement or shrinkage caused by movement..

Cracked tiles throughout the household detract from the overall appearance of the affected areas however it is unlikely to create or lead to any secondary defects.

While not considered a matter of urgency, replacement of cracked floor tiles is recommended at the clients discretion.

A tiling contractor may be appointed to perform these works. Where cracks become more numerous, contact a licensed building inspector for further investigation.

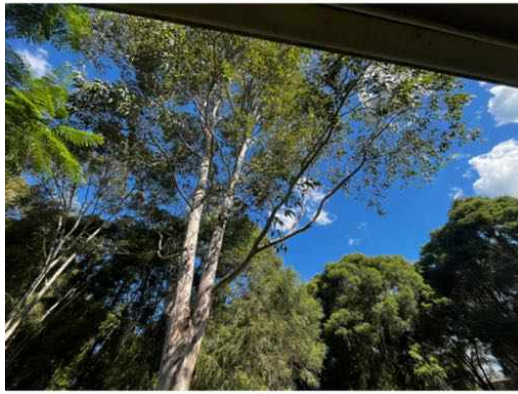
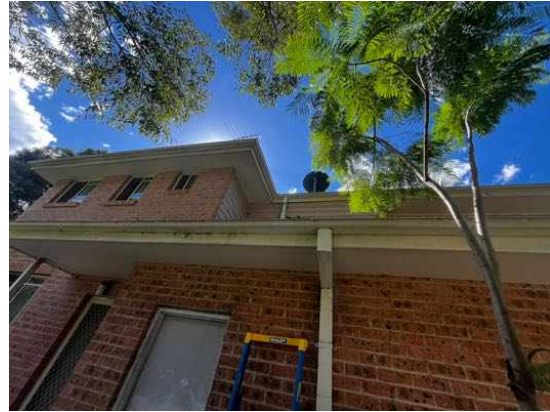
Finding 3.04

Building:	Main Building
Location:	Yard Side
Finding:	Trees - Overhanging and filling gutters
Information:	Overhanging trees often result in excessive amounts of leaf debris accumulating in gutters.

Gutters are a critical part of the building's management of storm water and rain. It is therefore important that they be kept clear to prevent secondary damage to associated building elements, including exterior and interior walls, ceiling linings and any adjoining building elements. Where gutters are blocked, pooling of rainwater is likely to occur, fast-tracking rust and corrosion of the roof plumbing elements.

It is highly advised that all overhanging tree branches be removed as soon as possible to prevent any further damage. Repair and/or replacement of sections of damaged guttering may also be required where the extent of the damage necessitates.

Such works should be performed by the homeowner; however, appointment of a landscape contractor or an arborist may be required. Consultation with a licensed roof plumber is required where guttering has been damaged.

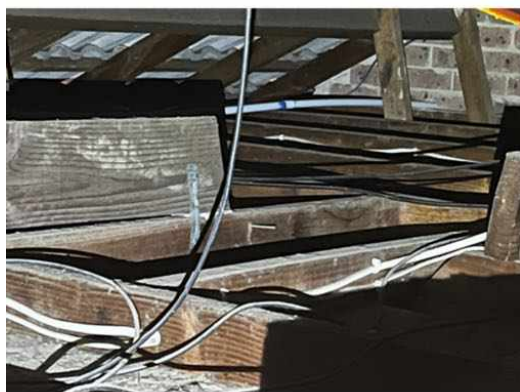
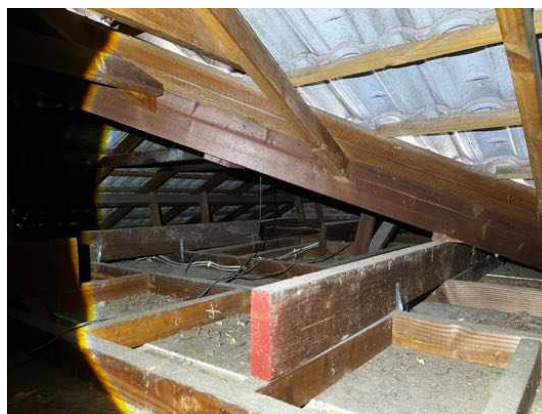
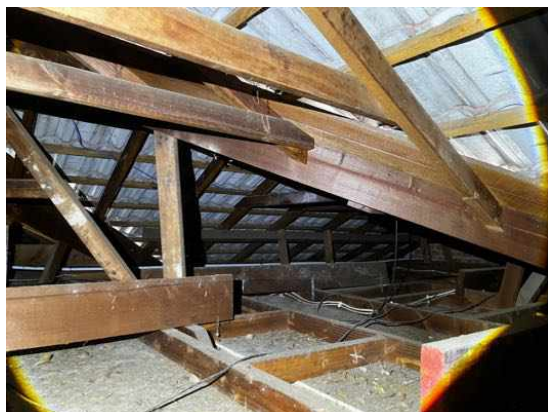
Building:	Main Building
Location:	Roof
Finding:	Insulation - Missing
Information:	Upon inspection of the roof void it was noted that insulation is not present.

Insufficient insulation will result in a comparatively higher cost to heat and cool a property as there is a lack of Insulation (or uneven coverage of insulation) which works as a barrier to heat transfer. This helps to keep out unwanted heat in summer and preserves warmth inside your home in winter. It can also help soundproof your home from unwanted airborne noise transfer.

Where insulation is absent, the area does not meet current Australian Standards. Installation of adequate insulation is required and should be conducted as soon as possible.

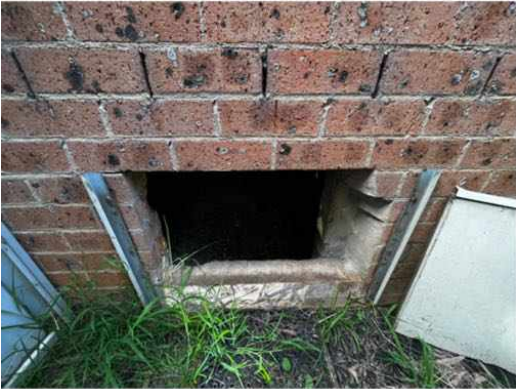
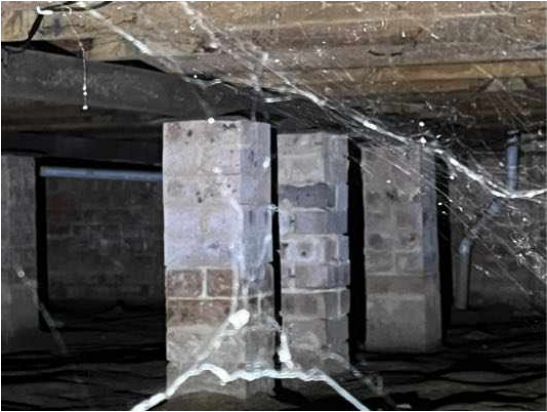
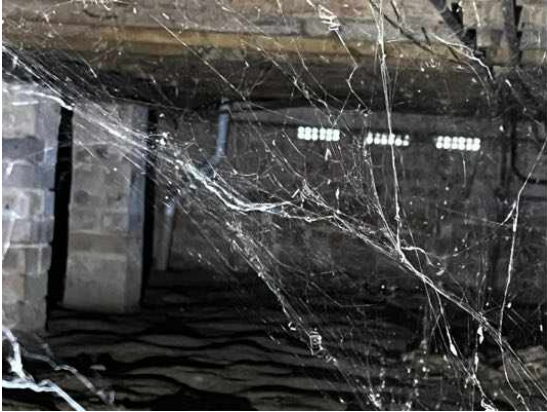
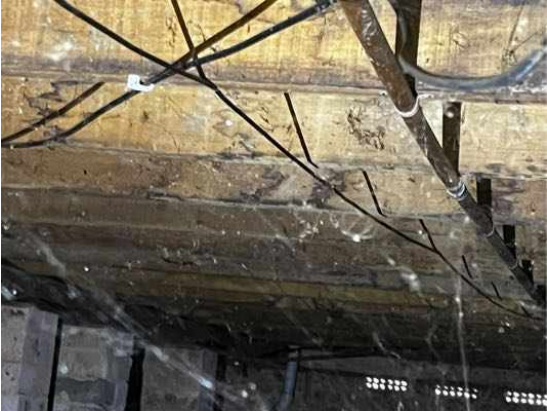
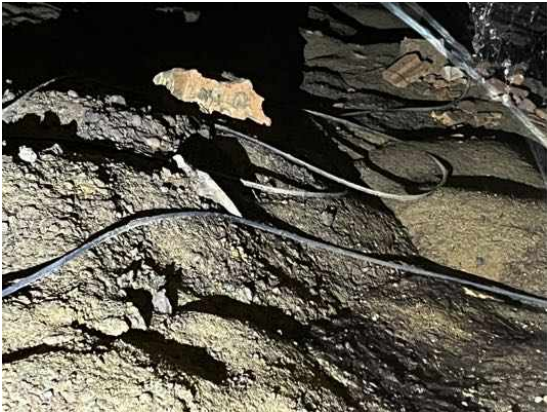
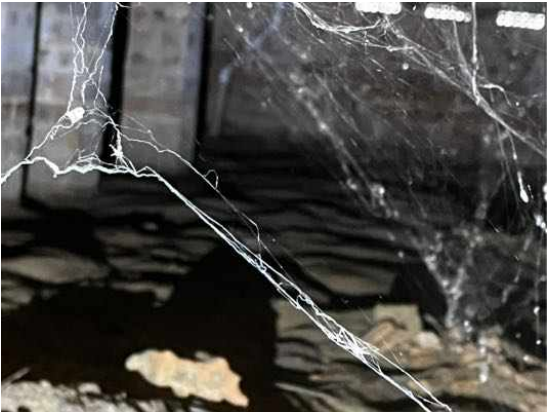
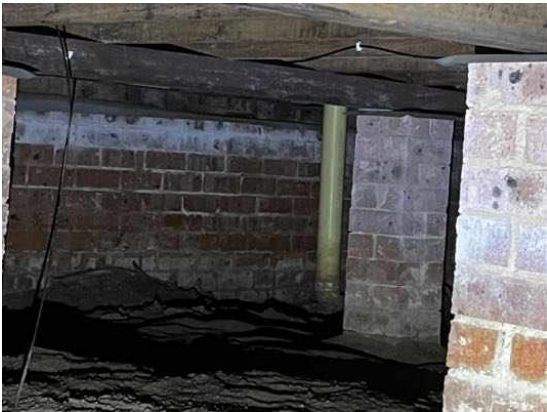
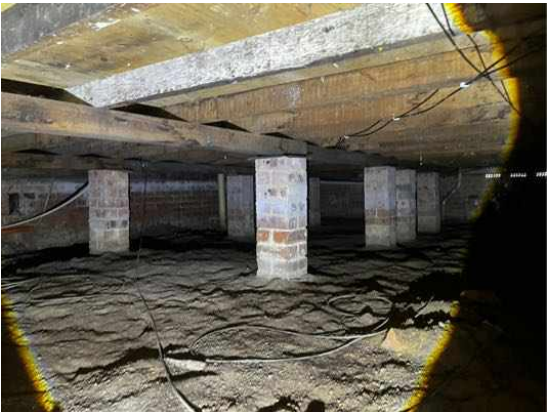
Finding 6.03

Building:	Main Building
Location:	Sub Floor
Finding:	Subfloor ventilation - Inadequate
Information:	Adequate subfloor ventilation aids in preventing excessive moisture wood rot and termite activity by ensuring a dry subfloor environment.

Where ventilation is substandard it is usually caused by factors such as failure to install adequate vents during construction subsequent building works or earth and vegetation covering over vents low subfloor clearance and items or debris in the subfloor restricting airflow.

Subfloor ventilation can be improved in most cases by addressing the causes such as exposing subfloor vents installing additional new vents installing mechanical (forced airflow) ventilation and removing debris from the subfloor.

A registered builder should be appointed as soon as possible to perform these works as necessary.

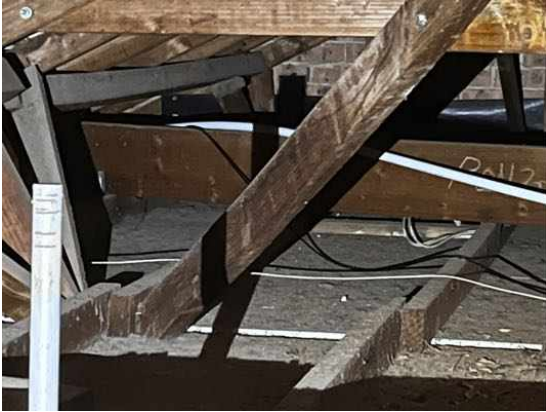
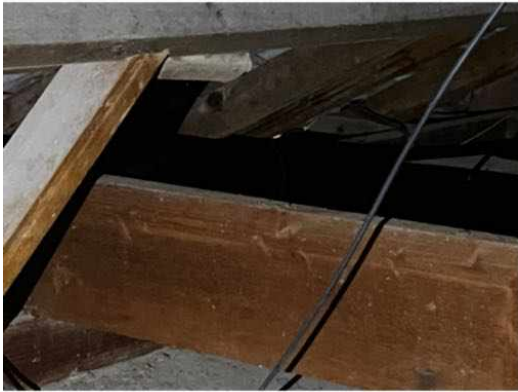
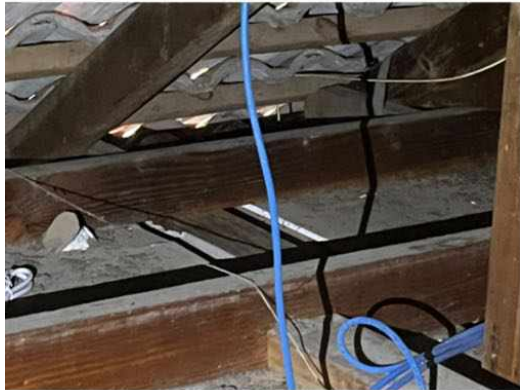
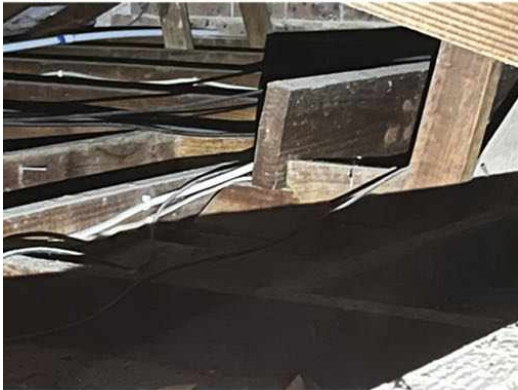
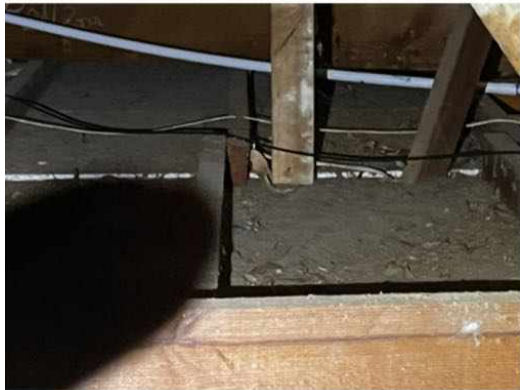
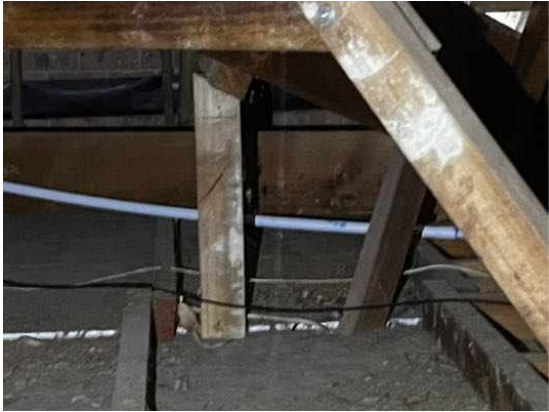
Building: Main Building
 Location: Roof Void/Upstairs
 Finding: Obstructions and Limitations - Roof space
 Information: Upon Inspection of the Roof void upto the point safe for inspection These photographs are an indication of the obstructions and limitations which impeded full inspection of the Roof Space/Void at the time of inspection such as Stored items, Ducting, Electrical wires , insulation and cross beams, rafters, low clearance as of the pitch in the roof. These obstructions can hide an array of defects and should be removed to allow full inspection to be carried out.

A re-inspection is recommended once the areas are made accessible.

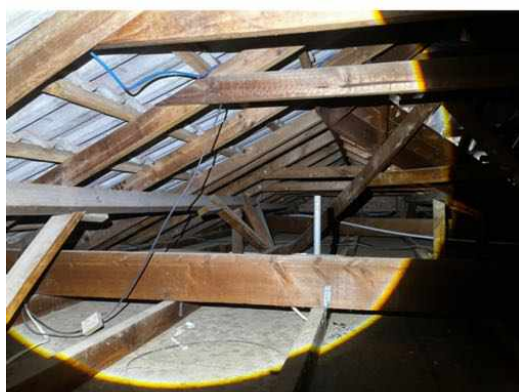
Building: Main Building
 Location: Roof
 Finding: Sarking - Missing
 Information: Sarking is missing under the roof sheeting. Sarking acts as an insulator that helps with noise reduction and protects against water penetration. Sarking plays a key role in the operation and function of the overall roofing structure and its performance.

Although not a requirement at the time of construction, replacement of any missing building element is advisable (although this can be quite expensive to do after the time of construction). Where sarking is missing, regular inspections of the roof tiles for cracking and potential moisture penetration is required.

Sarking may be retrospectively fitted by a registered builder at the discretion of the client.
