Building and Timber Pest Inspection Report

Inspection Date: Fri, 9 Jan 2026

Property Address: 305-309 Grey St, Glen Innes NSW 2370,
Australia

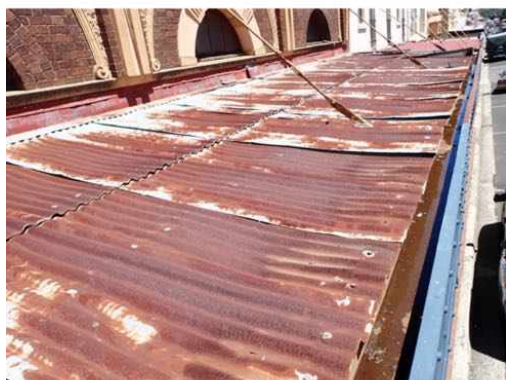
Finding 2.01

Building:	Main Building
Location:	Street awning
Finding:	Street awning poor condition
Information:	The tin cladding to the street awning was found to be in poor condition and in need of replacement. This is typically caused by age-related deterioration, weather exposure, and possible corrosion over time. The cladding may leak during rain, which could lead to water ingress and further deterioration if left unaddressed. Replacement by a suitably qualified contractor is recommended, as soon as possible.

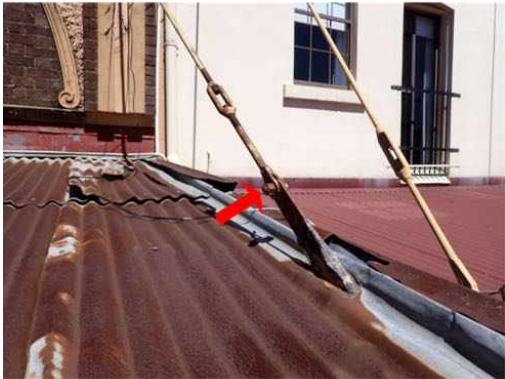
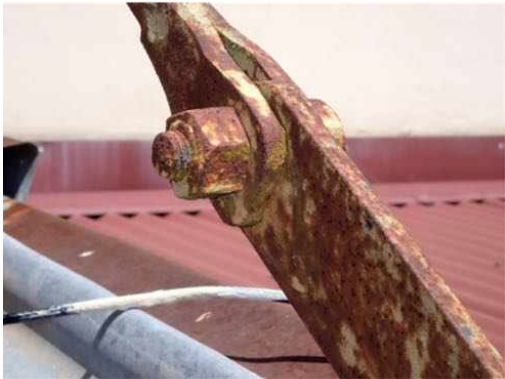
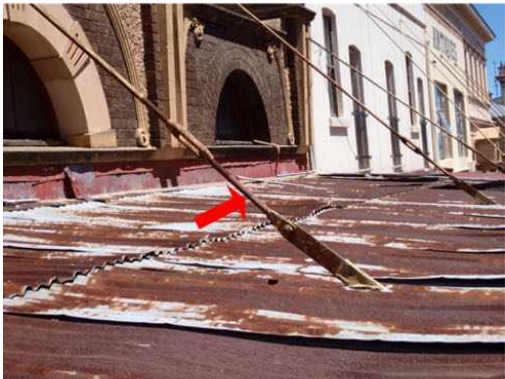
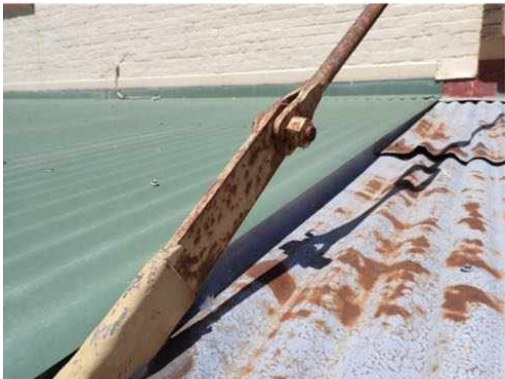
Finding 2.02

Building:	Main Building
Location:	Street awning
Finding:	Steel supports surface rust.
Information:	The steel supports to the street awning were generally in fair condition; however, surface rust was identified. This is a common defect for exposed steel and is typically caused by weather exposure over time. If left untreated, the rust may worsen and lead to further deterioration. Cleaning, treating, and repainting of the affected areas are recommended to help prevent ongoing corrosion. Due to the age of the structure, an inspection by a structural engineer is also recommended to gain a better understanding of the structural integrity of the supports and provide a scope out works if required.

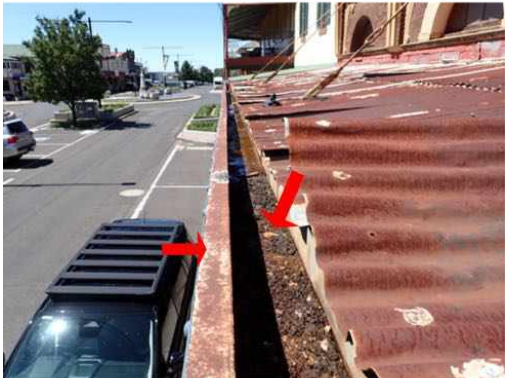
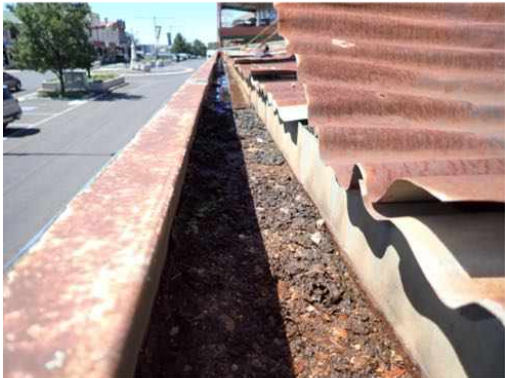
Finding 2.03

Building: Main Building
 Location: Street awning
 Finding: Rust identified to the street awning gutter
 Information: Rust was identified to the street awning gutter. This is a common defect for metal gutters and is typically caused by prolonged exposure to the weather and age-related deterioration. If left unaddressed, the rust may worsen and lead to leaks or failure of the gutter. Repair or replacement by a suitably qualified contractor is recommended.

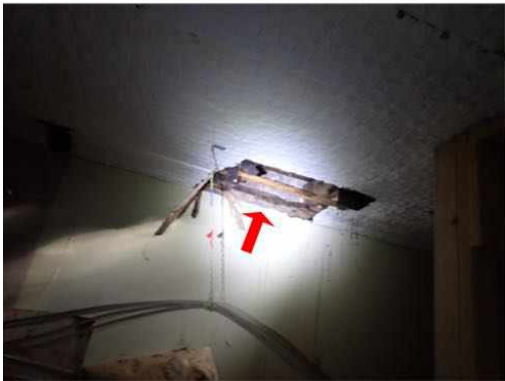
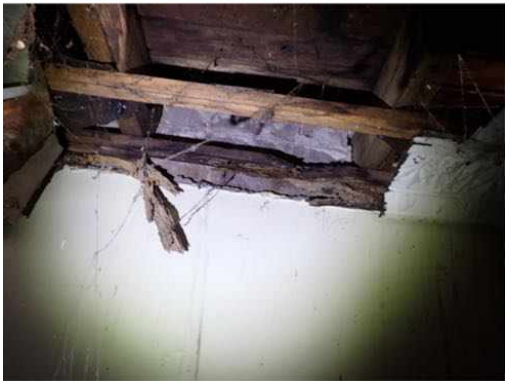
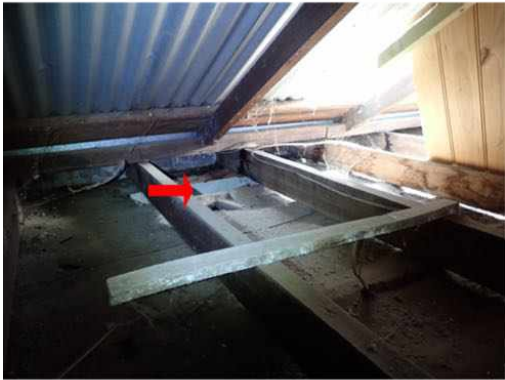
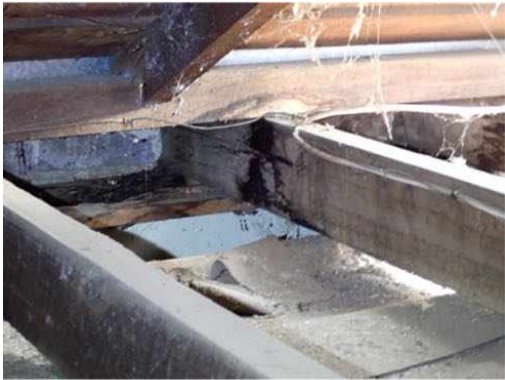
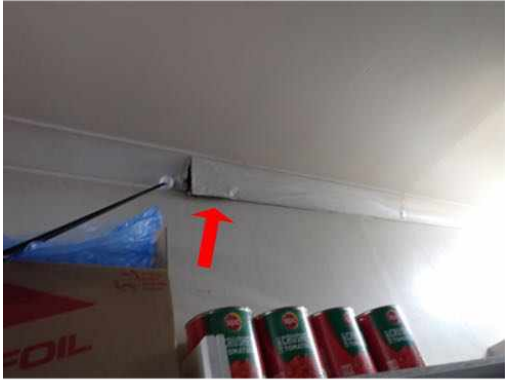
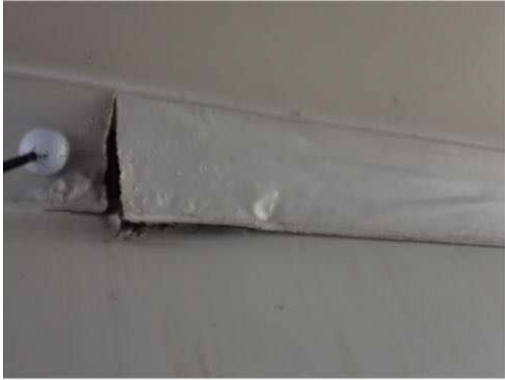
Finding 2.04

Building: Main Building
Location: Ceiling space
Finding: Water damage to ceiling space
Information: Water damage was identified in the ceiling space and to the ceiling cornice below. This is typically caused by a previous roof or plumbing leak. The affected area was dry at the time of inspection, indicating that the leak has likely been repaired. However, residual damage to the ceiling materials remains and may continue to deteriorate over time. Repair of the affected areas is recommended by a licensed builder, plasterer, and painter. If any further leaks are identified, a roof plumber should also be engaged. Ongoing monitoring is advised to ensure no further moisture issues occur.

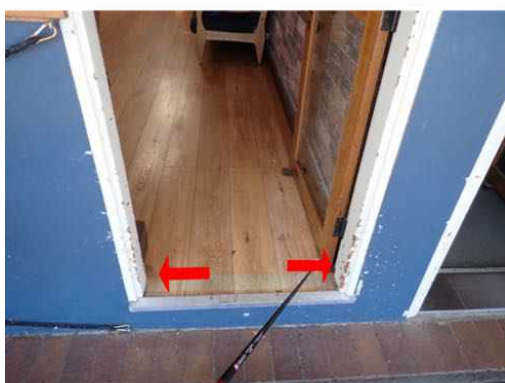
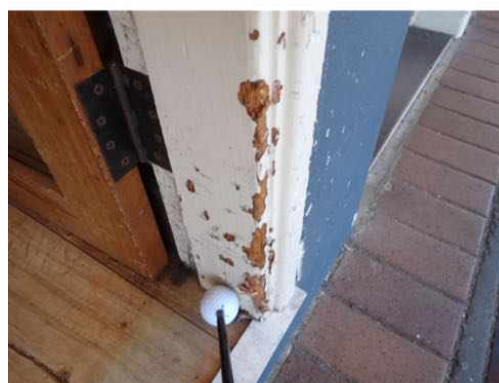
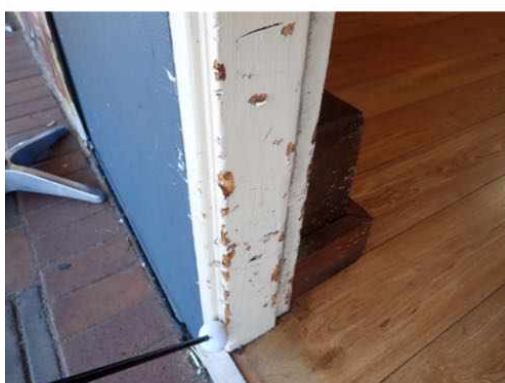
Finding 3.01

Building:	Main Building
Location:	Front entry door
Finding:	Damage to entry door jambs
Information:	Impact-related damage was identified to the front entry door jambs. This is typically caused by accidental knocks, door misuse, or furniture contact. While not considered structurally significant at the time of inspection, the damage is unsightly and may worsen if left unrepaired. Repair or replacement by a suitably qualified carpenter is recommended to restore the appearance and prevent further deterioration.

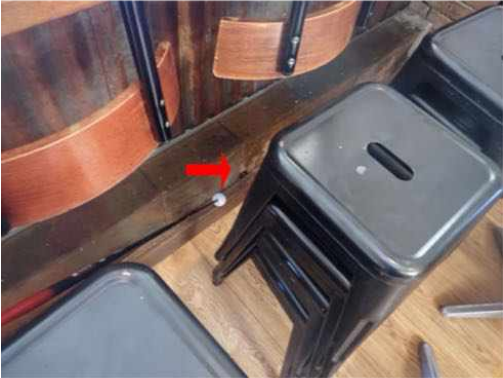
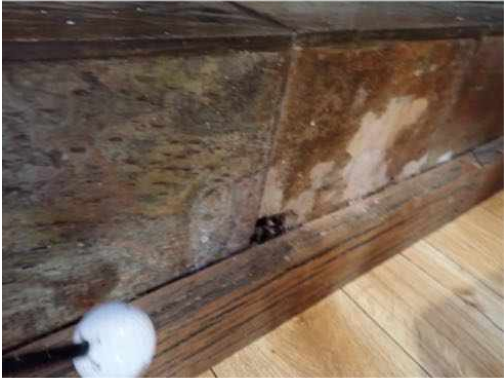
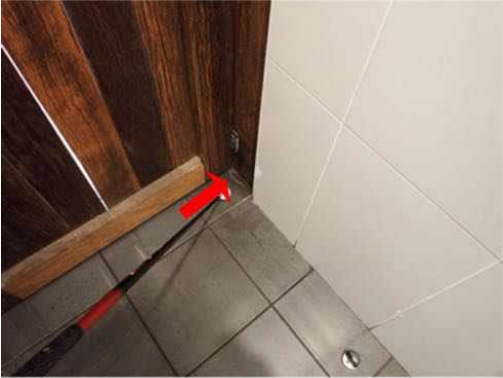
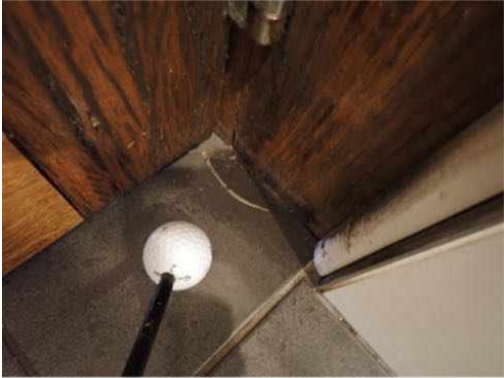
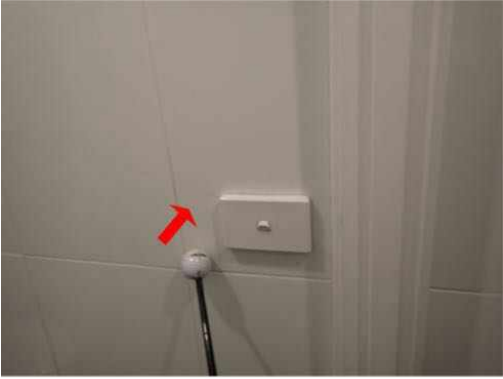
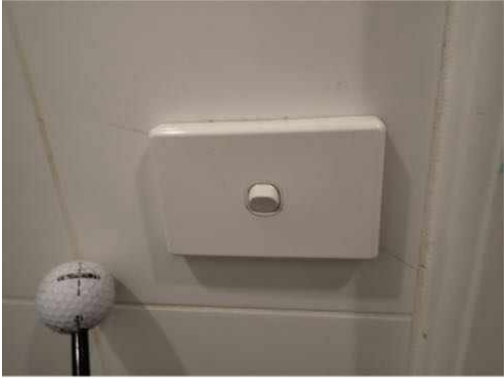
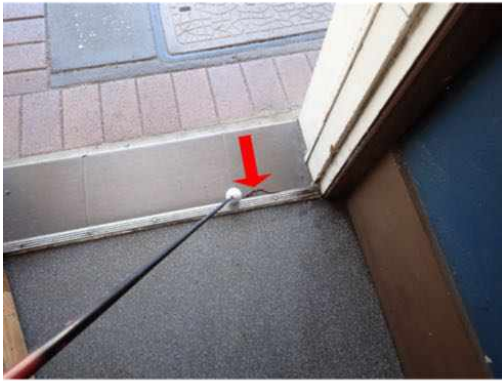
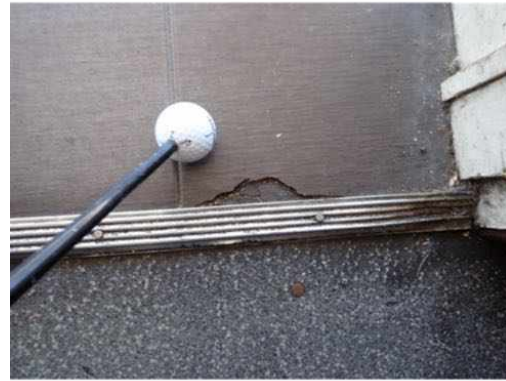
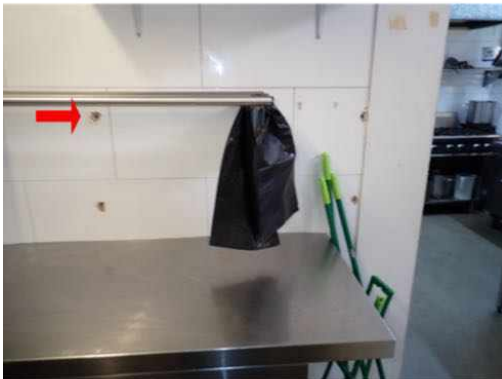
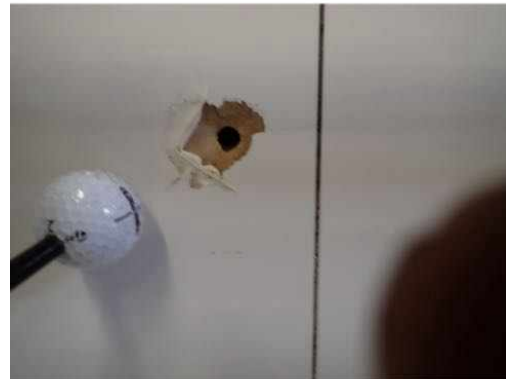
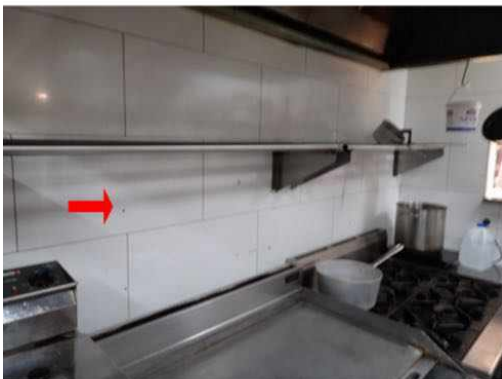
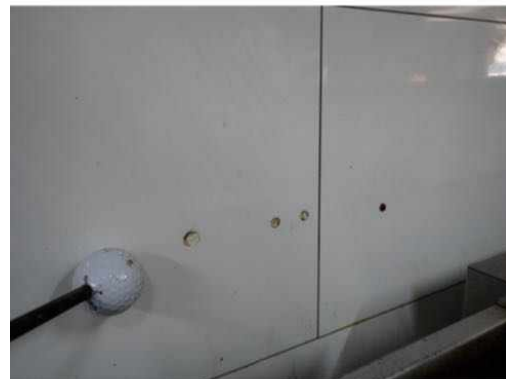
Finding 3.02

Building:	Main Building
Location:	Front entry door, bathroom, kitchen splash back and front bar area.
Finding:	Damaged tiles
Information:	Multiple damaged and cracked tiles were identified at several locations throughout the property. This is a common defect and is typically caused by minor substrate movement, thermal expansion, replacement of previous fixtures or impact damage. While not considered structurally significant at the time of inspection, the damaged

tiles may worsen and allow moisture ingress. Replacement of the affected tiles and ongoing monitoring are recommended, and if further movement is suspected, a tiling contractor should be engaged as deemed necessary.

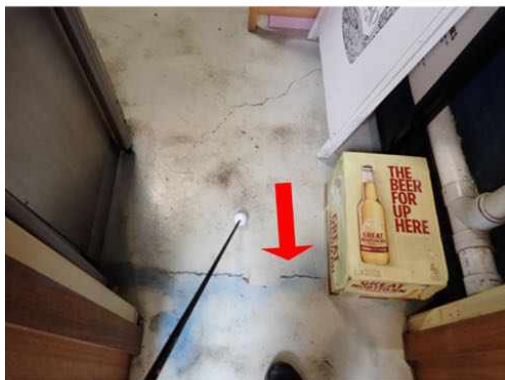
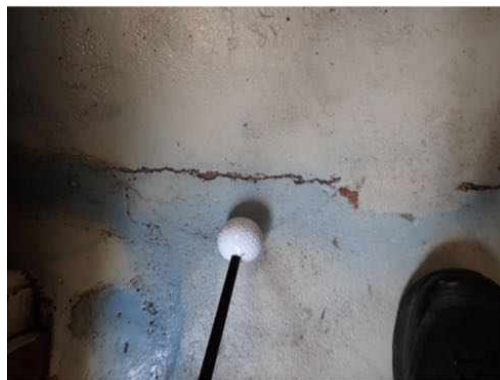
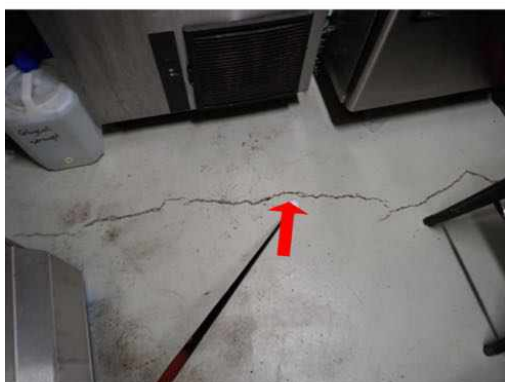
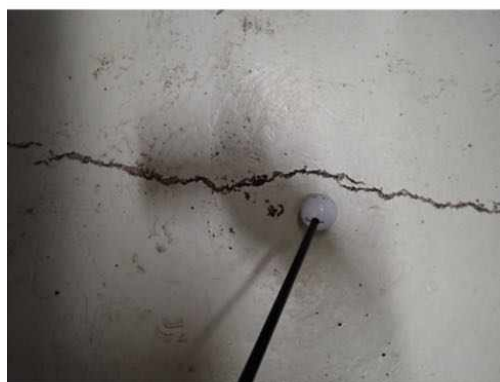
Finding 3.03

Finding: Cracks in store room concrete floor

Information: Cracks were identified in the concrete floor to the store room. This is a common defect for a slab of this age and is typically caused by natural shrinkage and minor ground movement. While not considered structurally significant at the time of inspection, the cracks may worsen over time and allow moisture ingress. Sealing and ongoing monitoring are recommended, and if the cracking increases, a concreting contractor or structural engineer should be engaged as deemed necessary.

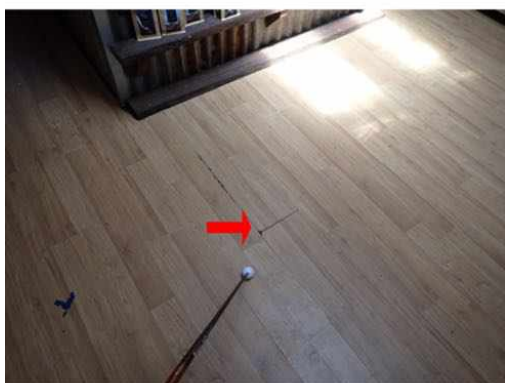
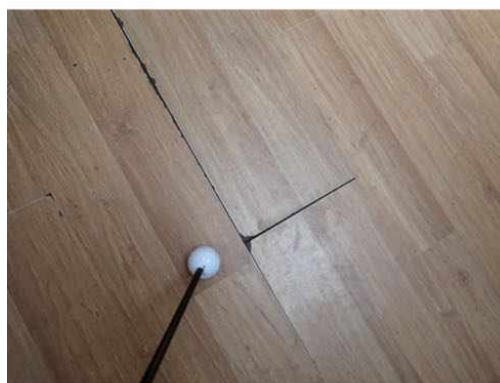
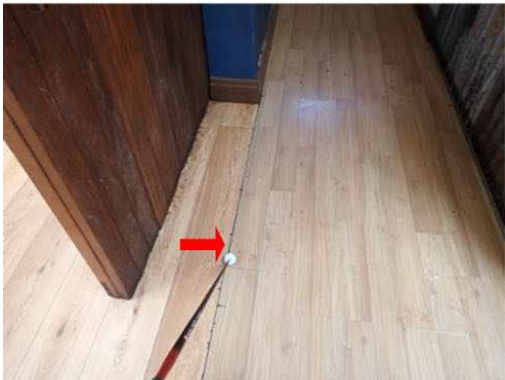
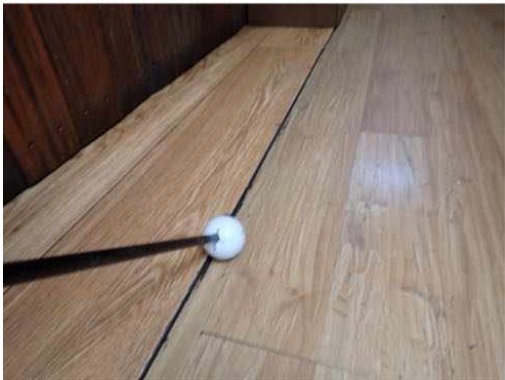
Finding 3.04

Building:	Main Building
Location:	Timber look flooring
Finding:	Flooring fair condition
Information:	The timber look flooring was generally in fair condition; however, some areas showed signs of wear from general use. This is a common condition for flooring of this age and is typically caused by normal foot traffic and everyday use. While not considered structurally significant, the worn areas affect the overall appearance. Ongoing monitoring is recommended, and repair or replacement can be carried out at the owner's discretion.

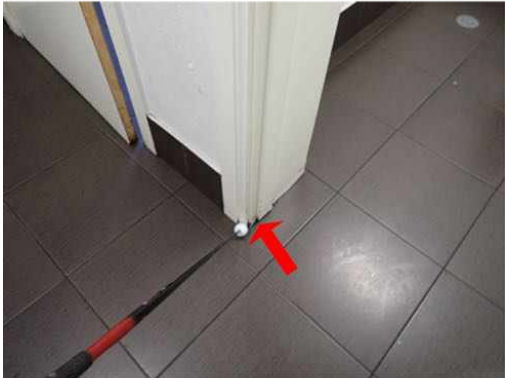
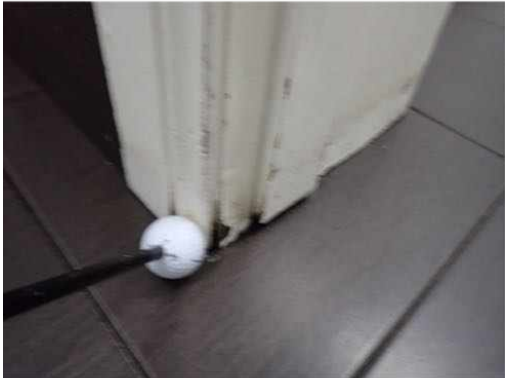
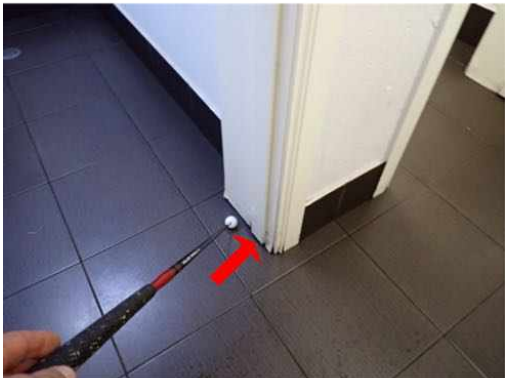
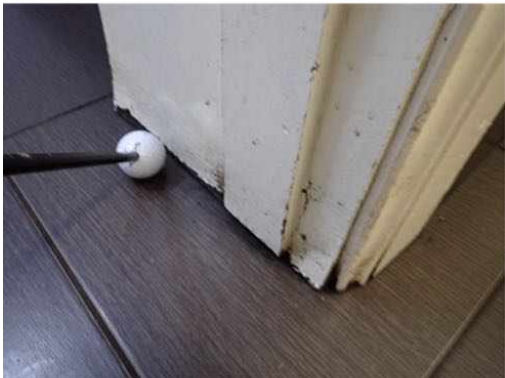
Finding 3.05

Building: Main Building
Location: Bathrooms
Finding: Door jambs swollen at bottom
Information: The MDF door jambs to the bathroom were swollen at the bottom. This is a common defect in wet areas and is typically caused by prolonged moisture exposure and poor moisture resistance of MDF materials. While not considered structurally significant at the time of inspection, the damage may worsen if moisture continues to be present. Repair or replacement with a more moisture-resistant material is recommended, along with addressing any sources of moisture ingress.

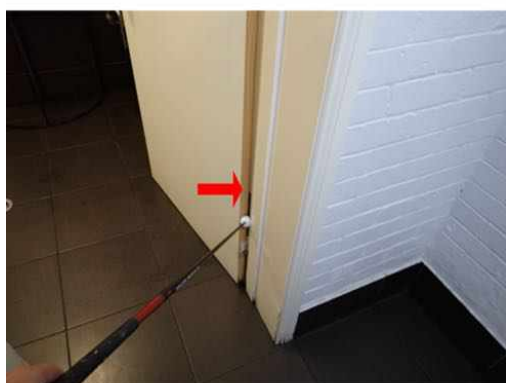
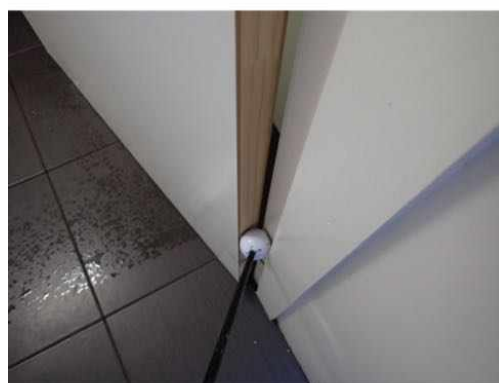
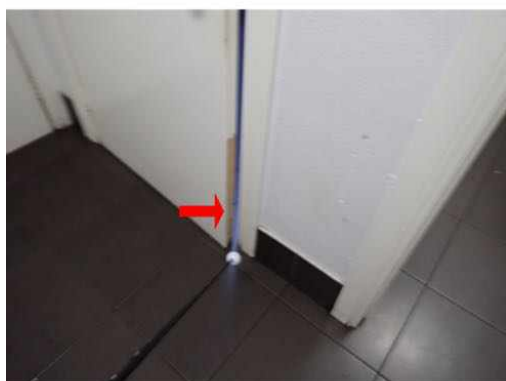
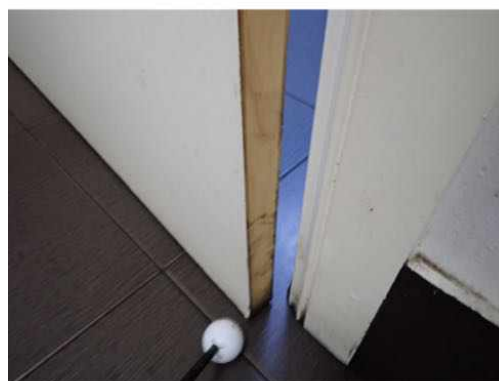
Finding 3.06

Building:	Main Building
Location:	Bathrooms
Finding:	Unpainted door ends
Information:	Unpainted door ends were identified to the bathroom doors. This is a common defect and is typically caused by incomplete finishing during installation or previous maintenance works. Unpainted timber is more susceptible to moisture absorption in wet areas, which may lead to swelling or deterioration over time. Painting and sealing of the door ends are recommended to help prevent moisture damage.

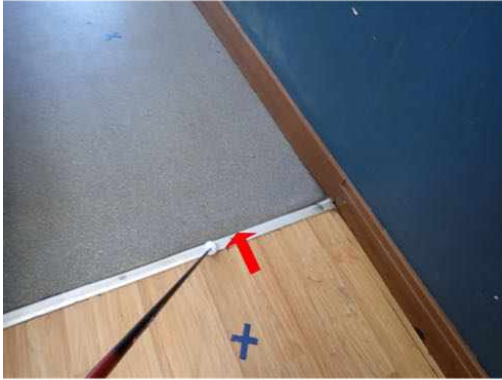
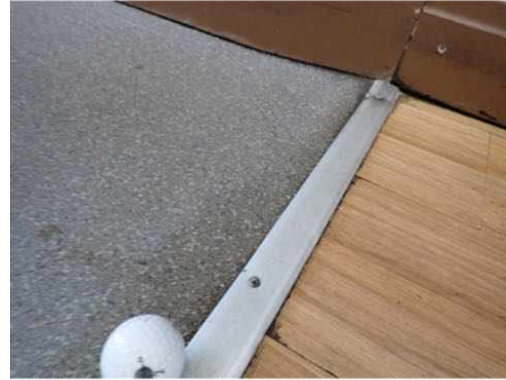
Finding 3.07

Building:	Main Building
Location:	Main entry ramp
Finding:	Vinyl flooring minor delaminating at end of ramp
Information:	The vinyl flooring at the end of the ramp was found to be delaminating. This is a common defect and is typically caused by moisture exposure, poor adhesion, or general wear over time. While not considered structurally significant at the time of inspection, the delaminated vinyl may worsen and could present a trip hazard. Repair or replacement by a suitably qualified flooring contractor is recommended.

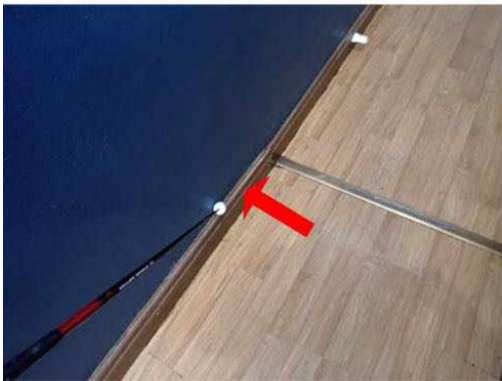
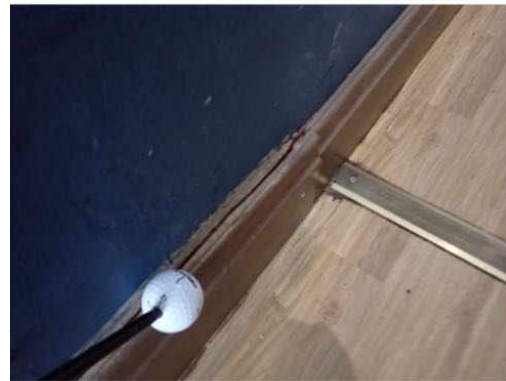
Finding 3.08

Finding: Timber skirting poor condition.

Information: The timber skirting to several locations throughout the property was found to be in poor condition. This is typically caused by general wear and tear, impact damage, and possible moisture exposure over time. The condition of the skirting may worsen if left unaddressed and detracts from the overall appearance. Repair or replacement by a suitably qualified carpenter or handyman is recommended.

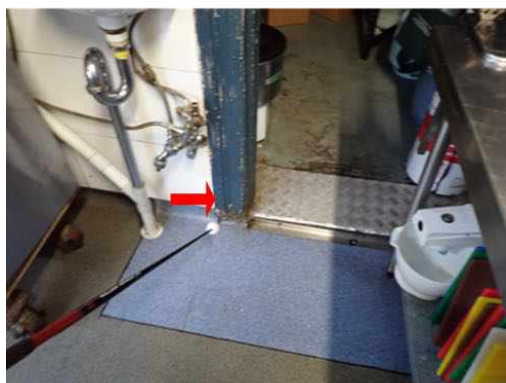
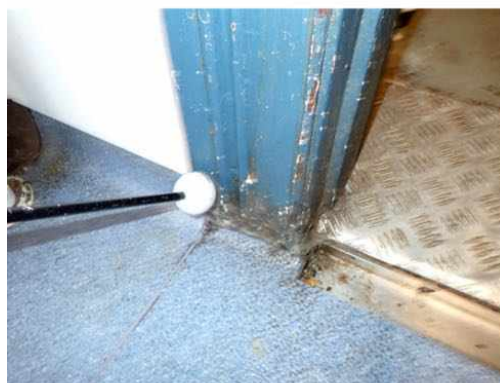
Finding 3.09

Finding: Door jamb store room poor condition

Information: The door jamb to the store room was found to be in poor condition. This is typically caused by general wear and tear, impact damage, and possible moisture exposure over time. If left unaddressed, the condition of the jamb may worsen and further detract from the overall appearance. Repair or replacement by a suitably qualified carpenter or handyman is recommended.

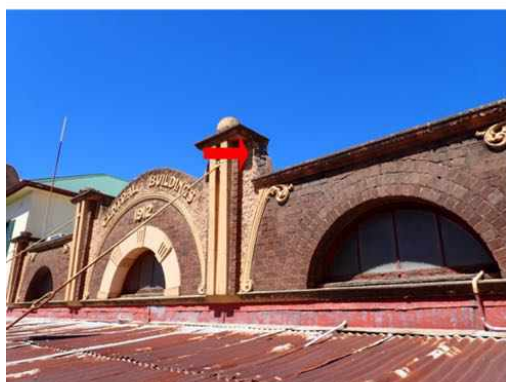
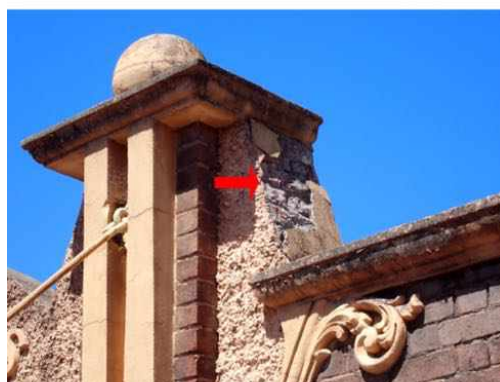
Finding 3.10

Building:	Main Building
Location:	Front elevation above street awning
Finding:	Damaged render
Information:	Damaged render was identified to the wall above the street awning. This is typically caused by weather exposure, impact damage, or age-related deterioration. If left unaddressed, the damage may worsen and allow moisture ingress into the underlying structure. Repair by a suitably qualified renderer or handyman is recommended.

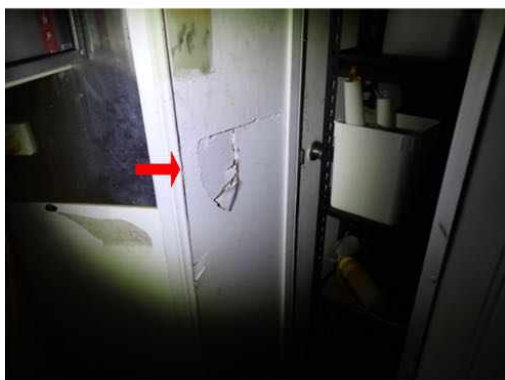
Finding 3.11

Building:	Main Building
Location:	Store room
Finding:	Store room cladding damage identified
Information:	Damage was identified to the internal cladding of the store room. This is typically caused by impact damage, general wear and tear, or previous use of the space. If left unaddressed, the damage may worsen and detract from the overall condition of the room. Repair by a suitably qualified contractor or handyman is recommended.

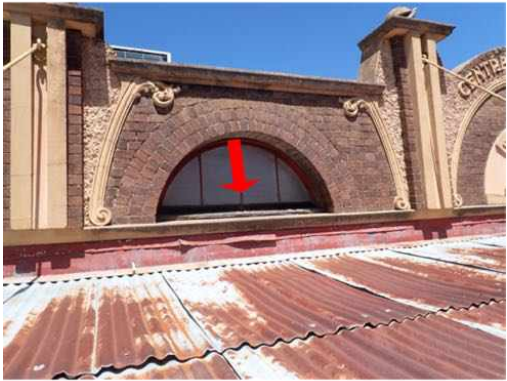
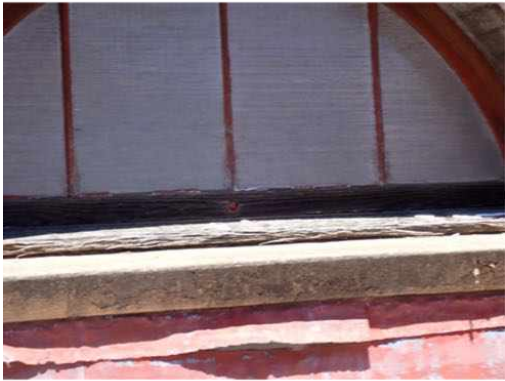
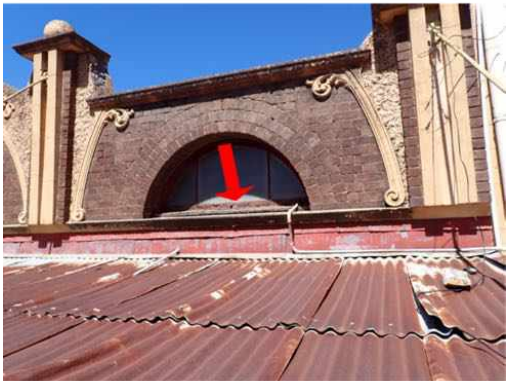
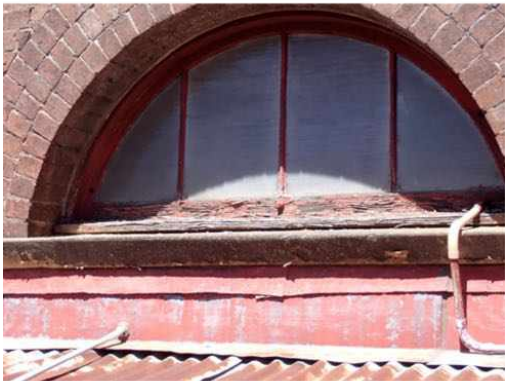
Finding 7.01

Building:	Main Building
Location:	Front elevation
Finding:	Wood rot front elevation windows
Information:	Wood rot was identified to the front elevation windows located above the street awning. This is typically caused by prolonged moisture exposure, poor sealing, and age-related deterioration of the timber. If left unaddressed, the rot may worsen and lead to further deterioration of the window frames and surrounding building materials. Repair or replacement by a suitably qualified carpenter is recommended, along with addressing any sources of moisture ingress.

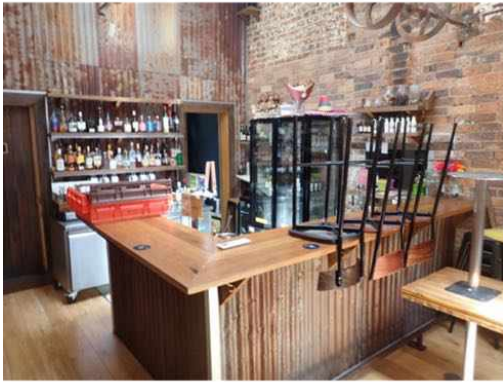
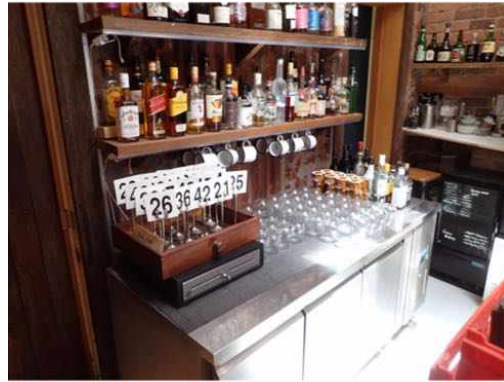
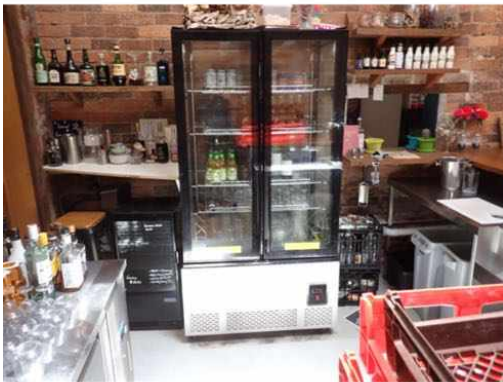
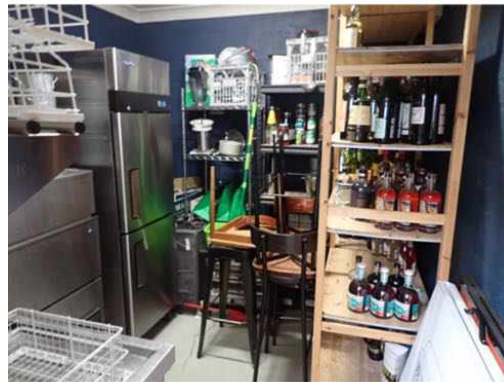
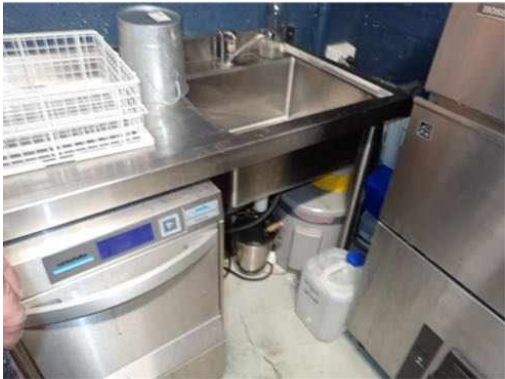
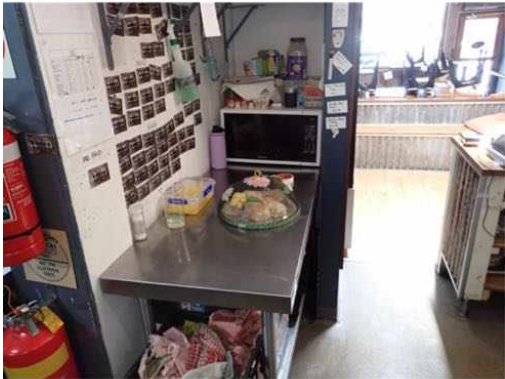
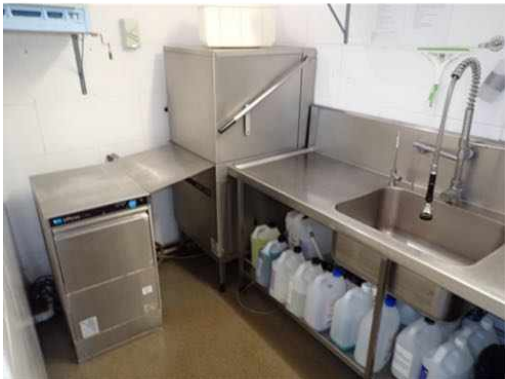
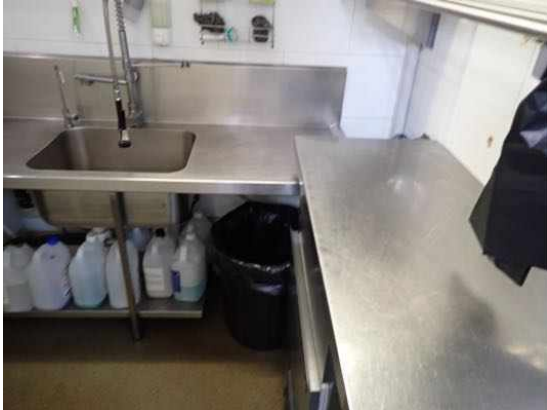
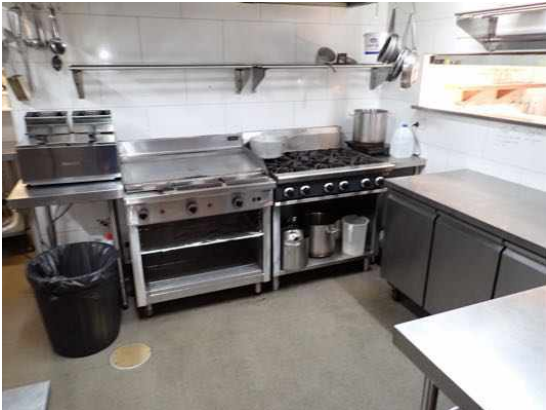
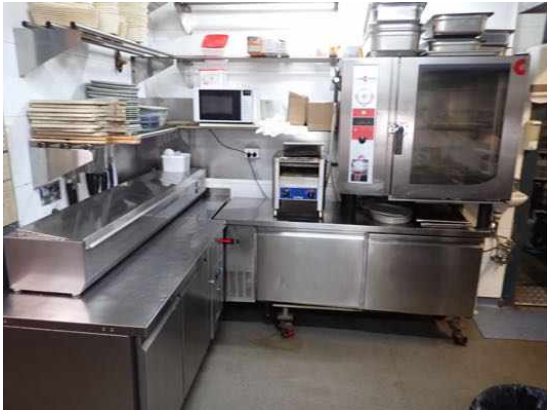
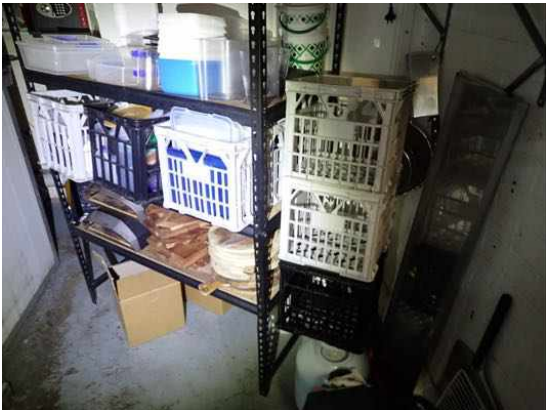
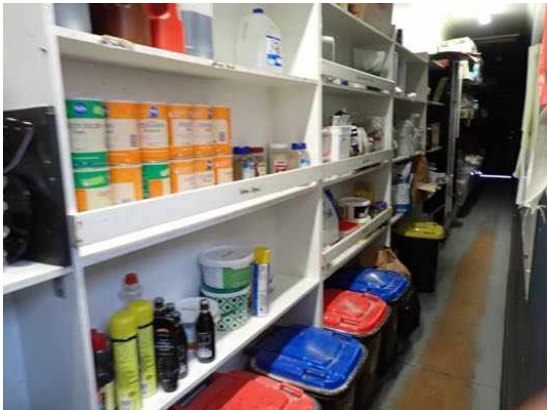
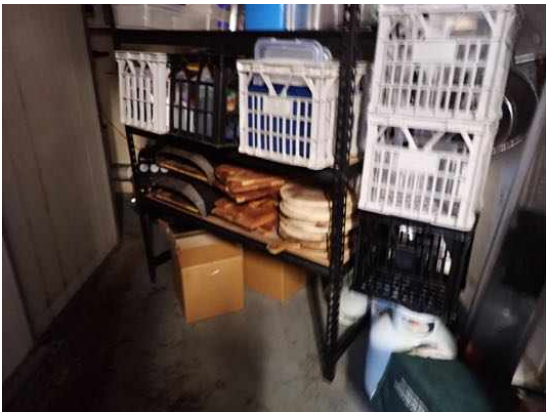
Building: Main Building
Location: All Areas
Finding: Additional Photos - Obstructions and Limitations
Information: These photographs are an indication of the obstructions and limitations which impeded full inspection of the area at the time of inspection. These obstructions can hide an array of defects and should be removed to allow full inspection to be carried out. A re-inspection is recommended once the areas are made accessible.
