Building and Timber Pest Inspection Report

Inspection Date: Fri, 16 Jan 2026

Property Address: 34 Currawong Street, Ingleburn NSW 2565

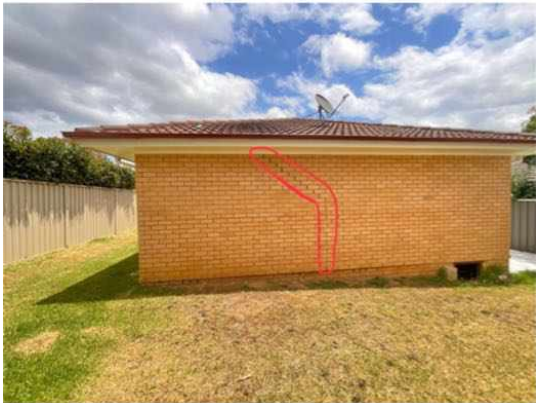
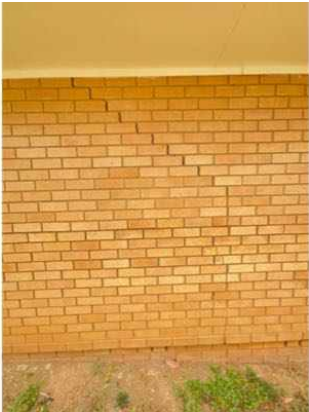
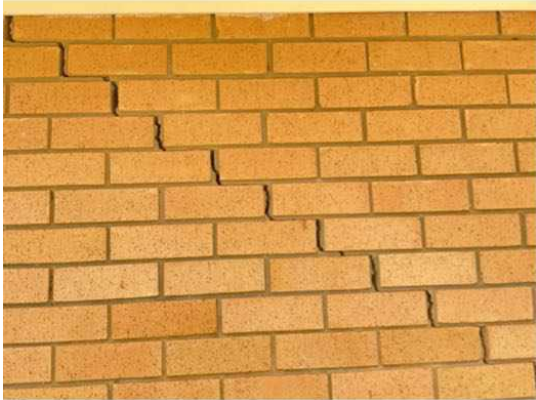
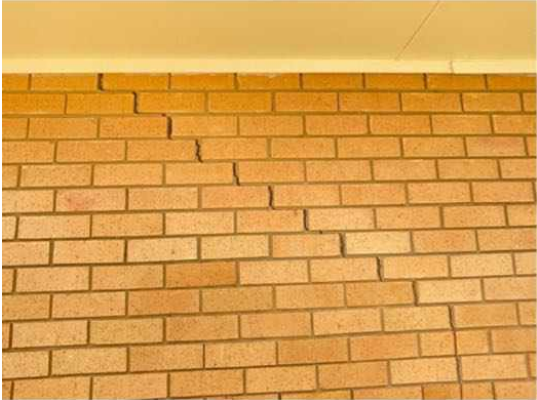
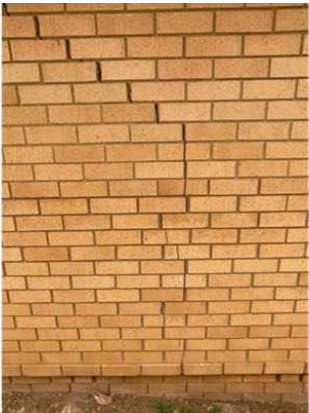
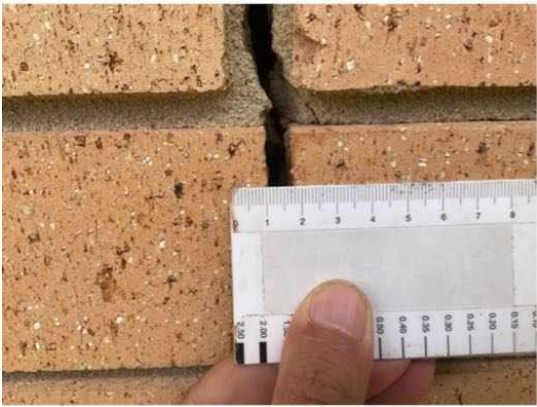
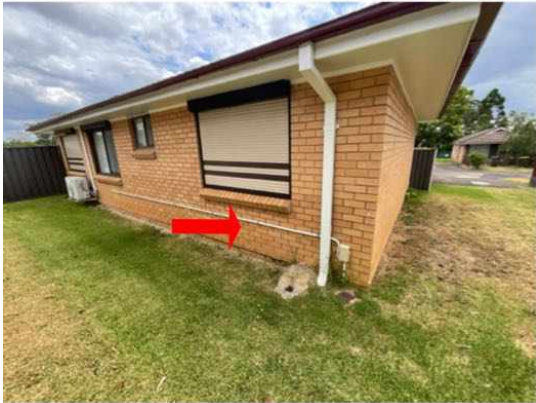
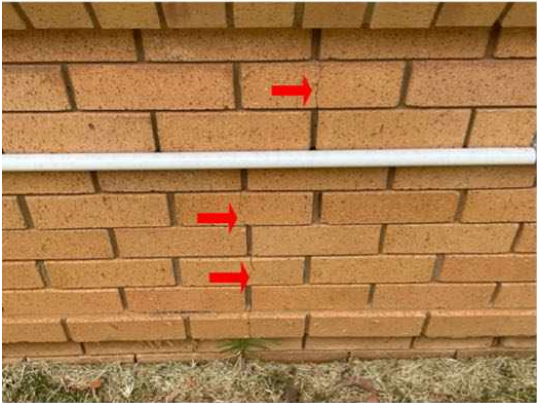
Building:	Main Building
Location:	Exterior walls - Rear right
Finding:	Major Defect – Significant Cracking and Potential Subsidence
Information:	Observation:

During the inspection, major cracking was identified to the rear wall of the building. Hairline cracks were also noted along the left and right sides of the property. The right rear corner of the building shows evidence of movement or potential subsidence, with the brickwork in this area exhibiting cracking consistent with structural movement.

The cracks observed are more extensive than typical cosmetic or shrinkage cracking and are likely associated with movement of the building elements. While minor cracking can occur naturally as a building settles over time, the severity, location, and pattern of the cracking in this instance indicate a potentially serious structural issue.

The pattern and severity of cracking, combined with evidence of differential movement at the rear right corner, strongly suggests that the structure may have been affected by foundation movement, commonly referred to as subsidence. General subsidence is often initiated by changes in soil moisture content, including drying or saturation of the soil beneath the building.

Given the combination of significant cracking, evidence of structural movement, and ongoing moisture issues, this condition represents a major defect with the potential to compromise the structural integrity of the building. Immediate attention is required to fully understand the extent and cause of the movement and to prevent further deterioration or safety risks.

Major Defect – Significant cracking, evidence of structural movement, and potential subsidence pose a serious risk to the structural integrity of the building and represent a critical concern in a pre-purchase context. Immediate investigation and remediation are strongly recommended prior to acquisition.

- Engage a structural engineer to assess the building and determine the cause, extent, and severity of the movement. The engineer should provide a detailed scope of remedial works.
- Consultation with a geotechnical engineer may be necessary if soil moisture changes or ground movement are evident, to provide guidance on soil stabilization or underpinning requirements.
- Remedial works, including underpinning, stabilization, or foundation repair, should be carried out by a registered builder in accordance with the recommendations of the structural engineer.
- Address ongoing moisture issues, including subfloor dampness and drainage improvements, to prevent recurrence of foundation movement.
- A follow-up inspection should be arranged post-remediation to confirm the stability and structural integrity of the building.

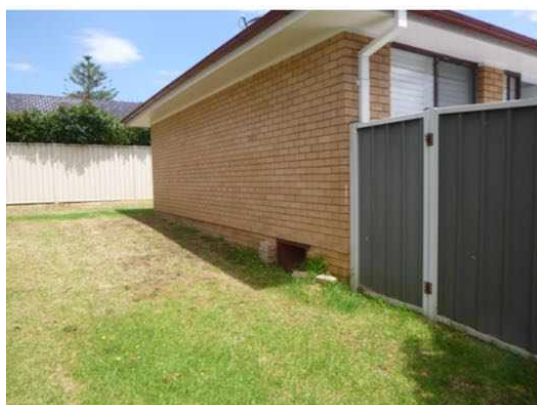
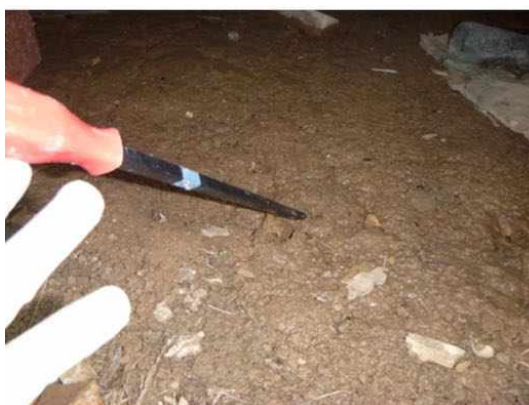
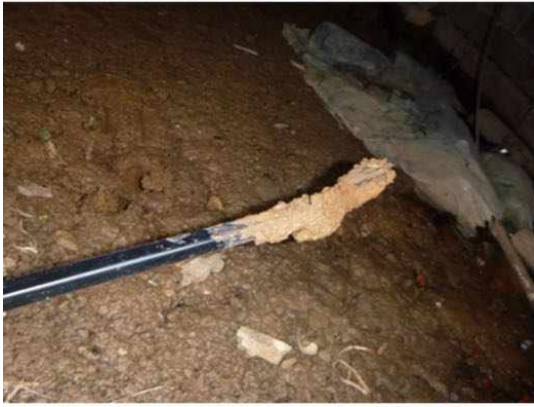
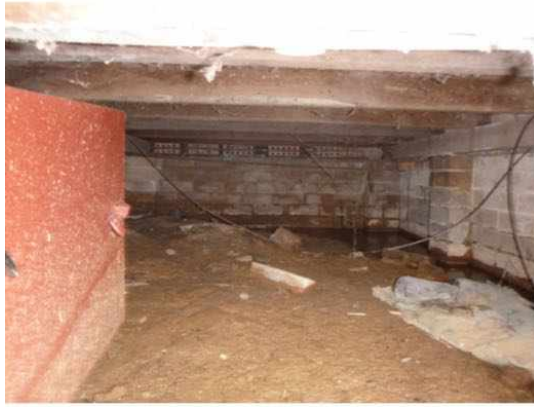
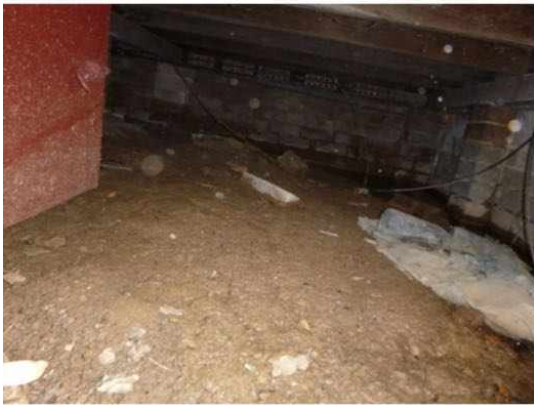
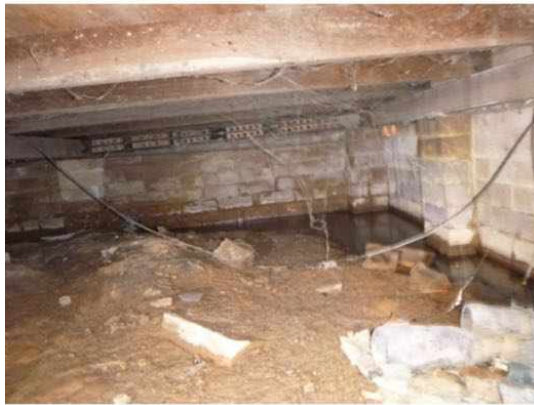
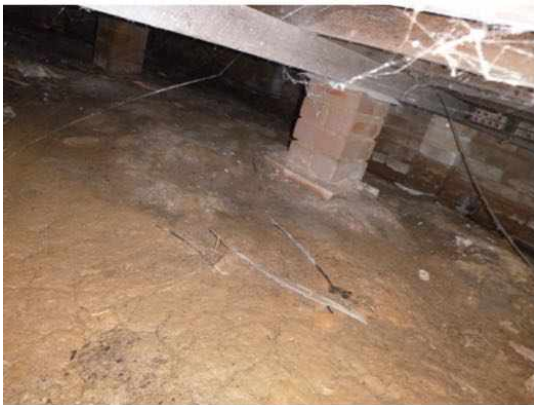
Finding 2.02

Building:	Main Building
Location:	Subfloor
Finding:	Major Defect – Excessive Subfloor Moisture and Inaccessible Subfloor
Information:	Observation:

At the time of inspection, excessive moisture was identified within the subfloor area. Elevated moisture levels and pooling water were present within the soil, creating damp conditions that prevented safe and reasonable access to the subfloor. As a result, the inspection was restricted to observations from the access hatch only, and the majority of the subfloor, including structural timbers and concealed areas, could not be inspected.

Despite the restricted access, visible signs of moisture-related issues were observed to the lower portions of walls in several areas, indicating ongoing water retention beneath the dwelling. These conditions were noted in the absence of recent or significant rainfall, suggesting a persistent moisture issue rather than a temporary weather-related condition.

Major Defect – The presence of excessive subfloor moisture, combined with the inability to safely access and inspect the subfloor, represents a significant risk to the building's structural integrity and durability. This condition has the potential to result in serious and costly damage if left unresolved.

- Engage a suitably qualified drainage contractor or builder to investigate and rectify the source of subfloor moisture as a matter of urgency.
- Improve site drainage and stormwater management to prevent water accumulation beneath the dwelling.
- Increase subfloor ventilation and clearance where practicable to promote drying and reduce moisture levels.
- Once conditions are remediated and safe access is available, arrange a comprehensive follow-up subfloor inspection, including a timber pest inspection, to assess the condition of all structural timbers and concealed areas prior to purchase.

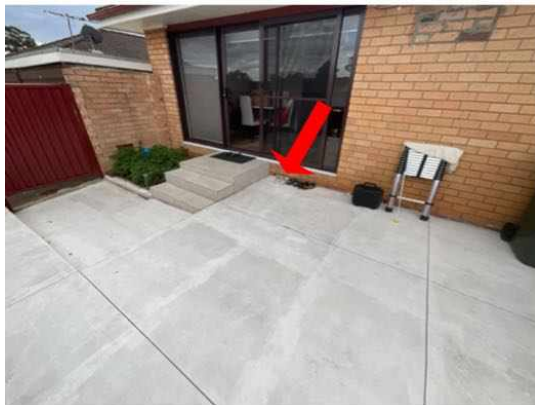
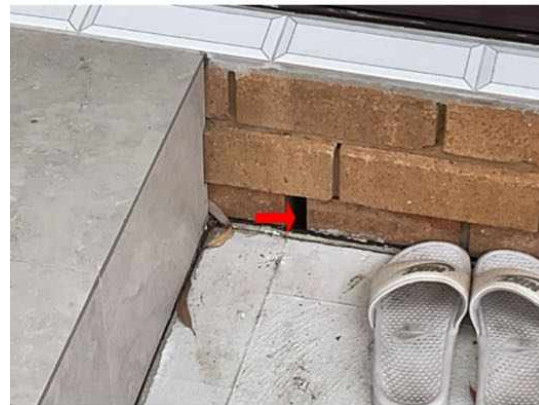
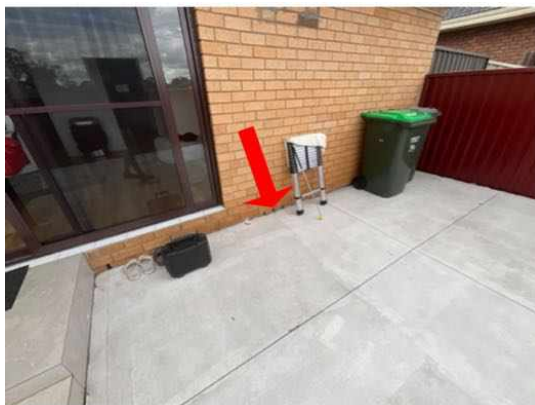
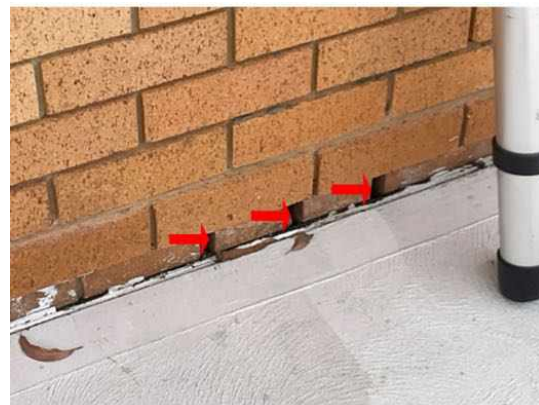
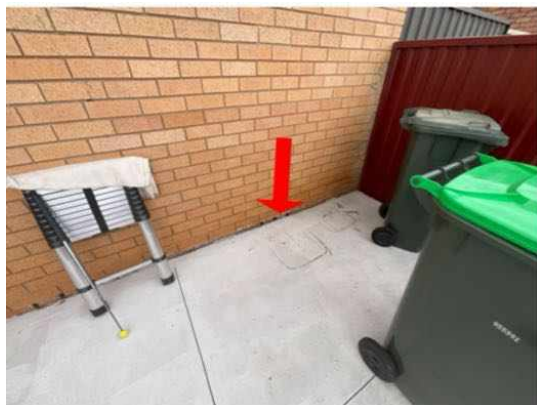
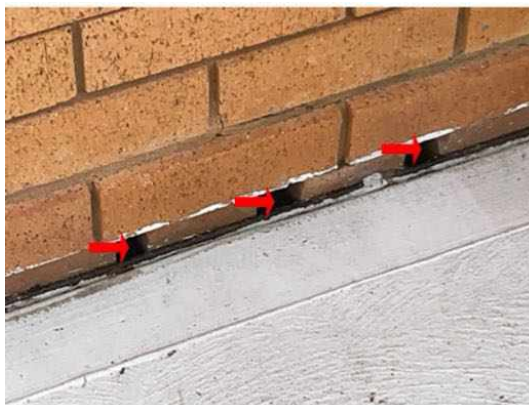
Finding 3.01

Building: Main Building
Location: Exterior walls - front
Finding: Subfloor ventilation - Too low.
Information: Subfloor Ventilation and Ground Levels – Moisture Risk
Observation

Subfloor wall vents in the inspected locations were found to be positioned too low due to substandard external landscaping and concrete levels increasing the likelihood that rainwater can enter the subfloor via the vents during wet conditions.

Ongoing moisture ingress into the subfloor can result in persistently elevated moisture levels. If left unrectified, these conditions may promote fungal growth, timber decay, deterioration of mortar and brickwork, and cracking or subsidence of supporting piers. Elevated moisture levels also increase the susceptibility of the property to termite and other timber pest activity. Secondary water damage is likely to occur over time if the issue remains unmanaged.

Perimeter landscaping and ground levels should be rectified to ensure adequate fall away from the building. As a general guide, paved surfaces should fall away from the structure by a minimum of 25 mm over the first metre, and bare ground should fall away by approximately 50 mm over the first metre. This will assist in preventing moisture from pooling against the building and entering the subfloor.

Where site drainage is inadequate or rectification is complex, a qualified plumber and landscaping contractor should be engaged to further assess the site and undertake appropriate remedial works to achieve and maintain a dry subfloor environment.

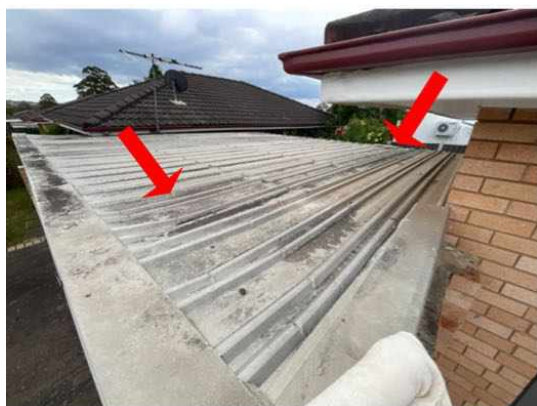
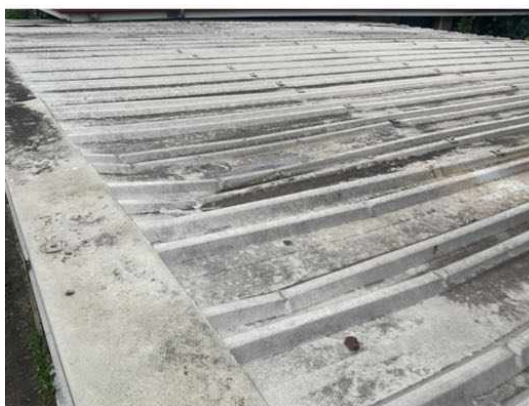
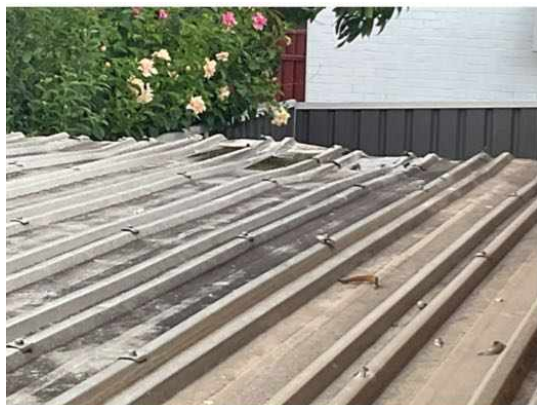
Finding 3.02

Building:	Carport
Location:	Roof Exterior
Finding:	Roof sheets - Water pooling.
Information:	Observation

Sections of the exterior roof exhibit inadequate drainage, with visible water pooling on the roof sheets at the time of inspection. This condition is commonly associated with insufficient roof plumbing capacity and/or roof structures that do not achieve effective falls due to the original construction method.

Persistent water ponding accelerates corrosion and deterioration of the affected roof sheets. If left unaddressed, this is likely to result in premature failure of the roofing material, water ingress, and the potential need for extensive and costly repair or replacement works.

A qualified roofing plumber should be engaged as soon as practicable to assess the roof drainage system and provide appropriate rectification measures. Depending on findings, additional works to address underlying structural or design deficiencies may also be required to ensure adequate roof drainage and long-term performance.

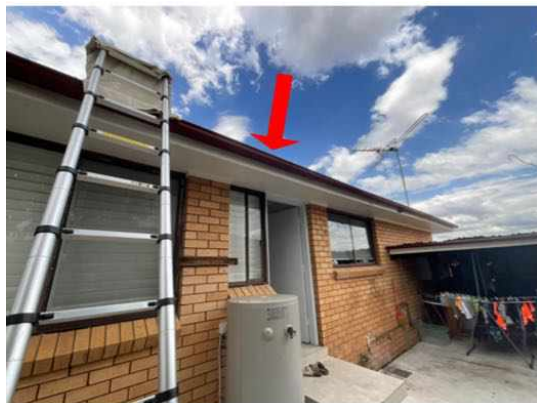
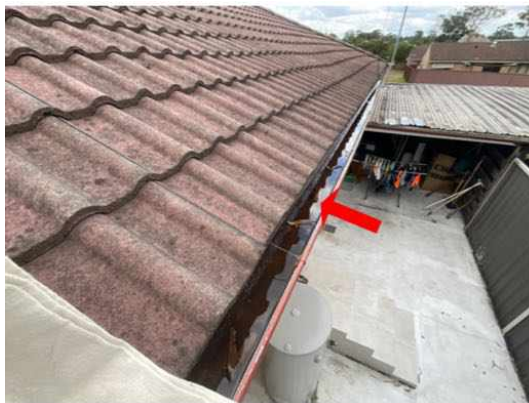
Finding 3.03

Building:	Main Building
Location:	Roof Exterior
Finding:	Roof gutter - Insufficient fall or angle
Information:	It was identified that there is insufficient fall or angle in the roof gutter which is leading to pooling of water.

The angle of the roof gutter is insufficient to facilitate the effective drainage of rain water to the roof plumbing system. Over time, if this defect is not addressed, further deterioration will develop.

Such defects are likely to include or lead to material deterioration, leaks and/or corrosion of associated building materials.

Consultation with a roofing plumber is recommended to reinstate the roof gutter.

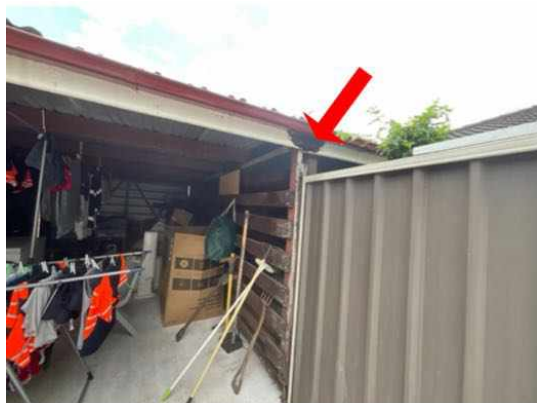
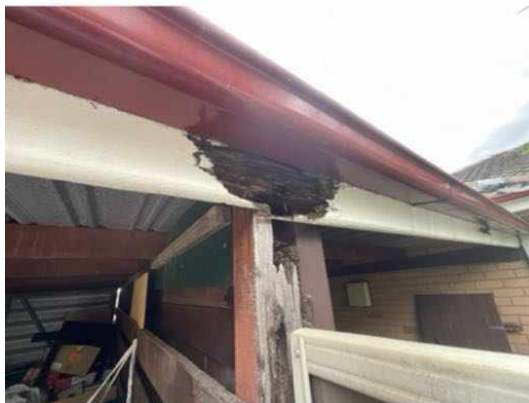
Finding 3.04

Building:	Carport
Location:	Roof Exterior
Finding:	External Timber – Wood Rot (Fungal Decay).
Information:	Observation:

Evidence of wood rot (fungal decay) was identified in some external timber building elements during the inspection. This condition typically arises when timber or other cellulose-based materials are exposed to persistent moisture, creating favourable conditions for fungal growth and structural breakdown.

In this instance, the decay is likely the result of frequent exposure to rain and weathering, particularly in areas where timber appears unsealed, poorly protected, or inadequately maintained.

- It is recommended that all damaged or decayed timber elements be promptly repaired or replaced to prevent further deterioration.
- A qualified carpenter should be engaged to assess the full extent of the damage and undertake all necessary remedial works.
- Ongoing maintenance, including sealing, painting, or treating exposed timbers, is advised to prolong the service life of both affected and adjacent building components.

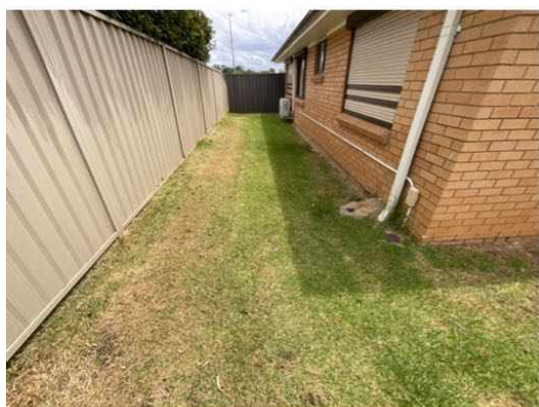
Finding 3.05

Building: Yard
 Location: Yard - Right Side
 Finding: Site/Yard Drainage – Below Average.
 Information: Defect – Below Average Site Drainage

Site drainage in the inspected areas appears to be below average, with no surface drains observed at the time of inspection. Ground surfaces and paved areas adjacent to the building do not appear to be adequately graded to facilitate effective surface water runoff.

- A licensed plumber and/or landscaping contractor should be engaged to:
 - Evaluate the current site grading and surface runoff conditions
 - Install or upgrade surface water drainage (e.g. strip drains, spoon drains, grated channels) as required
 - Improve grading around the building to ensure water flows away from the structure

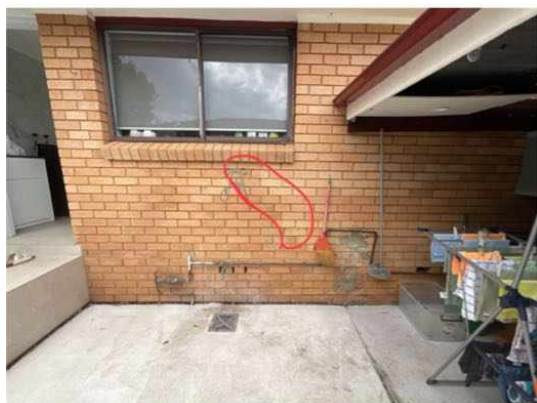
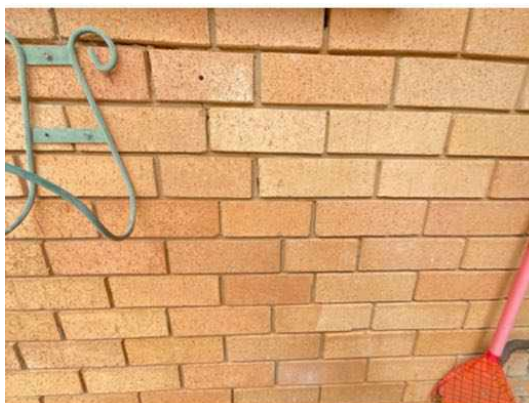
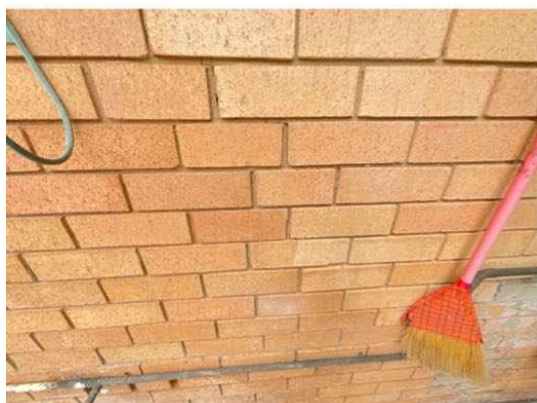
Finding 3.06

Building:	Main Building
Location:	Exterior walls - left side
Finding:	Brickwork - Cracking

Condition: Localised cracking observed

Step cracking was identified in the brickwork in this area at the time of inspection. This form of cracking typically follows the mortar joints in a stepped pattern and is a common indicator of movement in the adjacent footings or wall structure.

Visible mortar failure between the affected bricks further indicates that stresses and tension have developed within the wall.

- For a more detailed assessment, consultation with a qualified Structural Engineer is advised to determine if movement is ongoing and whether any remedial action is necessary

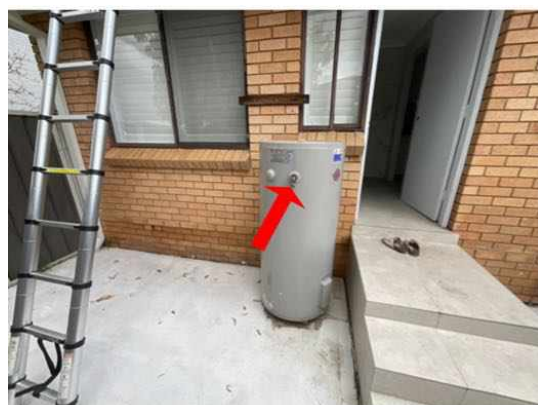
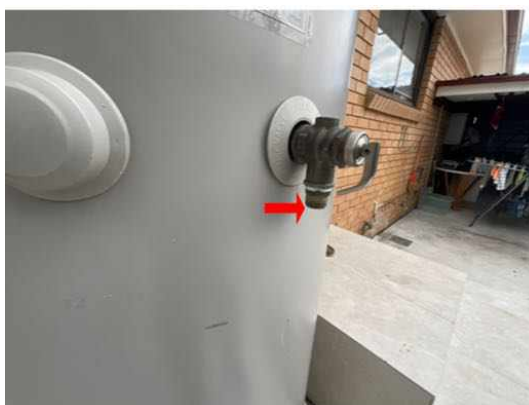
Location: All External Areas
Finding: Overflow Management – Risk of Termite Activity..
Information: Observation: Water Pooling from HWS and Air Conditioning Overflows

Water discharge from the Hot Water System (HWS) pressure relief valve and air conditioning unit overflows was observed discharging close to the base of the structure, contributing to water pooling around the building perimeter.

Persistent moisture near the foundation or subfloor area significantly increases the likelihood of termite activity. Termites are highly attracted to damp environments, and stagnant water near structural elements provides ideal conditions for foraging and infestation.

It is highly recommended that all overflows from the HWS and air conditioning units be redirected away from the building, preferably via fixed drainage or extension piping, to prevent water accumulation near the structure.

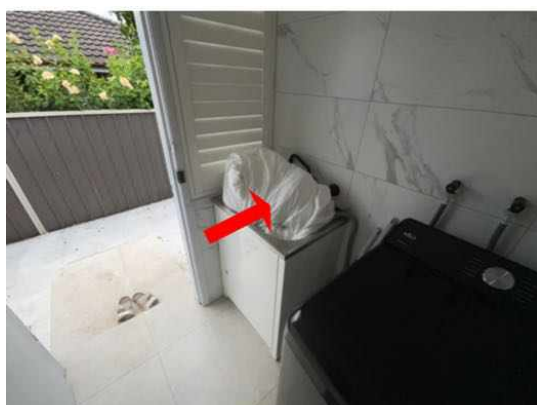
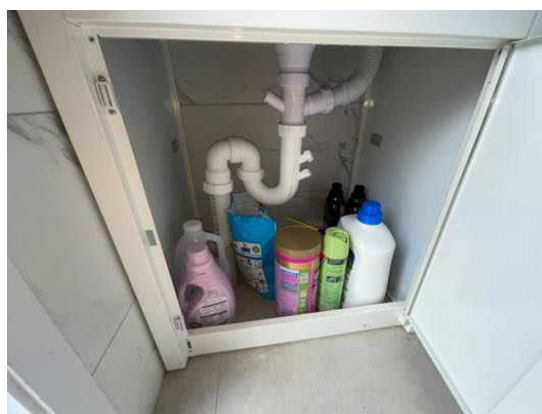
Building: Main Building
 Location: Laundry
 Finding: LaundryTub - Obstructions and Limitations.
 Information: Photographic Evidence – Obstructions & Limitations

It is strongly advised that these obstructions be removed to enable a complete inspection of the affected areas. Once access is granted, a re-inspection—particularly of tap fittings and drainage components—is recommended to ensure no concealed defects or leaks are present.
