Building and Timber Pest Inspection Report

Inspection Date: Wed, 1 Apr 2026

Property Address: 100 Katanna Rd, Wedderburn NSW 2560,
Australia

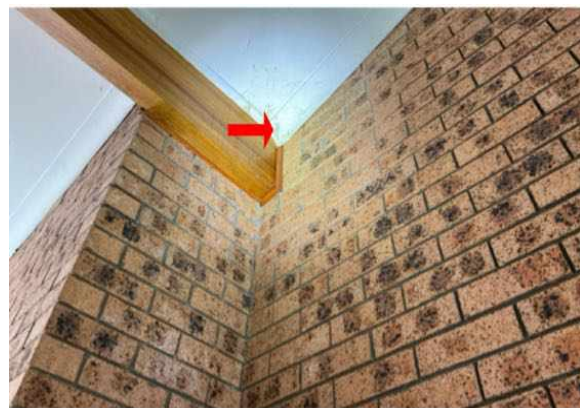
Black mould growth was observed along the cornice adjacent to the chimney in the family room. This condition is typically associated with elevated moisture levels and may indicate water ingress or condensation in the area.

Mould growth can impact indoor air quality and may lead to deterioration of surrounding building materials if left unaddressed. It is recommended that the source of moisture identified and reported in this report is rectified, and that the affected area be cleaned and treated by a qualified professional. Ongoing monitoring is advised to ensure the issue does not reoccur.

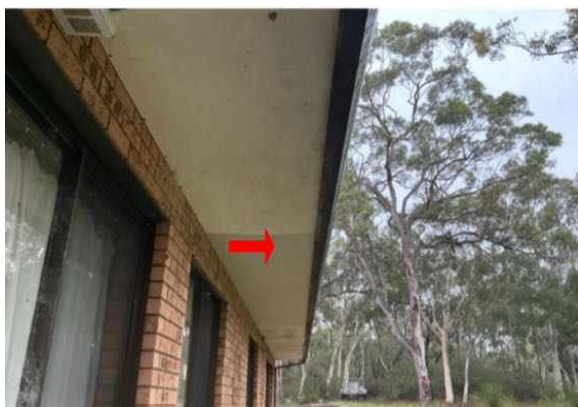
Finding: Gutters Insufficient Downpipes / Eaves Water Damage
 Information: During the inspection, the guttering system was found to have an insufficient number of downpipes, and water damage was observed to the eaves.

Insufficient downpipes can lead to gutter overflow during rainfall, which may result in water ingress into the eaves and surrounding building elements. Prolonged moisture exposure in these areas can contribute to material deterioration and create conditions conducive to termite activity.

It is recommended that a qualified roof plumber be engaged to assess the guttering system and install additional downpipes as required. Any damaged eaves linings should be repaired or replaced following rectification of the drainage issues.

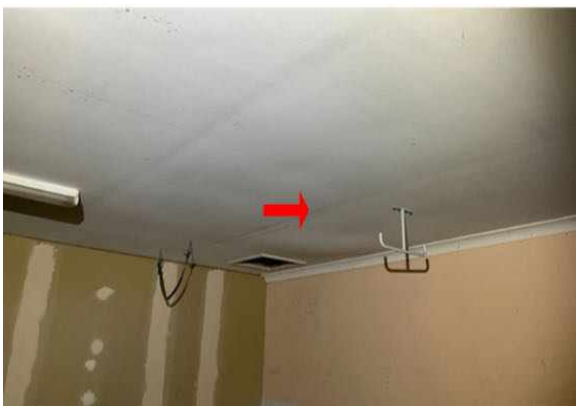
Finding 3.03

Building: Main Building
 Location: Garage
 Finding: Garage Ceiling Water Damage
 Information:

Old water damage was observed to the garage ceiling. The area appears to have been previously affected; however, the cosmetic repairs remain incomplete.

While the source of the issue may have been addressed, it is recommended that the ceiling be repaired and finished by a qualified tradesperson. The area should also be monitored during rainfall to ensure no ongoing water ingress is present.

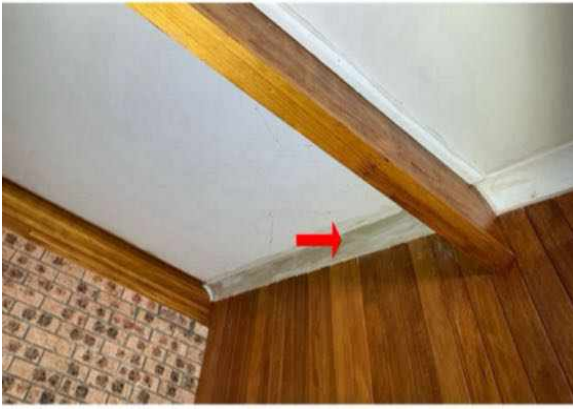
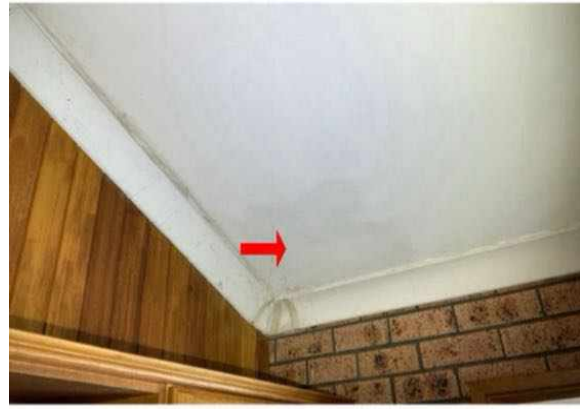
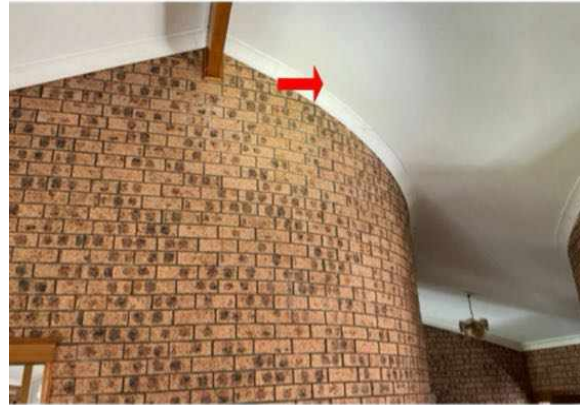
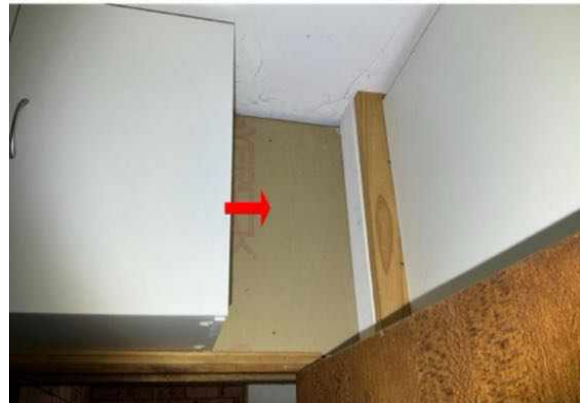
Finding 3.04

Building:	Main Building
Location:	All Areas
Finding:	Cosmetic Paint Defects
Information:	Incomplete paint coverage, minor surface blemishes, over-painting, inconsistent finishes, and colour variations were observed during the inspection. These conditions are generally considered cosmetic in nature and are commonly found in residential properties. Such irregularities may become more noticeable under certain lighting conditions while appearing less evident in lower light environments.

Rectification of these items is considered routine maintenance. To achieve a consistent appearance and improved finish, it is recommended that a qualified painter be engaged to prepare and repaint the affected areas, thereby enhancing both the visual presentation and long-term durability of the painted surfaces.

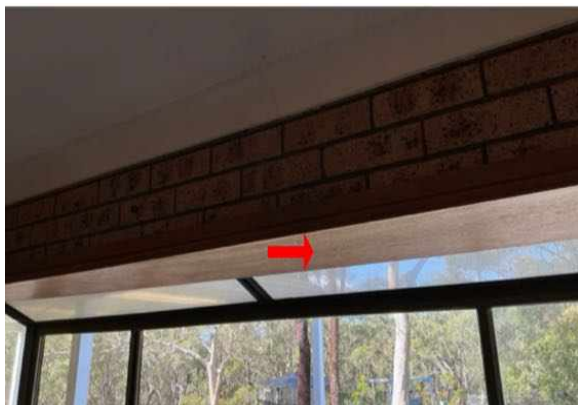
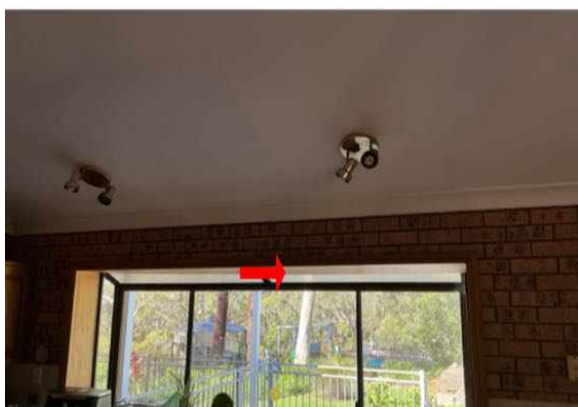
The window reveal was observed to be twisted, which may be due to prolonged sun exposure, material movement, or inadequate fixing.

This condition may affect the alignment and finish of the window and, if left unaddressed, could lead to further distortion or gaps. It is recommended that a qualified tradesperson assess the reveal and carry out any necessary adjustments or repairs to restore proper alignment and finish.

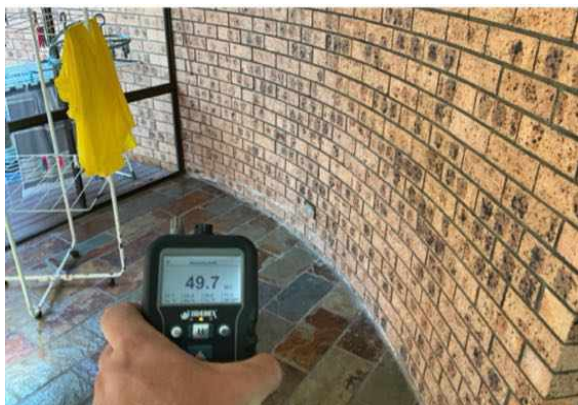
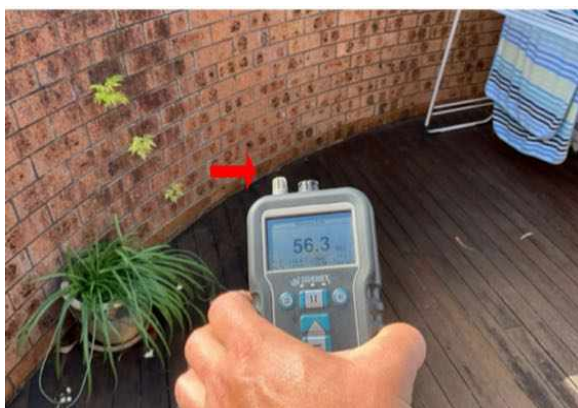
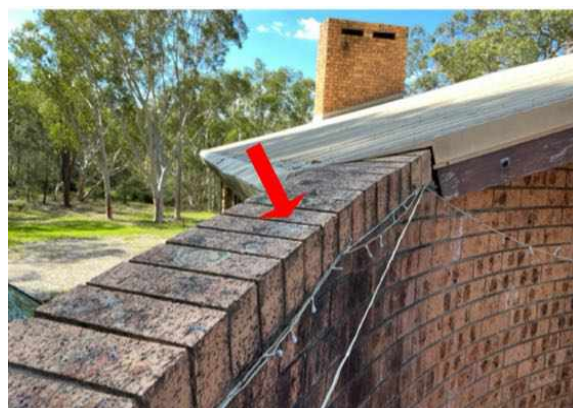
Finding 3.08

Building: Main Building
 Location: Interior and exterior
 Finding: Parapet Flashing Missing / Moisture Ingress
 Information:

The parapet flashing was found to be missing. Elevated moisture levels were detected in the adjacent masonry wall, extending from the external front outdoor area into the internal wall surfaces.

The absence of adequate flashing is likely allowing water ingress into the wall structure, which may lead to ongoing moisture-related damage, deterioration of building materials, and conditions conducive to timber pest activity.

It is recommended that a qualified roofing or waterproofing specialist install appropriate parapet flashing and assess the extent of moisture intrusion. Any affected areas should be repaired, and the area should be monitored following rectification, particularly during rainfall.

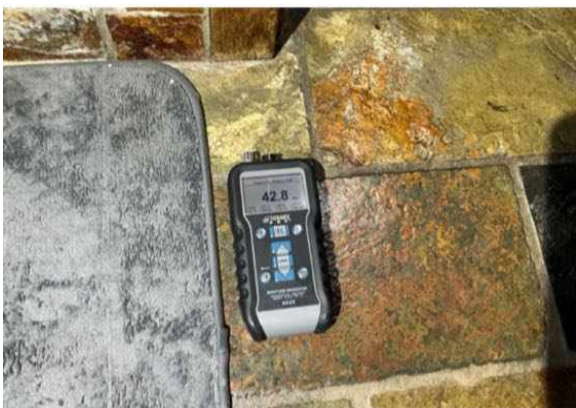
Finding 3.09

Building:	Main Building
Location:	Main Bathroom
Finding:	Shower Cracked Tiles & Elevated Moisture
Information:	During the inspection, cracked tiles were identified in the shower area. Non-invasive moisture testing confirmed elevated moisture levels beneath the tiled surface, indicating water penetration into concealed areas.

As this was a visual, non-invasive inspection, the full extent of moisture ingress and any associated damage could not be determined. A special-purpose invasive inspection is recommended to assess the severity and extent of any underlying issues.

Prolonged moisture in these areas may lead to conditions conducive to termite and timber pest activity, fungal growth, timber decay, and potential structural deterioration. It is strongly recommended that a qualified bathroom specialist be engaged to undertake the necessary remedial works. Prompt action, along with ongoing maintenance and regular inspection of wet areas, is advised to prevent further deterioration and protect the long-term integrity of the structure.

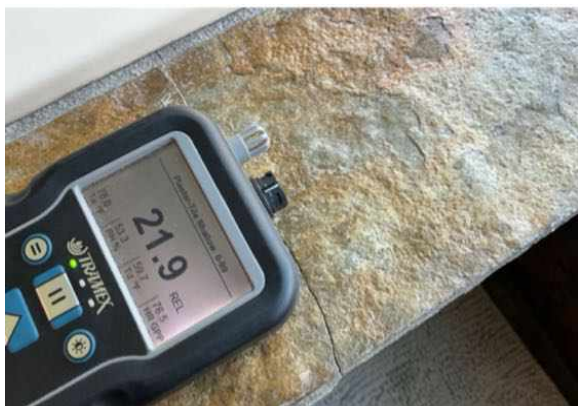
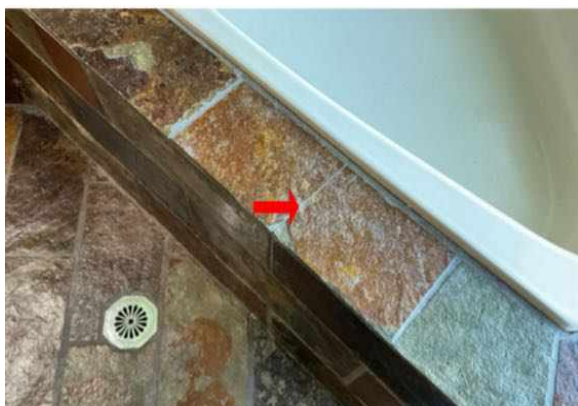
Finding 3.10

Building:	Main Building
Location:	Main Bathroom
Finding:	Cracked Tiles Bathtub
Information:	During the inspection, cracked tiles were observed on the wall of the bathtub. Non-invasive moisture testing in the affected area did not detect elevated moisture levels at the time of inspection.

Although no active moisture ingress was identified, the damaged tiles may compromise the waterproofing integrity over time if left unaddressed. It is recommended that the affected tiles be repaired or replaced to maintain the integrity of the wet area and prevent potential future moisture-related issues.

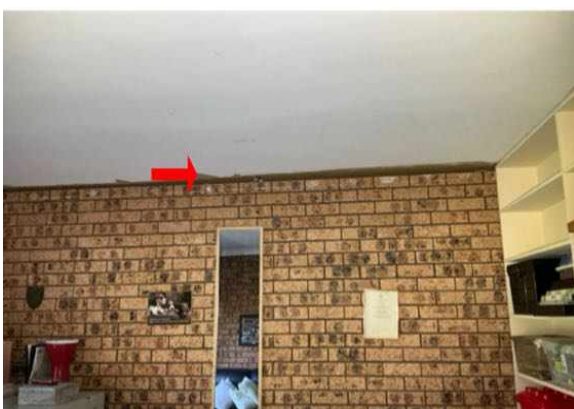
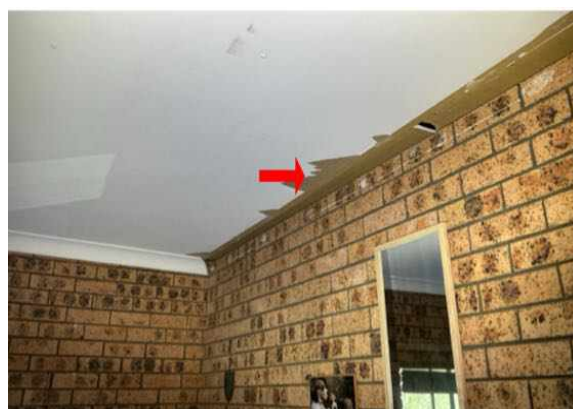
Building: Main Building
 Location: Office
 Finding: Missing Ceiling Cornice (Office)
 Information:

The ceiling cornice in the office has been removed and not reinstated, resulting in an incomplete finish at the wall-to-ceiling junction. This may leave the joint exposed and more susceptible to minor cracking or movement over time. It is recommended that a suitable cornice be installed to restore the finish and provide a neat, continuous junction.

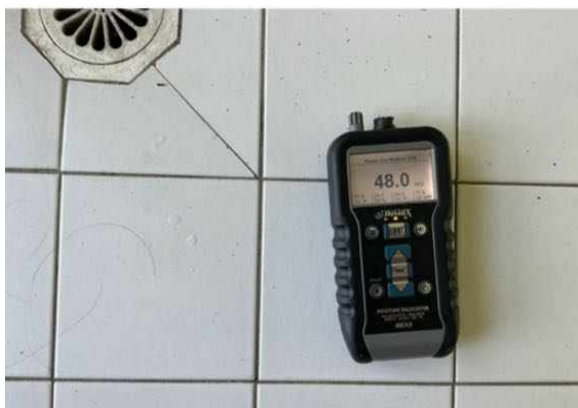
Finding 3.13

Building: Main Building
 Location: All Areas
 Finding: Elevated Moisture to Shower Area
 Information:

During the inspection, elevated moisture levels were recorded beneath the tiled surface in the ensuite shower, and extending beyond the shower zone using non-invasive moisture testing. This indicates water penetration behind the tiles and into concealed spaces.

Prolonged moisture in these areas may lead to conditions conducive to termite and

timber pest activity, fungal growth, and timber decay, potentially compromising the structural integrity of surrounding building elements.

It is recommended that a qualified bathroom renovation specialist or builder be engaged to assess the extent of the issue and carry out necessary remedial works. In addition, regular maintenance, inspection of wet areas, and ongoing moisture monitoring are essential for early detection and prevention of further deterioration.

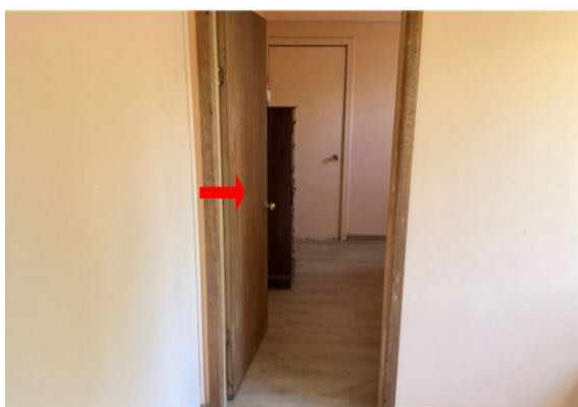
Finding 3.14

Building: Main Building
 Location: Granny Flat Bedroom
 Finding: Bedroom Door Jamming (Granny Flat)
 Information:

The bedroom door in the granny flat was found to be jamming during operation. This may be due to movement, misalignment, or deterioration of the door hardware or reveal over time. It is recommended that the door and frame be adjusted or repaired to ensure smooth operation and proper function.

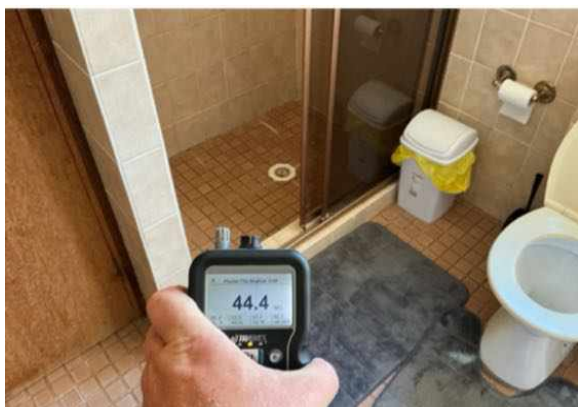
Finding 3.15

Building: Granny-Flat
 Location: Bathroom

Finding: Moisture Ingress and Efflorescence
Information: Efflorescence was observed on the grout lines of the floor tiles, indicating the presence of moisture migration through the tiled surface. Non-invasive moisture testing confirmed elevated moisture levels beneath the tiles in the shower area, extending beyond the immediate shower zone, which suggests active water penetration into concealed areas.

Due to the limitations of a visual, non-invasive inspection, the full extent of the issue could not be determined without further invasive investigation. Prolonged moisture in these areas may lead to deterioration of building materials and create conditions conducive to termite activity, timber decay, and fungal growth.

It is recommended that a qualified bathroom specialist or builder be engaged to assess the extent of the moisture issue and carry out necessary remedial works. Ongoing maintenance, regular inspection of wet areas, and moisture monitoring are advised to prevent further deterioration.

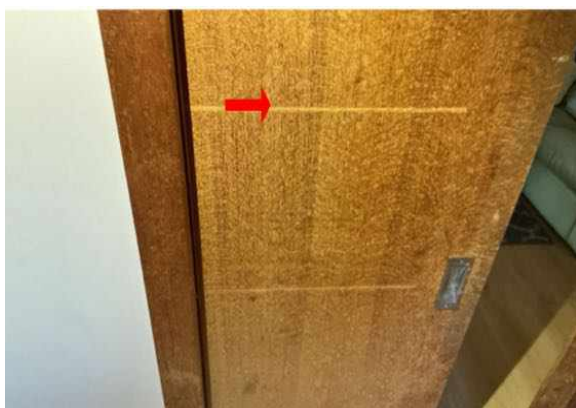
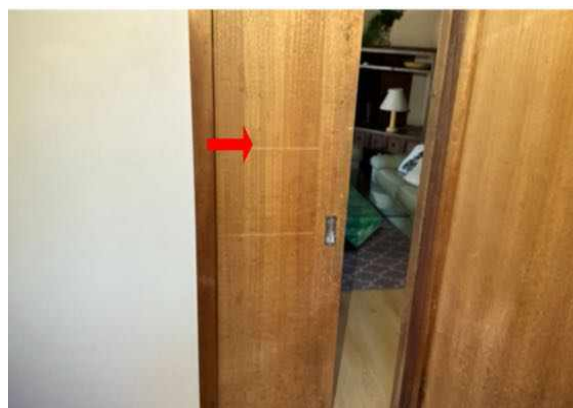
Finding 3.16

Building: Granny-Flat
Location: Bathroom
Finding: Scratched Sliding Door
Information: During the inspection, the granny flat bathroom sliding door was found to be scratched, likely due to contact with exposed nails or sharp fixings within the door cavity. This has caused visible surface damage, which may affect the door's appearance and long-term performance. It is recommended to have the cavity inspected and repaired by a qualified carpenter to remove or reposition the offending fixings. The door panel may require refinishing or replacement depending on the extent of the damage and the client's preferences.

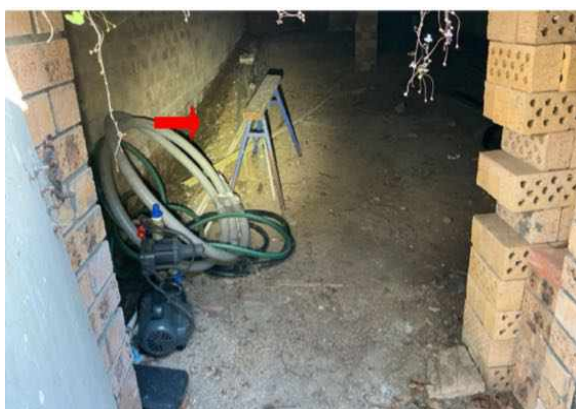
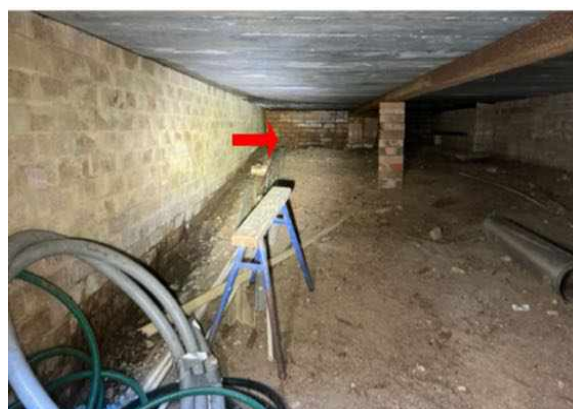
Finding 3.17

Building: Main Building
 Location: Alfresco
 Finding: Subfloor Dampness (Alfresco Area)
 Information:

Damp conditions were observed in the subfloor below the alfresco area. This is likely due to inadequate site drainage and insufficient subfloor ventilation. Prolonged dampness may lead to timber decay, mould growth, and conditions conducive to termite activity. It is recommended to improve drainage around the area and increase subfloor ventilation to reduce moisture levels.

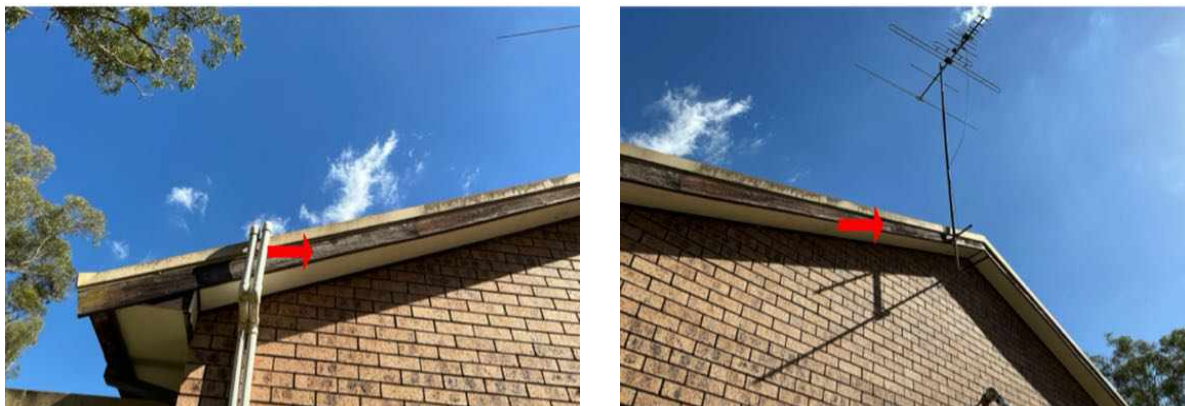
Finding 3.18

Building: Main Building
 Location: Exterior walls
 Finding: Deterioration of Exterior Painting
 Information: Due to frequent exposure to weather conditions, deterioration of the exterior painted surfaces is expected in a property of this age and condition. Where paint deterioration has occurred, the protective layer is compromised, which can lead to moisture ingress, surface degradation, and the eventual need for repair or replacement of the affected building elements. It is recommended to engage a qualified painting contractor to carry out the necessary preparation and repainting works. This will

improve the appearance of the affected areas and help protect the underlying materials from further weather-related deterioration. Regular maintenance of external finishes is essential to prolong the life of building elements and maintain overall property condition.

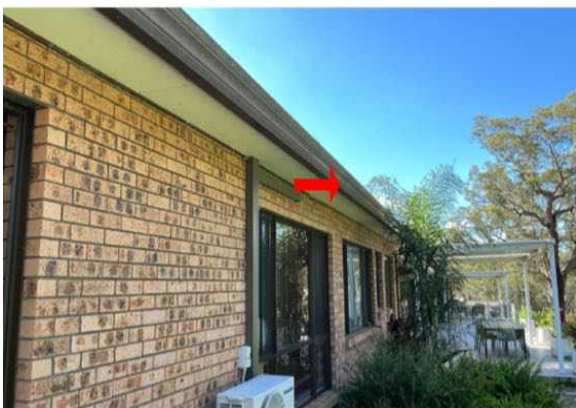
Finding 3.19

Building:	Main Building
Location:	Exterior walls
Finding:	Gutters Insufficient Downpipes
Information:	During the inspection, it was noted that the guttering system appears to have an insufficient number of downpipes, which may reduce the overall drainage performance of the roof. During heavy rainfall, this can lead to water pooling or overflowing from the gutters.

Over time, overflow can contribute to moisture around the eaves, ceilings, and building perimeter. Persistent moisture in these areas may increase maintenance requirements and can also create conditions that are attractive to termites and timber pests.

This is a common condition in homes of similar age and is generally manageable. To improve stormwater performance and reduce long-term maintenance risks, it is recommended that a qualified roof plumber assess the system and install additional downpipes if required. Improving drainage will help protect the building and support its long-term durability.

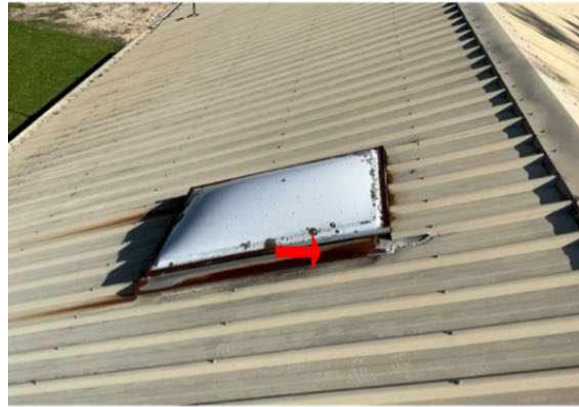
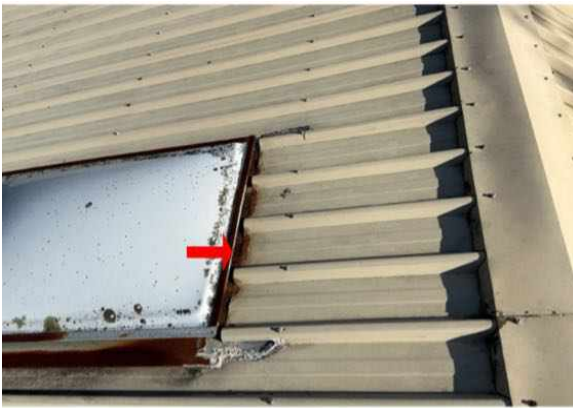
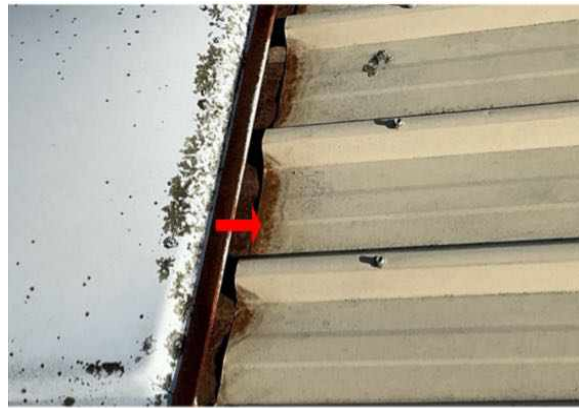
Building: Main Building
Location:
Finding: Skylight Rust Deterioration
Information:

Rust was observed to the skylight, which had been noted in the previous inspection. The corrosion has since progressed and is now extending to the surrounding roof sheets. If left unaddressed, continued deterioration may lead to water ingress and further damage to the roof structure. It is recommended that a licensed roof plumber

assess and carry out necessary repairs, including treating the rust and repairing or replacing affected components as required.

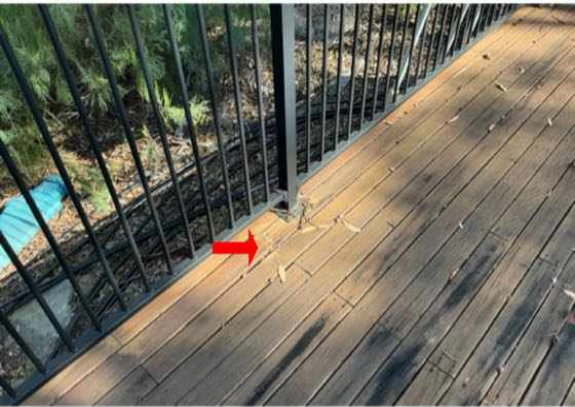
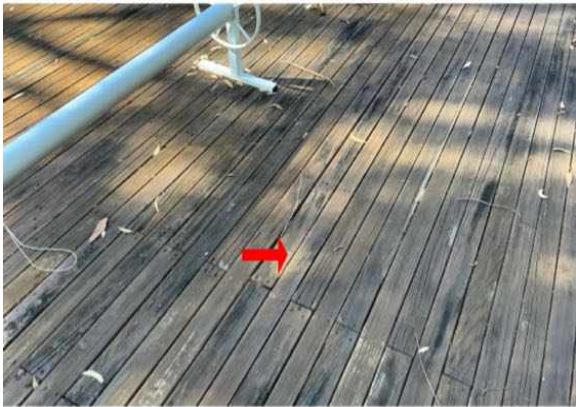
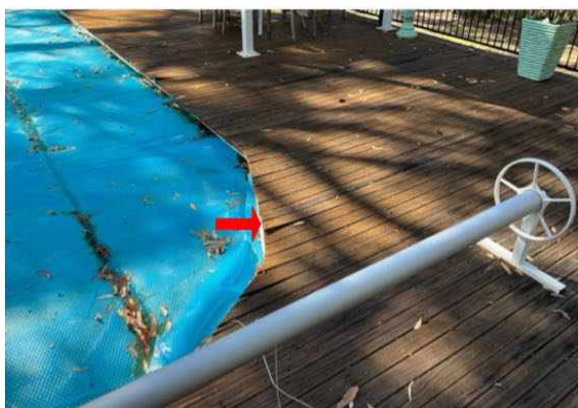
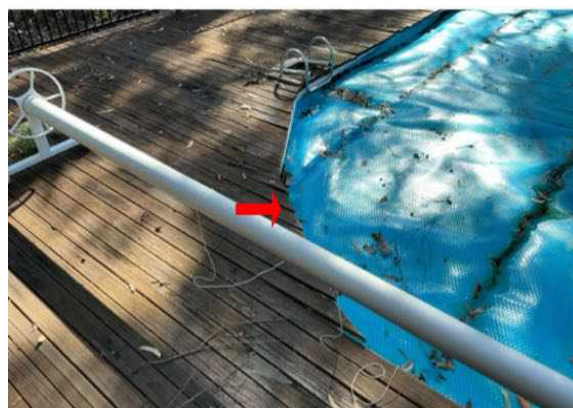
Building: Main Building
Location: All Areas
Finding: Pool Timber Decking Deterioration
Information:

Deterioration of the timber decking surrounding the pool was observed, with some boards found to be loose and twisted. This defect was also noted in the previous year's inspection and has not been addressed. If left unattended, the condition is likely to continue to deteriorate, potentially affecting the durability and safety of the decking. It is recommended that maintenance works be carried out, including securing or replacing affected boards, followed by sanding and application of a suitable protective coating to preserve the timber and extend its service life.

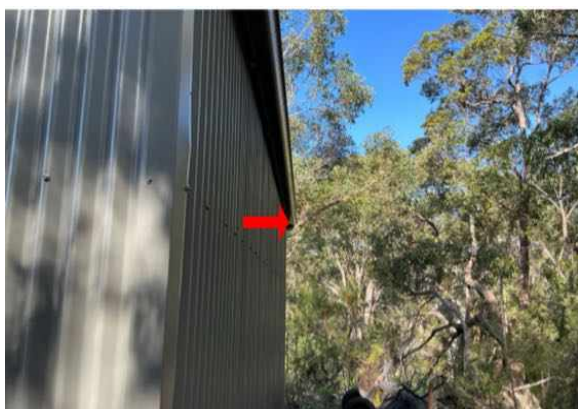
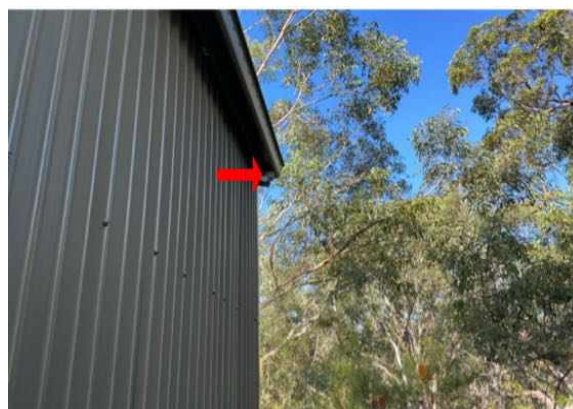
Finding 3.26

Building: Main Building
 Location: All Areas
 Finding: Incomplete Roof Plumbing (Disconnected Downpipes)
 Information:

The roof plumbing to the newly constructed shed was found to be incomplete, with downpipes left disconnected at the time of inspection. This condition prevents proper drainage of rainwater and may lead to water pooling around the structure, potentially causing moisture ingress and conditions conducive to timber pest activity. It is recommended that a licensed roof plumber complete the installation to ensure effective stormwater collection.

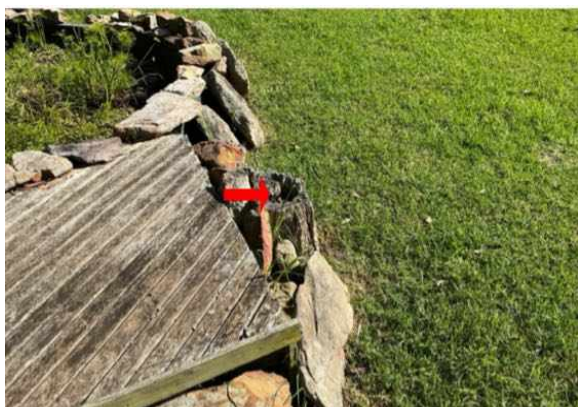
Location:	Meter Box Front and Rear Elevation
Finding:	Previous Termite Damage to Tree Stumps
Information:	During the inspection, evidence of previous termite damage was observed in tree stumps located at the front and rear of the property. This condition has been previously reported and remains present. No active termite activity was identified at the time of inspection, however, retained stumps and damaged timber may continue to attract termite activity if not addressed.

It is recommended that the affected stumps be removed or treated by a licensed pest control professional to reduce the risk of future infestation.

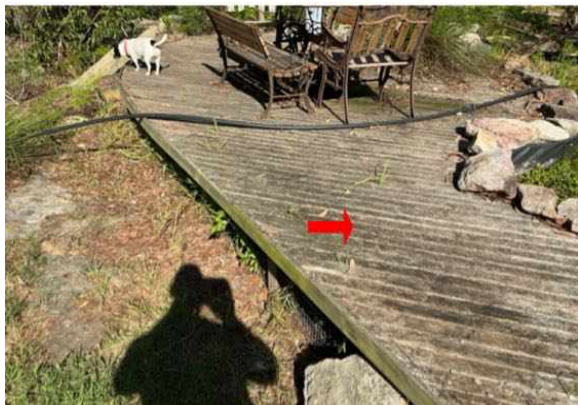
Finding 6.01

Building:	Main Building
Location:	All Areas
Finding:	In Contact With The Ground
Information:	During the inspection, wood and timber materials were observed in direct contact with the ground. This condition is highly conducive to timber pest activity, particularly termites, as it provides an ideal environment for infestation and timber decay due to elevated moisture levels, concealment, and direct access to cellulose material. Untreated or inadequately protected timber in ground contact significantly increases the risk of concealed termite entry and potential structural damage.

To reduce the risk of infestation, all ground-contacting timber should be promptly removed. It is recommended to engage a qualified pest control to assess the subfloor and implement appropriate termite management system, in accordance with AS 3660.2. Regular timber pest inspections, ideally every 90 days, are advised until all conducive conditions have been fully addressed.

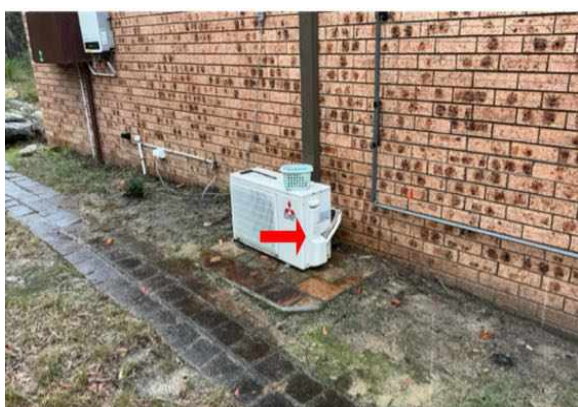
Finding 6.02

Information: During the inspection, it was observed that the overflows are not connected to the stormwater drainage system. This condition may result in moisture accumulation around the property and creating conditions conducive to termite activity. To mitigate these risks, it is recommended to engage a qualified plumber to connect the overflows to the stormwater drainage system. This will prevent excessive moisture accumulation, reduce the risk of termite infestations, and protect the surrounding structures from potential water-related deterioration.

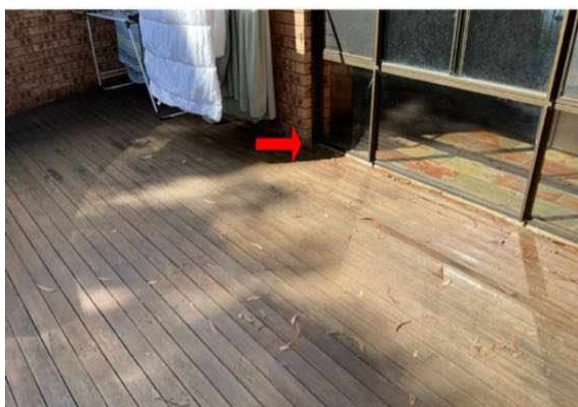
Finding 6.03

To safeguard your property from termite infestations, it is essential to maintain a minimum clearance of 75mm from the exposed slab edge. This clearance forces termites into the open, where they can be more easily detected during regular inspections. If this clearance is not achievable, it is crucial to conduct consistent timber pest inspections every 30 days or implement a post-construction termite management system compliant with Australian Standard AS 3660. Taking these precautionary measures helps ensure the property remains protected from termite threats and allows for early detection and intervention.

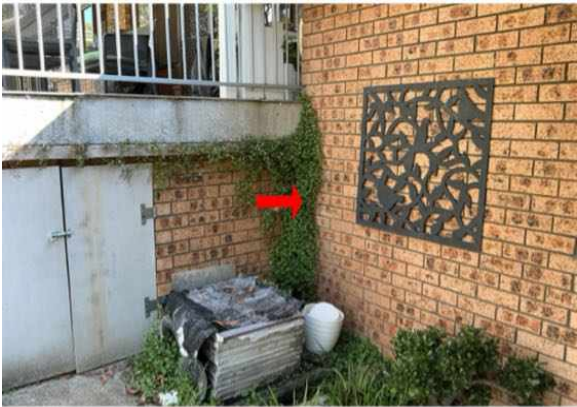
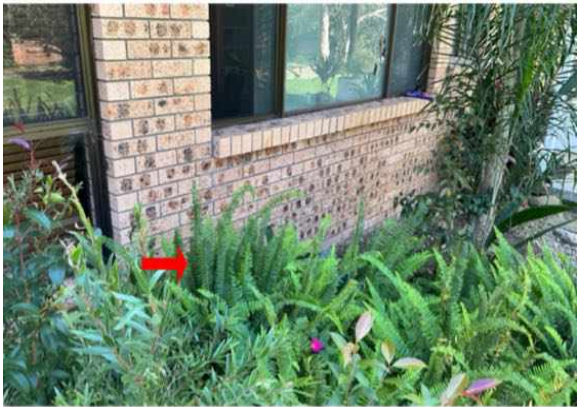
Finding 6.04

Information: Vegetation close to or in contact with the exterior walls provides cover and shade, creating an environment conducive to termite infestation. This obstruction hampers full inspection, leaving moisture or dampness undetected and increasing the risk of termite activity. To mitigate this risk, it is recommended to remove or trim back any vegetation that could lead to bridging. Replanting with species that do not provide cover or shade is advised. The removal of such materials should be carried out, followed by a re-inspection to minimize the risk of termite attack.

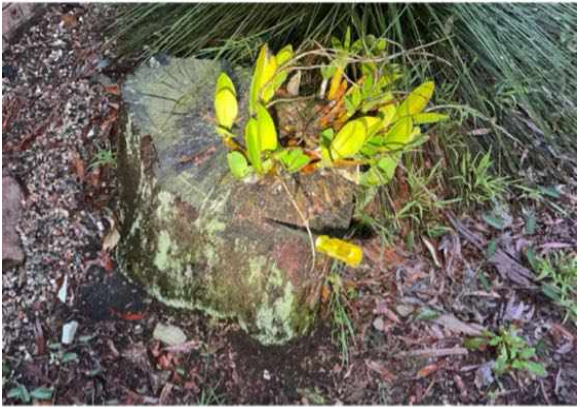
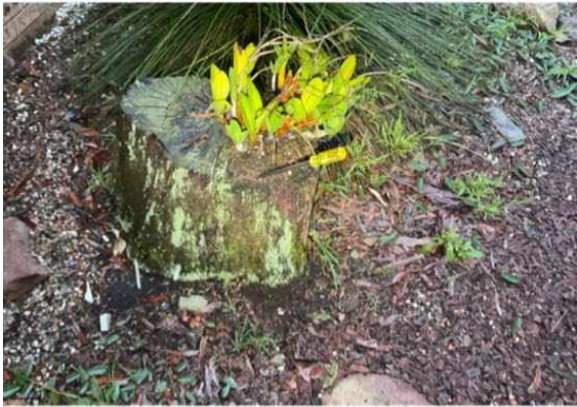
Finding 7.01

Building: Main Building
Location: All Areas
Finding: Wood Rot / Fungal Decay
Information: Wood rot was found in the exterior timbers, a condition commonly caused by prolonged moisture exposure. This accelerates the decay process and creates an environment conducive to termite activity and fungal growth. To prevent further deterioration and reduce the risk of termite infestations, it is essential to replace the affected timber with treated or moisture-resistant alternatives. It is recommended to engage a qualified carpenter or landscaper to undertake the necessary replacements and ensure the long-term durability of the building materials.

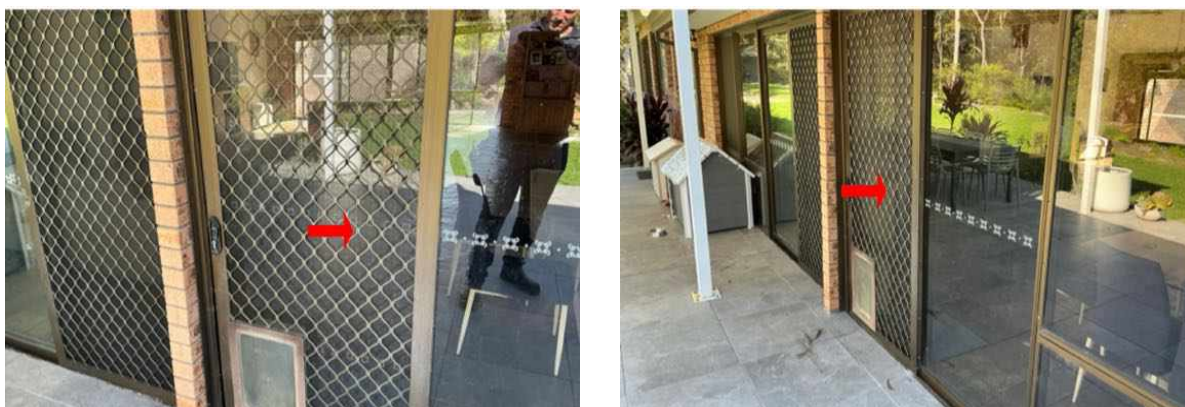
Some sliding doors, flyscreen doors, and windows were found to be difficult to open and operate. This is likely due to worn or deteriorated running hardware and is a common issue in older buildings. It is recommended that the running hardware be repaired or replaced to restore smooth operation and improve overall performance.
