Building and Timber Pest Inspection Report

Inspection Date: Fri, 23 Jan 2026

Property Address: 3A Coach Cres, Currans Hill NSW 2567,
Australia

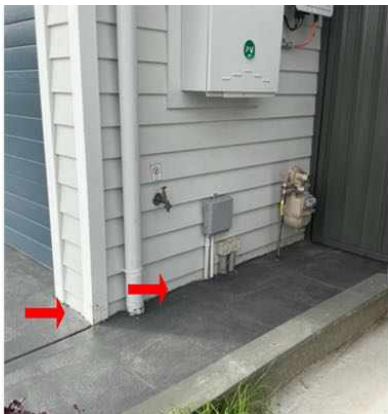
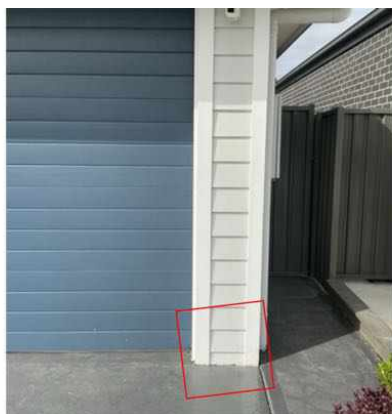
Finding 3.01

Building:	Main Building
Location:	All Internal Areas
Finding:	External Slab-to-Cladding– Moisture Bridging Risk
Information:	The external concrete path/apron appears to be finished hard against the wall cladding with minimal or no visible clearance at the base. This configuration may allow moisture bridging and capillary transfer to the lower wall elements, particularly during heavy rainfall or ponding events, and can contribute to deterioration of sealants, coatings, and lower cladding edges over time. While no active water ingress was observed at the time of inspection, the detailing limits drainage and drying at the wall base. Ongoing monitoring and maintenance of joints and clearances is recommended to reduce long-term moisture-related risks.

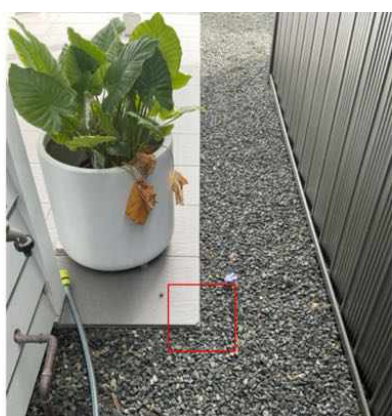
Finding 3.02

Building:	Main Building
Location:	All External Areas - Front
Finding:	Tiles - Cracked or damaged
Information:	Cracking was evident to the tiling in this area at the time of inspection. While the cracking appears to be minor, this area is frequently exposed to water, allowing potential for water penetration into adjoining sections of walls or flooring.

If left unmanaged, water penetration to these areas may lead to subsequent water damage, which is likely necessitate repair work to affected building elements.

A tiling contractor should be appointed to ensure that no further water damage occurs. The re-application of silicone and grouting throughout remaining tile work is also advised, to further protect the area against water penetration.

Where water penetration has led to water damage, appointment of a relevant tradesperson may be required to repair damaged building elements.

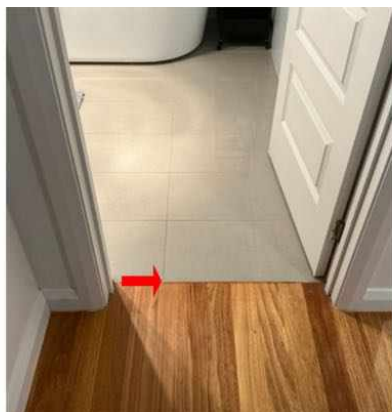
Finding 3.03

Building:	Main Building
Location:	Bathroom, Laundry
Finding:	Bathroom & external floor threshold

Information: The bathroom floor is at the same level as the adjoining timber flooring. This configuration is typical in modern builds and is permitted where compliant waterproofing and floor falls are provided. No evidence of moisture damage was observed at the time of inspection, however, waterproofing performance cannot be confirmed without invasive inspection.

Care should be taken to avoid excessive water migration beyond the bathroom during use.

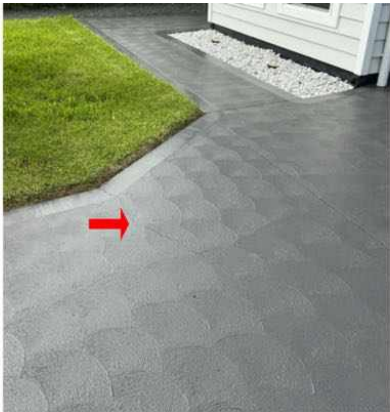
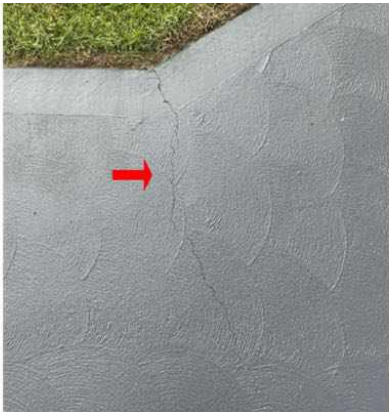
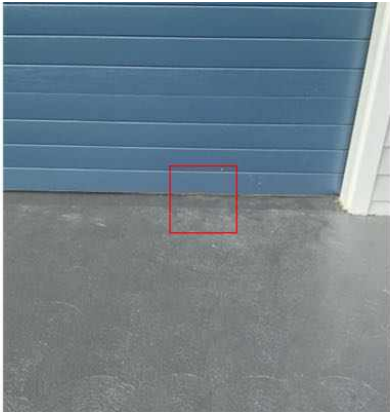
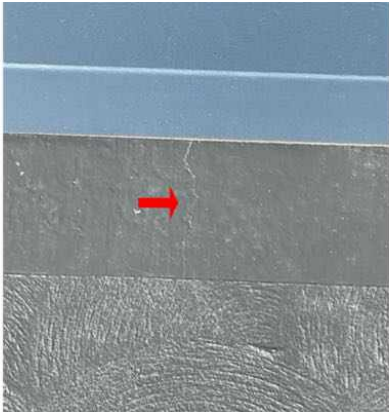
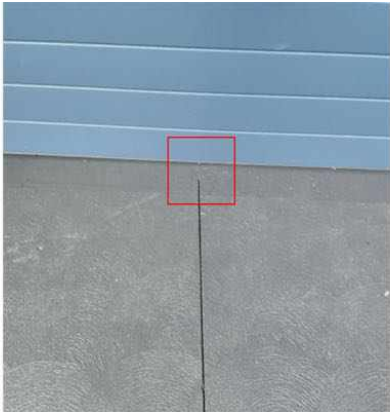
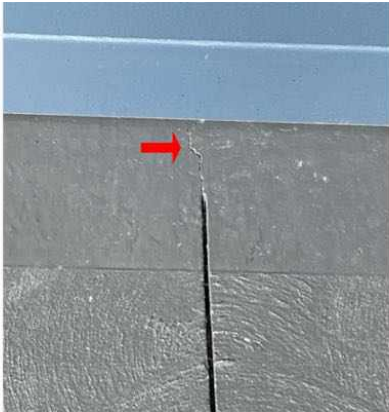
Building:	Main Building
Location:	All External Areas
Finding:	Cracking - External Concrete Paving Damage Category 1 - Fine (less than 2mm)
Information:	Fine cracks were identified in external concrete paving. Although fine cracks are quite noticeable, they are often only considered to be an appearance defect, and usually do not indicate any structural damage. To be considered a Category 1 or fine crack, the crack is found to be less than 2mm in width.

Generally the cause of a hairline crack in existing concrete paving such as driveways and pathways is indicative of the expansion and contraction of the concrete. Such causes are generally due to environmental factors, such as moisture levels, weather

conditions, root systems of nearby trees or the soil types on which they are laid.

Fine cracks may also be due to poor original installation of the concrete. Factors such as poor compaction of the sub surface and/or inadequate reinforcing of the slab may create cracking and other secondary defects.

Monitoring of all cracking should be conducted frequently. Always contact a building inspector should cracks widen, lengthen, or become more numerous.

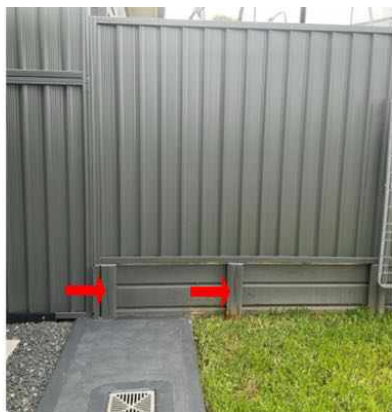
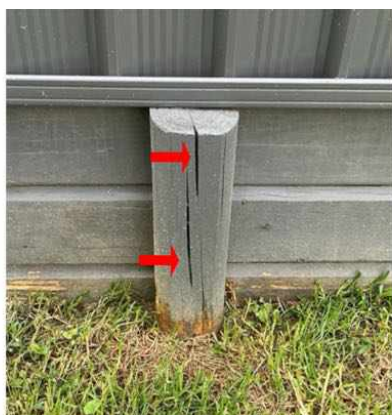
Finding 3.06

Building:	Main Building
Location:	All External Areas
Finding:	Retaining wall - Defective - Timber splitting
Information:	The retaining wall in this area was found to be defective at the time of inspection (Timber splitting). The split appears consistent with shrinkage and natural timber movement, rather than impact damage or structural failure. At the time of inspection, the post remains upright, in position, and continues to provide support to the adjoining retaining wall and fence, with no visible signs of displacement, rotation, or loss of function.

Generally, defective retaining walls are caused by poor original design or material use. However, deteriorated retaining walls may also be a result of substandard construction, poor site drainage or unmanaged stormwater flows.

If left unmanaged, the retaining wall may become a safety hazard if it continues to destabilise. Where retaining walls further rot and decay, an environment is created that is conducive to termite and pest infestation.

Significant repair and replacement should be expected. Where retaining walls are considered structural walls, a structural engineer / surveyor should be consulted regarding required remedial works. Otherwise, a landscaper or retaining wall installer may be appointed to repair or replace the wall, at the discretion of the client.

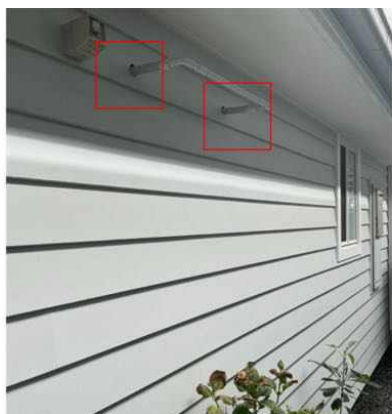
Finding 3.07

Building:	Main Building
Location:	All External Areas - Left side
Finding:	Incomplete or substandard works - Holes not sealed
Information:	The works to this area appear to be incomplete or have been completed to a substandard level.

Works that have not been completed to a satisfactory level create potential for the development of building defects and may impede on the safety and integrity of the overall structure.

It is highly recommended that the relevant trades be appointed to complete these works and ensure the safety of the area and the longevity of all associated building elements.

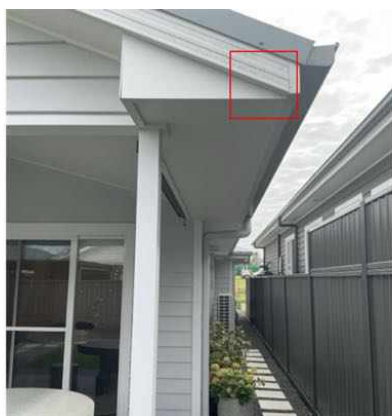
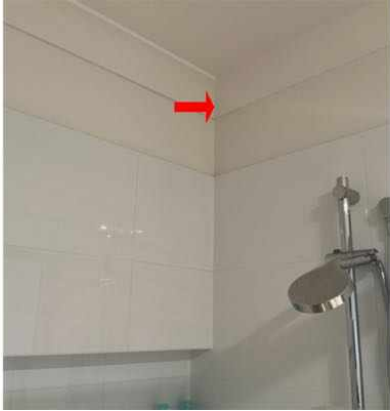
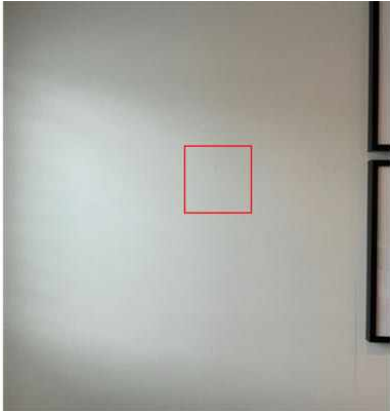
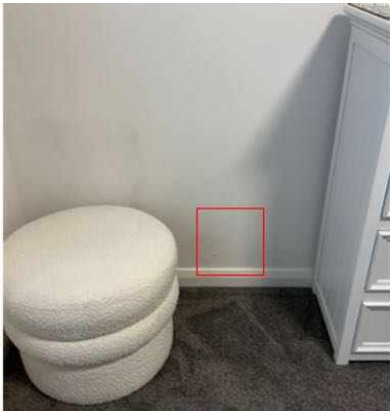
Finding 3.08

Building:	Main Building
Location:	All Internal Areas
Finding:	Paint Finish & Hairline Cracking - To some areas
Information:	The paint finish in this area was identified as being incomplete or substandard at the time of inspection including some hairline minor cracking/separation. Monitoring is recommended where cracking and separation is evident.

Whilst incomplete or missing paint finish is generally an appearance defect, it can also lead to the development of secondary building defects over time. Incomplete areas of paint finish expose the area to moisture, potentially accelerating the deterioration of underlying building materials.

Incomplete paint finishes should be sanded back, filled, leveled and painted, as applicable. Where inadequate or missing paint protection has led to the deterioration of the associated building element, repair and/or replacement of this building element may be required.

A painting contractor should be appointed as soon as possible to perform necessary works to aid the appearance of the affected area and to ensure the area is protected against further deterioration. Alternatively, the homeowner following manufacturer instructions may perform these works.

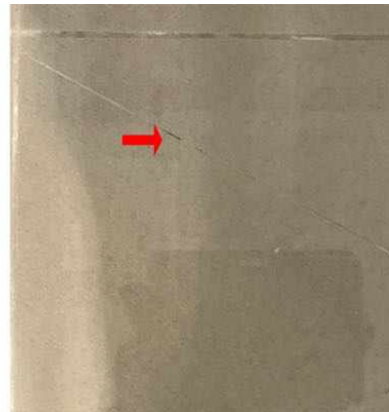
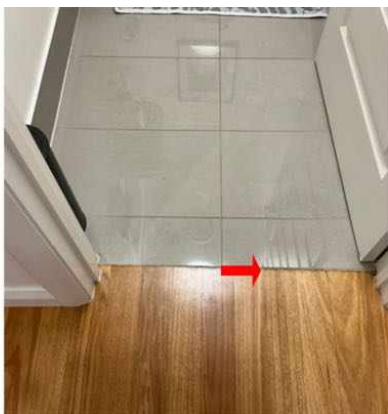
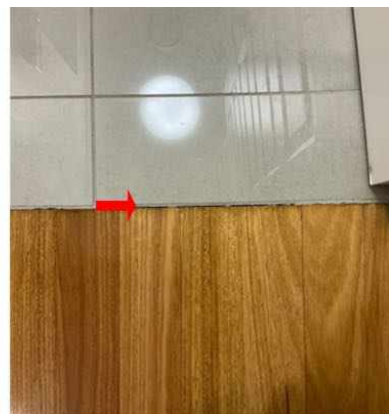
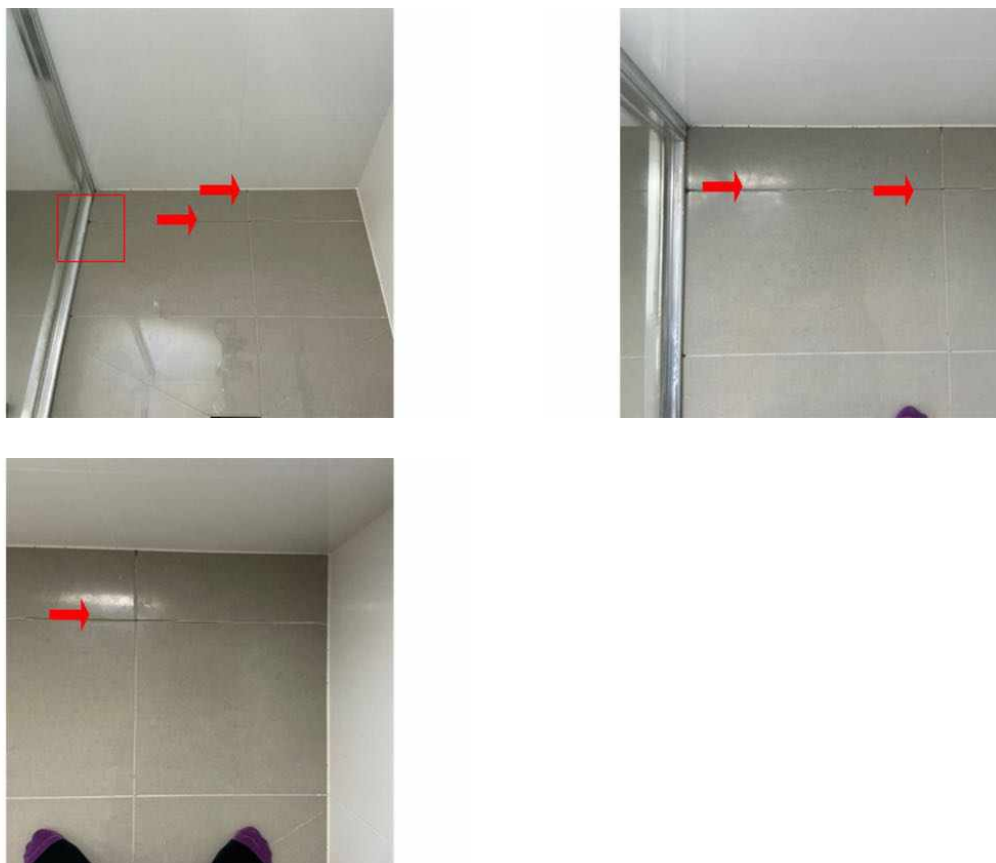
Finding 3.09

Building: Main Building
Location: All Internal Areas
Finding: Sealant and grouting - Missing or degraded
Information: It was noted on inspection that sealant or grout is degraded.

Different materials and floor areas move at different rates, generally causing cracking to grout or sealant at this point. A flexible sealant is required to allow for expected expansion and contraction, while keeping the joint water tight and protective of all associated building materials.

Excessive mould to the sealant and grout may require scraping out and replacement.

Flexible and mould resistant materials should be applied to affected areas to prevent any subsequent water damage that is likely to occur. Regular maintenance and replacement of damage or missing or damaged sealant and grout is highly recommended to the wet areas, as this is a regular wear and tear defect. Sealant and grouting in areas that come into regular contact with water should be maintained for the long term care of your property.

A sealant specialist or tiling contractor should be appointed to complete these works as soon as possible

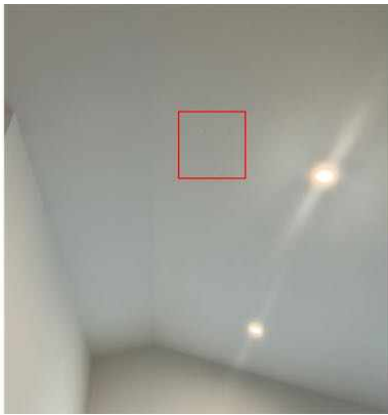
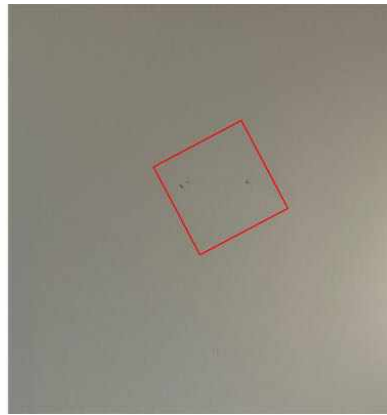
Finding 3.10

Building:	Main Building
Location:	All Internal Areas - Lounge
Finding:	Ceiling nails - Popping To some areas
Information:	Numerous popped nails were identified in the internal ceiling at the time of inspection. Nails and screws hold simply by the friction between them and the surface they are applied to. Over time, the nails and screws can back out, which is often a result of general ageing and deterioration of the building structure.

If left unmanaged, the ceiling sheets may become loose and unstable, increasing the rate of deterioration of the internal ceiling and creating potential for the development of secondary defects.

Re-fastening of popped nails will help to maintain the stability of the internal ceiling and associated building elements. Such minor works will also help to improve the appearance of the affected area and secure the ceiling sheets, so as to prevent the onset of ceiling sagging. These works should be performed by a qualified carpenter or plasterer at client discretion.

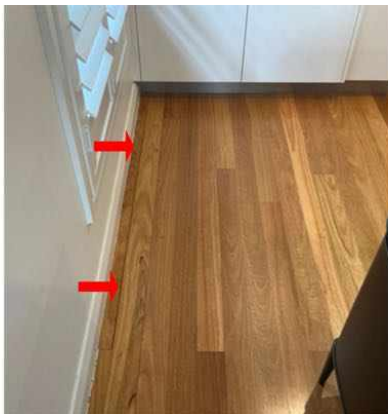
Finding 3.11

Building:	Main Building
Location:	Kitchen
Finding:	Installation - substandard or incomplete - Floorboard gaps (localised)
Information:	The installation of this building element appears to have been completed to a substandard level of workmanship or is incomplete. Generally substandard repairs or installation are related to poor workmanship, the use of inappropriate materials, or a failure to complete installation to a suitable standard.

Where installation is substandard and/or incomplete, the client should contact the responsible trade to undertake rectification. Unfinished and substandard building works are likely to degrade more quickly and may create potential for secondary defects to associated building elements.

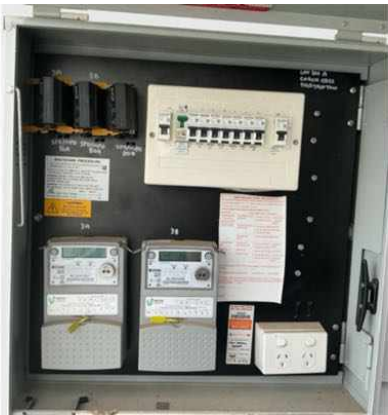
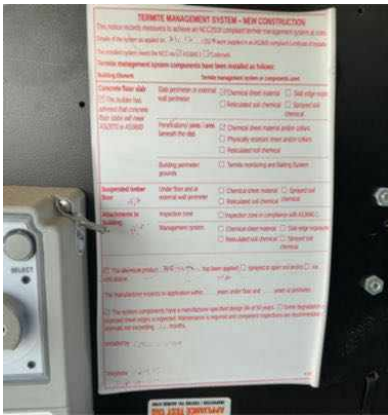
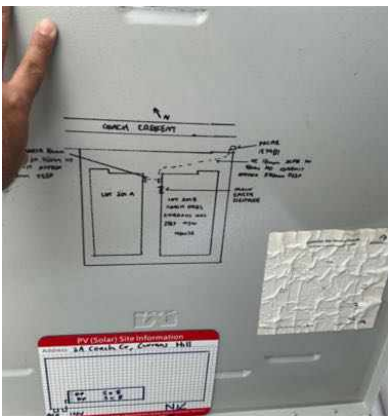
Building: Main Building
 Location: All External Areas
 Finding: Termite Management System - no evidence of a chemical installation
 Information: The application of a post-construction chemical termite barrier is highly recommended for all properties, particularly if live termite activity has been found on the site previously. Such barriers are highly effective in preventing termite attack on any timber building elements throughout the property.

A durable notice should be placed in the switchboard unit to indicate current termite barriers. At the time of inspection, it appeared as though no termite management system has been installed, with no evidence to suggest preventative works taking place.

The client may consider gaining further advice from a pest controller as to the costs and procedures involved with this application. It is recommended that obtaining such advice be a short-term priority.

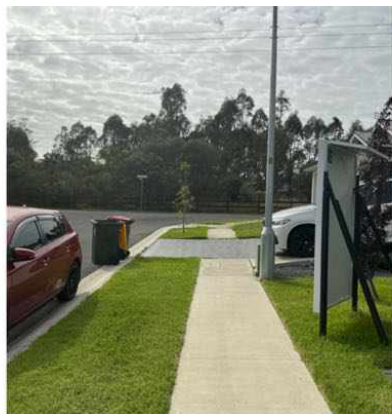
Finding 6.02

Building:	Main Building
Location:	All External Areas
Finding:	Trees within 50m
Information:	Trees within 50m of the property can be conducive to termite activity. It is recommended an invasive inspection of all trees within 50m to the property be carried out by a qualified pest control expert.

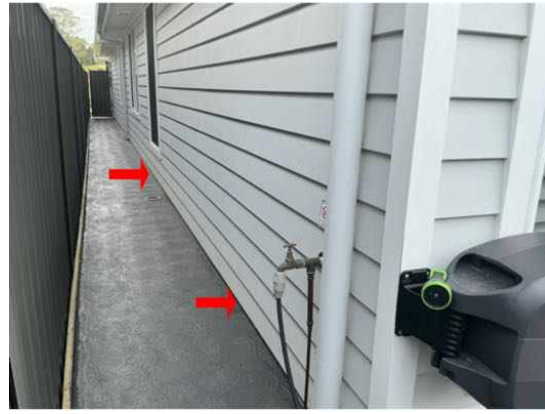
Finding 6.03

Building:	Main Building
Location:	All External Areas
Finding:	Slab Edge - Exposure
Information:	An inspection zone of at least 75mm in relation to the exposed slab edge, between the bottom brick and the perimeter pavement, is required. This inspection zone should be maintained in order to force termites into the open where they can be detected more readily during regular inspections. The slab edge should not be concealed by anything that may prevent inspection of the area, including render, landscaping, soil, turf, paving, concrete cladding or other structures.

If the slab edge is not properly exposed there is a high risk of termite attack. Sometimes, in order to determine the type of slab, a suitably qualified person such as an architect or builder may be required to consult the construction plans.

Where the slab edge cannot be properly inspected, it is highly recommended that termite or timber pest inspections be carried out every 6-12 months to aid protection of the property against infestation.

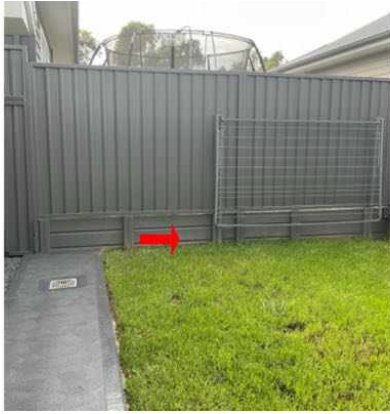
Finding 6.04

Building: Main Building
 Location: All External Areas
 Finding: In ground contact - Timber
 Information: Any timbers in direct ground contact provide opportunity for concealed termite entry and are likely to be subject to premature rot and decay as the soil retains moisture or damp conditions against the timbers.

Remove untreated timber that is in direct contact with external grounds. Consider replacement with more durable materials i.e. treated timber or non timber elements. Frequent pest inspections are advised to readily identify any termite activity in these areas.

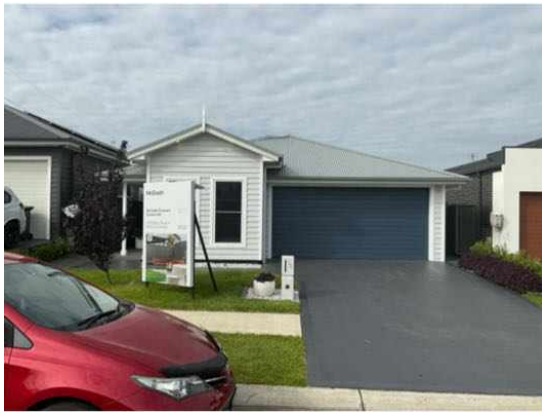
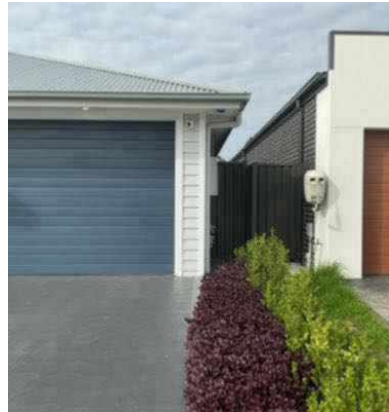
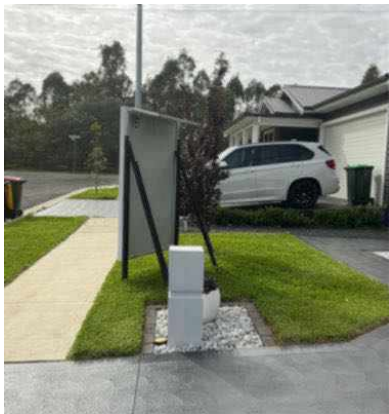
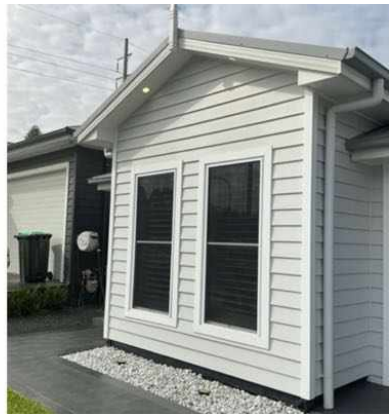
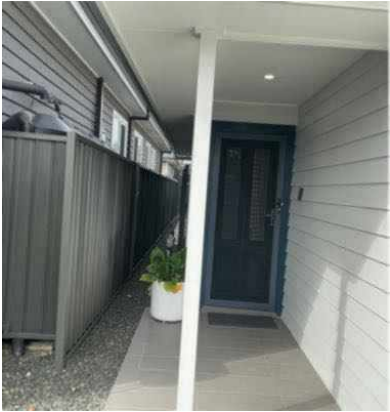
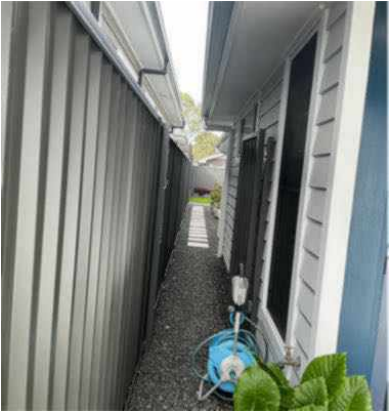
Building: Main Building
Location: All External Areas
Finding: Additional Photos - Obstructions and Limitations
Information: These photographs are an indication of the obstructions and limitations which impeded full inspection of the property at the time of inspection. These obstructions can hide an array of defects and should be removed to allow full inspection to be carried out. A re-inspection is recommended once the areas are made accessible.

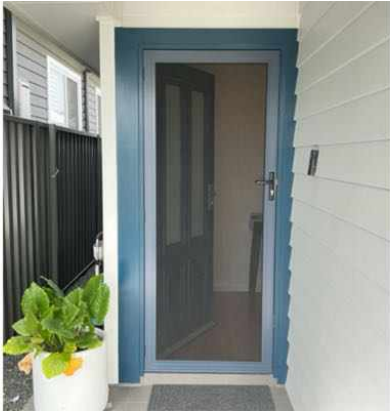
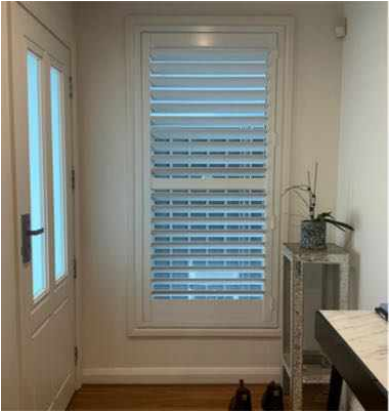
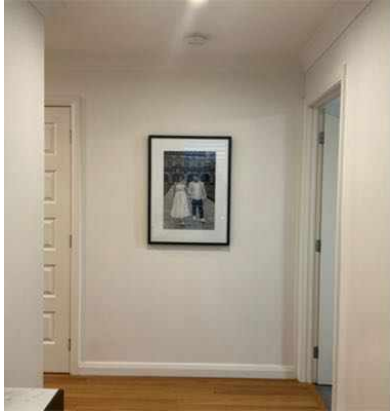
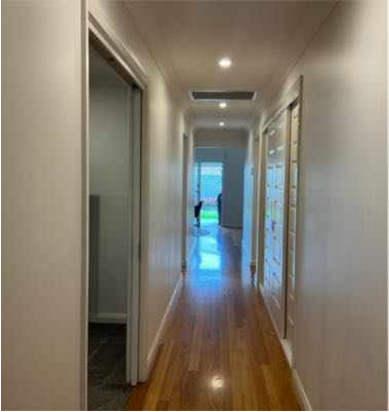
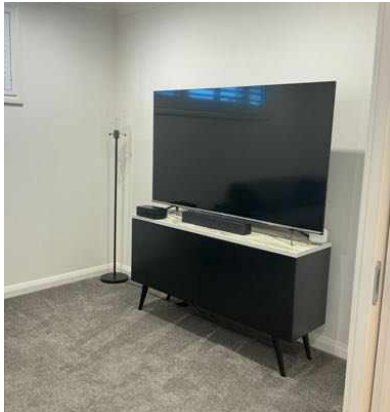
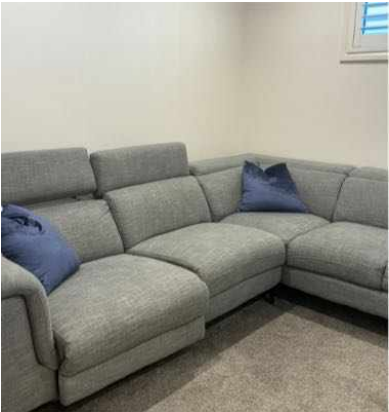
Building:	Main Building
Location:	All Internal Areas
Finding:	Additional Photos - Obstructions and Limitations
Information:	These photographs are an indication of the obstructions and limitations which impeded full inspection of the property at the time of inspection. These obstructions can hide an array of defects and should be removed to allow full inspection to be carried out. A re-inspection is recommended once the areas are made accessible.

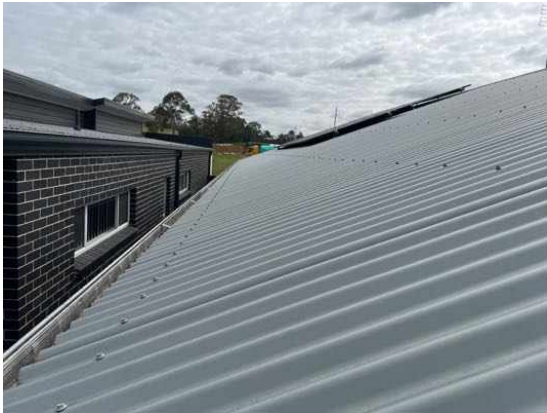
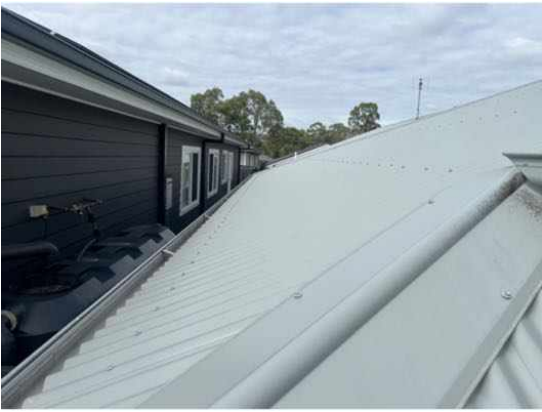
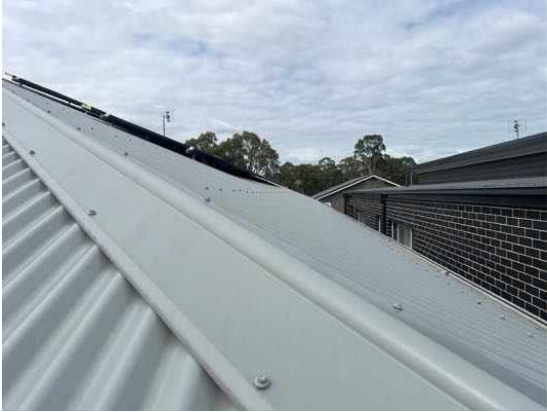
Building: Main Building
Location: Roof Exterior
Finding: Additional Photos - Obstructions and Limitations
Information: These photographs are an indication of the obstructions and limitations which impeded full inspection of the property at the time of inspection. These obstructions can hide an array of defects and should be removed to allow full inspection to be carried out. A re-inspection is recommended once the areas are made accessible.

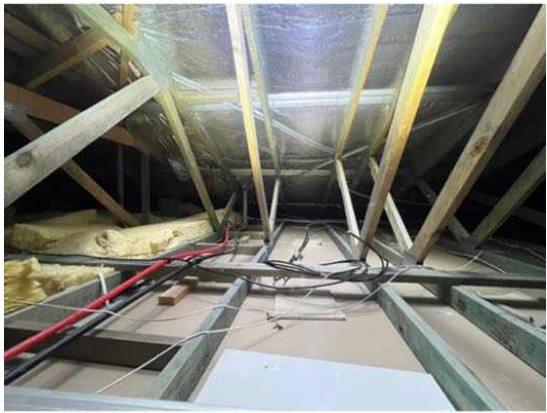
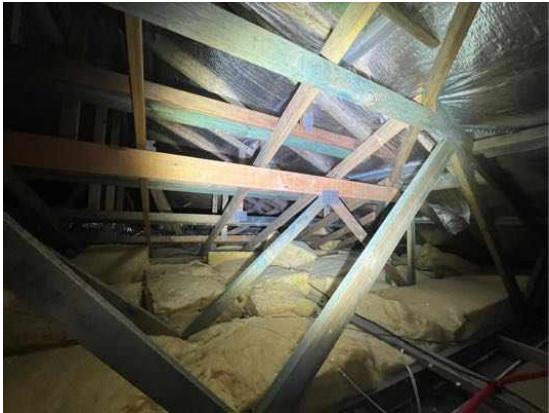
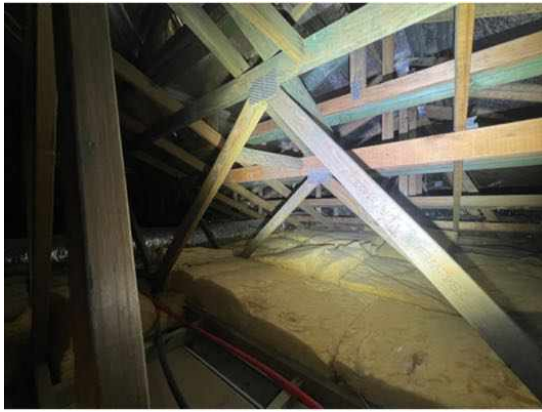
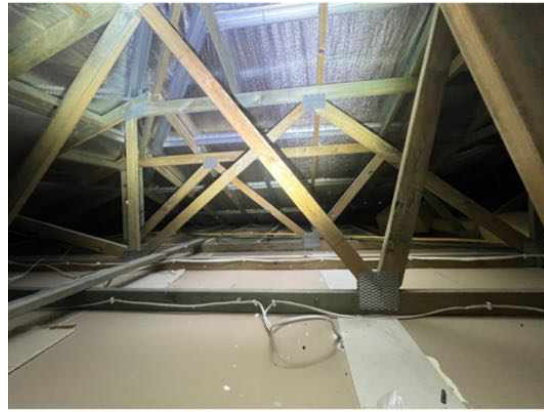
Building: Main Building
Location: Roof Void
Finding: Additional Photos - Obstructions and Limitations
Information: These photographs are an indication of the obstructions and limitations which impeded full inspection of the property at the time of inspection. These obstructions can hide an array of defects and should be removed to allow full inspection to be carried out. A re-inspection is recommended once the areas are made accessible.
