Building and Timber Pest Inspection Report

Inspection Date: Thu, 26 Mar 2026

Property Address: 6 Bournemouth St, Bundeena NSW 2230,
Australia

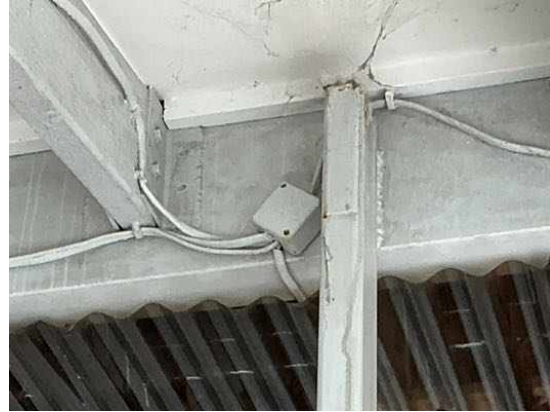
Finding 1.04

Building: Main Building
Location: Ground subfloor entry - manhole, carport
Finding: Electrical wires exposed
Information: Exposed electrical wiring was identified. Exposed electrical wiring represents a potential safety hazard including for fire and personal contact. Contact a licensed electrician urgently for further inspection investigation and rectification.

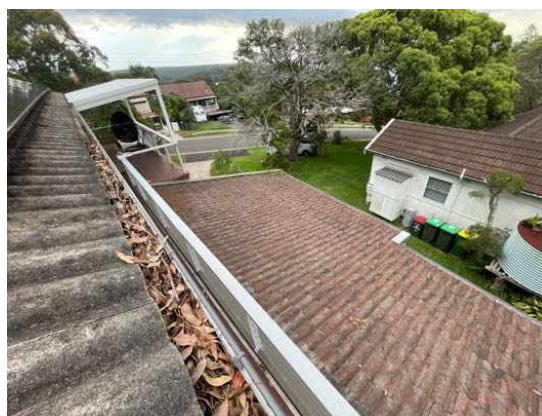
Blocked gutters are likely to lead to high levels of moisture in the affected areas. Such moisture will not only cause rust and decay of the associated building materials, but can also provide conditions that are conducive to termite and timber pest activity. Blockages in gutters should therefore be removed immediately to ensure dry conditions are maintained.

Consult a Licensed Plumber for further specific advice on remedial works that may be required. In the interim, it is highly advised that blocked gutters be removed by the homeowner or a general handyperson as a matter of urgency.

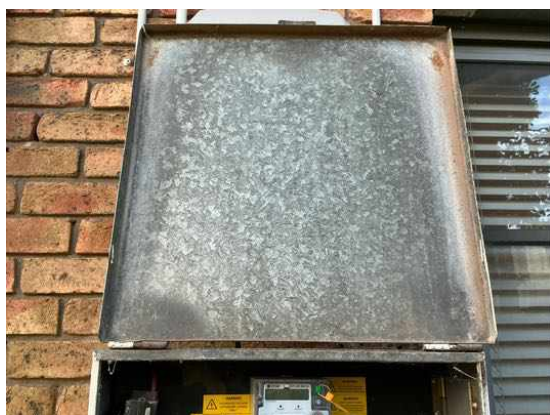
Building:	Main Building
Location:	Meter box, under kitchen sink
Finding:	Termite Management System - no evidence of a chemical installation
Information:	The application of a post-construction chemical termite barrier is highly recommended for all properties, particularly if live termite activity has been found on the site previously. Such barriers are highly effective in preventing termite attack on any timber building elements throughout the property.

A durable notice should be placed in the switchboard unit to indicate current termite barriers. At the time of inspection, it appeared as though no termite management system has been installed, with no evidence to suggest preventative works taking place.

The client may consider gaining further advice from a pest controller as to the costs and procedures involved with this application. It is recommended that obtaining such advice be a short-term priority.

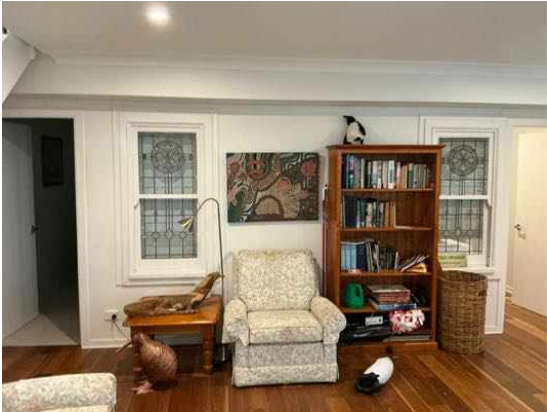
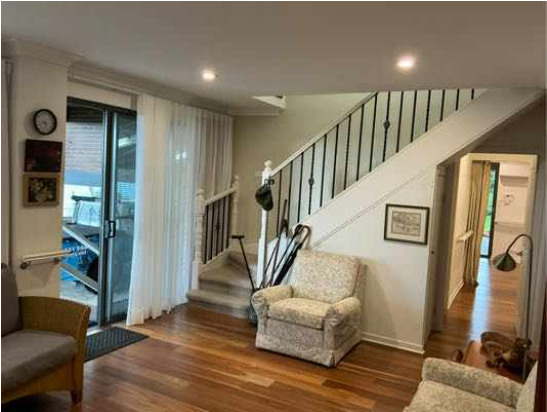
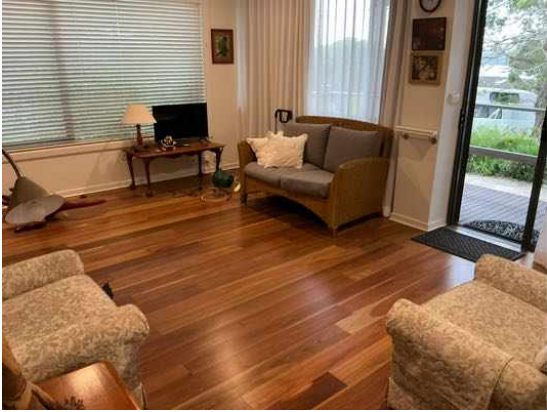
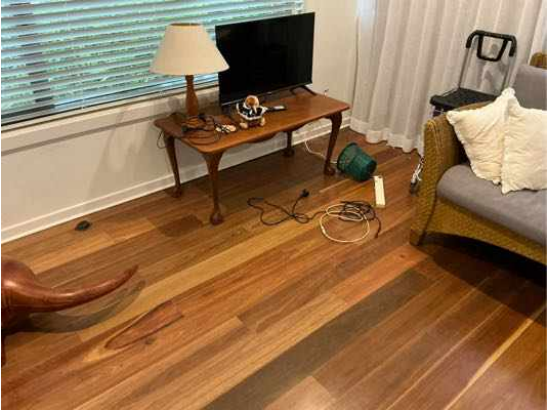
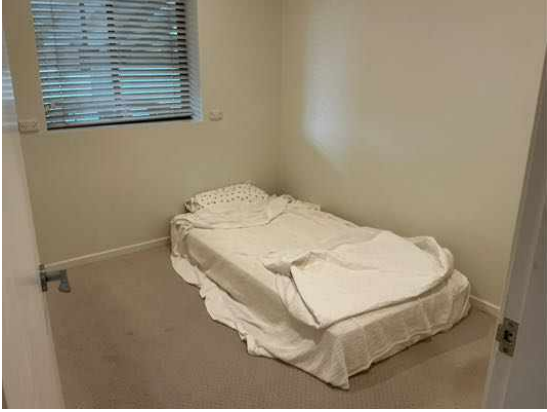
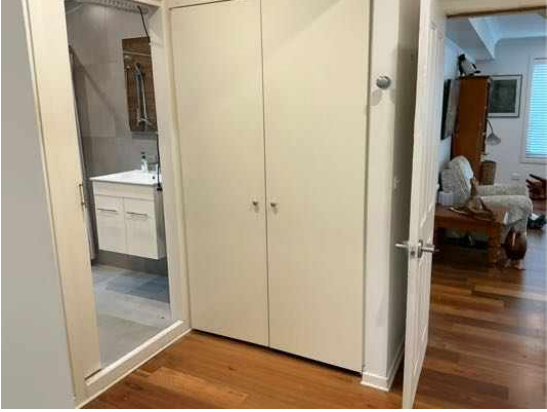
Building: Main Building
 Location: All Areas-internal
 Finding: Additional Photos - Obstructions and Limitations
 Information: These photographs are an indication of the obstructions and limitations which impeded full inspection of the property at the time of inspection. These obstructions can hide an array of defects and should be removed to allow full inspection to be

carried out. A re-inspection is recommended once the areas are made accessible.

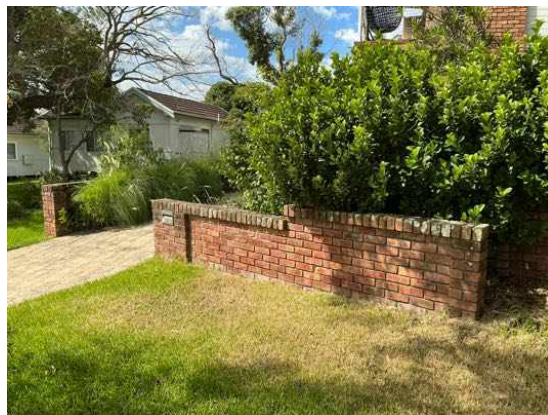
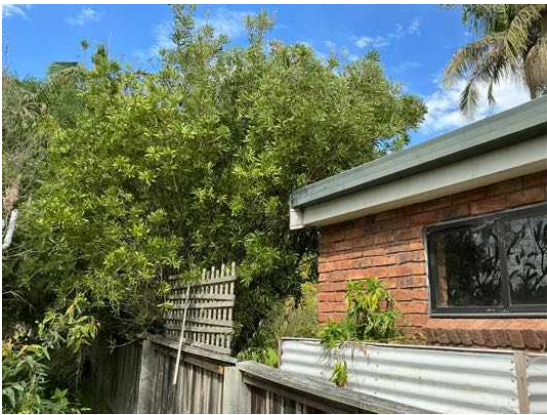
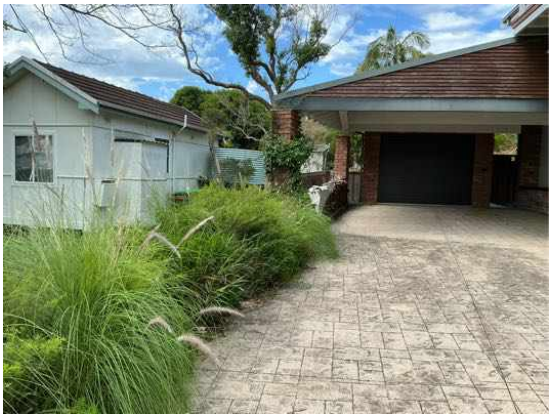
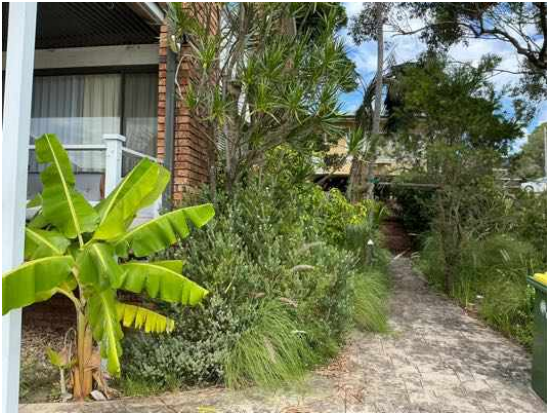
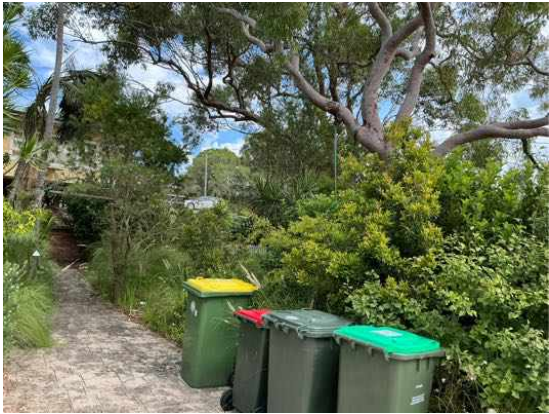
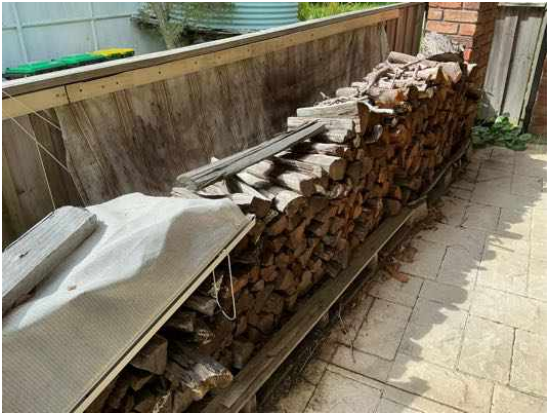
Building: Main Building
 Location: All Areas- external areas
 Finding: Additional Photos - Obstructions and Limitations
 Information: These photographs are an indication of the obstructions and limitations which impeded full inspection of the property at the time of inspection. These obstructions can hide an array of defects and should be removed to allow full inspection to be carried out. A re-inspection is recommended once the areas are made accessible.

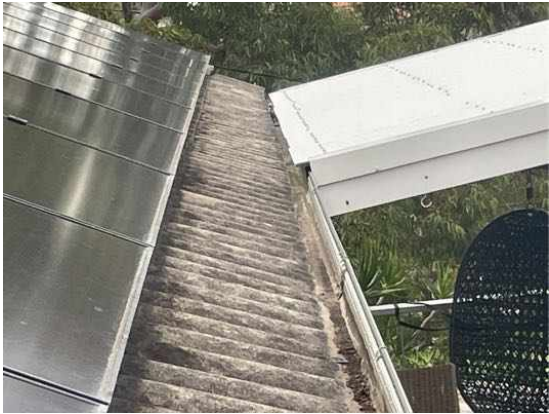
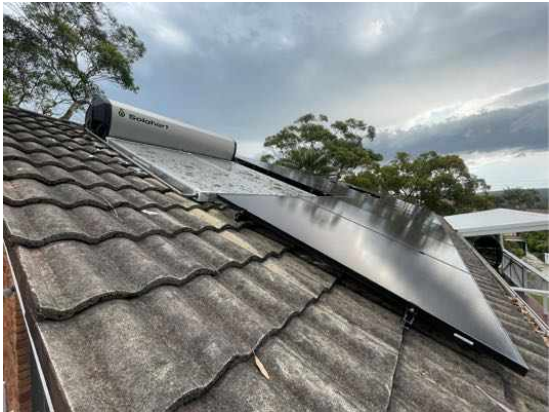
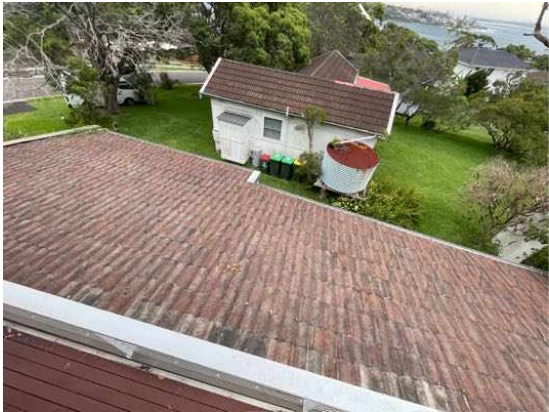
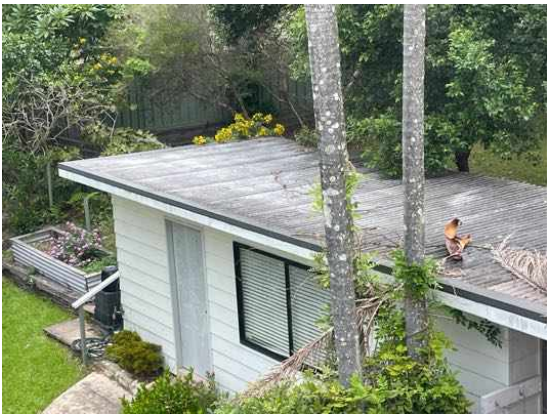
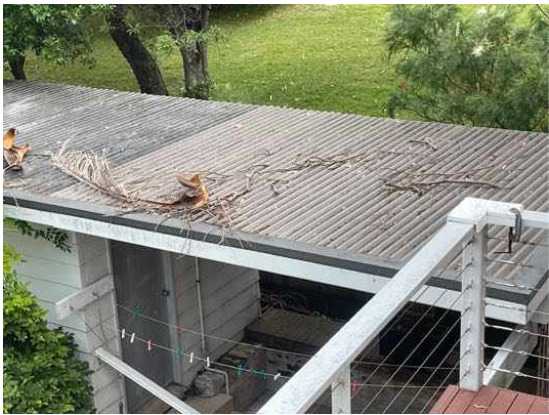
Building: Main Building
Location: Roof Exterior
Finding: Additional Photos - Obstructions and Limitations
Information: These photographs are an indication of the obstructions and limitations which impeded full inspection of the property at the time of inspection. These obstructions can hide an array of defects and should be removed to allow full inspection to be carried out. A re-inspection is recommended once the areas are made accessible.

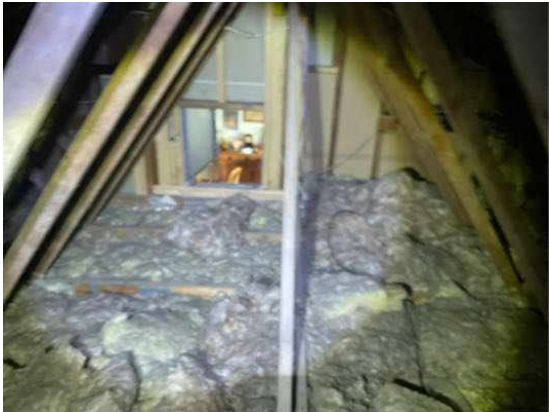
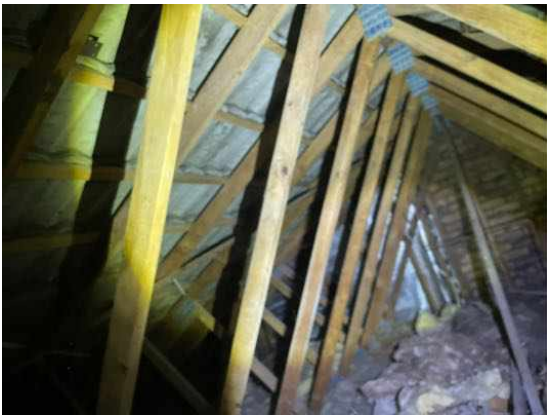
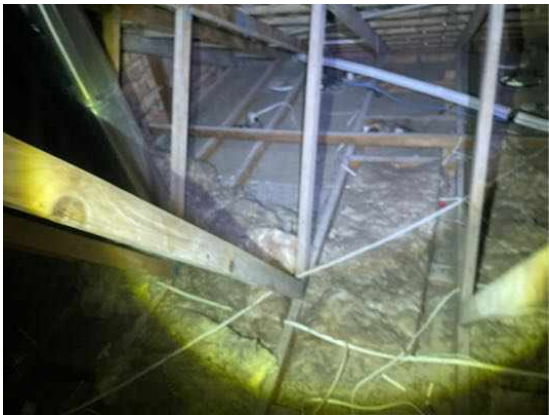
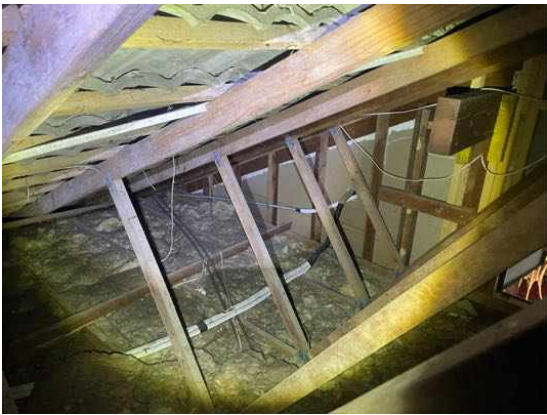
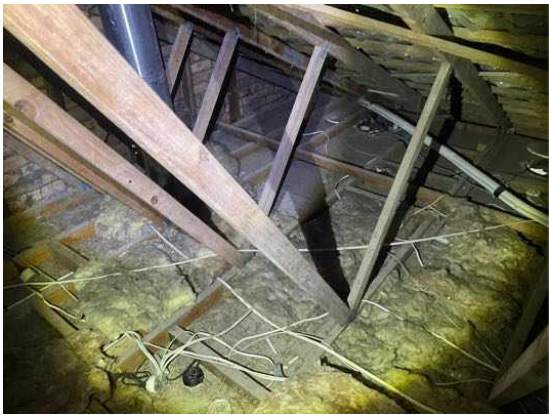
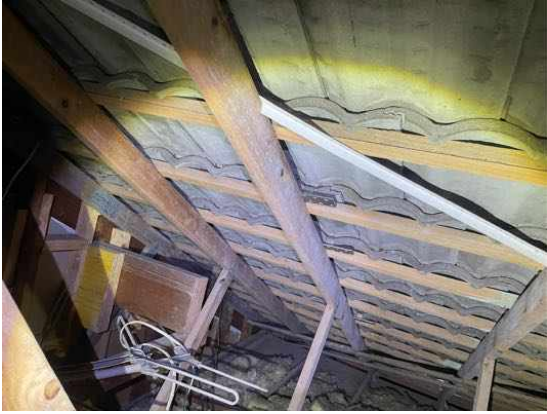
Building: Main Building
Location: Roof Void
Finding: Additional Photos - Obstructions and Limitations
Information: These photographs are an indication of the obstructions and limitations which impeded full inspection of the property at the time of inspection. These obstructions can hide an array of defects and should be removed to allow full inspection to be carried out. A re-inspection is recommended once the areas are made accessible.
