Building and Timber Pest Inspection Report

Inspection Date: Tue, 7 Apr 2026

Property Address: 111 Village Circuit, Gregory Hills NSW 2557

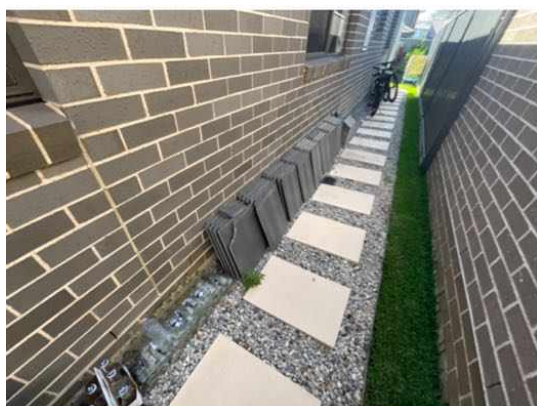
At the time of inspection, it was noted that the weep holes in the external brickwork of the property are concealed by stored building material. This creates a bridging point for termites, allowing undetected access over or around the termite barrier system and into the structure. As a result, a full inspection of this area could not be achieved.

- Concealed termite entry becomes possible when weep holes are obstructed by ground levels, paving, concrete slabs, footpaths, garden beds, or built-up landscaping.
- These obstructions also provide moist, shaded environments that are attractive to termite activity.
- Moisture build-up due to covered weep holes further increases the risk of timber pest infestation and wood decay.

- All weep holes should remain exposed and unobstructed across the entire property to allow for effective drainage and visual termite inspections.
- It is strongly advised that any material or structure covering weep holes be removed promptly, and a re-inspection carried out to ensure termite entry is not occurring undetected.

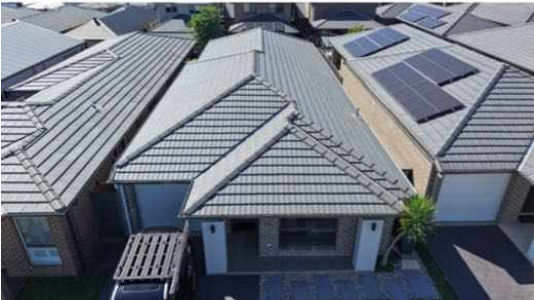
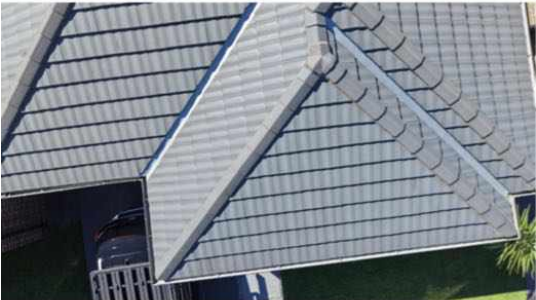
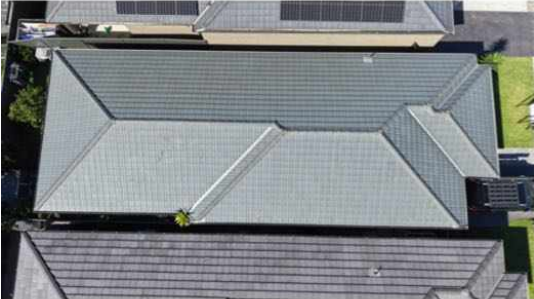
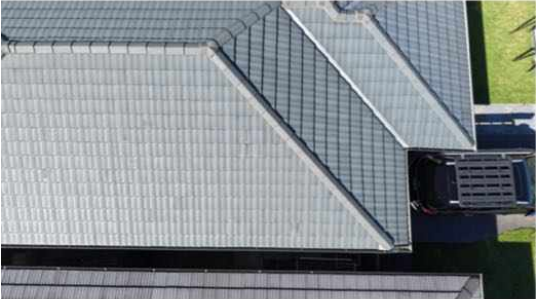
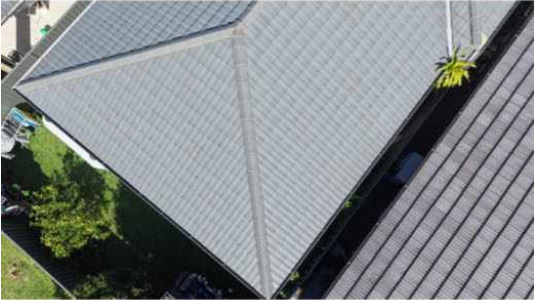
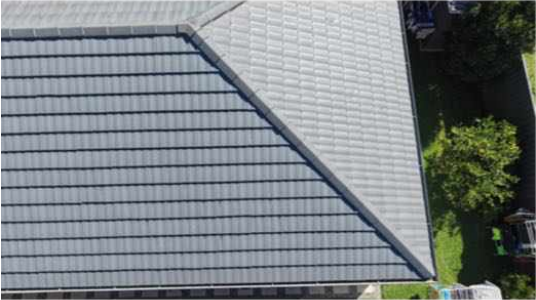
Building:	Main Building
Location:	Roof Exterior
Finding:	Roof Tiles – External Inspection.

Upon inspection of the exterior roofing, the majority of roof tiles were found to be in good condition. The mortar to the capping tiles appeared sound, with no significant signs of deterioration. General weathering of the roof tiles is consistent with the age and type of the property and does not raise immediate concern.

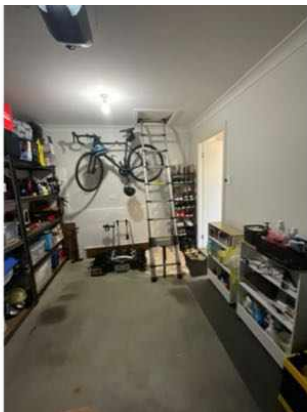
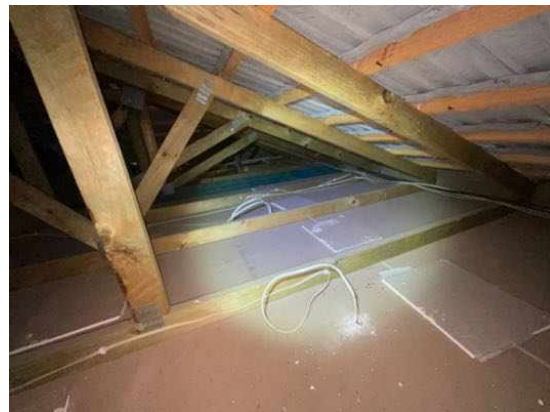
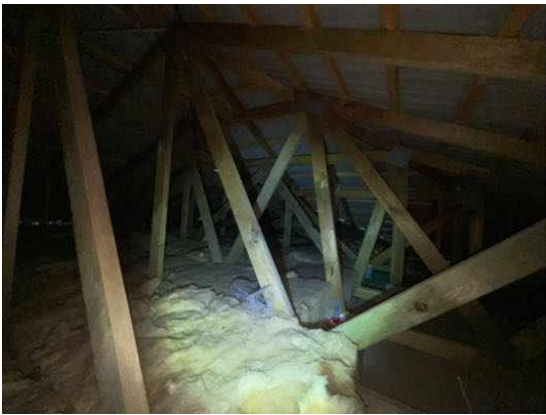
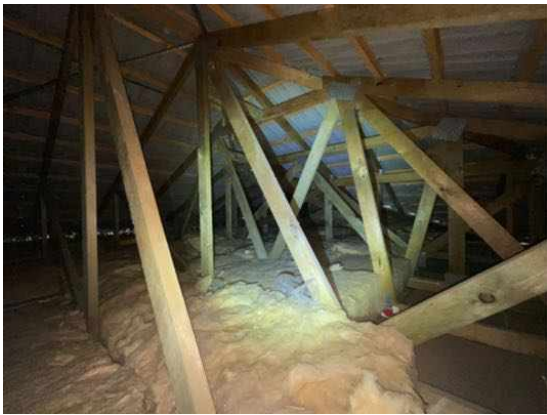
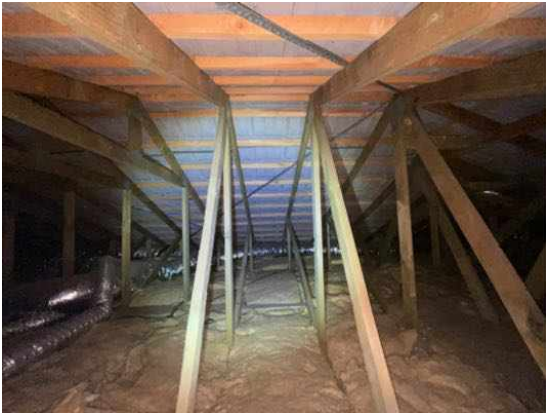
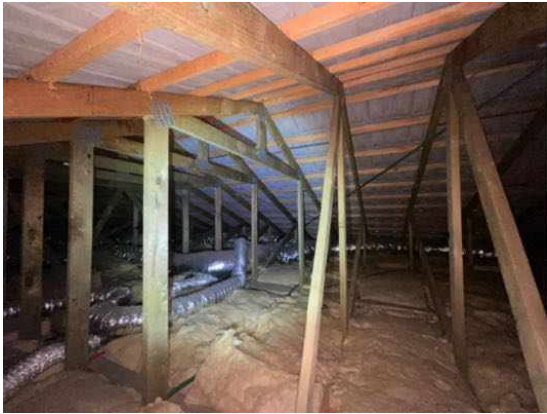
A full inspection of the roof space is not achievable unless all obstructions—including insulation and restricted access points—are removed, and full, safe access is provided. Termite activity or timber pest damage may go undetected in concealed or inaccessible areas.

Installation of an additional manhole is recommended to facilitate a re-inspection and enable a more thorough assessment of the roof void in the future. This will help ensure that all structural elements and concealed areas are properly evaluated.

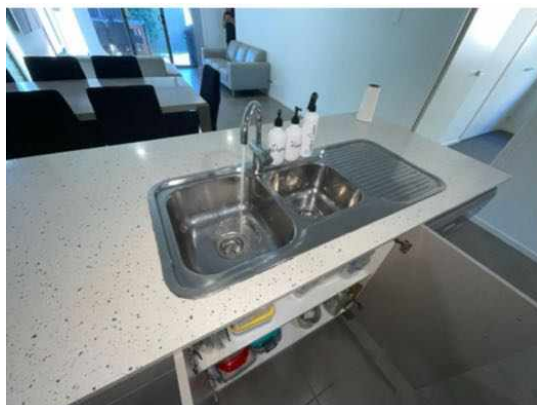
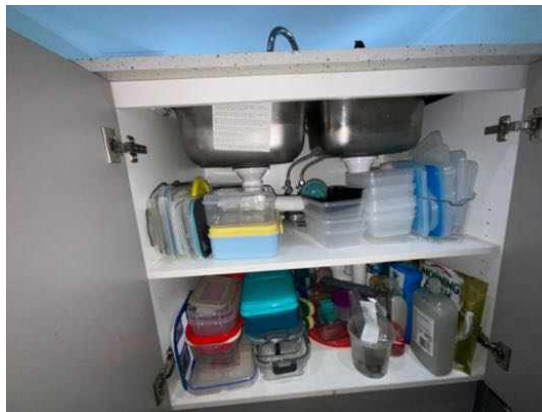
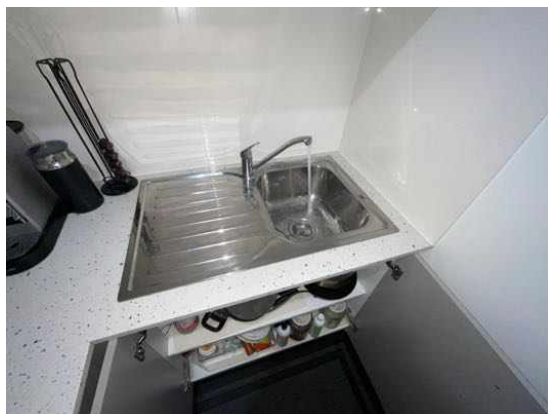
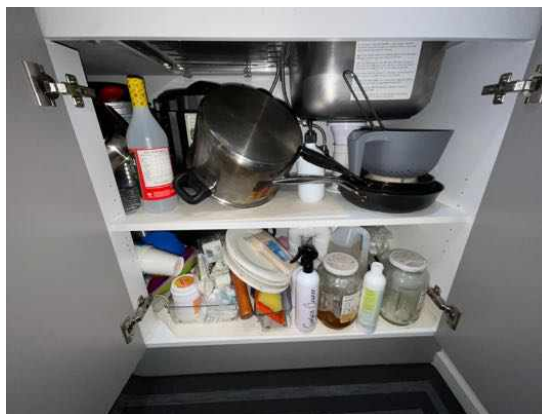
Building: Main Building
Location: Kitchen
Finding: Kitchen Sink – Overall Condition & Recommendations.
Information: Observations:

- The kitchen sink tap(s) were water tested at the time of inspection, with no evidence of leaks or blockages observed in the visible plumbing or drainage.
- No significant water damage was observed to the cabinetry/unit.
- Stored items under the sink obstructed access, limiting a full inspection of the plumbing and internal cabinetry.

- Further monitoring and testing are recommended once the tap(s) are in constant use, to identify any drainage issues or signs of slow leaks not evident during the limited inspection.
- It is recommended that the stored items beneath the sink be removed to allow for a full re-inspection of the plumbing and cabinetry, ensuring no concealed defects are present.

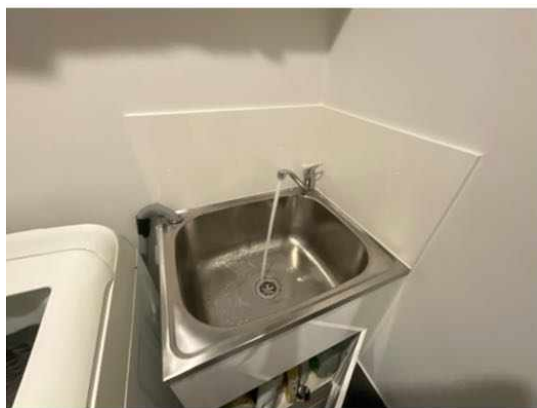
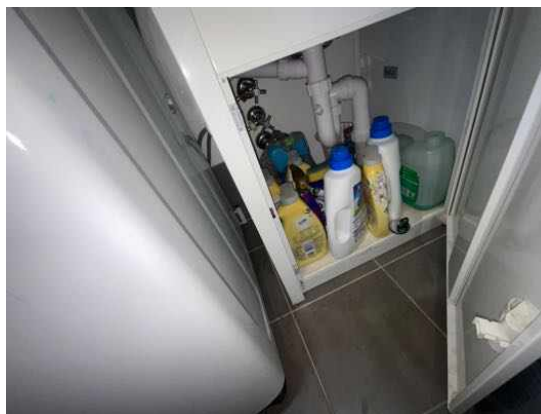
Building: Main Building
 Location: Laundry
 Finding: Laundry - Taps/Plumbing/Drainage.
 Information: Observation: Laundry Tub – Taps, Plumbing, and Cabinetry

- The taps to the laundry tub were water tested and inspected, with no evidence of plumbing or drainage leaks observed at the time of inspection.
- No visible signs of water damage, rust, or corrosion were noted to the cabinetry or surrounding unit during the inspection.

- Further monitoring or testing is recommended once the taps are placed into regular use, to ensure no leaks develop over time and that the drainage system continues to perform adequately.
- Sealant and grouting in wet areas should be maintained as part of the long-term care and upkeep of the property.

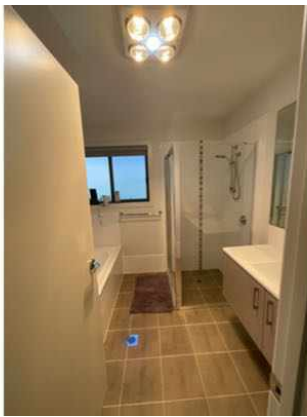
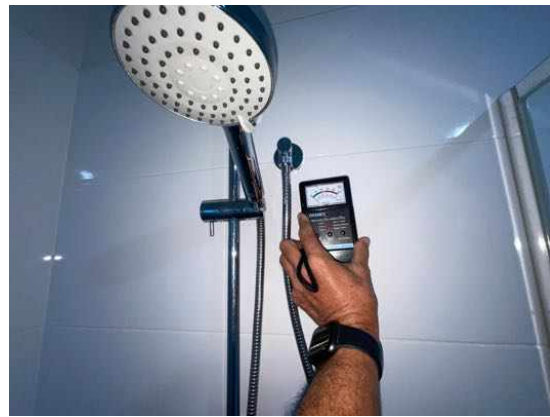
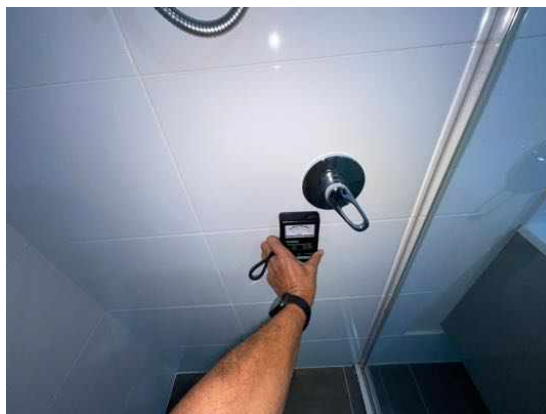
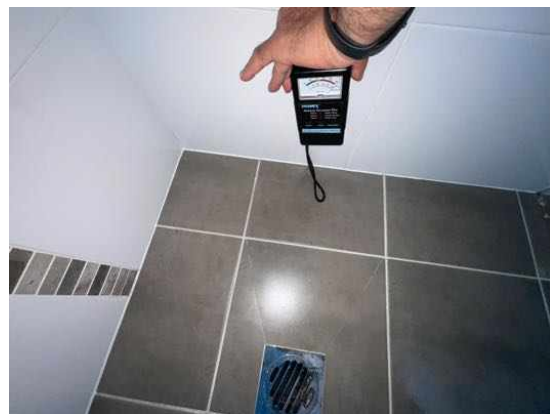
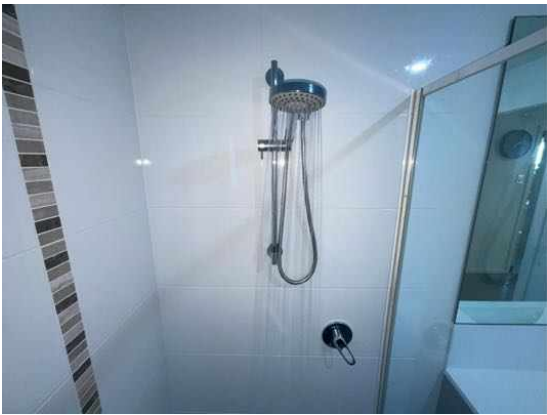
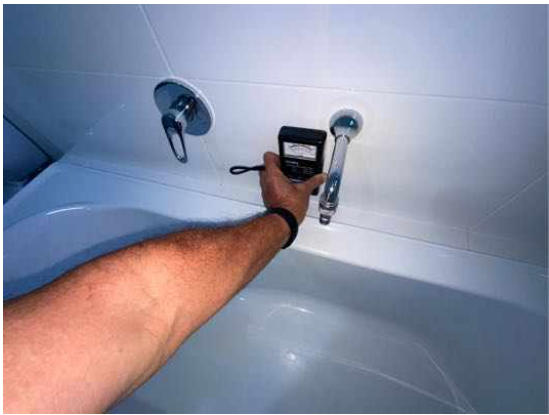
Building: Main Building
 Location: Bathroom
 Finding: Wet Areas - Bathroom(s) - Overall Condition & Recommendations.
 Information: Overall Condition & Recommendations

- Floor waste was found to be clear and free of blockages at the time of inspection. Further monitoring is advised after consistent use to identify any drainage issues or buildup requiring cleaning.

- No elevated moisture readings were detected around the tap fittings or behind the shower walls (as viewed from adjacent rooms), suggesting no active plumbing leaks at the time of inspection.

- Elevated moisture readings were found in the lower shower walls, which is a common occurrence with certain tile types that naturally absorb more moisture. This should be monitored over time.

- Sealing of grout and tiles is recommended to prevent moisture buildup and mould growth in damp areas such as showers.
- The condition of grout and sealant appeared to be good.

- Flood testing of the shower recess is recommended. This may reveal inadequacies in the waterproofing or shower screens, which could lead to water damage in surrounding areas.

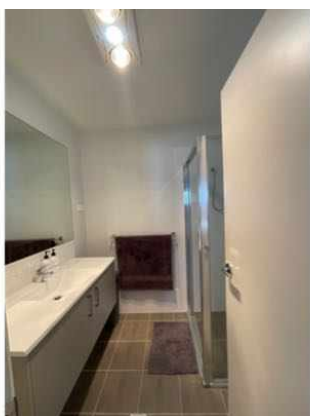
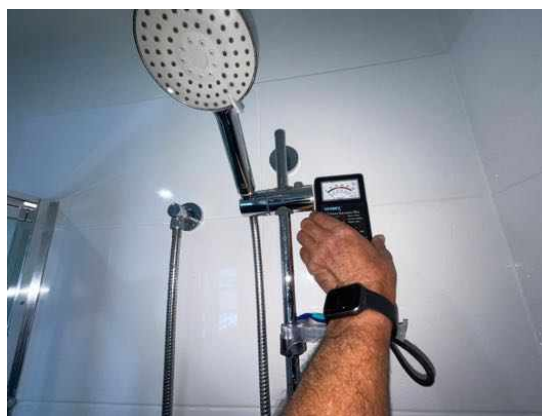
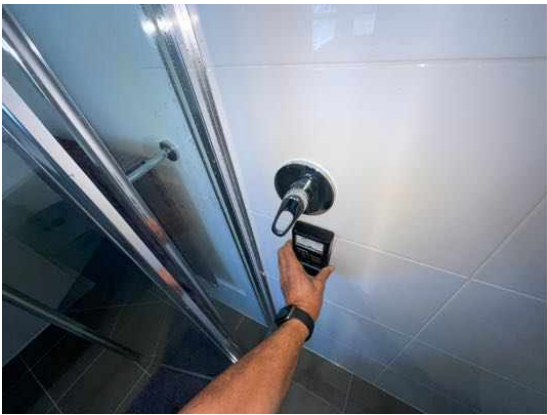
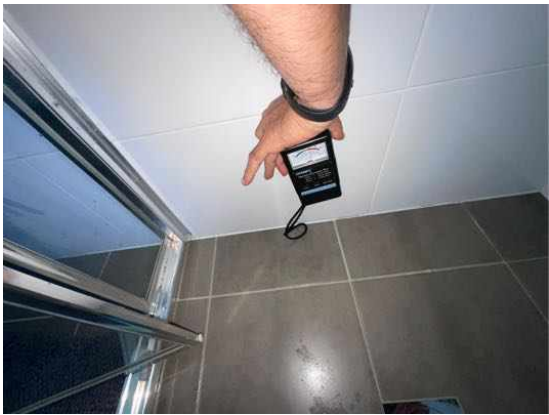
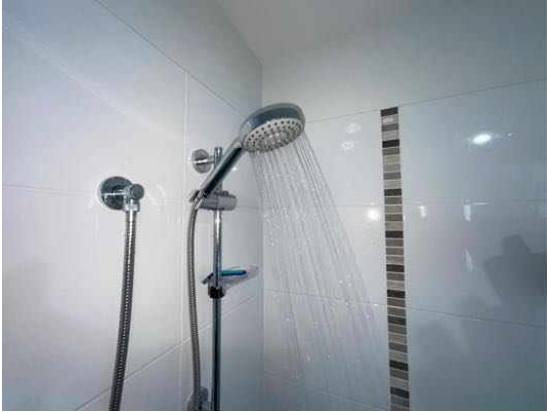
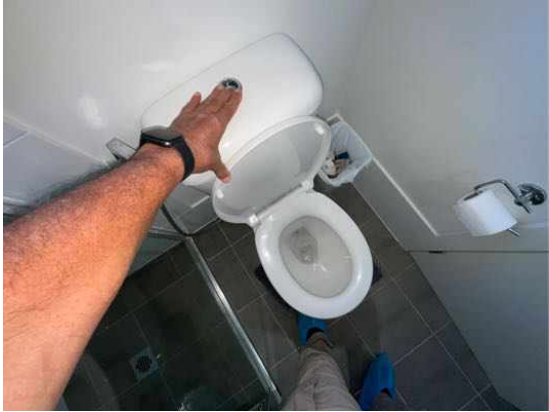
Building: Main Building
Location: Ensuite
Finding: Wet Areas - Bathroom(s) - Overall Condition & Recommendations.
Information: Overall Condition & Recommendations

- Floor waste was found to be clear and free of blockages at the time of inspection. Further monitoring is advised after consistent use to identify any drainage issues or buildup requiring cleaning.

- No elevated moisture readings were detected around the tap fittings or behind the shower walls (as viewed from adjacent rooms), suggesting no active plumbing leaks at the time of inspection.

- Flood testing of the shower recess is recommended. This may reveal inadequacies in the waterproofing or shower screens, which could lead to water damage in surrounding areas.
