# Building and Timber Pest Inspection Report

Inspection Date: Fri, 6 Mar 2026

Property Address: 162/8 Starling St, Buderim QLD 4556,  
Australia

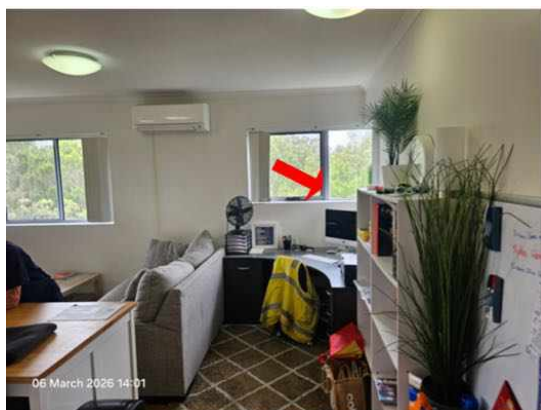
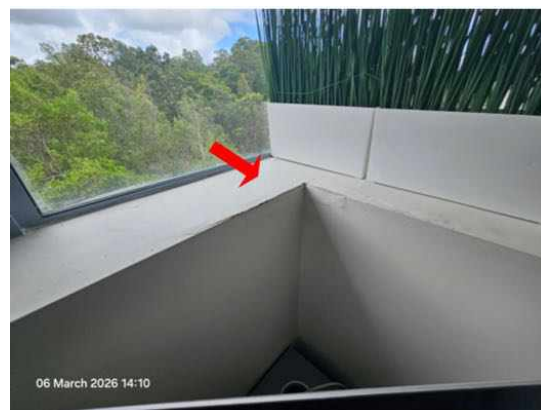
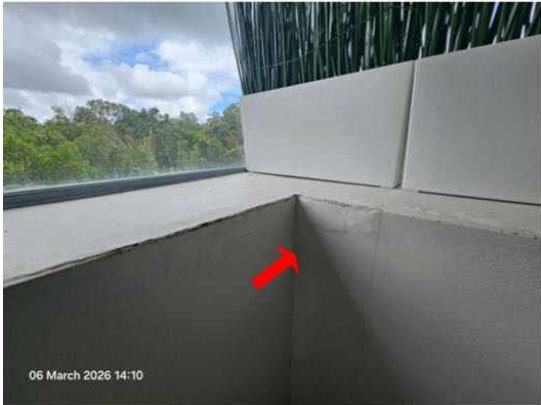
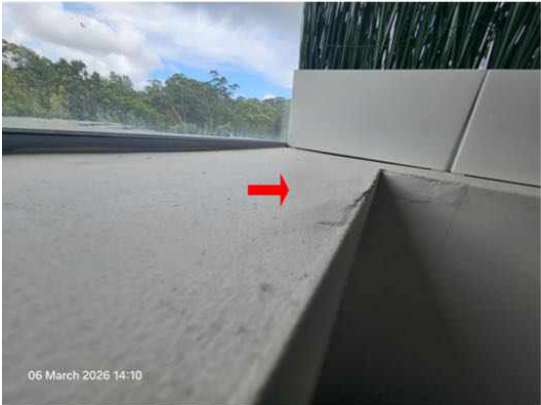
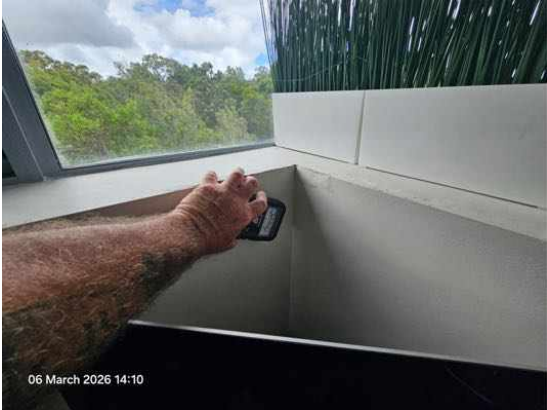
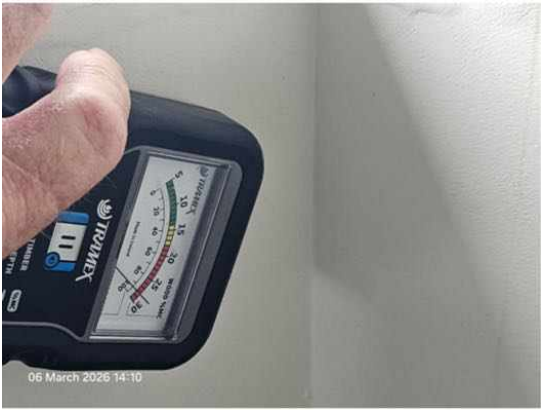
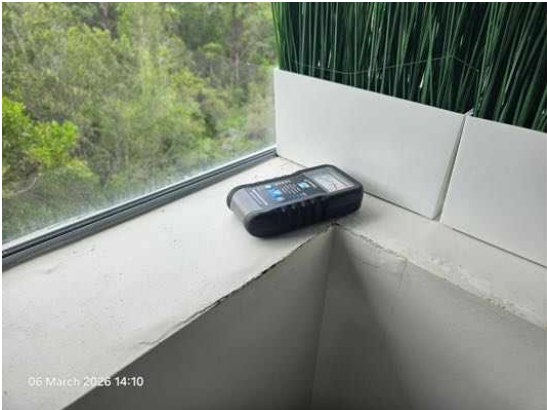
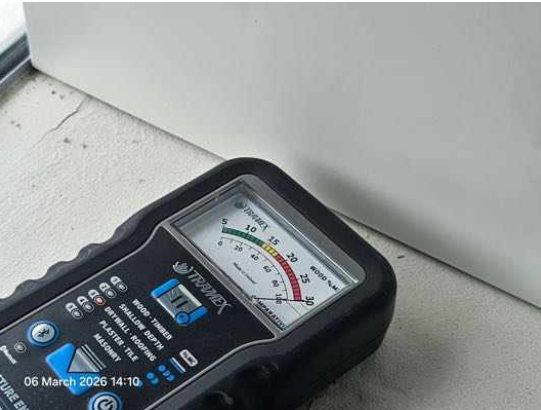
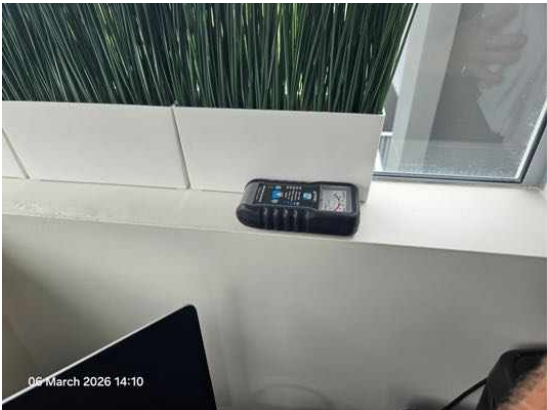
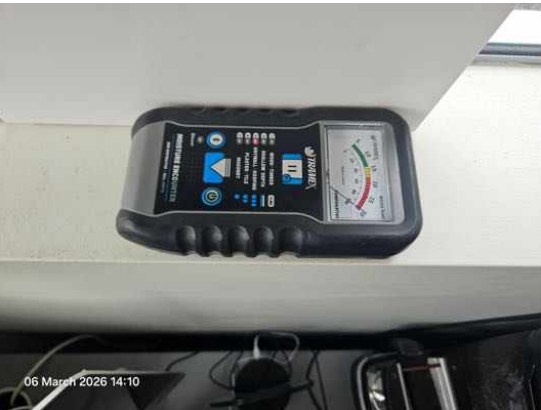
#### Finding 3.01

Building: Main Building  
Location: Living Room  
Finding: Window sill / reveal damage  
Information: During the inspection moisture damage and elevated moisture readings were noted in the plastered reveal of the corner window of the living room as shown. Damage is mostly isolated to the bottom sill and external / internal corners, which would indicate that moisture may be entering through the corner joint between the two panes of glass.

It is not uncommon for this type of finish to be affected in building close to the coast. It was also noticeable that the moisture is affecting the metal external plaster angle.

This should be monitored and if there is no change in the reveal appearance, a licensed plasterer or painter should be engaged to carry out the necessary repairs.

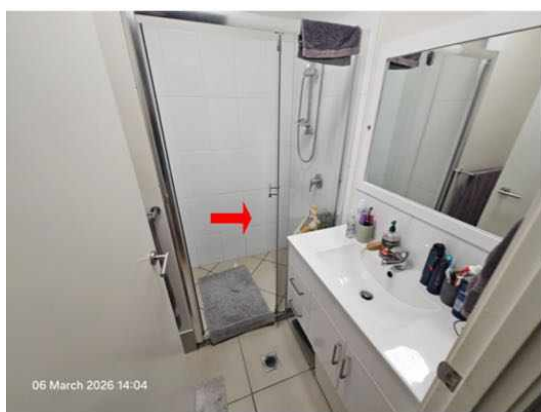
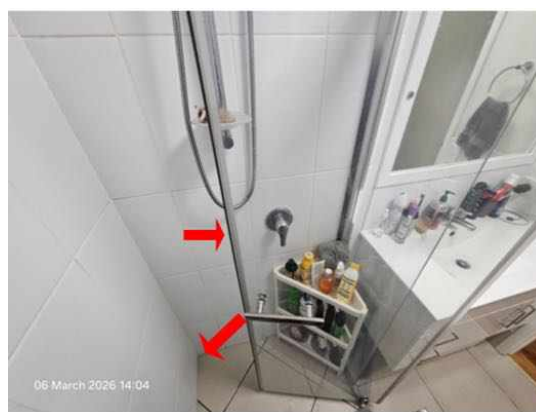
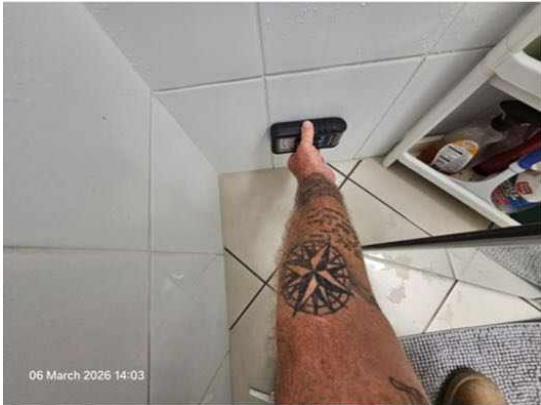
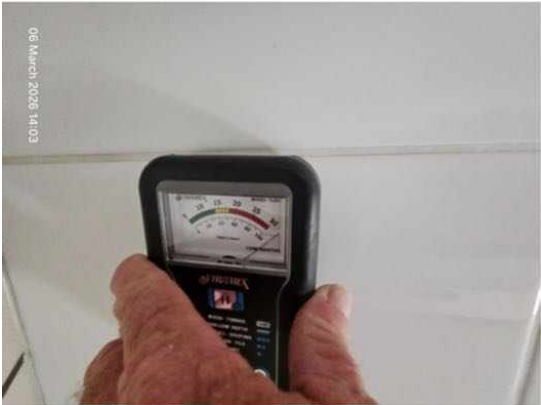
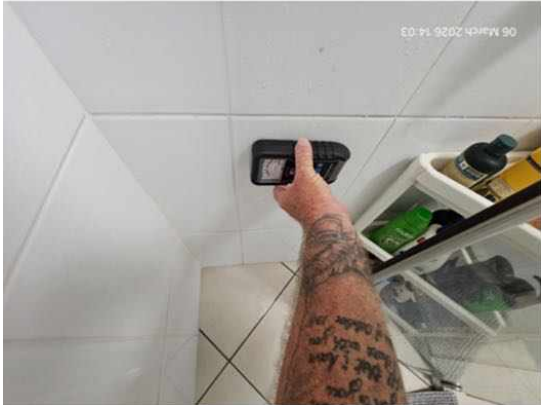
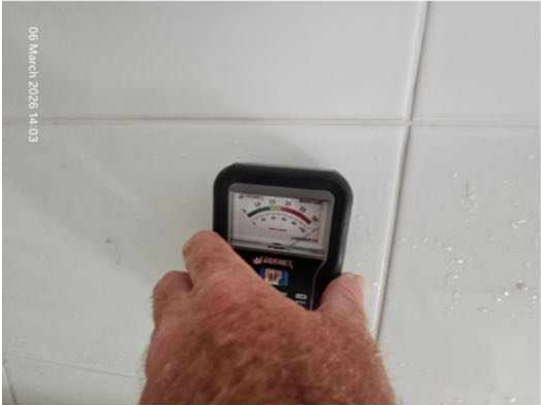
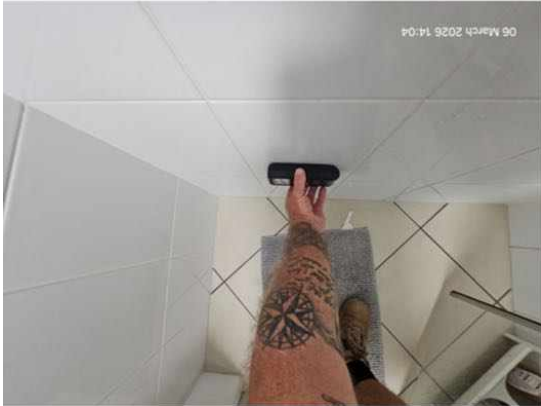
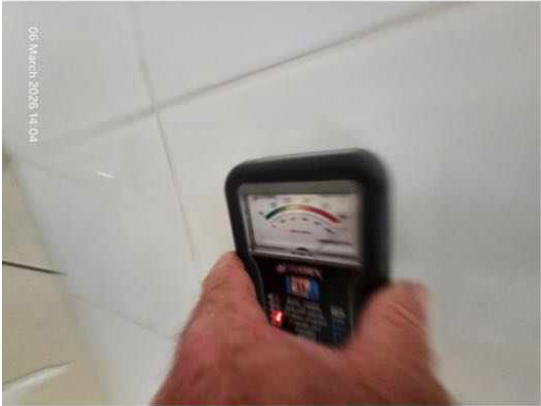
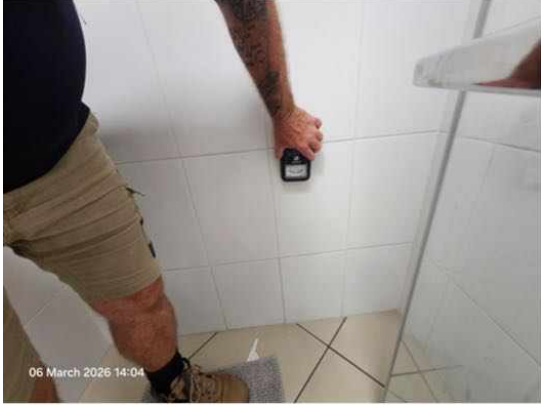
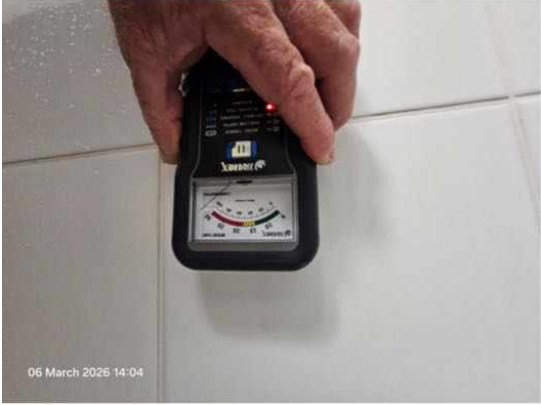
**Finding 3.02**

Building: Main Building  
Location: Bathroom  
Finding: Elevated moisture present at the time of inspection - bathroom  
Information: Elevated moisture was noted in the lower tiled wall surfaces of the bathroom shower.

The levels varied at differing points throughout the recess. This could possibly be due to deteriorated grout and silicone sealants and / or plumbing fittings and fixtures. The grouts and sealants can break down over time and become porous, allowing moisture to enter the wall sheet surface behind the tiles. Some wear and scouring was noted in the grout joints.

Readings were not able to be taken on the reverse sides of the walls due to obstructions.

Plumbing, and shower fittings and fixtures, can be areas of water penetration if not installed correctly and sealed completely. Whenever a fitting is screwed / fitted to the tiled shower walls, the holes and fittings should be sealed with an appropriate sealant to prevent water from entering the wall cavity. This is a common fault.

Elevated moisture can attract timber pests and vermin, and produce conditions that promote timber pest attack, fungal growth and wood decay.

It is recommended that the moisture levels in these areas be minored over time and the grout and silicone could be renewed to possibly eliminate any further moisture penetration.

A licensed tiler and / or sealant specialist could be engaged to renew these elements.

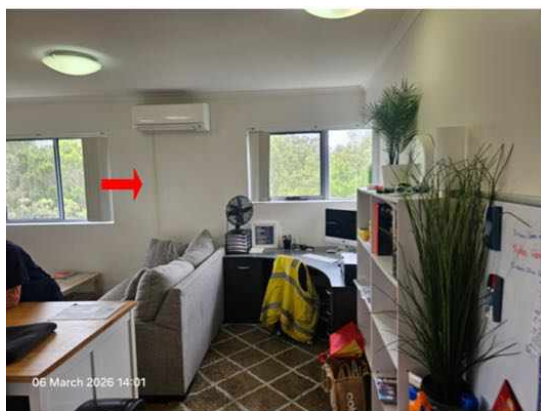
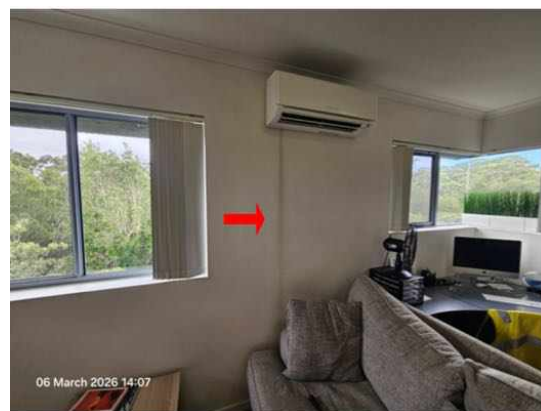
**Finding 3.03**

Building: Main Building  
 Location: Living Room  
 Finding: Wall - moisture stained, minor damage  
 Information: Moisture damage to the wall lining on the interior surface of the external wall beneath the air conditioner was noted on the day of inspection and is generally an indication of moisture being present at some time previously from a leak in the air conditioner head unit.

It appears that the leak may have been resolved as there were no elevated readings shown on the day.

Monitor this in the future and ensure regular servicing is carried out on the air conditioner.

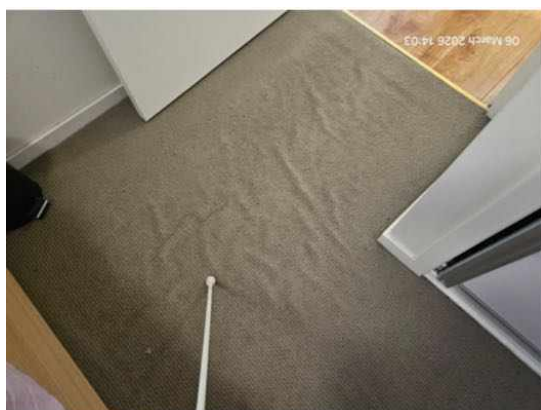
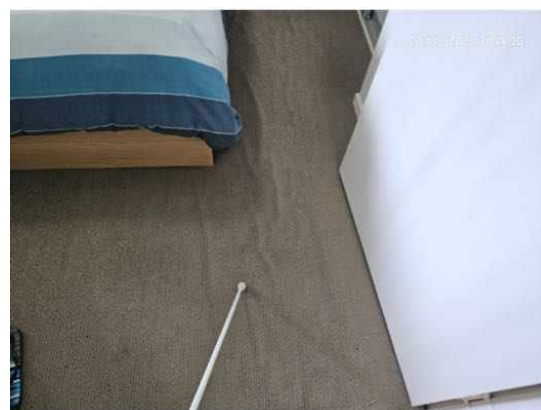
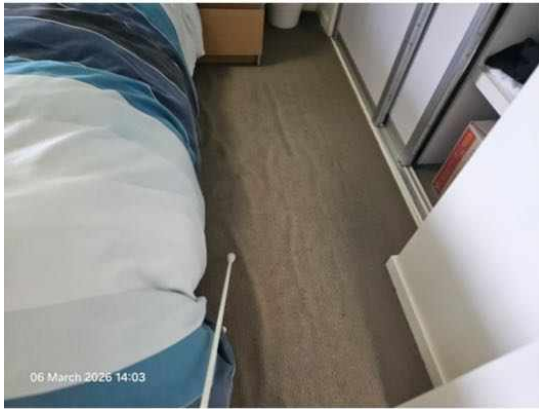
### Finding 3.04

Building: Main Building  
 Location: Bedrooms  
 Finding: Carpet overstretched  
 Information: At the time of inspection the carpet in the bedrooms appears to be overstretched and is loose. A carport / flooring contractor could be engaged to make good the carpet surface.

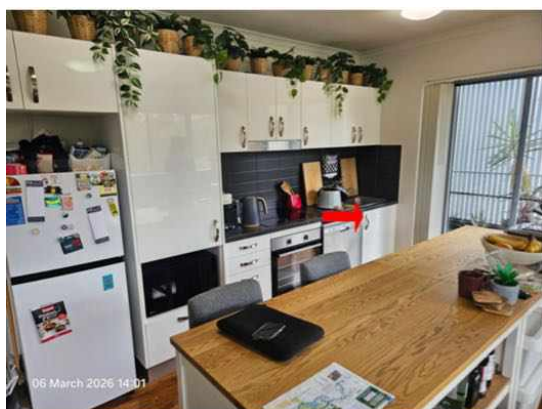
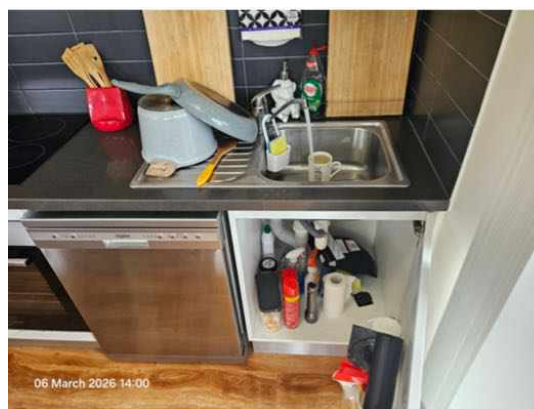
Building: Main Building  
 Location: Kitchen cupboard  
 Finding: Durable timber pest notice - not assessable  
 Information: On the day of inspection it was noted that the durable pest inspection / treatment notice was missing, not visible or out of date. These notices / stickers are to verify the currency and type of timber pest system / barrier in place or being used in and around the property.

It will be assumed that there is no current system in use.

It is recommend that a licensed timber pest controller be contacted to assess the properties needs and provide costings.

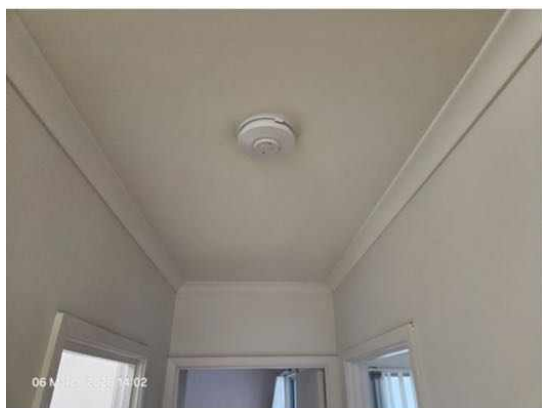
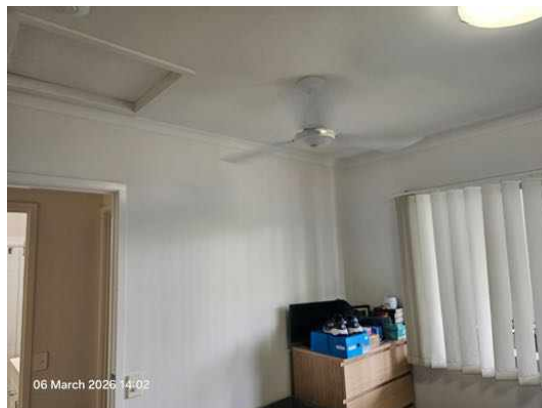
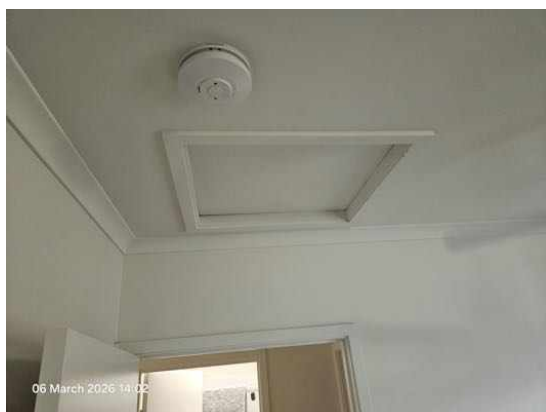
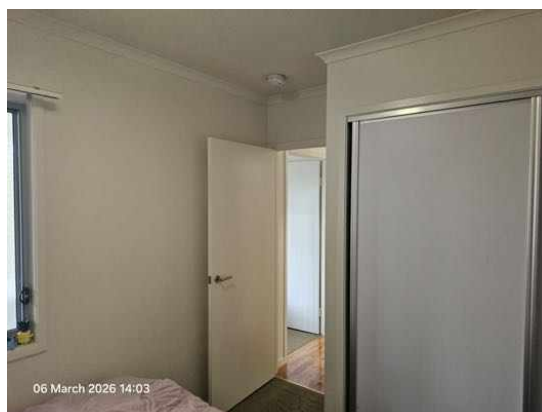
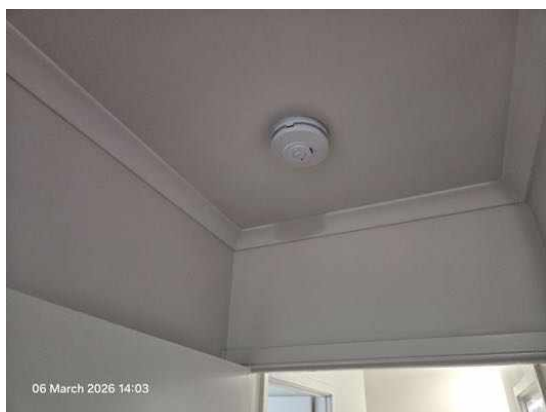
Building: Main Building  
 Location: All Internal Areas  
 Finding: Smoke Detectors and Alarms. AS 3786:2014  
 Information: Reporting on Smoke Detectors or Alarms, including hard wired smoke detection systems and their legislative requirements, is outside the Scope of this Report.

Always ensure sufficient working and suitable smoke detectors are installed prior to occupying any building. Additionally, it is advised that all smoke detectors be tested by the homeowner on a monthly basis.

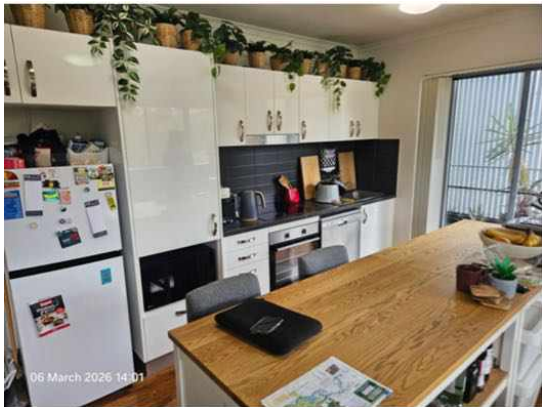
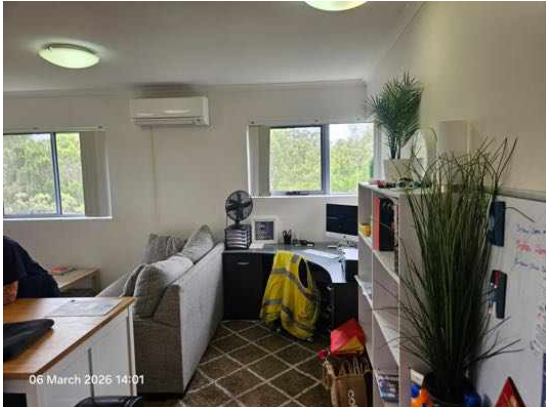
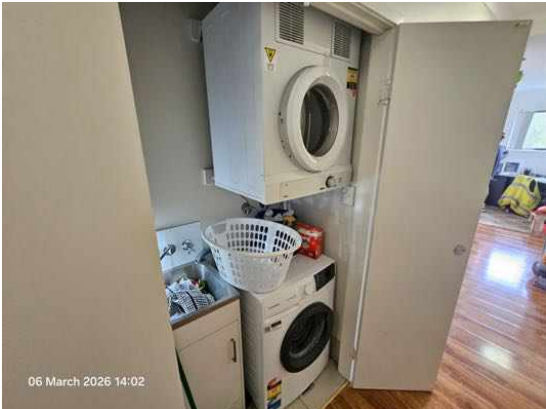
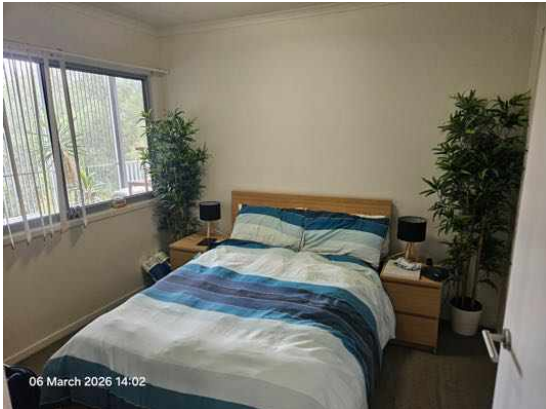
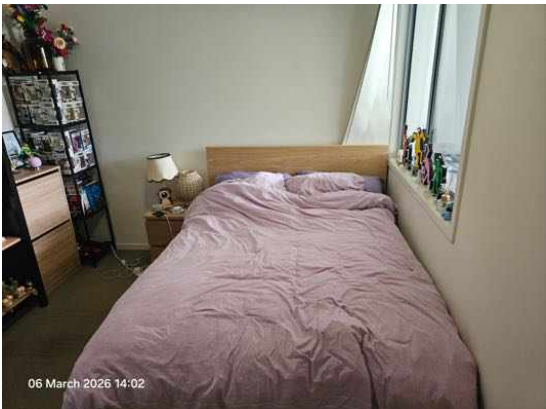
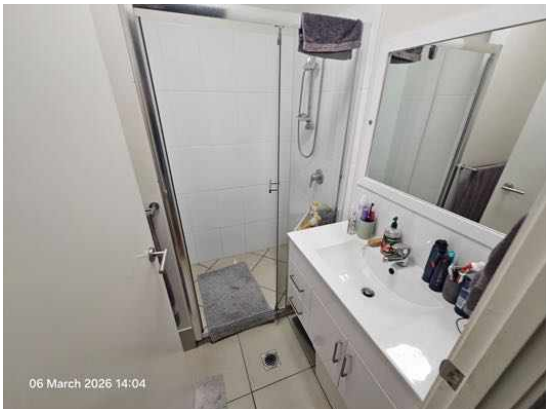
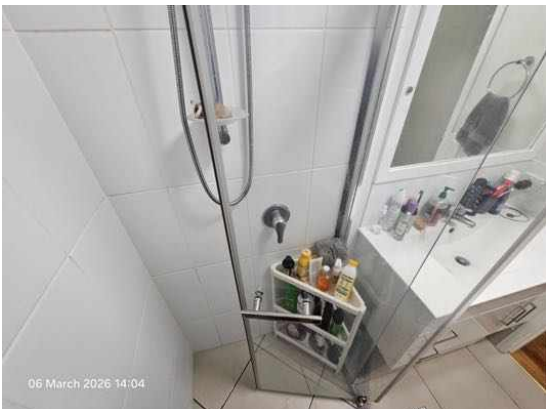
Building:	Main Building
Location:	All Areas
Finding:	Additional Photos - Obstructions and Limitations
Information:	These photographs are an indication of the obstructions and limitations which impeded full inspection of the property at the time of inspection. These obstructions can hide an array of defects and should be removed to allow full inspection to be carried out. A re-inspection is recommended once the areas are made accessible.
