Building Inspection Report VR

Inspection Date: Sun, 8 Mar 2026

Property Address: 5 Courtley Ave, Kellyville Ridge NSW 2155,
Australia

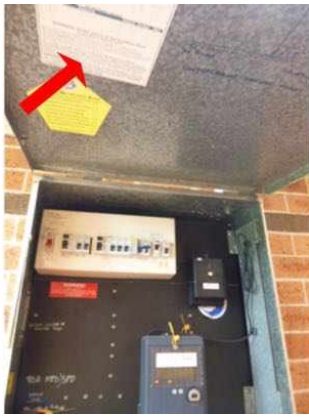
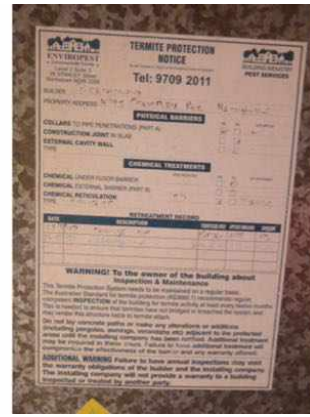
Building:	Main Building
Location:	Meter Box
Finding:	Termite Management System - Evidence of installation
Information:	<p>There are a number of factors which indicate the presence of a previously installed or applied termite barrier. The most common are a durable notice (to the inside of your meter box) observable physical barriers installed to building perimeter and in ground reticulation systems. Where a Termite Management System has been identified you should refer to the type of barrier date of installation warranty conditions and any documentation provided by a builder or past owner. Consult the company who installed the barrier to confirm whether the system is still under warranty.</p> <p>Most chemical termite management systems expire and require replenishment and all physical systems are primarily designed to prevent concealed entry. The client may consider gaining further advice from a pest controller as to the costs and procedures involved with this application. It is recommended that obtaining such advice be a short-term priority.</p>

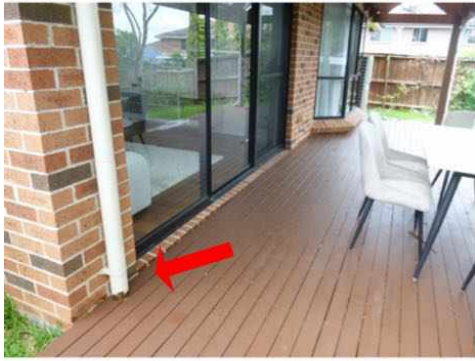
Building: Main Building
 Location: Alfresco
 Finding: Bridging of termite barrier
 Information: Bridging of termite barriers occurs when termites bridge (usually by building a mud tunnel) a termite barrier or inspection zone or where termites have a passage allowing them to bridge the barrier.

Generally this takes the form of finished ground levels external paving or concrete being retrospectively installed above the damp course level the adjacent internal floor level or weep and ventilation holes.

Where bridging has occurred full inspection is prevented and termites may enter a property in a concealed or undetectable manner.

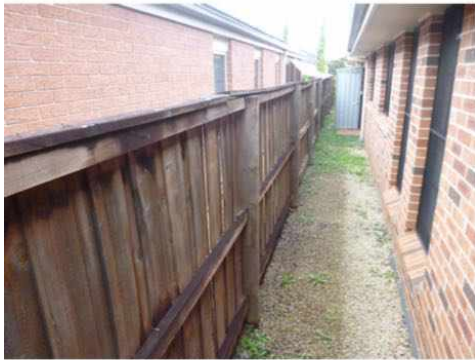
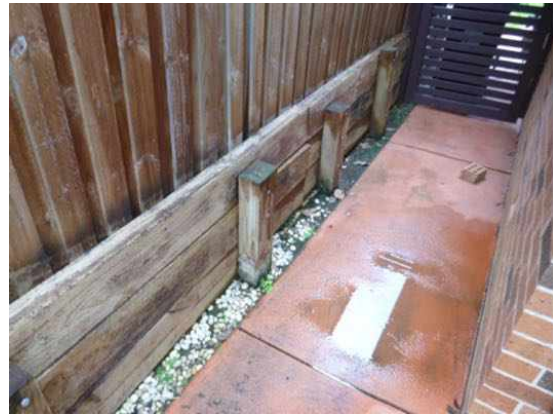
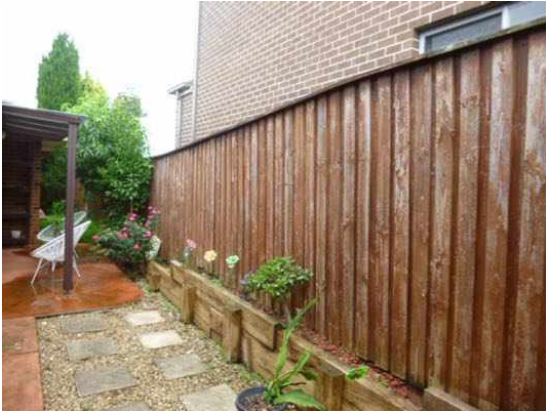
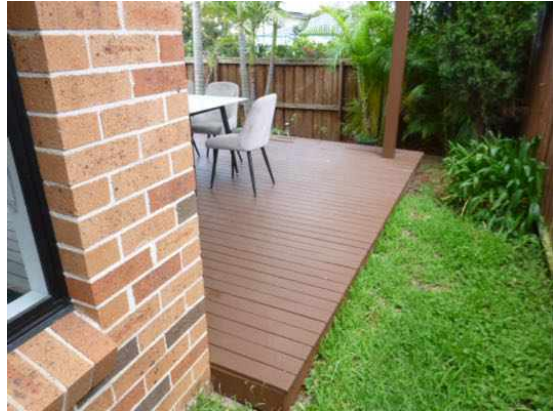
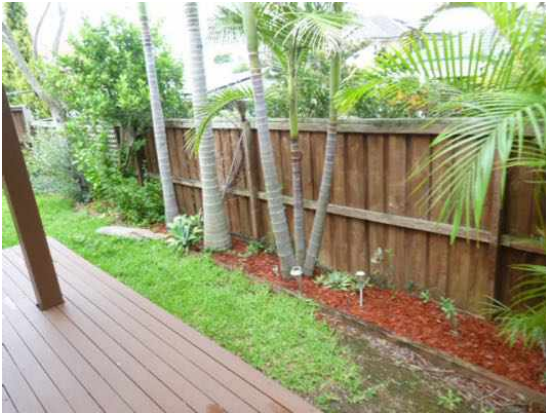
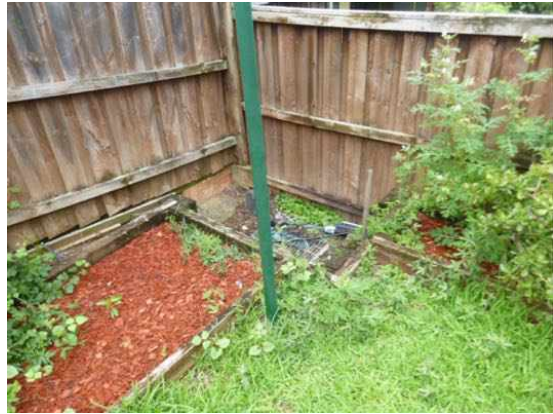
Building:	Main Building
Location:	All External Areas
Finding:	Landscaping Timber
Information:	There is no evidence of termite damage in these timber.

Any timbers in direct ground contact provide opportunity for concealed termite entry and are likely to be subject to premature rot and decay as the soil retains moisture or damp conditions against the timbers. Remove untreated timber that is in direct contact with external grounds. If there is old tree stumps present frequent pest inspections are advised to readily identify any termite activity in these areas. Monitor treated landscape timbers within the garden area, as treated pine breaks down and rots over a period of time causing conducive conditions for termite activity.

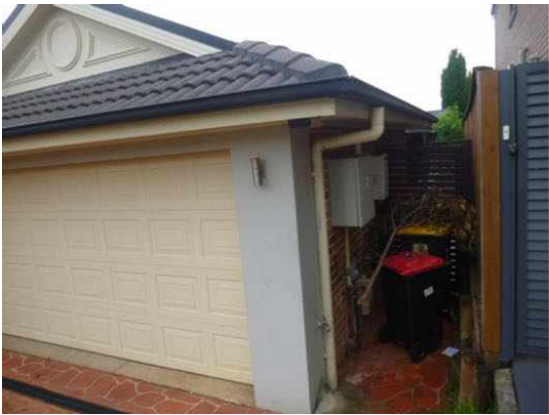
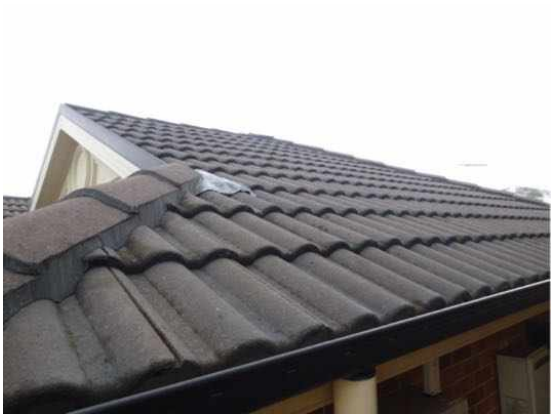
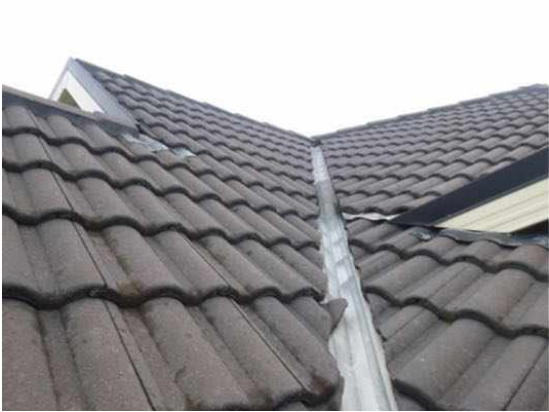
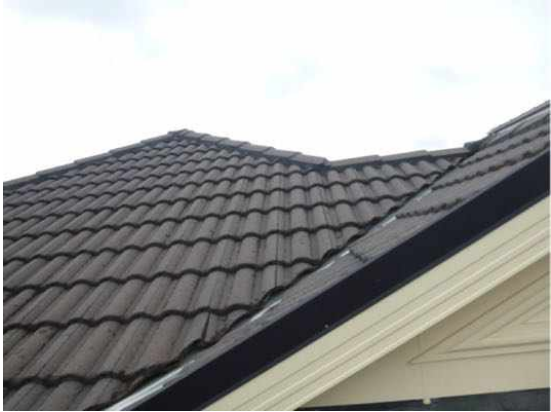
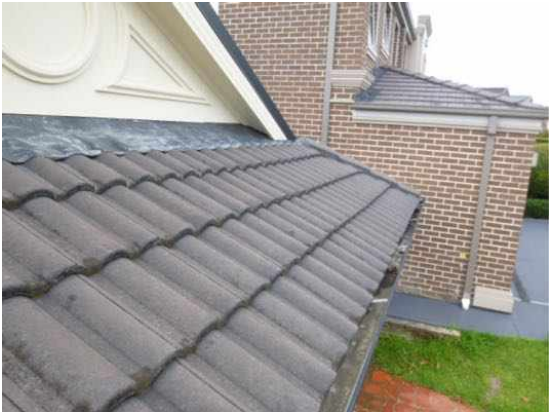
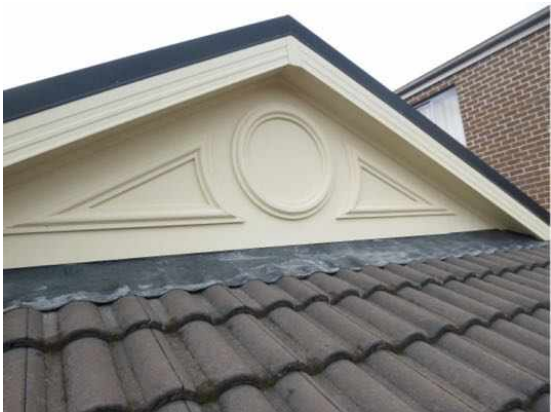
Building: Main Building
Location: Roof Exterior
Finding: Roof Tile - Good condition
Information: Upon inspection of the exterior and interior roofing, the majority of rood tiles were considered to be in a good condition. There is no leakages at the time of the inspection.

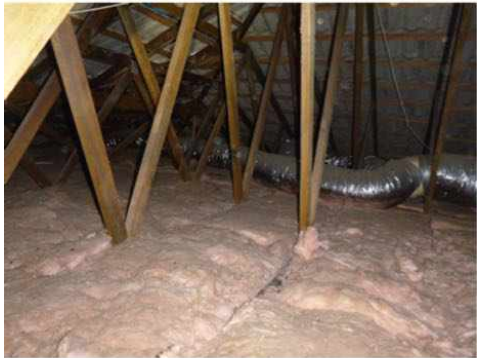
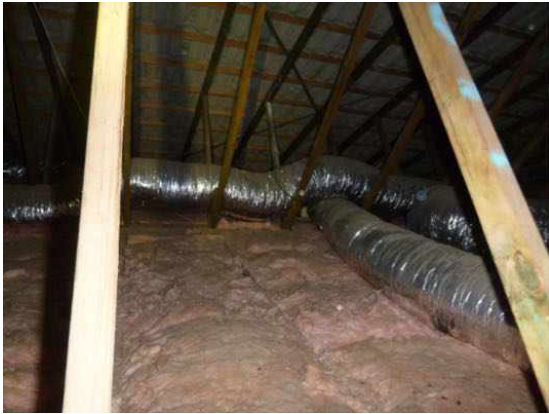
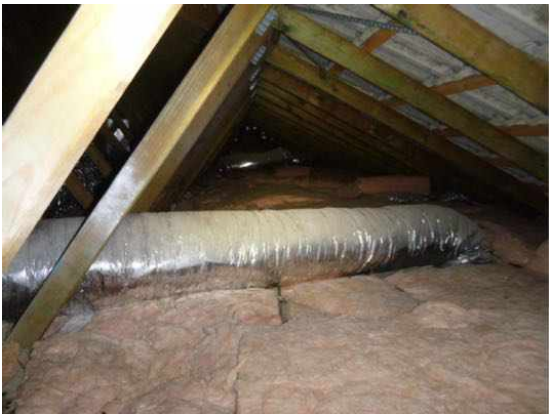
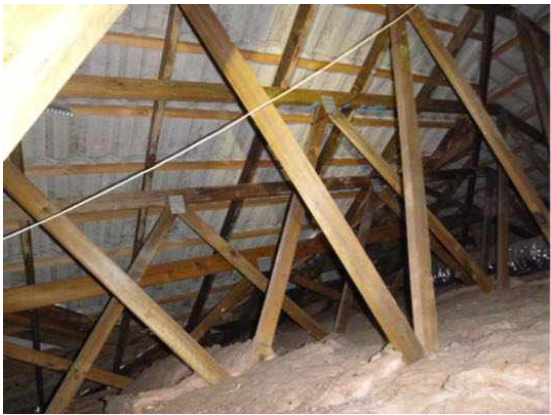
Building: Main Building
Location: Roof Void
Finding: Insulation - adequate
Information: Upon inspection of the roof void it was noted that there is adequate insulation. Insufficient insulation will result in a comparatively higher cost to heat and cool a property as there is adequate Insulation which works as a barrier to heat transfer. This helps to keep out unwanted heat in summer and preserves warmth inside your home in winter. It can also help soundproof your home from unwanted airborne noise transfer.

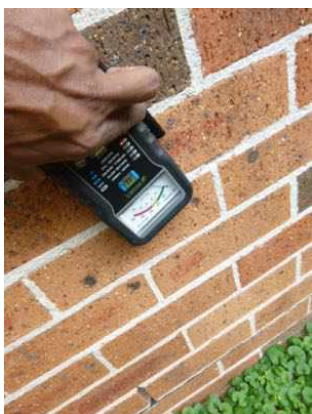
Building: Main Building
Location: All Areas
Finding: No Excessive Moisture
Information: All areas of the dwelling are checked with particular attention paid to wet areas which were closely assessed to check for excessive levels of moisture and temperature anomalies. No evidence of excessive moisture was found inside the house at the time of the inspection.

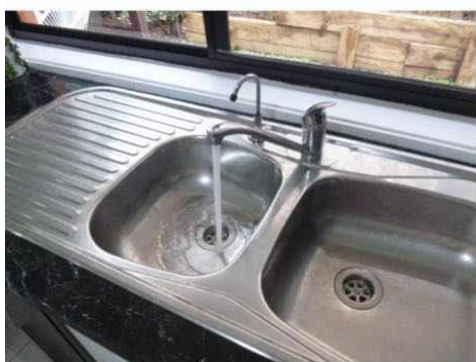
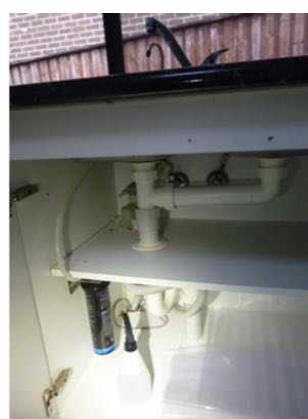
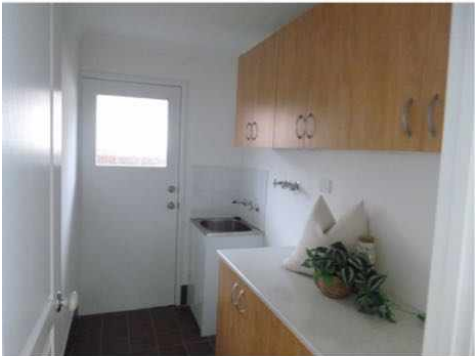
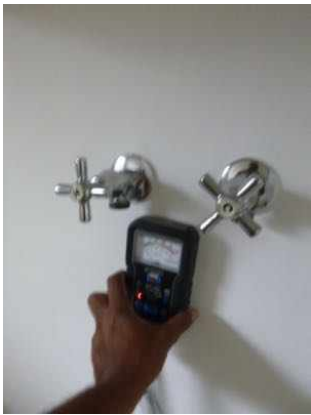
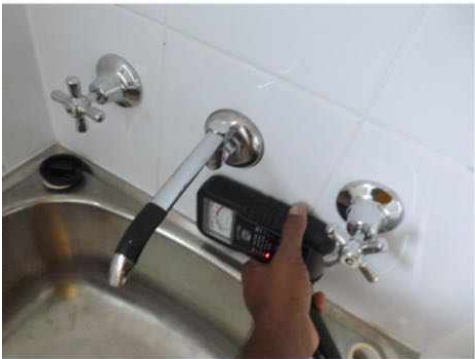
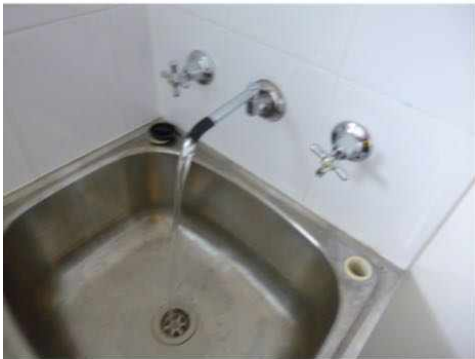
Building: Main Building
 Location: Bathroom And other wet area
 Finding: No evidence of excessive moisture- Bathroom & Laundry
 Information: All areas of the dwelling are checked with particular attention paid to wet areas which were closely assessed to check for excessive levels of moisture and temperature anomalies. There was NO evidence of excessive moisture present at the time of inspection in bathrooms.

Regular maintenance and replacement of damage or missing or damaged sealant and grout is highly recommended to the wet areas, as this is a regular wear and tear defect. Sealant and grouting in areas that come into regular contact with water should be maintained for the long term care of your property. Excessive moisture can attract termites and produce conditions that promote termite attack fungal growth and wood decay. It is highly recommended that all plumbing and drainage fixtures and fittings be maintained regularly in order to prevent excessive moisture being present in the external / internal property.

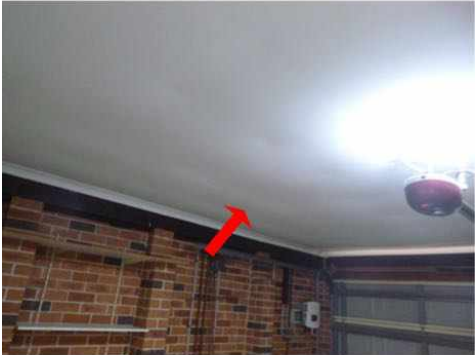
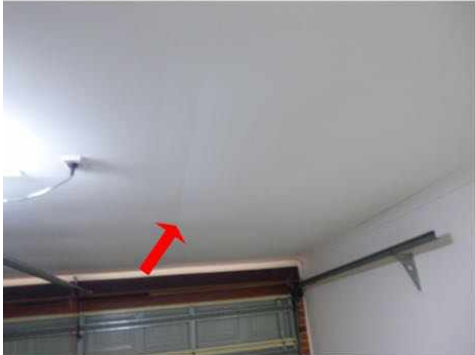
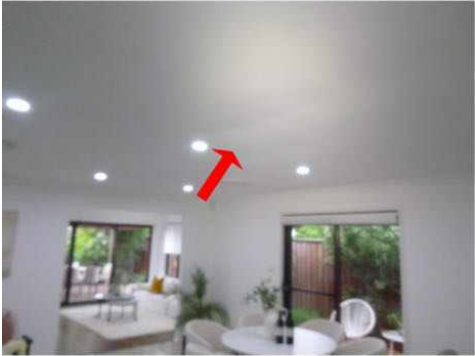
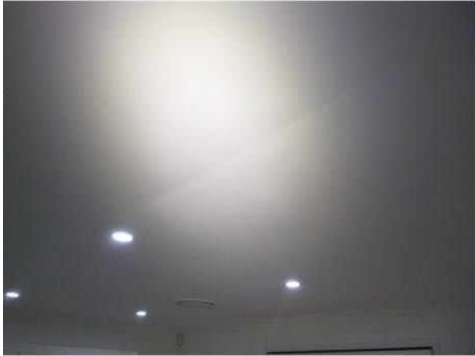
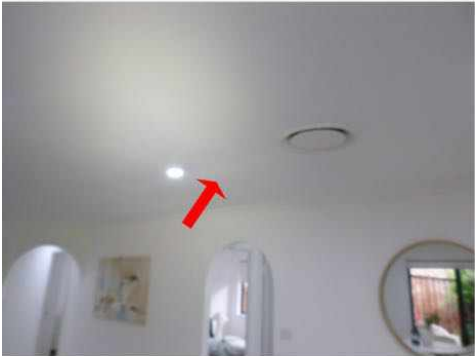
Building: Main Building
 Location: Garage Living
 Finding: Ceiling - Minor sagging
 Information: Sections of the ceiling were found to be minor sagging at the time of inspection. Sagging to the fixed ceiling structure generally indicates that the building materials have swollen, due to contact with water, or that fixings (e.g. nails or glue) have become loose and require reattachment.

Where minor sagging is evident, comparatively minor works, such as re-gluing of ceiling sheets, may be required. Such works may be performed by relevant tradespeople, such as plasterers and painters. Where excessive moisture has caused

the roofing structure to swell and sag, the source of the water leak should primarily be identified prior to any remedial works being performed.

The appropriate action should be taken by the client as soon as possible to ensure that any potential further damage is limited.

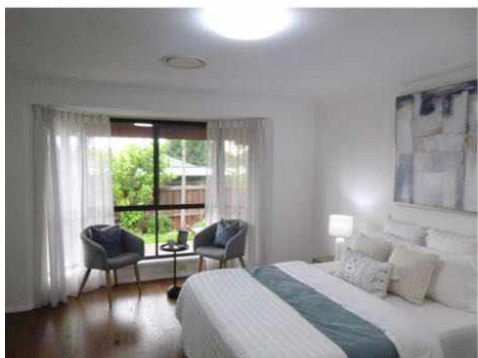
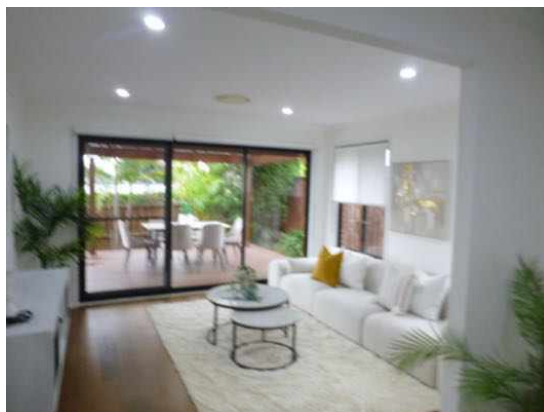
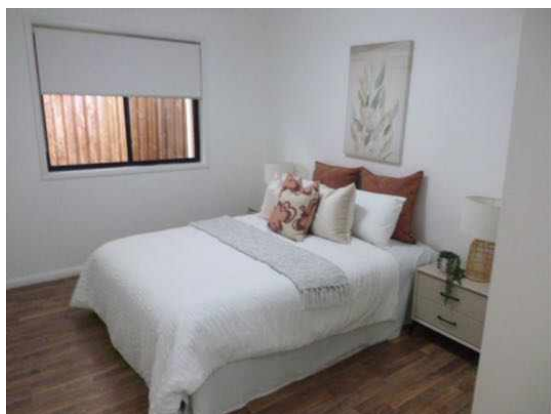
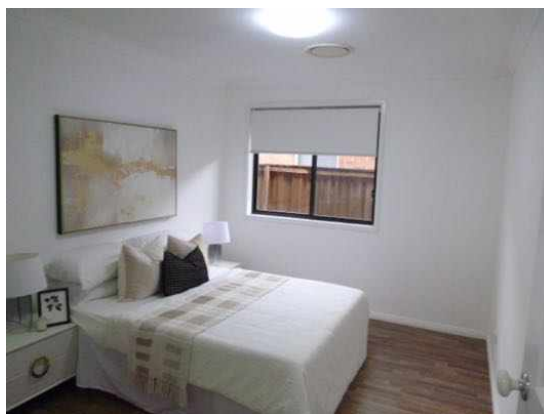
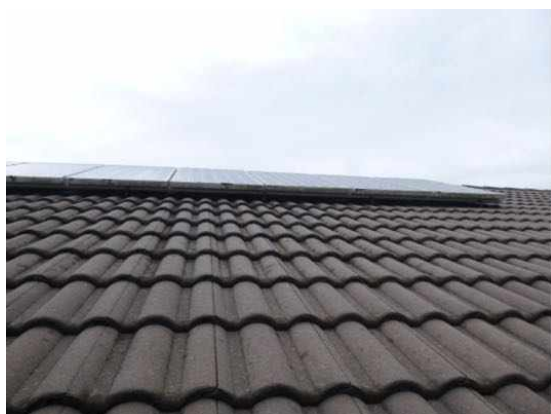
Building: Main Building
Location: All Areas
Finding: Additional Photos - Obstructions and Limitations
Information: These photographs are an indication of the obstructions and limitations which

impeded full inspection of the property at the time of inspection. These obstructions can hide an array of defects and should be removed to allow full inspection to be carried out.
