Building Inspection Report

Inspection Date: Thu, 5 Mar 2026

Property Address: 10/ 548 Marine Parade, Biggera Waters
QLD

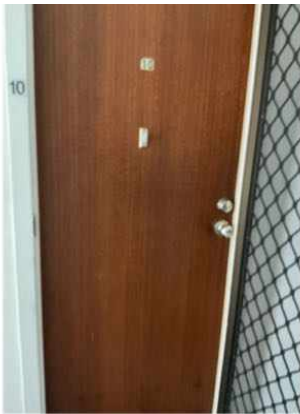
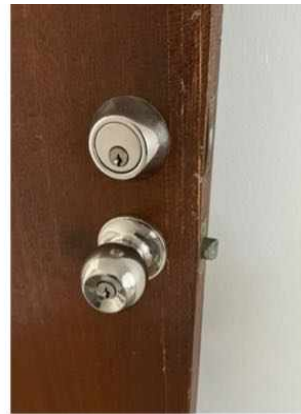
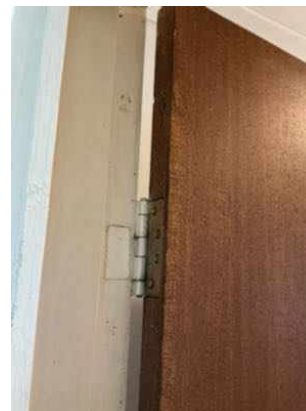
Defects 1.01

Building: Main Building
 Location: Entry > Front
 Finding: Door entry - Damaged
 Information: It was noted at the time of inspection that the entry door is damaged. This deterioration is suspected to have been caused by impact damage.

Front entry door is damaged and requires repairs or replacement.

Please note, front door may contain asbestos and may require additional safety precautions if any works are carried out.

Replacement or repairs of the door is advised to ensure the protection and longevity of any associated building elements. Such works may be performed by a general handyman or qualified carpenter.

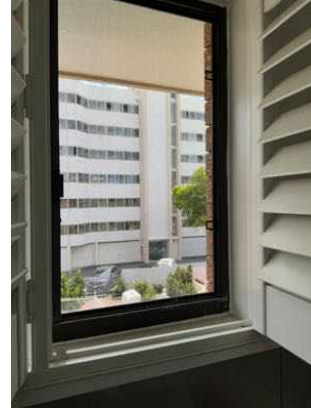
Defects 1.02

Building: Main Building
 Location: Kitchen > Front
 Finding: Window restrictors not installed.
 Information: At the time of inspection it was noted that windows to leisure room (first floor) does not have window restrictors installed.

Accordance with NCC volume1 clause d2.24 or NCC volume 2 clause 3.9.2.6 any window that has a fall of 2 meters or more should be restricted so that a sphere of 125mm (12.5cm) cannot pass through the opening at force of 250n or 25kg of force.

It recommended that restrictors be fitted before handover.

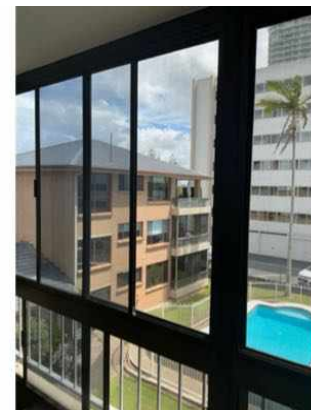
Defects 1.03

Building: Main Building

Location: Sunroom > Front

Finding: Window restrictors not installed.

Information: At the time of inspection it was noted that windows to leisure room (first floor) does not have window restrictors installed.

Accordance with NCC volume1 clause d2.24 or NCC volume 2 clause 3.9.2.6 any window that has a fall of 2 meters or more should be restricted so that a sphere of 125mm (12.5cm) cannot pass through the opening at force of 250n or 25kg of force.

It recommended that restrictors be fitted before handover.

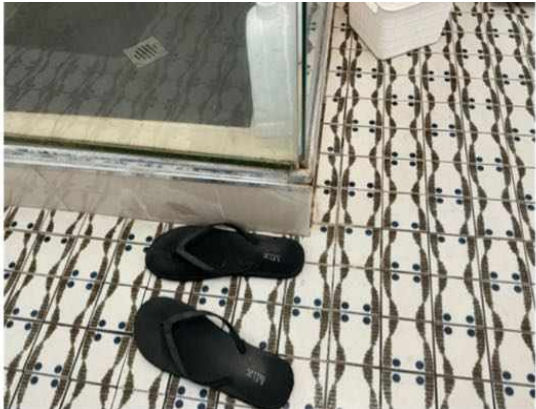
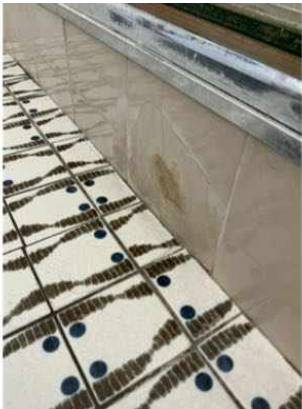
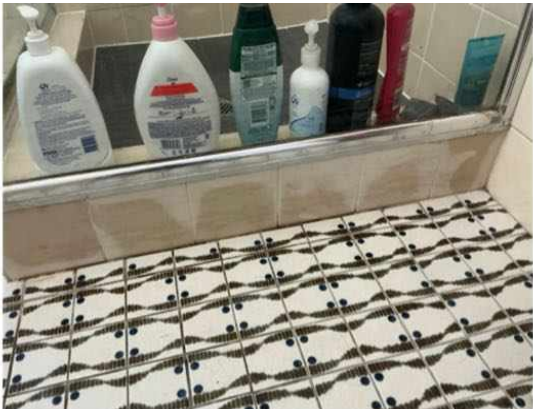
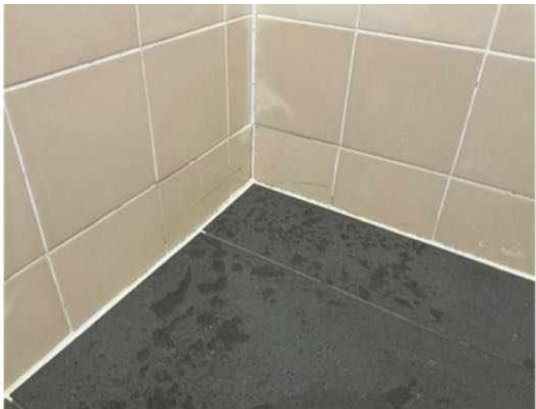
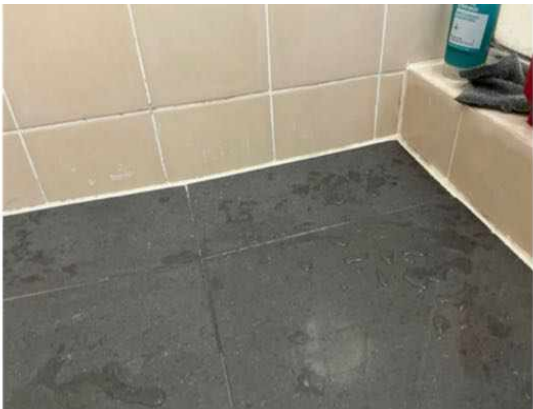
Defects 2.01

Building:	Main Building
Location:	Bathroom > Existing
Finding:	Shower base - Cracked
Information:	Cracking was evident to the shower base at the time of inspection. The cracking is more than likely due to impact damage, but may have also been caused by general ageing and deterioration of associated building elements. While the cracking appears to be minor, any additional impact may lead to further cracking.

As this area is frequently exposed to water, any cracking is likely to allow water penetration to adjoining building elements. If left unmanaged, water penetration may cause water damage to these elements, and necessitate additional reparation works.

Evidence of discolouration and cracking to shower base tiles which require replacing.

Appointment of a tiling contractor is required to repair the cracked shower base, so as to ensure no further water penetration occurs. Replacement of the shower base may be required, dependent on the extent of the cracking.

Where water damage has affected the associated building elements, the relevant tradesperson should be appointed to perform rectification works as necessary.

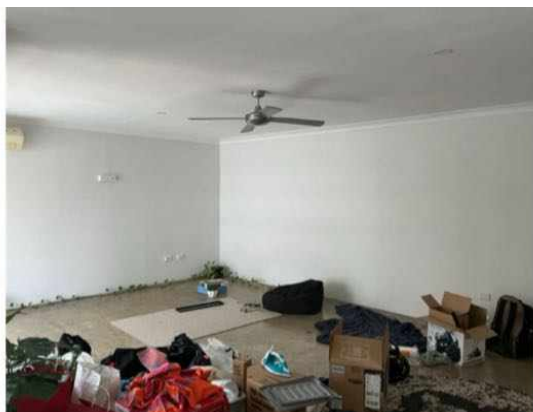
Defects 3.01

Building: Main Building
Location: Living Room > Existing
Finding: Ceiling - plaster cracking
Information: Cracking was observed to the ceiling plaster surface.

Cracks may be due to building movement poor insulation temperature or humidity variations or in adequate joint finishing.

Visible cracking on plaster joints and or across ceiling surfaces, some section showed minor separation at joints.

Dining, kitchen and living room ceilings show evidence of plaster cracking, rectification works should be considered.

It is recommended a plasterer be engaged to rectify this condition.

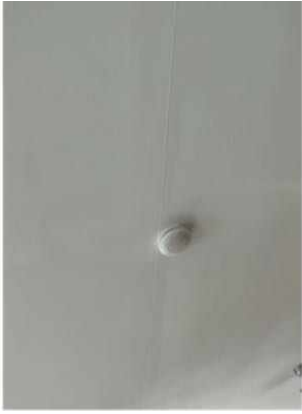
Defects 3.02

Building: Main Building
Location: Dining Room > Centre
Finding: Ceiling - plaster cracking
Information: Cracking was observed to the ceiling plaster surface.

Cracks may be due to building movement poor insulation temperature or humidity variations or in adequate joint finishing.

Visible cracking on plaster joints and or across ceiling surfaces, some section showed minor separation at joints.

It is recommended a plasterer be engaged to rectify this condition.

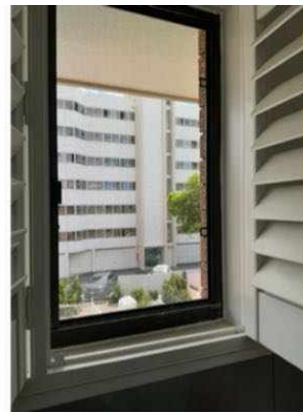
Defects 3.03

Building: Main Building
Location: Kitchen > Centre Left
Finding: Ceiling - plaster cracking
Information: Cracking was observed to the ceiling plaster surface.

Cracks may be due to building movement poor insulation temperature or humidity variations or in adequate joint finishing.

Visible cracking on plaster joints and or across ceiling surfaces, some section showed minor separation at joints.

It is recommended a plasterer be engaged to rectify this condition.

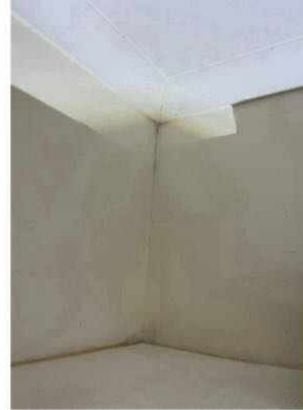
Defects 3.05

Building:	Main Building
Location:	Bedroom - Master > Centre Left
Finding:	Door handle - Not latching
Information:	It was noted that the door in this area was not latching during operation at the time of inspection. Whilst detracting from the functionality of this building element, this minor defect may also be a security risk, and may therefore have serious implications if left unattended.

It is suspected that this defect has occurred due to minor issues with the associated hinges. Such damage is identified as general wear and tear, which is expected for building elements of this age.

Master bedroom door handle not latching and requires rectification work.
Walk in robe shows evidence of render cracking and should be monitored.

A qualified carpenter or general handyperson may be appointed to perform rectification works as necessary, at client discretion. If left unattended, further functional impairment is likely to occur.

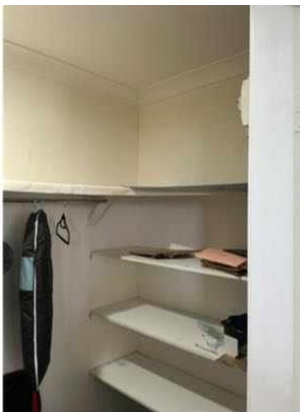
Defects 3.06

Building: Main Building
 Location: Walk-In Robe - Master > Rear Right
 Finding: Cracks to internal render - Category 1
 Information: It has been observed that cracking to internal rendered surfaces has occurred. The degree of damage falls within Category 1, described as fine cracks that do not need repair and which are less than 1.0mm in width limit.

Damage of this category is not considered a defect for rectification. Always contact your building inspector should cracks widen, lengthen, or become more numerous.

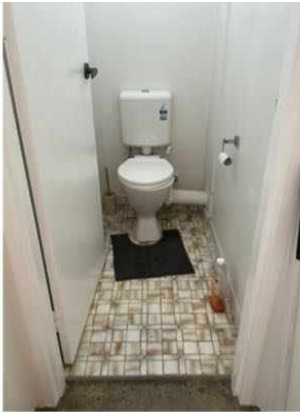
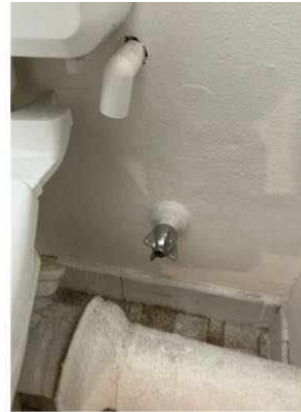
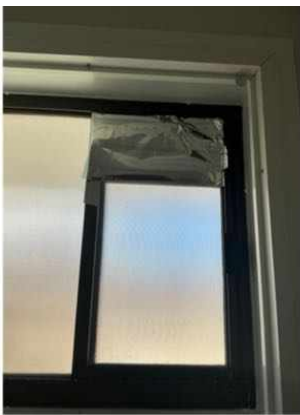
Defects 3.08

Building:	Main Building
Location:	Toilet (WC) > Rear
Finding:	Unconventional handyman work
Information:	This handyman work appears to have been completed to a substandard level and does not comply with regular building practices. Where handyman work is not completed satisfactorily, accelerated deterioration of the associated building elements is likely to occur and secondary defects to surrounding structures may develop.

The client should exercise care when coming into the immediate vicinity of the

substandard works. Rectification works are advised as soon as possible by the appropriate trades.

It is highly recommended that the substandard work be rectified by professional services. Works to improve this area are likely to increase the safety and the operation of the associated building elements.

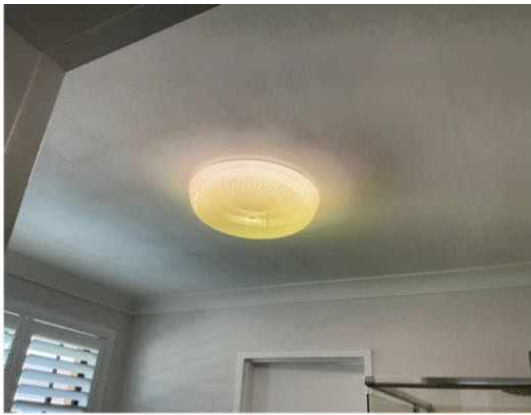
Noted Item

Building:	Main Building
Location:	Bathroom > Centre
Finding:	Surface - Discoloured
Information:	Discolouration was evident to the surface of this building element at the time of inspection. This degree of surface damage is consistent with general deterioration, which is generally expected of a property of this age and condition.

Discolouration usually occurs when the surface has been stained by foreign substances or water. Despite surface discolouration in this area, it is unlikely that this defect indicates any major underlying defects.

Discoloured surfaces are unlikely to cause secondary damage to associated building elements and do not require repair or replacement. However, the client may wish to seek quotations for the cost of refurbishment and/or replacement of any affected building elements.

A general handyman or painting contractor may be appointed to restore the condition of discoloured surfaces.

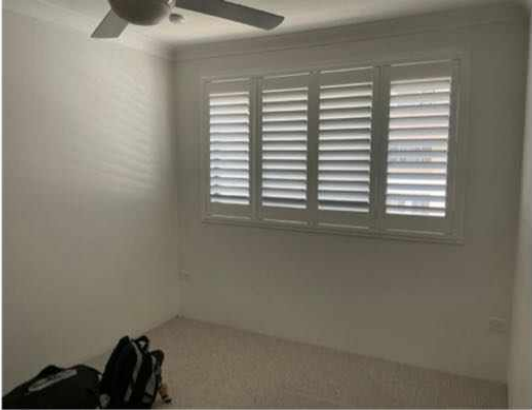
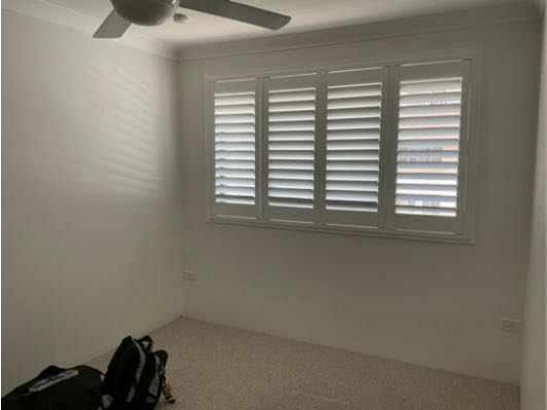
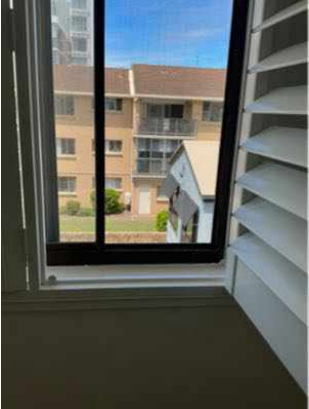
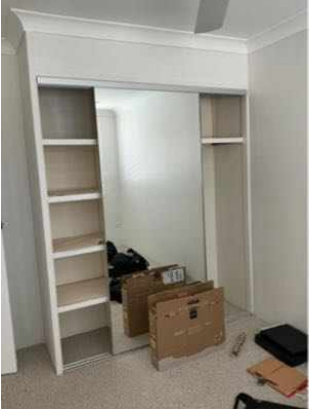
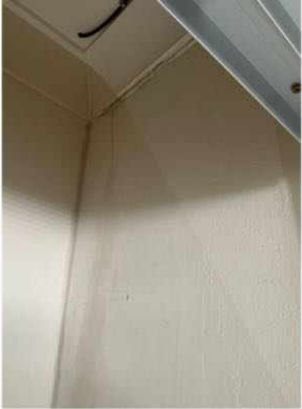
Noted Item

Building: Main Building
Location: Bedroom 2 > Rear Right
Finding: Cracks to internal render - Category 2

It has been observed that cracking to internal rendered surfaces has occurred. The degree of damage falls within Category 2, described as noticeable cracks which are easily filled. Cracking of this size are generally less than 5mm in width.

Category 2 damage is required to be monitored for a period of 12 months. After the monitoring period, a crack rated at Category 2 or above is considered a defect requiring rectification.

Always contact your building inspector should cracks widen, lengthen, or become more numerous.
