Building and Timber Pest Inspection Report

Inspection Date: Fri, 20 Feb 2026

Property Address: 12 Rosemary Cres, Bowral NSW 2576,
Australia

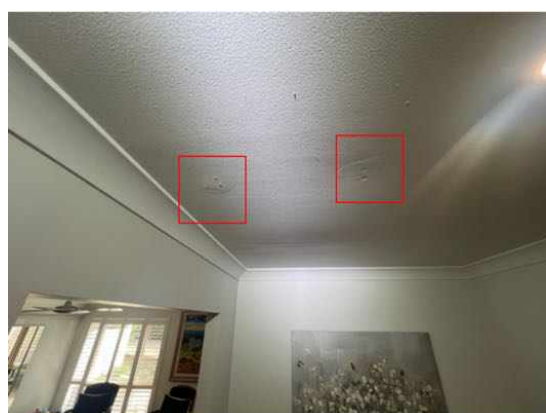
Building: Main Building
Location: All Internal Areas
Finding: Ceiling nails - Popping
Information: Numerous popped nails were identified in the internal ceiling at the time of inspection. Nails and screws hold simply by the friction between them and the surface they are applied to. Over time, the nails and screws can back out, which is often a result of general ageing and deterioration of the building structure.

If left unmanaged, the ceiling sheets may become loose and unstable, increasing the rate of deterioration of the internal ceiling and creating potential for the development of secondary defects.

Re-fastening of popped nails will help to maintain the stability of the internal ceiling and associated building elements. Such minor works will also help to improve the appearance of the affected area and secure the ceiling sheets, so as to prevent the onset of ceiling sagging. These works should be performed by a qualified carpenter or plasterer at client discretion.

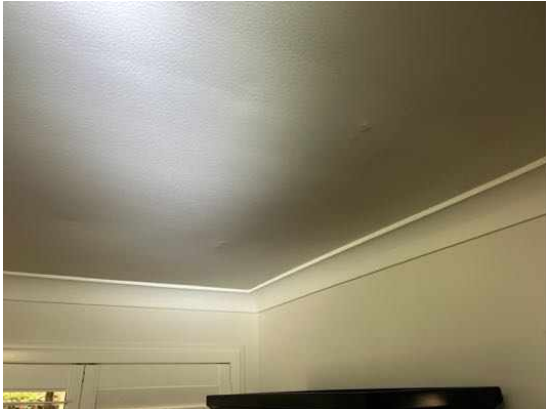
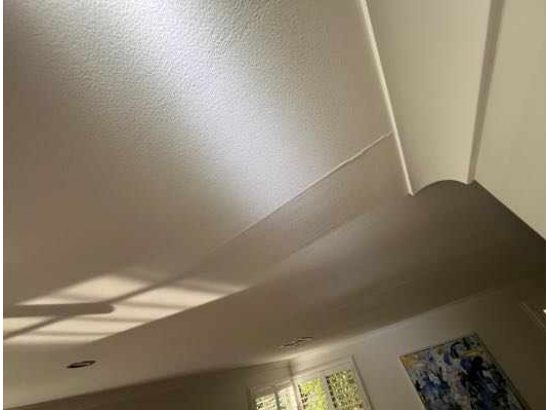
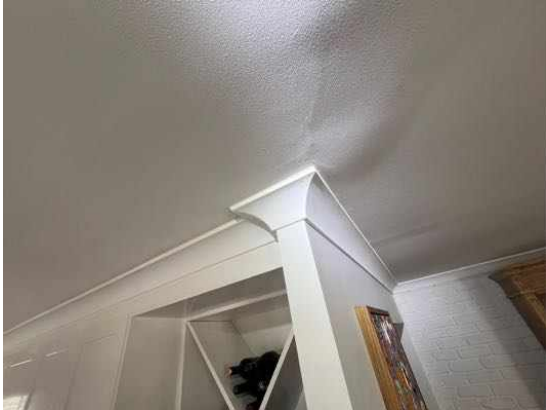
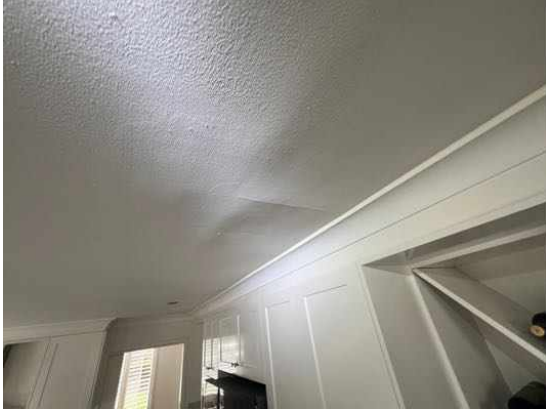
Building:	Main Building
Location:	All Internal Areas
Finding:	Ceiling - localised sagging, hairline cracks, substandard works
Information:	The internal ceiling lining in this area exhibits localised sagging between framing members, accompanied by hairline cracking and substandard flushing to joints and screw fixings. Sagging of this nature generally occurs where ceiling sheets are inadequately fixed, where fixings have loosened over time, or where the ceiling lining has not been properly supported during installation. Hairline cracking to joints and screw heads is commonly associated with minor movement within the framing or insufficient joint finishing.

If left unmanaged, continued movement or loosening of fixings may result in further joint separation, visible deflection, and deterioration of the ceiling finish.

It is recommended that a qualified plasterer assess the affected ceiling area and undertake rectification works as required to restore alignment and finish.

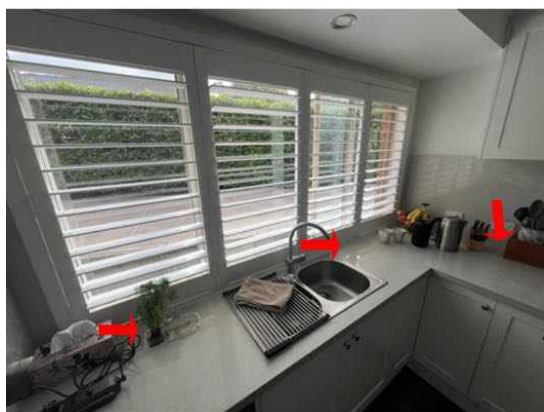
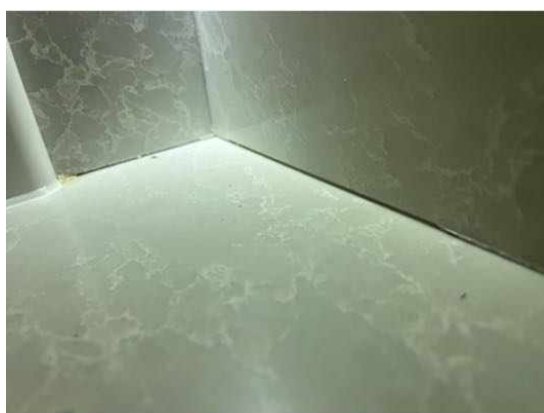
Building:	Main Building
Location:	Kitchen
Finding:	Kitchen Sealant - degraded
Information:	It was noted on inspection that sealant or grout is degraded to the kitchen sink and splashback.

Different materials move at different rates, generally causing cracking to grout or sealant at this point. A flexible sealant is required to allow for expected expansion and contraction, while keeping the joint water tight and protective of all associated building materials.

Flexible and mould resistant materials should be applied to affected areas to prevent any subsequent water damage that is likely to occur. Regular maintenance and replacement of damage or missing or damaged sealant and grout is highly recommended to the wet areas, as this is a regular wear and tear defect. Sealant and grouting in areas that come into regular contact with water should be maintained for the long term care of your property.

A sealant specialist or tiling contractor should be appointed to complete these works as soon as possible

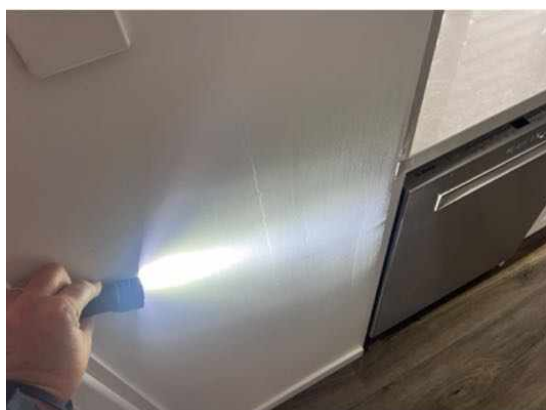
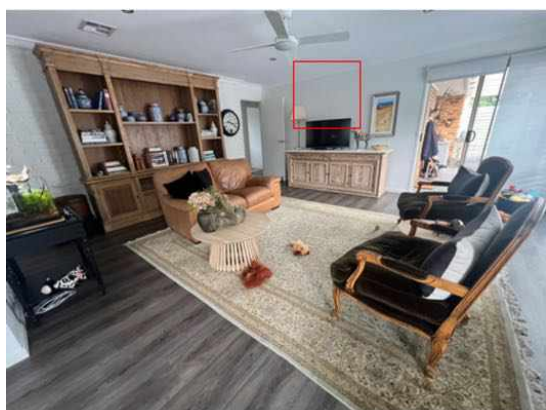
Finding 3.05

Building: Main Building
 Location: Kitchen, Family Room
 Finding: Wall - Incomplete or substandard works
 Information: The plasterboard finishing to this area appear to be incomplete or have been completed to a substandard level.

Works that have not been completed to a satisfactory level create potential for the development of building defects and may impede on the safety and integrity of the overall structure.

It is highly recommended that a licensed plasterboard contractor or painter should be appointed to finish the wall.

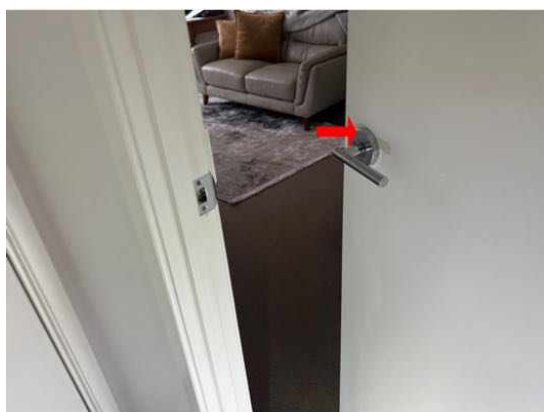
Finding 3.06

Building: Main Building
 Location: Bedroom 2, Laundry, Bedroom - Guest, Bedroom - Master
 Finding: Door Handle - Loose
 Information: The door handle in this area was identified as loose at the time of inspection. A loose door handle can impede the proper operation of the door and, if left unattended, may lead to further deterioration or damage to the associated door structure.

This defect is typically caused by wear and tear, insufficient fixing, or deterioration of

the handle's components.

It is recommended that a qualified carpenter or general handyman be appointed to secure or replace the handle to restore its functionality and ensure proper operation.

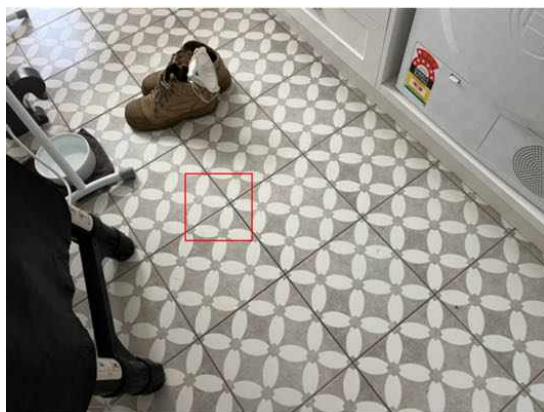
Building:	Main Building
Location:	Laundry
Finding:	Grout - Missing
Information:	Grout is missing in this area. Grout is used to protect gaps and crevices in building materials to ensure that they are water-tight and prevent water penetration to the associated structures.

Where grout is missing, a tiling contractor should be appointed immediately to apply grout and re-apply any silicone where necessary. Failure to do so is likely to lead to water damage to the surrounding area.

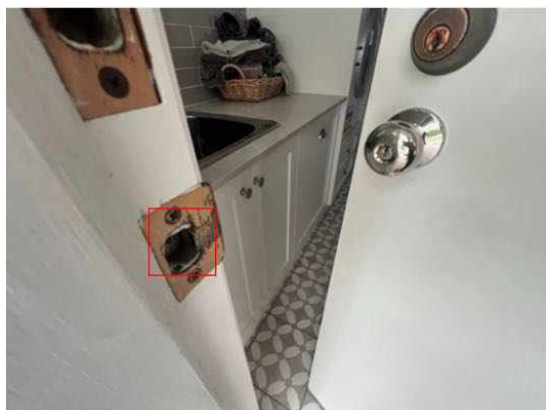
Finding 3.09

Building:	Main Building
Location:	Laundry, Bedroom - Master
Finding:	Doors - Striker plates misaligned. Doors rattle when closed.
Information:	The striker plates to a few doors throughout the home appear to have become misaligned and has consequently resulted in the door's operation being compromised.

This is a common defect and is expected in a property of this age, whether being due to substandard installation or general deterioration of the door hardware.

Readjustment of the striker plate is recommended at client discretion. Works such as these can be completed by a general handyman or qualified carpenter.

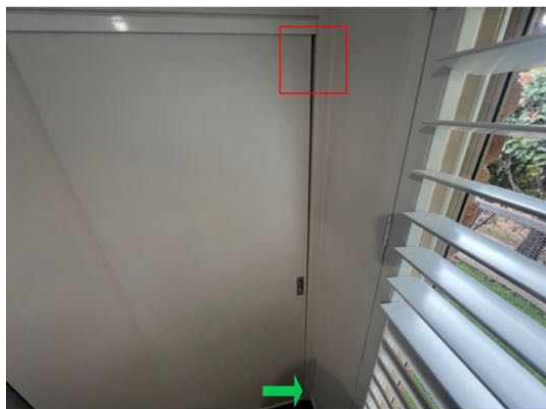
Finding 3.10

Finding: Robe Sliding door - not plumb

Information: The sliding robe doors are not plumb with the wall when closed, resulting in visible misalignment. This issue is generally caused by improper track installation, frame movement, or an out-of-square opening. Misaligned robe doors can affect operation, closing functionality, and the overall finish. The responsible carpenter or installer should assess the issue and undertake corrective work as required to ensure the doors align properly within the opening.

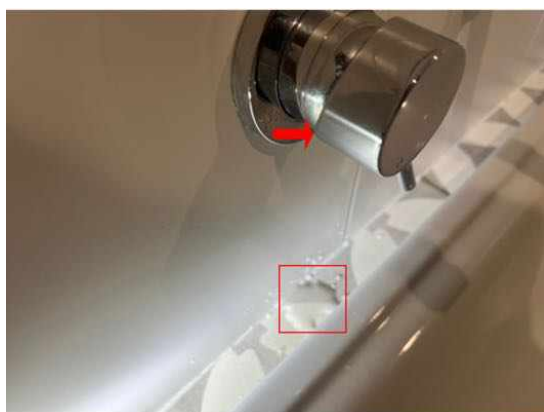
Finding: Tap - Leaking

Information: The tap in this area was found to be leaking at the time of inspection. This is a common defect that is consistent with general ageing of the building element. However, it may be indicative of substandard plumbing workmanship if the tap is relatively new.

While this defect only seems minor, if left unmanaged, it is likely to result in the development of rust, water damage and/or extensive water usage.

It is advised that a handyman or licensed plumber be appointed to perform remedial works on the affected tap. Such works should be performed prior to the development of secondary defects to ensure adequate functionality of all associated building elements.

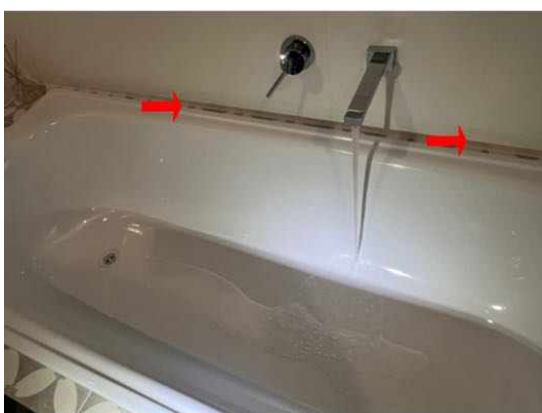
Building:	Main Building
Location:	Bathroom, Ensuite - Guest, Ensuite - Master
Finding:	Sealant - degraded/missing
Information:	It was noted on inspection that sealant or grout is degraded/missing to this area.

Different materials move at different rates, generally causing cracking to grout or sealant at this point. A flexible sealant is required to allow for expected expansion and contraction, while keeping the joint water tight and protective of all associated building materials.

Flexible and mould resistant materials should be applied to affected areas to prevent any subsequent water damage that is likely to occur. Regular maintenance and replacement of damage or missing or damaged sealant and grout is highly recommended to the wet areas, as this is a regular wear and tear defect. Sealant and grouting in areas that come into regular contact with water should be maintained for the long term care of your property.

A sealant specialist or tiling contractor should be appointed to complete these works as soon as possible

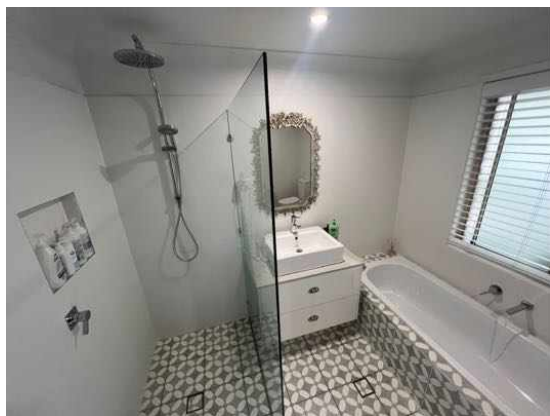
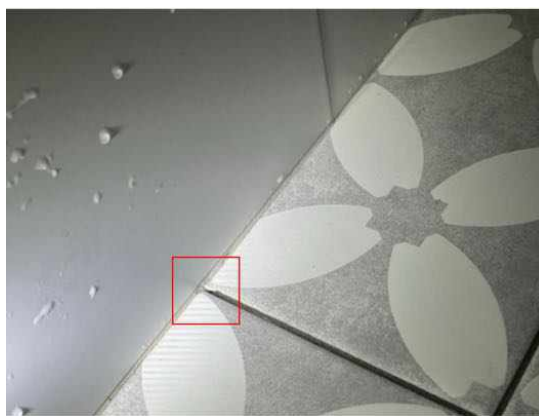
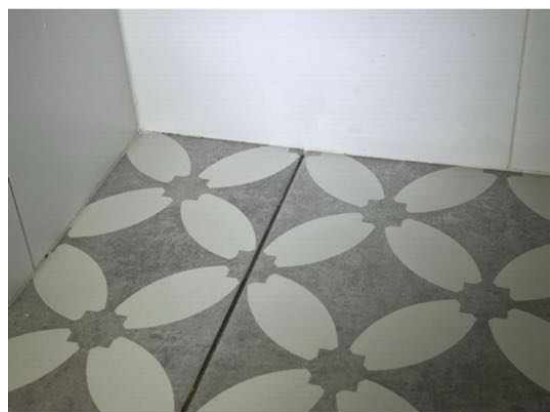
Finding 3.15

Building:	Main Building
Location:	Bathroom, Ensuite - Guest, Ensuite - Master
Finding:	Sealant and grouting - Missing or damaged
Information:	It was noted on inspection that sealant or grout is degraded to the tiled shower alcove and or other areas of the bathroom.

Different materials and floor areas move at different rates, generally causing cracking to grout or sealant at this point. A flexible sealant is required to allow for expected expansion and contraction, while keeping the joint water tight and protective of all associated building materials.

There appears to be excessive mould to the sealant and grout which will likely require scraping out and replacement.

Flexible and mould resistant materials should be applied to affected areas to prevent any subsequent water damage that is likely to occur. Regular maintenance and replacement of damage or missing or damaged sealant and grout is highly recommended to the wet areas, as this is a regular wear and tear defect. Sealant and grouting in areas that come into regular contact with water should be maintained for the long term care of your property.

A sealant specialist or tiling contractor should be appointed to complete these works as soon as possible

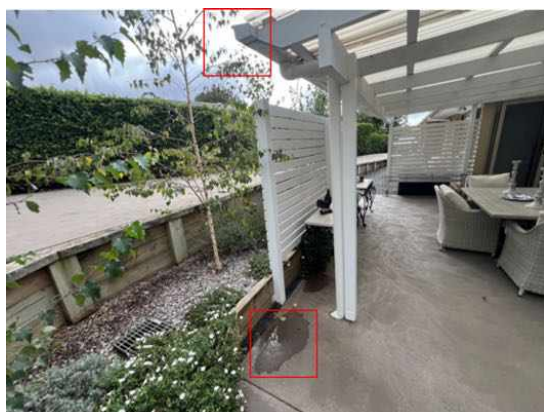
Finding 3.30

Building:	Main Building
Location:	Pergola
Finding:	Water leak - External
Information:	Water leaks were found to be present to exterior plumbing work. Leaks are generally

It is highly advised that a licensed plumber be appointed to rectify any water leaks that may be present. Areas of repair and replacement of plumbing fittings and fixtures may be required and, as such, a quotation should be sought.

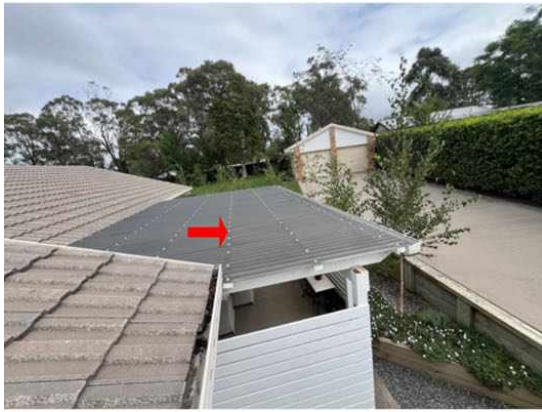
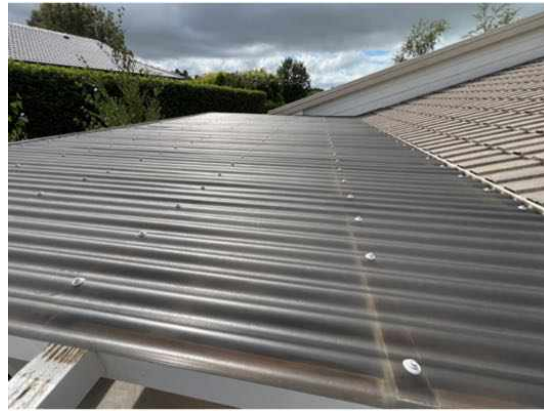
Finding 3.31

Building:	Main Building
Location:	Pergola
Finding:	Roof plumbing - Flashing inadequate
Information:	Some sections of the roof are missing or have inadequate roof flashings. Flashings are metal and other materials which are applied to seals and intersections between roof coverings and building elements. They are designed to aid in weatherproofing of roof joins.

Consultation with a roofing plumber or roofing restoration contractor is required for quotations regarding these works. Where water pooling is quite significant, structural alterations to the roof may potentially be expensive and time-consuming.

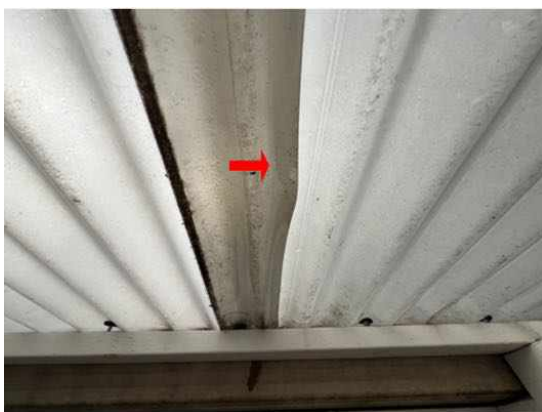
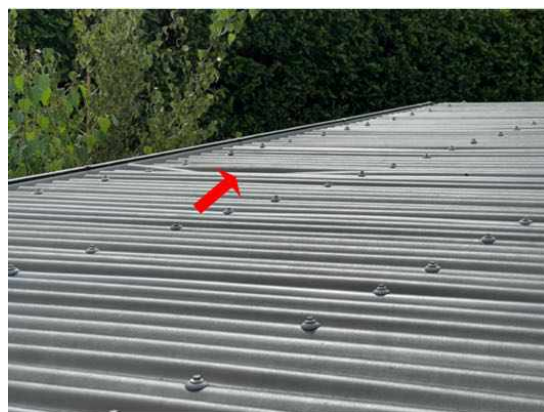
Finding 3.33

Building:	Main Building
Location:	Pergola
Finding:	Polycarbonate sheeting - Damaged
Information:	The polycarbonate sheeting has deteriorated as a result of exposure to weather conditions over a prolonged period of time. Exposure to elements, such as heavy rain and hailstorms, is likely to damage polycarbonate sheeting, which is not as strong as other roof coverings.

Repair and replacement of several sections of the sheeting is required. Appointment of a roofing restorer is required to perform these works as soon as possible to prevent any further damage being sustained.

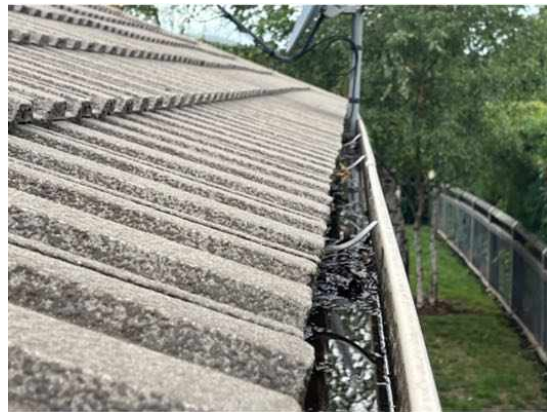
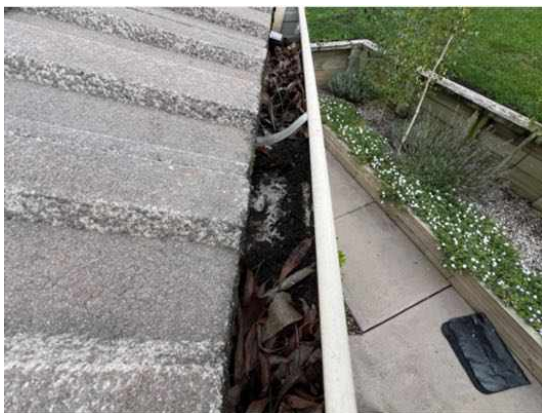
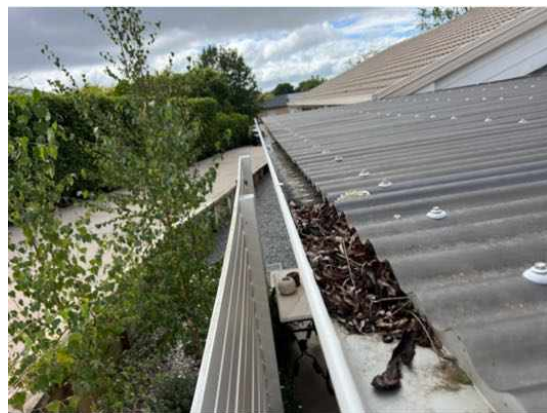
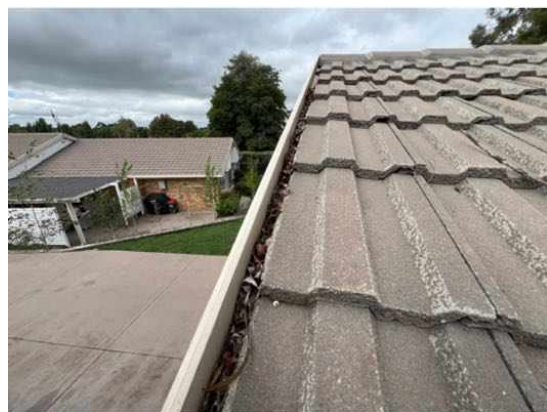
Finding 3.35

Building:
Location: Roof Exterior -Main Building, Garage
Finding: Gutters - Water pooling
Information: Water was found to be pooling in sections of the roof guttering. This is generally a secondary defect caused by blocked or partially blocked gutters. Such blockages and subsequent water pooling are likely to lead to rust and water damage to associated structures if left unattended.

Consult a Licensed Plumber for further specific advice on remedial works that may be required. In the interim, it is highly advised that blocked gutters be removed by the homeowner or a general handyperson as a matter of urgency.

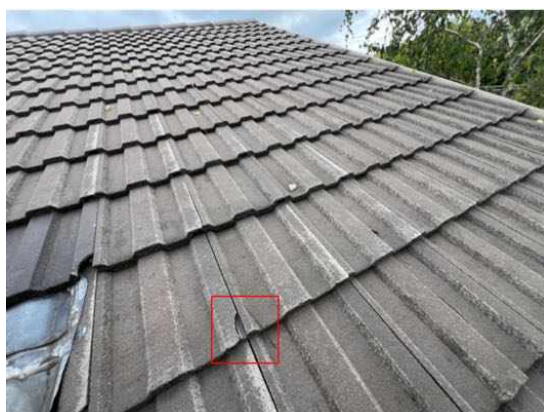
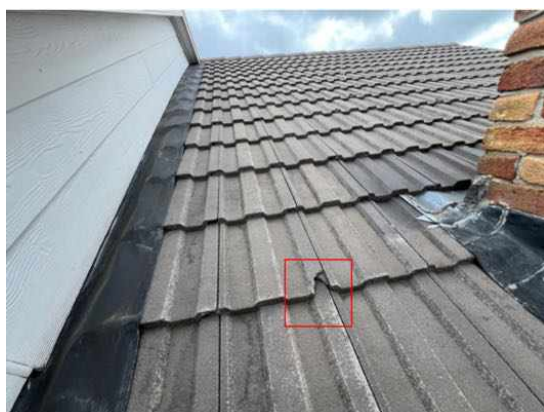
Finding 3.38

Finding: Roof tiles - Broken

Replacement of broken tiles is required and should be performed by a roofing contractor as soon as possible.

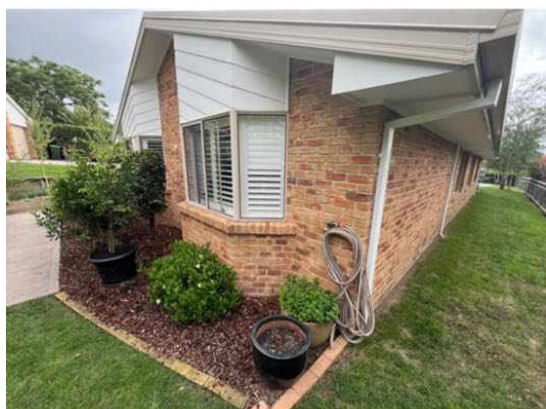
Finding 6.09

Building:	Main Building
Location:	All External Areas
Finding:	Garden Beds - Conditions Conducive to Termites
Information:	Garden beds were observed around the perimeter of the building, obstructing visual inspection of lower wall areas and providing potential concealed termite entry points.

It is recommended that garden beds be reduced or cleared from the building perimeter, or that regular timber pest inspections be carried out in accordance with AS 4349.3 or AS 3660.2 to monitor risk.
