# Building and Timber Pest Inspection Report

Inspection Date: Wed, 1 Apr 2026

Property Address: 12 Bramwell Ave, Leneva VIC 3691,  
Australia

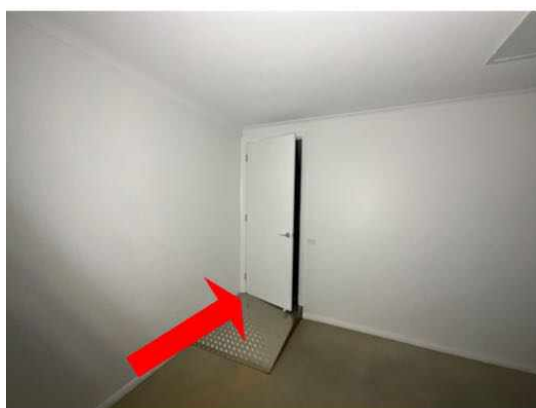
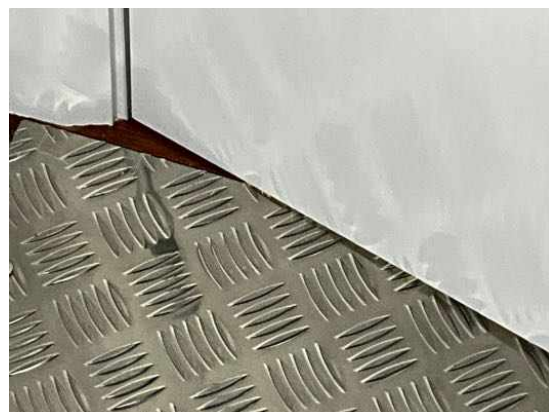
#### Finding 3.01

Building: Building 1

Location: Garage

Finding: Door- Binding

Information: Binding and/or jamming of this door is evident during standard operation. This defect inhibits the functionality of the affected door as well as creating potential for secondary defects to associated building elements, such as damage to the floor covering.

A door that binds to flooring or to the associated door frame may have several causes, ranging from minor defects, such as poor installation of the door or deteriorated hinges, through to major structural issues, such as damage to subfloor structures.

A qualified carpenter or general handyperson should be appointed to perform minor rectification works at client discretion.

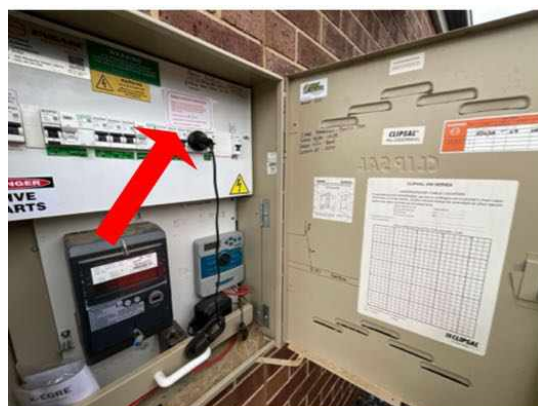
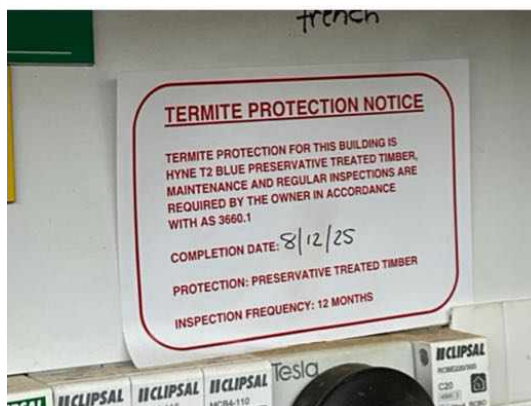
### Finding 6.01

Building:	Building 1
Location:	All External Areas
Finding:	Termite Management System- evidence of a chemical installation
Information:	The application of a post-construction chemical termite barrier is highly recommended for all properties, particularly if live termite activity has been found on the site previously. Such barriers are highly effective in preventing termite attack on any timber building elements throughout the property.

A durable notice has been placed in the switchboard unit to indicate current termite barriers. At the time of inspection, it appeared as though a termite management system has been installed. The recency of any treatment cannot be determined.

The client may consider gaining further advice from a pest controller as to the costs and procedures involved with this application. It is recommended that obtaining such advice be a short-term priority.

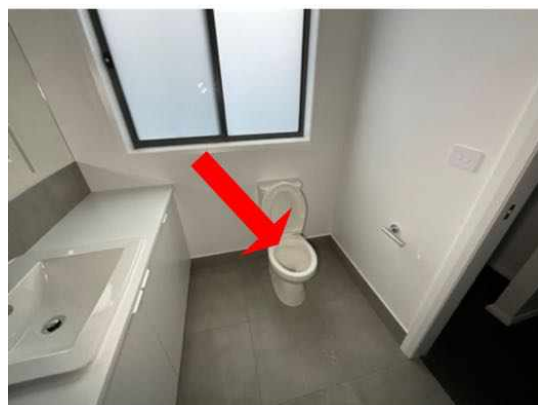
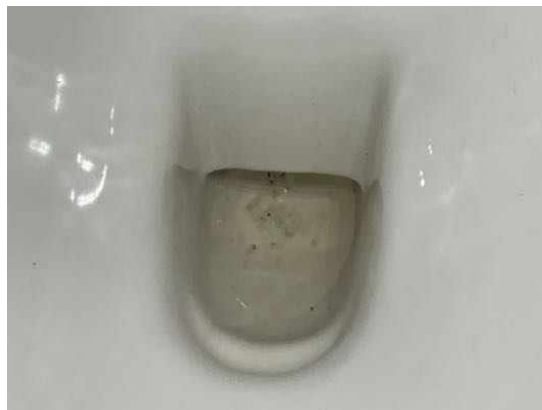
Building:	Building 1
Location:	All Areas
Finding:	Musty smell
Information:	The question of the origin of the 'musty' smell can be answered. The smell is obvious when first entering the property.

Initially it was thought the smell was mainly the type of carpet laid in the front rooms. This type of carpet can have a dull petrol/plastic smell for a while after initial installation. This is only partly true. The same carpet in the back bedrooms has no strong smell.

After inspection of the drainage traps it was found that they have been allowed to dry out in a few cases. This most notably in the two WC pans. This has allowed sewer gas to enter the interior of the property.

Running the taps and flushing has re sealed the traps against gas emissions into the interior of the home.

These actions should have solved the problem. If any persistent problems exist after airing out of the home, a plumber should be contacted immediately to investigate the possibility of cracked or damaged drains under the slab or in the yard.

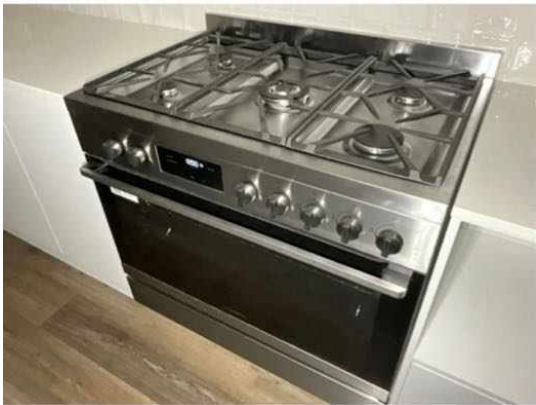
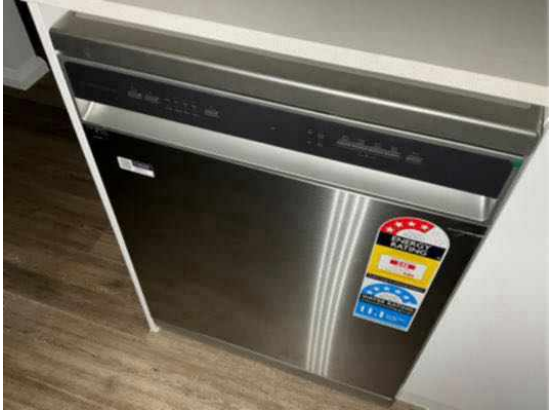
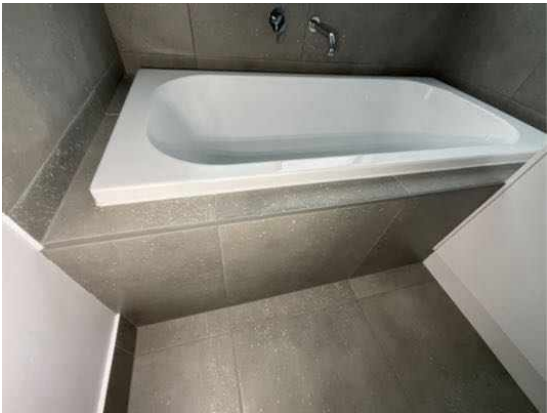
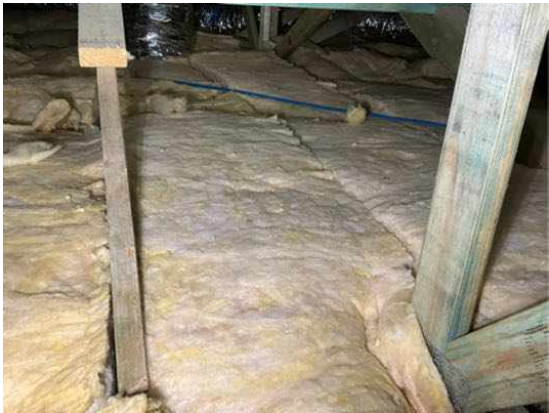
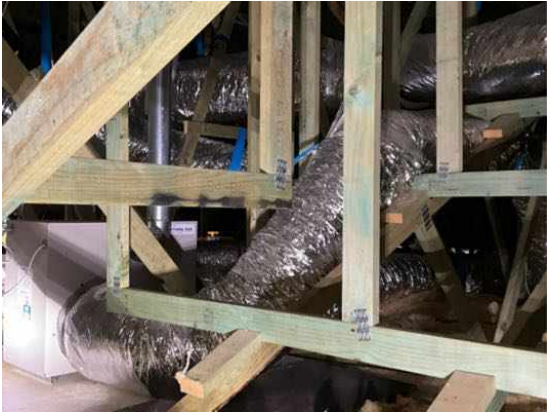
Building:	Building 1
Location:	All Areas
Finding:	Additional Photos - Obstructions and Limitations
Information:	These photographs are an indication of the obstructions and limitations which impeded full inspection of the property at the time of inspection. These obstructions

can hide an array of defects and should be removed to allow full inspection to be carried out. A re-inspection is recommended once the areas are made accessible.
