Building and Timber Pest Inspection Report

Inspection Date: Tue, 19 Aug 2025

Property Address: 16 Maytone Ave, Killara NSW 2071,
Australia

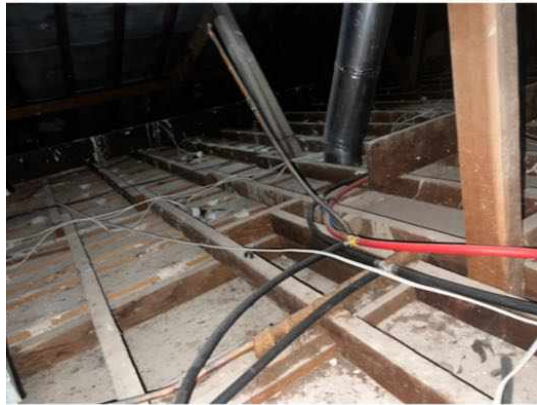
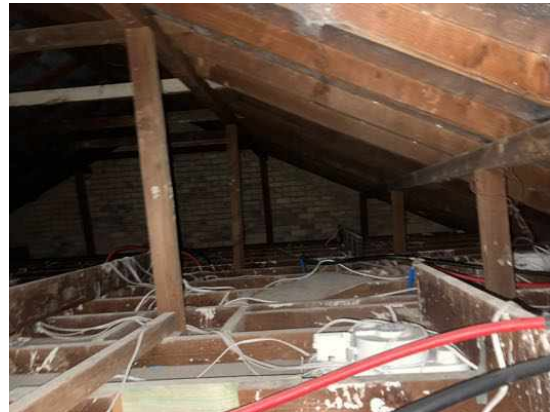
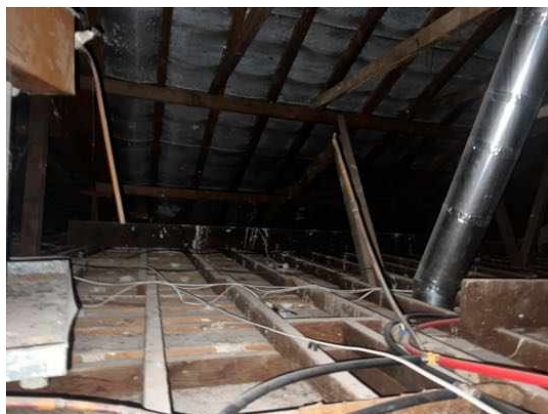
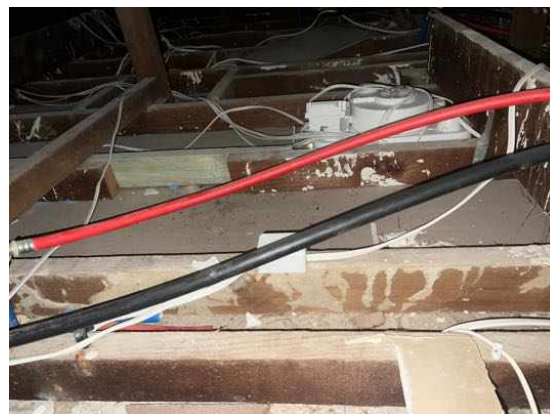
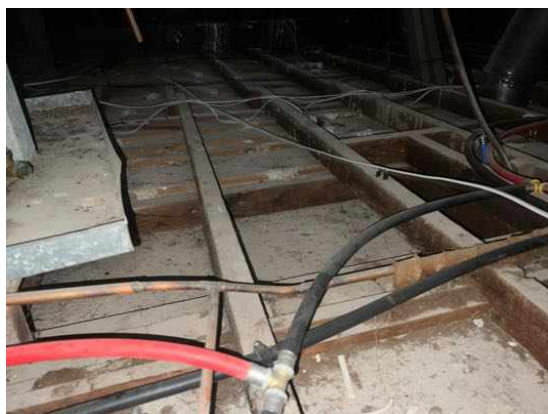
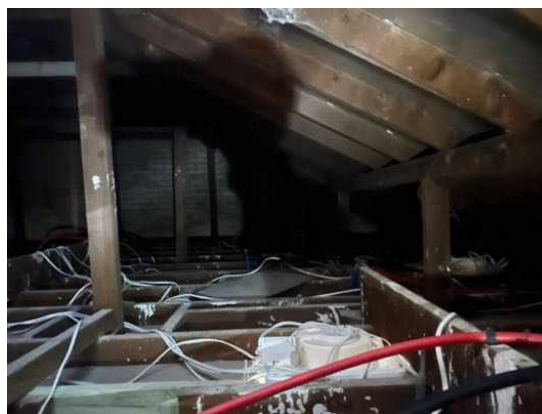
Building: Main Building
Location: Roof Void > All Areas
Finding: Cables and Wires - Not clipped off
Information: Cables and electrical wires in the roof void area have not been correctly clipped off (secured) to the adjoining structure. Where cables and wires have not been clipped off, they are more susceptible to impact damage, particularly if they are in direct contact with the timber and ceiling sheet.

A qualified electrician should be appointed immediately to provide adequate clipping for the cables and wires.

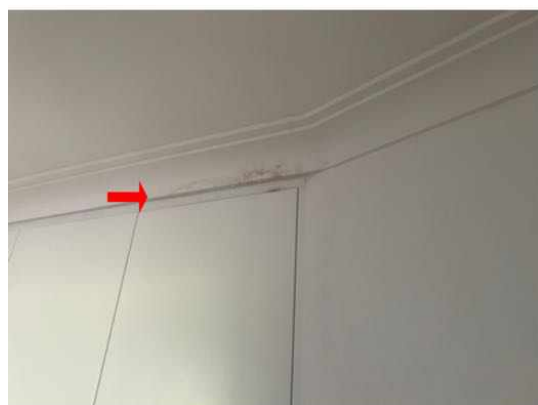
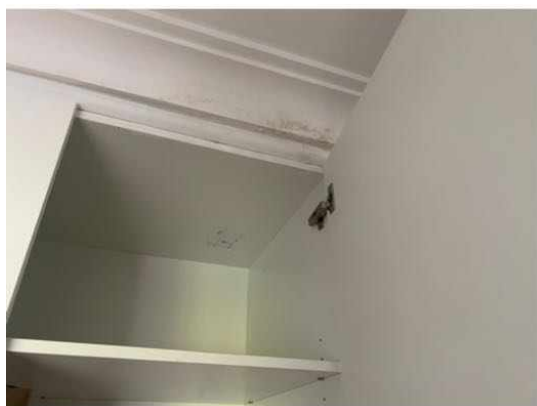
Finding 2.01

| Finding: | Water leak - Active |
| Information: | Generally, water leaks occur when a particular area of the property is not weather or water tight. As the surrounding area was found to be damp at the time of inspection, the leak is considered ongoing and hence requires urgent action. |

Regardless of the location, even minor leaks that are left unmanaged can lead to serious damage of associated building elements and result in the need for replacement of building materials. Mould and other hazards such as electrical hazards may also arise if the leak is left to develop.

The main issue i encountered was an active water leak in the area of the ground floor hallway adjacent to the linen cupboard.

It is highly advised that the cause of the leak be identified and resolved immediately by a licensed plumber to prevent any further damage. Depending on the extent of the damage previously sustained, repair and/or replacement of any affected building materials may be required.

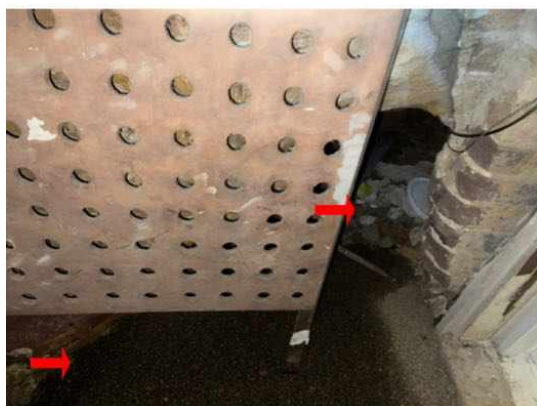
Finding 2.02

| Finding: | Excessive moisture - identified |
| Information: | Excessive moisture can attract termites and produce conditions that promote fungal growth and wood decay. |

Excessive moisture is generally caused by deteriorated, inadequate or missing roof drainage, leaking plumbing pipes or fixtures, poorly plumbed HWS overflows or condenser units and poor site drainage.

In this case the position of the dwelling and the site conditions (being built into sandstone) means the subfloor and the perimeter of the building are subject to higher than usual levels of moisture.

It is crucial that these levels are monitored to ensure no damage to the dwellings is sustained. Humidity levels in the lower ground floor areas are relatively high.

There were also signs of water in the subfloor area as well as rust appearing on painted structural steel members supporting the floor structure above.

The corridor of the lower ground floor had a distinct smell of moisture present during the inspection. High moisture reading in. The plasterboard to the right side of the hall way indicate groundwater in the subfloor which is affecting moisture levels to the lower ground floor area.

I recommend a mechanical ventilation contractor be engaged to discuss and plan a suitable ventilation system to service and protect the lower ground floor area

I have recommended a specialist in subfloor ventilation be engaged to assess the property.

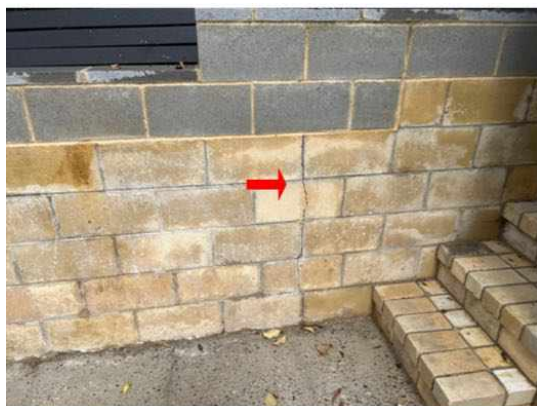
Finding 2.03

| Finding: | Retaining wall - Defective |
| Information: | The retaining wall in this area was found to be defective at the time of inspection. Generally, defective retaining walls are caused by poor original design or material use. However, deteriorated retaining walls may also be a result of substandard construction, poor site drainage or unmanaged stormwater flows. |

If left unmanaged, the retaining wall may become a safety hazard if it continues to destabilise. Where retaining walls further rot and decay, an environment is created that is conducive to termite and pest infestation.

Significant repair and replacement should be expected. Where retaining walls are considered structural walls, a structural engineer / surveyor should be consulted regarding required remedial works. Otherwise, a landscaper or retaining wall installer may be appointed to repair or replace the wall, at the discretion of the client.

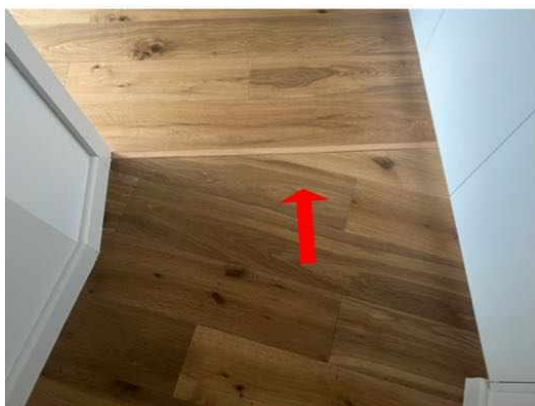
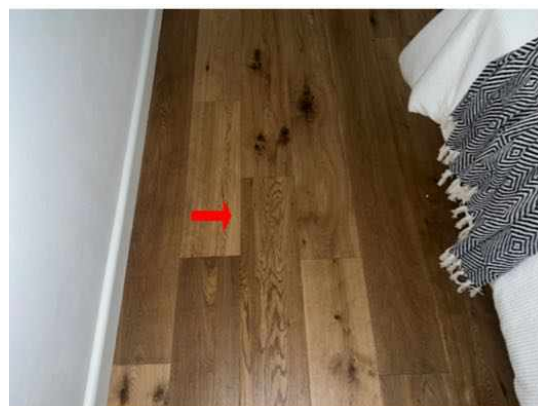
| Information: | The internal flooring in this area is out of level and uneven. Uneven flooring is likely to indicate minor defects such as expected movement of the foundations of the property, but may also indicate subsidence of the associated subfloor structure. |

It is advised that the flooring be closely monitored to identify any further movement. Where flooring remains relatively unchanged for an extended period of time (i.e. several months), it is likely that this defect has been caused by expected movement of the foundations of the property.

However, where flooring is uneven further, potentially invasive inspection of the subfloor structures and stumps in this area is required. In this case, works to repair are likely to be required, and would be carried out by a registered builder specialising in foundation rectification.

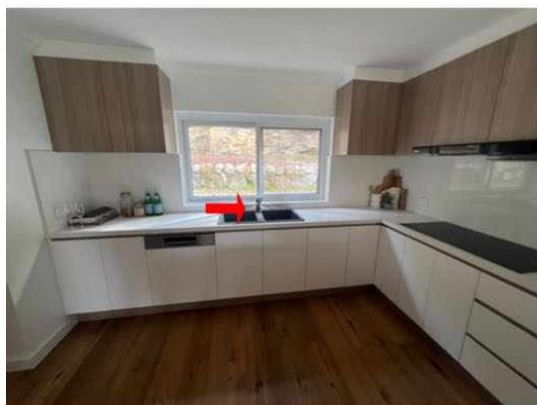
Finding 3.02

Building: Main Building
 Location: Kitchen > Centre
 Finding: Tap - Water hammer
 Information: This tap shows evidence of water hammer being present. Water hammer, a pressure surge resulting when a fluid is forced to suddenly change direction, is a common defect in plumbing fittings, particularly those that are aged and not frequently maintained. Water hammer is generally caused by factors that create high water pressure in the affected plumbing fixture, usually evidenced by a faint banging noise during operation of the affected tap.

Although water hammer is generally considered to be a minor defect, subsequent damage such as erosion of tap hardware and/or water damage to associated building elements is likely to occur if left unmanaged.

A licensed plumber should be appointed as soon as possible to replace any affected tap hardware and perform any remedial works as necessary. Please be advised that the appointment of a cabinet maker or qualified carpenter may be necessary if water damage to associated building elements has occurred.

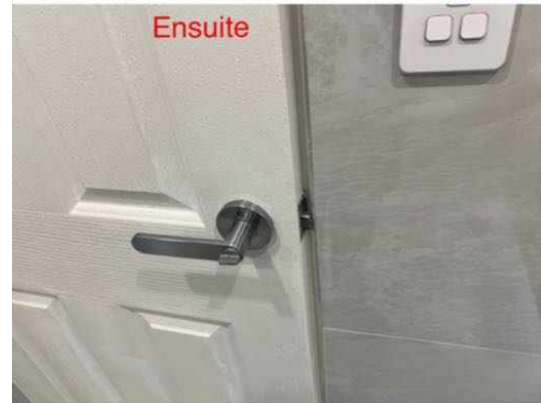
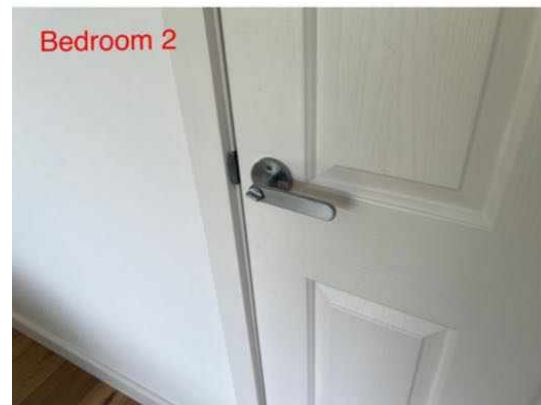
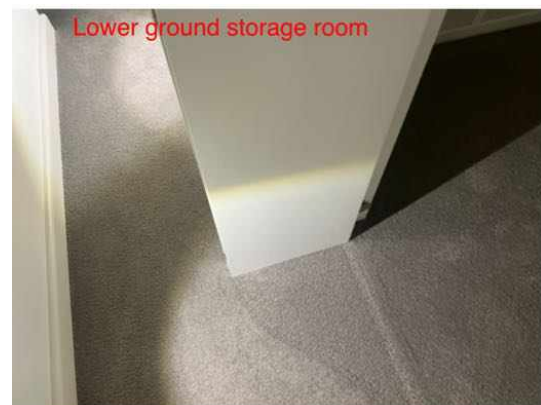
Finding 3.03

Building: Main Building
 Location: All Areas > All Areas
 Finding: Doors - Binding/Jamming
 Information: Binding and/or jamming of several doors throughout the property were evident during standard operation. This defect inhibits the functionality of affected doors as well as creating potential for secondary defects to associated building elements, such as damage to the floor covering.

A door that binds to flooring or to the associated door frame may have several causes, ranging from minor defects, such as poor installation of the door or deteriorated hinges, through to major structural issues, such as damage to subfloor structures.

Where door binding/jamming appears to indicate major structural issues, a registered builder specialising in re-stumping should be appointed to provide an estimate on the cost of rectification.

For minor causes, a qualified carpenter or general handyman should be appointed to perform minor rectification works at client discretion.

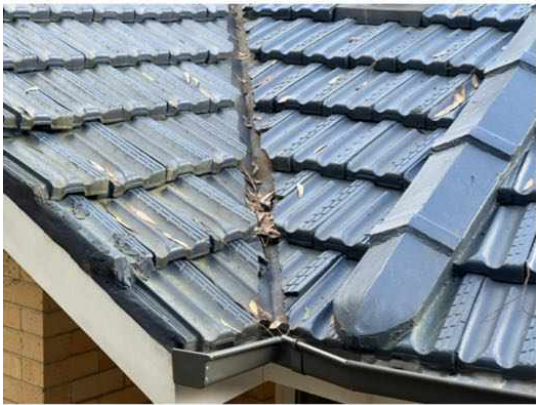
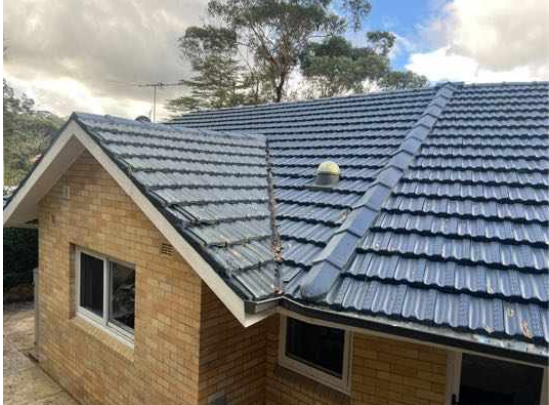
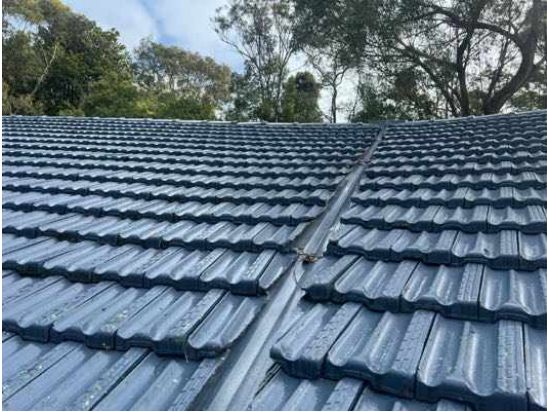
Gutters are a critical part of the building's management of storm water and rain. It is therefore important that they be kept clear to prevent secondary damage to associated building elements, including exterior and interior walls, ceiling linings and any adjoining building elements. Where gutters are blocked, pooling of rainwater is likely to occur, fast-tracking rust and corrosion of the roof plumbing elements.

It is highly advised that all overhanging tree branches be removed as soon as possible to prevent any further damage. Repair and/or replacement of sections of damaged guttering may also be required where the extent of the damage necessitates.

Such works should be performed by the homeowner; however, appointment of a landscape contractor or an arborist may be required. Consultation with a licensed roof plumber is required where guttering has been damaged.

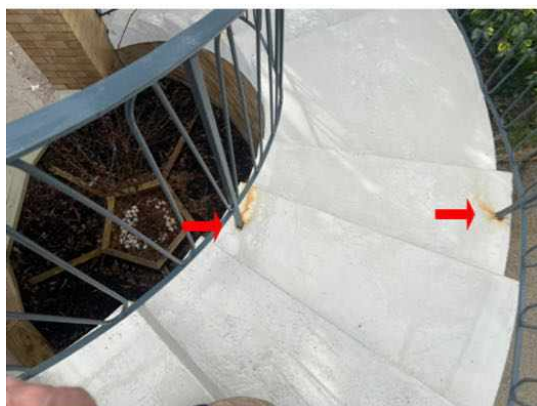
Finding 3.06

Building: Main Building
Location: All Areas > All Areas
Finding: Deteriorated components
Information: It was identified that some elements around the exterior of the home have suffered from environmental effects.

Rust has formed in various areas where metal has been exposed to the elements for prolonged periods of time and the paint has not been unkept.

Secondary defects are likely if the issue is not addressed.

A licensed painter is recommended to take back affected areas and treat prior to painting. If areas of serious damage are found a licensed builder should be engaged to remedy.

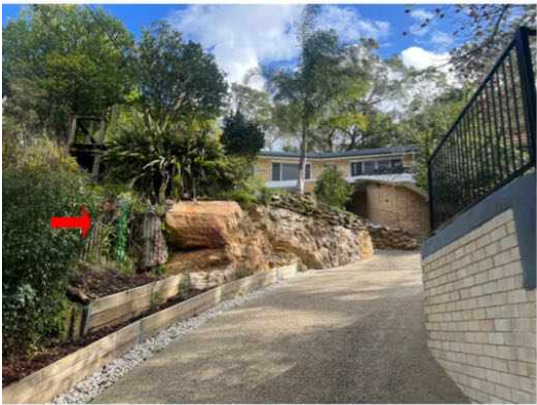
Finding 3.07

| Finding: | Fencing - Deteriorated |
| Information: | It was noted at the time of inspection that sections of the fencing throughout the property have deteriorated. Typically fencing deteriorates due to age and or wear, rot and or rust which is generally expected for a structure of this age, due to prolonged exposure to weather conditions. Sometimes inadequate installation or maintenance can be to blame. |

If left unattended, it is likely that further damage will occur. It is suspected that repair of several elements of the fencing may be required however replacement may be a consideration of the client also.

A licensed fencing contractor should be appointed to provide further advice and perform rectification works as necessary.

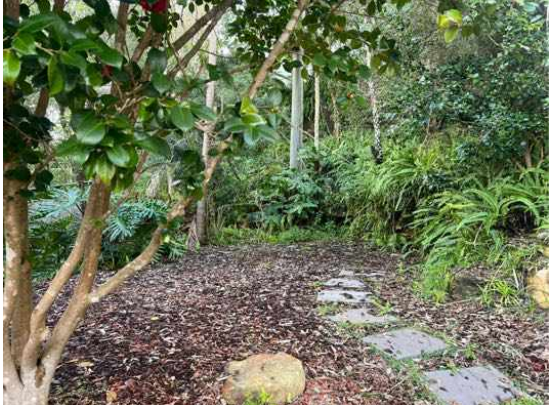
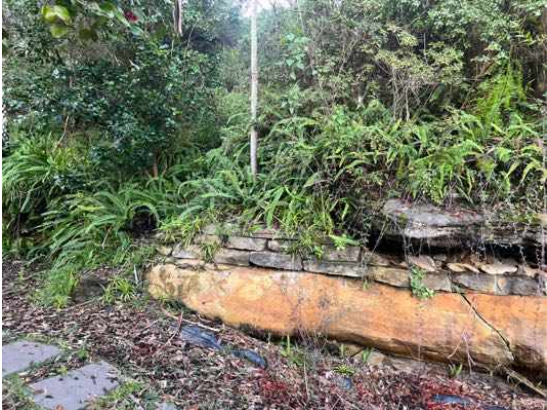
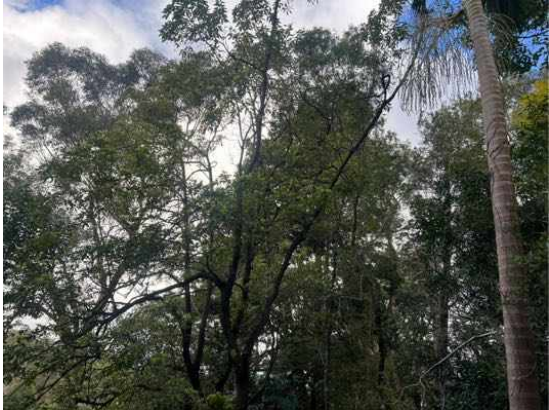
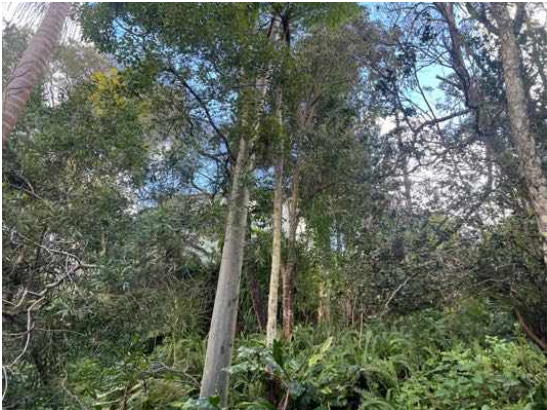
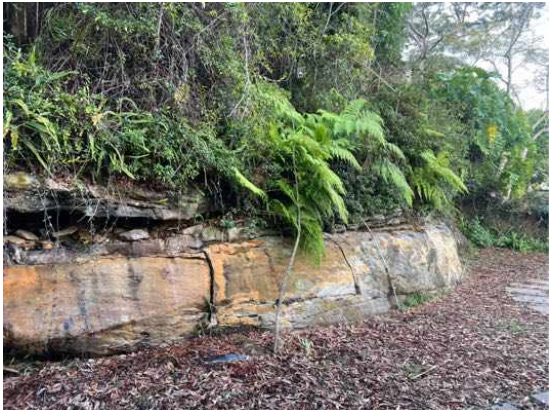
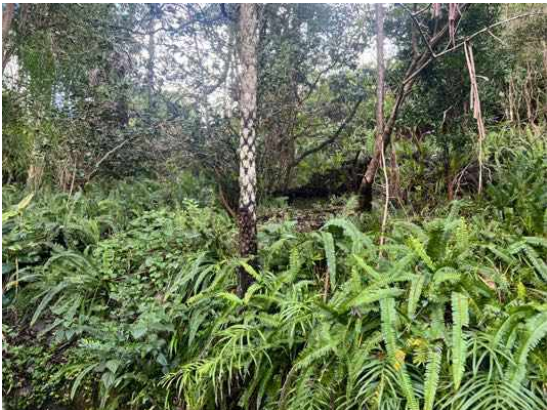
Finding 6.01

Building: Main Building
Location: All Areas > All Areas
Finding: Dwelling Location - Highly susceptible to timber pest
Information: The dwelling is located in a very green, leafy area. It is also built into sandstone which is a moist/damp environment. The combination of these two factors makes the site highly susceptible to timber pest. This has been included for your information.

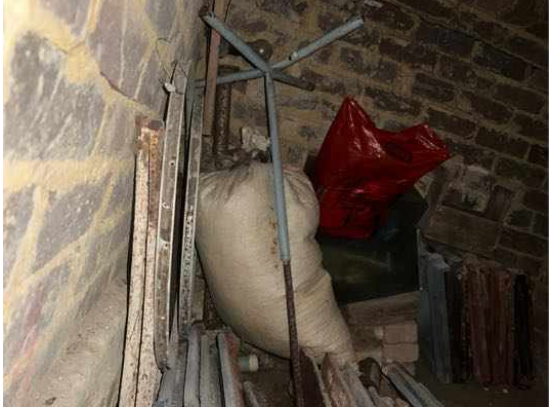
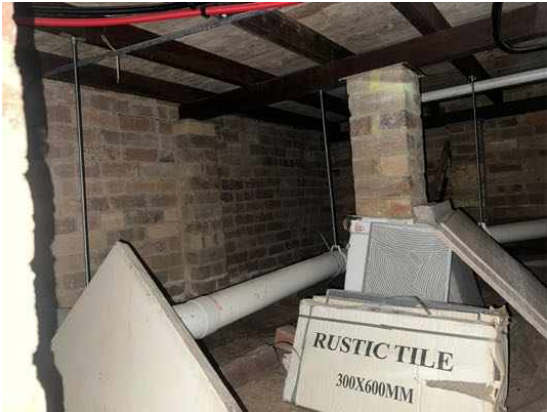
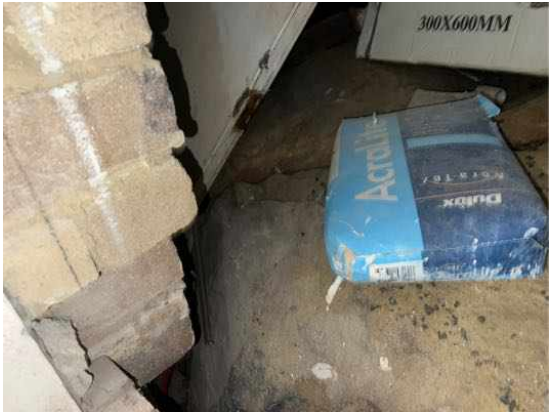
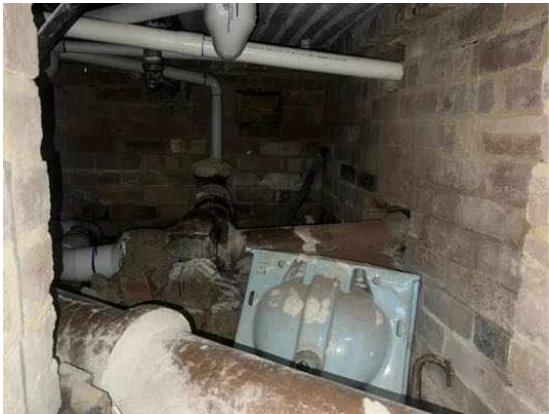
| Information: | An array of debris was found in the subfloor area at the time of inspection. Debris in this area restricts subfloor ventilation and creates potential for concealed pest entry. Stored timbers and other materials may also make the area susceptible to termite activity and wood rot. |

A clear and empty subfloor will be better ventilated and easier to maintain in a dry condition. The removal of any timber debris is vital in minimising the risk of termite or wood borer activity.

Debris in the subfloor should be removed as soon as possible. Depending on the location and amount of debris and stored items, the homeowner may elect to undertake this task. Alternatively there are a large number of rubbish removal subcontractors that could undertake these works.

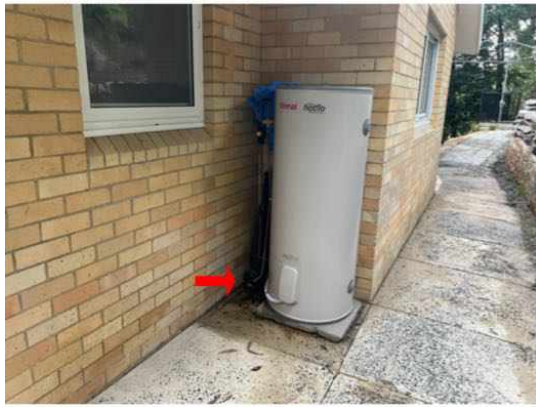
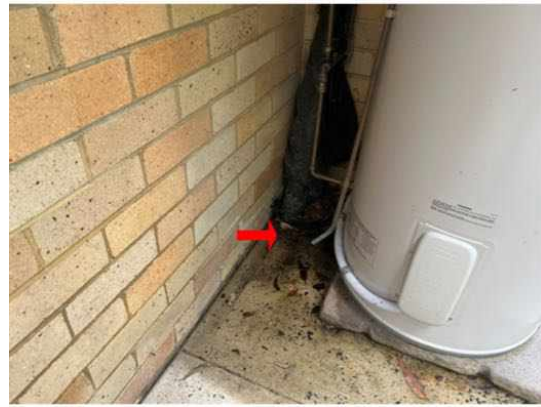
| Information: | The Hot Water System (HWS) overflow was found to be disconnected from storm water drainage and is creating excessive moisture in the surrounding area. |

These damp conditions can lead to secondary defects such as rot, rust or corrosion of associated building elements, the formation of fungal decay, or even the creation of potential slip hazards. When coupled with poor site drainage, pooling of water may also attract termite activity to this area.

It is highly recommended that a licensed plumber be appointed to connect the HWS overflow in order to prevent such an environment from being created. These minor works should be carried out as soon as possible.

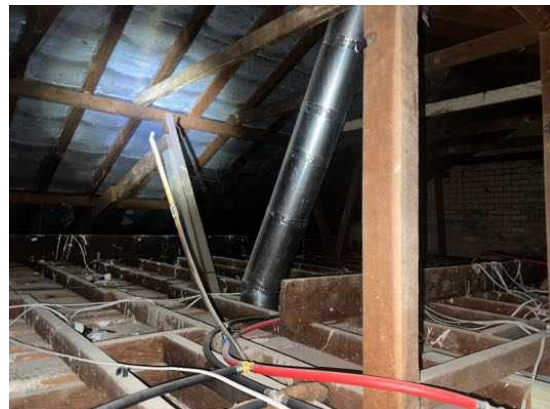
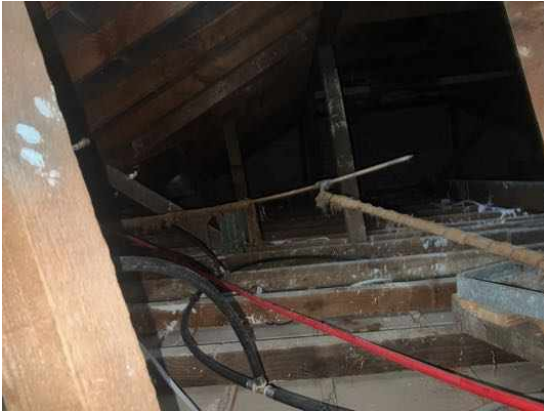
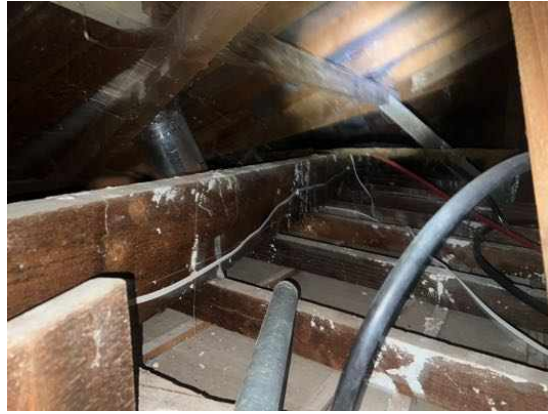
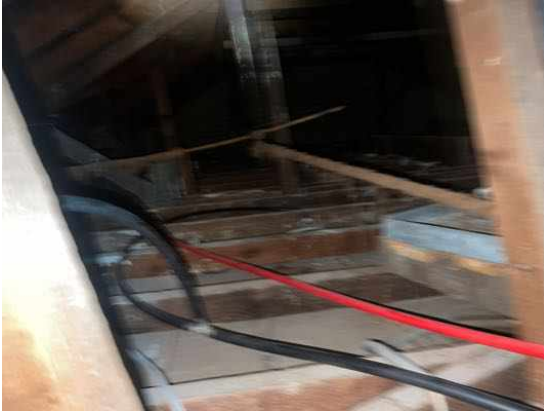
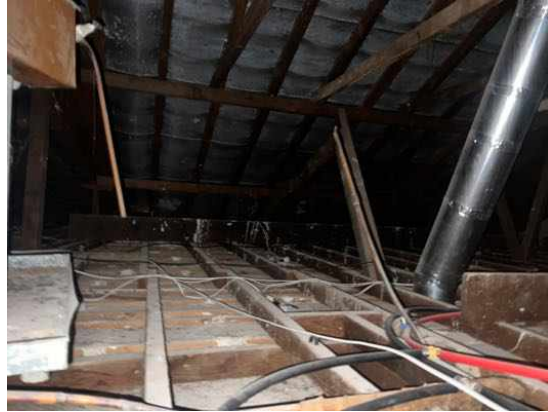
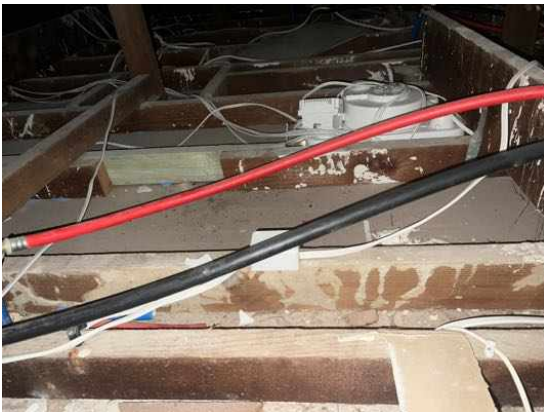
Building: Main Building
 Location: Roof Void > All Areas
 Finding: Insulation - Missing
 Information: Upon inspection of the roof void it was noted that insulation is not present.

Insufficient insulation will result in a comparatively higher cost to heat and cool a property as there is a lack of Insulation (or uneven coverage of insulation) which works as a barrier to heat transfer. This helps to keep out unwanted heat in summer and preserves warmth inside your home in winter. It can also help soundproof your home from unwanted airborne noise transfer.

Where insulation is absent, the area does not meet current Australian Standards. Installation of adequate insulation is required and should be conducted as soon as possible.
