Building and Timber Pest Inspection Report

Inspection Date: Thu, 26 Mar 2026

Property Address: 2/91 Lamington Dr, Redbank Plains QLD
4301, Australia

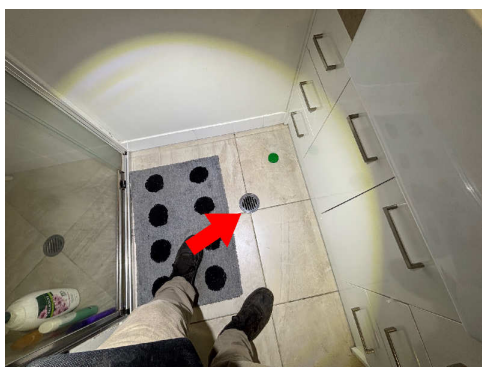
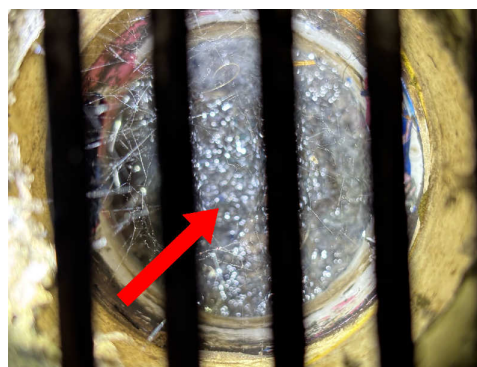
Finding 3.01

Finding: Bathroom - floor drain build up

Information: At the time of the inspection, it was noted that there was a build up of waste in the floor drain trap in the bathroom. Currently, water is flowing freely, however, if left unaddressed, this build up may cause a blockage in the floor waste trap. The shower and vanity drains flow into this trap.

A licensed plumber should be engaged to clear the build up of waste from the floor drain trap. This should be done as a short term priority.

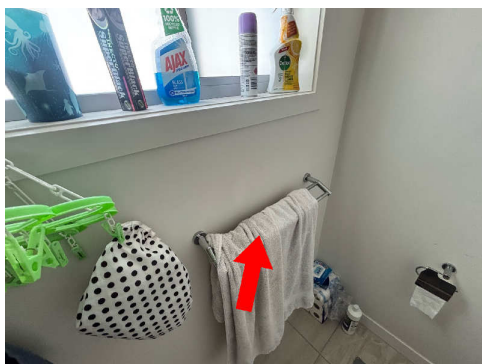
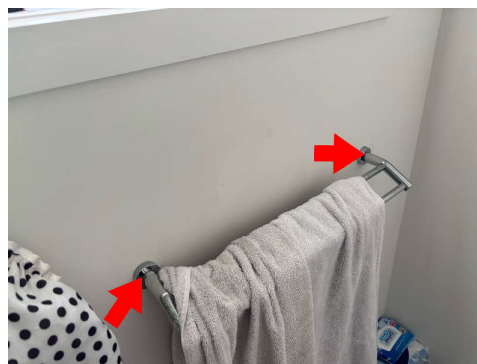
Finding 3.02

Finding: Bathroom - towel rail loose

Information: At the time of the inspection, it was noted that the towel rail in the bathroom was loose. This appears to be from general wear and tear. If left unaddressed, the towel rail may come away from the wall.

The towel rail needs to be re-secured. A building maintenance professional could be engaged to carry out this minor repair. This can be done at the clients discretion.

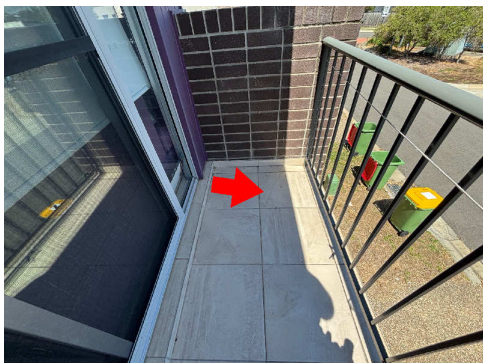
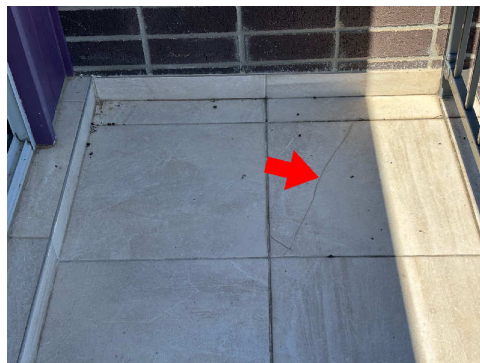
Finding 3.03

Finding: Balcony - cracked tile

Information: At the time of the inspection it was noted that a tile was cracked on the balcony floor. This appears to be purely an aesthetic issues and could be attended to at the clients discretion.

A tiler or building maintenance professional would be able to carry out the necessary works.

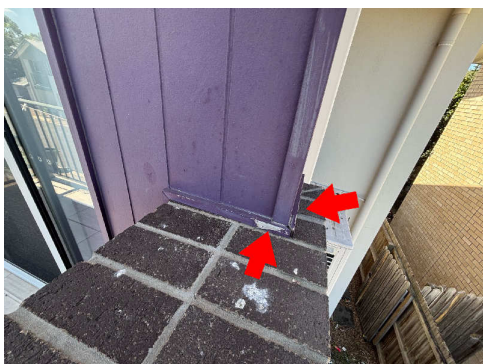
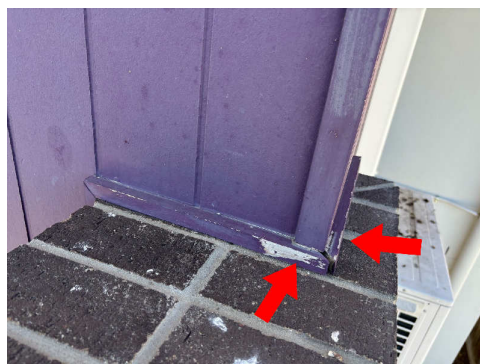
Finding 3.04

Finding: Balcony - loose moulding

Information: At the time of the inspection, it was noted that a timber moulding was loose on the balcony.

A building maintenance professional could be engaged to re-secure the affected timber moulding. This can be done at the clients discretion.

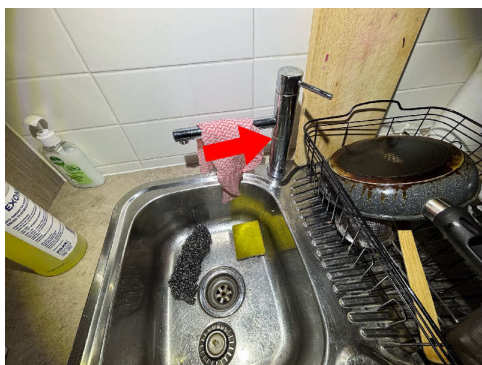
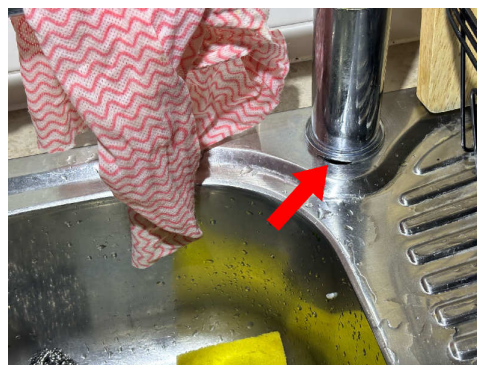
Finding 3.05

Finding: Kitchen - mixer tap not seated properly

Information: At the time of the inspection, it was noted that the kitchen mixer tap was not seated properly on the sink. As a result, there is a hole which can allow moisture to enter the kitchen sink cabinet.

A licensed plumber should be engaged to re-seat the mixer tap to cover up the hole. This should be done as a short term priority.

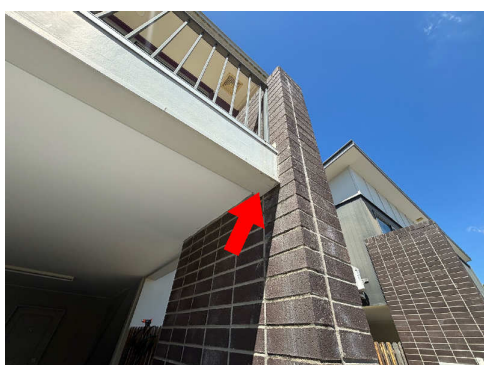
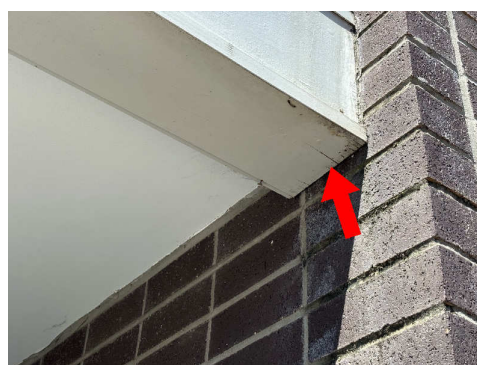
Finding 7.01

Finding: Wood rot

Information: At the time of the inspection, it was noted that there was evidence of wood rot to one end of the timber jamb in the carport. This may be due to the age of the timber building elements and general weathering.

This building element shows evidence of wood rot. Wood rot, also known as Fungal Decay, occurs when timbers and other cellulose building materials are exposed to damp conditions on an ongoing basis.

Early intervention and regular maintenance, particularly of exterior timbers, will prolong the useful life of these building elements. Prior to any works being performed, the cause of the moisture that has created the visible wood rot should be identified and addressed in a suitable manner. Replacement of affected timbers may then be a necessary step in protecting surrounding building elements from such deterioration.

A qualified carpenter or registered builder may also be required to replace affected building materials.

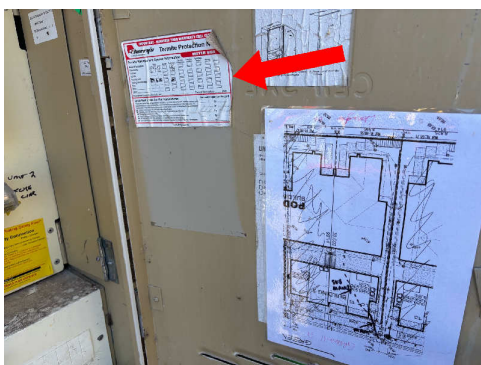
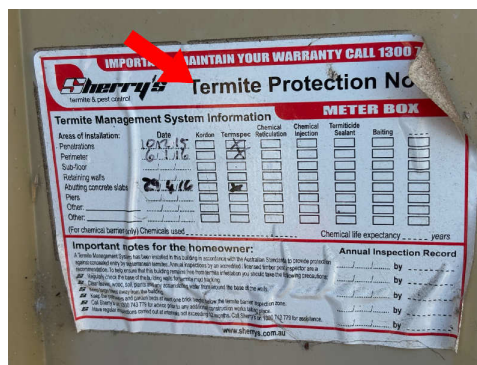
Finding 9.01

Finding: Evidence of a physical termite management system was identified.

Information: At the time of the inspection, evidence of a physical termite management system was found by way of a durable notice in the electricity meter box.

A physical termite barrier was installed to the slab penetrations, perimeter and abutting concrete slabs during construction. The durable notice is dated the 10/12/2015, 06/01/2016 and the 29/04/2016. The last recorded annual termite inspection was carried out on the 06/05/2025.

A termite and timber pest technician should be engaged to carry out annual termite inspections as per AS 3660 in order to further protect the dwelling. Annual termite inspections must be carried out in partnership with any termite treatment system, physical or chemical, as no termite treatment system can be expected to be 100% effective.

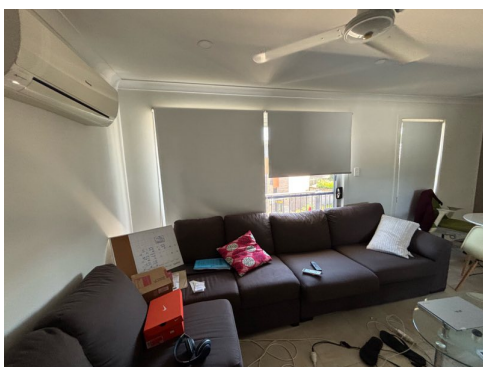
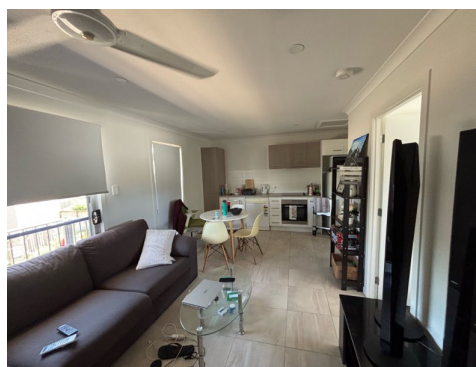
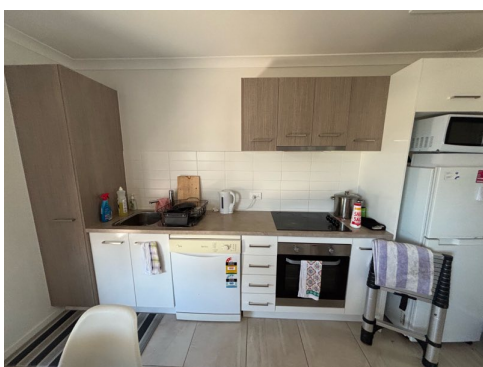
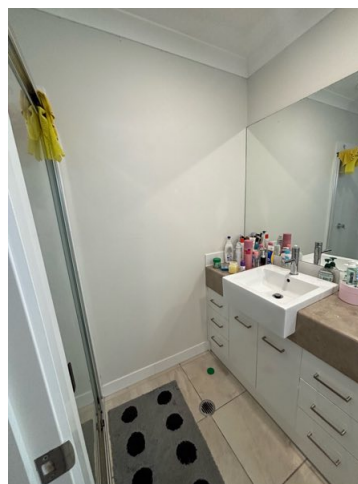
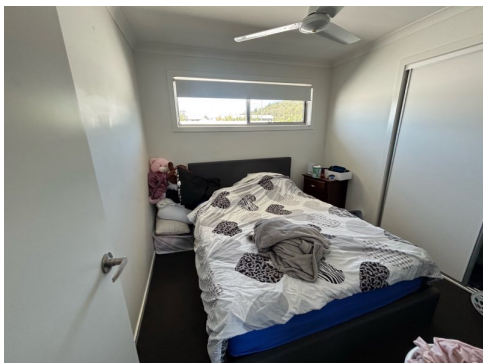
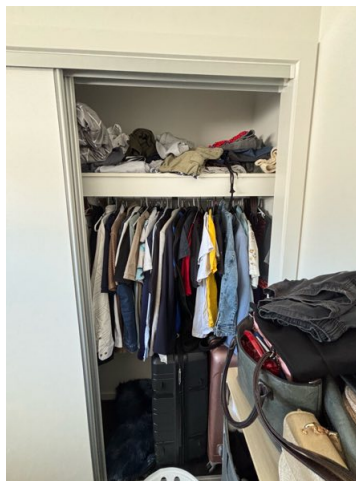
Finding: Obstructions and Limitations - Internal areas

Information: These photographs are an indication of the obstructions and limitations which impeded full inspection of the property of the internal areas at the time of inspection. These obstructions can hide an array of defects and should be removed to allow full inspection to be carried out. A re-inspection is recommended once the areas are made accessible.

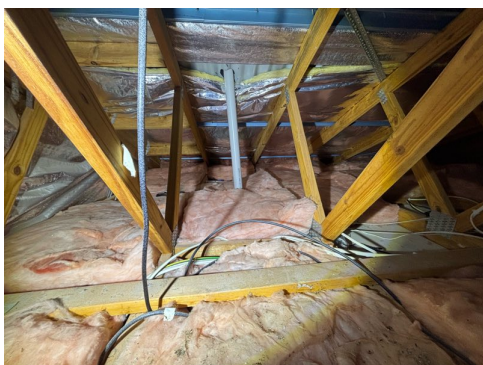
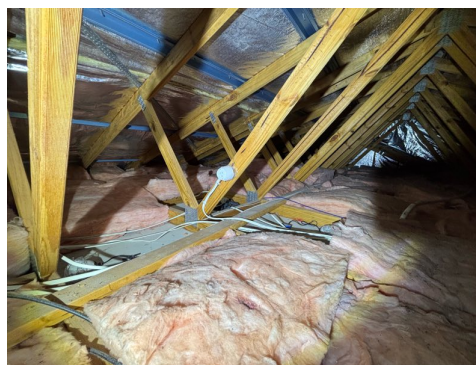
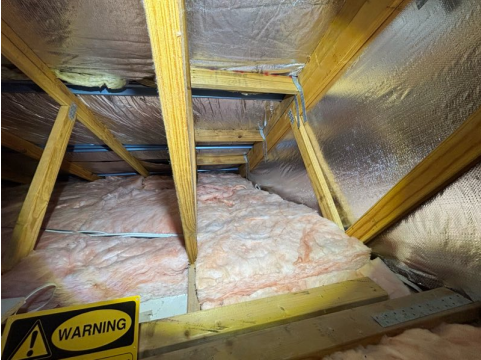
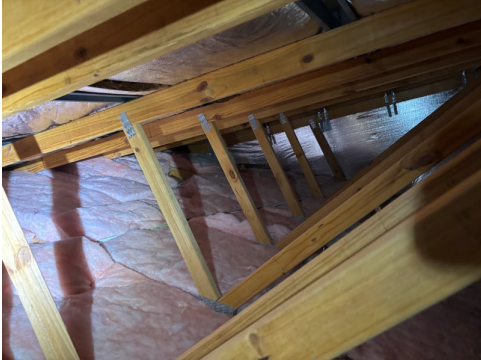
Finding: Obstructions and Limitations - Roof cavity

Information: These photographs are an indication of the obstructions and limitations which impeded full inspection of the property of the roof cavity at the time of inspection. These obstructions can hide an array of defects and should be removed to allow full inspection to be carried out. A re-inspection is recommended once the areas are made accessible.
