# Building and Timber Pest Inspection Report

Inspection Date: Wed, 28 Jan 2026

Property Address: 14/27 James St, Enmore NSW 2042,  
Australia

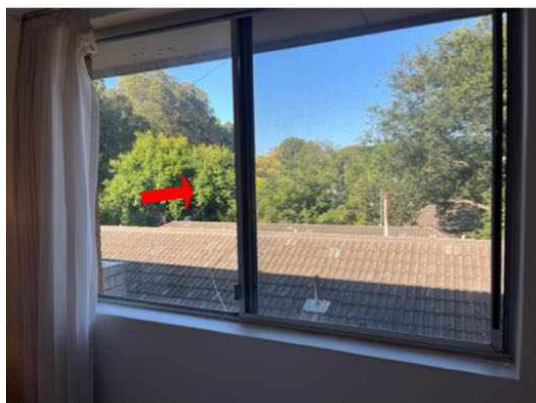
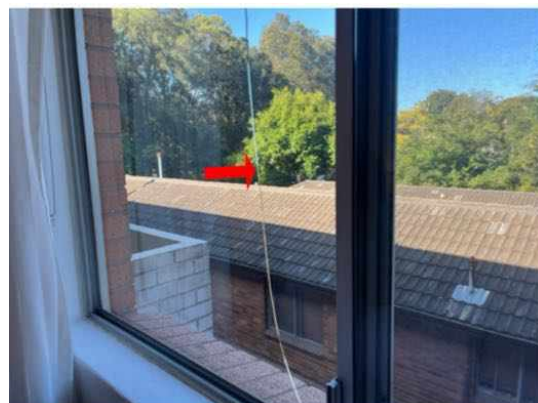
Building:	Main Building
Location:	Bedroom 1
Finding:	Window - Cracked
Information:	A significant crack was identified in the main bedroom window at the time of inspection. Such cracking is generally the result of impact damage and is likely to worsen if not rectified.

The risk of the windowpane further cracking or shattering increases significantly over time, posing a potential safety hazard. Additionally, the damaged glass may compromise the weather-tightness of the building, increasing the likelihood of minor water ingress.

It is recommended that a qualified glazier be engaged to repair or replace the window promptly. Caution is advised for anyone coming into contact with the cracked glass to prevent potential injury.

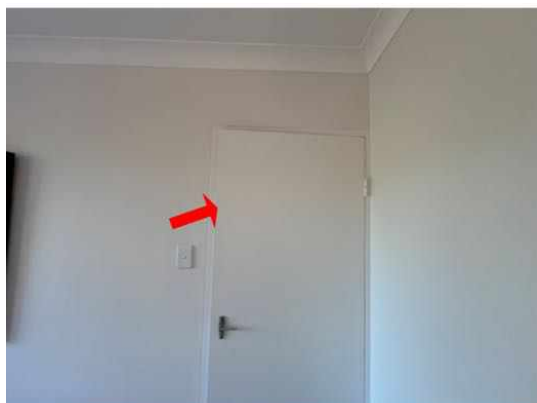
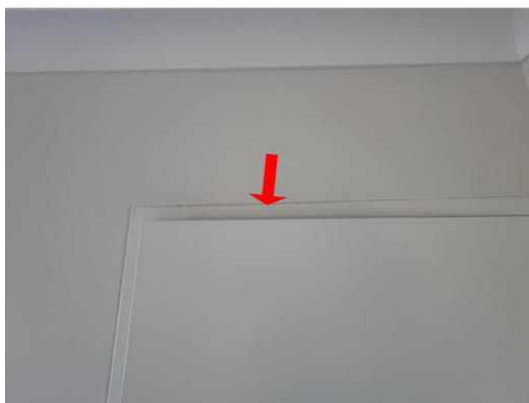
Information: Binding of this door was observed during normal operation. This defect affects the door's functionality and may cause secondary damage to surrounding building elements, such as floor coverings.

Causes of door binding can vary and may include minor issues like poor installation, worn hinges, or general wear and tear.

It is recommended that a qualified carpenter or general handyperson be engaged to assess and carry out any necessary minor repairs at the client's discretion.

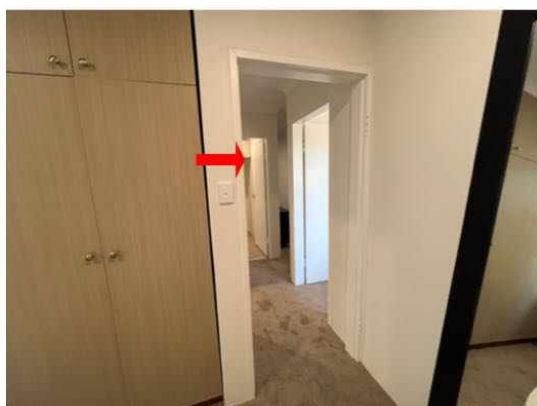
### Finding 3.02

Building: Main Building  
 Location: Bedroom 2  
 Finding: Door - Missing  
 Information: It was noted that the door to Bedroom 2 was missing or not installed at the time of inspection. Although some building elements may seem irrelevant or unnecessary, all building elements play a key role in the operation and function of the overall structure and its performance.

A qualified carpenter or handy person should be appointed to carry out the installation of a new door at client's discretion.

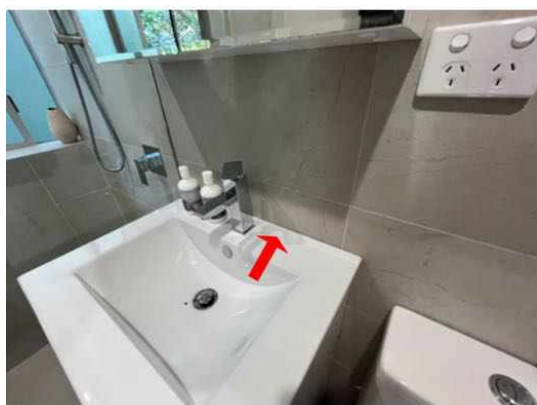
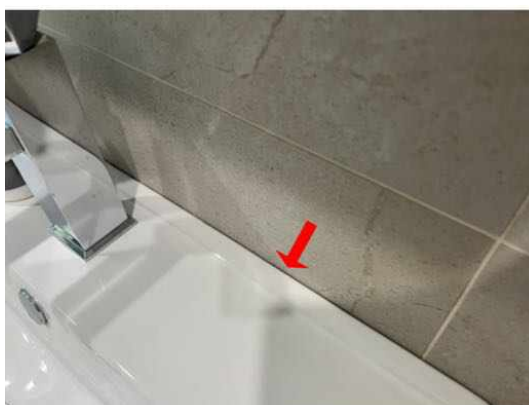
### Finding 3.03

Building:	Main Building
Location:	Bathroom
Finding:	Sealant - Missing
Information:	It was noted on inspection that the sealant in this area was missing at the time of inspection.

Flexible and mould resistant sealant should be applied to affected areas to prevent any subsequent water damage that is likely to occur. Regular maintenance and replacement of missing or damaged sealant is highly recommended to the wet areas, as this is a regular wear and tear defect. Sealant in areas that come into regular contact with water should be maintained for the long term care of your property.

A building contractor should be appointed to complete these works as soon as possible. Alternatively, the homeowner can carry out the work as required following manufacturers instructions.

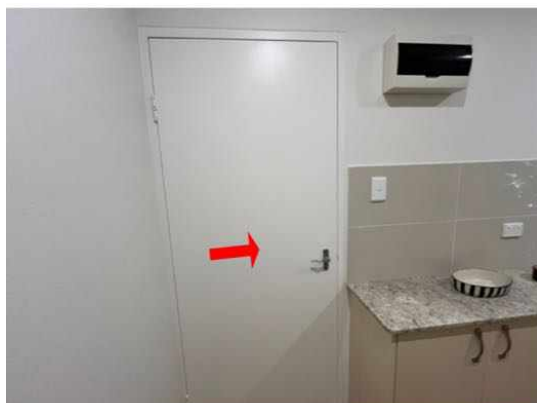
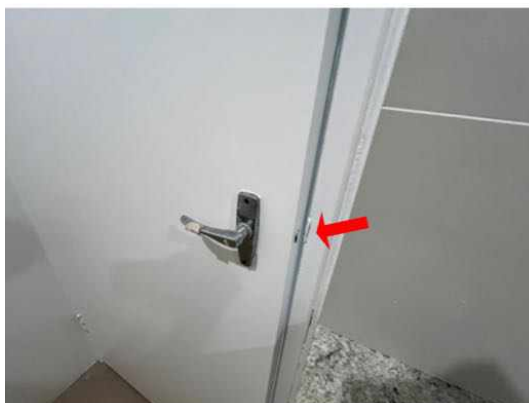
### Finding 3.04

Building:	Main Building
Location:	Kitchen
Finding:	Door - Not latching
Information:	It was noted that the door in this area was not latching during operation at the time of inspection.

It is suspected that this defect has occurred due to minor misalignment or issues with the associated latching mechanism. Such defect is identified as general wear and tear, which is expected for building elements of this age.

A qualified carpenter or general handyperson may be appointed to perform

rectification works as necessary, at client's discretion.

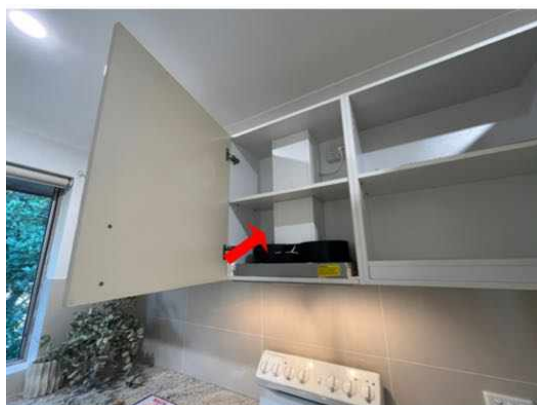
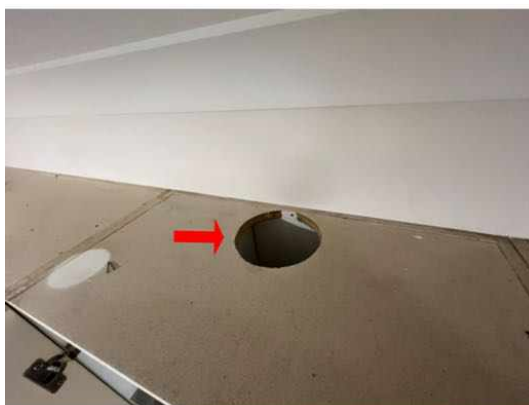
### Finding 3.05

Building: Main Building  
 Location: Kitchen  
 Finding: Rangehood Exhaust - Not vented externally  
 Information: At the time of the inspection, it was noted that the rangehood exhaust was not ducted to the external area. The current setup can negatively impact the functionality of the exhaust fan that allows the emission of steam and evaporative moisture into the interior areas.

It is recommended that a licensed electrician be consulted to adequately install the exhaust duct to allow the emission of gases into the external environment. Works should be completed at the client's discretion.

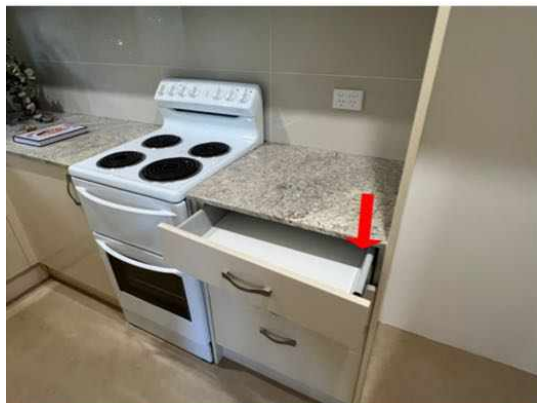
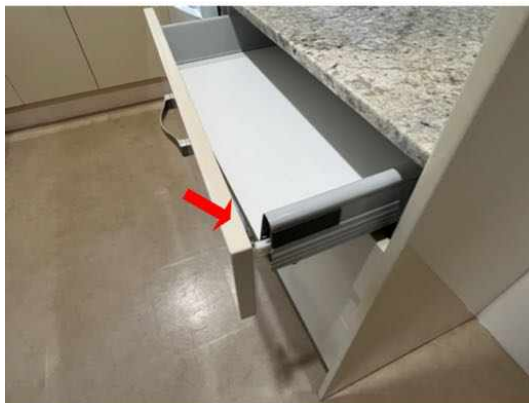
### Finding 3.06

Building: Main Building  
 Location: Kitchen  
 Finding: Kitchen drawer - Deteriorated  
 Information: It was observed that the kitchen drawer showed evidence of deterioration at the time of inspection.

If left in such conditions, further deterioration is likely to occur. It is recommended that the affected drawer be repaired or replaced as soon as possible.

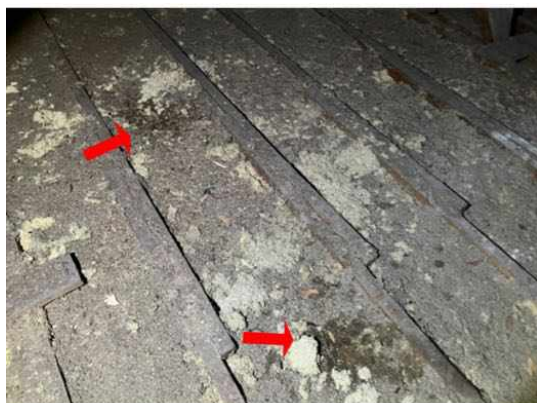
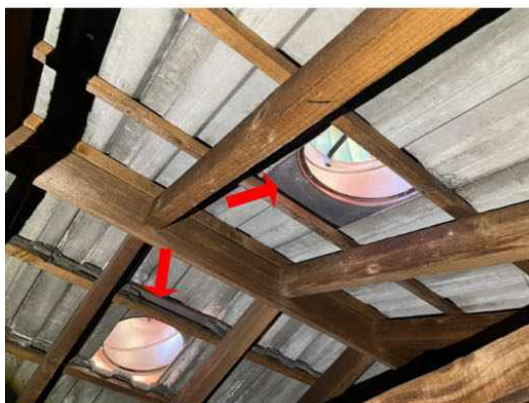
### Finding 3.07

Finding: Roof leak - Identified (Monitor)

Information: An inactive roof leak was identified in the roof void at the time of inspection, indicated by the presence of a water stain on the insulation. It is suspected that a defective or malfunctioning whirlybird fan was responsible for this leak.

Where water leaks are active, rain penetration is likely to cause water damage to associated structures and building elements in this area, which can have a range of implications.

It is recommended that the area be closely monitored for any recurring leaks. A qualified building contractor should also be appointed to further assess the water-damaged ceiling and provide any repair works as necessary.

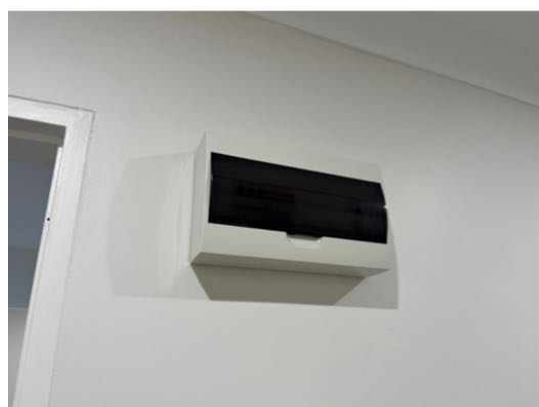
Building:	Main Building
Location:	Meter Box
Finding:	Termite Management System - Not identified
Information:	There was no evidence of a termite management system found at the property at the time of inspection. The application of a post-construction chemical termite barrier is highly recommended for all properties. Such barriers are highly effective in preventing termite attacks on any timber building elements throughout the property.

A durable notice should be placed in the switchboard to indicate current termite barriers. At the time of inspection, it appeared as though no termite management system had been installed, with no evidence to suggest preventative work taking place.

It is recommended that the client inquire about the above finding with the strata managing company regarding any current or previous termite management system that has been put in place for the building. The client may consider gaining further advice from a licensed pest technician as to the costs and procedures involved with this application.

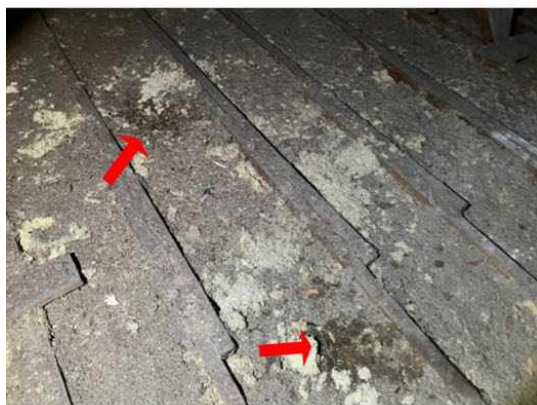
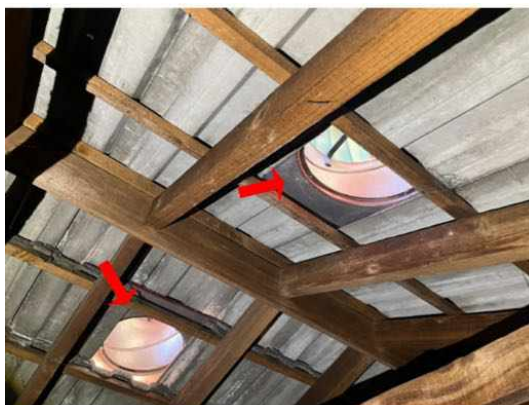
### Finding 6.02

Building:	Main Building
Location:	Roof Void
Finding:	Roof Leak - Identified (Monitor)

Information: An inactive roof leak was identified in the roof void at the time of inspection, indicated by the presence of a water stain on the insulation. It is suspected that a defective or malfunctioning whirlybird fan was responsible for this leak.

Where water leaks are active, rain penetration is likely to cause water damage to associated structures and building elements in this area, which can have a range of implications. Such conditions create an environment that is conducive to termite and timber pest activities.

It is recommended that the area be closely monitored for any recurring leaks. A qualified building contractor should also be appointed to further assess the water-damaged ceiling and provide any repair works as necessary.

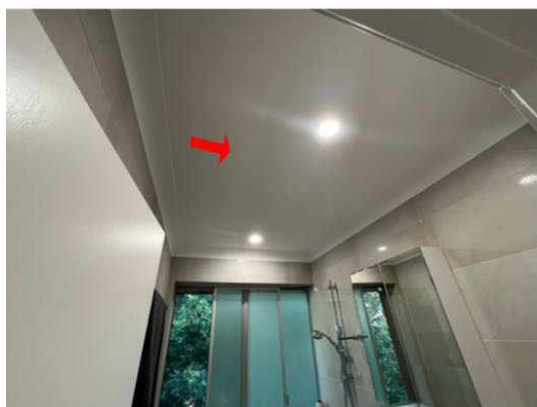
Building:	Main Building
Location:	Bathroom
Finding:	Exhaust fan - Not Installed
Information:	It was observed that an exhaust fan had not been installed in this bathroom at the time of inspection. However, an operable window was installed in this bathroom in place of the exhaust fan. The client is recommended to keep the window open while the bathroom is in use to prevent the development of mould.

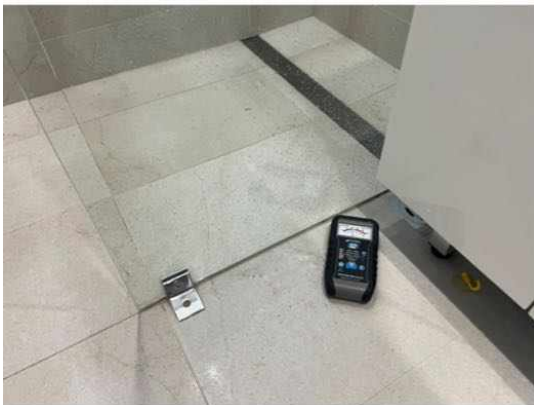
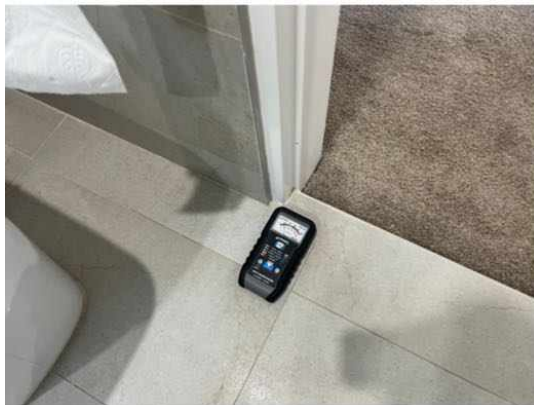
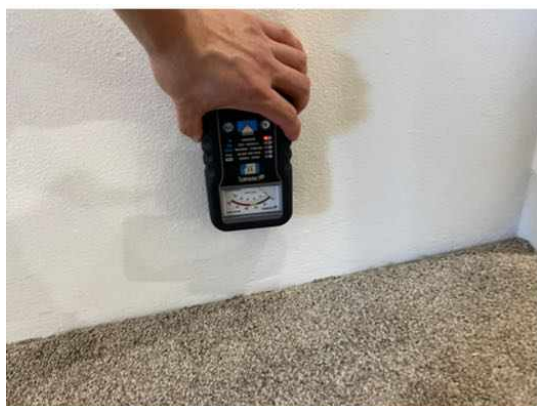
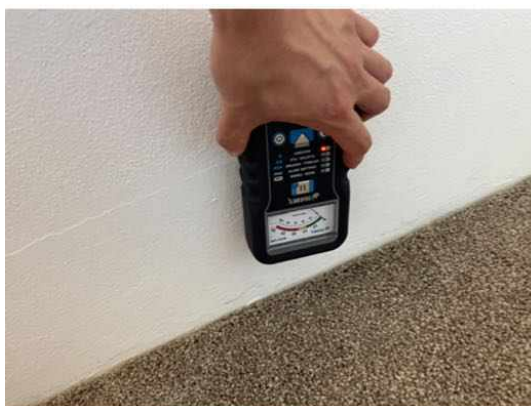
Finding: Moisture Reading

Information: The accessible areas of the bathroom were inspected for evidence of excessive moisture using a moisture meter and visual inspections. There was no evidence of excessive moisture identified at the time of inspection.

However, as the property has been unoccupied and shower use has been minimal, it is recommended to monitor the bathroom areas once regular use resumes and consider reinspection if any signs of moisture develop.

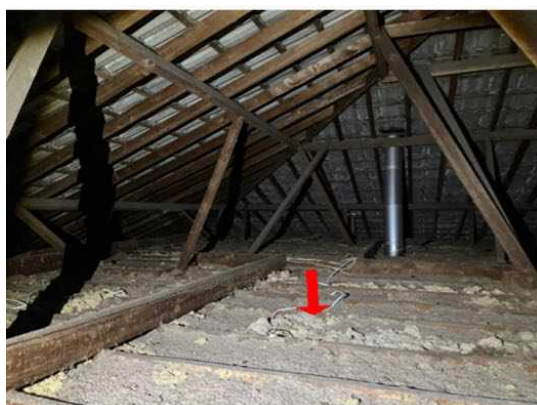
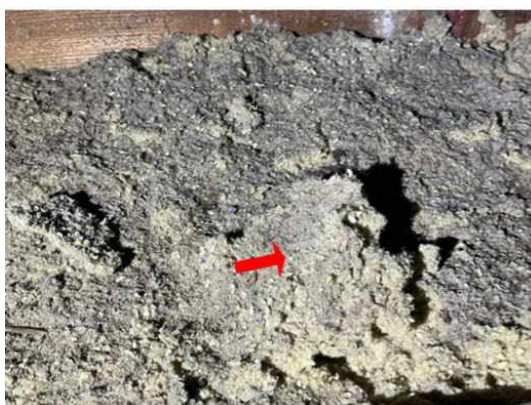
Building: Main Building  
Location: Roof Void  
Finding: Suspected Asbestos Identified on Site - Loose-fill Insulation (Information Only)  
Information: Reporting on Asbestos is outside the Scope of this Report. This suspected defect is highlighted as a caution only. It was noted that loose-fill insulation was installed in the roof cavity of the property.

As Asbestos Reporting is outside the scope of this report, it is strongly advised that a separate asbestos inspection and condition audit be carried out, which can include the taking of samples for definitive confirmation of the presence of asbestos.

In the interim, the client is advised to act with caution, especially when considering any damage to building materials general wear and tear, renovations, demolition and general maintenance activities due to the suspected presence of asbestos.

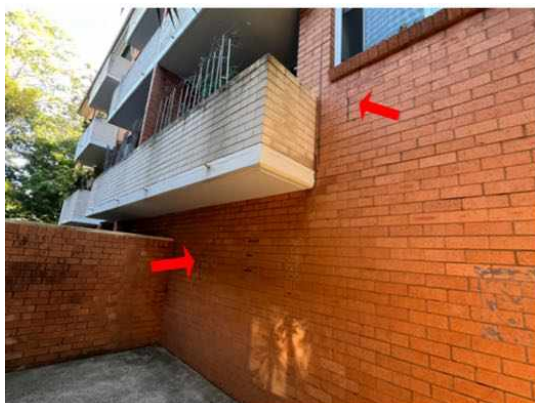
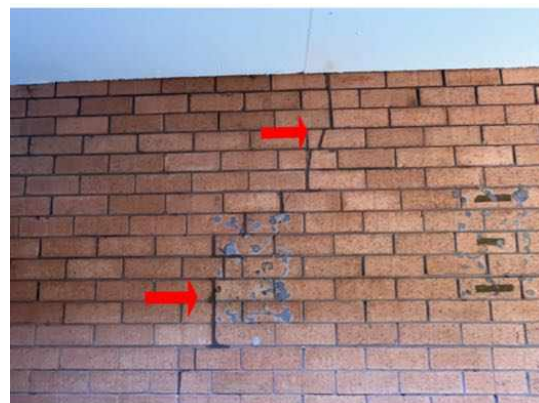
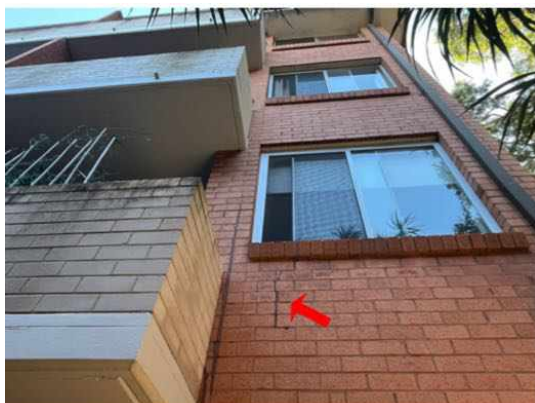
Building:	Main Building
Location:	Exterior wall - left side (Common area)
Finding:	Brickwork - Step cracking
Information:	Step cracking was identified in the brickwork in this area at the time of inspection. Step cracking is a relatively common defect, and is most likely to occur adjacent to windows, doors and other openings. Mortar failure in the gaps between affected bricks indicates the stresses and tensions affecting the wall.

Minor step cracking can be used as a warning sign to address factors causing stress to the wall, which can include the effect of surrounding trees, water leaks, soil erosion, or even the presence of reactive soils in the surrounding area.

Where step cracking is minor, it is recommended that the affected area be closely monitored over the next 12 months. If the conditions continue to deteriorate over the monitoring period (crack widening, lengthening or more numerous), a structural engineer should be engaged for advice on remedial works as required.

Where step cracking is extensive or severe, the client is advised to consult a structural engineer as soon as possible for rectification works.

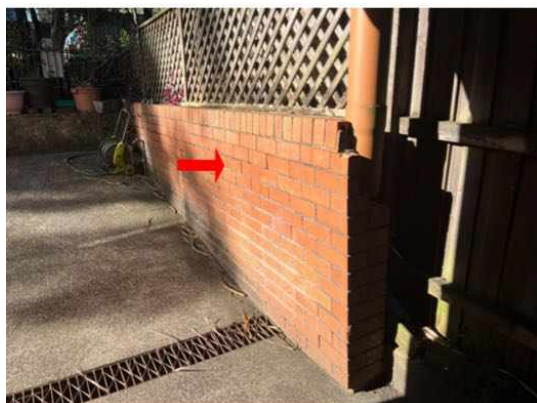
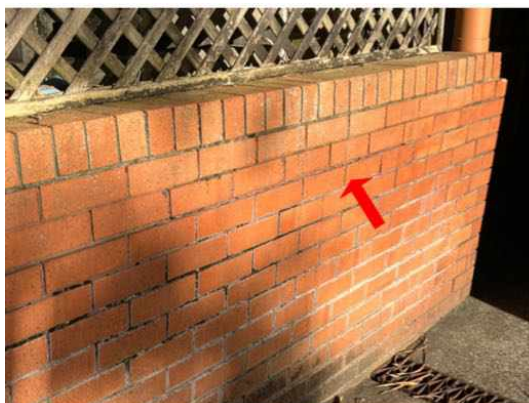
Building:	Main Building
Location:	Fencing - Left side (Common area)
Finding:	Retaining walls - Noticeable cracks
Information:	It was observed that the brickworks to the front left retaining wall had noticeable cracks at the time of inspection.

Noticeable cracks are a common occurrence to external brickwork and are a likely result of age, expected settlement, general expansion, and/or contraction of building materials in different weather conditions. Noticeable cracks in brickwork may develop if left unattended, with potential for necessitating major remedial works or replacement.

It is highly advised that a qualified bricklayer be appointed to provide necessary works to this area of the retaining wall to prevent any further damage.

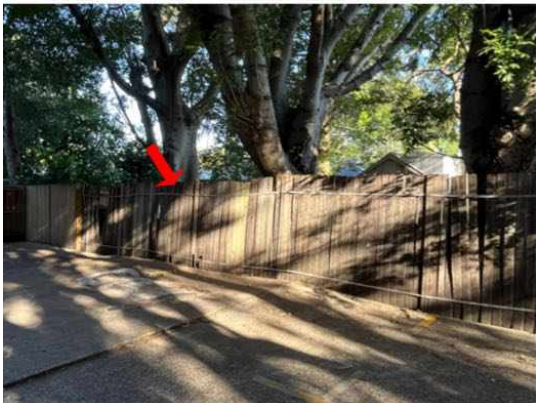
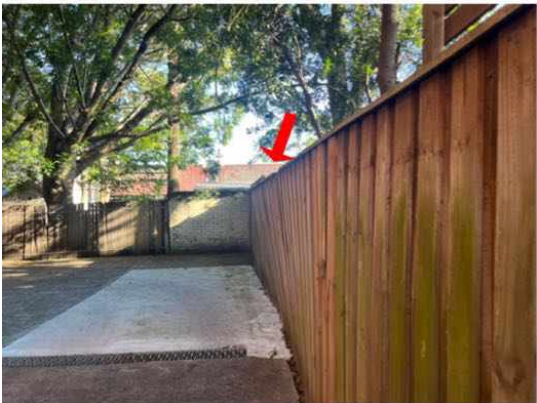
Building:	Main Building
Location:	Fencing - side & rear
Finding:	Fencing - Deteriorated
Information:	It was noted at the time of inspection that the fencing in this area had deteriorated. Typically fencing deteriorates due to age, wear and rot which is generally expected for a structure of this age, due to prolonged exposure to weather conditions. Sometimes inadequate installation or maintenance can be to blame.

If left unattended, further damage will likely occur. It is suspected that repair of several elements of the fencing may be required however replacement may be a consideration of the client also. A licensed fencing contractor should be appointed to provide further advice and perform rectification works as necessary.
