Building Inspection Report

Inspection Date: Wed, 18 Mar 2026

Property Address: 21 Horton St, Elizabeth Park SA 5113,
Australia

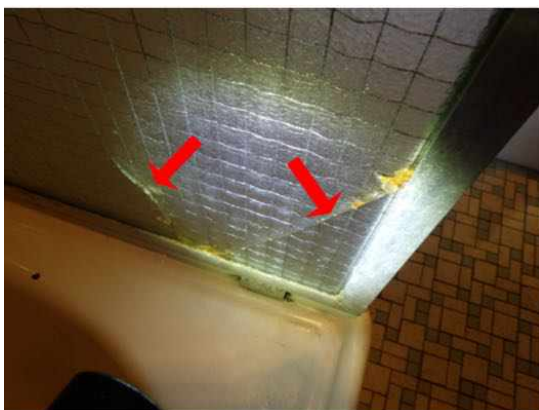
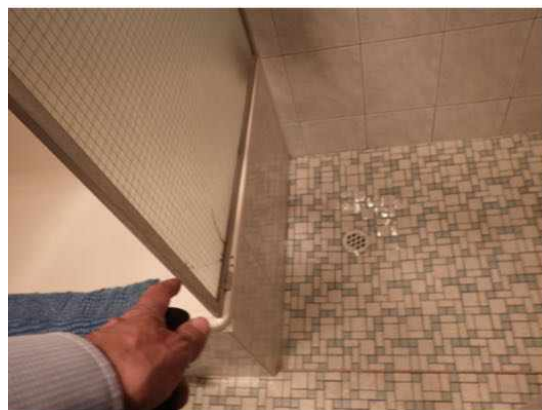
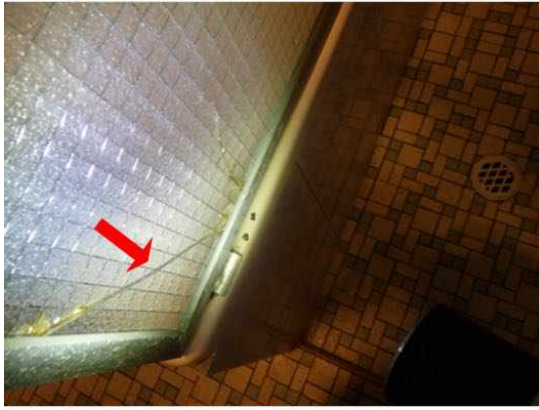
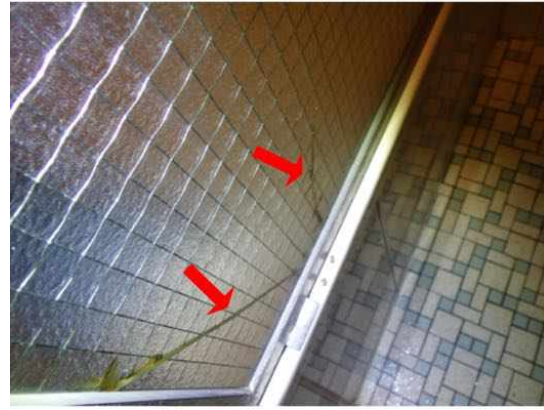
Defects 1.01

Building:	Building 1
Location:	Bathroom
Finding:	Shower screen - Cracked
Information:	Cracking was evident to the shower screen at the time of inspection, which is suspected to be due to accidental impact damage.

While the cracking appears to be minor, any further impact may lead to additional cracking and or shattering of the shower screen, creating a potential safety hazard in the area. Further damage would almost certainly necessitate replacement of the entire shower screen.

A qualified glazier is required to repair the shower screen as soon as possible. Please be advised that any persons coming into contact with the cracked shower screen should do so with due caution to avoid any personal injury that may ensue.

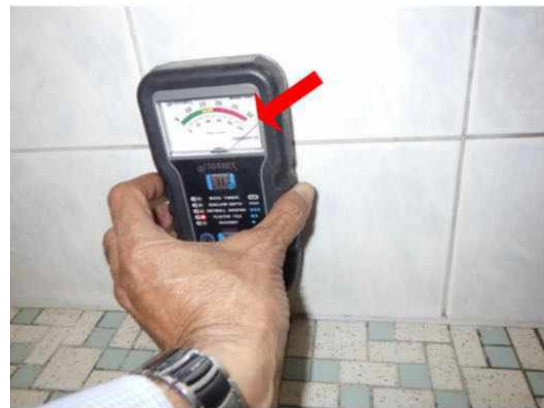
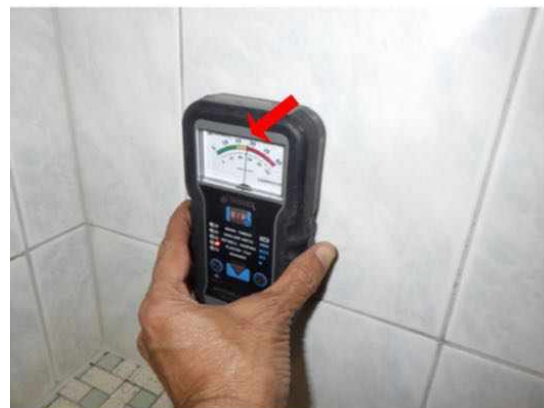
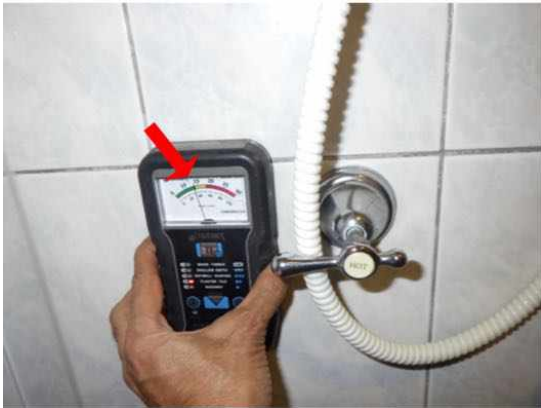
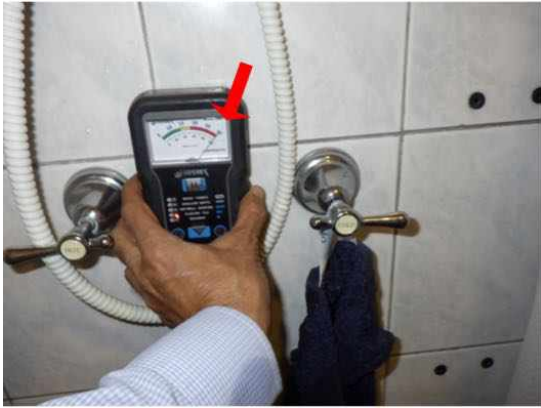
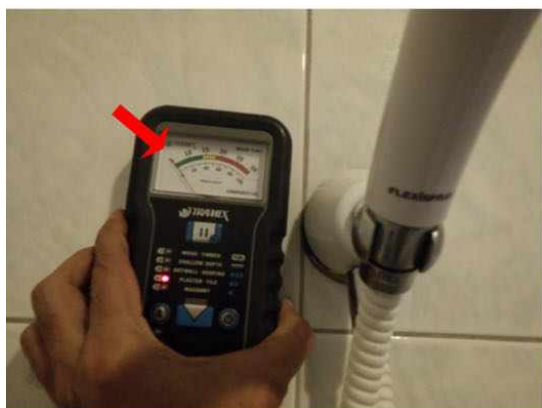
Defects 2.01

Building:	Building 1
Location:	Bathroom
Finding:	Shower Alcove - Damp
Information:	Damp is evident to the lower 400mm approximately of wall to the shower alcove. This defect is quite common, and is suspected to have been caused by moisture permeating through the grouting in this area, which shows evidence of deterioration.

Leaking pipes within the adjoining wall is also a possible cause.

Unmanaged damp in the shower recess is likely to facilitate the formation and development of mould and fungi growth, decaying associated building materials and compromising their structural integrity. Exposure to these contaminants is associated with a wide range of respiratory and other health-related problems.

Consultation with a qualified plumber or bathroom specialist is advised immediately to identify the cause of damp and to perform remedial works as required. Where excessive mould growth is present, further inspection by a specialist environmental health inspector should also be considered.

Always ensure that sealant and grout is in good condition to prevent any moisture issues occurring in the future.

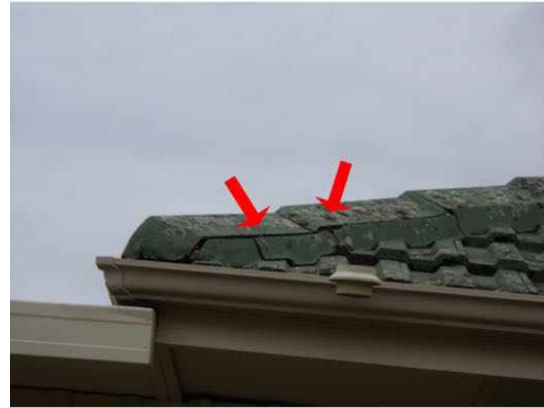
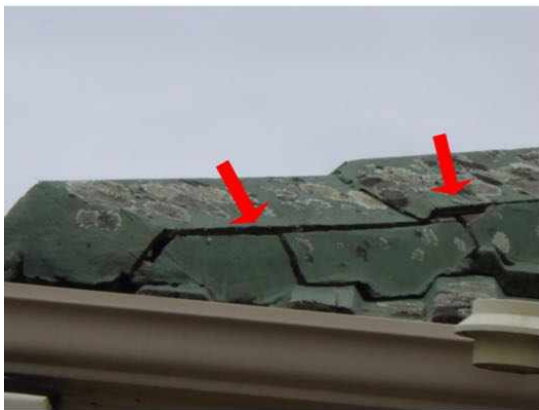
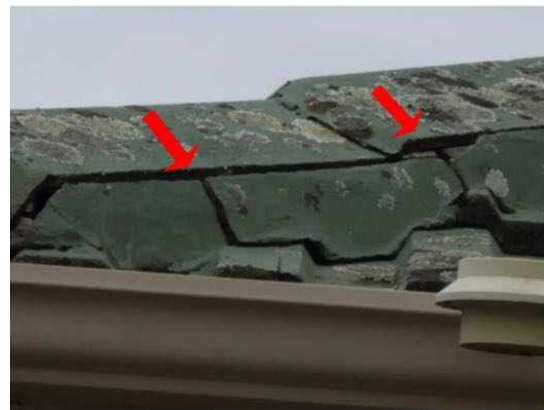
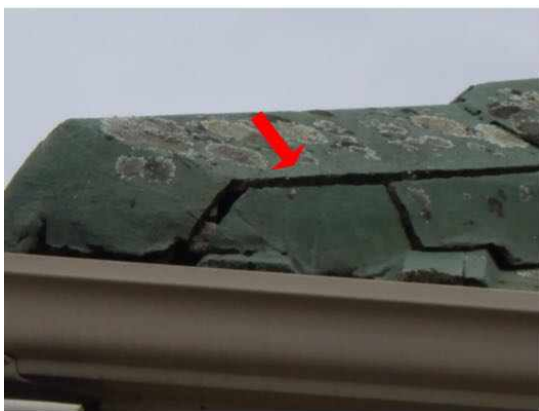
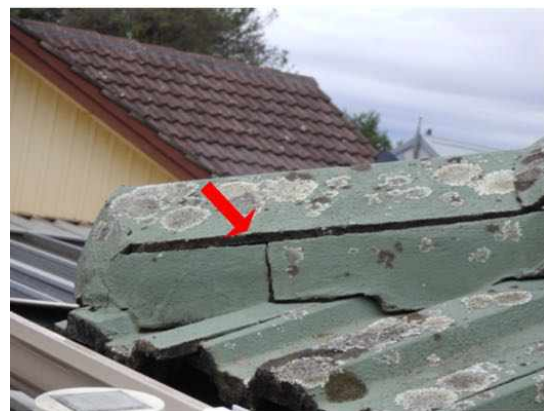
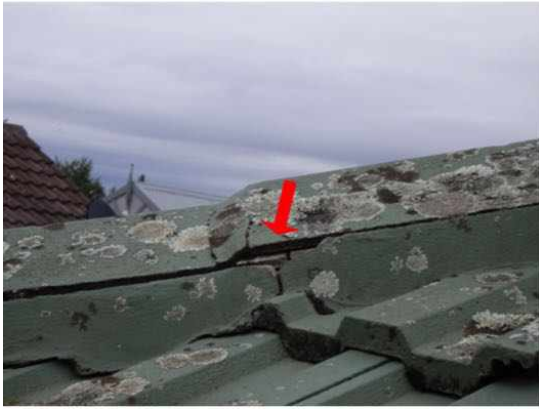
Defects 3.02

Building: Building 1
 Location: All External Areas >
 Finding: Mortar - Deterioration
 Information: At the time of inspection it was noticed that evidence of mortar deterioration to few tiles around the property.

Mortar, or 'bedding', is the material which fills joins and intersections between tiles and other building elements on the exterior roof covering, such as gable ends, hip capping and valleys. Upon inspection of the exterior roof, it was noted that sections of the mortar show varying levels of deterioration.

Mortar generally deteriorates as a result of frequent exposure to weather conditions over a prolonged period of time. Mortar that is deteriorating may allow water ingress into the roof void, putting associated building elements and roofing structures at risk of water damage. Deteriorated mortar also detracts from the functionality of roof tiles and other roofing elements, potentially decreasing weather tightness and roof drainage.

Mortar deterioration can be attended to by a handyperson where areas of deterioration are localised and easily accessible. Otherwise, consultation with a roofing contractor is advised where greater works are required.

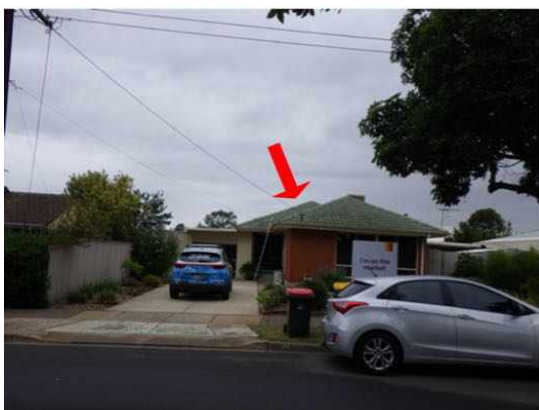
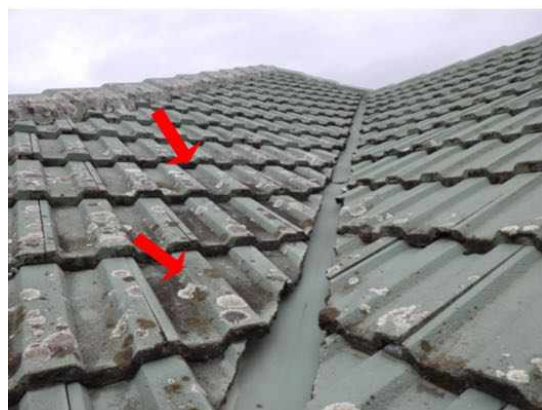
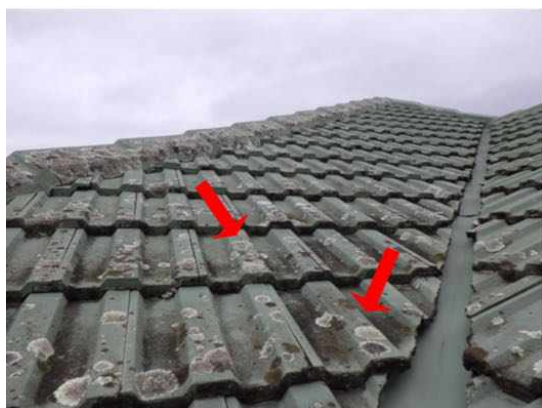
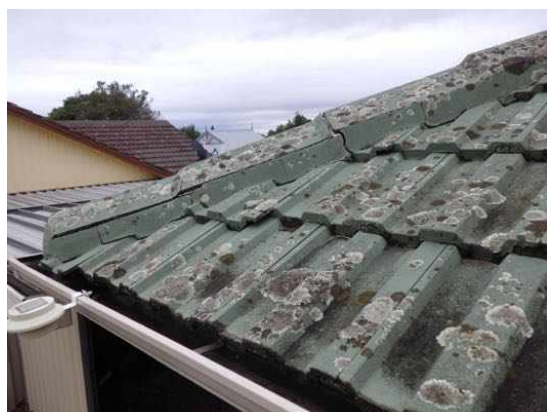
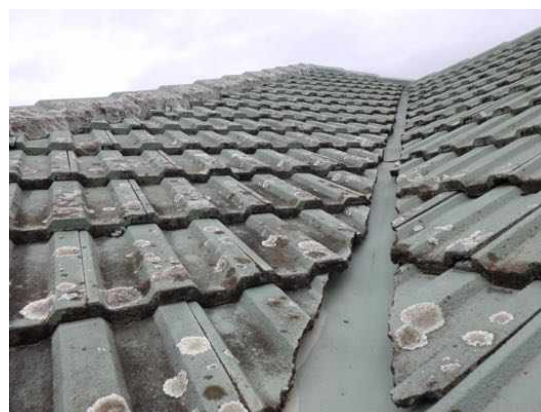
Defects 3.03

Building:	Building 1
Location:	All External Areas
Finding:	Roof tiles - Weathered
Information:	Upon inspection of the exterior roofing, the majority of roof tiles were considered to be in a fair condition. While weathering of the tiles is consistent with the age of the property, maintenance works are required.

Isolated areas of mortar have come loose in the valleys and minor cracking is also present. Re-pointing and re-sealing the may be considered as an interim solution by the client to help preserve and extend the life span of the tiles.

Where left unmanaged, deteriorating roof tiles are likely to lead to a number of secondary defects, including minor water leaks and weather exposure to internal roofing structures.

Consultation with a roofing contractor is highly advised to gain advice on cost of remedial works that may be required in the short to medium term. Remedial works are likely to increase the longevity of the exterior roofing structure.

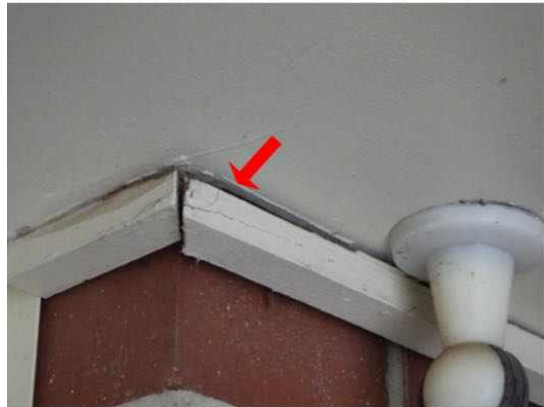
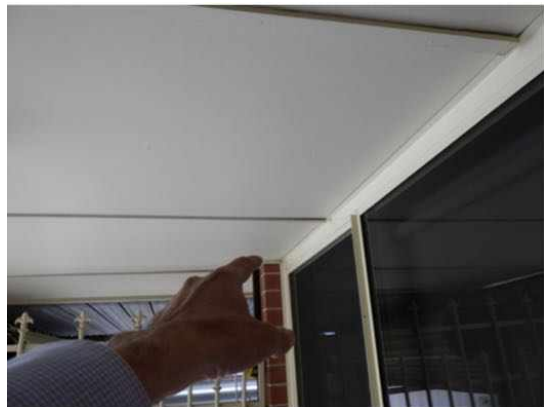
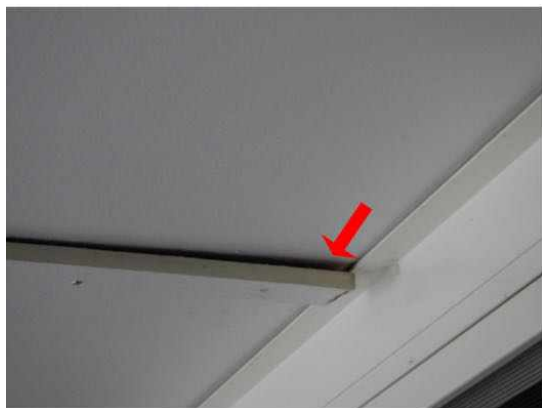
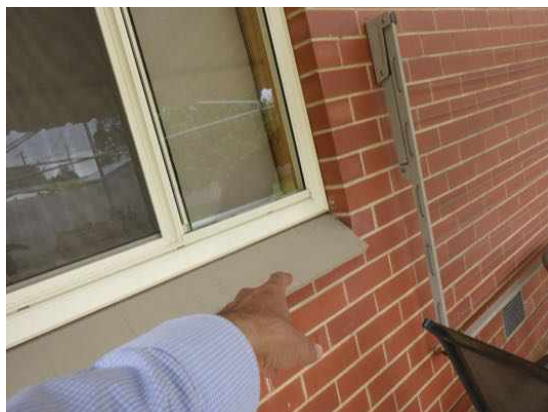
Defects 3.05

Building: Building 1
Location: All External Areas
Finding: Building element - Damaged/ Loose from its original fixing
Information: At the time of inspection it was noticed at few sections of building elements were damaged / loose from its original fixing around property.

Breakage occurs generally when the building materials have either aged and decayed, or as a result of damage (accidental or deliberate).

Repair and/or replacement of broken elements is advised to ensure that additional secondary defects do not arise as a consequence. Such works are necessary, as all building elements play a key role in the operation and function of the overall structure and its performance.

A relevant tradesperson should be appointed to repair or replace the affected building element prior to any subsequent damage being caused.

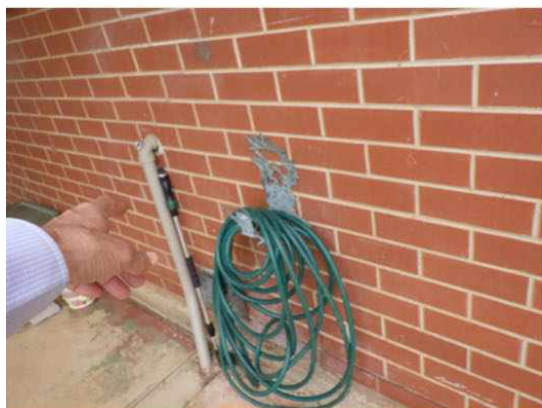
Defects 3.07

Gaps and holes around pipework makes the area susceptible to insect and vermin ingress, as well as allowing water penetration to the cavity wall. As such, associated building elements are likely to deteriorate at an accelerated rate, and major implications are expected if holes around the pipework are left unmanaged.

All excessive holes, gaps or cracks should be adequately filled by a suitable sealant or trimmings as soon as possible to prevent any further damage. Such works may be conducted by a general handyperson or licensed plumber.

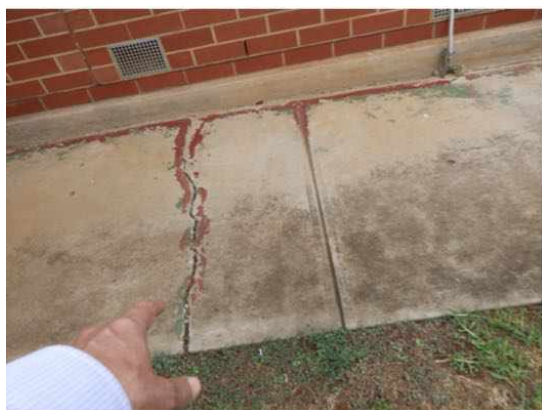
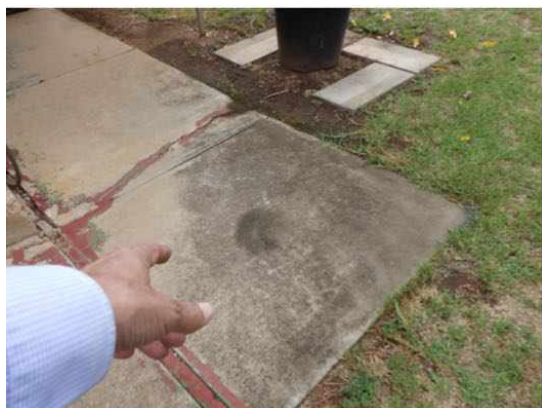
Defects 3.08

Building:	Building 1
Location:	All External Areas
Finding:	Paving - Uneven
Information:	Sections of the external paved area are uneven, creating a potential trip hazard. It appears as though the area has been subject to rough installation, or that paving sections have lifted due to movements in the foundation of the property.

Where paving creates a trip hazard, personal injury may ensue if due caution is not taken by all persons within this area.

Re-paving of the area is required as soon as possible to remedy this situation. Further consultation with a specialist concreter is advised.

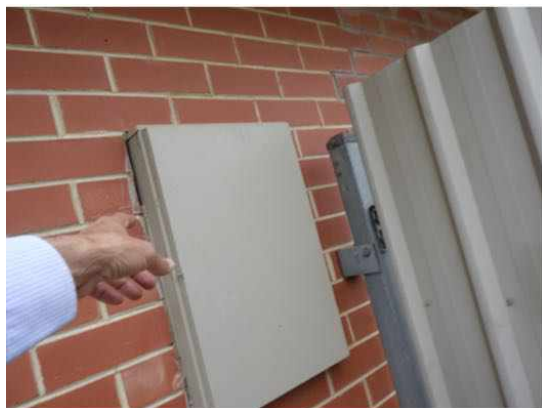
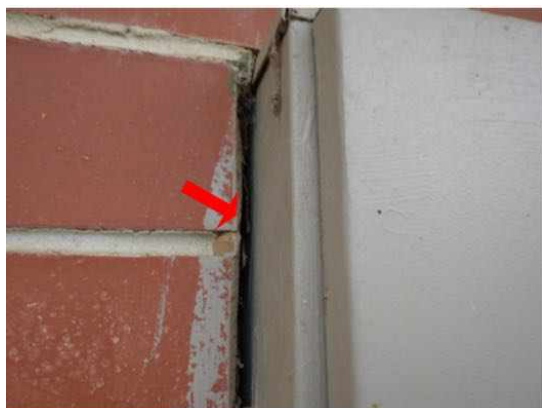
Defects 3.09

Building:	Building 1
Location:	All External Areas
Finding:	Brickwork - Deteriorated mortar
Information:	At the time of inspection it was noticed that evidence of mortar deterioration / missing from this external meter box area.

Mortar, or 'bedding', is the material which fills joins and intersections between bricks in masonry walls and structures. Sections of mortar in this brickwork were identified as having deteriorated, which is generally expected for a property of this age and condition.

Mortar may deteriorate as a result of age of building materials, minor movement of bricks, or frequent exposure to weathering. Mortar should be replaced to ensure that bricks remain in their intended location and to prevent gaps, which would allow water or moisture ingress and secondary damage as a result.

Mortar deterioration can be addressed by a bricklayer where areas of deterioration are localised and easily accessible. Alternatively, appointment of a registered builder is advised, to repoint large areas of decaying mortar. Where secondary structural defects have become evident, consultation with a structural engineer may be required.

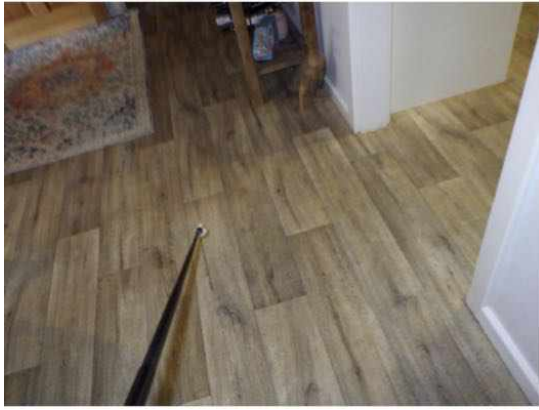
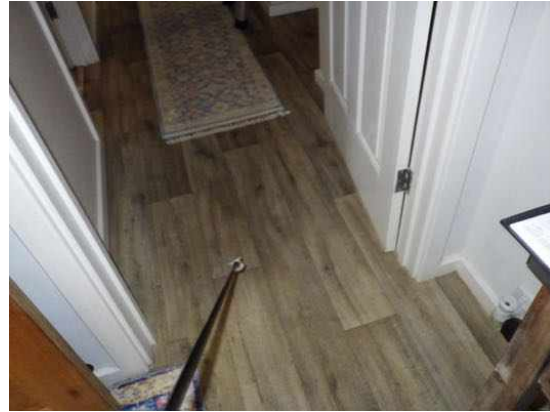
Defects 3.10

Building:	Building 1
Location:	All Internal Areas
Finding:	Floors - bouncy
Information:	The internal flooring in this area was identified as being bouncy at the time of inspection. A bouncy floor surface generally presents as a discernible change in level as they are walked across, in noisy or creaking flooring, or in consequent movement of surrounding furniture and fixtures.

Bouncy floors generally indicate that the floorboards or the subfloor structures are coming loose from the joists that they are installed on. Bouncy flooring may also be the result of gaps between flooring and stumps or joist structures, which require packing.

The client is advised to seek quotations for required repairs from a Registered Builder specialising in re-stumping. The potential resolution may range from packing gaps in subfloor structures through to replacement of subfloors stumps and refixing of flooring.

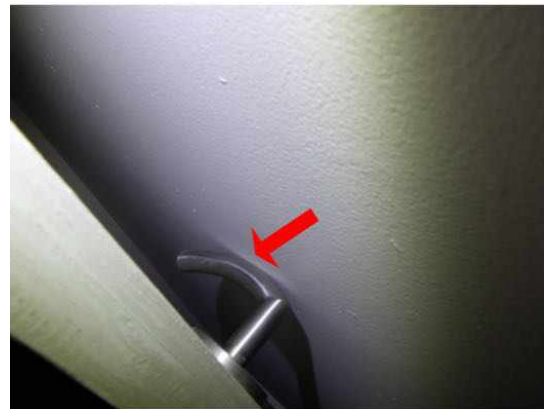
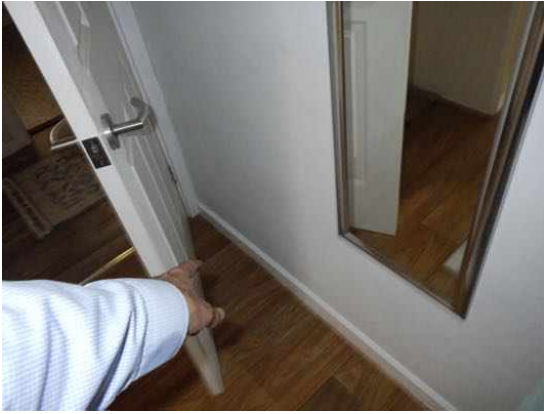
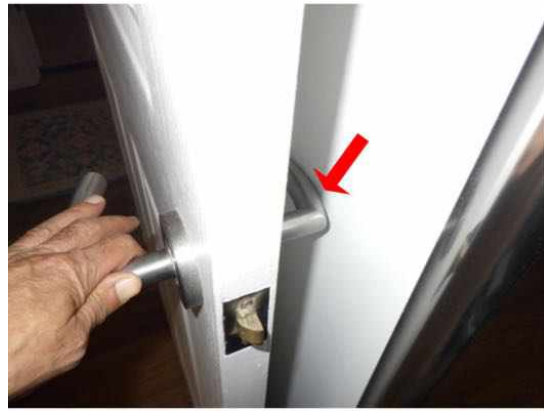
Defects 3.11

Building:	Building 1
Location:	All Internal Areas
Finding:	Door stop - Missing
Information:	The door stop is missing or is inadequate to stop the door handle from damaging the wall. Although some building elements may seem irrelevant or unnecessary, all building elements play a key role in the operation and function of the overall structure and its performance.

Re-installation or replacement of the door stop is advised as soon as possible to prevent any subsequent damage to the door or associated structures. A general handyman may be appointed to perform these works at client discretion.

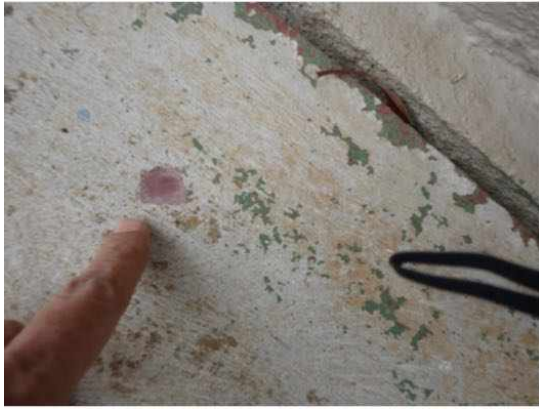
Where a Termite Management System has been identified you should refer to the type of barrier date of installation warranty conditions and any documentation provided by a builder or past owner. Consult the company who installed the barrier to confirm whether the system is still under warranty.

Most chemical termite management systems expire and require replenishment and all physical systems are primarily designed to prevent concealed entry.

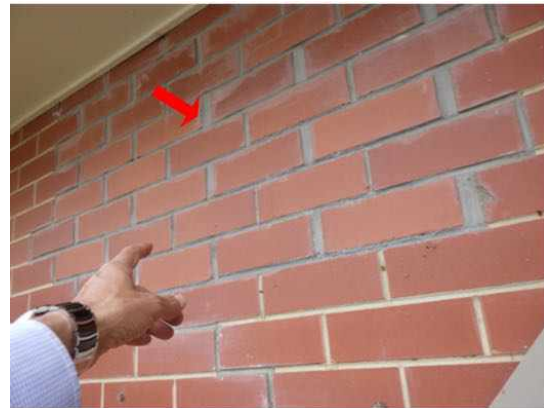
Building: Building 1
Location: All External Areas
Finding: External walls - Evidence of repairs
Information: At the time of inspection it was noticed that evidence of repairs to the few sections of external walls.

For further details please discuss with your realestate agent or appropriate trades.
