# Building and Timber Pest Inspection Report

Inspection Date: Wed, 11 Mar 2026

Property Address: 2/71 Prospect St, Rosehill NSW 2142,  
Australia

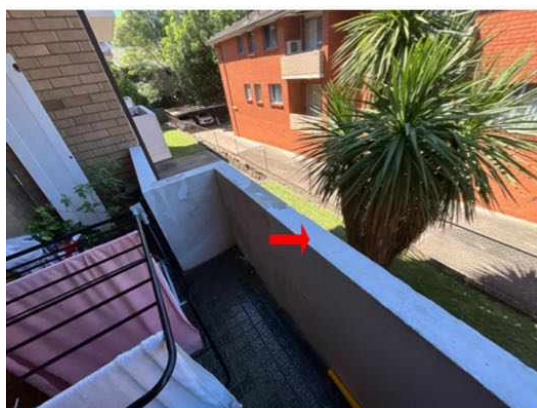
Building:	Main Building
Location:	Balcony
Finding:	Balustrade - Suspected Non-Compliance
Information:	The balustrade was measured and found to less than the present building regulation requirement of 1000mm high.

The balcony balustrade was found to be non-compliant, requiring immediate rectifications by a licensed builder.

This defect creates a potential safety hazard and should be rectified as soon as possible to ensure the safety of the area and to meet present building standards and regulations.

A licensed builder should be contacted to discuss possible rectification solutions.

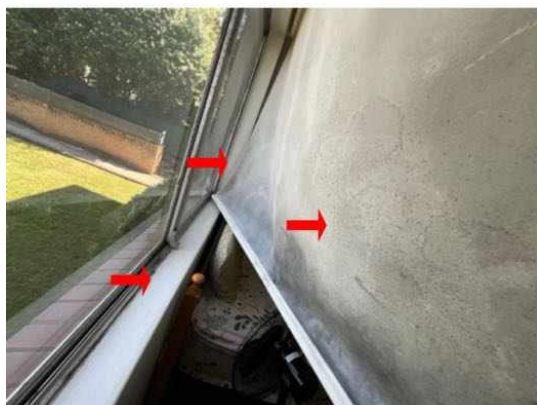
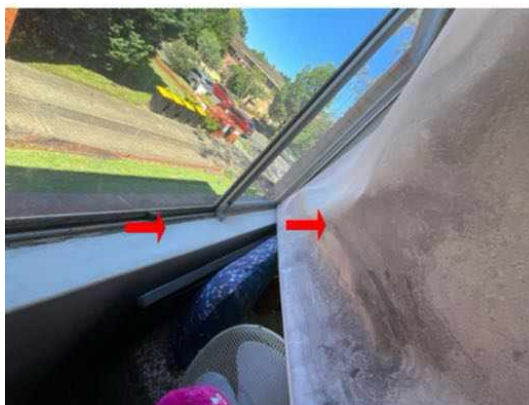
#### Finding 1.02

Building:	Main Building
Location:	Both bedrooms
Finding:	Mould - Present
Information:	Evidence of mould growth was noted, which is believed to have grown due to lack of ventilation to the area. Where evidence of mould growth was noted, there may be environmental, biological or health issues associated with the report. A specialist inspection by a suitably qualified environmental health inspector is warranted, where

Another safety hazard is due to mould. A mould remediation contractor is required to treat this mould urgently.

Generally, the client is advised to ensure that the general environment is free of moisture and humidity to aid in the prevention of mould formation and development. Any mould found during the inspection should be cleaned immediately by a cleaning contractor or the homeowner as applicable.

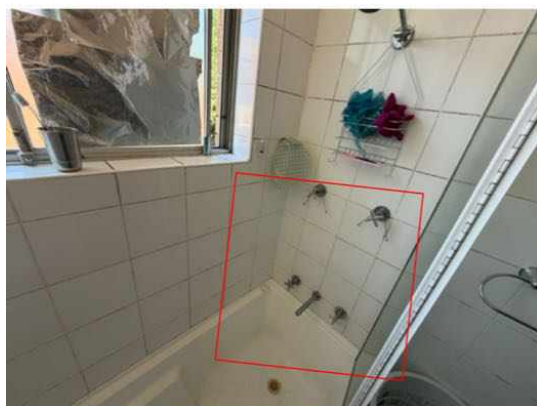
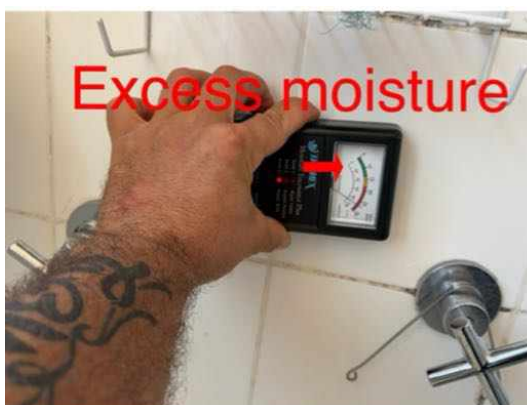
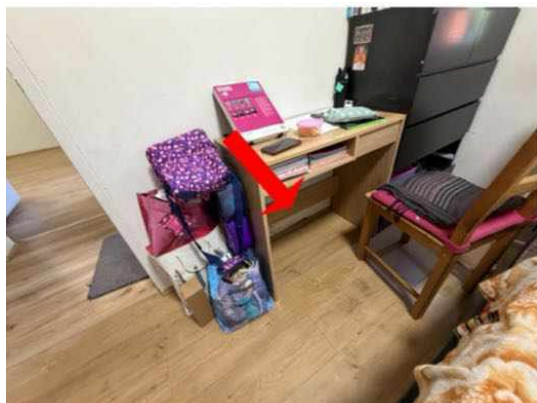
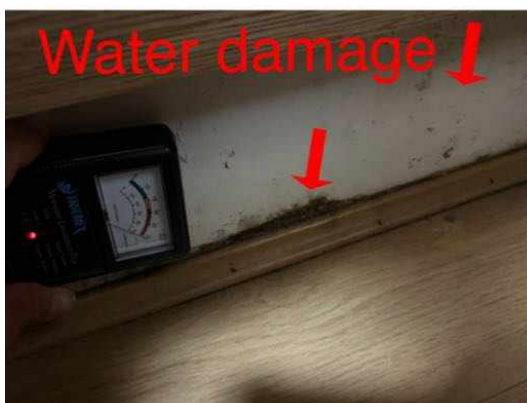
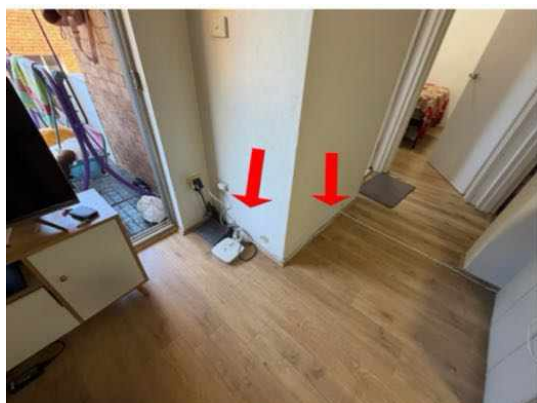
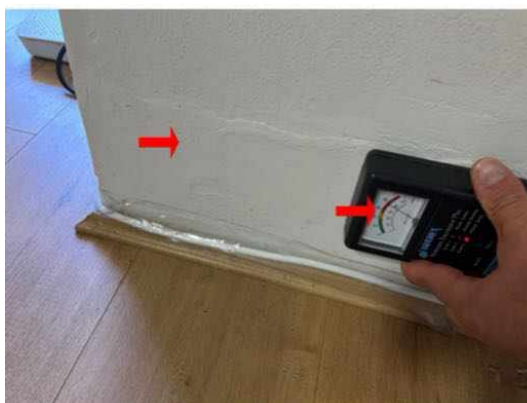
### Finding 2.01

Building:	Main Building
Location:	Bathroom
Finding:	Water leak suspected - Internal
Information:	A water leak is suspected in this area at the time of inspection. Internal water leaks can be detrimental to surrounding building elements; their potential causes include damage to plumbing fittings and fixtures, through to water damage and deterioration of associated building elements.

Rust, corrosion, decay and water damage are potential outcomes where a minor water leak is left unattended. More serious defects may also result, such as electrical hazards, or water damage to structural building elements.

Internal water leak is suspected to the bathroom. Water damages and excess moisture was measured to the surfaces. A bathroom specialist must be engaged immediately for repairs.

In extreme cases, structural damage may develop due to a prolonged water leak. It is highly advised that a bathroom specialist be appointed immediately for assessment and repairs.

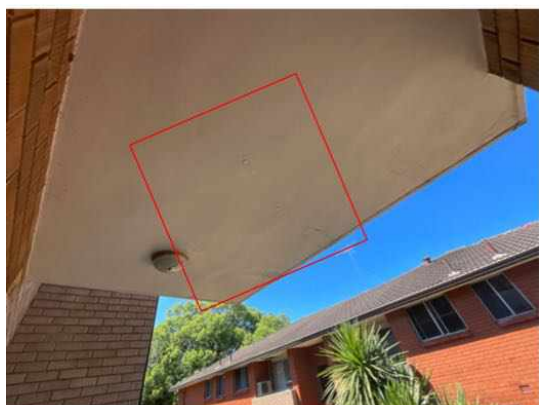
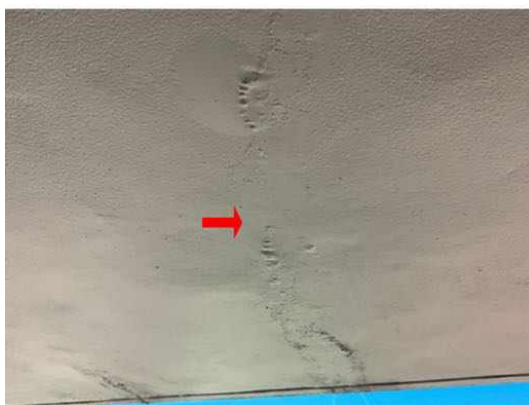
## Finding 2.02

Building:	Main Building
Location:	Balcony
Finding:	Water Damage
Information:	Water damage is generally an indication of excessive moisture being present, usually via a leak. It is suspected that the balcony above is leaking.

Water damage was identified to the balcony ceiling, indicating that the balcony above is leaking. A licensed plumber must be appointed urgently for further assessment and repair.

Where water damage is evident, the primary requirement is to identify and rectify the source of the leak. A licensed plumber should be appointed as soon as possible to identify the leak and perform rectification works as necessary, ensuring the water damage is restricted.

Once the leak is repaired, consultation with relevant tradespeople, including a painter, is advised.

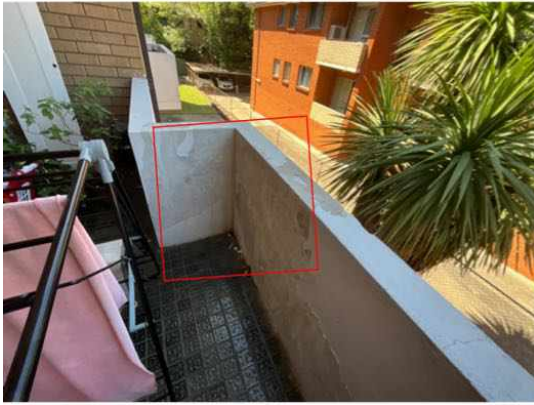
### Finding 3.01

Building:	Main Building
Location:	Balcony
Finding:	External painting deteriorated
Information:	The external paintwork in this area has been neglected and require attention to prepare and re-paint.

Whilst incomplete or missing paint finish is generally an appearance defect, it can also lead to the development of secondary building defects over time. Incomplete areas of paint finish expose the area to moisture, potentially accelerating the deterioration of underlying building materials.

Degraded paint finishes should be sanded back, filled, leveled and painted, as applicable. Where inadequate or missing paint protection has led to the deterioration of the associated building element, repair and/or replacement of this building element may be required.

A painting contractor should be appointed as soon as possible to perform necessary works to aid the appearance of the affected area and to ensure the area is protected against further deterioration. Alternatively, the homeowner following manufacturer instructions may perform these works.

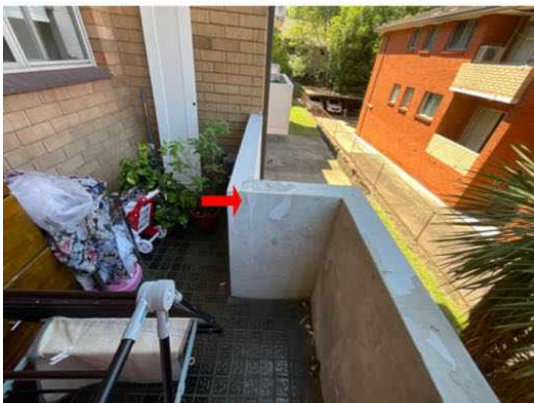
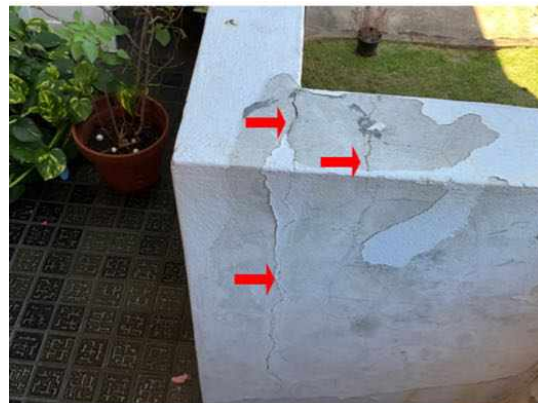
### Finding 3.02

Building:	Main Building
Location:	Balcony
Finding:	External render — Cracked (minor)
Information:	Rendered surfaces were identified to be cracked at the time of inspection. The width of these cracks are under 1mm and are not significant.

This generally does not indicate a structural defect and may be due to poor workmanship during construction. Other causes include age, general wear and tear, expected building movement, general expansion/contraction of building materials in different weather conditions, and/or minor failings in the installation or application of building materials.

Any exposure to moisture is capable of causing rendered areas to become drummy and/or crack further. A licensed renderer or painter should be appointed for rectification works in short term.

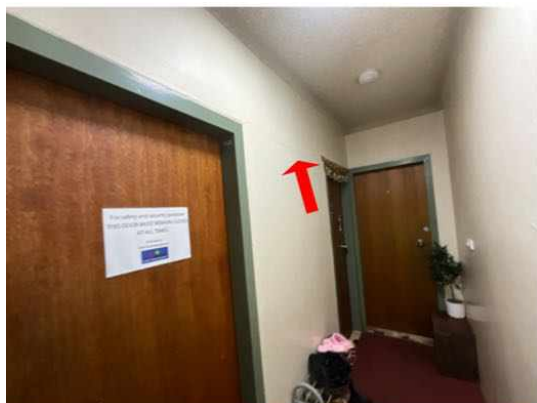
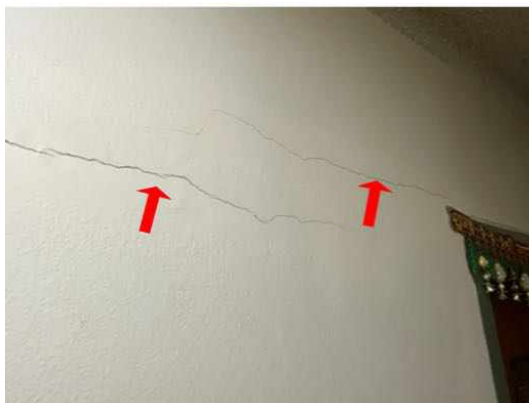
### Finding 3.03

Location: Entry  
 Finding: Cracks to internal render - Category 1  
 Information: It has been observed that cracking to internal rendered surfaces has occurred. The degree of damage falls within Category 1, described as fine cracks that do not need repair and which are less than 1.0mm in width limit.

Damage of this category is not considered a defect for rectification. Always contact your building inspector should cracks widen, lengthen, or become more numerous.

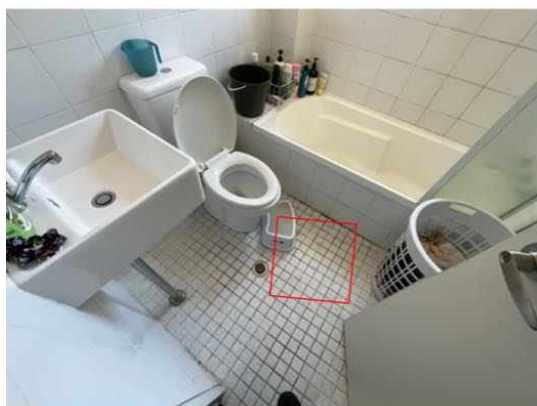
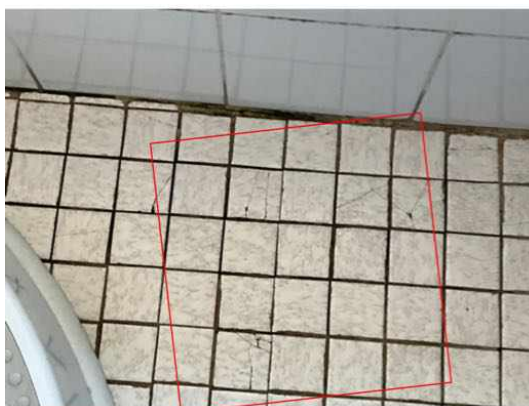
### Finding 3.04

Building: Main Building  
 Location: Bathroom  
 Finding: Wet area tiles - Cracked or damaged  
 Information: Cracking was evident to the tiling in this area at the time of inspection. While the cracking appears to be minor, this area is frequently exposed to water, allowing potential for water penetration into adjoining sections of walls or flooring.

If left unmanaged, water penetration to these areas may lead to subsequent water damage, which is likely necessitate repair work to affected building elements.

A bathroom specialist should be appointed to determine the integrity of the bathroom waterproofing membrane. If the membrane was found to be intact then relatively minor works to replace the cracked tiles should be carried out to ensure no further damage occurs. The re-application of silicone and grouting throughout remaining tile work is also advised, to further protect the area against water penetration.

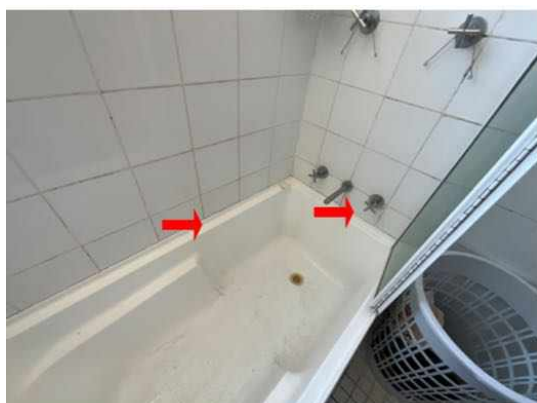
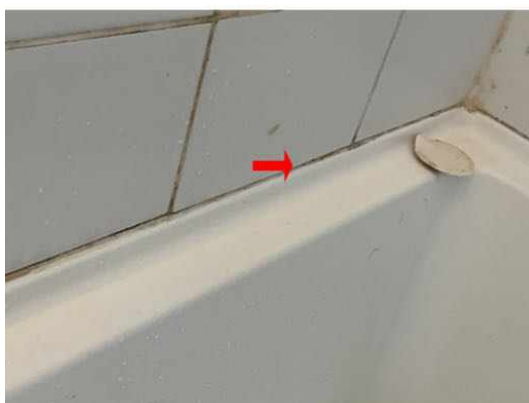
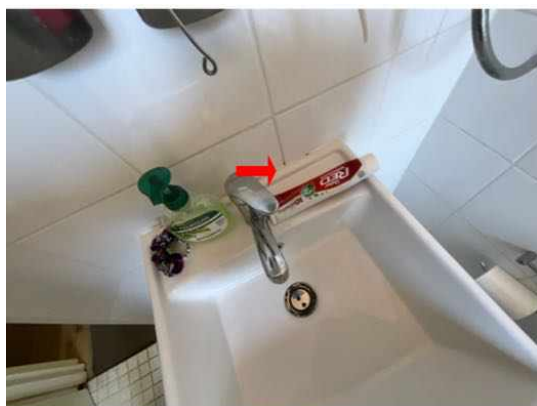
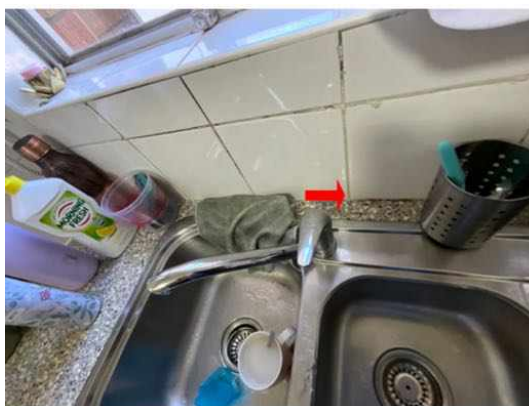
### Finding 3.05

Building: Main Building  
 Location: All Wet Areas  
 Finding: Sealant and grouting - Missing or damaged  
 Information:

It was noted on inspection that sealant or grout is degraded to this area.

Different materials and floor areas move at different rates, generally causing cracking to grout or sealant at this point. A flexible sealant is required to allow for expected expansion and contraction, while keeping the joint water tight and protective of all associated building materials.

Flexible and mould resistant materials should be applied to affected areas to prevent any subsequent water damage that is likely to occur. Regular maintenance and replacement of damage or missing or damaged sealant and grout is highly recommended to the wet areas, as this is a regular wear and tear defect. Sealant and grouting in areas that come into regular contact with water should be maintained for the long term care of your property.

A sealant specialist should be appointed to complete these works as soon as possible.

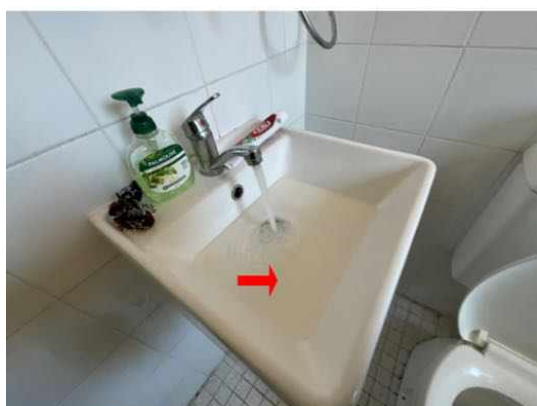
### Finding 3.06

Building: Main Building  
 Location: Bathroom  
 Finding: Sink/basin - slow draining  
 Information:

The sink/basin drain appeared to be partially blocked at the time of inspection. Blockages here are usually caused by hair and other debris. If left unmanaged, a lack of general maintenance may lead to the development of more significant defects, such as water damage to surrounding building materials.

A licensed plumber should be appointed to remove the blockage at the client discretion.

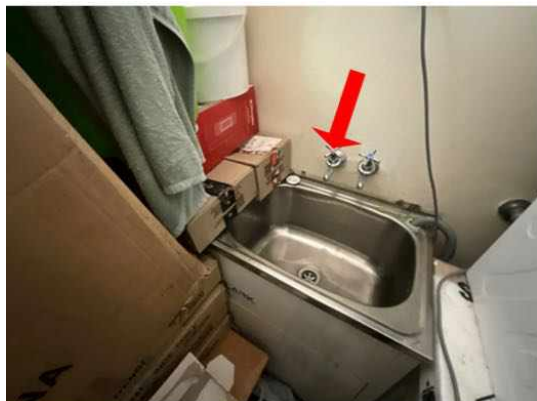
### Finding 3.07

Building: Main Building  
 Location: Laundry  
 Finding: Building element - Damaged  
 Information: Breakage occurs generally when the building materials have either aged and decayed, or as a result of damage (accidental or deliberate).

Repair and/or replacement of broken elements is advised to ensure that additional secondary defects do not arise as a consequence. Such works are necessary, as all

building elements play a key role in the operation and function of the overall structure and its performance.

A licensed plumber should be appointed to repair or replace the affected building element prior to any subsequent damage being caused.

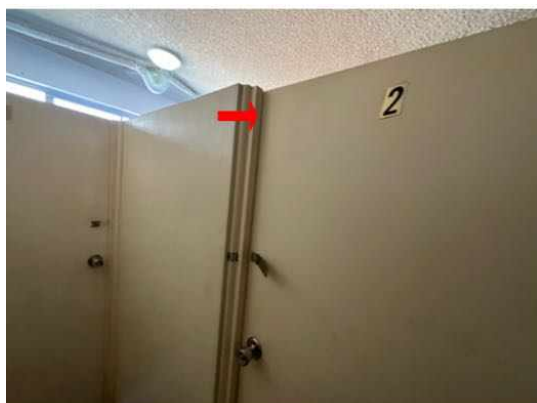
### Finding 3.08

Building: Main Building  
Location: Laundry  
Finding: Door - Binding/jamming  
Information:

Binding and/or jamming of this door is evident during standard operation. This defect inhibits the functionality of the affected door as well as creating potential for secondary defects to associated building elements, such as damage to the floor covering or adjacent frame.

A door that binds to flooring or to the associated door frame may have several causes, ranging from minor defects, such as poor installation of the door or deteriorated hinges.

A licensed carpenter should be appointed to perform minor rectification works at client discretion.

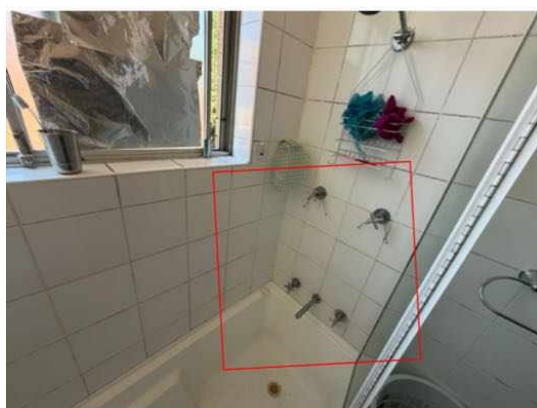
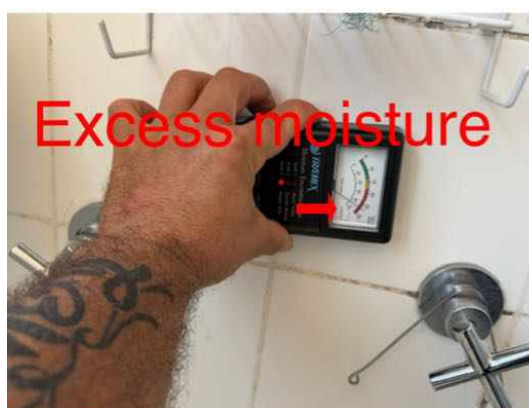
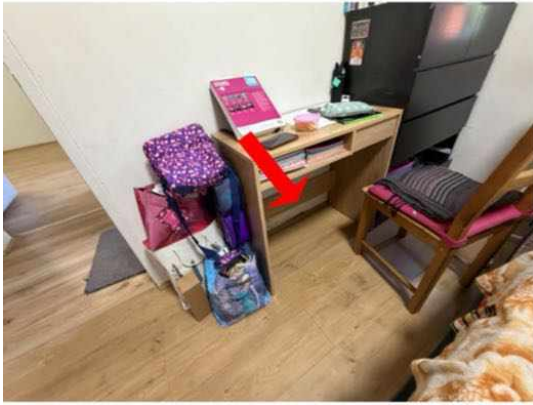
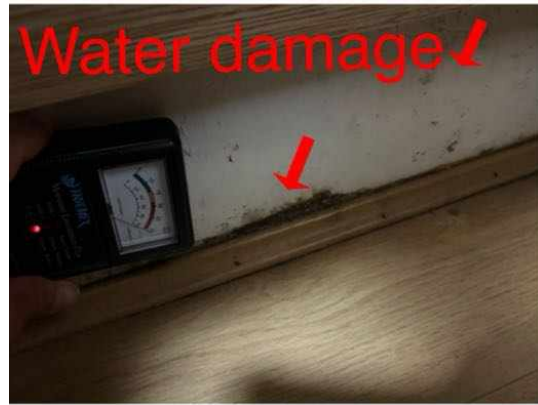
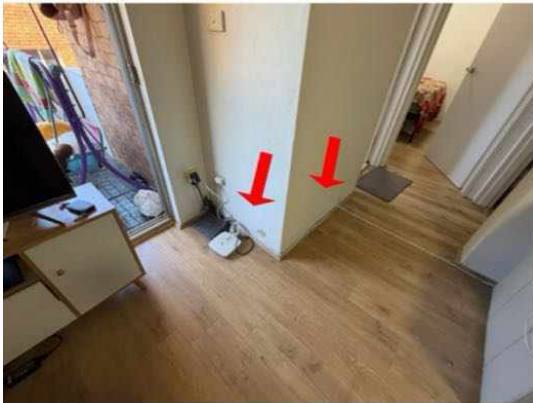
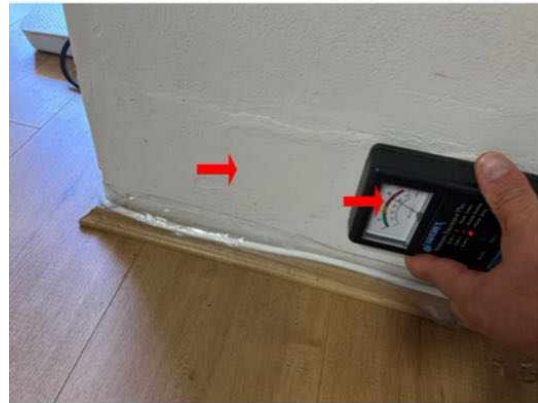
Building: Main Building  
 Location: Bathroom  
 Finding: Water leak suspected - Internal  
 Information: A water leak is suspected in this area at the time of inspection. Internal water leaks can be detrimental to surrounding building elements; their potential causes include damage to plumbing fittings and fixtures, through to water damage and deterioration of associated building elements.

Rust, corrosion, decay and water damage are potential outcomes where a minor water leak is left unattended. More serious defects may also result, such as electrical hazards, or water damage to structural building elements.

In extreme cases, structural damage may develop due to a prolonged water leak. It is highly advised that a bathroom specialist be appointed immediately for assessment and repairs.
