Building Inspection Report

Inspection Date: Wed, 4 Mar 2026

Property Address: 154 Charman Rd, Mentone VIC 3194,
Australia

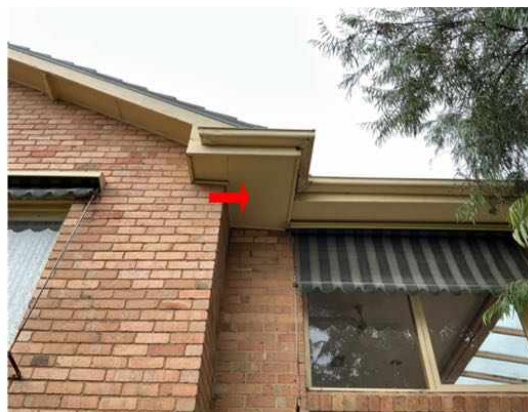
Defects 1.01

Building:	Main Building
Location:	Eaves
Finding:	Asbestos - Suspected ACM Identified on Site
Information:	Reporting on Asbestos is outside the Scope of this Report. This suspected defect is highlighted as a caution only. We suspect, based on our experience in the building industry, that there is a higher risk of the identified building element containing asbestos.

As Asbestos Reporting is outside the scope of this report, we advise that you consider a separate Asbestos Inspection and Condition Audit, which can include the taking of samples for definitive confirmation of the presence of Asbestos.

In the interim, the client is advised to act with caution, especially when considering any damage to building materials general wear and tear renovations extensions demolition and general maintenance activities due to the suspected presence of Asbestos.

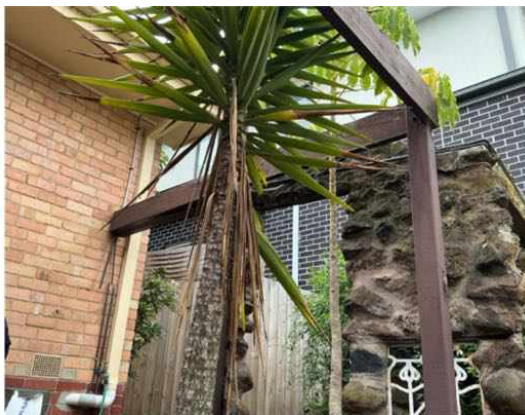
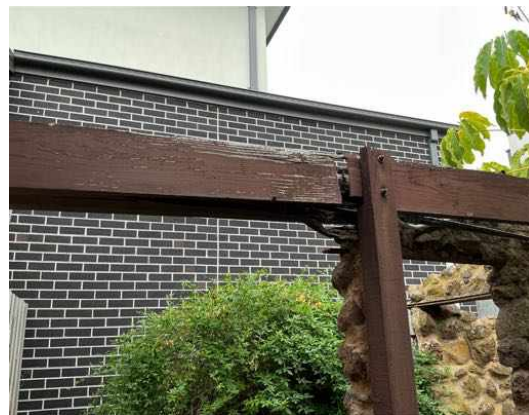
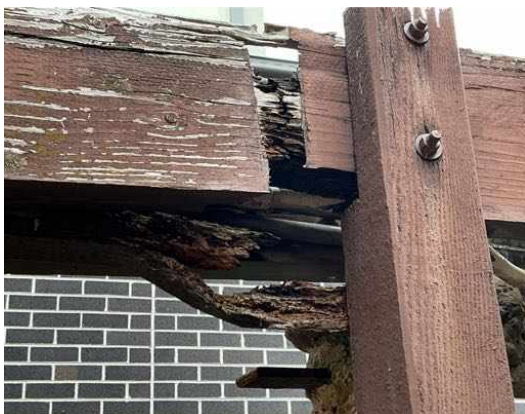
Defects 1.02

Building:	Main Building
Location:	All Areas
Finding:	Wood rot
Information:	This building element shows evidence of wood rot. Wood rot, also known as Fungal Decay, occurs when timbers and other cellulose building materials are exposed to damp conditions on an ongoing basis. This could be the result of exposure to weathering over a prolonged period of time, or the attraction of excessive moisture from other abutting building materials. Contributing factors also include poor air ventilation in the area.

Wood rot is often associated with general damp problems and is evidenced by a 'musty' smell or mould and mildew occurring on surfaces. If left unmanaged, damp conditions can lead to further health problems and the decay of timbers will continue.

Early intervention and regular maintenance, particularly of exterior timbers, will prolong the useful life of these building elements. Prior to any works being performed, the cause of the moisture that has created the visible wood rot should be identified and addressed in a suitable manner. Replacement of affected timbers may then be a necessary step in protecting surrounding building elements from such deterioration.

A qualified plumber may be appointed to assess the cause of excessive moisture and to provide advice on any remedial works as required. A qualified carpenter or registered builder may also be required to replace affected building materials.

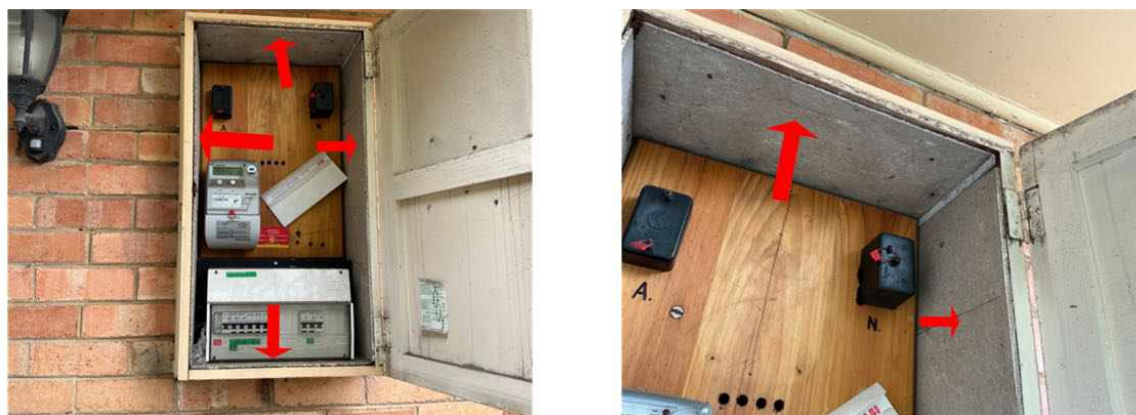
Defects 1.03

Building:	Main Building
Location:	Electrical Switchboard
Finding:	Asbestos - Suspected ACM Identified on Site
Information:	Reporting on Asbestos is outside the Scope of this Report. This suspected defect is highlighted as a caution only. We suspect, based on our experience in the building industry, that there is a higher risk of the identified building element containing asbestos.

As Asbestos Reporting is outside the scope of this report, we advise that you consider a separate Asbestos Inspection and Condition Audit, which can include the taking of samples for definitive confirmation of the presence of Asbestos.

In the interim, the client is advised to act with caution, especially when considering any damage to building materials general wear and tear renovations extensions demolition and general maintenance activities due to the suspected presence of Asbestos.

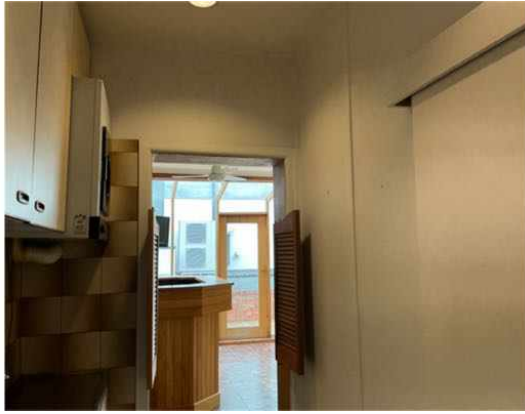
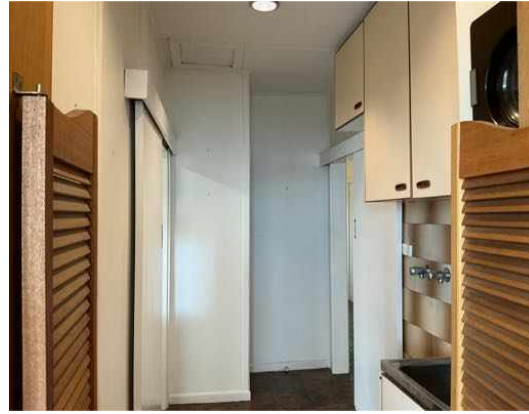
Defects 1.04

Building:	Main Building
Location:	Laundry walls and ceiling
Finding:	Asbestos - Suspected ACM Identified on Site
Information:	Reporting on Asbestos is outside the Scope of this Report. This suspected defect is highlighted as a caution only. We suspect, based on our experience in the building industry, that there is a higher risk of the identified building element containing asbestos.

As Asbestos Reporting is outside the scope of this report, we advise that you consider a separate Asbestos Inspection and Condition Audit, which can include the taking of samples for definitive confirmation of the presence of Asbestos.

In the interim, the client is advised to act with caution, especially when considering any damage to building materials general wear and tear renovations extensions demolition and general maintenance activities due to the suspected presence of Asbestos.

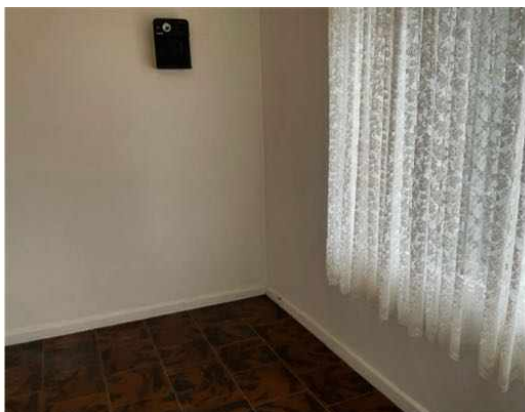
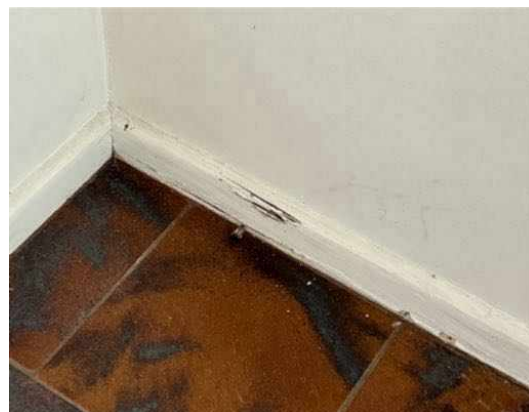
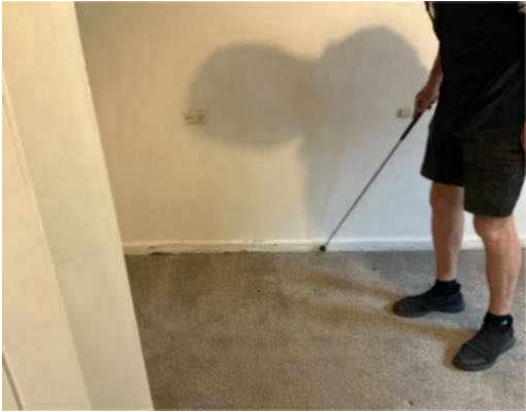
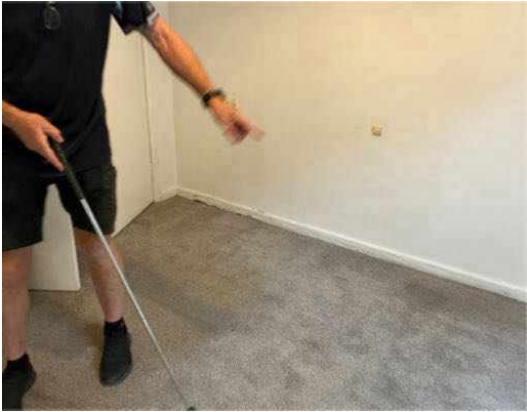
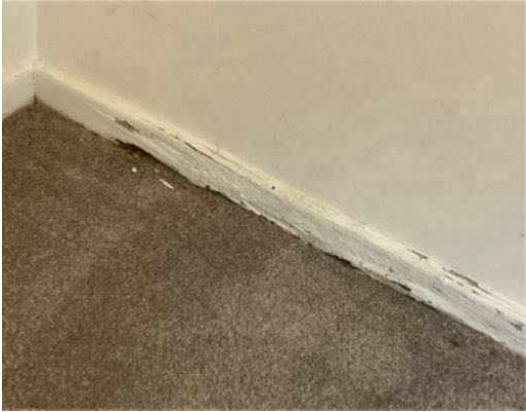
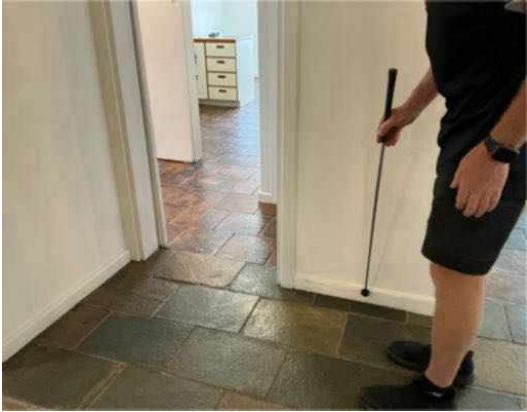
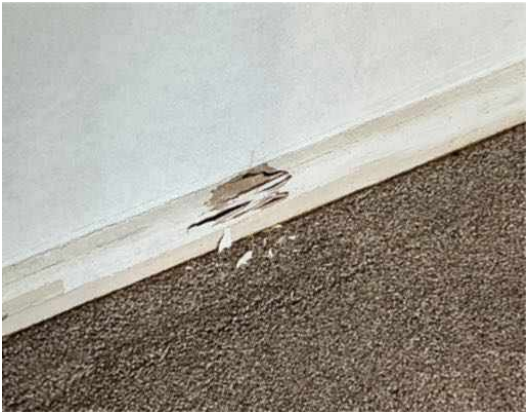
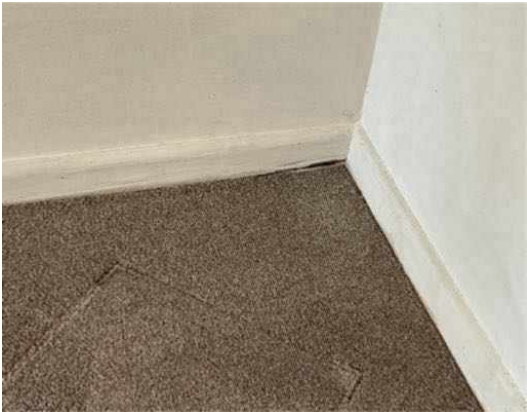
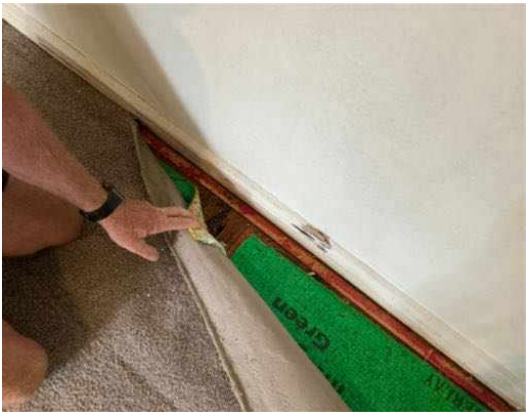
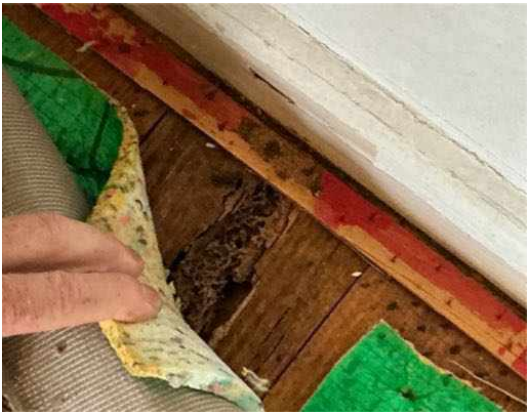
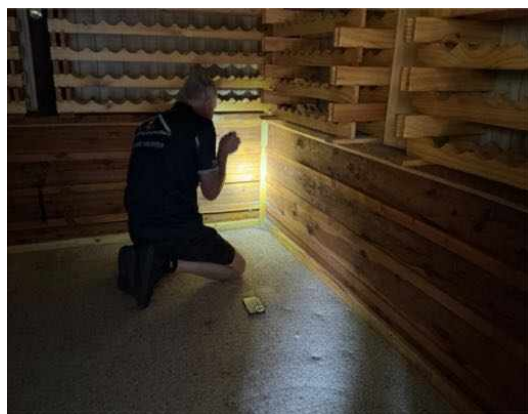
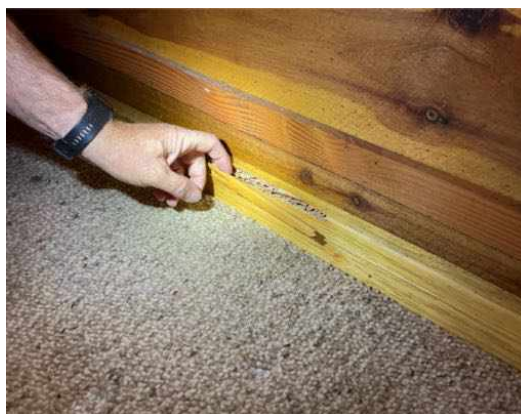
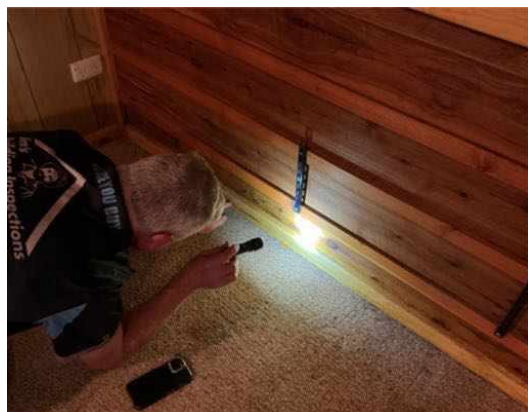
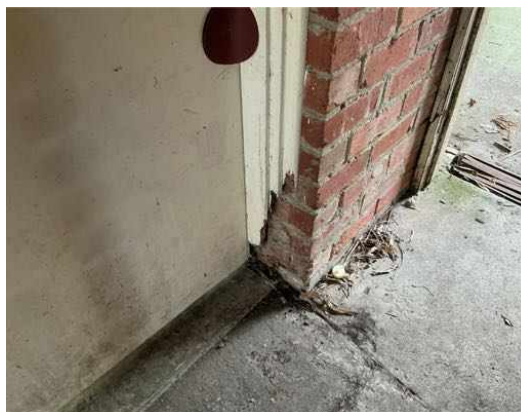
Defects 2.01

Building:	Main Building
Location:	All Areas
Finding:	Suspected termite activity identified
Information:	Although no evidence of live termite activity was found at the time of inspection it is suspected that a termite colony is present on the property. Further inspection of external and internal areas is required in order to correctly identify the presence of termite activity and may include works of an intrusive nature.

Extensive suspected termite damage was found throughout the property.

The subfloor was unable to be inspected due to subfloor debris

1/Extensive suspected termite damage found in flooring, skirting, and other areas throughout.

It is strongly recommended that further inspection by a timber pest specialist be conducted as soon as possible in order to prevent any further damage that may ensue.

We strongly recommend immediate inspection by a qualified timber pest technician to ascertain the extent of the termite damage, identify colonies, and suggest treatment plans. Purchasers should be aware that where timber pests have damaged this property extensive renovations will be required. These renovations can prove costly and purchasers should be prepared to meet these costs.

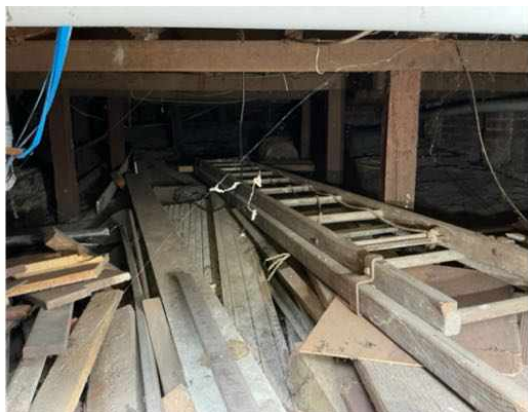
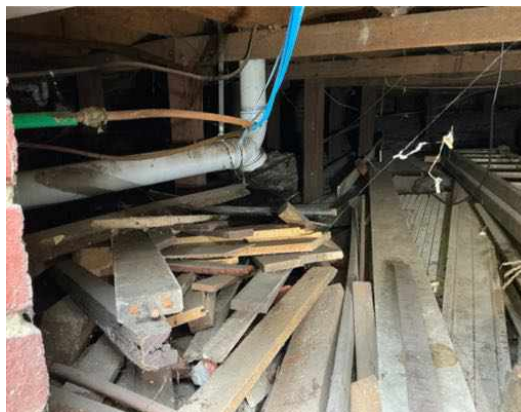
Defects 2.02

Building:	Main Building
Location:	Subfloor
Finding:	Timber stumps - Suspected deterioration
Information:	It was noted that the property has timber stumps. Inspection of the condition of the timber stumps - below the surface of the ground - is excluded from the scope of this report. However, it is suspected that several timber stumps are deteriorating, evidenced by secondary defects such as uneven flooring, visually-observable subsidence or major cracking within the property. Even without these secondary defects, deteriorated stumps may still be present.

Where timber stumps are failing, a high degree of maintenance or even replacement of stumps may be required in the short- to medium-term future. It is probable that there is some degree of wood rot or deterioration beginning to occur in areas that are currently inaccessible for inspection. Timber stumps are no longer used in current building practices due to their susceptibility to wood rot and deterioration over a prolonged period of time.

The client should be prepared that in purchasing a property with timber stumps, that the need to restump the property in the short- to medium-term future is highly likely, which involves expensive works.

2/Timber stumps were found to subfloor area, timber stumps are considered a major defect as they have the propensity to rot in the ground.

A registered builder specialising in re-stumping may be appointed to provide a more

invasive inspection of the timber stumps and provide estimates on any works that may be required.

Timber stumps are no longer used in current building practice, they will need to be replaced by concrete stumps in the short term. Restumping may be carried out by a registered builder specializing in restumping and underpinning, purchasers should be prepared to meet the costs of these works.

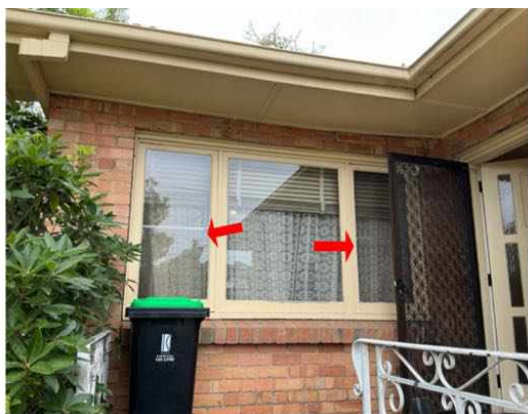
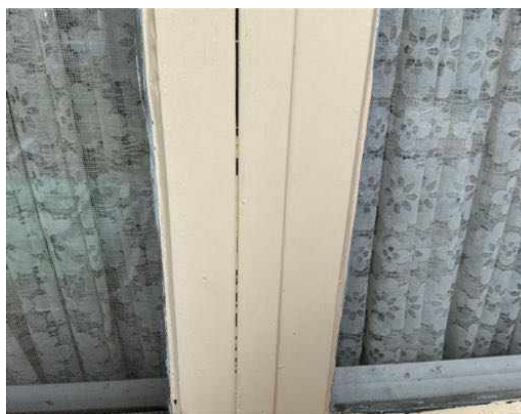
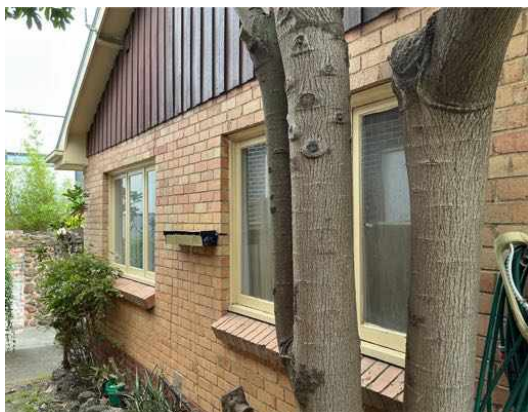
Defects 3.01

Building: Main Building

Location: Front Elevation

Finding: Windows - Sash painted shut

Information: Where window sashes have been painted shut, it is generally indicative of poor, rushed workmanship. The window is difficult if not impossible to open and close until remedial works have been undertaken.

Windows provide ventilation to the adjoining area and should be at a fully operational level to ensure user comfort. Restricted function of the window may also pose as a potential safety hazard if required for emergency egress from the building.

Where windows have been painted shut the seal of the paint needs to be broken. This is generally done by breaking the seal of the paint and then maintaining the sash tracks clearing and lubricating them with silicone. Remedial paint work will likely be required and can be completed along with the rest of the remedial works necessary by a general handyman.

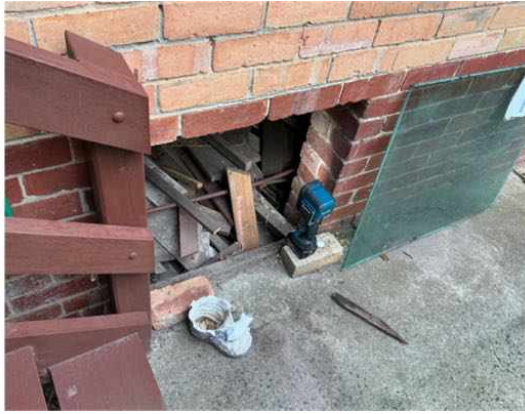
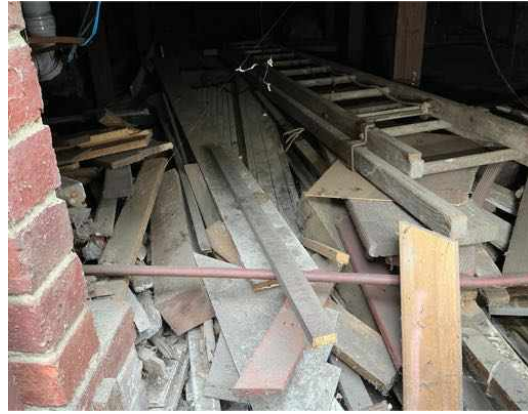
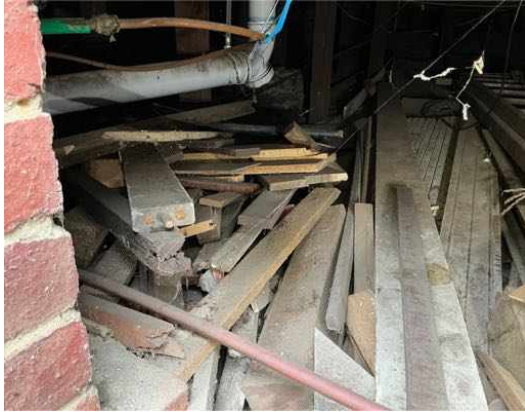
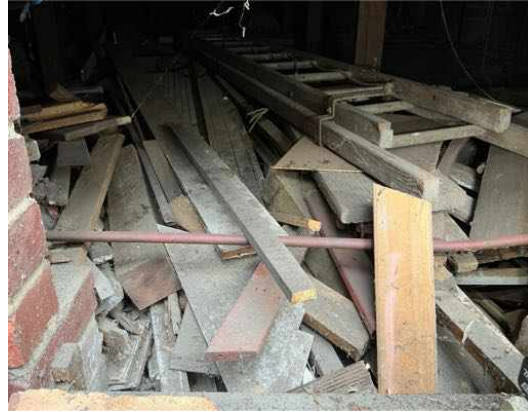
Defects 3.02

Building:	Main Building
Location:	Subfloor
Finding:	Stored timbers - subfloor space or external area
Information:	The storing of timbers in the subfloor space or around the external property increases the risk of termite activity being present. As they are likely to come into contact with weather conditions or excessive moisture wood rot is likely to develop on timbers that are not treated.

It is highly recommended that any stored timbers be immediately removed from areas in which they may attract any termite / timber pest attack. Minimisation of risk / prevention of termite attack is far more adequate than dealing with the presence of termite activity.

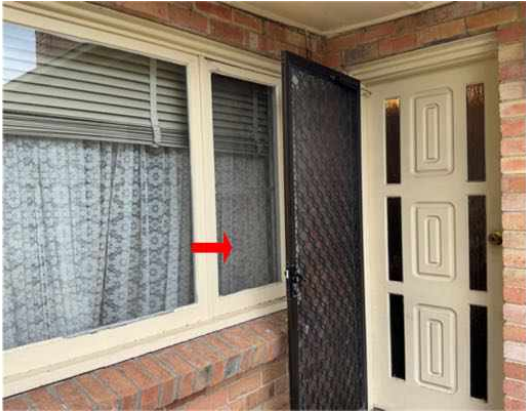
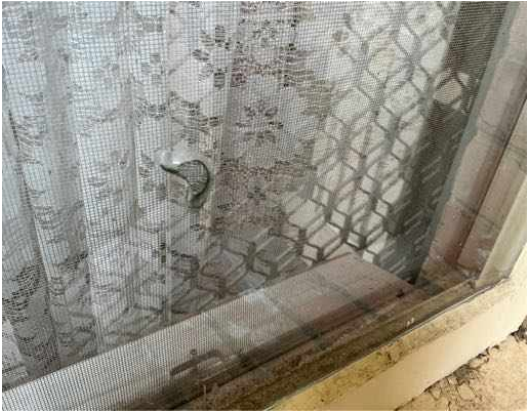
Defects 3.03

Building: Main Building
 Location: Front Elevation
 Finding: Window - Cracked
 Information: Cracks were identified in the window in this area. Cracking in windows is generally the result of impact damage, and is likely to develop further when left unmanaged.

The likelihood of this windowpane further cracking and shattering is increased exponentially, providing a safety hazard in the area. The cracked window also impairs the weather tightness of the building, creating potential for minor water leaks.

A qualified glazier is required to repair the window as soon as possible. Depending on the extent of the cracking, replacement of the window may be required. Please be advised that any persons coming into contact with the cracked window should do so with due caution to avoid any personal injury that may ensue.

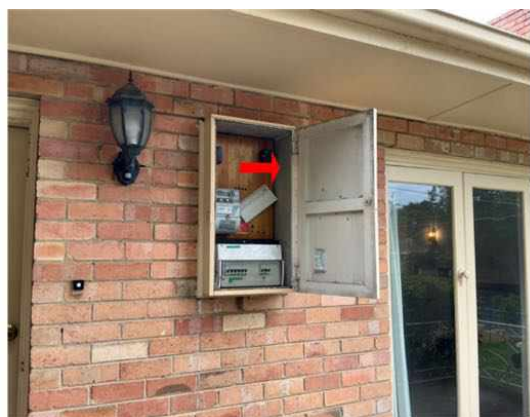
Building: Main Building
 Location: Electrical Switchboard
 Finding: Termite Management System - no evidence of a chemical installation
 Information: The application of a post-construction chemical termite barrier is highly recommended for all properties, particularly if live termite activity has been found on the site previously. Such barriers are highly effective in preventing termite attack on any timber building elements throughout the property.

A durable notice should be placed in the switchboard unit to indicate current termite barriers. At the time of inspection, it appeared as though no termite management system has been installed, with no evidence to suggest preventative works taking place.

The client may consider gaining further advice from a pest controller as to the costs and procedures involved with this application. It is recommended that obtaining such advice be a short-term priority.

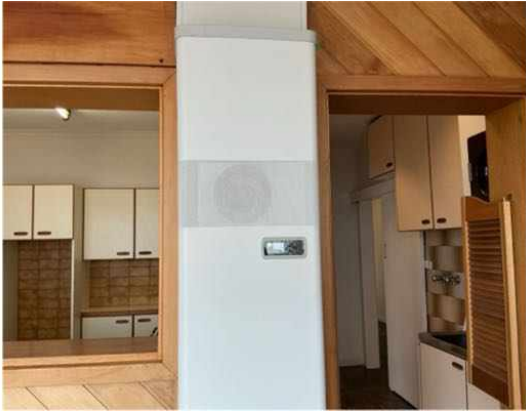
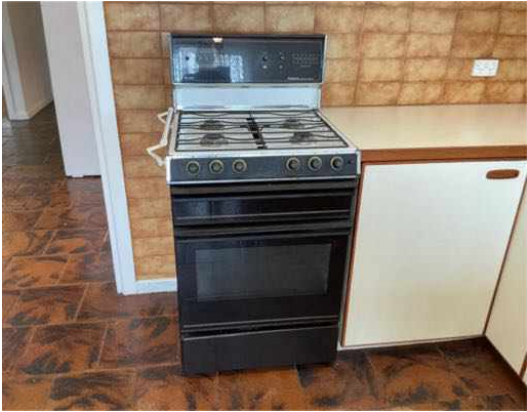
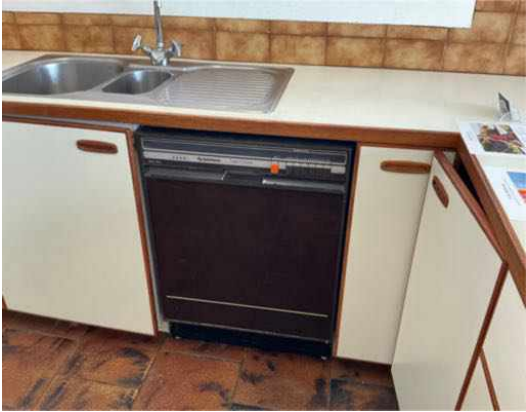
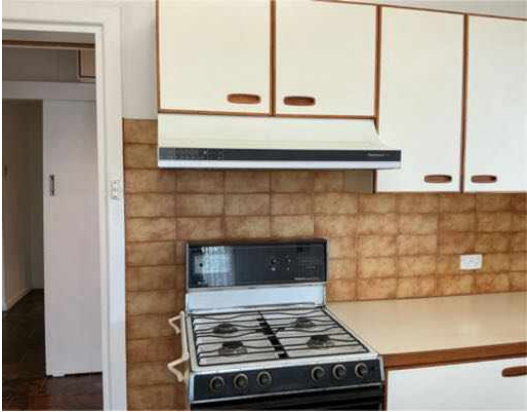
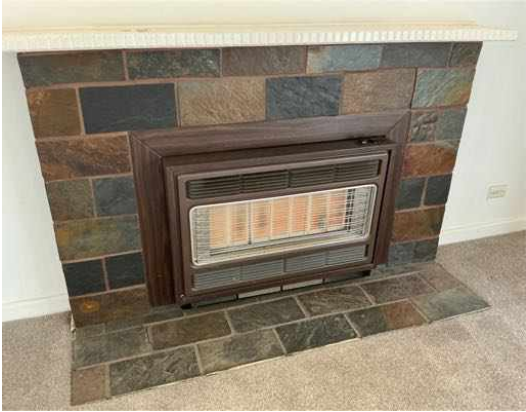
Building: Main Building
 Location: All Areas
 Finding: Warranty - Expired
 Information: Where appliances are beyond their warranty period, the owner should be prepared to meet the cost of replacement or repair of the item at any time. The operation of the appliance can not be guaranteed and further inspection by an appropriately qualified tradesperson may be required.
