## Building Inspection Report

Inspection Date: Thu, 5 Mar 2026

Property Address: 10/ 548 Marine Parade, Biggera Waters  
QLD

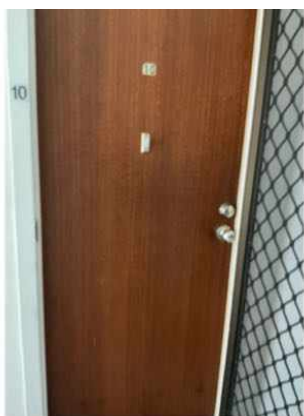
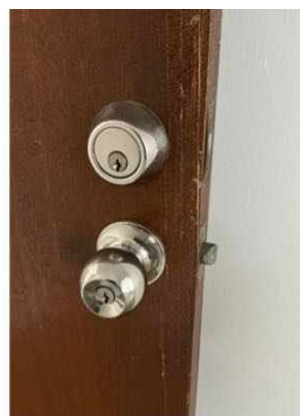
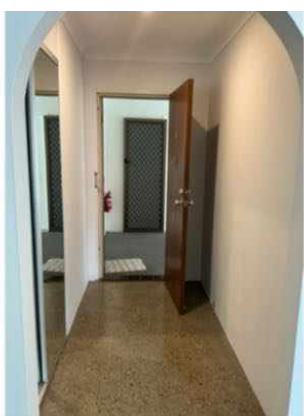
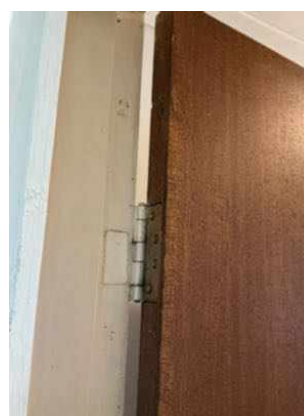
#### Defects 1.01

Building: Main Building  
 Location: Entry > Front  
 Finding: Door entry - Damaged  
 Information: It was noted at the time of inspection that the entry door is damaged. This deterioration is suspected to have been caused by impact damage.

Front entry door is damaged and requires repairs or replacement.

Please note, front door may contain asbestos and may require additional safety precautions if any works are carried out.

Replacement or repairs of the door is advised to ensure the protection and longevity of any associated building elements. Such works may be performed by a general handyman or qualified carpenter.

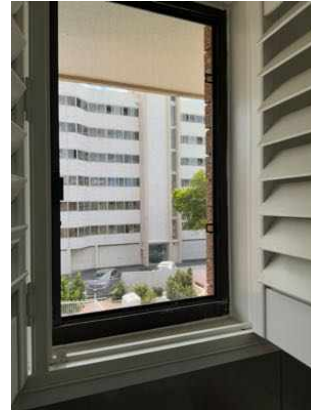
#### Defects 1.02

Building: Main Building  
 Location: Kitchen > Front  
 Finding: Window restrictors not installed.  
 Information: At the time of inspection it was noted that windows to leisure room ( first floor ) does not have window restrictors installed.

Accordance with NCC volume1 clause d2.24 or NCC volume 2 clause 3.9.2.6 any window that has a fall of 2 meters or more should be restricted so that a sphere of 125mm (12.5cm) cannot pass through the opening at force of 250n or 25kg of force.

It recommended that restrictors be fitted before handover.

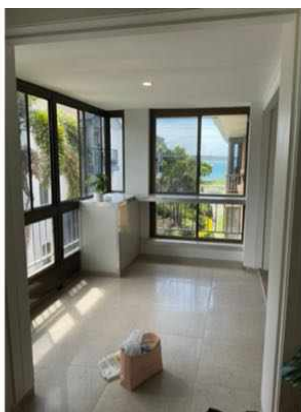
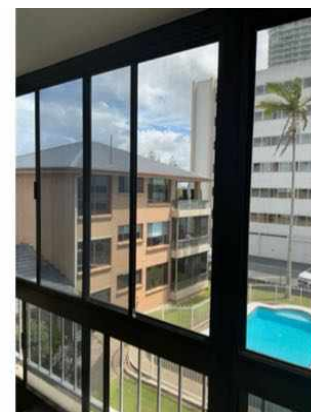
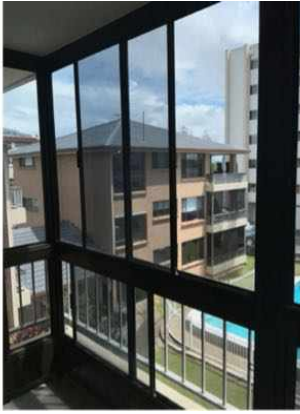
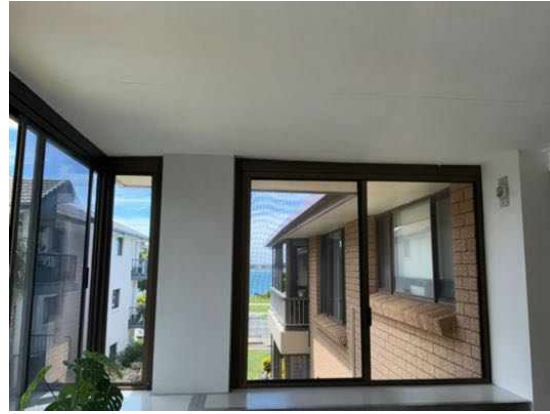
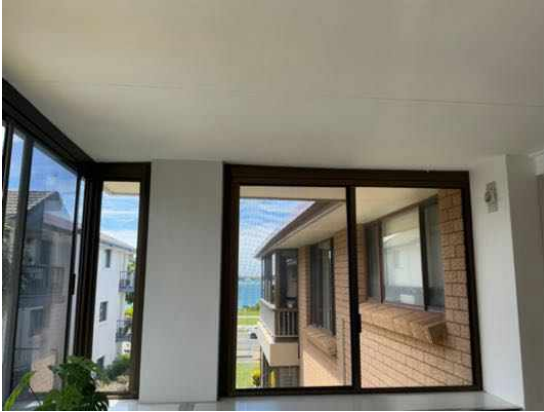
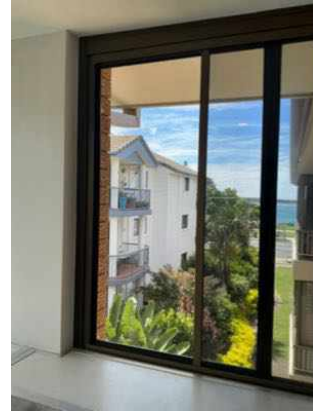
### Defects 1.03

Finding: Window restrictors not installed.

Information: At the time of inspection it was noted that windows to leisure room ( first floor ) does not have window restrictors installed.

Accordance with NCC volume1 clause d2.24 or NCC volume 2 clause 3.9.2.6 any window that has a fall of 2 meters or more should be restricted so that a sphere of 125mm (12.5cm) cannot pass through the opening at force of 250n or 25kg of force.

It recommended that restrictors be fitted before handover.

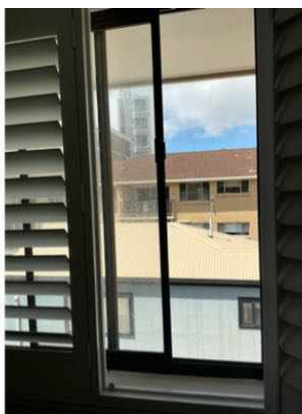
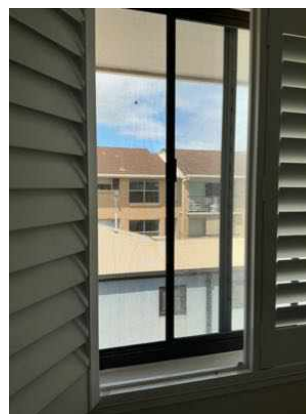
## Defects 1.04

Building: Main Building  
Location: Bedroom - Master > Rear  
Finding: Window restrictors not installed.  
Information: At the time of inspection it was noted that windows to leisure room ( first floor ) does not have window restrictors installed.

Accordance with NCC volume1 clause d2.24 or NCC volume 2 clause 3.9.2.6 any window that has a fall of 2 meters or more should be restricted so that a sphere of 125mm (12.5cm) cannot pass through the opening at force of 250n or 25kg of force.

It recommended that restrictors be fitted before handover.

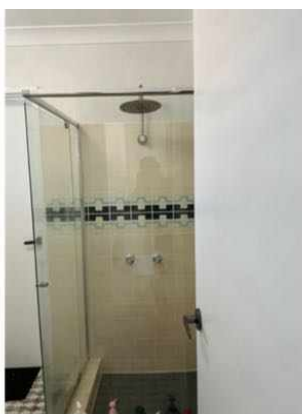
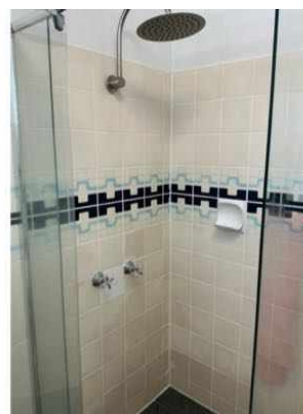
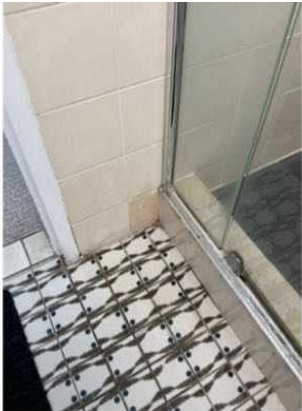
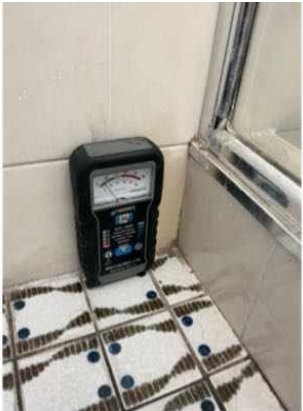
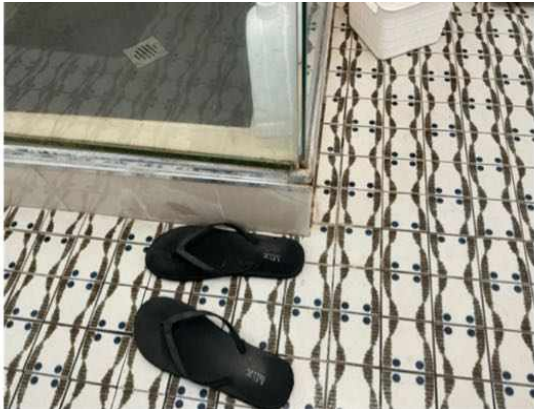
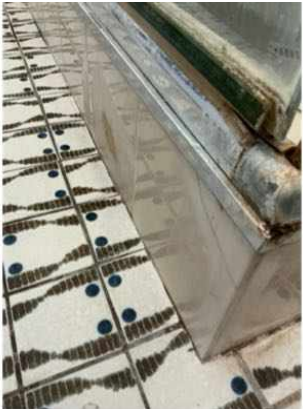
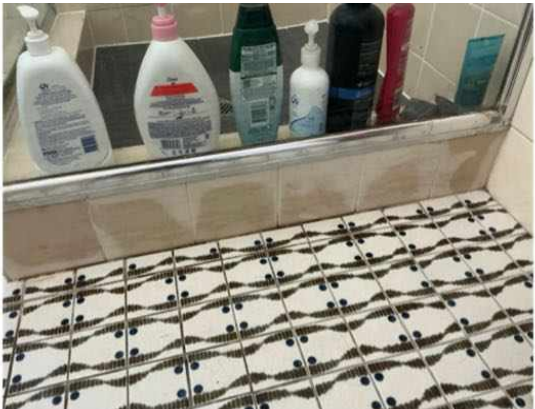
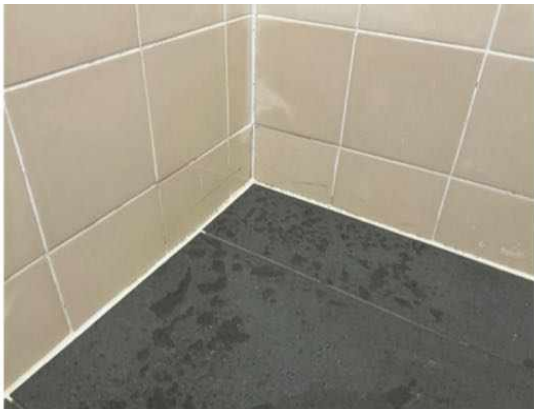
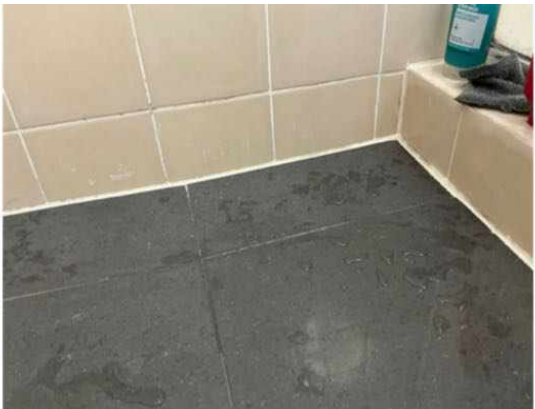
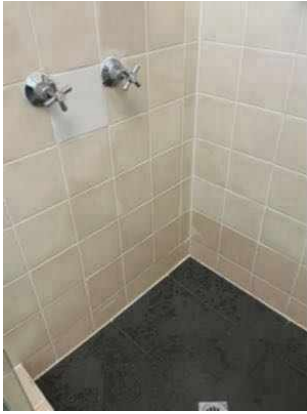
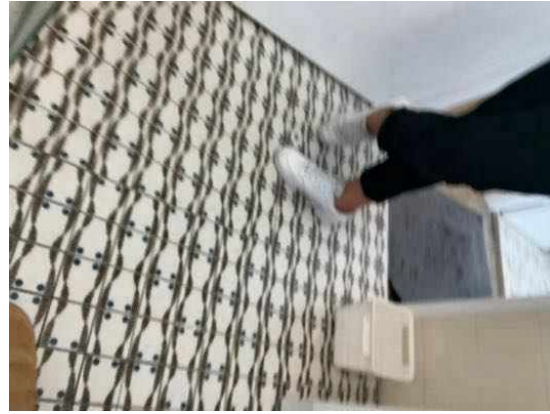
### Defects 2.01

Building:	Main Building
Location:	Bathroom > Existing
Finding:	Shower base - Cracked
Information:	Cracking was evident to the shower base at the time of inspection. The cracking is more than likely due to impact damage, but may have also been caused by general ageing and deterioration of associated building elements. While the cracking appears to be minor, any additional impact may lead to further cracking.

As this area is frequently exposed to water, any cracking is likely to allow water penetration to adjoining building elements. If left unmanaged, water penetration may cause water damage to these elements, and necessitate additional reparation works.

Evidence of discolouration and cracking to shower base tiles which require replacing.

Appointment of a tiling contractor is required to repair the cracked shower base, so as to ensure no further water penetration occurs. Replacement of the shower base may be required, dependent on the extent of the cracking.

Where water damage has affected the associated building elements, the relevant tradesperson should be appointed to perform rectification works as necessary.

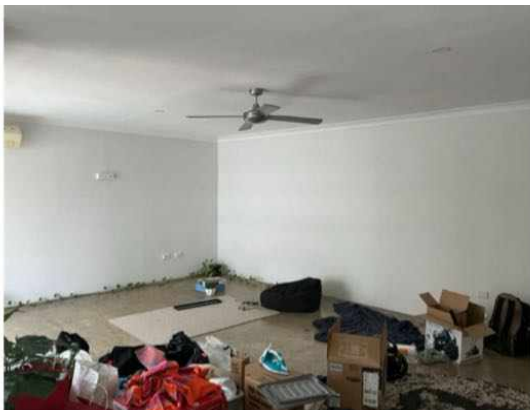
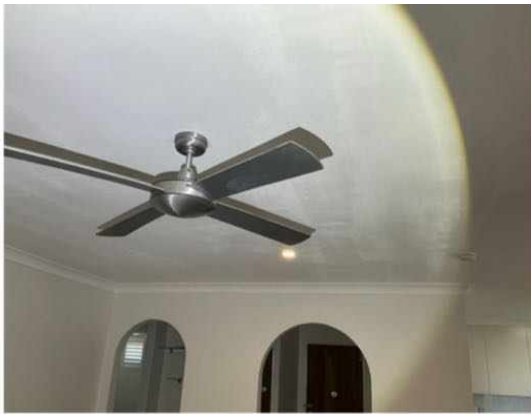
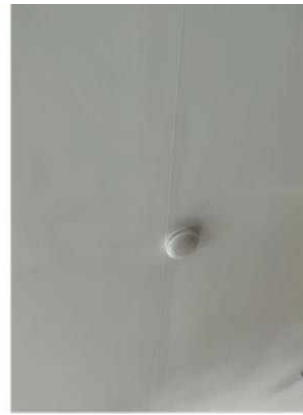
### Defects 3.01

Building: Main Building  
 Location: Living Room > Existing  
 Finding: Ceiling - plaster cracking  
 Information: Cracking was observed to the ceiling plaster surface.

Cracks may be due to building movement poor insulation temperature or humidity variations or in adequate joint finishing.

Visible cracking on plaster joints and or across ceiling surfaces, some section showed minor separation at joints.

It is recommended a plasterer be engaged to rectify this condition.

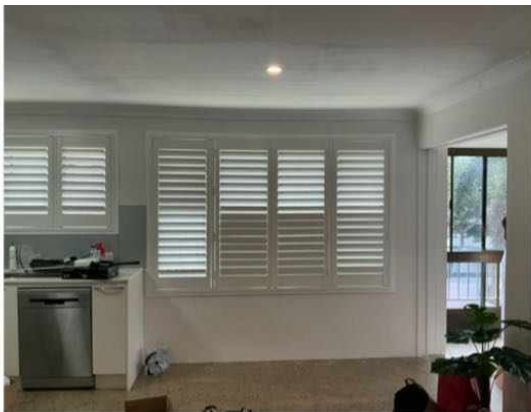
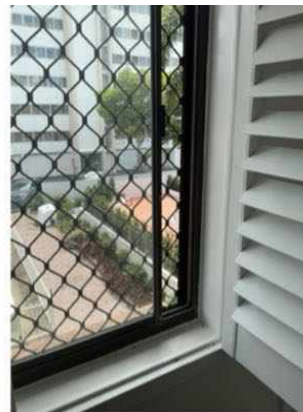
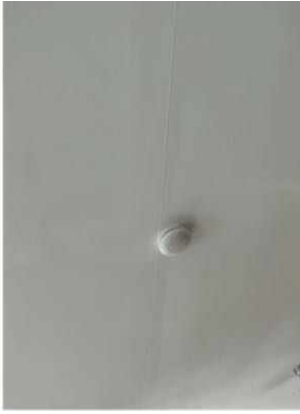
### Defects 3.02

Building: Main Building  
Location: Dining Room > Centre  
Finding: Ceiling - plaster cracking  
Information: Cracking was observed to the ceiling plaster surface.

Cracks may be due to building movement poor insulation temperature or humidity variations or in adequate joint finishing.

Visible cracking on plaster joints and or across ceiling surfaces, some section showed minor separation at joints.

It is recommended a plasterer be engaged to rectify this condition.

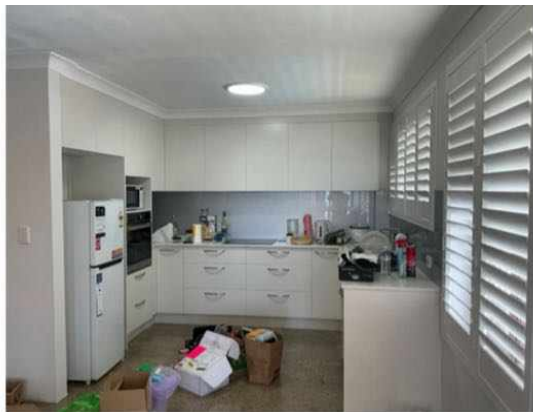
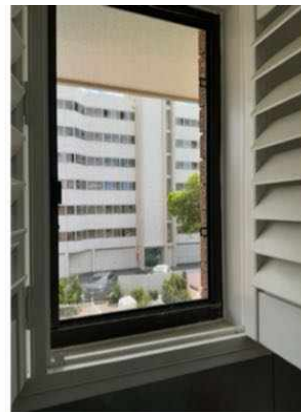
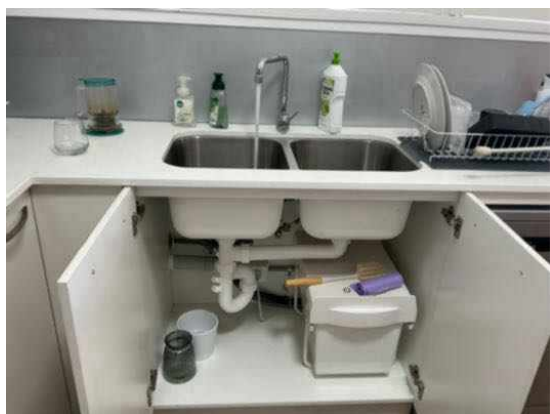
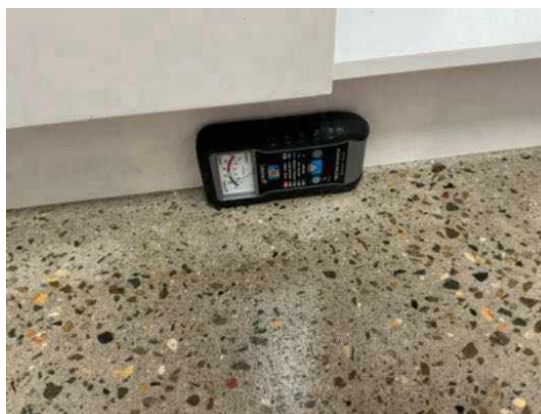
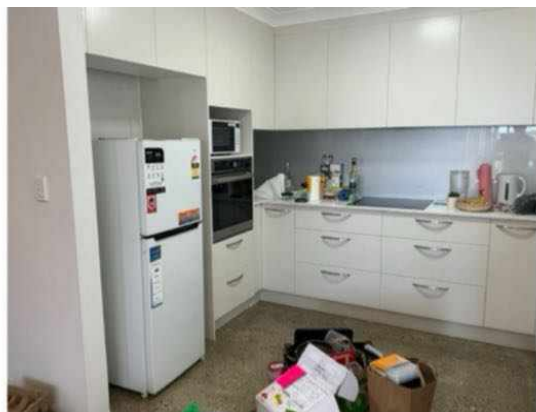
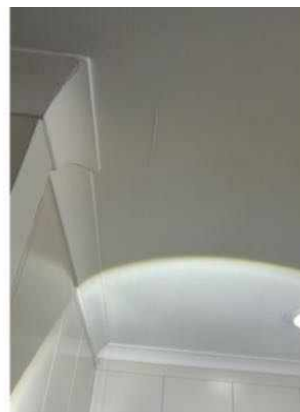
### Defects 3.03

Building: Main Building  
Location: Kitchen > Centre Left  
Finding: Ceiling - plaster cracking  
Information: Cracking was observed to the ceiling plaster surface.

Cracks may be due to building movement poor insulation temperature or humidity variations or in adequate joint finishing.

Visible cracking on plaster joints and or across ceiling surfaces, some section showed minor separation at joints.

It is recommended a plasterer be engaged to rectify this condition.

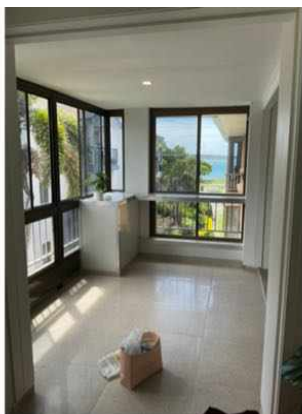
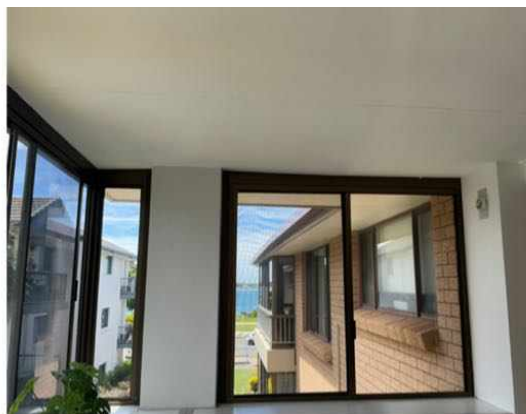
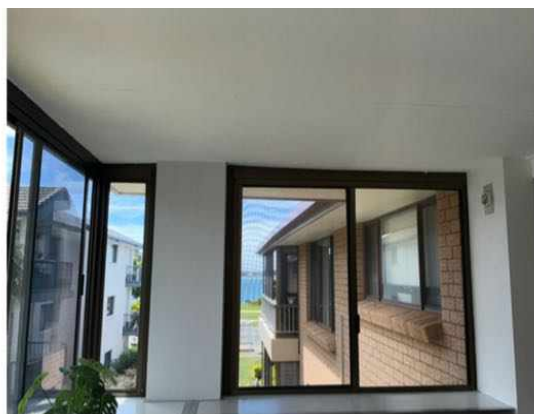
### Defects 3.04

Building:	Main Building
Location:	Sunroom > Rear
Finding:	Ceiling - Sagging
Information:	Sections of the ceiling were found to be sagging at the time of inspection. Sagging to the fixed ceiling structure generally indicates that the building materials have swollen, due to contact with water, or that fixings (e.g. nails or glue) have become loose and require reattachment.

Enclosed sunroom ceilings show evidence of sagging, rectification works may be required.

Where minor sagging is evident, comparatively minor works, such as re-gluing of ceiling sheets, may be required. Such works may be performed by relevant tradespeople, such as plasterers and painters. Where excessive moisture has caused the roofing structure to swell and sag, the source of the water leak should primarily be identified prior to any remedial works being performed.

In some cases, sagging ceiling linings may also indicate that there are structural issues, causing surfaces to warp, twist or sag. Where sagging appears to be major, appointment of a structural engineer is advised to further inspect the property and identify the source and rectification works required.

The appropriate action should be taken by the client as soon as possible to ensure that any potential further damage is limited.

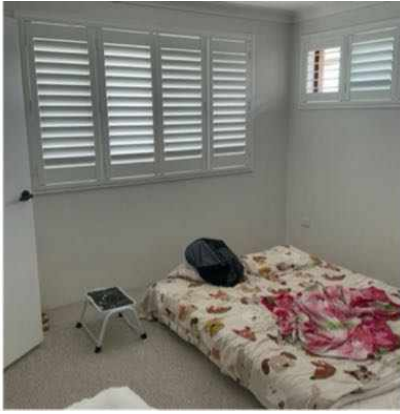
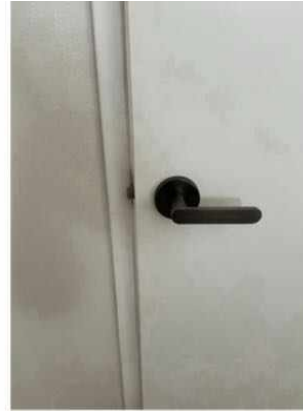
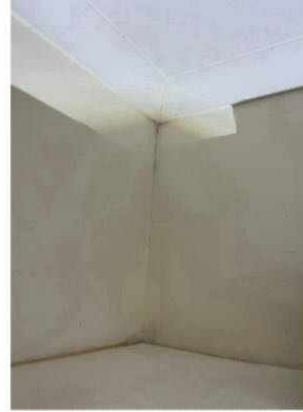
### Defects 3.05

Building:	Main Building
Location:	Bedroom - Master > Centre Left
Finding:	Door handle - Not latching
Information:	It was noted that the door in this area was not latching during operation at the time of inspection. Whilst detracting from the functionality of this building element, this minor defect may also be a security risk, and may therefore have serious implications if left unattended.

It is suspected that this defect has occurred due to minor issues with the associated hinges. Such damage is identified as general wear and tear, which is expected for building elements of this age.

A qualified carpenter or general handyperson may be appointed to perform rectification works as necessary, at client discretion. If left unattended, further functional impairment is likely to occur.

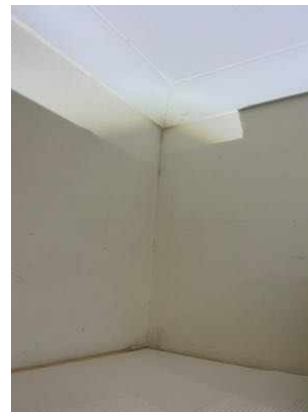
### Defects 3.06

Building: Main Building  
 Location: Walk-In Robe - Master > Rear Right  
 Finding: Cracks to internal render - Category 1  
 Information: It has been observed that cracking to internal rendered surfaces has occurred. The degree of damage falls within Category 1, described as fine cracks that do not need repair and which are less than 1.0mm in width limit.

Damage of this category is not considered a defect for rectification. Always contact your building inspector should cracks widen, lengthen, or become more numerous.

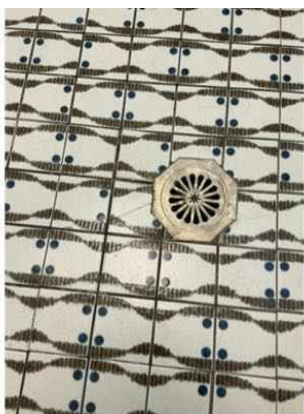
## Defects 3.07

Building:	Main Building
Location:	Bathroom > Centre
Finding:	Tiles - Cracked or damaged
Information:	Cracking was evident to the tiling in this area at the time of inspection. While the cracking appears to be minor, this area is frequently exposed to water, allowing potential for water penetration into adjoining sections of walls or flooring.

If left unmanaged, water penetration to these areas may lead to subsequent water damage, which is likely necessitate repair work to affected building elements.

A tiling contractor should be appointed to ensure that no further water damage occurs. The re-application of silicone and grouting throughout remaining tile work is also advised, to further protect the area against water penetration.

Where water penetration has led to water damage, appointment of a relevant tradesperson may be required to repair damaged building elements.

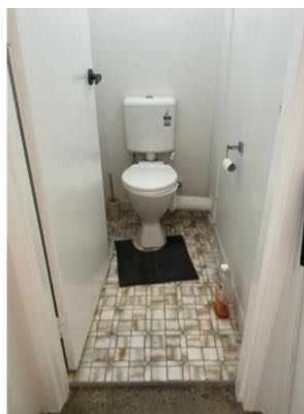
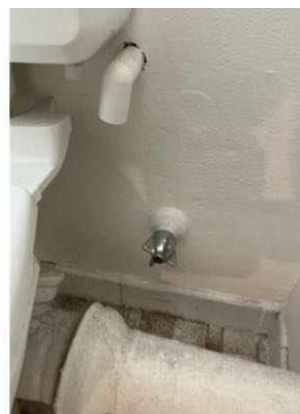
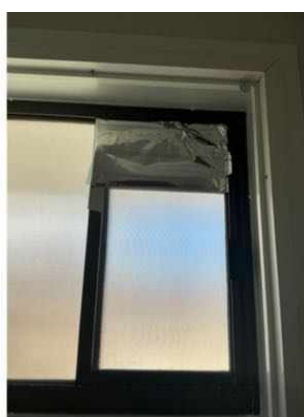
## Defects 3.08

Building:	Main Building
Location:	Toilet (WC) > Rear
Finding:	Unconventional handyman work
Information:	This handyman work appears to have been completed to a substandard level and does not comply with regular building practices. Where handyman work is not completed satisfactorily, accelerated deterioration of the associated building elements is likely to occur and secondary defects to surrounding structures may develop.

It is highly recommended that the substandard work be rectified by professional services. Works to improve this area are likely to increase the safety and the operation of the associated building elements.

The client should exercise care when coming into the immediate vicinity of the

substandard works. Rectification works are advised as soon as possible by the appropriate trades.

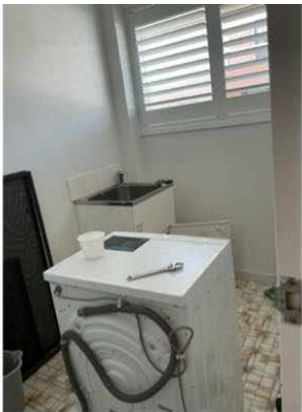
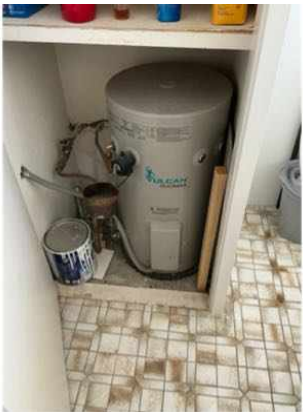
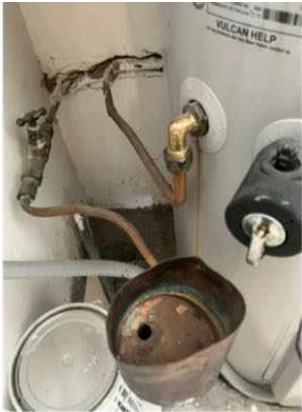
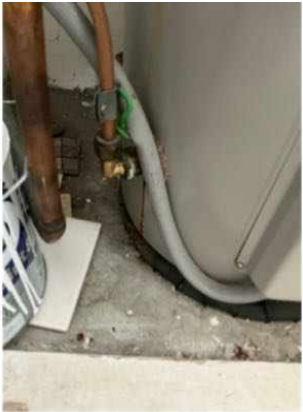
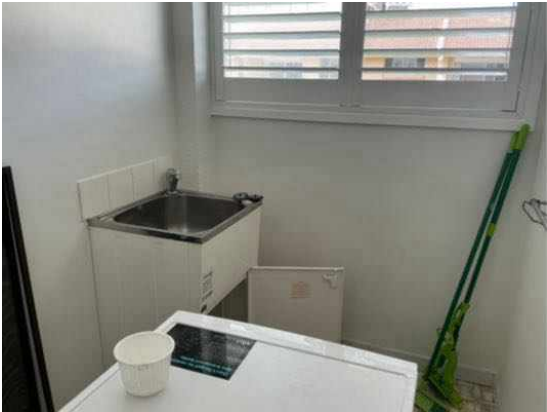
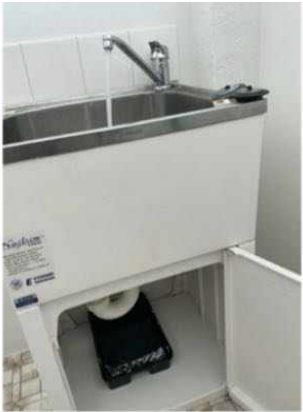
### Defects 3.09

Building:	Main Building
Location:	Laundry > Existing
Finding:	Hot water - system needs service
Information:	The hot water service showed signs of deterioration and requires maintenance.

Observed issues may include corrosion to components, ageing fittings, and general wear consistent with prolonged service life.

The system's condition could affect performance, efficiency, and long term reliability.

Hot water system shows evidence of water staining to external fittings and may require servicing.

A licensed plumber should inspect service and test the hot water system prior to settlement.

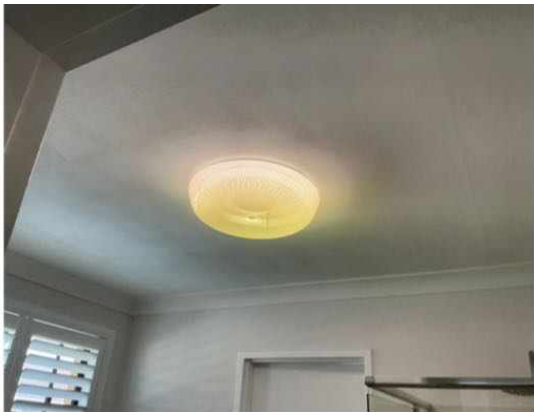
Building:	Main Building
Location:	Bathroom > Centre
Finding:	Surface - Discoloured
Information:	Discolouration was evident to the surface of this building element at the time of inspection. This degree of surface damage is consistent with general deterioration, which is generally expected of a property of this age and condition.

Discolouration usually occurs when the surface has been stained by foreign substances or water. Despite surface discolouration in this area, it is unlikely that this defect indicates any major underlying defects.

Discoloured surfaces are unlikely to cause secondary damage to associated building elements and do not require repair or replacement. However, the client may wish to seek quotations for the cost of refurbishment and/or replacement of any affected building elements.

A general handyman or painting contractor may be appointed to restore the condition of discoloured surfaces.

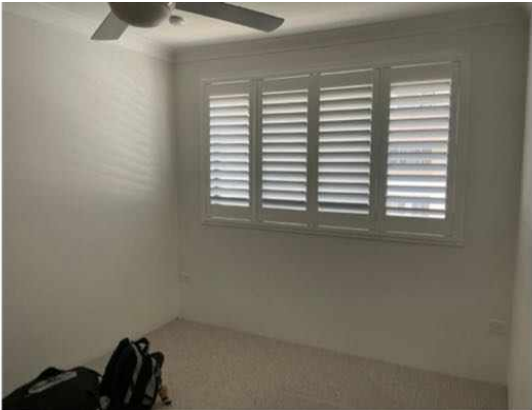
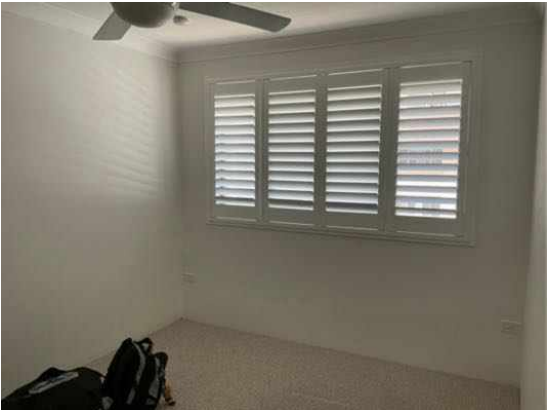
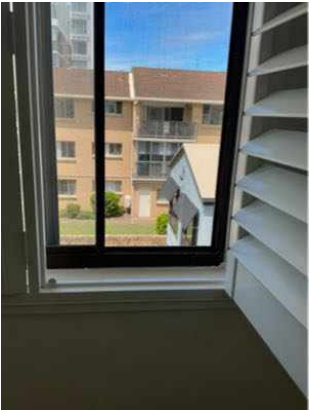
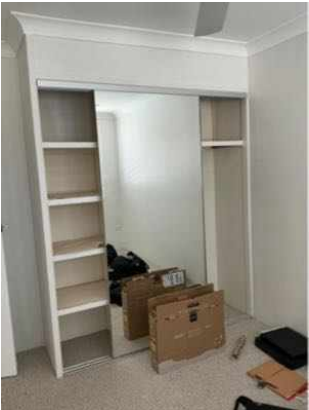
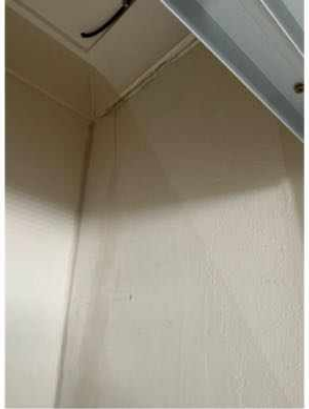
Building: Main Building  
Location: Bedroom 2 > Rear Right  
Finding: Cracks to internal render - Category 2

It has been observed that cracking to internal rendered surfaces has occurred. The degree of damage falls within Category 2, described as noticeable cracks which are easily filled. Cracking of this size are generally less than 5mm in width.

Category 2 damage is required to be monitored for a period of 12 months. After the monitoring period, a crack rated at Category 2 or above is considered a defect requiring rectification.

Always contact your building inspector should cracks widen, lengthen, or become more numerous.
