Building and Timber Pest Inspection Report

Inspection Date: Tue, 17 Mar 2026

Property Address: 201/55 Hill Rd, Wentworth Point NSW
2127, Australia

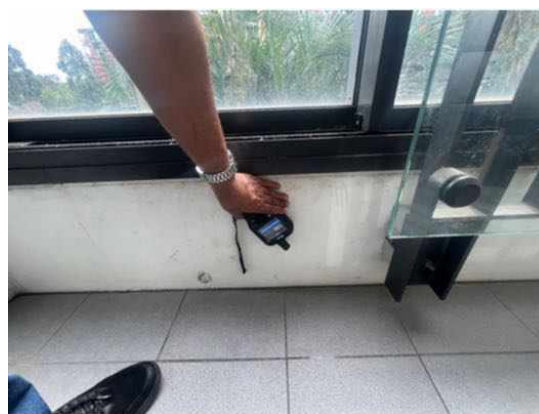
Building: Main Building
Location: Balcony
Finding: Balcony Elevated Moisture - Strata (No internal visible damage noted at the time of inspection)
Information: Elevated moisture was recorded at the base of the balcony wall, internal adjacent wall and tiles. While no internal damage was visible at the time of inspection, balconies in multi-unit dwellings are high-risk areas for waterproofing failure, which can lead to leaks into adjoining units and significant rectification costs. Further investigation by a licensed waterproofing contractor is recommended.

Depending on the strata plan, this area may form part of the common property, in which case remedial responsibility may rest with the owners corporation (strata). Purchasers should seek clarification from the strata manager and legal adviser prior to purchase.

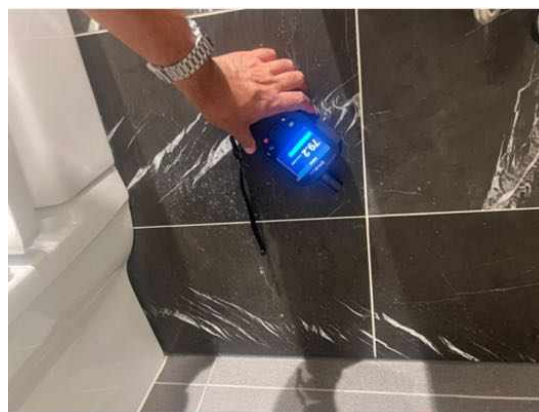
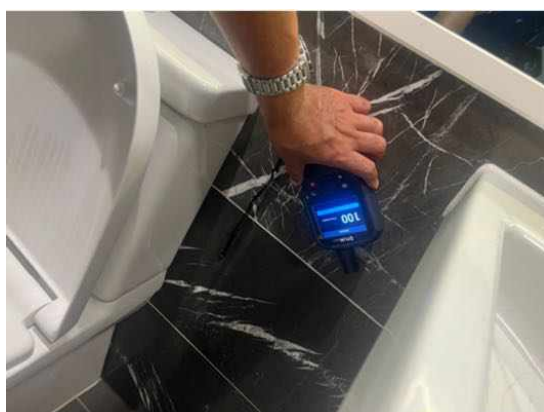
Finding 3.02

Building:	Main Building
Location:	Bathroom
Finding:	Elevated Moisture Bathroom (No visible deterioration)
Information:	Elevated moisture levels were detected to tiled surfaces in bathroom floor, wall around sink area and shower areas. Persistent moisture ingress can lead to concealed damage, including timber rot and mould growth.

Elevated moisture readings in tiled wet areas can occur from normal shower use, age/deterioration of waterproofing membranes, plumbing leaks or moisture absorption through grout lines. While no damage was visible, elevated readings may indicate moisture retention behind tiles, which can be a conducive condition for future deterioration if not monitored.

No immediate action required. Monitor the area over time for signs of drumming, efflorescence, tile movement, or grout deterioration. A further inspection by a licensed waterproofing specialist and/or plumber is recommended to determine cause of elevated moisture.

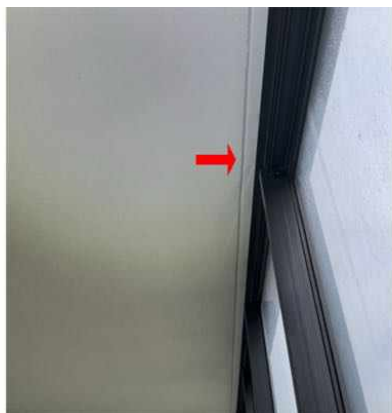
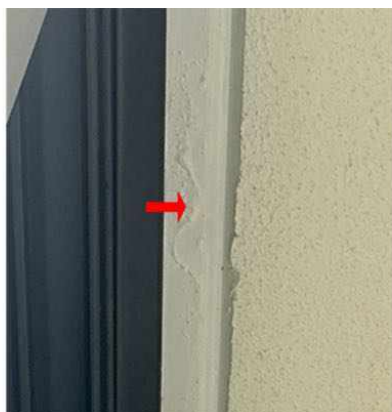
Finding 3.03

Building:	Main Building
Location:	Balcony soffit
Finding:	Painted surface - Bubbling
Information:	Sections of paint in this area was found to have bubbled and deteriorated. Paint bubbling is generally an indication of excessive moisture in the area, that is currently hidden by the painted surface.

The presence of excessive moisture can have major implications on associated building elements if left unattended. While only seemingly minor at this stage, the damage cannot be determined due to the paint obstructing any further inspection of the damage.

It is highly advised that the affected paint be cleaned to allow a further, more invasive inspection by a licensed plumber. Failure to act on this defect may necessitate major works in the future.

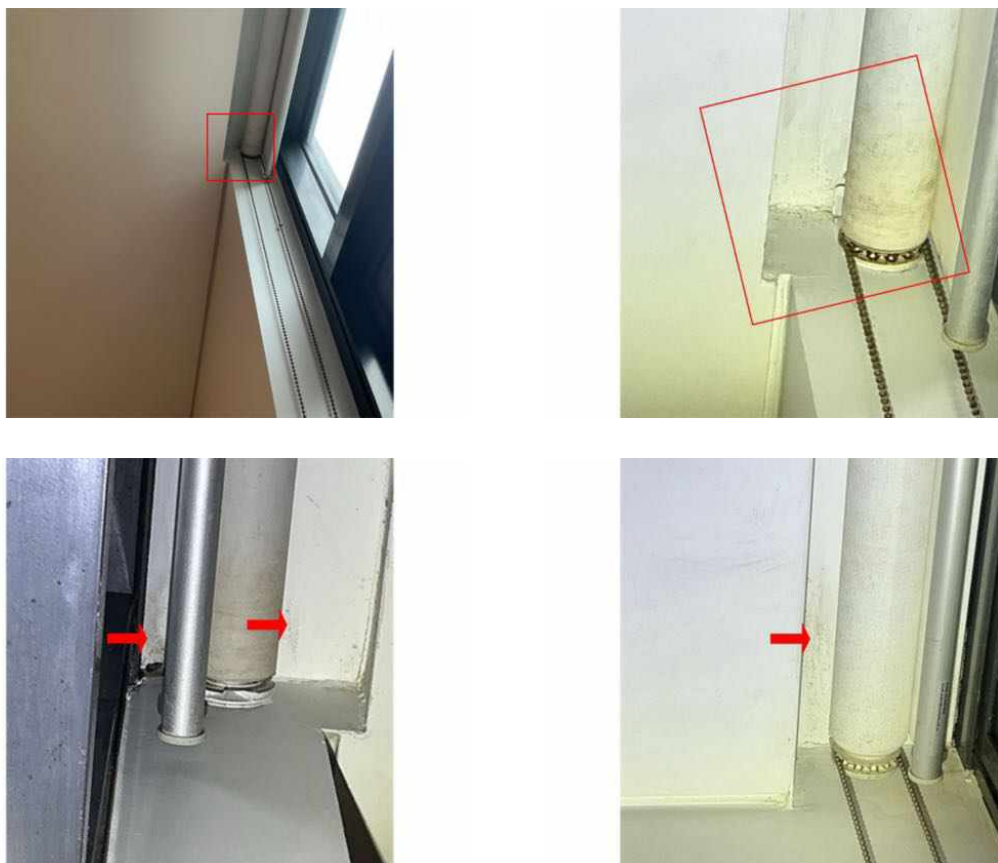
Finding 3.04

Building:	Main Building
Location:	Bedroom
Finding:	Minor Mould Growth – Window Reveal
Information:	Minor mould growth was observed to the internal window reveal and adjacent surface finishes. The extent appears localised and superficial, commonly associated with condensation and limited ventilation rather than active water ingress. No evidence of material deterioration or structural impact was observed at the time of inspection. This condition is classified as a minor defect. Cleaning with an appropriate mould treatment and improving ventilation are recommended to reduce recurrence. Further investigation by a licensed plumber is recommended

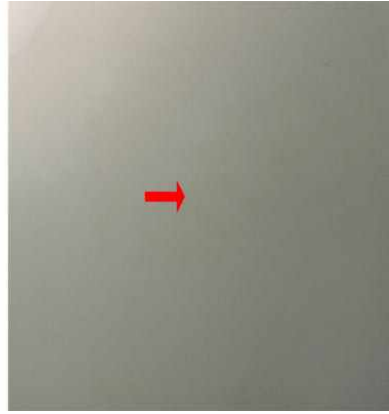
Finding 3.05

Finding: Water staining

Information: Water staining was evident in this area at the time of inspection. Water staining indicates that surfaces have been exposed to excessive moisture over time. The minerals and other elements in the water lead to staining, which may graduate to corrosion and deterioration if left unmanaged.

While mostly an appearance defect, water staining can be indicative of more serious defects, which may be currently concealed by other building elements.

Where water staining is active, a licensed plumber must be consulted to identify the cause of the staining and to provide advice on any reparation works that may be required. Replacement of any broken or damaged structures is advised.

Conversely, where water staining is old and inactive, affected building materials may be repaired or replaced at client discretion. A qualified carpenter or registered builder may be appointed to perform these works.

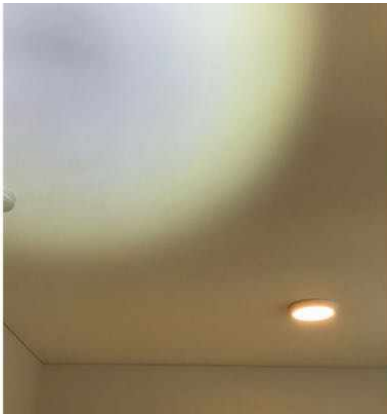
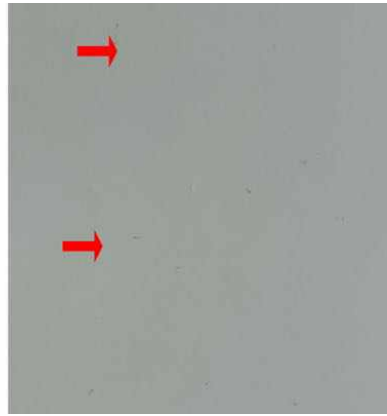
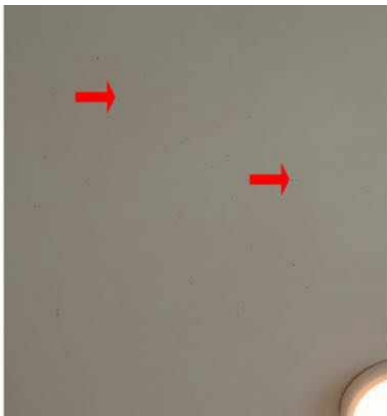
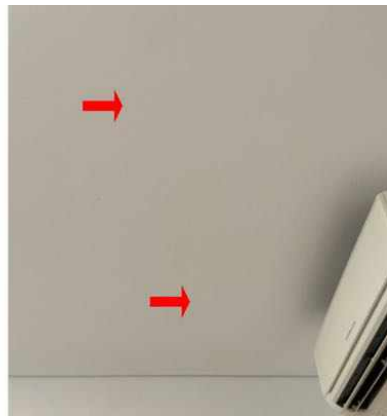
Finding 3.06

Building:	Main Building
Location:	Lounge Room
Finding:	Fainted Dark Spots - Ceiling
Information:	Very minor spotting was identified at the time of inspection, the pattern is consistent with airborne dust accumulation and/or minor environmental staining or possible insect droppings. No visible evidence of moisture ingress or structural defect was observed at the time of inspection.

Cleaning and repainting may be undertaken for cosmetic improvement. Regular cleaning and maintenance of air-conditioning filters and ventilation is recommended.

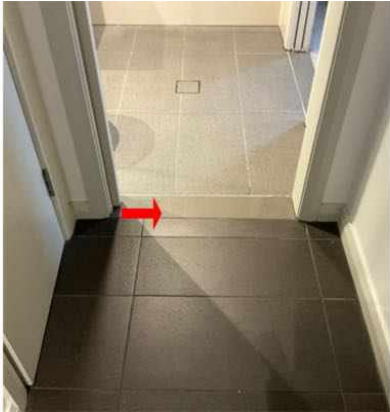
Finding 3.07

Information: The bathroom floor is at the same level as the adjoining timber flooring. This configuration is typical in modern apartments and is permitted where compliant waterproofing and floor falls are provided. No evidence of moisture damage was observed at the time of inspection; however, waterproofing performance cannot be confirmed without invasive inspection.

Care should be taken to avoid excessive water migration beyond the bathroom during

use.

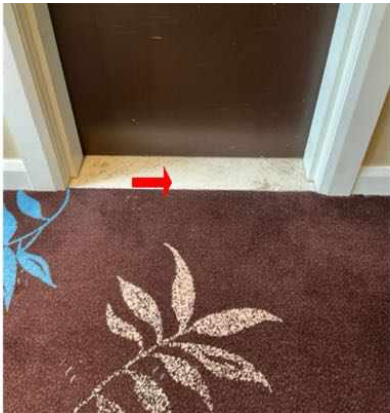
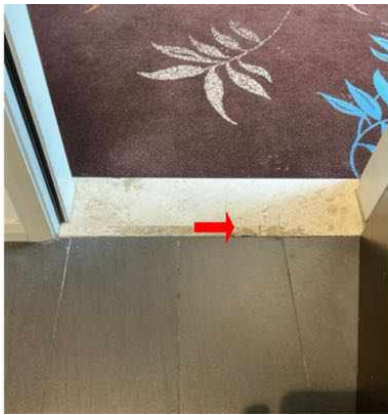
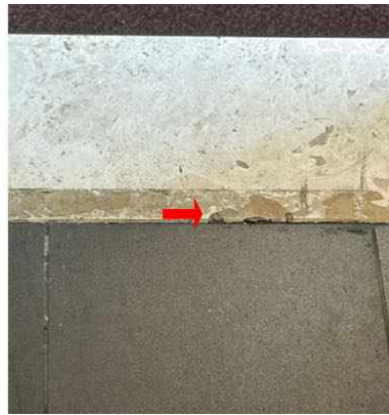
Finding 3.08

Building: Main Building
Location: All Internal Areas - Front
Finding: Tiles - Cracked or damaged
Information:

Cracking was evident to the tiling in this area at the time of inspection. While the cracking appears to be minor, this area is frequently exposed to water, allowing potential for water penetration into adjoining sections of walls or flooring.

If left unmanaged, water penetration to these areas may lead to subsequent water damage, which is likely necessitate repair work to affected building elements.

A tiling contractor should be appointed to ensure that no further water damage occurs. The re-application of silicone and grouting throughout remaining tile work is also advised, to further protect the area against water penetration.

Where water penetration has led to water damage, appointment of a relevant tradesperson may be required to repair damaged building elements.

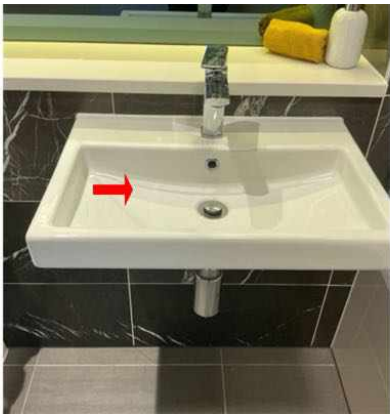
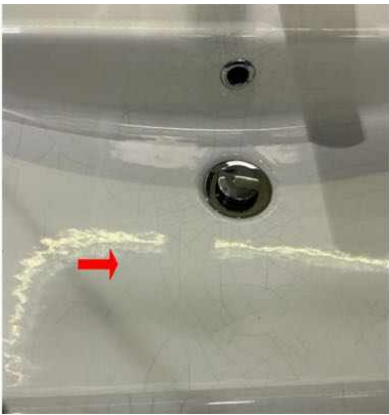
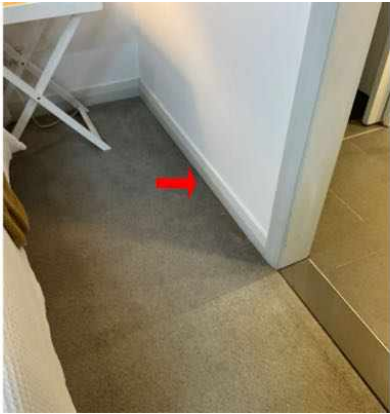
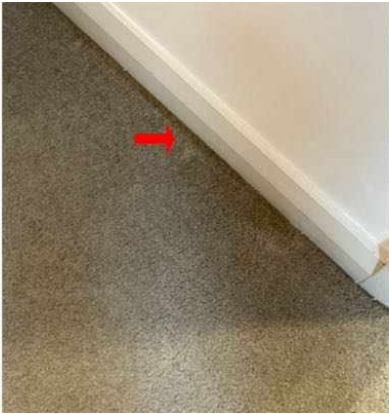
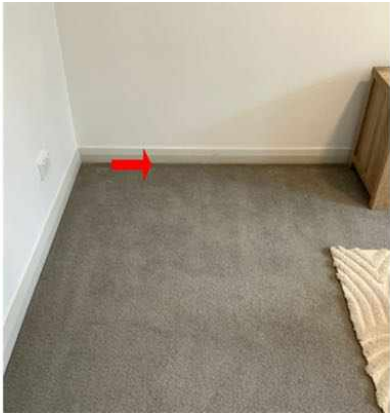
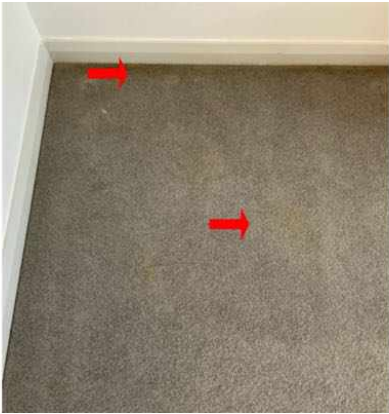
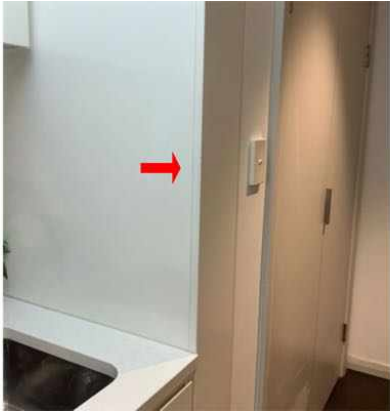
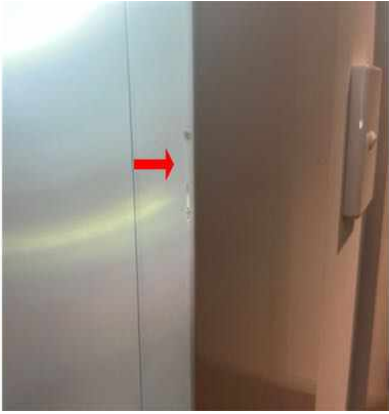
Finding 3.09

Building:	Main Building
Location:	All Internal Areas
Finding:	Building element - Damaged - Mirror desilvering bathroom , Basin hairline cracking , carpet stained to some areas , kitchen cupboards minor chips , splash back minor hairline scratch
Information:	Breakage occurs generally when the building materials have either aged and decayed, or as a result of damage (accidental or deliberate).

Repair and/or replacement of broken elements is advised to ensure that additional secondary defects do not arise as a consequence. Such works are necessary, as all building elements play a key role in the operation and function of the overall structure and its performance.

A relevant tradesperson should be appointed to repair or replace the affected building element prior to any subsequent damage being caused.

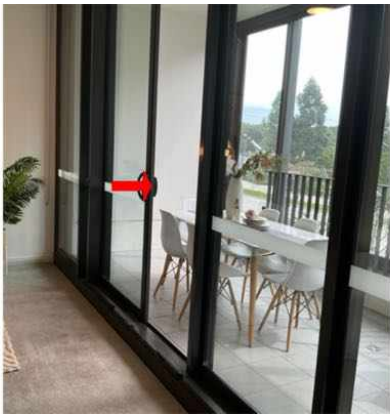
Finding 3.10

Information: Several doors throughout the property were jammed and difficult to slide along the associated tracks at the time of the inspection. Restricted function of the affected doors may pose as a potential safety hazard if required for emergency egress from the building.

Generally, factors such as general age of the building element and a lack of maintenance are the usual causes for this type of defect.

Replacement of door hardware or tracks may be required, as well as minor repairs and cleaning. A registered builder or general handy person will be required to repair the affected doors.

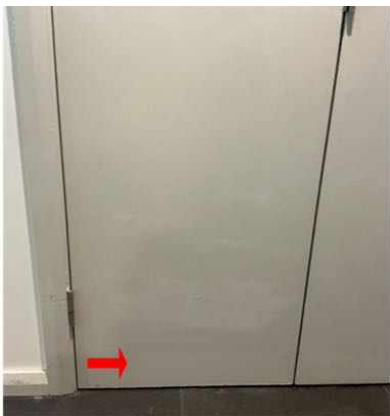
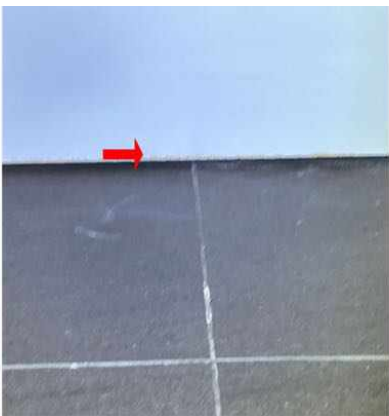
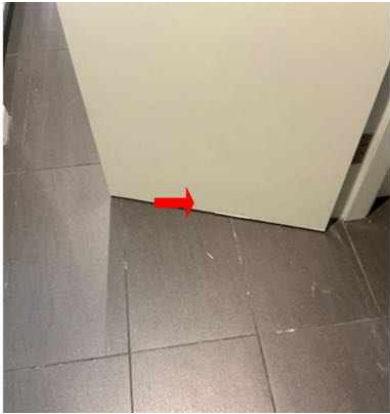
Finding 3.11

Building: Main Building
Location: Hallway
Finding: Delamination of timbers
Information: Localised delamination and surface deterioration were observed to sections of laminated joinery panels. This condition commonly occurs where moisture exposure or wear causes separation of laminate finishes from the underlying substrate. The defect is generally cosmetic in nature but may worsen over time if moisture exposure continues. Repair or replacement of affected joinery components may be considered as part of routine maintenance.

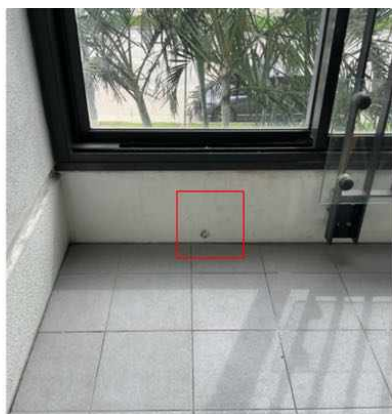
Finding 3.12

Building:	Main Building
Location:	Balcony
Finding:	Building element - Damaged - Hole not sealed
Information:	Breakage occurs generally when the building materials have either aged and decayed, or as a result of damage (accidental or deliberate).

Repair and/or replacement of broken elements is advised to ensure that additional secondary defects do not arise as a consequence. Such works are necessary, as all building elements play a key role in the operation and function of the overall structure and its performance.

A relevant tradesperson should be appointed to repair or replace the affected building element prior to any subsequent damage being caused.

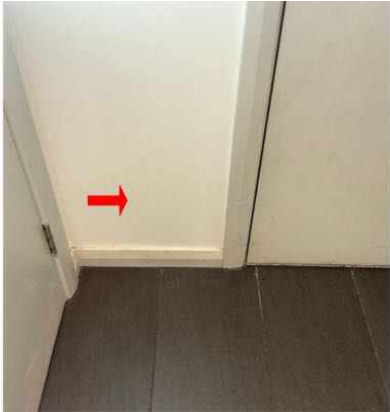
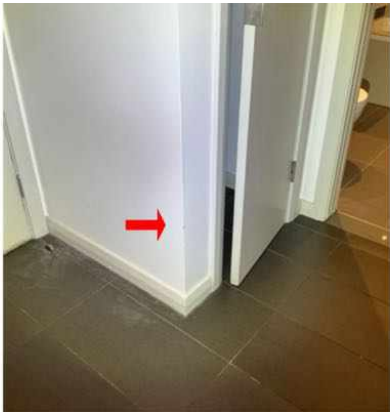
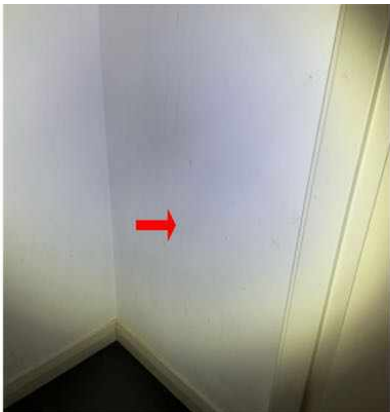
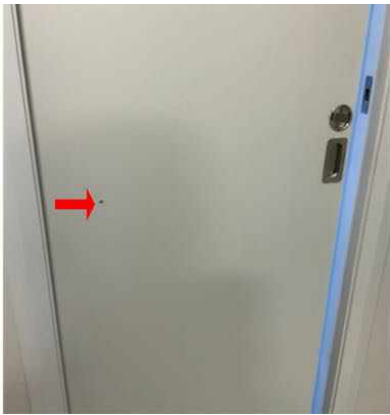
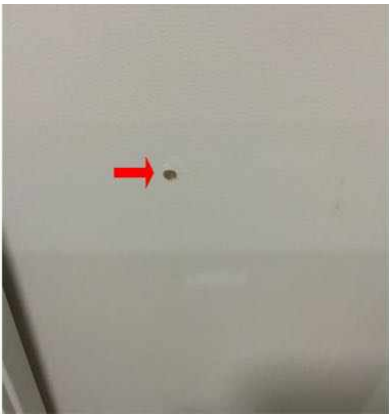
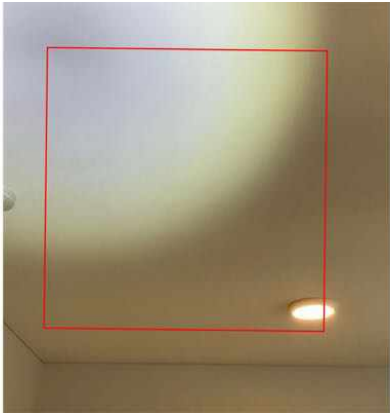
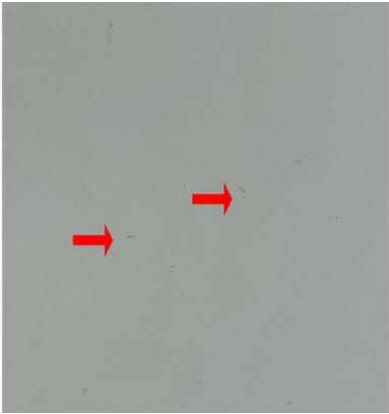
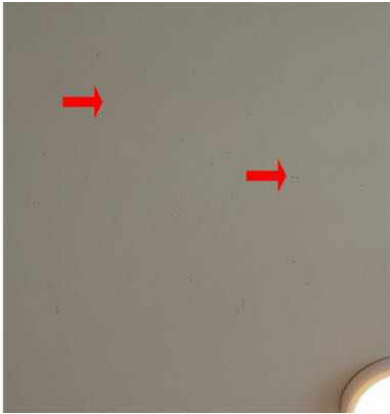
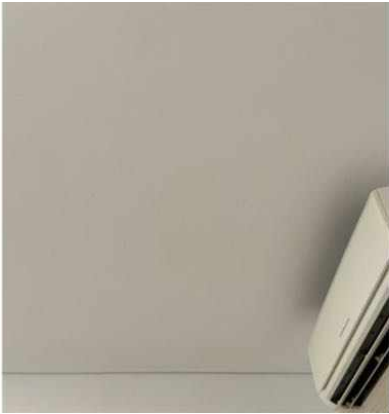
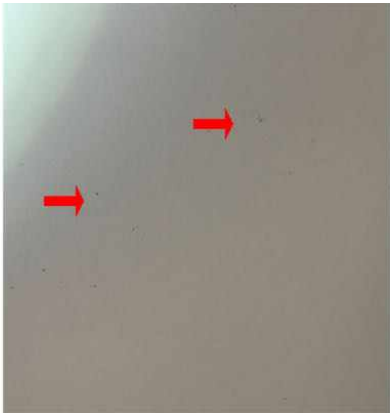
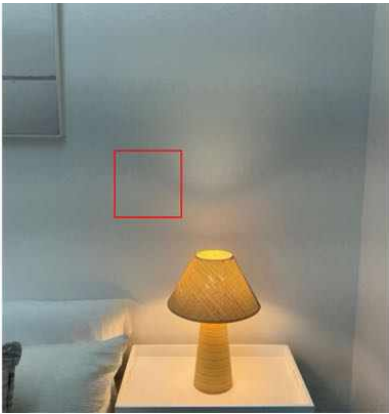
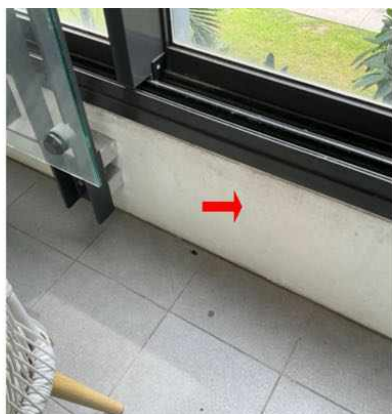
Finding 3.13

Building:	Main Building
Location:	All Internal Areas
Finding:	Paint finish and hairline cracking to some areas
Information:	The paint finish in this area was identical at the time of inspection including some hairline minor cracking.

Whilst incomplete or missing paint finish is generally an appearance defect, it can also lead to the development of secondary building defects over time. Incomplete areas of paint finish expose the area to moisture, potentially accelerating the deterioration of underlying building materials.

Incomplete paint finishes should be sanded back, filled, leveled and painted, as applicable. Where inadequate or missing paint protection has led to the deterioration of the associated building element, repair and/or replacement of this building element may be required.

A painting contractor should be appointed as soon as possible to perform necessary works to aid the appearance of the affected area and to ensure the area is protected against further deterioration. Alternatively, the homeowner following manufacturer instructions may perform these works.

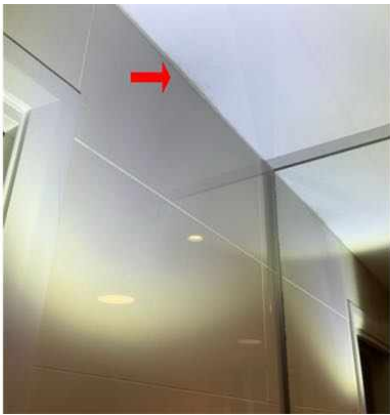
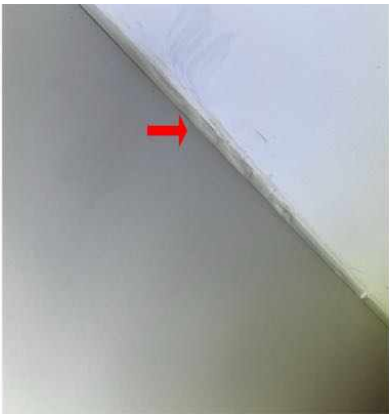
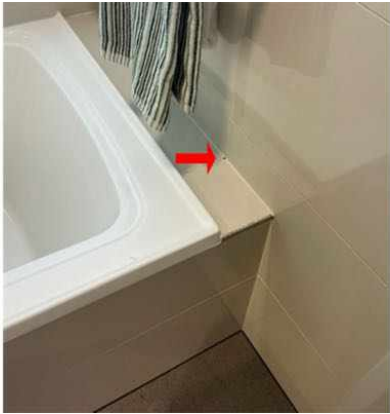
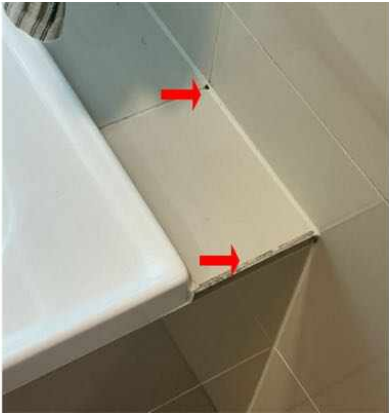
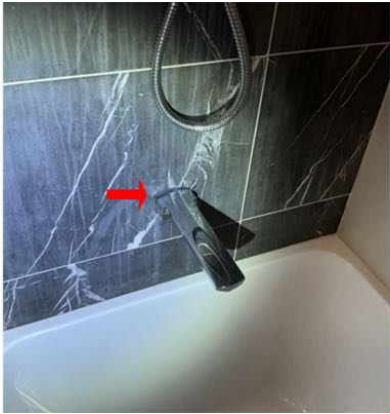
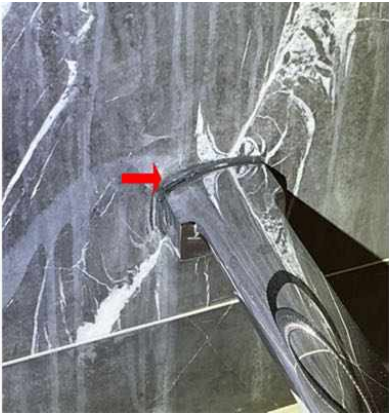
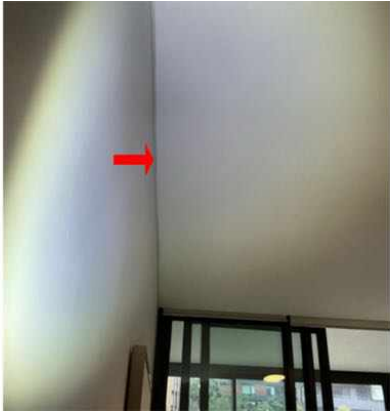
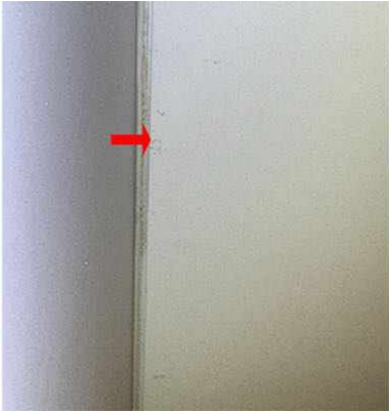
Finding 3.14

Building:	Main Building
Location:	All Internal Areas
Finding:	Sealant and grouting - Missing or degraded
Information:	It was noted on inspection that sealant or grout is degraded. There is also evidence of poor workmanship and excessive use of sealant. Silicone should never be used as a first line of defence against waterproofing. Further inspection by a licensed waterproofing contractor is highly recommended.

Different materials and floor areas move at different rates, generally causing cracking to grout or sealant at this point. A flexible sealant is required to allow for expected expansion and contraction, while keeping the joint water tight and protective of all associated building materials.

There appears to be excessive mould to the sealant and grout which will likely require scraping out and replacement.

Flexible and mould resistant materials should be applied to affected areas to prevent any subsequent water damage that is likely to occur. Regular maintenance and replacement of damage or missing or damaged sealant and grout is highly recommended to the wet areas, as this is a regular wear and tear defect. Sealant and grouting in areas that come into regular contact with water should be maintained for the long term care of your property.

A sealant specialist or tiling contractor should be appointed to complete these works as soon as possible.

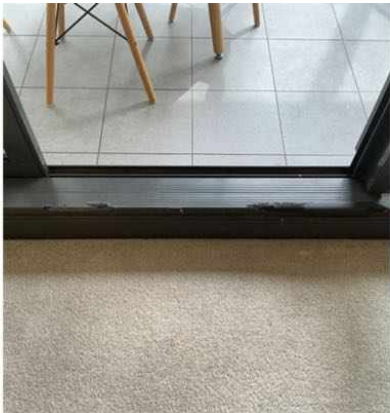
Building: Main Building
Location: All Internal Areas
Finding: Balcony Floor Level Differential
Information: The balcony finished surface appears to be close to, or at the same level as, the internal floor. Standard construction practice requires a step-down of approximately 50 mm unless a fully engineered threshold drainage system is provided. No such drainage features were visible during inspection. This configuration increases the risk of water ingress, and confirmation of the balcony waterproofing detail through strata/building management is recommended.
