Building and Timber Pest Inspection Report

Inspection Date: Wed, 4 Feb 2026

Property Address: 6 Cambridge Way, Ripley QLD 4306, Australia

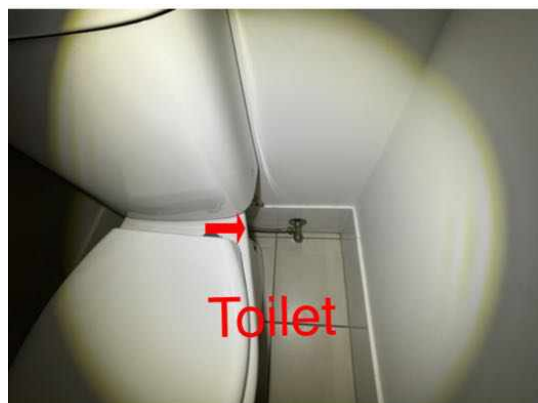
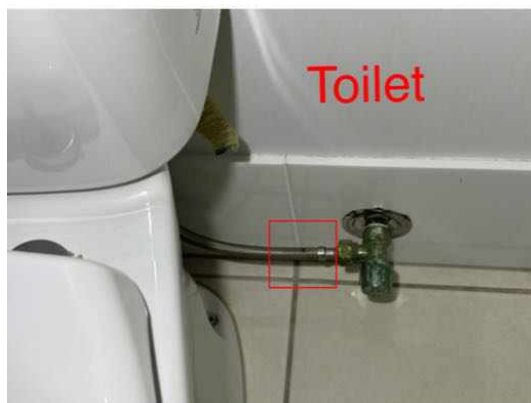
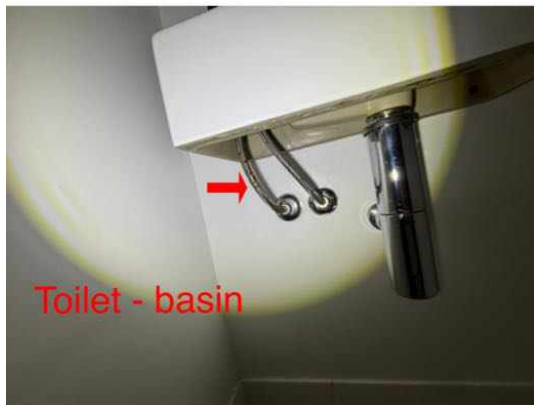
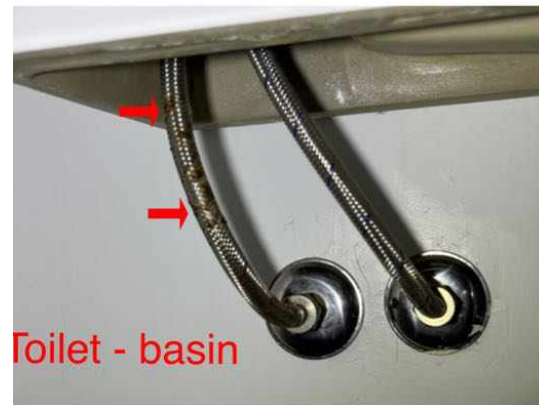
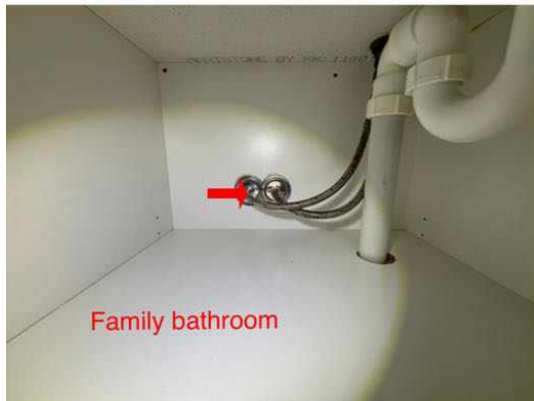
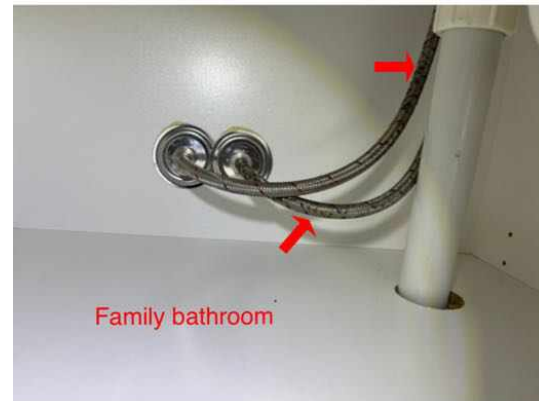
Finding 3.01

Building: Main Building
Location: All Internal Areas
Finding: Powder room and family bathroom - flexible hoses have signs of rust
Information: At the time of the inspection, it was noted that a flexible hoses to the toilet and basin mixer in the powder room and the vanity mixer in he family bathroom had signs of rusting. This may be due to the age of the hose. Flexible hoses typically have a 5 - 10 year lifespan. It is recommended that they be changed if they have signs of bulging, fraying, kinking or rust.

A licensed plumber should be engaged to replace the affected flexible hoses in the powder room and family bathroom. This should be done as a matter of urgency.

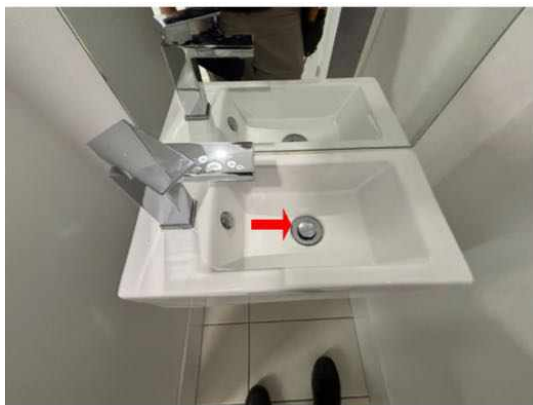
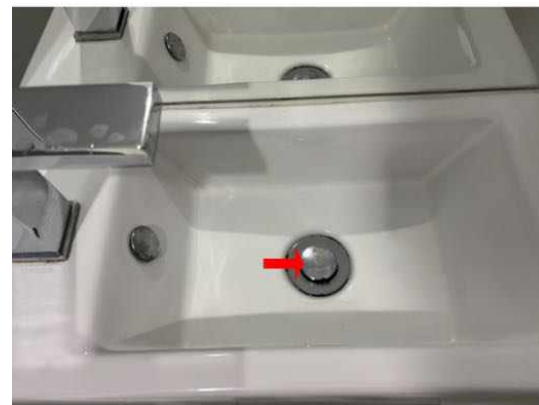
Finding 3.02

Location: Powder room

Finding: Pop up waste - stuck in the open position

Information: At the time of the inspection, it was noted that the pop up plug waste to the basin in the powder room was stuck in the open position. The basin cannot be filled.

A licensed plumber should be engaged to replace the pop up plug waste. This can be done at the clients discretion.

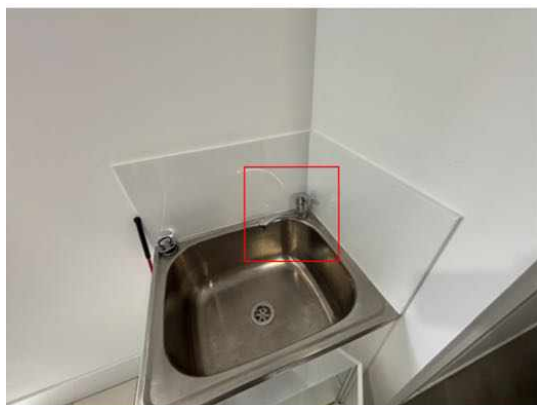
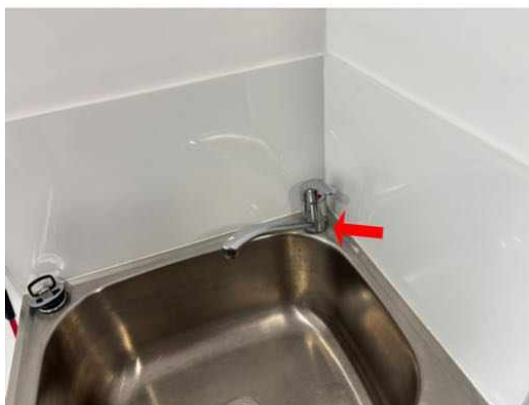
Finding 3.03

Building: Main Building
 Location: Laundry
 Finding: Laundry - mixer tap loose
 Information: At the time of the inspection, it was noted that the mixer tap to the laundry tub was loose. Deterioration of the mixer tap may occur if left unaddressed.

A licensed plumber should be engaged to tighten the laundry mixer tap. This should be done as a short term priority.

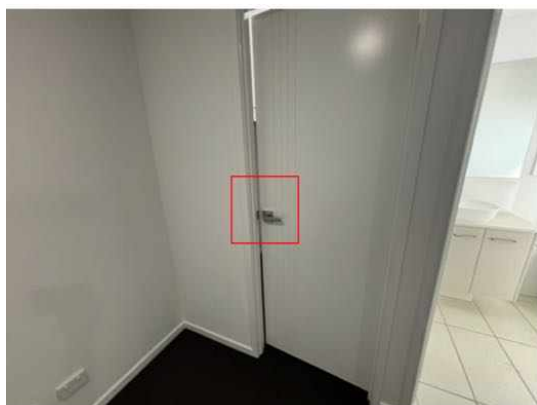
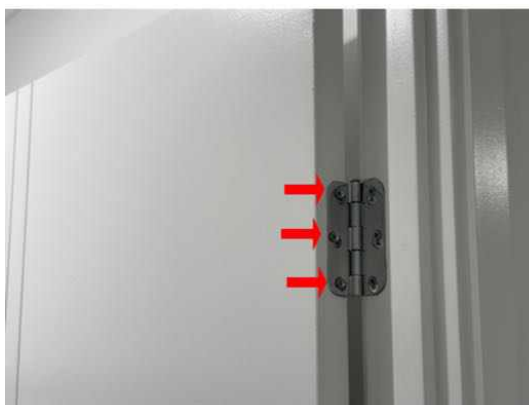
Finding 3.04

Building: Main Building
 Location: Walk in robe
 Finding: Walk in robe - door handle not latching
 Information: At the time of the inspection, it was noted that the door to the walk in robe was not latching during normal operation. This appears to be due to the screws for the top hinge not being able to be tightened.

A qualified carpenter or building maintenance professional may be appointed to perform rectification works as necessary, at client discretion. If left unattended, further functional impairment is likely to occur.

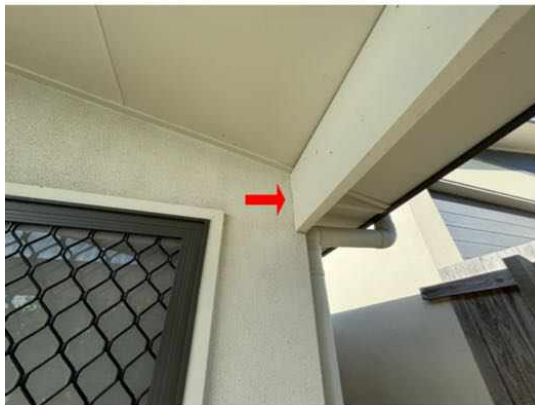
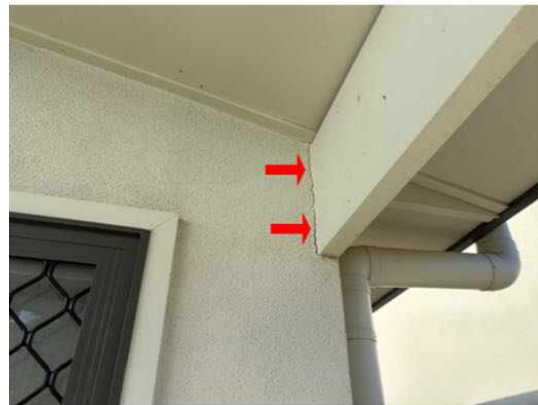
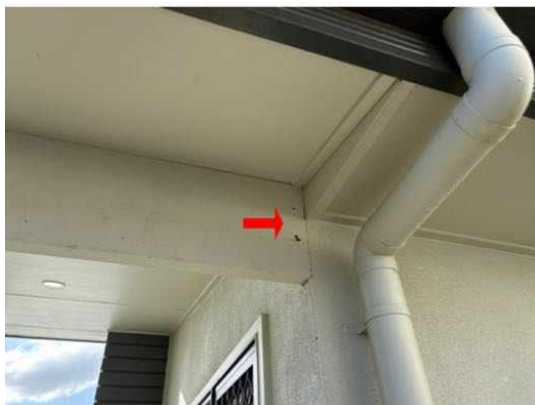
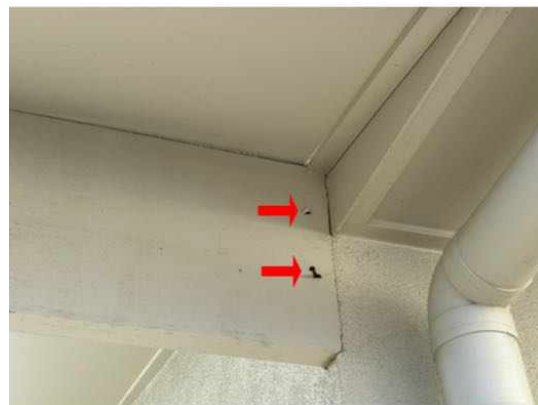
Finding 3.05

Building: Main Building
Location: Front elevation
Finding: Front entry - minor crack
Information: At the time of the inspection, it was noted that there was a minor crack next to the decorative timber at the front of the dwelling. This is caused by the fasteners(nails) for the timber coming loose. These nails should be replaced by screws to securely fasten the timber to the dwelling.

A building maintenance professional or licensed carpenter could be engaged to carry out this minor repair. This can be done at the clients discretion.

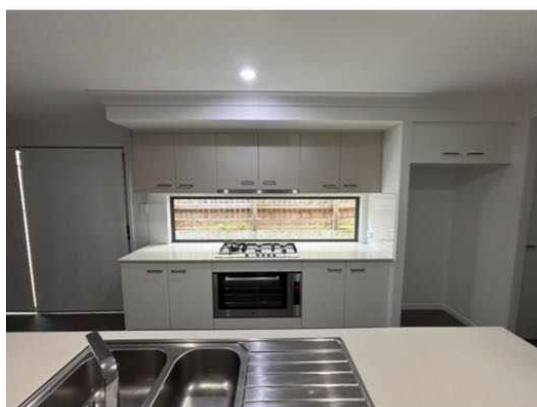
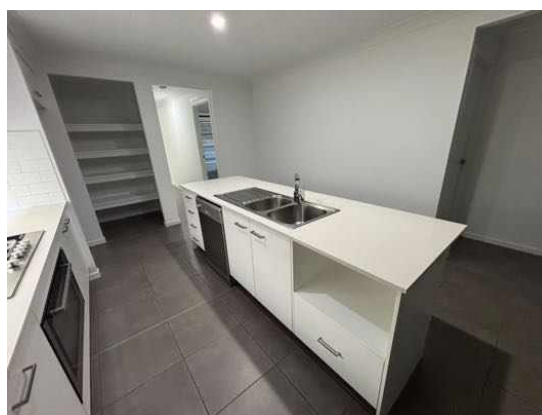
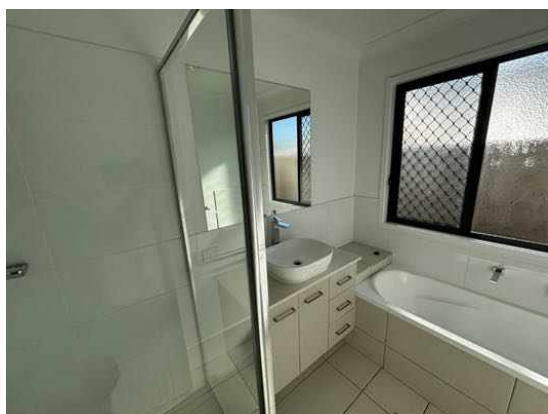
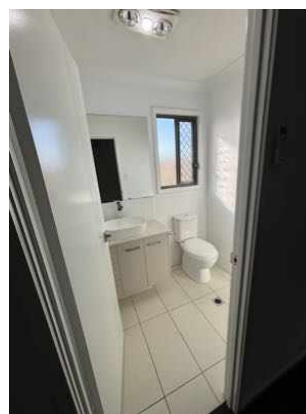
Building: Main Building
 Location: All Internal Areas
 Finding: Obstructions and Limitations - Internal areas
 Information: These photographs are an indication of the obstructions and limitations which impeded full inspection of the property of the internal areas at the time of inspection. These obstructions can hide an array of defects and should be removed to allow full inspection to be carried out. A re-inspection is recommended once the areas are made accessible.

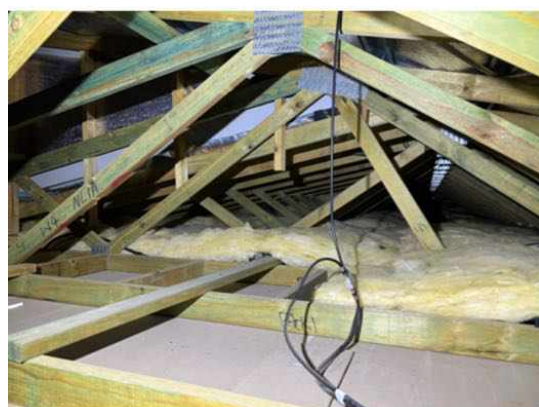
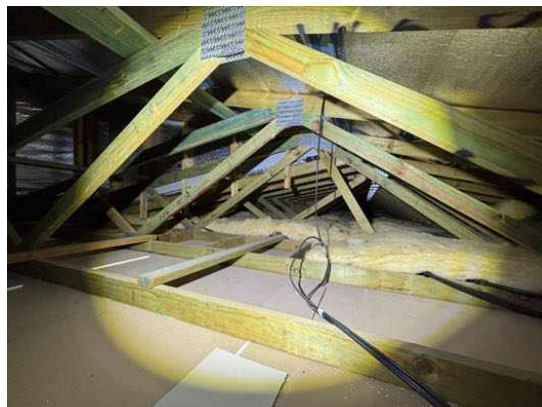
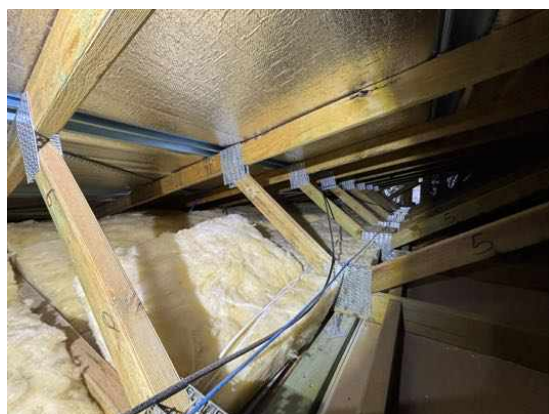
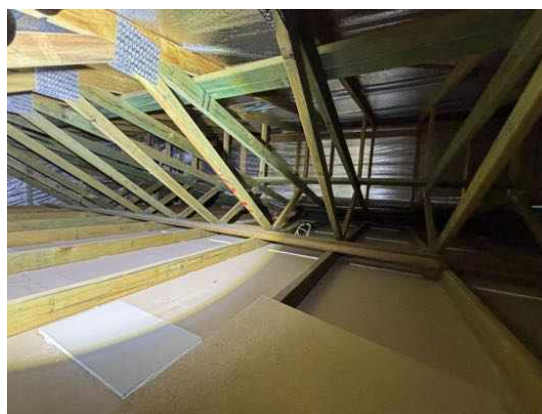
Building: Main Building
 Location: Roof Void
 Finding: Obstructions and Limitations - Roof cavity
 Information: These photographs are an indication of the obstructions and limitations which impeded full inspection of the property of the roof cavity

at the time of inspection. These obstructions can hide an array of defects and should be removed to allow full inspection to be carried out. A re-inspection is recommended once the areas are made accessible.

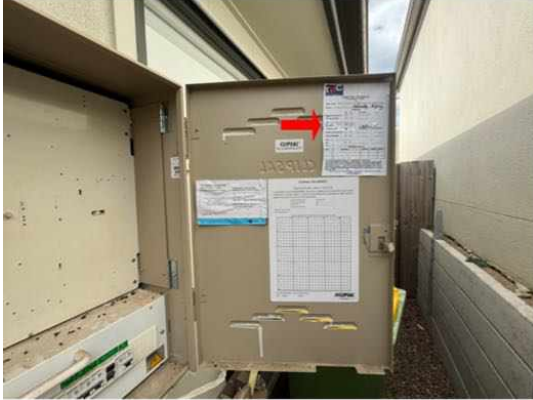
Building:	Main Building
Location:	All External Areas
Finding:	Evidence of a physical termite management system was identified.
Information:	At the time of the inspection, evidence of a physical termite management system was found by way of a durable notice in the electricity meter box.

A physical termite barrier was installed to the slab penetrations, perimeter and construction joints during construction. The durable notice is dated the 27/07/2019 to the 19/09/2019.

A termite and timber pest technician should be engaged to carry out annual termite inspections as per AS 3660 in order to further protect the dwelling. Annual termite inspections must be carried out in partnership with any termite treatment system,

physical or chemical, as no termite treatment system can be expected to be 100% effective.
