Building and Timber Pest Inspection Report

Inspection Date: Wed, 4 Mar 2026

Property Address: 35 Merrick Cct, Kiama NSW 2533, Australia

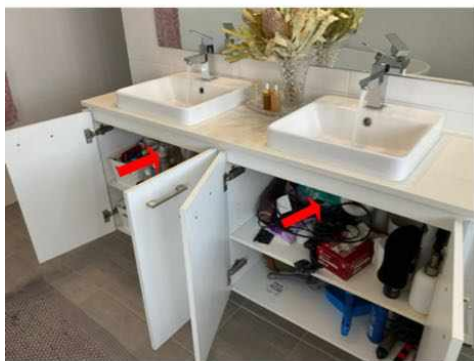
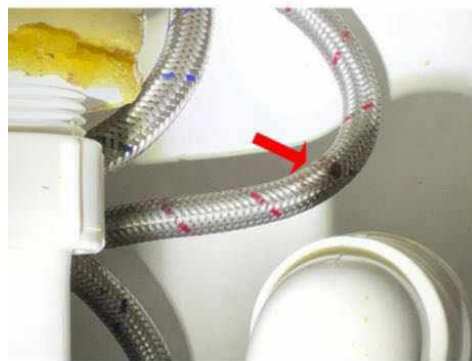
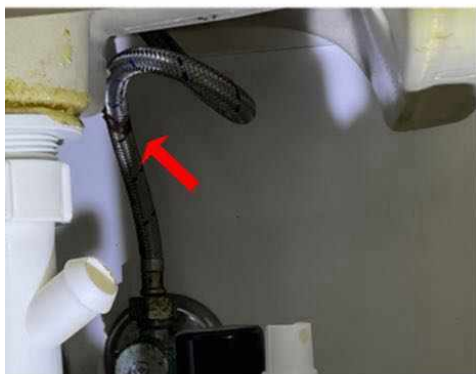
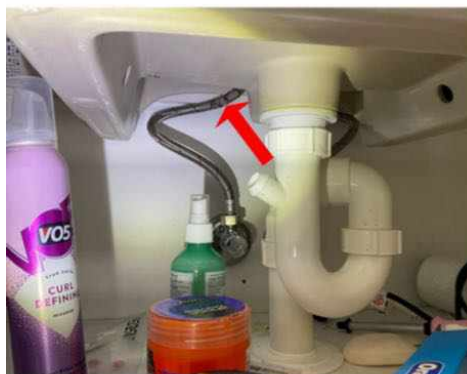
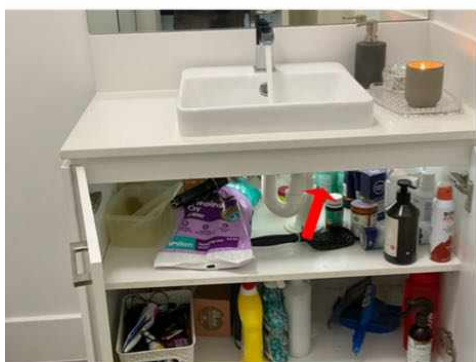
Building: Building 1
Location: All Bathrooms
Finding: Areas rusted plumbing lines
Information: These vanity areas shows evidence of rusting and corrosion, which is likely to have developed as a result of excessive exposure to moisture and or inadequate coatings.

A registered plumber or skilled handy person should be appointed immediately to replace these plumbing lines that have been severely affected by rust or water damage.

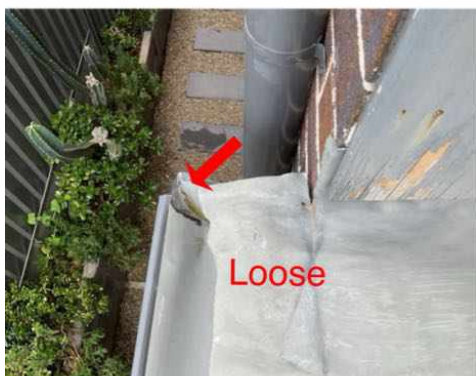
Building:	Building 1
Location:	Walls - right middle area
Finding:	Site drainage - Inadequate
Information:	The site drainage in this right area was found to be unfinished at the time of inspection, creating potential for subsequent water damage to associated building elements.

A qualified plumber should be appointed to finish off this Ag drain. The right rear roof gutter has a loose end cap requiring repair. Secondary defects are likely to occur if left unmanaged.

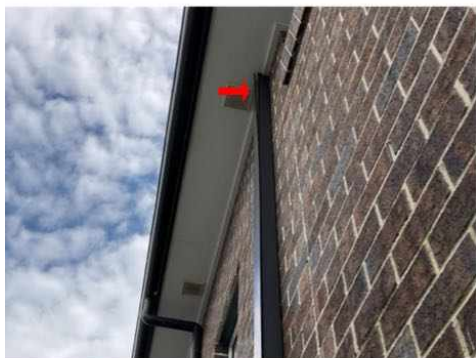
Building:	Building 1
Location:	Exterior walls - right side
Finding:	Duct - Damaged
Information:	Evidence of minor damaged areas was identified at the time of the inspection. The AC electrical ducting is loose.

A carpenter or electrician would be the trade responsible for rectification of these areas when convenient.

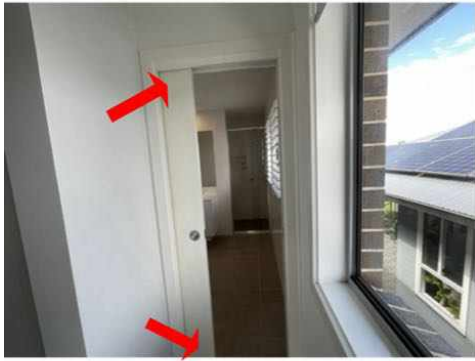
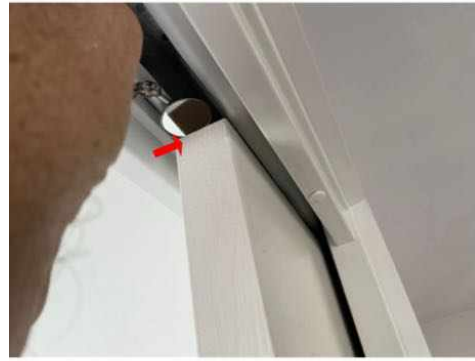
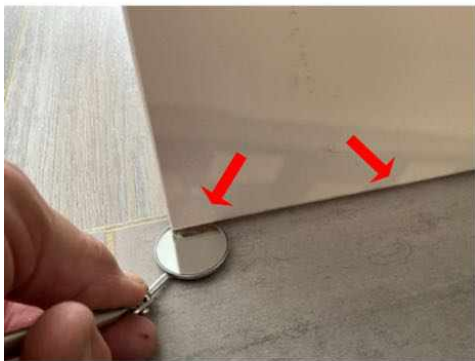
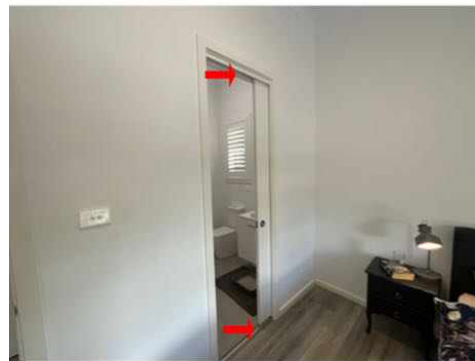
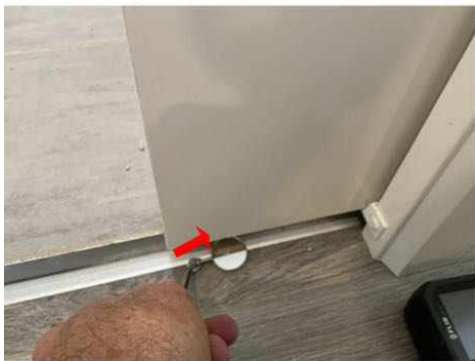
Finding 3.06

Building:	Building 1
Location:	Both ensuite doors
Finding:	Paint finish on doors - Incomplete
Information:	The paint finish in this sliding doors was identified as being incomplete at the time of inspection.

NSW Guide to Standards and Tolerances 9.6 states that “door leaves are defective if they do not have all sides, top and bottom edges sealed/painted

Whilst incomplete or missing paint finish is generally an appearance defect, it can also lead to the development of secondary building defects over time. Incomplete areas of paint finish expose the area to moisture, potentially accelerating the deterioration of underlying building materials.

Incomplete paint finishes should be sanded back, filled, leveled and painted, as applicable. Where inadequate or missing paint protection has led to the deterioration of the associated building element, repair and/or replacement of this building element may be required.

A painting contractor should be appointed as soon as possible to perform necessary works to aid the appearance of the affected area and to ensure the area is protected against further deterioration. Alternatively, the homeowner following manufacturer instructions may perform these works.

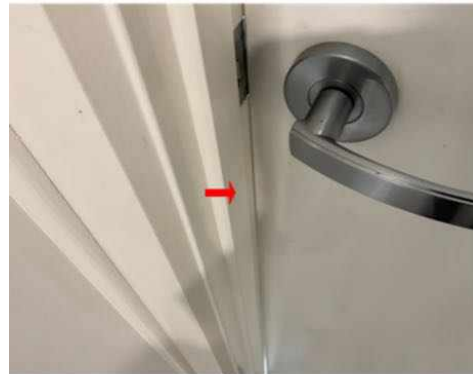
Finding 3.07

Building:	Building 1
Location:	Bedroom - Master
Finding:	Door - Binding/jamming
Information:	Binding and/or jamming of this door is evident during standard operation. This defect inhibits the functionality of the affected door as well as creating potential for secondary defects to associated building elements, such as damage to the floor covering.

A door that binds to flooring or to the associated door frame may have several causes, ranging from minor defects, such as poor installation of the door or deteriorated hinges, through to major structural issues, such as damage to subfloor structures.

For this minor cause, a qualified carpenter or general handyperson should be appointed to perform minor rectification works at client discretion.

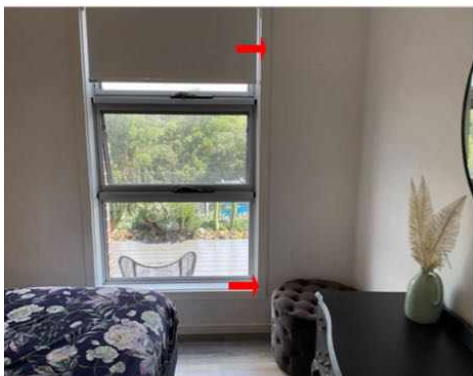
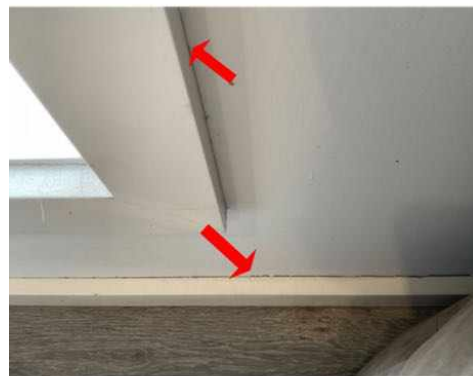
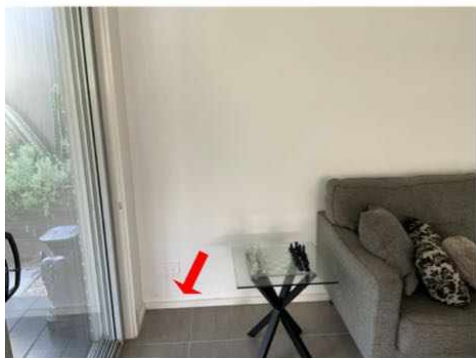
Finding 3.08

Building:	Building 1
Location:	Master bedroom and lounge room
Finding:	Cracking - Damage Category 1 - Fine (up to 1mm)
Information:	Although fine cracks are quite noticeable, they are often only considered to be an appearance defect, and usually do not indicate any structural damage. Generally, the cause of a fine crack is indicative of a separation between building materials and finishes (e.g. paint, plaster, etc.) along joins.

Cracking of this nature can generally be repaired with minor sanding, filling and/or repainting. Such works should be performed by a qualified painter or a general handyman.

Monitoring of all cracking should be conducted frequently. Always contact a building inspector should cracks widen, lengthen, or become more numerous.

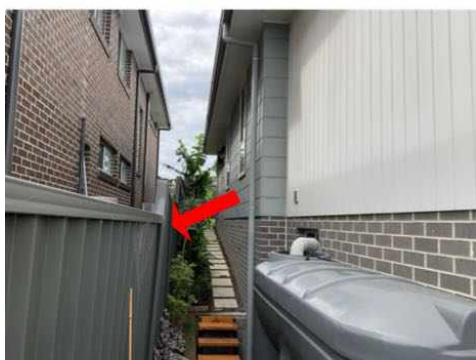
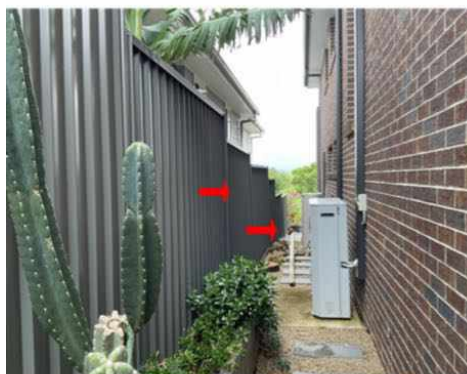
Finding 3.09

Building:	Building 1
Location:	Pictured fence
Finding:	Fence damaged - leaning
Information:	Evidence of damage to the pictured fence was identified at the time of the inspection. The likely cause of this fence leaning is not enough concrete used in the post footings.

If left unmanaged this fence may deteriorate further.

It is suggest a fencing contractor be engaged for rectification when convenient.

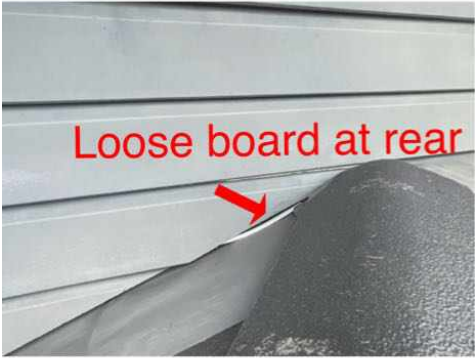
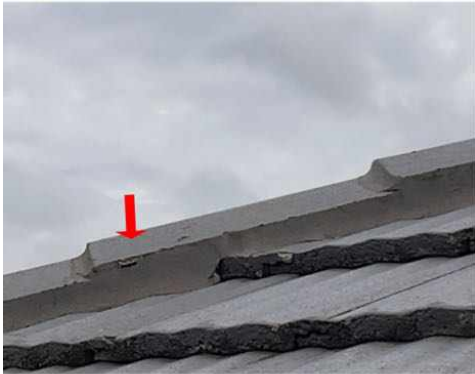
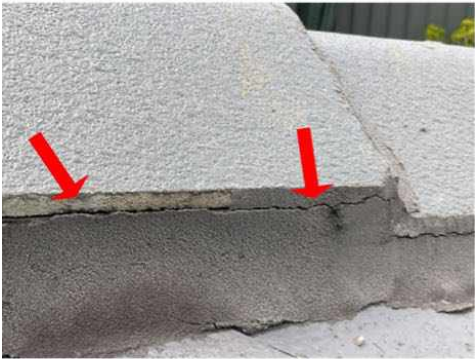
Finding 3.10

Building:	Building 1
Location:	Roof Exterior
Finding:	Roof tiles - Weathered
Information:	Upon inspection of the exterior roofing, the majority of roof tiles were considered to be in a good condition. While weathering of the tiles is consistent with the age of the property, maintenance works are required. Isolated areas of mortar show minor cracking. Re-pointing and re-sealing the may be considered as an interim solution by the client to help preserve and extend the life span of the tiles. A roofing contractor

can repair these minor areas in the near future.

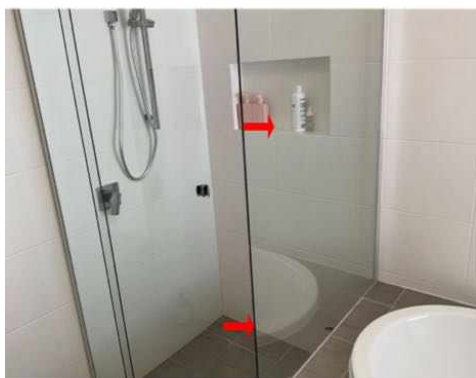
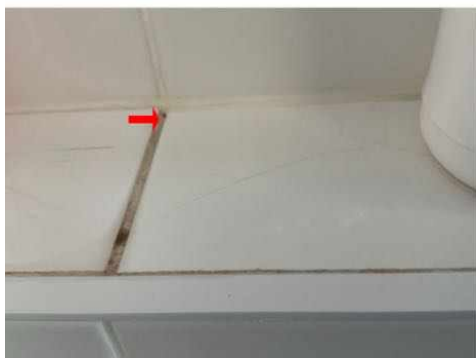
Finding 3.11

Building: Building 1
Location: Bathroom
Finding: Sealant and grouting - Missing or damaged
Information: It was noted on inspection that sealant or grout is degraded to these pictured areas.

Different materials and floor areas move at different rates, generally causing cracking to grout or sealant at this point. A flexible sealant is required to allow for expected

Flexible and mould resistant materials should be applied to affected areas to prevent any subsequent water damage that is likely to occur. Regular maintenance and replacement of damage or missing or damaged sealant and grout is highly recommended to the wet areas, as this is a regular wear and tear defect. Sealant and grouting in areas that come into regular contact with water should be maintained for the long term care of your property.

A sealant specialist or tiling contractor should be appointed to complete these works as soon as possible

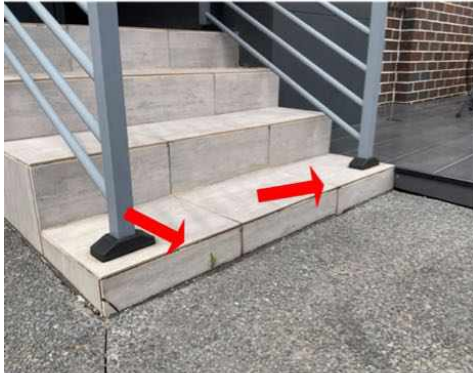
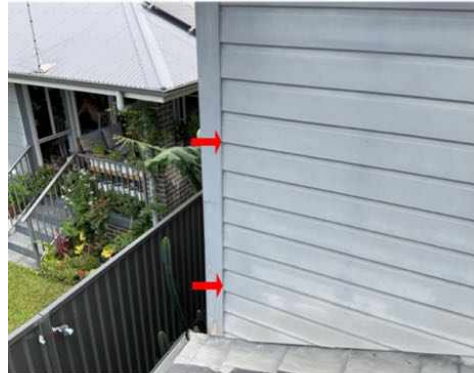
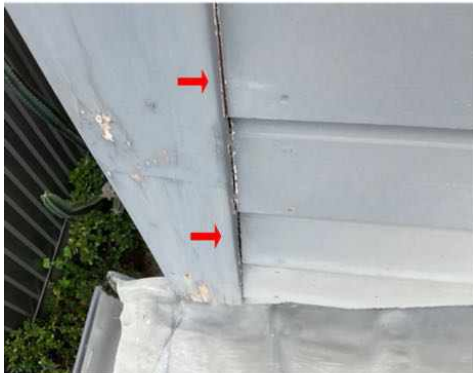
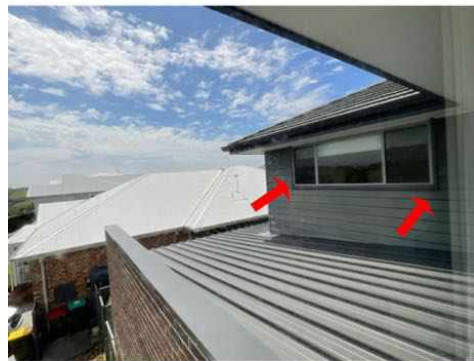
Finding 3.12

Building:	Building 1
Location:	Exterior walls
Finding:	Sealant (external) - missing
Information:	It was noted on inspection that areas of external sealant was missing to small areas of the external walls.

Flexible sealants should be applied to these affected areas to prevent any subsequent water damage that is likely to occur.

A sealant specialist or skilled handy person should be appointed to complete these works as soon as possible

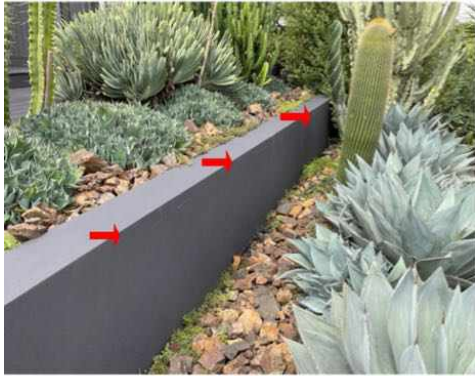
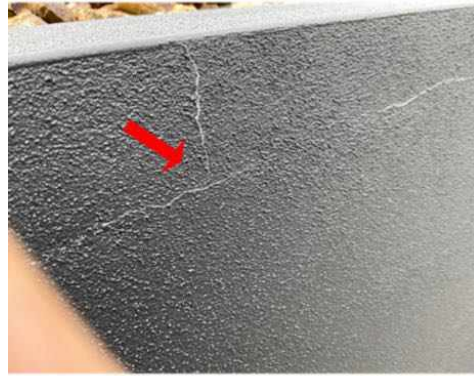
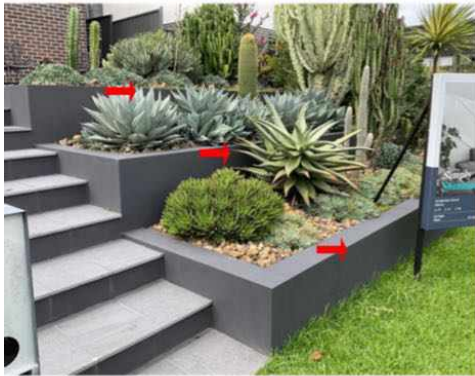
Finding 3.13

Building:	Building 1
Location:	Exterior walls - right side
Finding:	Render (external) cracking very minor
Information:	It has been observed that cracking to some external rendered surfaces. The degree of damage is described as "slight" noticeable cracks which are easily filled. Cracking of this size are generally less than 1mm in width.

Always contact your building inspector should cracks widen, lengthen, or become more numerous.

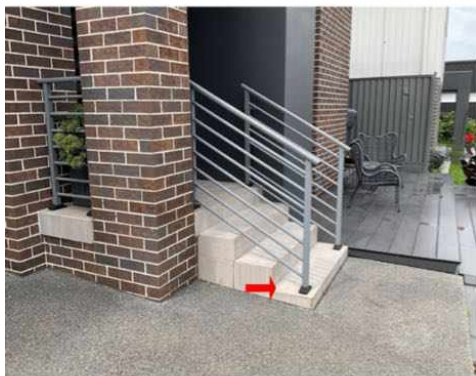
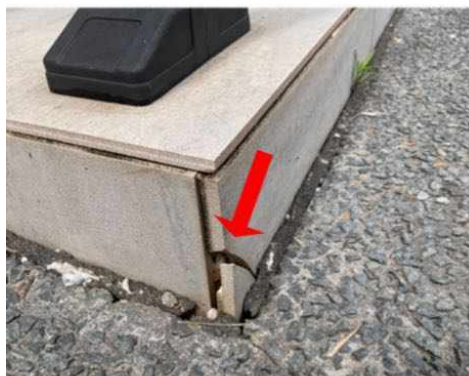
Finding 3.14

Building: Building 1
 Location: Porch
 Finding: Tile cracked
 Information:

A cracked tile was evident in these pictured areas at the time of inspection. It is suspected that this cracking has occurred as a result of minor settlement. Cracked tiles throughout the household detract from the overall appearance of the affected areas.

Replacement of cracked tiles is recommended as soon as possible. A tiling contractor may be appointed to perform these works. Where cracks become more numerous, contact a licensed building inspector for further investigation.

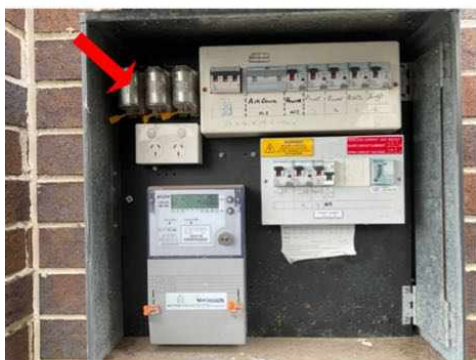
Building: Building 1
Location: Meter Box
Finding: Termite Management System - no evidence of a chemical installation
Information: The application of a post-construction chemical termite barrier is highly recommended for all properties. Such barriers are highly effective in preventing termite attack on any timber building elements throughout the property.

A durable notice should be placed in the switchboard unit to indicate current termite barriers. At the time of inspection, no durable notice was evident and it appeared as though no chemical termite management system has been installed, with no evidence to suggest preventative works taking place since the property was built.

The client may consider gaining further advice from a pest controller as to the costs and procedures involved with a 'chemical' application. It is recommended that obtaining such advice be a short-term priority.

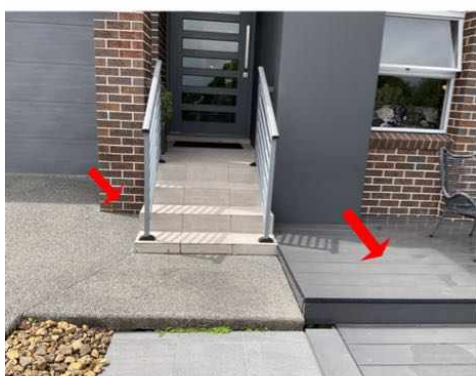
Finding 6.02

Building:	Building 1
Location:	Exterior walls
Finding:	Slab Edge - Exposure
Information:	An inspection zone of at least 75mm in relation to the exposed slab edge, between the bottom brick and the perimeter pavement, is required. This inspection zone should be maintained in order to force termites into the open where they can be detected more readily during regular inspections. The slab edge should not be concealed by anything that may prevent inspection of the area, including render, landscaping, soil, turf, paving, concrete cladding or other structures.

If the slab edge is not properly exposed there is a high risk of termite attack. Sometimes, in order to determine the type of slab, a suitably qualified person such as an architect or builder may be required to consult the construction plans.

Where the slab edge cannot be properly inspected, it is highly recommended that termite or timber pest inspections be carried out every 6-12 months to aid protection of the property against infestation.
