Building and Timber Pest Inspection Report

Inspection Date: Tue, 17 Feb 2026

Property Address: 11/33 Clovelly Rd, Hornsby NSW 2077,
Australia

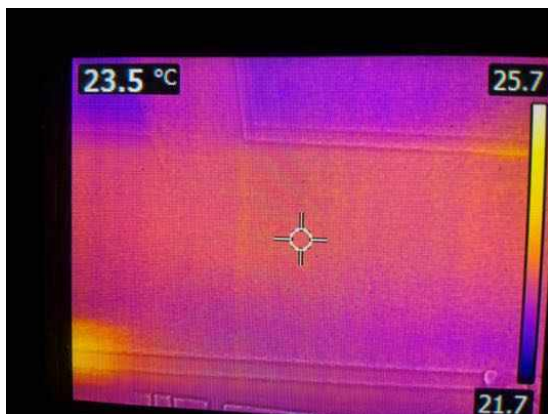
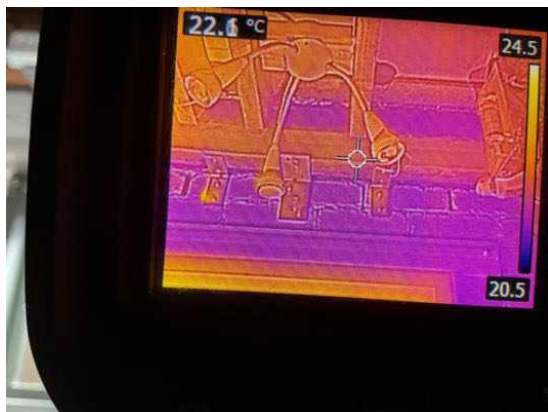
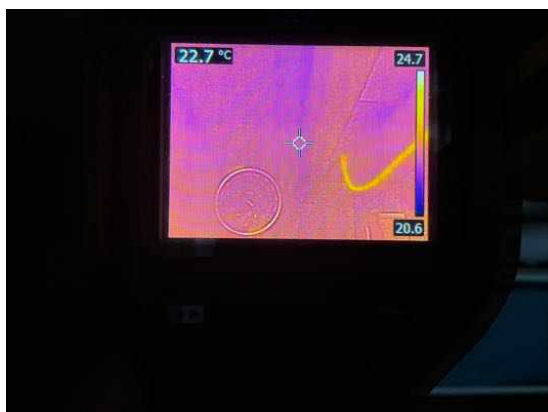
Building: Main Building
Location: Store Room, Workshop
Finding: Stains (Dry)
Information:

At the time of inspection, staining was noted to sections of the accessible structural timbers and adjoining surfaces within the subfloor and external undercroft areas. The affected areas appeared dry at the time of inspection, and thermal imaging did not indicate the presence of active moisture. The staining is consistent with previous moisture exposure, which may have been the result of past plumbing leaks, water ingress, or condensation; however, no active leakage was identified during the inspection. While the areas currently appear stable, historic moisture can contribute to timber deterioration or mould growth if conditions recur. The client is advised to monitor these areas over time and to ensure that all plumbing, drainage and ventilation systems remain in good working order. Should any signs of renewed dampness, mould growth, odour, or timber deterioration become evident, a licensed plumber or suitably qualified contractor should be engaged

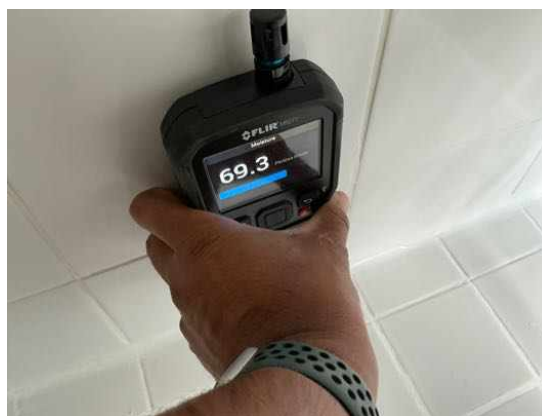
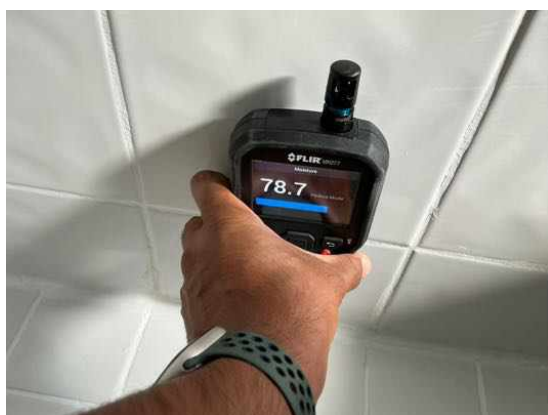
Finding 3.04

Building:	Main Building
Location:	Bathroom
Finding:	Excessive Moisture - Shower Damp
Information:	At the time of inspection, excessive moisture was noted within the shower area, which is a common issue in wet areas due to the continual exposure to water. This condition is typically caused by moisture seeping through grout lines and settling behind tiles, resulting in localised high-moisture zones. Provided there is no evidence of water staining or elevated moisture readings on the opposite side of the wall, this is considered a minor defect.

However, persistently damp conditions may act as conducive conditions for termite

activity, as termites are strongly attracted to moisture-rich environments. It is recommended that the client ensures regular use of the exhaust fan and maintains adequate ventilation after shower use to promote drying and reduce long-term moisture build-up, thereby also reducing the risk of attracting termites.

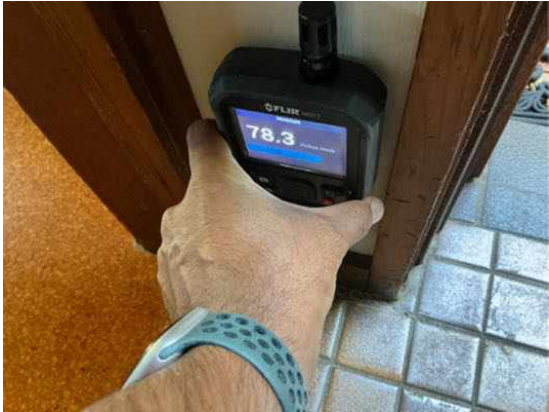
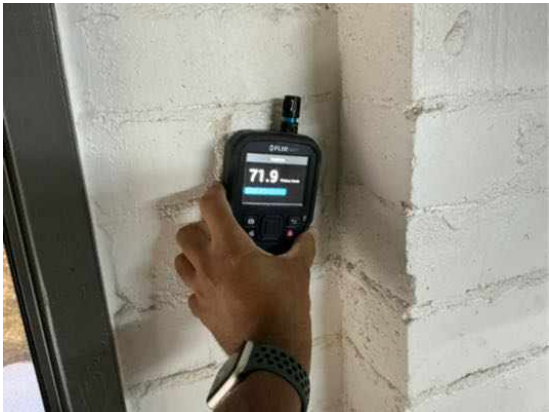
Finding 3.05

Building:	Main Building
Location:	Dining Room, Laundry, Workshop
Finding:	Damp - Rising
Information:	At the time of inspection, rising damp was identified within the property. This condition results from the upward movement of moisture through porous building materials, such as bricks, sandstone, or mortar, via capillary action. A damp-proof course (DPC), an impermeable barrier installed at the base of walls above ground level during construction, is typically used to prevent rising damp. However, the absence, deterioration, or bridging of the DPC can compromise its effectiveness, specially in older buildings, leading to moisture ingress. Inadequate site drainage, which allows water to accumulate around the foundation, is a common contributing factor to this issue.

If left unaddressed, rising damp can pose significant health risks due to mould growth and cause extensive damage to building elements, including wall finishes such as paint and plasterwork. The current condition should be monitored over a 12-month

period to assess its progression.

It is strongly recommended that the client engage a qualified damp-proofing specialist for remedial actions. Additionally, consulting a qualified plumber or drainage specialist to assess and improve site drainage is advised to mitigate further risks. Monitoring the condition for 12 months is essential to evaluate its status and prevent potential recurrence or further damage.

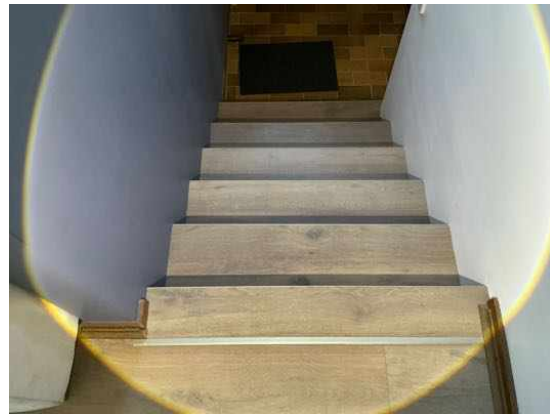
Information: During the inspection, noise was observed when walking on the stairs. This issue is typically caused by movement between the stair components, such as loose treads or risers, or due to wooden parts expanding and contracting with changes in humidity. Over time, normal wear and tear can cause the stair joints or fasteners to become loose, leading to the noise when pressure is applied to the steps.

It is recommended that the client engage a carpenter or builder to inspect the stairs and determine the exact cause of the noise. Repairing loose components or tightening connections will help to eliminate the issue and ensure the structural integrity and safety of the stairs. If required, additional reinforcement or repairs should be carried out to prevent further deterioration.

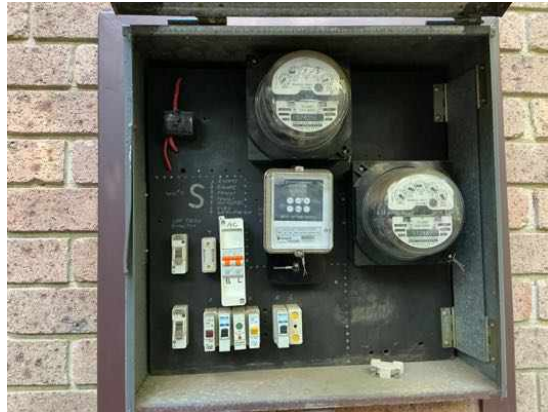
Information: The application of a post-construction chemical termite barrier is strongly recommended for all properties, especially if there has been any history of live termite activity on-site. These barriers are highly effective in protecting timber building elements throughout the property by preventing termite attacks. It is also advisable to install a durable notice within the switchboard unit, indicating the presence of any termite barriers for future reference.

During the inspection, there was no indication that a termite management system had been installed, nor was there any evidence to suggest that preventative measures had previously been undertaken. The client is encouraged to seek further advice from a licensed pest controller regarding the costs and procedures involved in the application of a termite barrier. Prioritizing this step in the short term is strongly advised to ensure long-term protection.

Additionally, the client may want to consult with the vendor to determine whether regular Timber Pest inspections, as per AS4349.3 or AS 3660.2, have been conducted in the past. This will provide further insights into any past termite management practices and help inform the appropriate course of action.

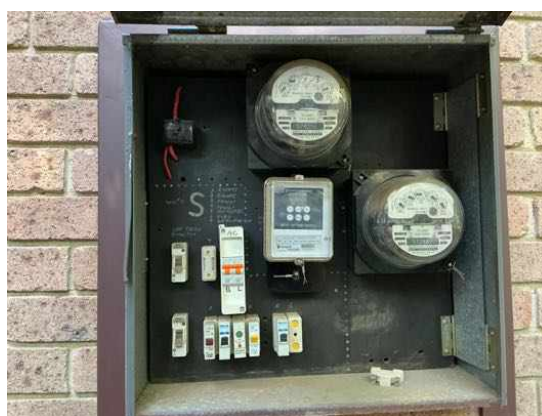
Noted Item

Building: Main Building
 Location: Meter Box
 Finding: Termite Management Recommendation – No Evidence of Chemical Installation
 Information: At the time of inspection, there was no visible evidence of a chemical termite management system installed around the property. Chemical barriers are a key component of termite protection and are particularly important in preventing concealed termite entry into timber elements of the structure.

In accordance with standard requirements, a durable notice should be located within the electrical switchboard to detail any termite protection systems applied, including chemical treatments. No such notice was observed during the inspection.

It is recommended that the client engage a licensed pest controller to assess the suitability of installing a chemical barrier, and to provide advice on associated costs and procedures. This should be considered a short-term priority, particularly if the property has any history of termite activity or is located in a high-risk area.
