Building and Timber Pest Inspection Report

Inspection Date: Tue, 17 Mar 2026

Property Address: 310/26-32 Marsh St, Wollie Creek NSW
2205, Australia

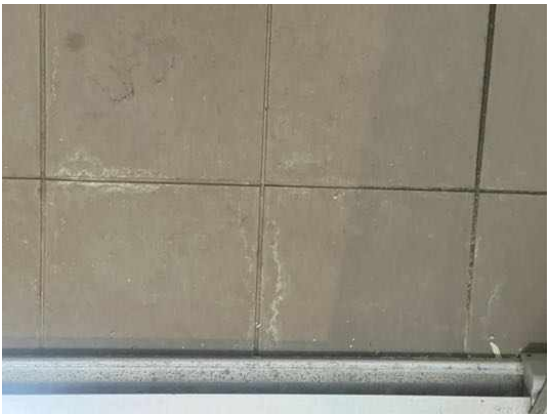
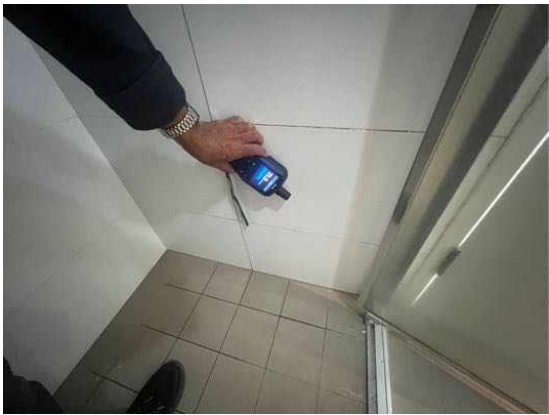
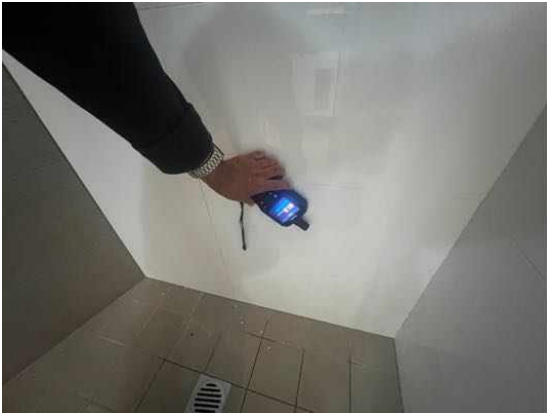
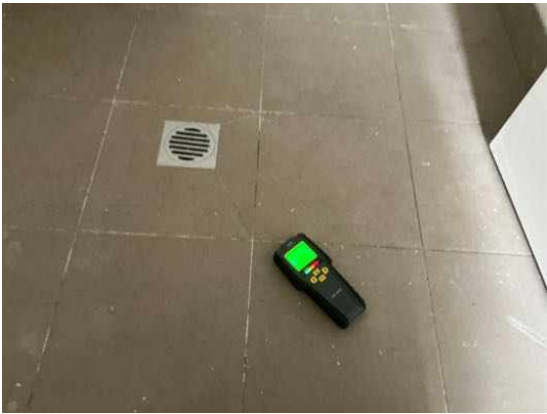
Building: Main Building
Location: Bathrooms, Laundry
Finding: Elevated Moisture Bathroom
Information: Elevated moisture levels were detected to tiled surfaces in bathroom/shower areas and laundry with minor deterioration also present at the time of inspection. Persistent moisture ingress can lead to concealed damage.

Elevated moisture readings in tiled wet areas can occur from normal shower use, age/deterioration of waterproofing membranes, plumbing leaks or moisture absorption through grout lines. While no damage was visible, elevated readings may indicate moisture retention behind tiles, which can be a conducive condition for future deterioration if not monitored.

A further inspection by a licensed waterproofing specialist is recommended to determine cause of elevated moisture (e.g., pressure testing, membrane assessment) and advise remedial actions.

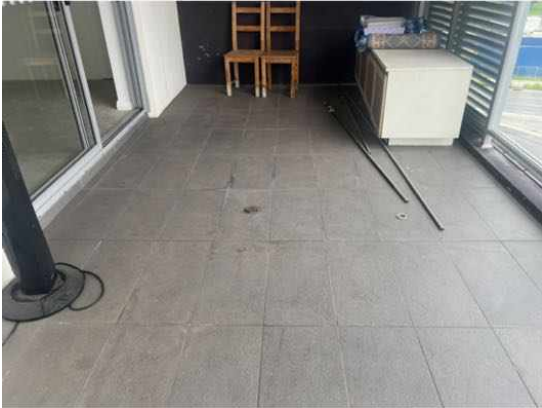
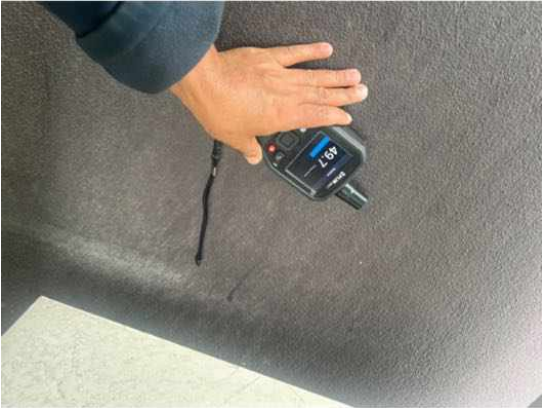
Finding 3.02

Building: Main Building
Location: Balcony
Finding: Balcony Elevated Moisture - Strata
Information:

Elevated moisture was recorded at the base of the balcony wall and tiles, with associated staining consistent with water exposure. While no internal damage was visible at the time of inspection, balconies in multi-unit dwellings are high-risk areas for waterproofing failure, which can lead to leaks into adjoining units and significant rectification costs. Further investigation by a licensed waterproofing contractor is strongly recommended.

Depending on the strata plan, this area may form part of the common property, in which case remedial responsibility may rest with the owners corporation (strata). Purchasers should seek clarification from the strata manager and legal adviser prior to purchase.

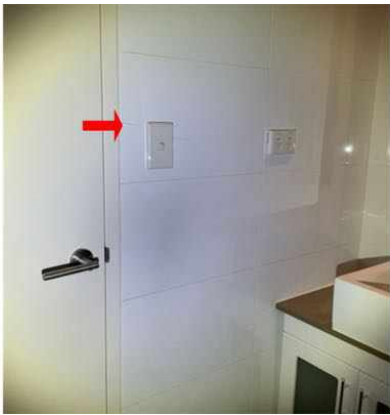
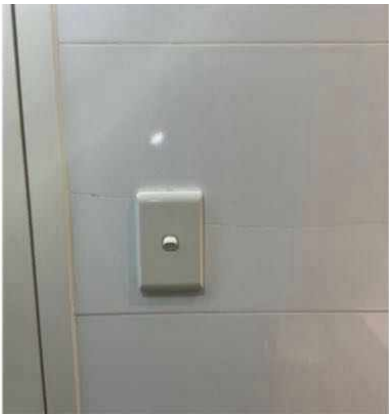
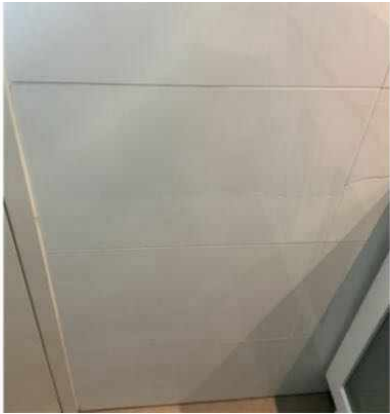
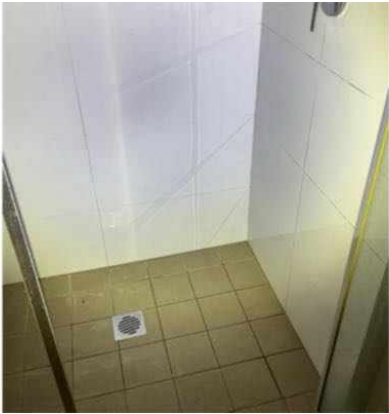
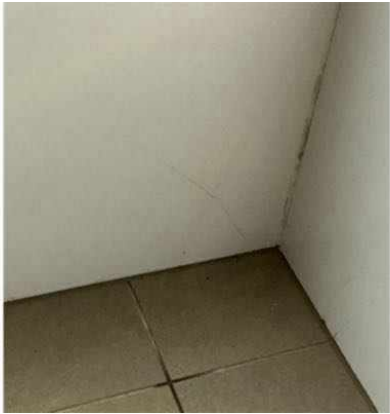
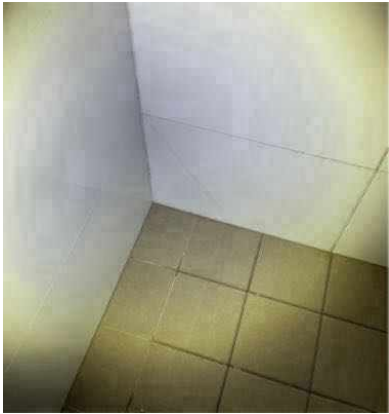
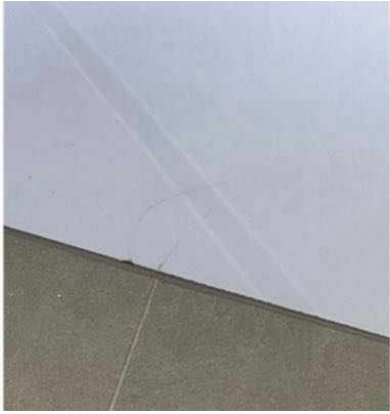
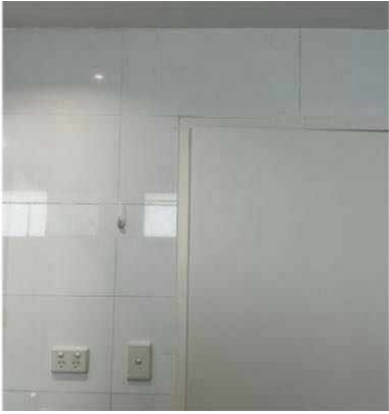
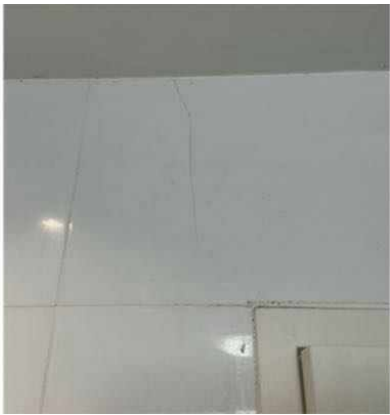
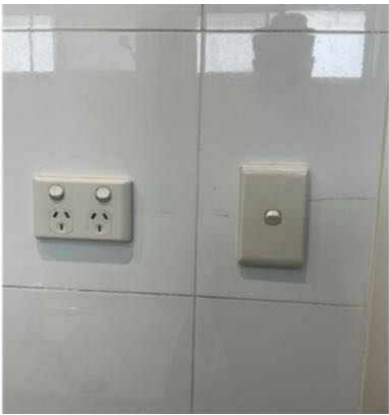
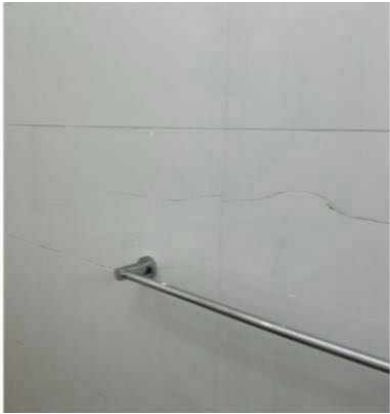
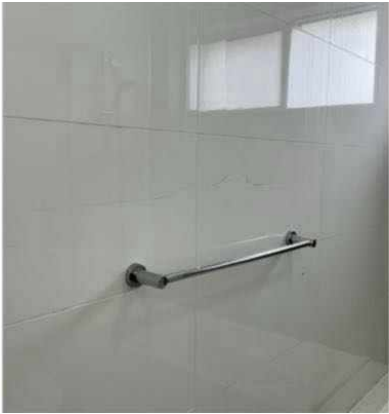
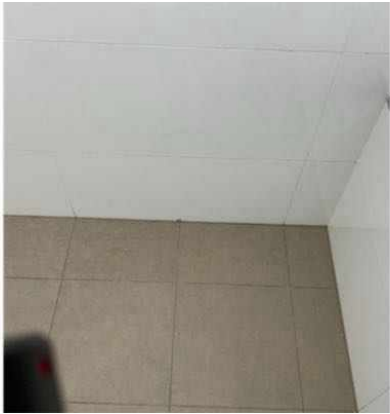
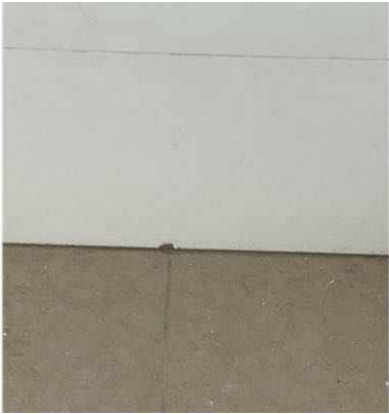
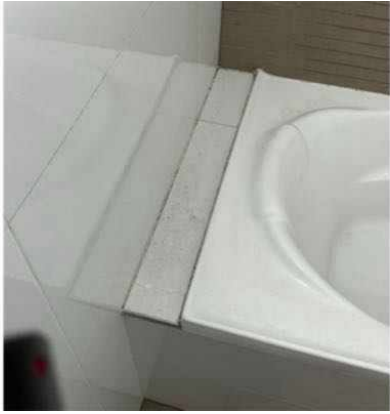
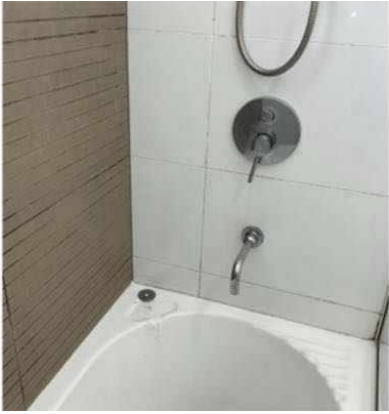
Finding 3.03

Building:	Main Building
Location:	Ensuite, main bath , laundry, balcony , front entrance , balcony
Finding:	Tiles - Cracked or damaged
Information:	Cracking was evident to the tiling in this area at the time of inspection. While the cracking appears to be minor, this area is frequently exposed to water, allowing potential for water penetration into adjoining sections of walls or flooring.

If left unmanaged, water penetration to these areas may lead to subsequent water damage, which is likely necessitate repair work to affected building elements.

A tiling contractor should be appointed to ensure that no further water damage occurs. The re-application of silicone and grouting throughout remaining tile work is also advised, to further protect the area against water penetration.

Where water penetration has led to water damage, appointment of a relevant tradesperson may be required to repair damaged building elements.

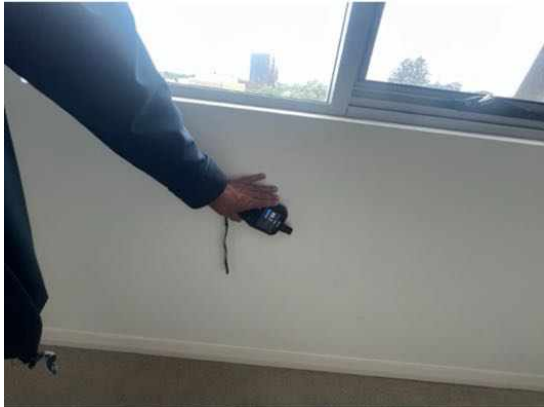
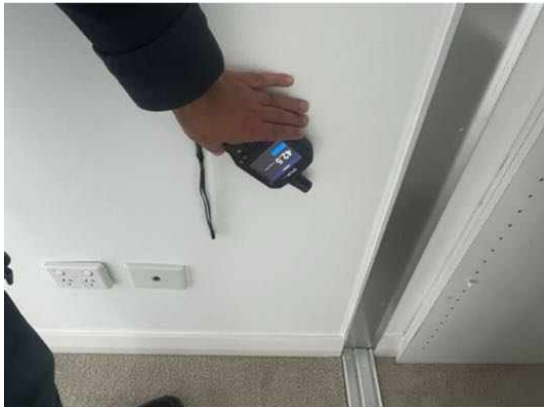
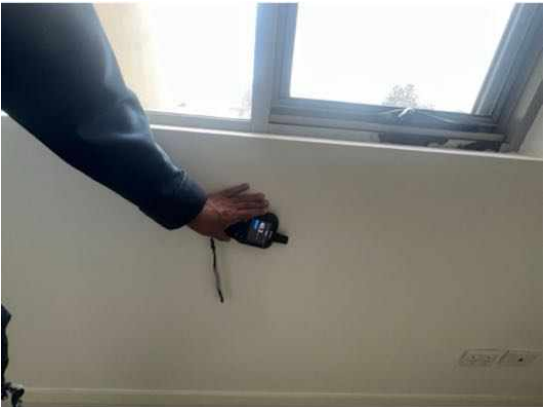
Finding 3.04

Building: Main Building
Location: All Internal Areas. Bedroom wall and window reveals
Finding: Elevated moisture - No visible deterioration
Information: Elevated moisture meter readings were recorded to the wall bases and window reveals when tested using a non-invasive (pinless) moisture meter. No visual evidence of moisture ingress, staining, mould growth, or related moisture damage was observed at the time of inspection. Ongoing monitoring is recommended, and further investigation by a strata appointed licensed plumber is recommended.

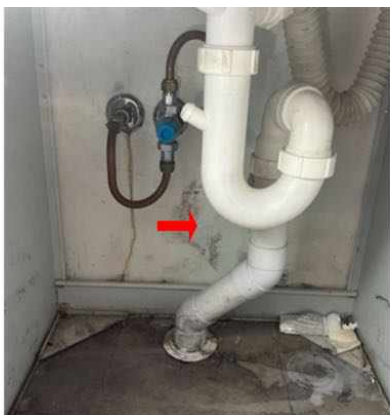
Finding 3.05

Building:	Main Building
Location:	Laundry
Finding:	Minor Mould Growth
Information:	Minor mould growth was observed to the laundry. The exact cause could not be confirmed due to the non-invasive nature of the inspection. Cleaning, improved ventilation, and ongoing monitoring are recommended. A further investigation by a licensed plumber is advised.

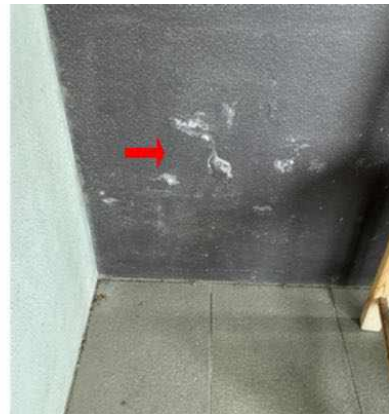
Finding 3.06

Building:	Main Building
Location:	Balcony
Finding:	Painted surface - Bubbling
Information:	Sections of paint in this area was found to have bubbled and deteriorated. Paint bubbling is generally an indication of excessive moisture in the area, that is currently hidden by the painted surface.

The presence of excessive moisture can have major implications on associated building elements if left unattended. While only seemingly minor at this stage, the damage cannot be determined due to the paint obstructing any further inspection of the damage.

It is highly advised that the affected paint be cleaned to allow a further, more invasive inspection by a licensed plumber. Failure to act on this defect may necessitate major works in the future.

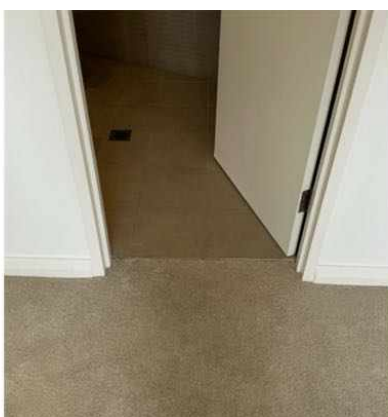
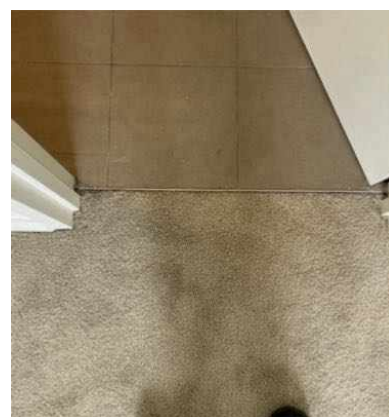
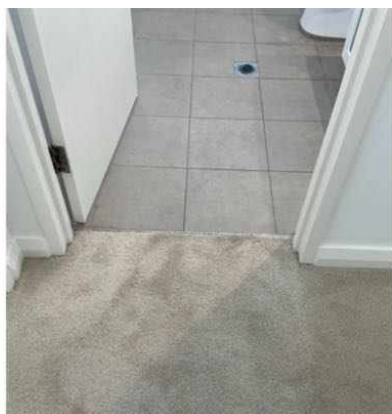
Finding 3.07

Information: The bathroom floor is at the same level as the adjoining timber flooring. This configuration is typical in modern apartments and is permitted where compliant waterproofing and floor falls are provided. No evidence of moisture damage was observed at the time of inspection; however, waterproofing performance cannot be confirmed without invasive inspection.

Care should be taken to avoid excessive water migration beyond the bathroom during use.

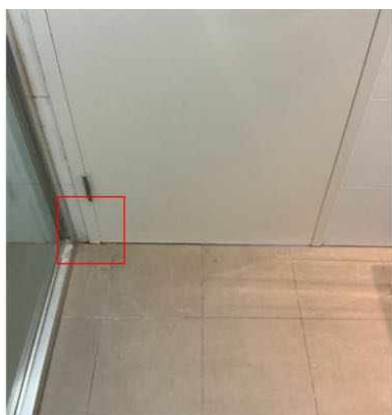
Finding 3.08

Building:	Main Building
Location:	Ensuite
Finding:	Wet-Area Door Jambs – Moisture Staining / Decay
Information:	moisture staining and deterioration were observed at the base of the wet-area door jamb and architraves. This is commonly due to water splashing or moisture tracking from the bathroom floor into adjacent joinery or inadequate waterproof transition at the bathroom threshold.

Further inspection by a licensed waterproofing contractor is recommended to verify exact cause and remedial measures.

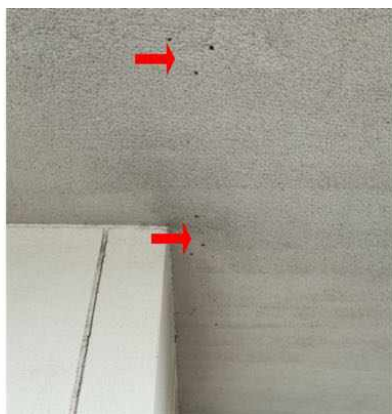
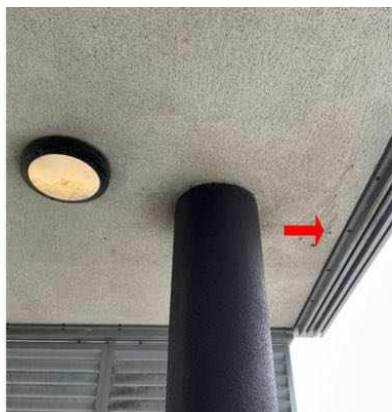
Finding: Rust Staining - Balcony soffit

Information: The marks appear consistent with historic screw penetrations and minor rust staining through paint. No symptoms of concrete spalling was observed. Recommend the Owners Corporation engage a painter or remedial contractor to seal any exposed steel and apply an appropriate external-grade coating during routine maintenance. If moisture staining worsens or cracking develops, further investigation by a remedial engineer is advisable.

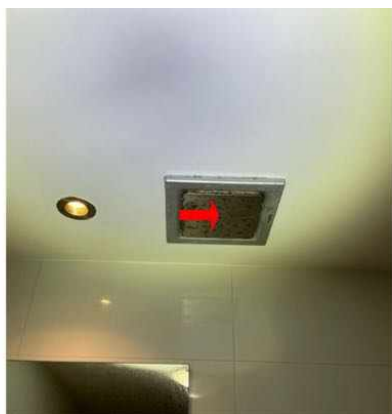
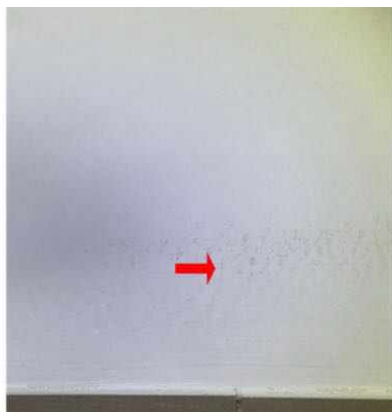
Finding 3.11

Building:	Main Building
Location:	Ensuite
Finding:	Water Staining - Humidity or Ventilation
Information:	The ceiling surface shows peeling paint and water staining on the walls faint commonly consistent with humidity-related staining, often found in bathroom or wet areas with insufficient ventilation. While there is no visible sagging or major water damage, the pattern suggests prolonged moisture exposure, possibly due to steam accumulation or minor condensation issues. According to AS 4349.1–2007 (Appendix C), this would be classified as a minor defect unless further deterioration or active leaks are found. Recommend improving mechanical or natural ventilation, cleaning the surface with mould treatment, and monitoring for recurrence.

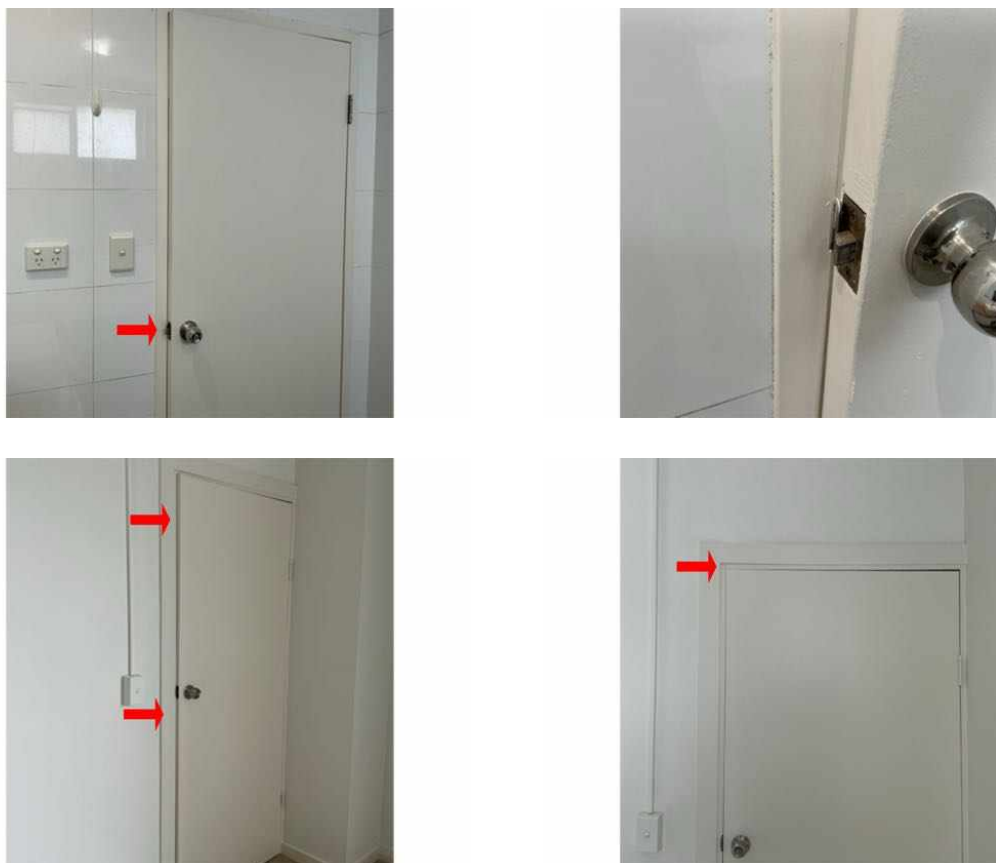
Finding 3.12

Building:	Main Building
Location:	Bathroom , bedroom right side
Finding:	Door - Binding/jamming
Information:	Binding and/or jamming of this door is evident during standard operation. This defect inhibits the functionality of the affected door as well as creating potential for secondary defects to associated building elements, such as damage to the floor covering.

A door that binds to flooring or to the associated door frame may have several causes, ranging from minor defects, such as poor installation of the door or deteriorated hinges, through to major structural issues, such as damage to subfloor structures.

Where door binding/jamming appears to indicate major structural issues, a registered builder specialising in re-stumping should be appointed to provide an estimate on the cost of rectification.

For minor causes, a qualified carpenter or general handyperson should be appointed to perform minor rectification works at client discretion.

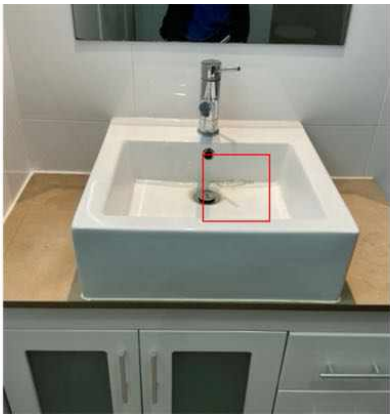
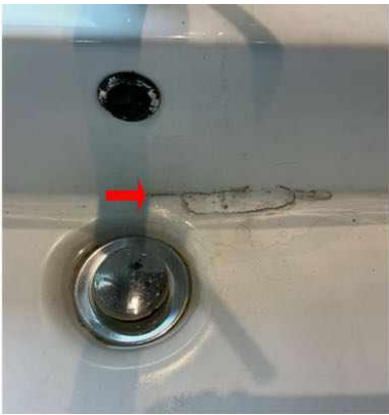
Finding 3.13

Building:	Main Building
Location:	All Internal Areas
Finding:	Building element - Damaged - Ensuite basin damaged , vanity chipped ensuite , mirror desilvering ensuite and bathroom , kitchen cabinets scratches, minor chips on kitchen top
Information:	Breakage occurs generally when the building materials have either aged and decayed, or as a result of damage (accidental or deliberate).

Repair and/or replacement of broken elements is advised to ensure that additional secondary defects do not arise as a consequence. Such works are necessary, as all building elements play a key role in the operation and function of the overall structure and its performance.

A relevant tradesperson should be appointed to repair or replace the affected building element prior to any subsequent damage being caused.

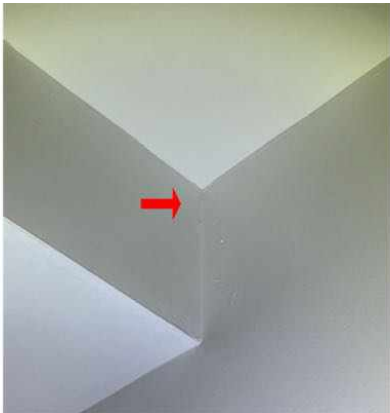
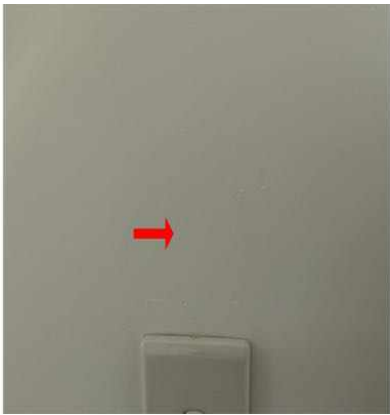
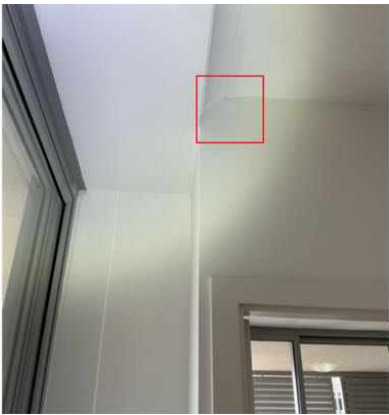
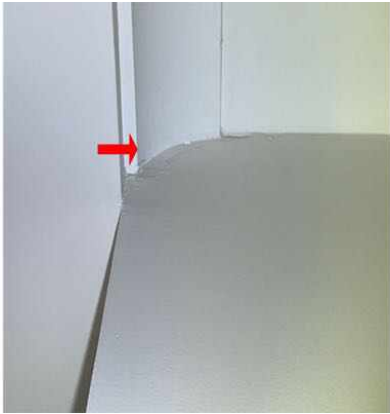
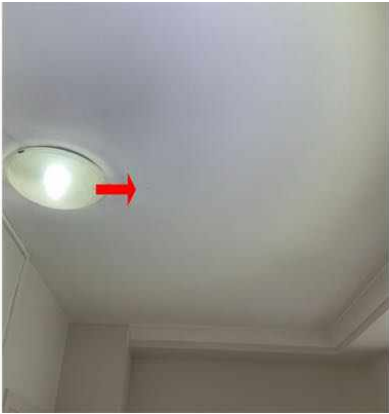
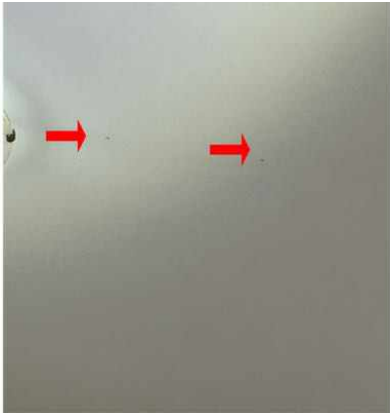
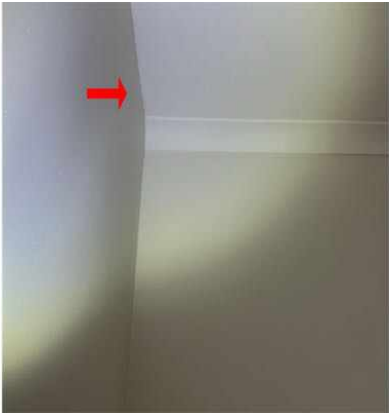
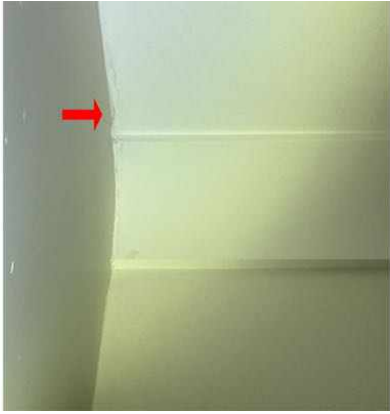
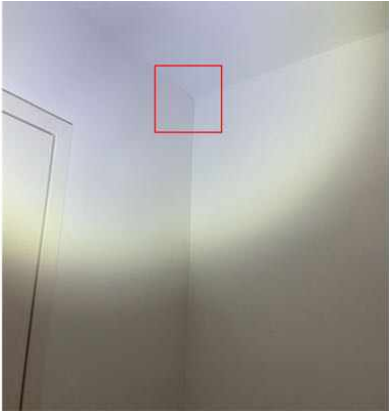
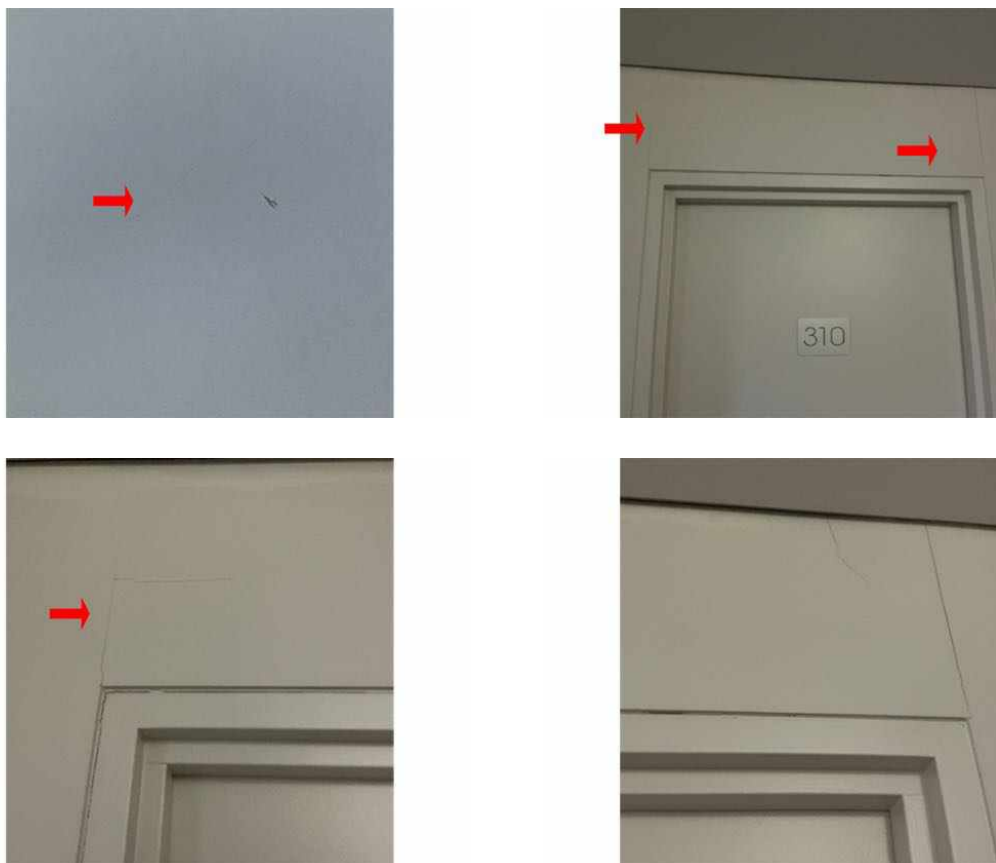
Finding 3.14

Building: Main Building
Location: All Internal Areas
Finding: Paint finish and hairline cracking
Information: The paint finish in this area was identified as being incomplete at the time of inspection including some hairline minor cracking.

Whilst incomplete or missing paint finish is generally an appearance defect, it can also lead to the development of secondary building defects over time. Incomplete areas of paint finish expose the area to moisture, potentially accelerating the deterioration of underlying building materials.

Incomplete paint finishes should be sanded back, filled, leveled and painted, as applicable. Where inadequate or missing paint protection has led to the deterioration of the associated building element, repair and/or replacement of this building element may be required.

A painting contractor should be appointed as soon as possible to perform necessary works to aid the appearance of the affected area and to ensure the area is protected against further deterioration. Alternatively, the homeowner following manufacturer instructions may perform these works.

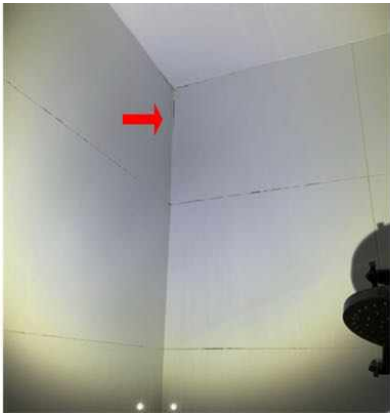
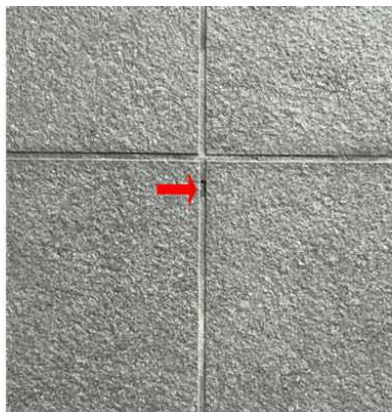
Finding 3.15

Building:	Main Building
Location:	All Internal Areas & balcony
Finding:	Sealant and grouting - Missing or degraded
Information:	It was noted on inspection that sealant or grout is degraded. There is also evidence of poor workmanship and excessive use of sealant. Silicone should never be used as a first line of defence against waterproofing. Further inspection by a licensed waterproofing contractor is highly recommended.

Different materials and floor areas move at different rates, generally causing cracking to grout or sealant at this point. A flexible sealant is required to allow for expected expansion and contraction, while keeping the joint water tight and protective of all associated building materials.

There appears to be excessive mould to the sealant and grout which will likely require scraping out and replacement.

Flexible and mould resistant materials should be applied to affected areas to prevent any subsequent water damage that is likely to occur. Regular maintenance and replacement of damage or missing or damaged sealant and grout is highly recommended to the wet areas, as this is a regular wear and tear defect. Sealant and grouting in areas that come into regular contact with water should be maintained for the long term care of your property.

A sealant specialist or tiling contractor should be appointed to complete these works as soon as possible

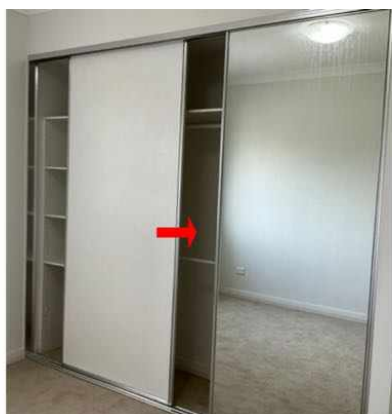
Finding 3.16

Building:	Main Building
Location:	Bedroom
Finding:	Building element - Missing - BIR door missing and one still to slide
Information:	Although some building elements may seem irrelevant or unnecessary, all building elements play a key role in the operation and function of the overall structure and its performance.

Replacement of any missing building element should be conducted as soon as possible to ensure that no damage or functional issues occur to associated building materials.

The appropriate tradesperson should be appointed as soon as possible to replace the missing building element.

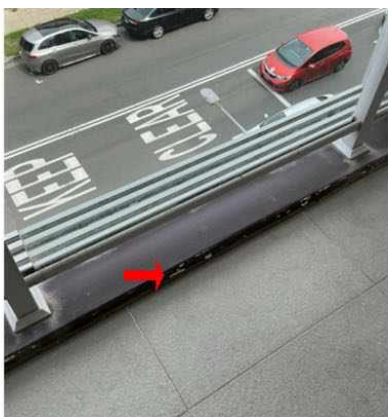
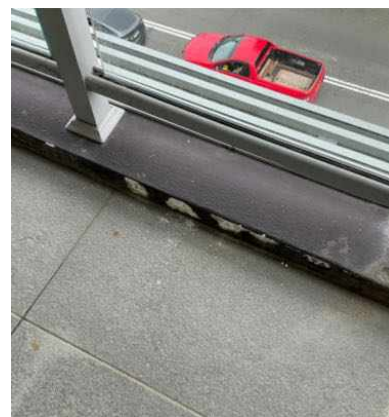
Finding 3.17

Building:	Main Building
Location:	Balcony
Finding:	Building element - Damaged - Render damaged and moisture staining
Information:	Breakage occurs generally when the building materials have either aged and decayed, or as a result of damage (accidental or deliberate).

Repair and/or replacement of broken elements is advised to ensure that additional secondary defects do not arise as a consequence. Such works are necessary, as all building elements play a key role in the operation and function of the overall structure and its performance.

A relevant tradesperson should be appointed to repair or replace the affected building element prior to any subsequent damage being caused.

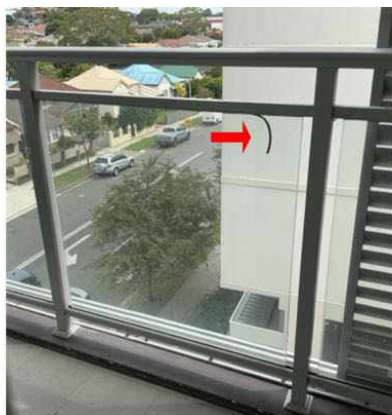
Finding 3.18

Building:	Main Building
Location:	Balcony
Finding:	Building element - Damaged - Balustrade seals coming off to some areas
Information:	Breakage occurs generally when the building materials have either aged and decayed, or as a result of damage (accidental or deliberate).

Repair and/or replacement of broken elements is advised to ensure that additional secondary defects do not arise as a consequence. Such works are necessary, as all building elements play a key role in the operation and function of the overall structure and its performance.

A relevant tradesperson should be appointed to repair or replace the affected building element prior to any subsequent damage being caused.
