Building and Timber Pest Inspection Report

Inspection Date: Thu, 12 Feb 2026

Property Address: a305/147 Great Western Hwy, Mays Hill
NSW 2145, Australia

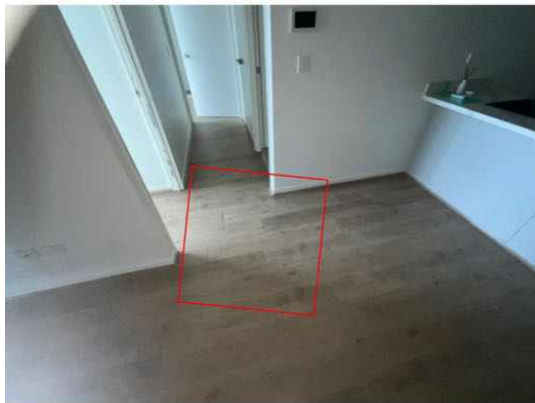
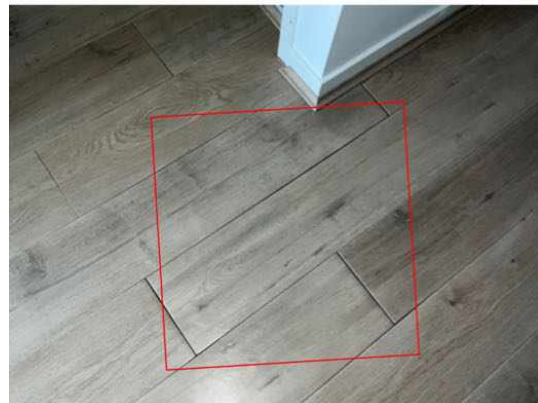
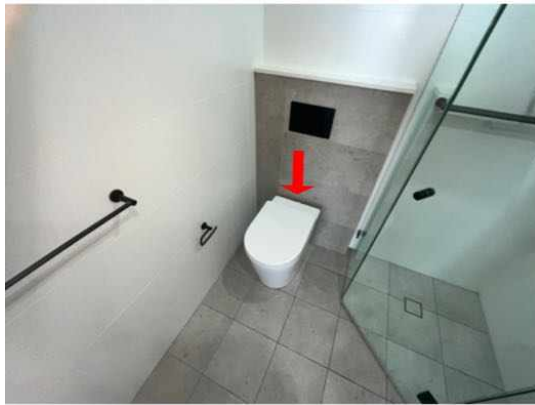
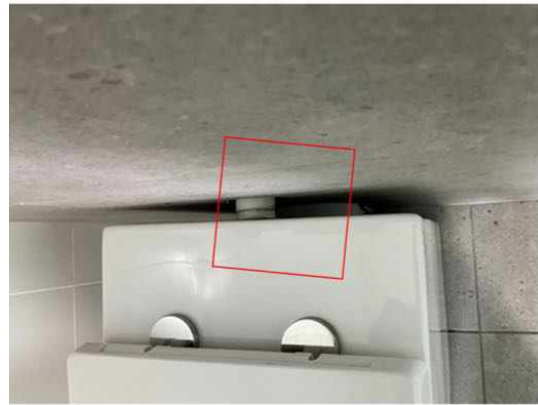
Finding 3.01

Building: Main Building
Location: Hallway, ensuite
Finding: Incomplete or substandard works
Information: The works to this area appear to be incomplete or have been completed to a substandard level.

Works that have not been completed to a satisfactory level create potential for the development of building defects and may impede on the safety and integrity of the overall structure.

It is highly recommended that the relevant trades be appointed to complete these works and ensure the safety of the area and the longevity of all associated building elements.

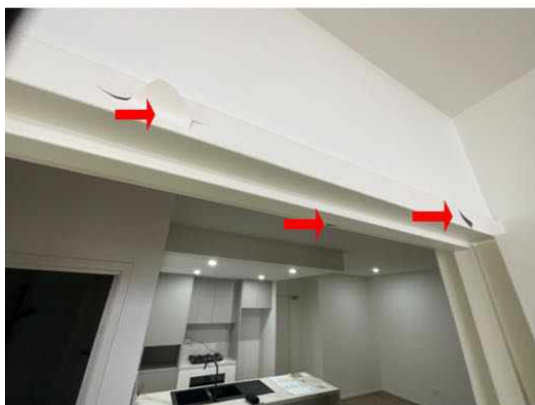
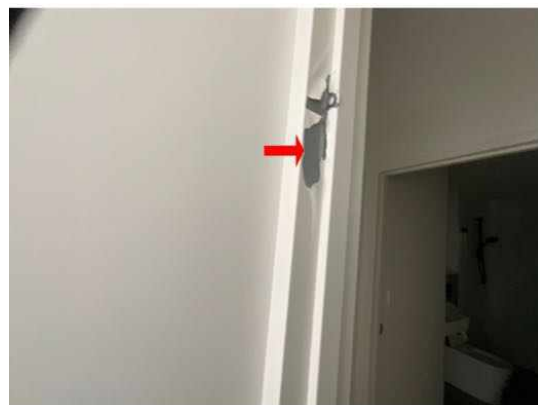
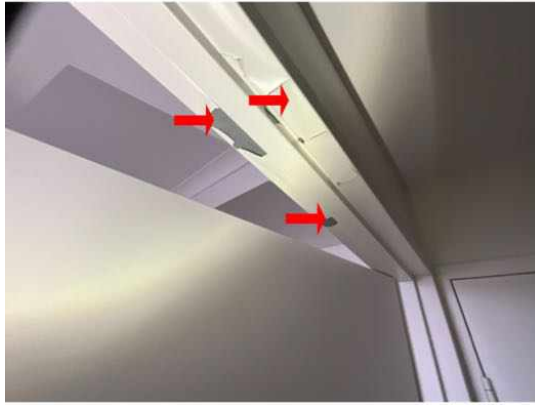
Finding 3.02

Building:	Main Building
Location:	Multiple door frames
Finding:	Paint cracking and peeling
Information:	Cracking and ultimately flaking of paint can occur for a variety of reasons. Often these failures are due to the fact that the paint has inadequate adhesion and flexibility, both common problems with lower quality exterior flat paints.

When timber is involved, moisture intrusion results in swelling of the wood surface followed by contraction as the wood dries. The expansion and contraction cycles, can result in cracking and subsequent paint failure by flaking and peeling.

Cracking and flaking can also result when paint is applied too thinly due to overspreading (higher-than-recommended spread rate) or excessive thinning. These practices tend to diminish the paint's final film thickness, so that it is more vulnerable to cracking and flaking.

Inadequate surface preparation can also cause these failures, especially when paint is applied to bare wood or a very porous surface without first applying a primer.

A qualified painter should be appointed to rectify the problem.

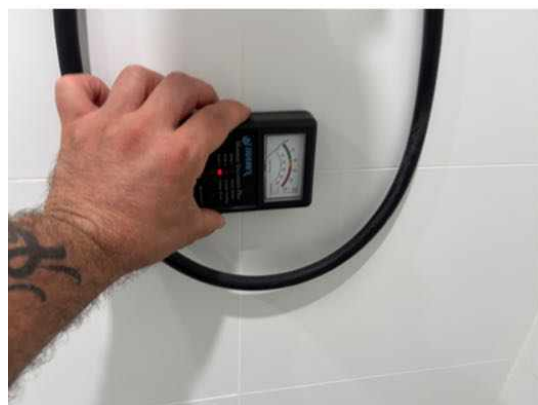
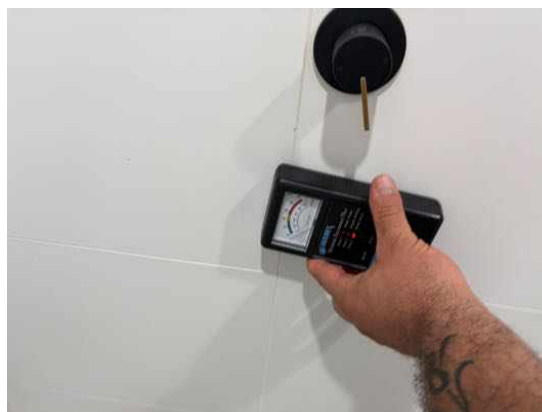
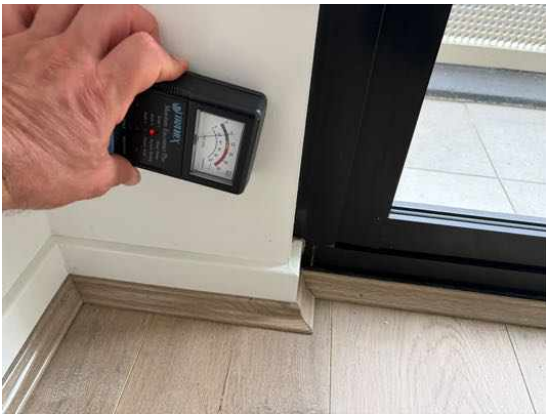
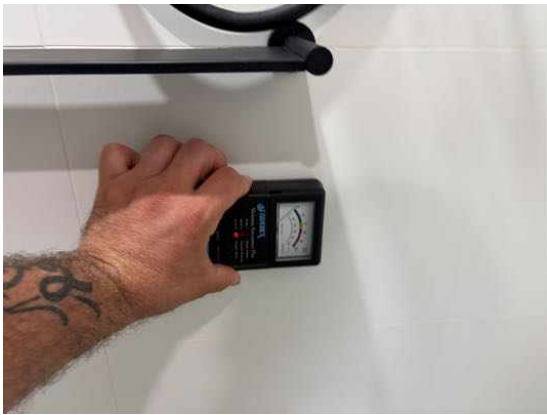
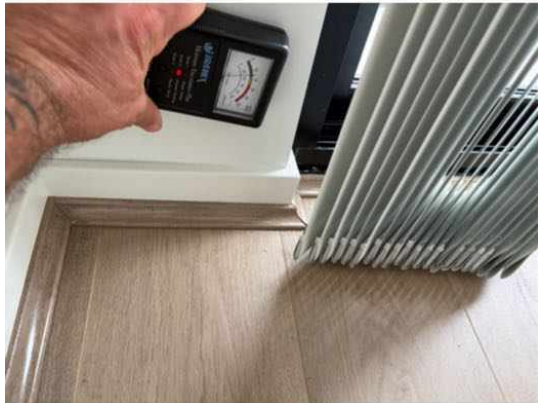
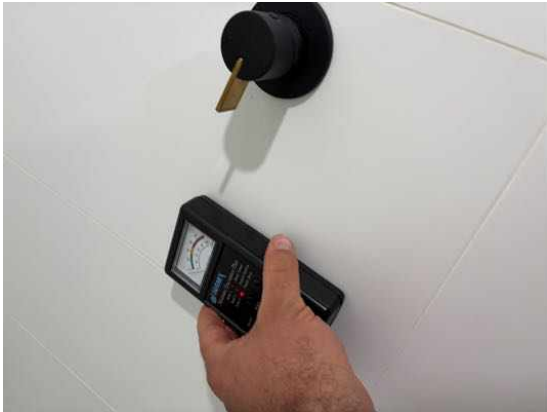
Building: Main Building
Location: All Areas
Finding: Moisture metre
Information: During the inspection the property was checked for moisture using a moisture metre.

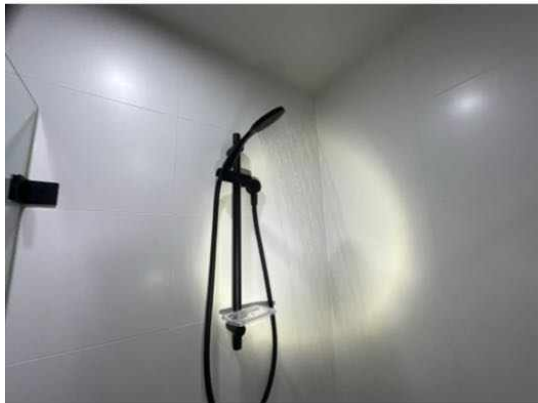
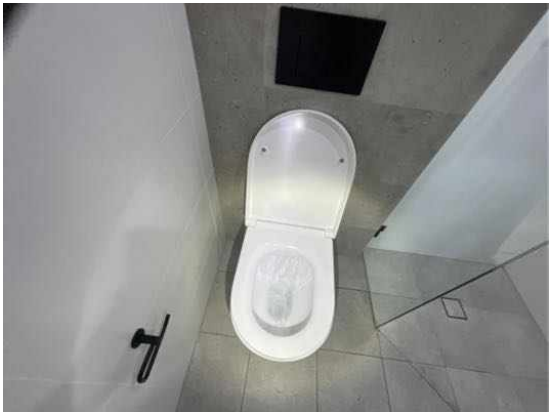
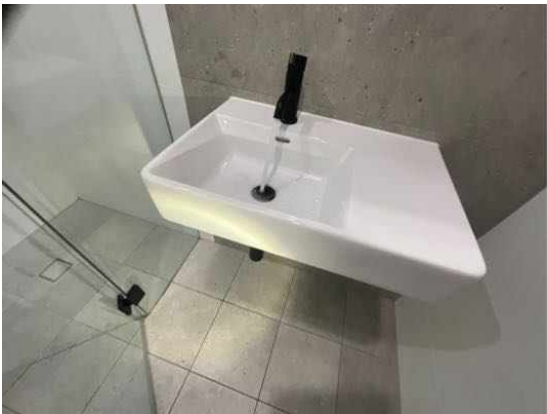
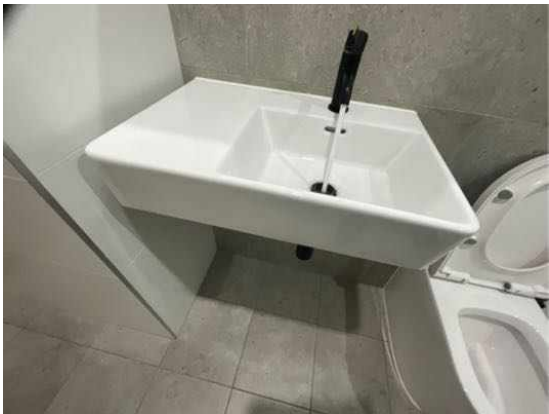
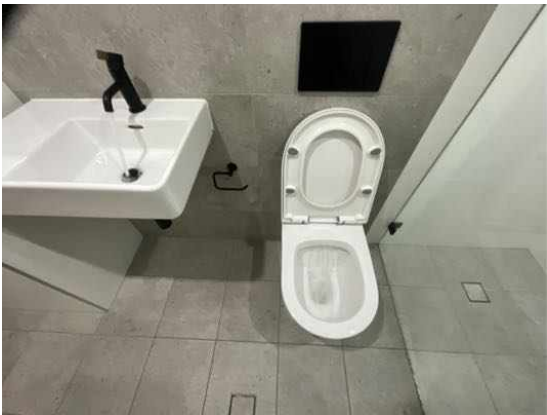
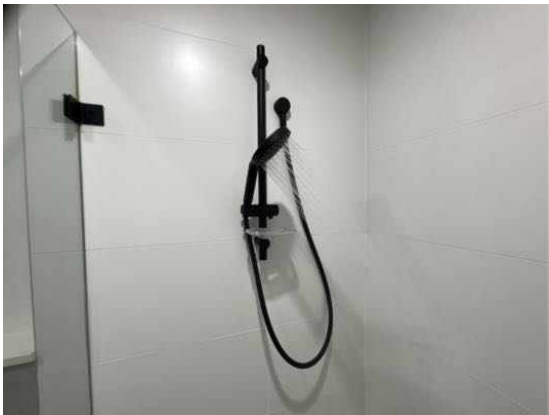
Building: Main Building
Location: All Wet Areas
Finding: Waterproofing
Information:

All taps, mixers and toilets were tested for operation, except for those obstructed. The waterproofing to the shower recess was assessed by checking the walls in and around the shower recess for varying moisture content. There were no significant variations across the tested areas. No sign of recent water damage was evident upon a visual inspection of the surrounding walls, where the visual nature of the inspection was possible.

Consequently, there is no conclusive evidence of any current shower recess leakage other than those which may have already been mentioned earlier in this report. It is reasonable to assume the shower waterproofing is sound. Note that if the shower is not used, or has not been used for some time, moisture readings would not vary significantly and this can lead to erroneous results. It is not possible under the visual inspection criteria (under which a prepurchase inspection is carried out) to categorically determine if there are leaks. If a more accurate assessment is required, a special purpose inspection should be requested. Alternatively, the assumption should be made that the shower may leak.
