Building and Timber Pest Inspection Report

Inspection Date: Tue, 3 Mar 2026

Property Address: 270 King St, Mascot NSW 2020, Australia

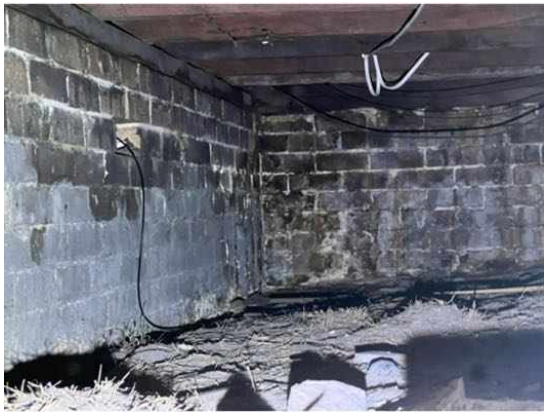
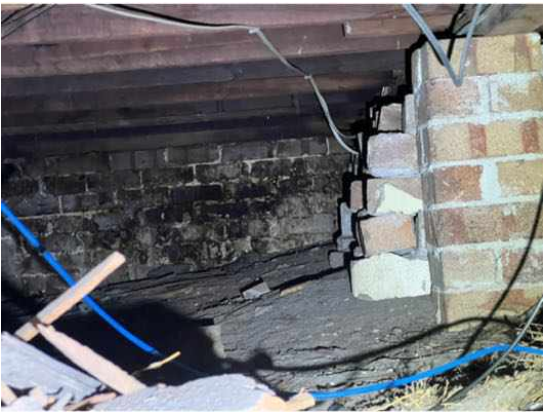
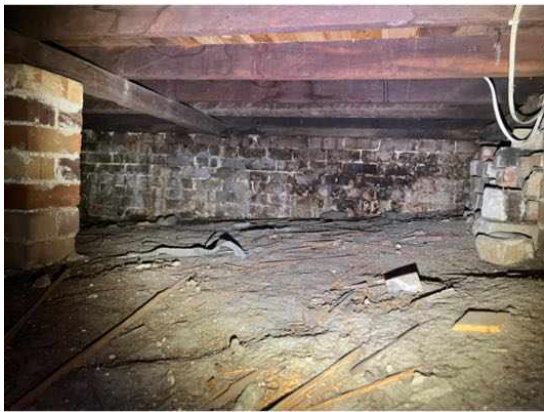
Building:	Main Building
Location:	All External Areas
Finding:	Damp - Also see Defect 3.1
Information:	Damp (or structural damp) refers to the presence of unwanted moisture in the structure of a building, either as the result of intrusion from outside, or condensation from within the structure. Generally, structural damp is caused by rain penetration, rising damp, and leaks from plumbing pipes.

Unmanaged damp facilitates the formation and development of mould, fungi growth and wood rot, decaying associated building materials and compromising their structural integrity. Damage to finishes is also likely to occur, including lifting, bubbling, peeling and staining of paint, plaster and wallpaper.

Consultation with a qualified plumber is advised immediately to identify the cause of damp and perform remedial works as required. Where excessive mould growth is present, further inspection by a specialist environmental health inspector should also be considered.

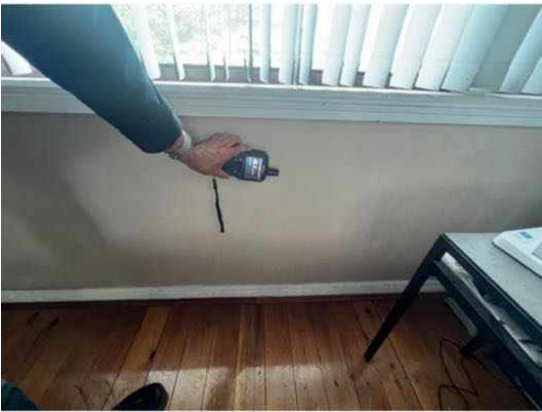
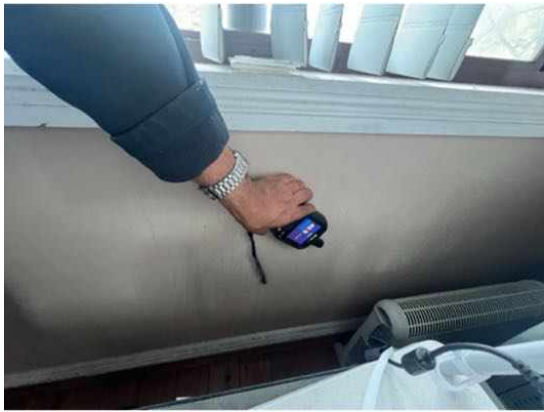
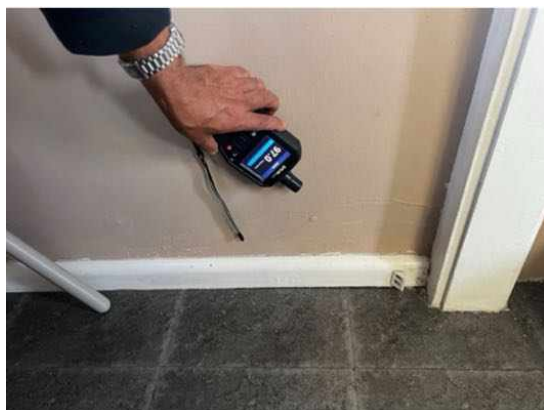
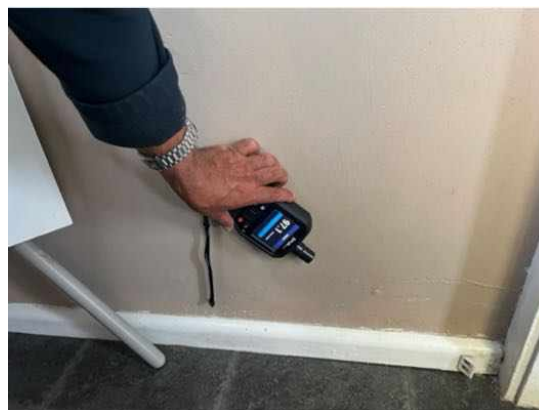
Finding 3.01

Building: Main Building
Location: Toilet (WC), front
Finding: Elevated Moisture – Further Investigation Recommended possible damp
Information: Elevated moisture readings were detected in several locations, with some areas also showing signs of dampness while others did not present visible surface issues, although no significant structural damage was evident at the time of inspection, dampness can contribute to deterioration if left unaddressed. A further investigation by a licensed plumber or waterproofing specialist is recommended to confirm the source and ensure no concealed issues are developing.

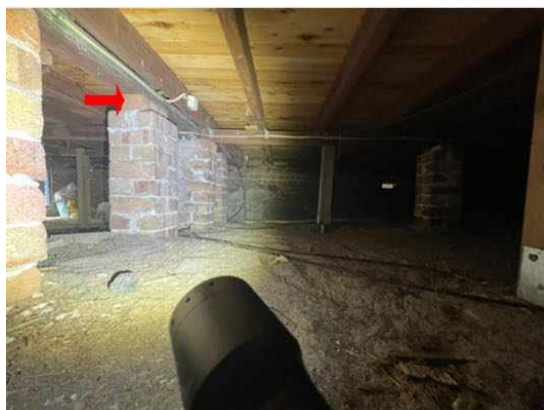
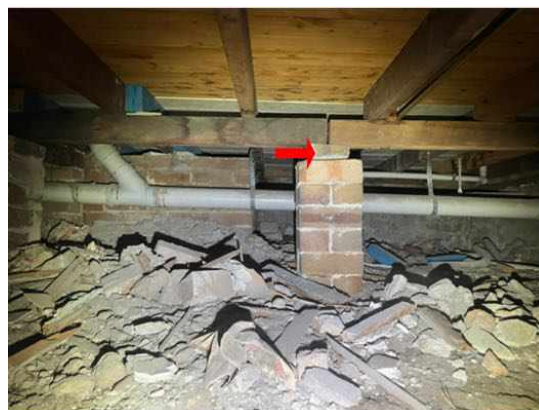
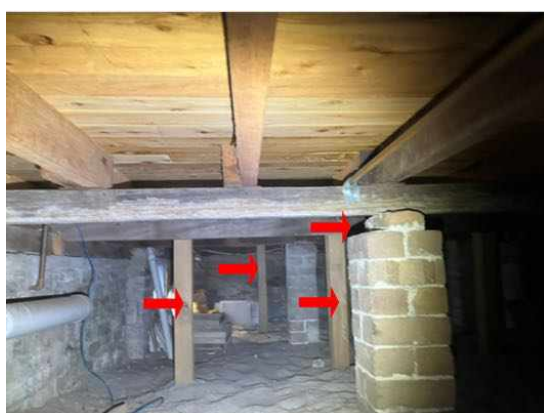
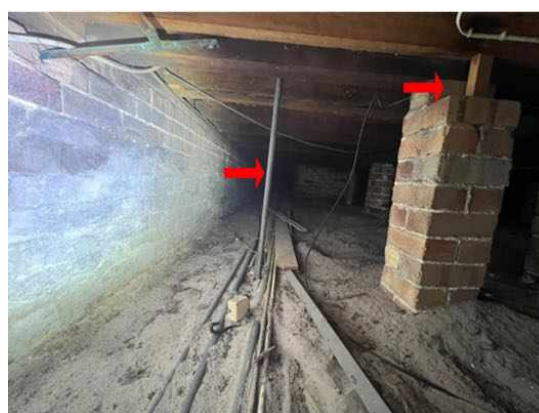
Building:	Main Building
Location:	Subfloor
Finding:	Subfloor - Packers (Further investigation recommended)
Information:	Subfloor brick pier exhibits minor displacement and uneven bearing beneath the timber bearer, with packing pieces and additional timber supports visible between the pier and framing. The load transfer appears irregular, and the presence of loose or improvised packing suggests previous adjustment to compensate for settlement or movement. While no immediate structural failure is evident, the condition indicates minor movement and may contribute to uneven floor levels or localised deflection over time. Recommend monitoring for further movement and consideration of re-levelling or

installation of solid, non-compressible packing or proper pier rectification by a licensed builder if movement progresses.

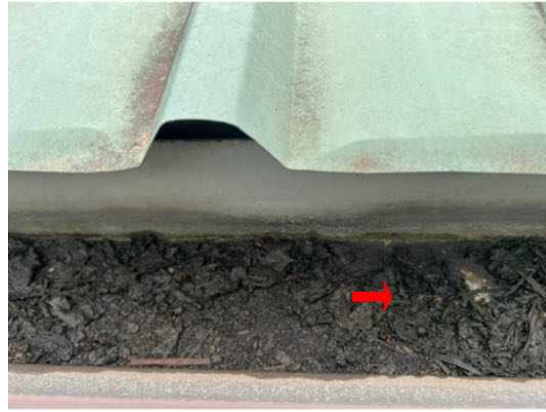
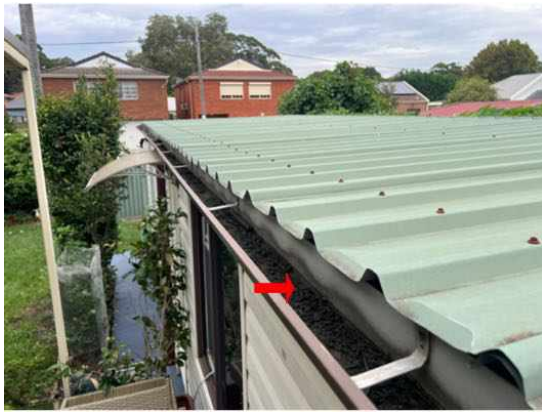
Blocked gutters are likely to lead to high levels of moisture in the affected areas. Such moisture will not only cause rust and decay of the associated building materials, but can also provide conditions that are conducive to termite and timber pest activity. Blockages in gutters should therefore be removed immediately to ensure dry conditions are maintained.

Consult a Licensed Plumber for further specific advice on remedial works that may be required. In the interim, it is highly advised that blocked gutters be removed by the homeowner or a general handyperson as a matter of urgency.

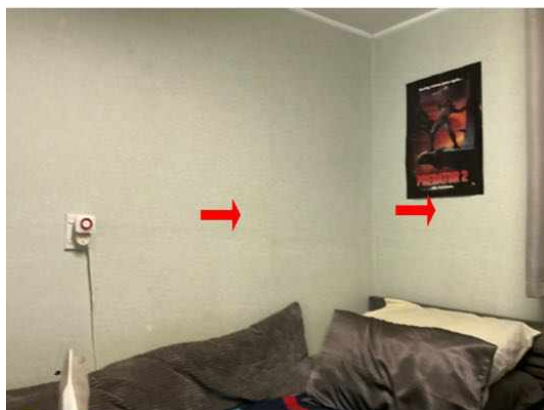
Finding 3.11

Building:	Main Building
Location:	All External Areas - Rear Garage
Finding:	Incomplete or substandard works - Poor workmanship - ceiling and wall paper
Information:	The works to this area appear to be incomplete or have been completed to a substandard level.

Works that have not been completed to a satisfactory level create potential for the development of building defects and may impede on the safety and integrity of the overall structure.

It is highly recommended that the relevant trades be appointed to complete these works and ensure the safety of the area and the longevity of all associated building elements.

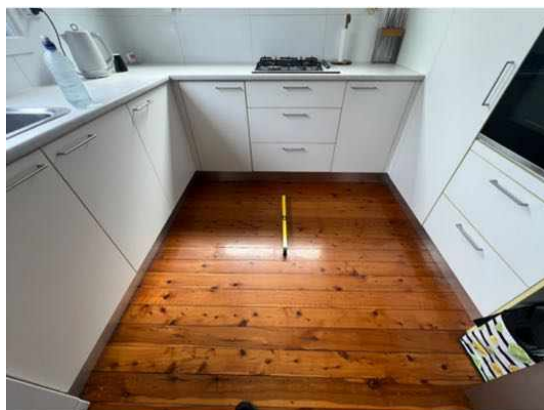
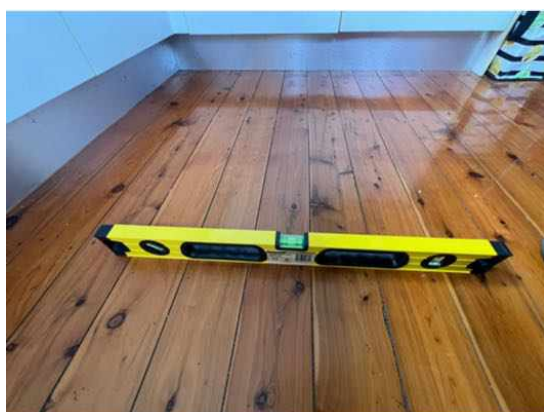
Building:	Main Building
Location:	All Internal Areas
Finding:	Flooring - Uneven to some areas
Information:	The internal flooring in this area is out of level and uneven. Uneven flooring is likely to indicate minor defects such as expected movement of the foundations of the property, but may also indicate subsidence of the associated subfloor stumps.

It is advised that the flooring be closely monitored to identify any further movement. Where flooring remains relatively unchanged for an extended period of time (i.e. several months), it is likely that this defect has been caused by expected movement of the foundations of the property.

However, where flooring is uneven further, potentially invasive inspection of the subfloor structures and stumps in this area is required. In this case, works to repair are likely to be required, and would be carried out by a registered builder specialising in re-stumping.

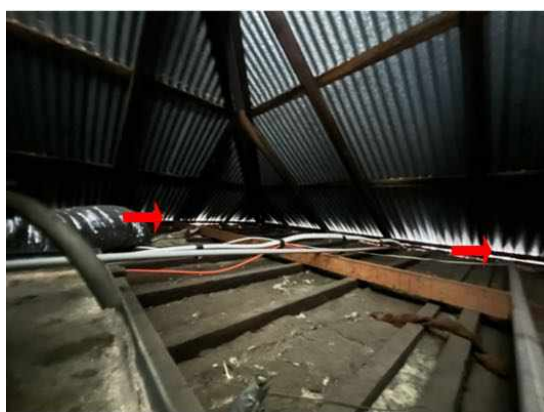
Building:	Main Building
Location:	Roof Void
Finding:	Roof Void – No Sarking & Light Ingress
Information:	Light ingress is visible through multiple roof tile laps, which is typical of older tile roofs without sarking and may allow minor wind-driven moisture or dust into the space, though no active leaks were observed.

Consider retrofitting sarking or roof wrap in the future to improve thermal and moisture performance.

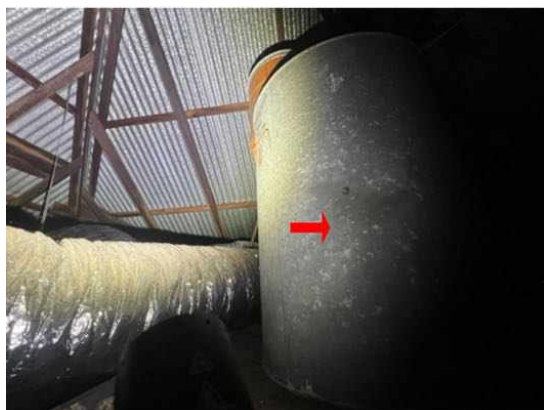
Finding 3.25

Building:	Main Building
Location:	Roof Void
Finding:	HWS - Gravity Fed (rusted)
Information:	A galvanised hot water storage tank is present in the roof void. Tanks of this type are typically part of older gravity-fed systems, many of which have since been decommissioned when properties were upgraded to mains pressure hot water. A licensed plumber should access whether the tank and advise on decommissioning or upgrading as necessary.

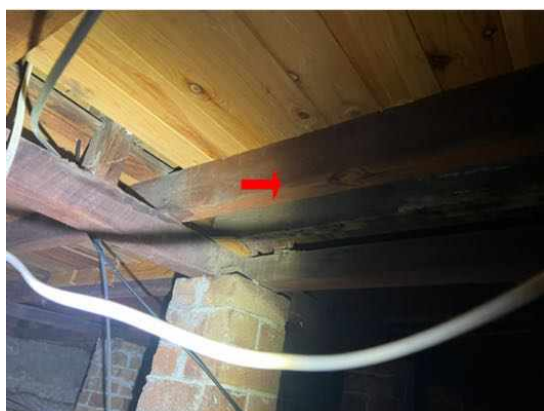
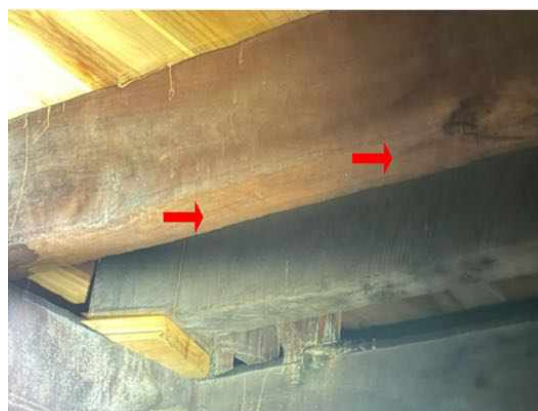
Finding 3.26

Finding: Timber Delignification - localised

Information: A section of roof framing timber was found to be deteriorated, with the surface crumbling into a fine yellowish powder. No signs of active or previous termite activity were detected, and the timber was not hollow internally. The condition is consistent with delignification, a chemical breakdown of lignin caused by prolonged exposure to heat and moisture in the roof void. While not pest-related, the affected timber should be assessed by a qualified carpenter for potential reinforcement or replacement.

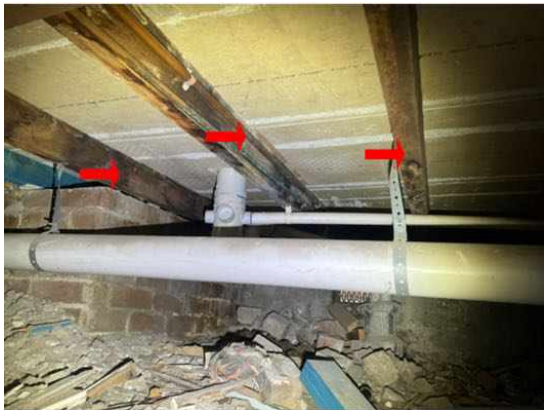
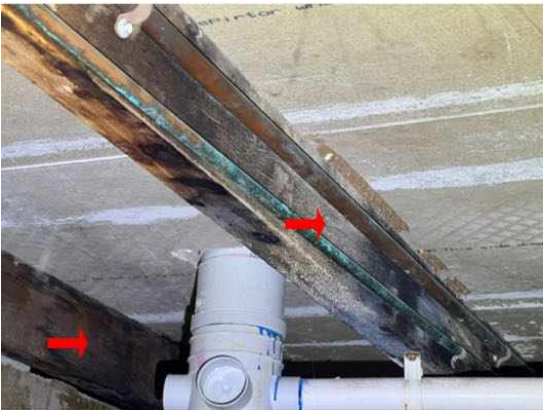
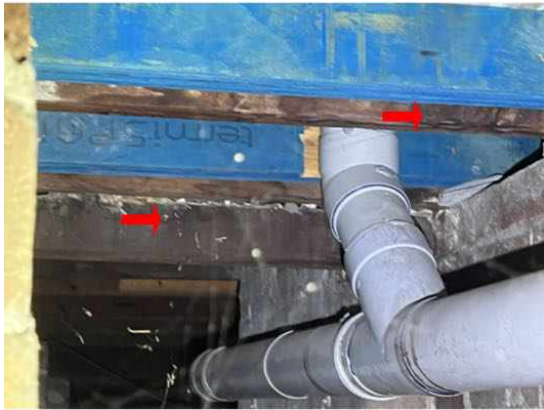
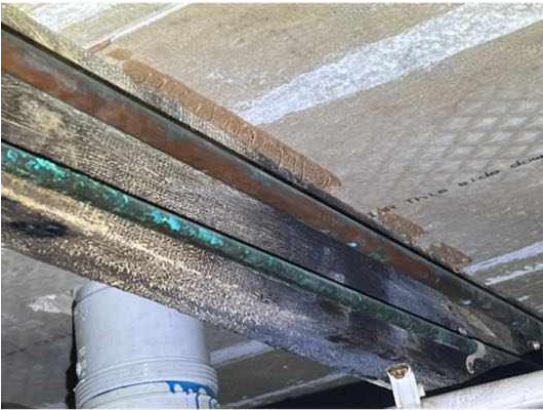
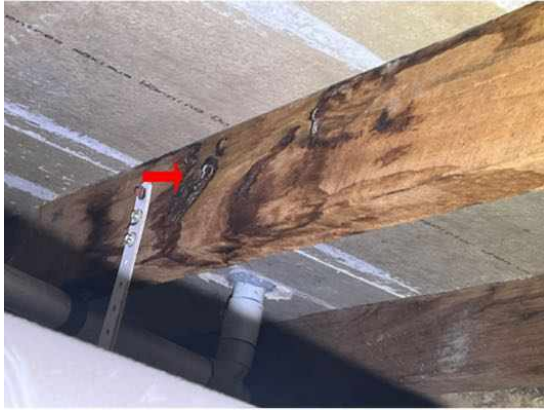
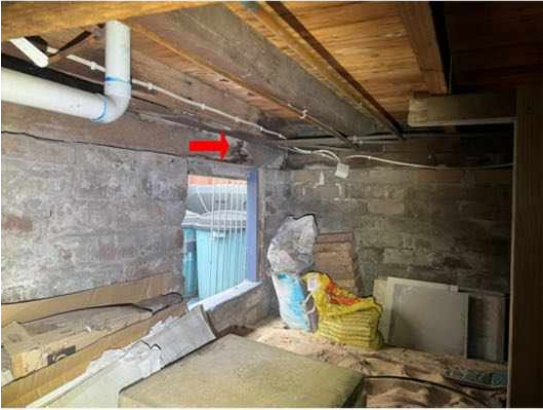
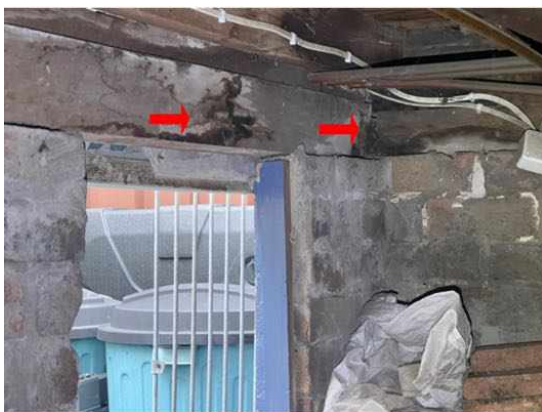
Finding 3.27

Information: Visible decay was noted to some areas, consistent with age-related shrinkage and general weathering. The affected areas also exhibited localised surface darkening and moisture stains which may indicate past moisture exposure. No evidence of structural compromise was observed at the time of inspection. These conditions appear typical for a dwelling of this age and construction, but ongoing monitoring is recommended. A licensed builder or licensed carpenter should be consulted if there is further

deterioration or leaks. It is also recommended for a licensed timber pest technician to perform invasive inspection for concealed timber pest activity.

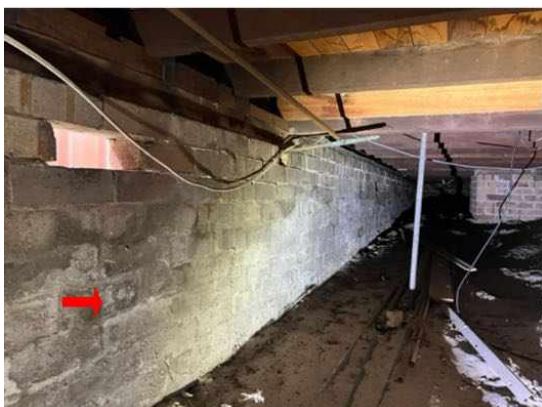
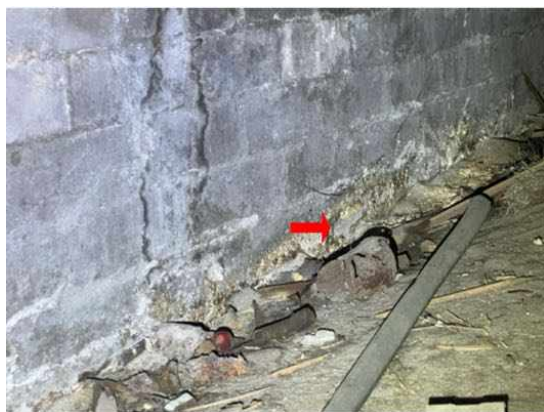
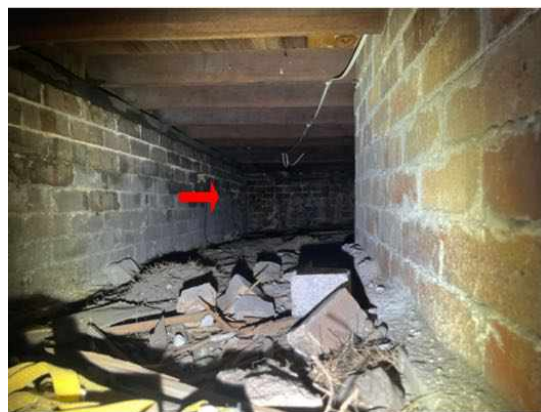
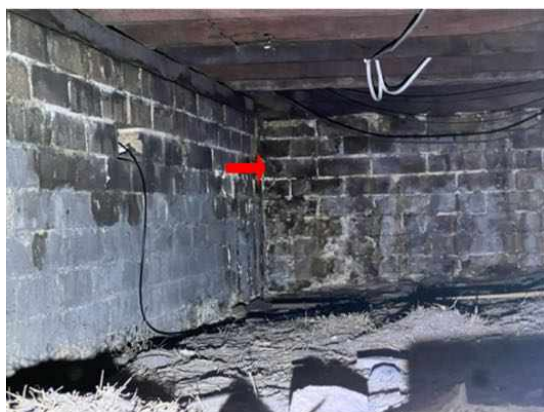
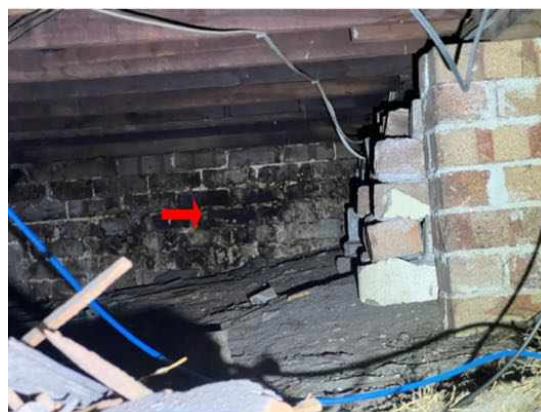
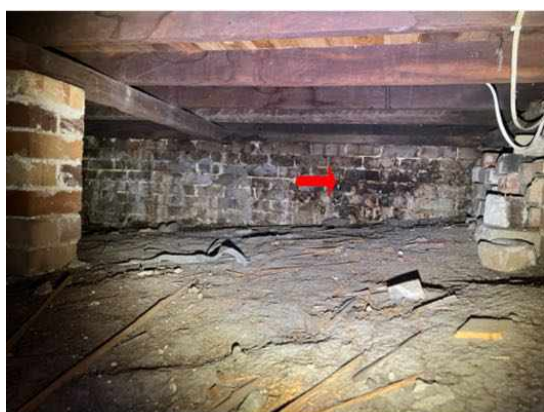
Finding 3.28

Building:	Main Building
Location:	Subfloor
Finding:	Subfloor Moisture and Efflorescence
Information:	efflorescence and visible damp staining were observed along the lower brickwork within the subfloor, indicating active or historic rising damp.

The presence of salt deposits and discolouration suggests that moisture is migrating through the masonry via capillary action, likely due to inadequate subfloor drainage or ventilation.

These conditions may contribute to further degradation of mortar joints, promote mould growth, and increase the risk of timber pest activity if left unaddressed. The area should be further assessed by a damp remediation specialist, and improvements to subfloor ventilation and moisture control are recommended. A further invasive timber pest inspection is recommended to check for any concealed activity.

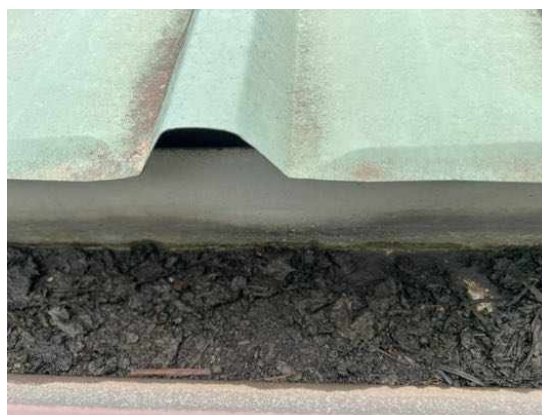
Blocked gutters are likely to lead to high levels of moisture in the affected areas. Such moisture will not only cause rust and decay of the associated building materials, but can also provide conditions that are conducive to termite and timber pest activity. Blockages in gutters should therefore be removed immediately to ensure dry conditions are maintained.

Consult a Licensed Plumber for further specific advice on remedial works that may be required. In the interim, it is highly advised that blocked gutters be removed by the homeowner or a general handyperson as a matter of urgency.

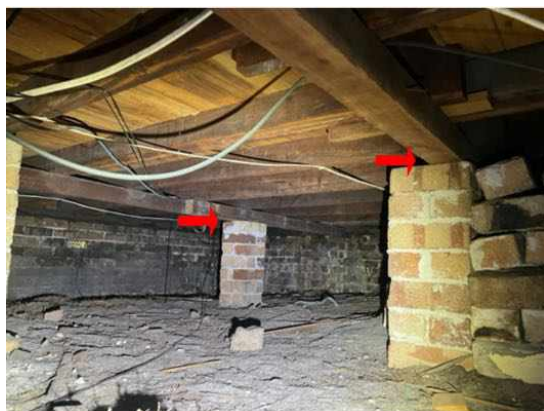
Installed during the construction process, ant caps are designed to easily identify termite or pest ingress from stumps to the adjoining bearers.

Where ant caps have not been installed, frequent monitoring of these areas should be carried out in order to identify any signs of termite or timber pest workings.
