Building and Timber Pest Inspection Report

Inspection Date: Tue, 3 Feb 2026

Property Address: 3-154 neerim rd Caulfield east

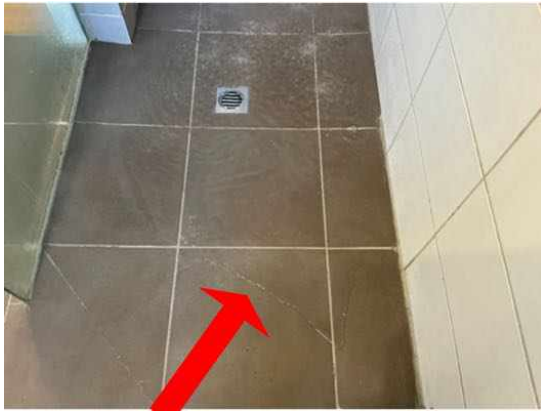
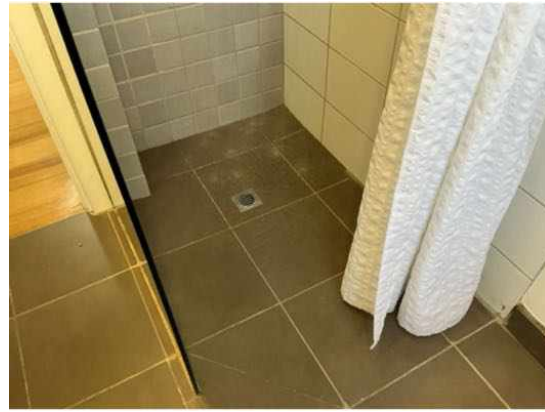
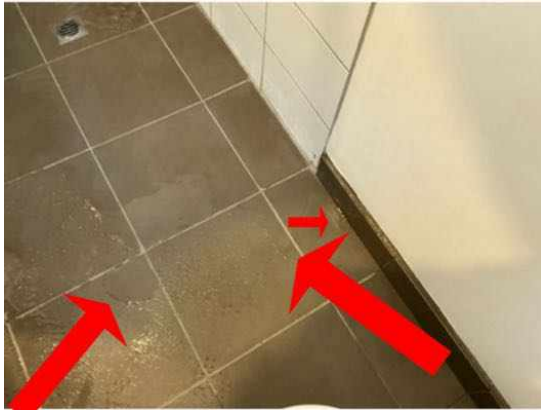
Building: Main Building
Location: Bathroom
Finding: Shower enclosure – water containment failure
Information: During inspection, the shower was operated for approximately one to two minutes. It was observed that water was not adequately contained within the shower enclosure and was escaping into the bathroom area. This condition indicates that the shower enclosure does not provide effective water containment.

Uncontrolled water escape may result in water damage to flooring, wall linings, fixtures, and adjacent areas. Ongoing exposure to moisture can also contribute to deterioration of building materials, mould growth, and potential structural damage as well as attracting termites.

This is considered a major defect as the shower is unable to perform its intended function without causing water damage.

Use of the shower in its current condition may lead to flooding and further damage. Prompt attention is advised.

A licensed plumber and/or qualified bathroom renovation contractor should be engaged to further investigate the cause (which may include inadequate shower screens, failed seals, incorrect falls, or waterproofing issues). Rectification works are recommended prior to continued use of the shower.

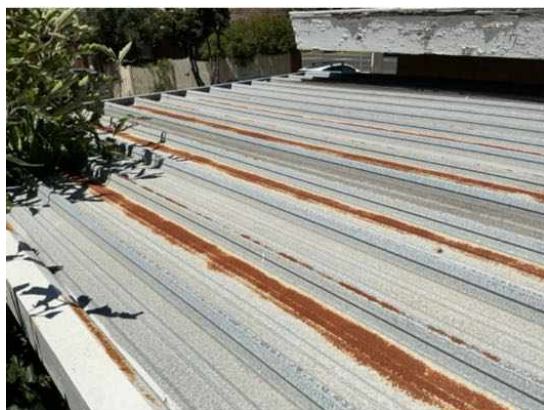
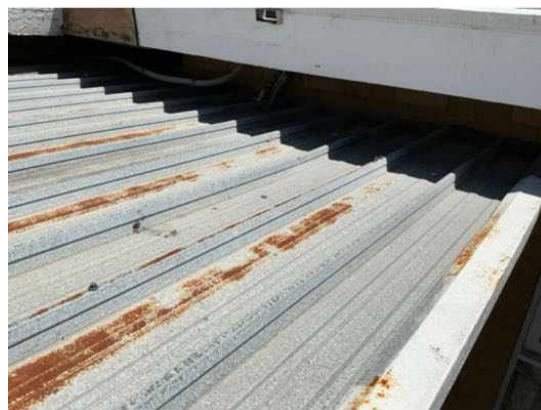
Finding 3.01

Building:	Main Building
Location:	Carport
Finding:	Carport roof rusting
Information:	The carport roof shows evidence of rusting and corrosion, which is likely to have developed as a result of excessive exposure to moisture and or inadequate coatings. This will cause excessive moisture which could attract termites.

As surface rust provides no protection to the underlying iron, the deteriorating condition is likely to worsen if not addressed in the short-term future.

Rusting and corrosion should be managed by ideally removing or limiting the affected surface from exposure to moisture. A registered builder may be appointed to replace any building elements that have been severely affected by rust or water damage.

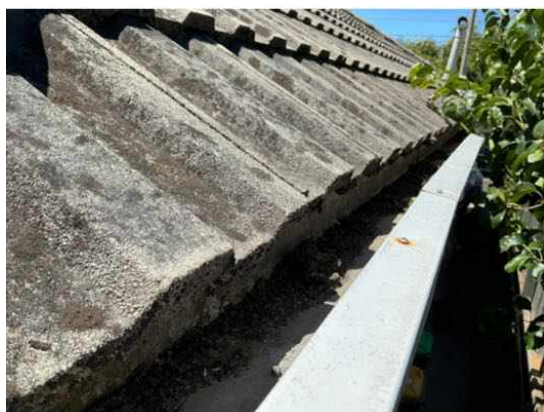
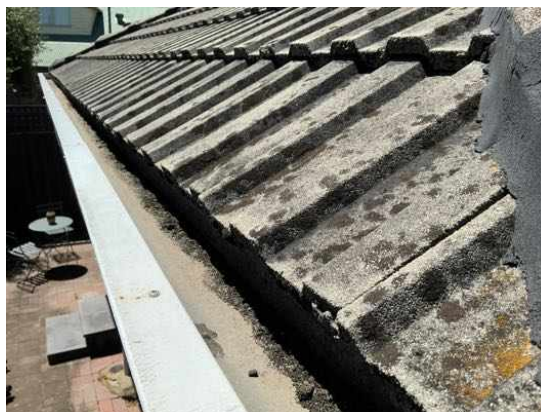
Finding 3.02

Blocked gutters are likely to lead to high levels of moisture in the affected areas. Such moisture will not only cause rust and decay of the associated building materials, but can also provide conditions that are conducive to termite and timber pest activity. Blockages in gutters should therefore be removed immediately to ensure dry conditions are maintained.

Consult a Licensed Plumber for further specific advice on remedial works that may be required. In the interim, it is highly advised that blocked gutters be removed by the homeowner or a general handyperson as a matter of urgency.

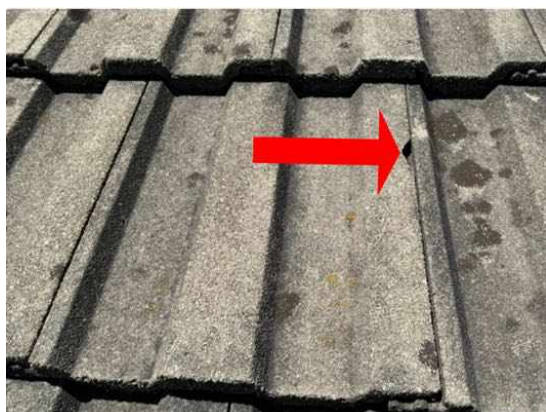
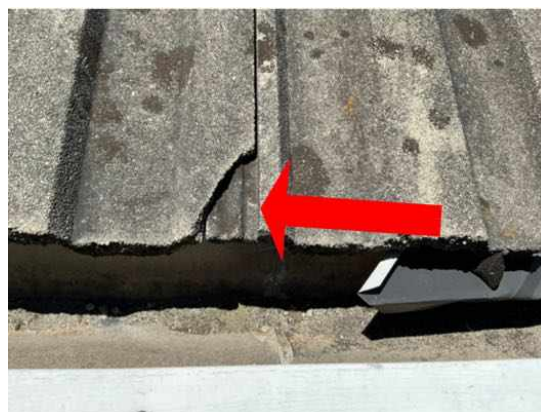
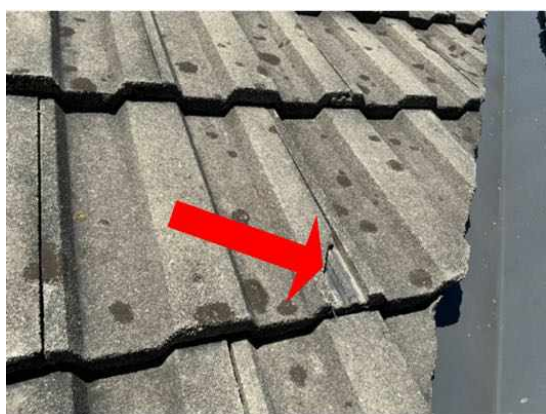
Finding 3.03

Building:	Main Building
Location:	Roof Exterior
Finding:	Roof tiles - Broken
Information:	Upon inspection of the exterior roof covering, broken roofing tiles were identified. Broken tiles are generally the result of ageing and weathering of what is essentially a porous material.

If left to further deteriorate, broken and brittle roof tiles are likely to lead to water penetration via the roof into the ceiling space, causing excessive moisture and secondary damage to ceiling linings, insulation and roof structures. Broken roof tiles are also likely to detract from the effectiveness of the roof drainage system, creating potential for secondary damage to the exterior roof covering and roof plumbing. Excessive moisture could attract termites.

Replacement of broken tiles is required and should be performed by a roofing contractor as soon as possible.

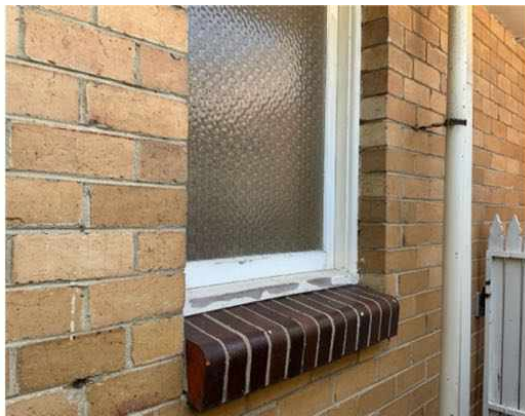
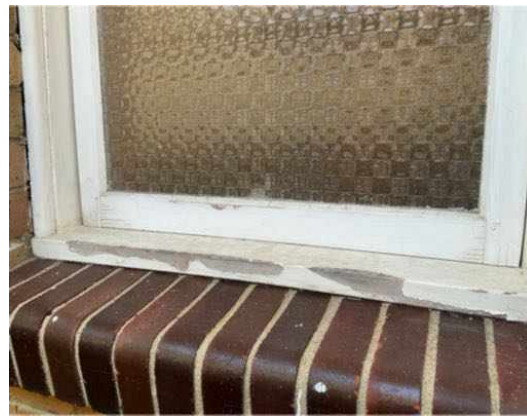
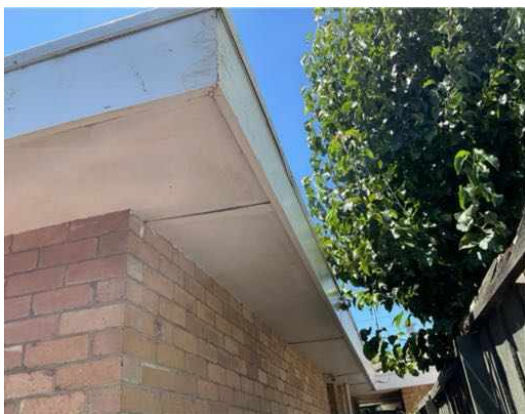
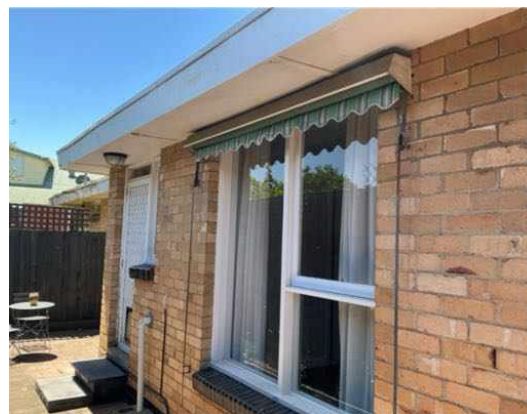
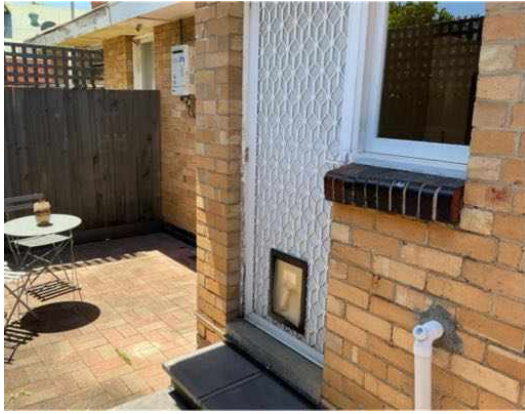
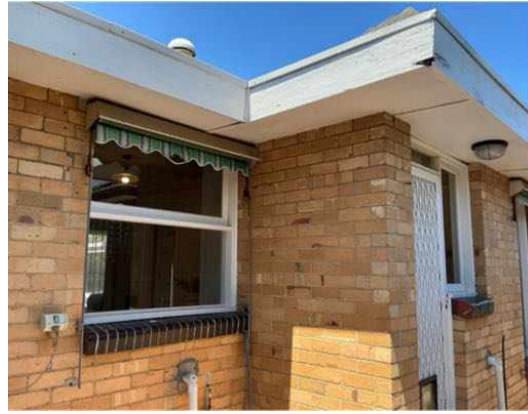
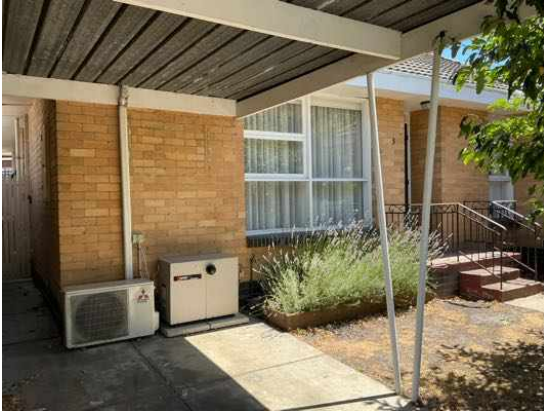
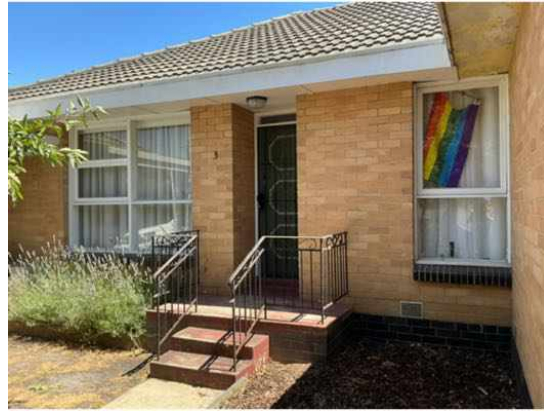
Finding 3.04

Building:	Main Building
Location:	Various parts of the building

Finding: External painting deteriorated
Information: Much of the external paintwork has been neglected and requires attention to prepare and re-paint.

Whilst incomplete or missing paint finish is generally an appearance defect, it can also lead to the development of secondary building defects over time. Incomplete areas of paint finish expose the area to moisture, potentially accelerating the deterioration of underlying building materials.

Degraded paint finishes should be sanded back, filled, leveled and painted, as applicable. Where inadequate or missing paint protection has led to the deterioration of the associated building element, repair and/or replacement of this building element may be required.

A painting contractor should be appointed as soon as possible to perform necessary works to aid the appearance of the affected area and to ensure the area is protected against further deterioration. Alternatively, the homeowner following manufacturer instructions may perform these works.

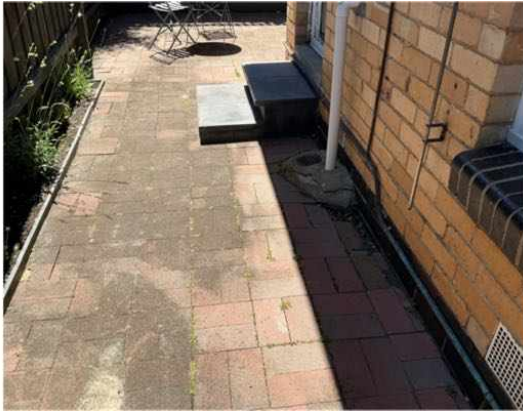
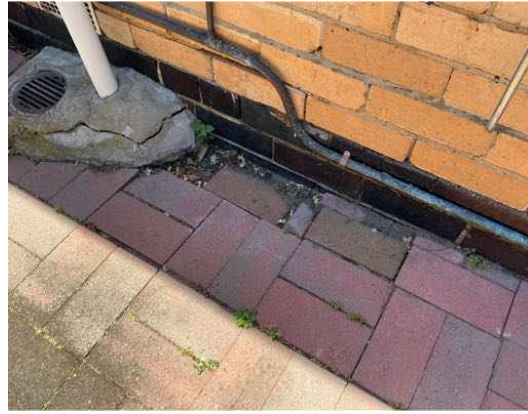
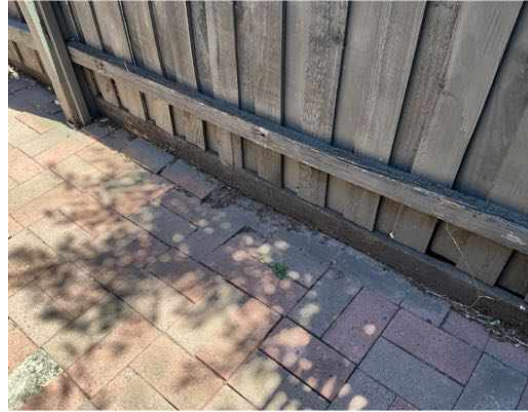
Finding 3.05

Information: Sections of the external paved area are uneven, creating a potential trip hazard. It appears as though the area has been subject to rough installation, or that paving sections have lifted due to movements in the foundation of the property.

Where paving creates a trip hazard, personal injury may ensue if due caution is not taken by all persons within this area.

Re-paving of the area is required as soon as possible to remedy this situation. Further consultation with a specialist concreter is advised.

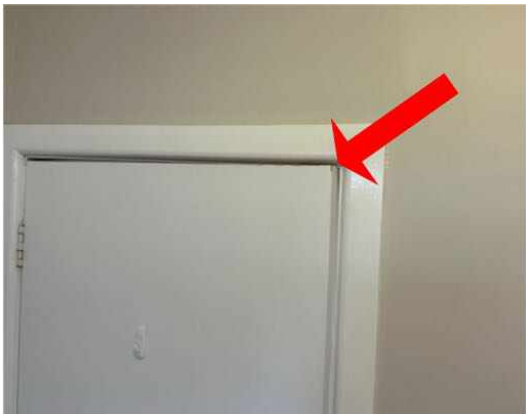
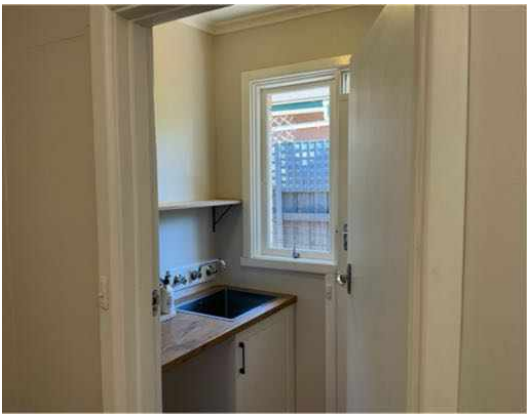
Finding 3.06

Building:	Main Building
Location:	Laundry
Finding:	Door - Binding/jamming laundry
Information:	Binding and/or jamming of the laundry door is evident during standard operation. This defect inhibits the functionality of the affected door as well as creating potential for secondary defects to associated building elements, such as damage to the floor covering.

A door that binds to flooring or to the associated door frame may have several causes, ranging from minor defects, such as poor installation of the door or deteriorated hinges.

For minor causes, a qualified carpenter or general handyperson should be appointed to perform minor rectification works at client discretion.

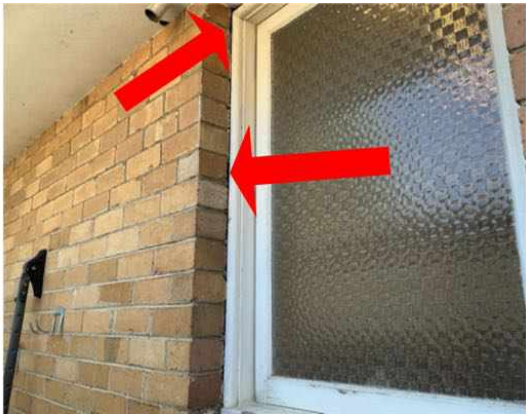
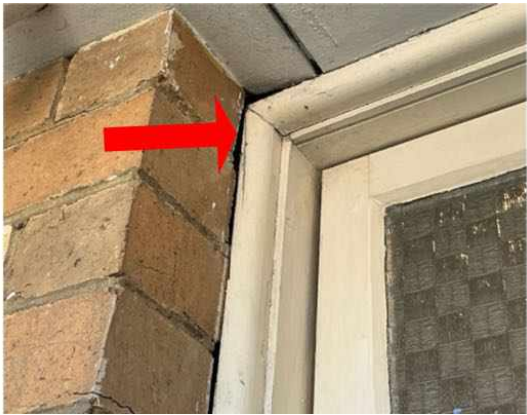
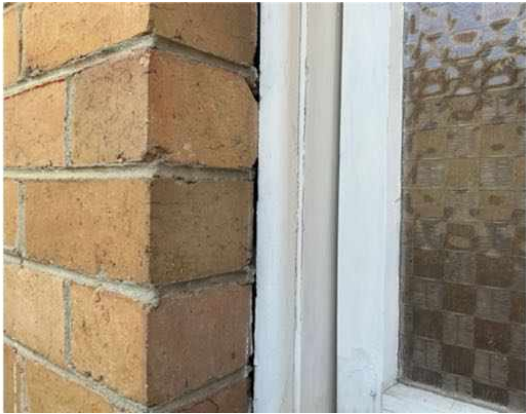
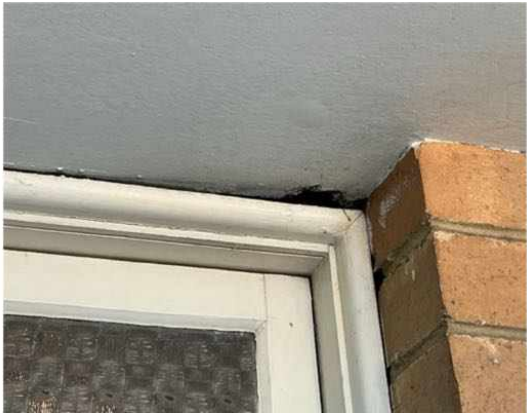
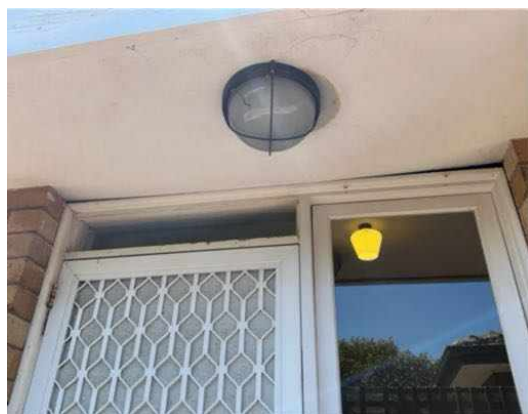
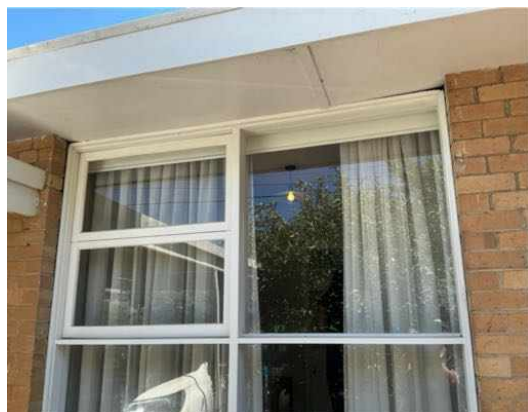
Finding 3.07

Building: Main Building
 Location: Various parts of the building
 Finding: A few gaps to the exterior walls/windows
 Information: A few gaps were noticed to some of the exterior walls/windows to the building. These gaps can let in water, drafts, and pests. Overtime moisture ingress may cause damage to internal walls, mould growth, or structural issues. Gaps also reduce the energy efficiency of the property. Recommend engaging a caulker to seal gaps with an exterior grade flexible sealant that is UV and weather resistant to reduce the risk of pest/water penetration to the building as soon as possible.

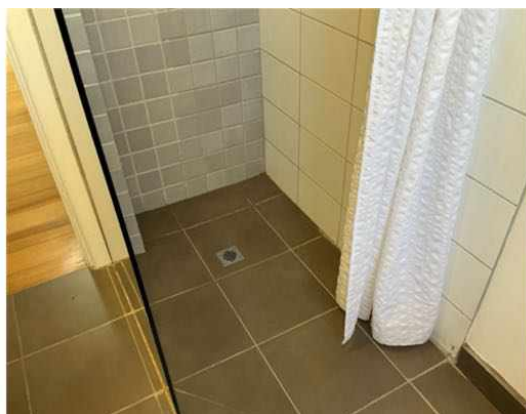
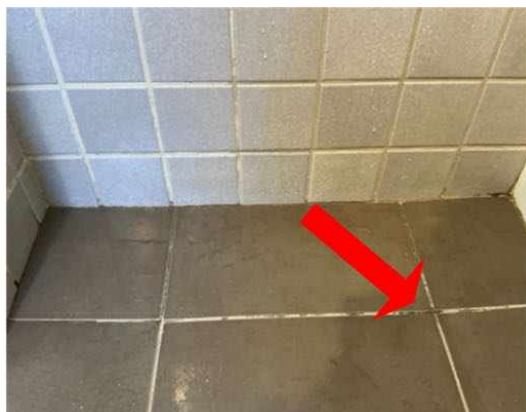
Finding 3.08

Building:	Main Building
Location:	Bathroom
Finding:	Bathroom Sealant and grouting - Missing or damaged
Information:	It was noted on inspection that sealant or grout is degraded to the tiled shower alcove and or other areas of the bathroom.

Different materials and floor areas move at different rates, generally causing cracking to grout or sealant at this point. A flexible sealant is required to allow for expected expansion and contraction, while keeping the joint water tight and protective of all associated building materials.

Flexible and mould resistant materials should be applied to affected areas to prevent any subsequent water damage that is likely to occur. Regular maintenance and replacement of damage or missing or damaged sealant and grout is highly recommended to the wet areas, as this is a regular wear and tear defect. Sealant and grouting in areas that come into regular contact with water should be maintained for the long term care of your property.

A sealant specialist or tiling contractor should be appointed to complete these works as soon as possible

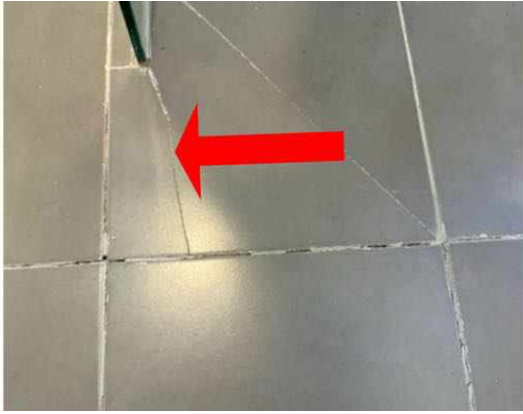
Finding 3.09

Building:	Main Building
Location:	Bathroom
Finding:	Cracked tile bathroom
Information:	A cracked tile was evident to the bathroom at the time of inspection. It is suspected that this cracking has occurred as a result of minor settlement of the building or poor workmanship.

Cracked tiles to the household detract from the overall appearance of the affected areas and it is likely to create or lead to any secondary defects.

While not considered a matter of urgency, replacement of cracked tiles is recommended at the clients discretion. A tiling contractor may be appointed to perform these works. Where cracks become more numerous, contact a licensed building inspector for further investigation.

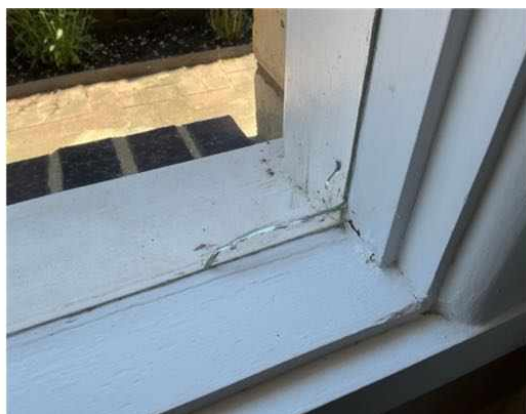
Finding 3.10

Building:	Main Building
Location:	Bedroom
Finding:	Window - glass broken
Information:	Broken glass identified in the bedroom window. Cracking in windows is generally the result of impact damage, and is likely to develop further when left unmanaged.

The likelihood of this windowpane further cracking and shattering is increased exponentially, providing a safety hazard in the area. The cracked window also impairs the weather tightness of the building, creating potential for minor water leaks.

A qualified glazier is required to repair the window as soon as possible. Depending on the extent of the cracking, replacement of the window may be required. Please be advised that any persons coming into contact with the cracked window should do so with due caution to avoid any personal injury that may ensue.

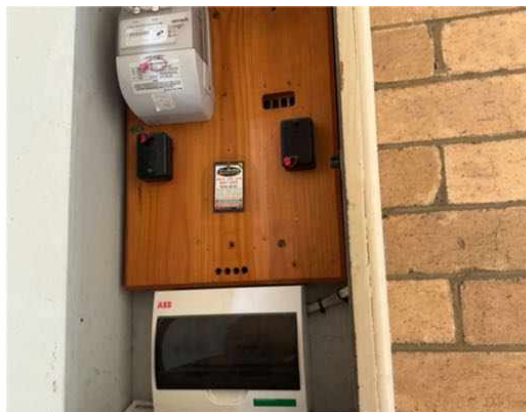
Building:	Main Building
Location:	All External Areas
Finding:	No Termite Management System - no evidence of a chemical installation
Information:	The application of a post-construction chemical termite barrier is highly recommended for all properties, particularly if live termite activity has been found on the site previously. Such barriers are highly effective in preventing termite attack on any timber building elements throughout the property.

A durable notice should be placed in the switchboard unit to indicate current termite barriers. At the time of inspection, it appeared as though no termite management system has been installed, with no evidence to suggest preventative works taking place.

The client may consider gaining further advice from a pest controller as to the costs and procedures involved with this application. It is recommended that obtaining such advice be a short-term priority.

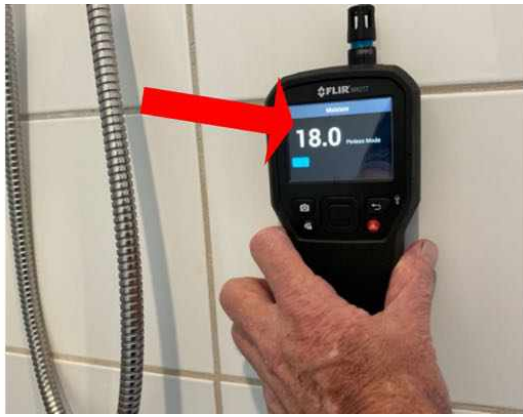
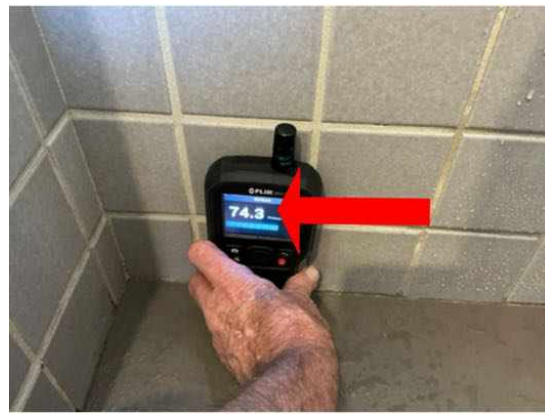
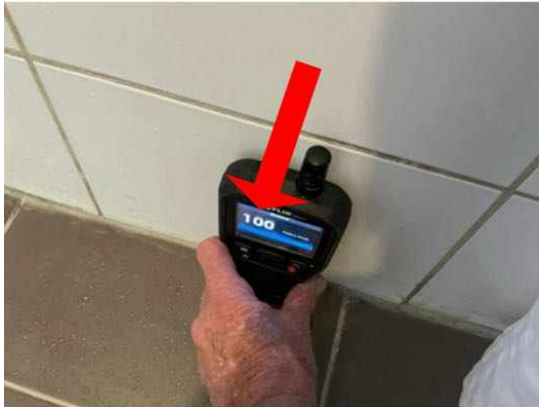
Finding 6.02

Building:	Main Building
Location:	Bathroom
Finding:	Shower - Damp
Information:	Damp is evident to parts of the bathroom shower alcove found using using a moisture meter. This defect is quite common, and is suspected to have been caused by moisture permeating through the grouting in this area, which shows evidence of deterioration creating moist conditions. Leaking pipes within the adjoining wall is also a possible cause. Excessive moisture can attract termites.

Damp (or structural damp) refers to the presence of unwanted moisture in the structure of a building, either as the result of intrusion from outside, or condensation from within the structure. In the shower area, internal water leaks or other sources of excessive moisture are generally the cause of damp.

Unmanaged damp in the shower recess is likely to facilitate the formation and development of mould and fungi growth, decaying associated building materials and compromising their structural integrity. It is important to address damp conditions, as the World Health Organisation notes that excess moisture leads - on almost all indoor materials - to growth of microbes such as moulds, fungi and bacteria, which subsequently emit spores and other matter into the indoor air. Exposure to these contaminants is associated with a wide range of respiratory and other health-related problems.

Consultation with a qualified plumber or bathroom specialist is advised immediately to identify the cause of damp and to perform remedial works as required. Where excessive mould growth is present, further inspection by a specialist environmental health inspector should also be considered.

Always ensure that sealant and grout is in good condition to prevent any moisture issues occurring in the future.

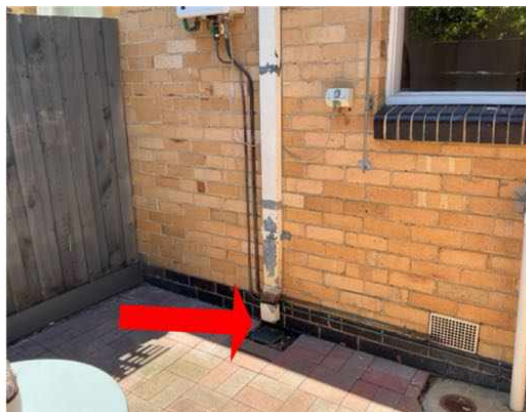
Finding 6.03

Building:	Main Building
Location:	Exterior walls - rear
Finding:	Downpipe not properly connected to stormwater
Information:	The rear downpipe is not properly connected to stormwater. This disconnection negatively impacts the functional capacity of the plumbing.

Where plumbing doesn't drain adequately, the area at the base perimeter can become excessively damp, potentially creating an environment that is susceptible to rust and corrosion of surrounding building elements, as well as attracting termites and other pests.

It is highly recommended that a plumber be appointed to further inspect the area and to install adequate drainage equipment immediately where necessary.

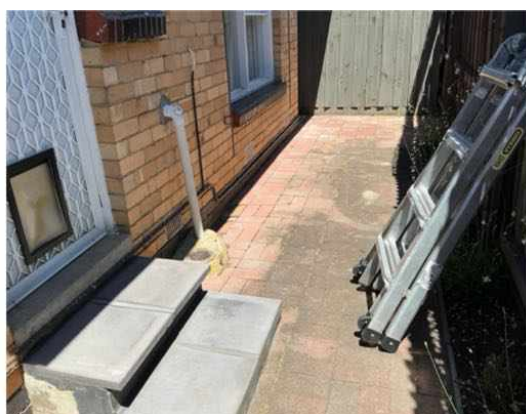
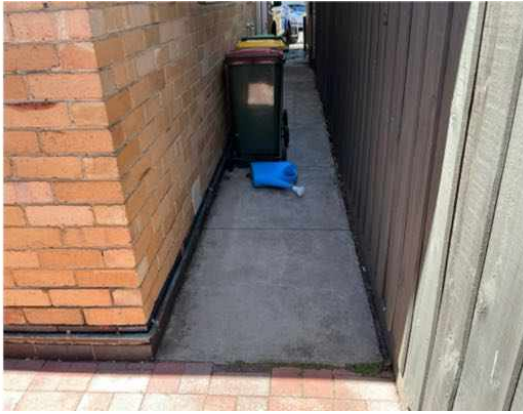
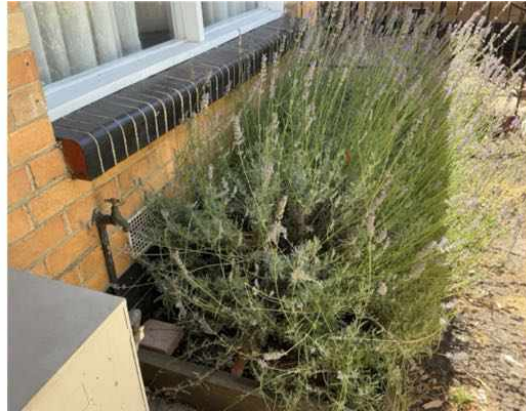
Finding 6.04

Finding: Site drainage - poor/inadequate

Information: The site drainage to parts of the yards was found to be inadequate, with water entering the subfloor space, at the time of inspection creating potential for excessive moisture and subsequent water damage to associated building elements. Excessive moisture can attract termites.

It is important that water does not lie against the base of walls; surrounding paths and ground levels should be sloped to drain water away from walls. Downpipes should not discharge stormwater onto lower walls or plinths. Stormwater should be carried away by large, regularly cleaned drains. Ground levels may need to be lowered to expose a buried DPC.

Where site drainage is inadequate, installation of an Agricultural (Aggie) Drain may be required. A qualified plumber should be appointed to further inspect the property and perform any remedial works as necessary. Water damage and secondary defects are likely to occur if left unmanaged.

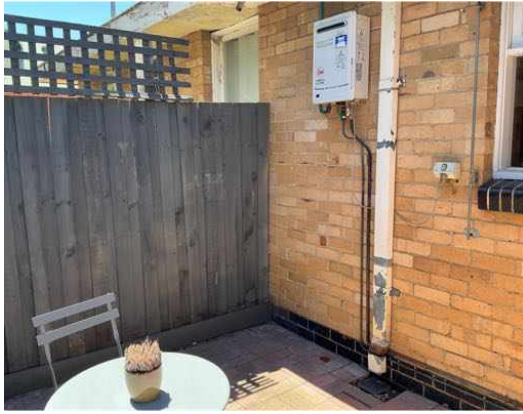
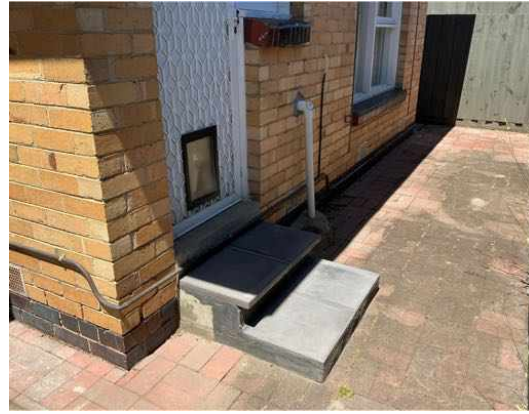
Finding 6.05

Building:	Main Building
Location:	Various parts of the building
Finding:	Bridging attachments to buildings
Information:	Bridging occurs when items against a building provide a concealed entry point for termites into the building or by passing around a termite management system.

Building attachments of this nature need to be frequently inspected for termite activity by a qualified inspector.

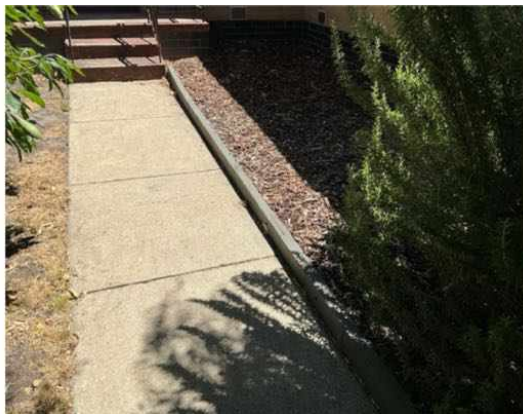
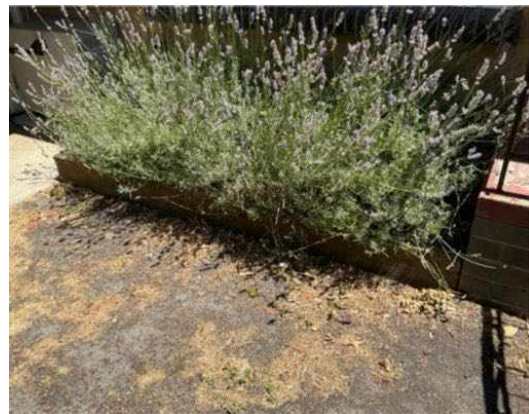
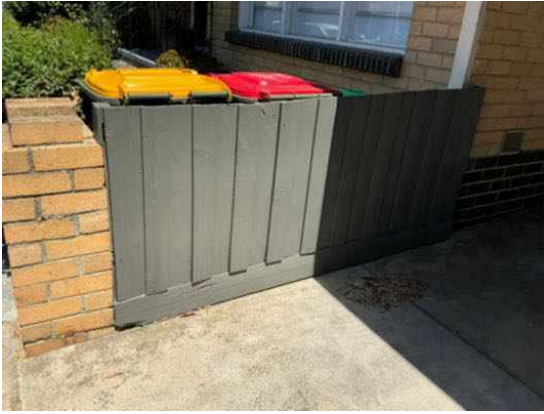
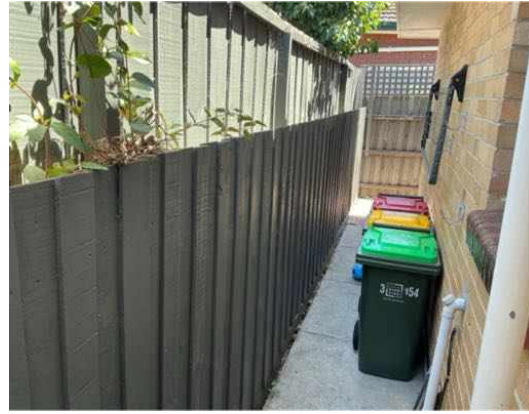
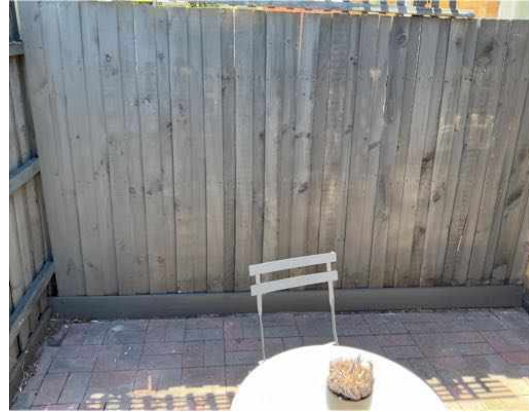
Finding 6.06

Building:	Main Building
Location:	Various parts of the building
Finding:	In ground contact
Information:	Any timbers in direct ground contact provide opportunity for concealed termite entry and are likely to be subject to premature rot and decay as the soil retains moisture or damp conditions against the timbers.

Remove untreated timber that is in direct contact with external grounds. Consider replacement with more durable materials i.e. treated timber or non timber elements. Frequent pest inspections are advised to readily identify any termite activity in these areas.

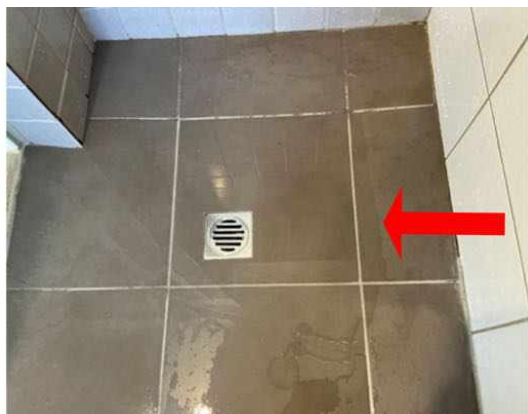
Building:	Main Building
Location:	Bathroom
Finding:	Shower base - Water pooling
Information:	Evidence of water pooling around the floor waste in the shower recess was noticed at the time of inspection. It is suspected that this excessive moisture is attributed to insufficient fall in the shower floor tiles.

This pooling is minor overall but is still considered unsatisfactory, as standard practices would not permit this situation to occur. Pooling water around floor wastes can create a slip hazard in extreme cases and create conditions that are conducive to mould growth over time. Where left unmanaged, the degradation of sealant and grouting is also likely to occur, possibly necessitating further repair works. Recommend engaging a plumber to rectify to reduce the risk of further deterioration as soon as possible.

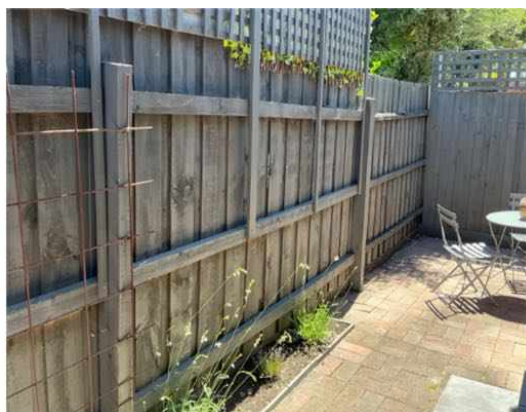
Finding 7.01

Building:	Main Building
Location:	Yard - Back
Finding:	Fencing - wood rot-fungal decay
Information:	It was noted at the time of inspection that sections of the rear fencing to the property have deteriorated and have fungal decay/wood rot present. Typically fencing deteriorates due to age and or wear, rot and or rust which is generally expected for a structure of this age, due to prolonged exposure to weather conditions. Sometimes inadequate installation or maintenance can be to blame.

If left unattended, it is likely that further damage will occur. It is suspected that repair of several elements of the fencing may be required however replacement may be a consideration of the client also.

A licensed fencing contractor should be appointed to provide further advice and perform rectification works as necessary.

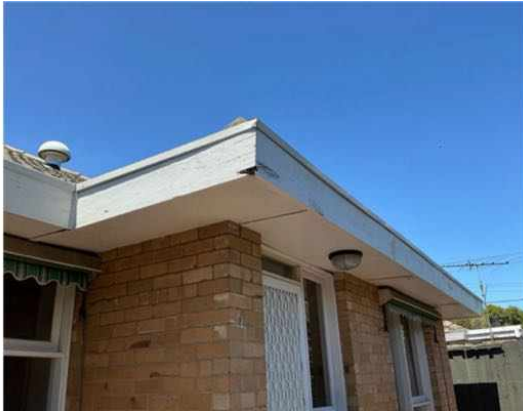
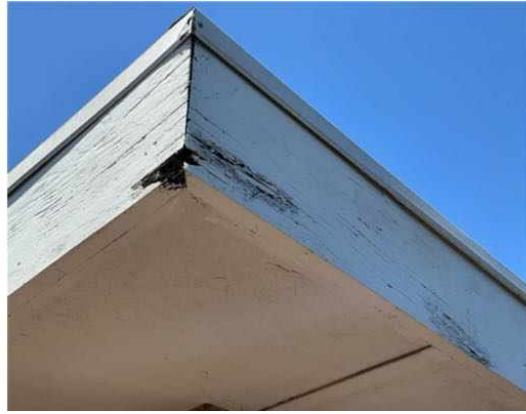
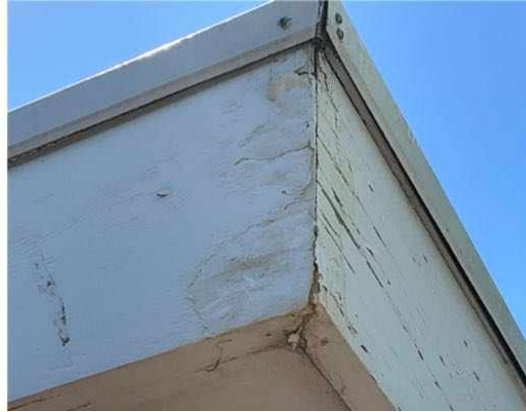
Finding 7.02

Building:	Main Building
Location:	Exterior walls - rear
Finding:	Fascias - Wood rot
Information:	Wood rot was found to be affecting the rear fascias of the building evidenced by the presence of mould on the surface in some areas. Wood rot, also known as Fungal Decay, occurs when timbers and other cellulose building materials are exposed to damp conditions on an ongoing basis.

It is likely that this wood rot has developed as a result of faults in the roof plumbing, creating excessive moisture in this areas. Frequent exposure to rain and other weather conditions also make fascias and barges susceptible to accelerated deterioration.

Early intervention and regular maintenance will prolong the useful life of these building elements. Prior to any works being performed, the cause of the moisture that has created the visible wood rot should be identified and addressed in a suitable manner.

It is advised that a roof plumber be appointed to inspect all roof plumbing and subsequently identify the cause of the wood rot. Replacement of affected fascias and barges may then be a necessary step in protecting surrounding building elements from such deterioration.

A qualified plumber may be appointed to assess the cause of excessive moisture and to provide advice on any remedial works as required. A qualified carpenter or registered builder may also be required to replace affected building materials.

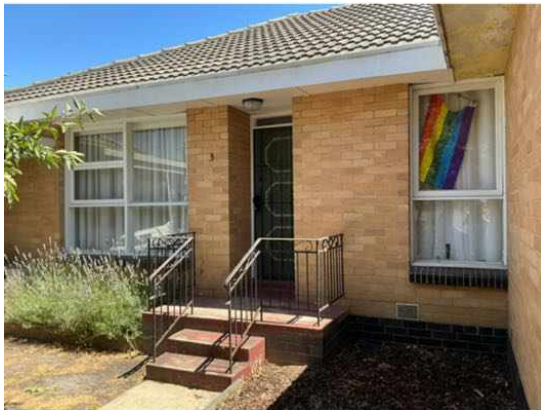
Building:	Main Building
Location:	All External Areas
Finding:	Obstructions and Limitations -exterior
Information:	These photographs are an indication of the obstructions and limitations which impeded full inspection of the exterior at the time of inspection. These obstructions can hide an array of defects and should be removed to allow full inspection to be carried out. A re-inspection is recommended once the areas are made accessible.

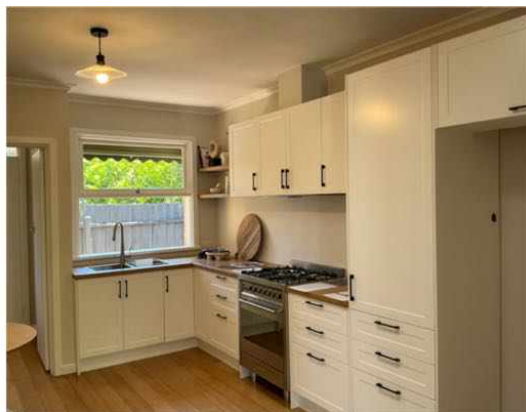
Building:	Main Building
Location:	All Internal Areas
Finding:	Obstructions and Limitations -internal area
Information:	These photographs are an indication of the obstructions and limitations which impeded full inspection of the internal area at the time of inspection. These obstructions can hide an array of defects and should be removed to allow full inspection to be carried out. A re-inspection is recommended once the areas are made accessible.

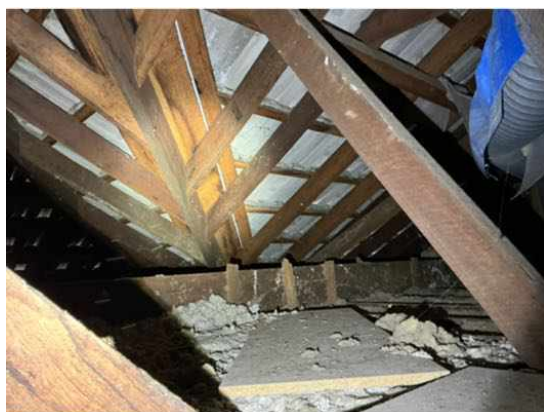
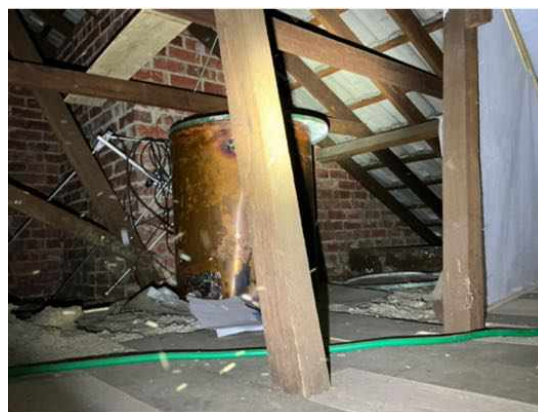
Building: Main Building
 Location: Roof Void
 Finding: Obstructions and Limitations -roof cavity
 Information: These photographs are an indication of the obstructions and limitations which impeded full inspection of the roof cavity at the time of inspection. These obstructions can hide an array of defects and should be removed to allow full inspection to be carried out. A re-inspection is recommended once the areas are made accessible.

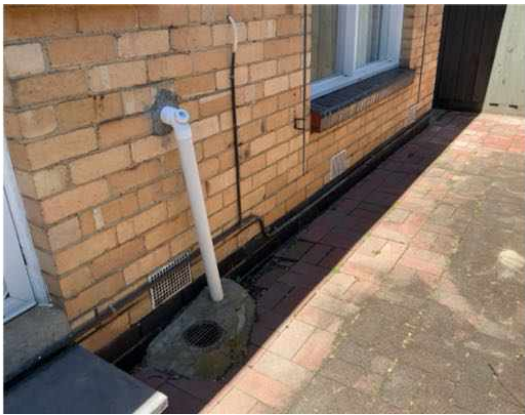
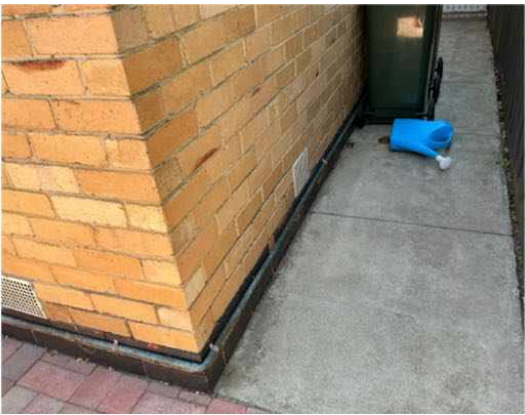
Building: Main Building
 Location: Subfloor
 Finding: Obstructions and Limitations -no access subfloor
 Information: The subfloor space was inaccessible at the time of inspection due to no access hole which impeded the inspection of the subfloor of the main building. This obstructions can hide an array of defects and it is highly recommended that an access hatch be constructed to allow full inspection to be carried out. A re inspection is recommended once the area is made accessible.
