Building and Timber Pest Inspection Report

Inspection Date: Thu, 12 Mar 2026

Property Address: 13 Gallipoli St, Condell Park NSW 2200, Australia

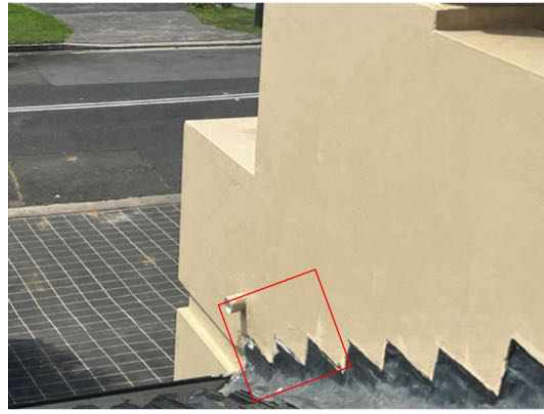
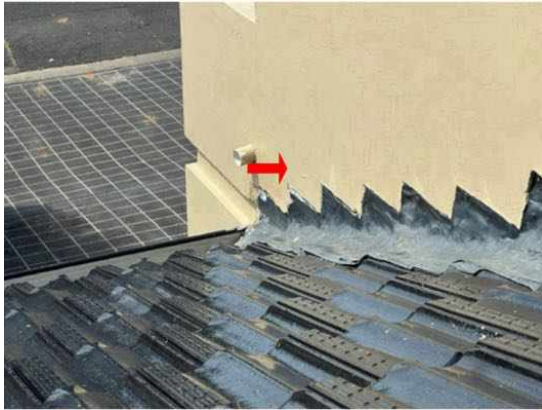
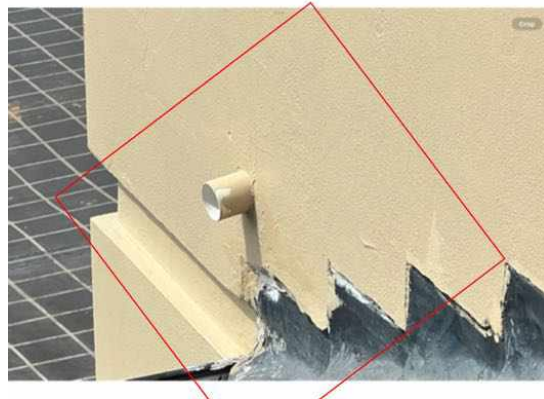
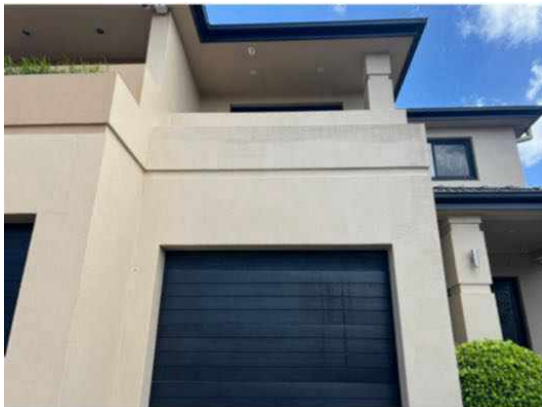
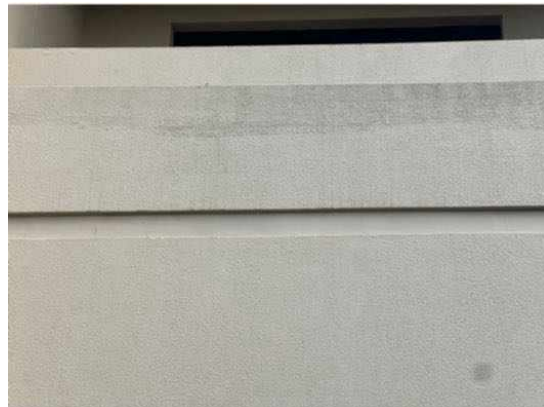
Building:	Main Building
Location:	Balcony
Finding:	Elevated Moisture – Further Investigation Recommended
Information:	Elevated moisture readings were detected in several locations and paint bubbling outside the balcony near planter area, with some areas also showing signs of dampness while others did not present visible surface issues, although no significant structural damage was evident at the time of inspection, dampness can contribute to deterioration if left unaddressed. A further investigation by a licensed plumber or waterproofing specialist is recommended to confirm the source and ensure no concealed issues are developing.

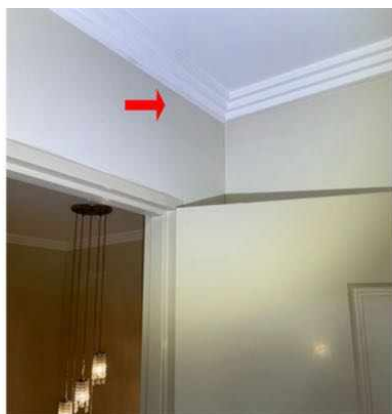
Finding 3.02

Building:	Main Building
Location:	All Areas
Finding:	Past Repairs - Refer to Defect 3.56 to 3.10 (Further investigation required)
Information:	Cracking to render , numerous tiles cracking in bathrooms , laundry areas, a door slightly binding and evidence of past repairs were noted in this area. The extent and adequacy of any previous repair work cannot be confirmed during a visual inspection. This pattern of defects may be consistent with past or ongoing building movement. Further assessment by a suitably qualified structural engineer is recommended to determine the cause and extent of movement.

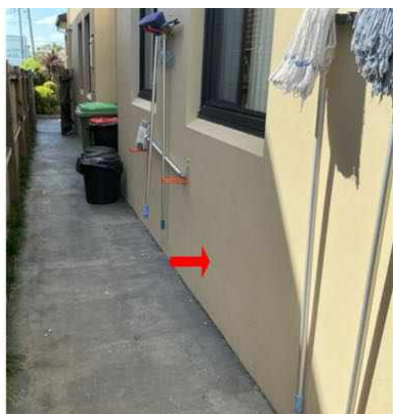
Finding 3.03

Information: Damp (or structural damp) refers to the presence of unwanted moisture in the structure of a building, either as the result of intrusion from outside, or condensation from within the structure. Generally, structural damp is caused by rain penetration, rising damp, and leaks from plumbing pipes.

Consultation with a qualified plumber is advised immediately to identify the cause of damp and perform remedial works as required. Where excessive mould growth is present, further inspection by a specialist environmental health inspector should also be considered.

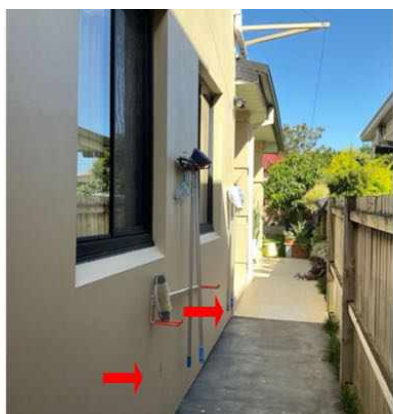
Finding 3.04

Building: Main Building
 Location: All External Areas
 Finding: Render Finish Covering Damp Membrane
 Information: During the inspection, it was noted that the applied render finish is covering the damp-proof membrane. This is affecting the membrane’s ability to prevent moisture movement above it, leading to moisture-related issues over time. It is recommended to consult a qualified builder to ensure the damp-proof membrane is properly exposed, maintaining its effectiveness in preventing moisture ingress.

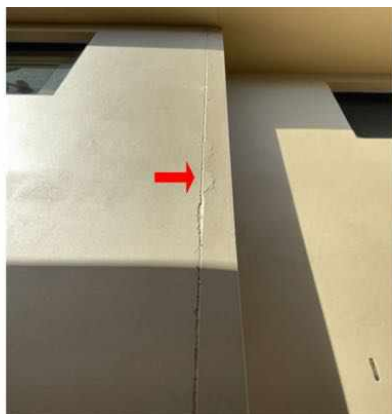
Finding: Cracks to render - Category 2

Information: It has been observed that cracking to rendered surfaces has occurred. The degree of damage falls within Category 2, described as noticeable cracks which are easily filled. Cracking of this size are generally less than 5mm in width.

Category 2 damage is required to be monitored for a period of 12 months. After the monitoring period, a crack rated at Category 2 or above is considered a defect requiring rectification.

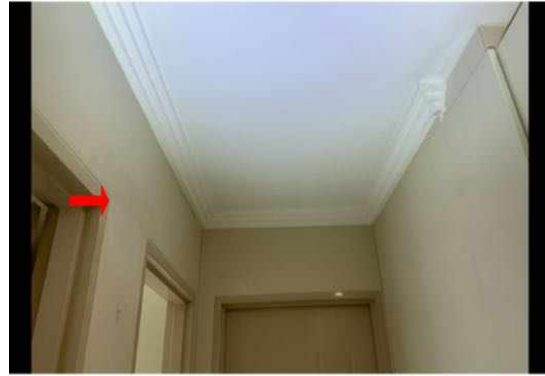
Building:	Main Building
Location:	All Internal Areas
Finding:	Cracks to internal render - Category 2
Information:	It has been observed that cracking to internal rendered surfaces has occurred. The degree of damage falls within Category 2, described as noticeable cracks which are easily filled. Cracking of this size are generally less than 5mm in width.

Category 2 damage is required to be monitored for a period of 12 months. After the monitoring period, a crack rated at Category 2 or above is considered a defect requiring rectification.

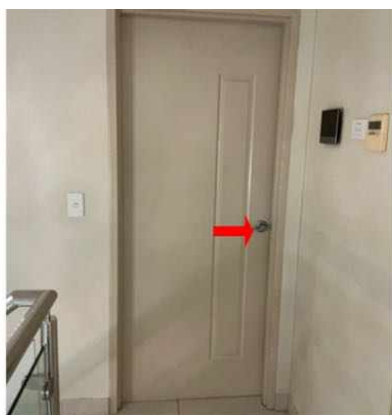
Finding: Doors - Binding/Jamming
Information: Binding and/or jamming of several doors throughout the property were evident during standard operation. This defect inhibits the functionality of affected doors as well as creating potential for secondary defects to associated building elements, such as damage to the floor covering.

A door that binds to flooring or to the associated door frame may have several causes, ranging from minor defects, such as poor installation of the door or deteriorated hinges, through to major structural issues, such as damage to subfloor structures.

Where door binding/jamming appears to indicate major structural issues, a registered builder specialising in re-stumping should be appointed to provide an estimate on the cost of rectification.

For minor causes, a qualified carpenter or general handyperson should be appointed to perform minor rectification works at client discretion.

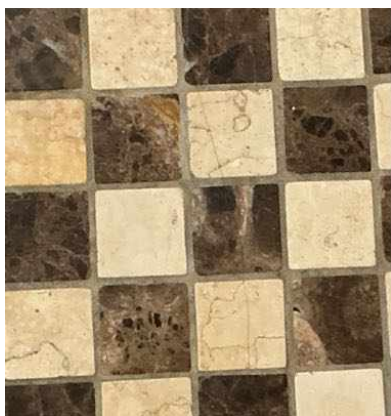
Finding 3.10

Building: Main Building
Location: All Internal Areas - laundry , ensuite , WC
Finding: Tiles Cracked - multiple tiles
Information: Hairline cracking was observed to wall tiles in the bathroom, extending vertically and branching. These defects are considered minor at present, but are likely caused by substrate movement, water-induced expansion, or installation stresses. Failure to address this may compromise waterproofing integrity. Prompt rectification by a qualified tiler is recommended to prevent further damage and potential water ingress behind the tiled surface.

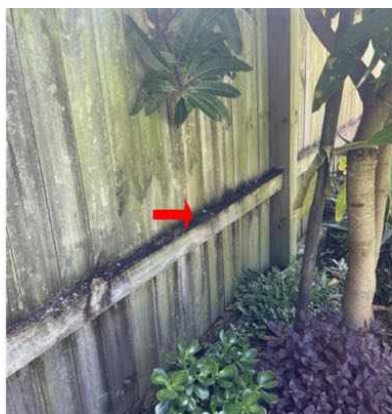
Finding 3.13

Building:	Main Building
Location:	All External Areas
Finding:	Wood rot to some areas
Information:	This building element shows evidence of wood rot. Wood rot, also known as Fungal Decay, occurs when timbers and other cellulose building materials are exposed to damp conditions on an ongoing basis. This could be the result of exposure to weathering over a prolonged period of time, or the attraction of excessive moisture from other abutting building materials. Contributing factors also include poor air ventilation in the area.

A qualified plumber may be appointed to assess the cause of excessive moisture and to provide advice on any remedial works as required. A qualified carpenter or registered builder may also be required to replace affected building materials.

Even though Liverpool termite activity was not visible. A further invasive inspection by a licensed termite technician its also highly recommended to eliminate possibility of potential termite activity.

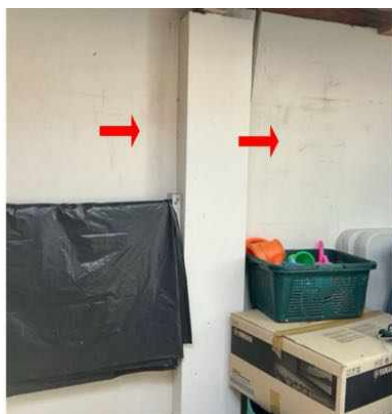
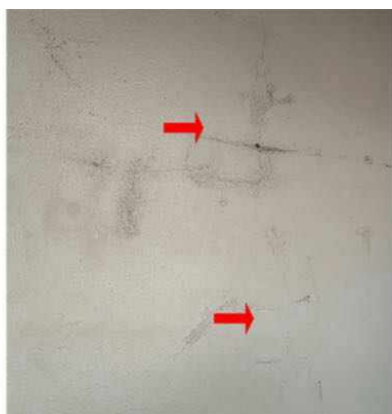
Finding 3.14

Building:	Main Building
Location:	All External Areas - Rear covered area
Finding:	Painted surface - Bubbling
Information:	Sections of paint in this area was found to have bubbled and deteriorated. Paint bubbling is generally an indication of excessive moisture in the area, that is currently hidden by the painted surface.

The presence of excessive moisture can have major implications on associated building elements if left unattended. While only seemingly minor at this stage, the damage cannot be determined due to the paint obstructing any further inspection of the damage.

It is highly advised that the affected paint be cleaned to allow a further, more invasive inspection by a licensed plumber. Failure to act on this defect may necessitate major works in the future.

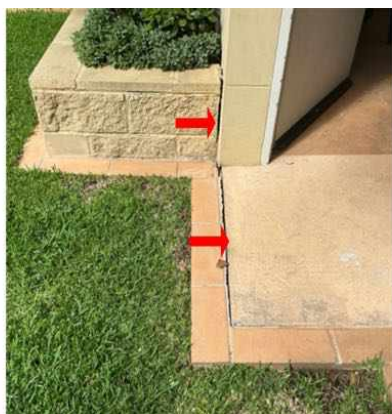
Finding 3.15

Building:	Main Building
Location:	All External Areas - rear , side
Finding:	Building element - Damaged - Paving separation , Fence leaning
Information:	Breakage occurs generally when the building materials have either aged and decayed, or as a result of damage (accidental or deliberate).

Repair and/or replacement of broken elements is advised to ensure that additional secondary defects do not arise as a consequence. Such works are necessary, as all building elements play a key role in the operation and function of the overall structure and its performance.

A relevant tradesperson should be appointed to repair or replace the affected building element prior to any subsequent damage being caused.

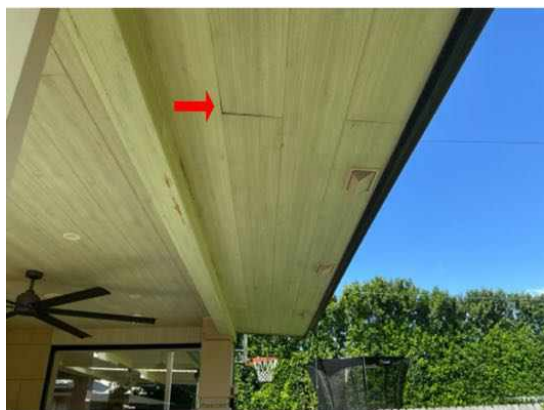
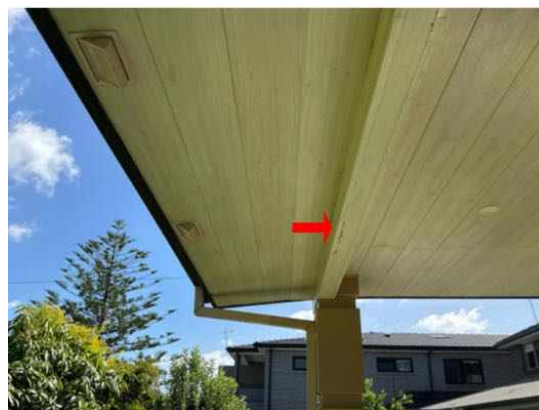
Finding 3.16

Building:	Main Building
Location:	All External Areas
Finding:	Incomplete or substandard works - Poor workmanship
Information:	The works to this area appear to be incomplete or have been completed to a substandard level.

Works that have not been completed to a satisfactory level create potential for the development of building defects and may impede on the safety and integrity of the overall structure.

It is highly recommended that the relevant trades be appointed to complete these works and ensure the safety of the area and the longevity of all associated building elements.

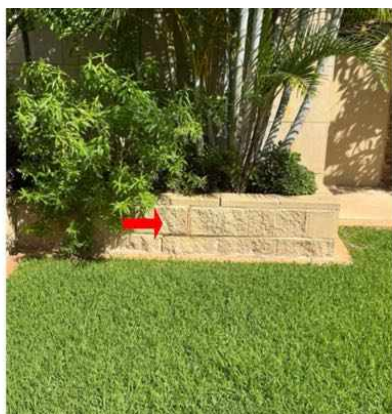
Finding 3.17

Building:	Main Building
Location:	All External Areas
Finding:	Retaining wall - Defective - Small planter wall cracking
Information:	The retaining wall in this area was found to be defective at the time of inspection. Generally, defective retaining walls are caused by poor original design or material use. However, deteriorated retaining walls may also be a result of substandard construction, poor site drainage or unmanaged stormwater flows.

Significant repair and replacement should be expected. Where retaining walls are considered structural walls, a structural engineer / surveyor should be consulted regarding required remedial works. Otherwise, a landscaper or retaining wall installer may be appointed to repair or replace the wall, at the discretion of the client.

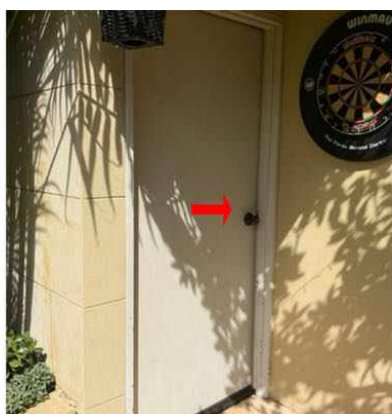
Finding 3.18

Building:	Main Building
Location:	All External Areas - Rear Shed
Finding:	Door - Binding/jamming
Information:	Binding and/or jamming of this door is evident during standard operation. This defect inhibits the functionality of the affected door as well as creating potential for secondary defects to associated building elements, such as damage to the floor covering.

For minor causes, a qualified carpenter or general handyperson should be appointed to perform minor rectification works at client discretion.

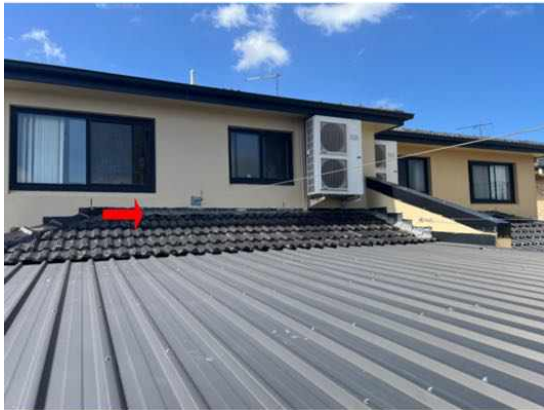
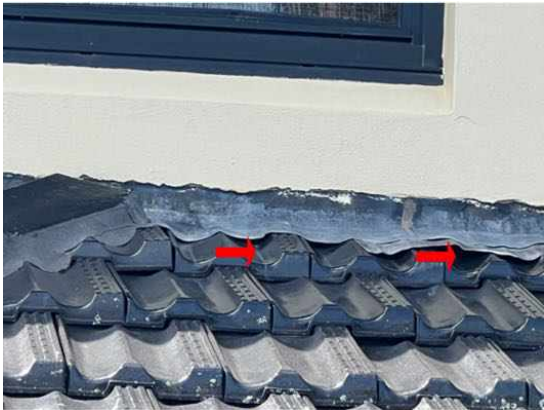
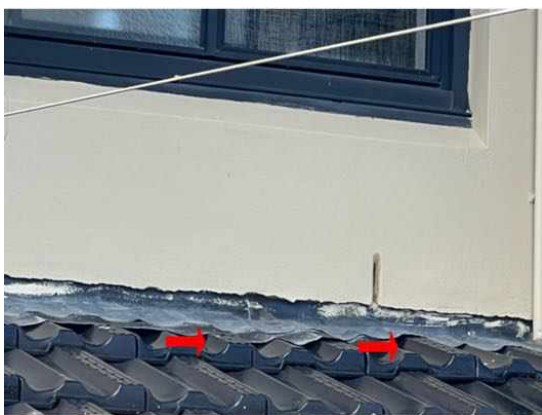
Finding 3.27

Building: Main Building
 Location: Roof Exterior
 Finding: Flashing defective -poor installation
 Information: The metal flashing at the wall junction appears inadequately installed, with visible gaps add or lifting and reliance on surface sealant rather than a properly chased and continuous detail. The junction does not appear fully weather-tight, increasing the risk of moisture ingress into the wall cavity or roof structure over time. Defective flashing installation can lead to concealed deterioration if not addressed. Recommend assessment and rectification by a qualified roofing contractor to ensure compliant and effective weatherproofing.

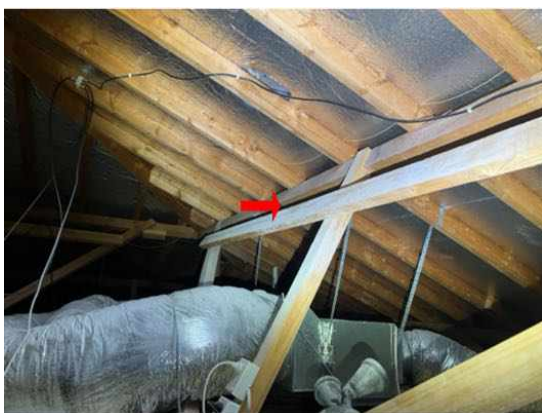
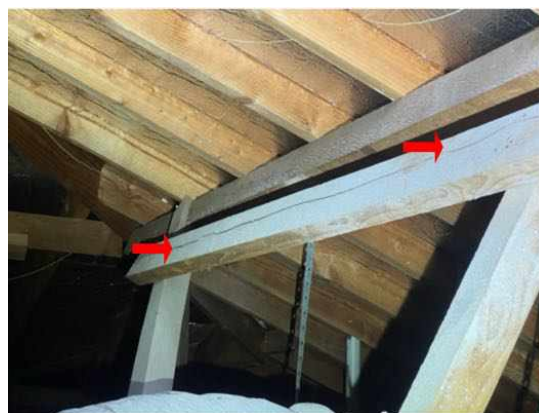
Finding 3.28

Building:	Main Building
Location:	Roof Void
Finding:	Roof Void Observation – Timber Splitting in Roof Framing
Information:	Hairline longitudinal splits were observed in roof framing members within the roof void. No signs of distortion, bowing, deflection, moisture ingress, or fungal decay were evident at the time of inspection. Current structural integrity does not appear compromised; however, routine monitoring during future roof or ceiling access is recommended. A licensed carpenter should be consulted to access further.

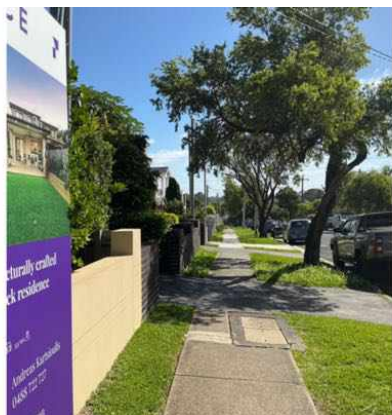
Finding:	Trees within 50m
Information:	Trees within 50m of the property can be conducive to termite activity. It is recommended an invasive inspection of all trees within 50m to the property be carried out by a qualified pest control expert.

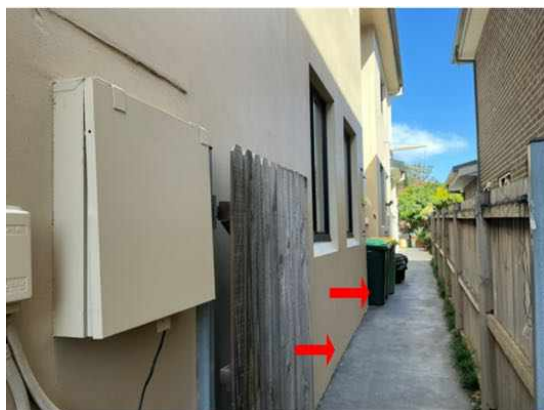
Finding 6.03

Building:	Main Building
Location:	All External Areas
Finding:	Slab Edge - Exposure
Information:	An inspection zone of at least 75mm in relation to the exposed slab edge, between the bottom brick and the perimeter pavement, is required. This inspection zone should be maintained in order to force termites into the open where they can be detected more readily during regular inspections. The slab edge should not be concealed by anything that may prevent inspection of the area, including render, landscaping, soil, turf, paving, concrete cladding or other structures.

Where the slab edge cannot be properly inspected, it is highly recommended that termite or timber pest inspections be carried out every 6-12 months to aid protection of the property against infestation.

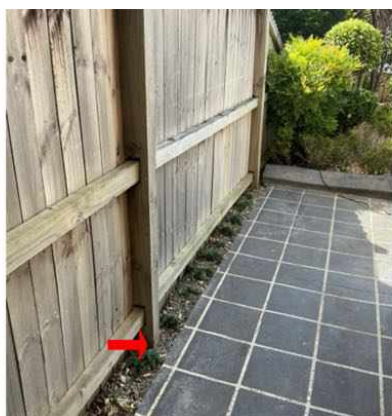
Finding 6.04

Building:	Main Building
Location:	All External Areas
Finding:	In ground contact - Timber
Information:	Any timbers in direct ground contact provide opportunity for concealed termite entry and are likely to be subject to premature rot and decay as the soil retains moisture or damp conditions against the timbers.

Remove untreated timber that is in direct contact with external grounds. Consider replacement with more durable materials i.e. treated timber or non timber elements. Frequent pest inspections are advised to readily identify any termite activity in these areas.
