## Building and Timber Pest Inspection Report

Inspection Date: Fri, 30 Jan 2026

Property Address: Unit 1/33 Windermere Ave, NORTHMEAD,  
NSW, 2152, Australia

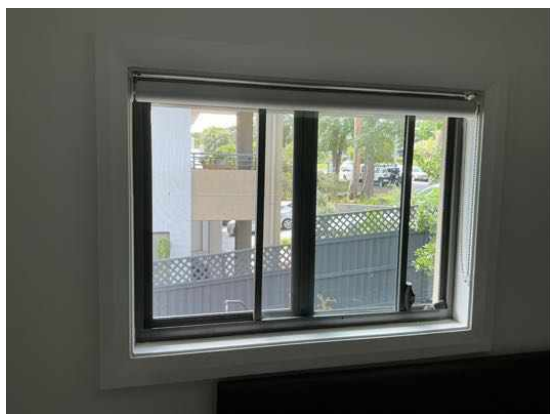
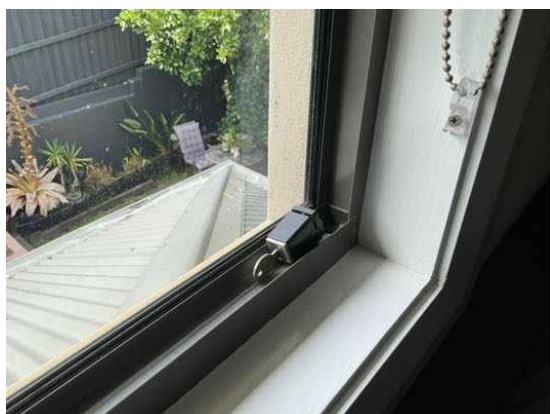
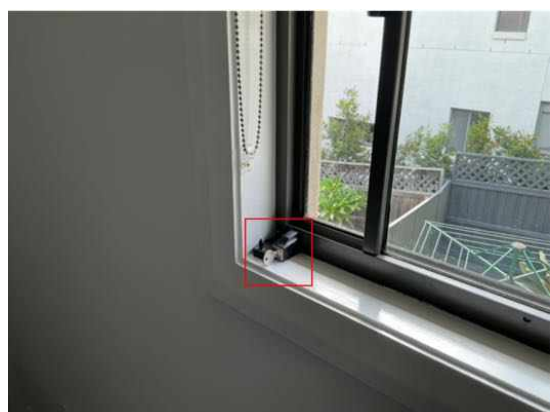
Building:	Main Building
Location:	All Areas > Upstairs
Finding:	Safety hazard - Window restrictors.
Information:	At the time of inspection, window restrictors were not present on one or more openable windows in the second-level.

The absence of window restrictors in this location presents a potential fall hazard, especially for children or vulnerable occupants.

It is recommended that a licensed window installer or builder be engaged to assess

This issue should be rectified as a priority to ensure occupant safety

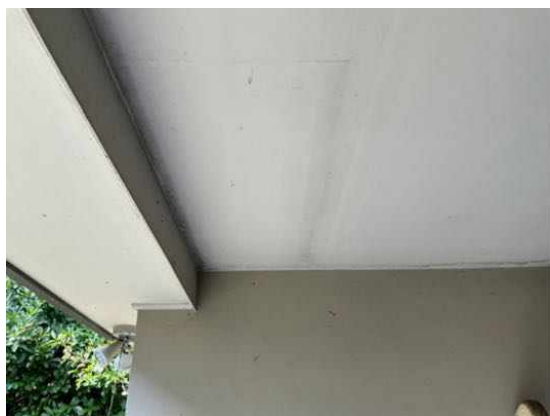
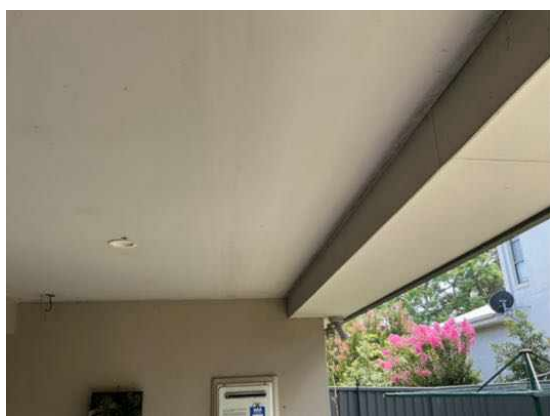
Building:	Main Building
Location:	Alfresco > All Areas
Finding:	Mould on alfresco ceiling
Information:	Mould growth was noted along the plaster setting lines to the alfresco ceiling at the time of inspection. This type of mould formation commonly occurs where moisture affects the plaster setting compounds, which are more porous than the surrounding plasterboard surface and therefore more susceptible to moisture absorption. Alfresco areas are particularly prone to this condition due to exposure to humidity, condensation and wind-driven moisture. The pattern of mould growth along the setting lines suggests that the surface may not have been adequately prepared or sealed prior to painting.

Where setting compounds are not properly sealed or primed, moisture can permeate into the plaster, creating conditions conducive to mould growth. The application of a suitable sealing or oil-based primer prior to painting is generally required to isolate the setting compound, reduce moisture absorption and minimise the risk of mould reoccurrence.

It is recommended that the affected areas be cleaned, treated for mould, appropriately sealed with a suitable primer and repainted to reduce the likelihood of ongoing mould formation.

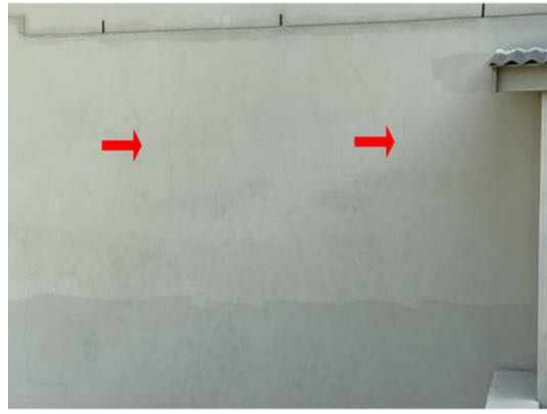
Building:	Main Building
Location:	Exterior walls > All Areas
Finding:	Surface - Marked
Information:	The external walls were noted to contain numerous surface marks, and hairline cracking was visible through the finish coatings at the time of inspection. These conditions are generally consistent with normal ageing, minor building movement and exposure to the elements for a dwelling of this age. The cracking observed was minor in nature and does not indicate a structural concern; however, it detracts from the overall presentation of the building. These items are noted as appearance-related conditions only and may be addressed as part of routine maintenance or future repainting at the client's discretion.

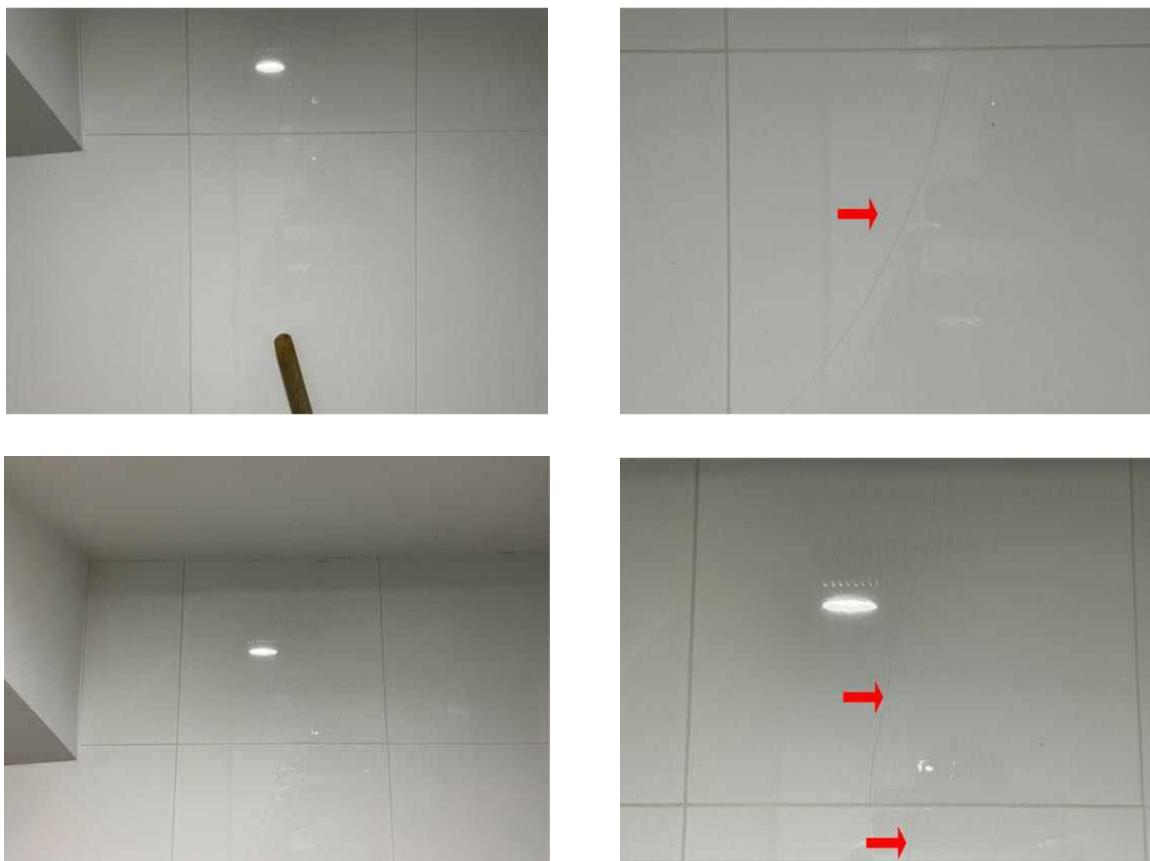
### Finding 3.11

Building:	Main Building
Location:	Laundry > Lower-Ground Level
Finding:	Tiles - Cracked
Information:	Multiple tiles within the laundry, located to the left of the garage, were noted to contain hairline cracking at the time of inspection. The cracking observed appears consistent with minor movement and is commonly associated with shrinkage or differential movement of the substrate. While the cracking is currently minor and does not appear to affect the structural integrity of the floor, it detracts from the presentation and may worsen over time if movement continues. It is recommended that the affected areas be monitored and, if the cracking progresses or tiles become loose, a suitably qualified tiler be engaged to further assess and carry out repairs as required.

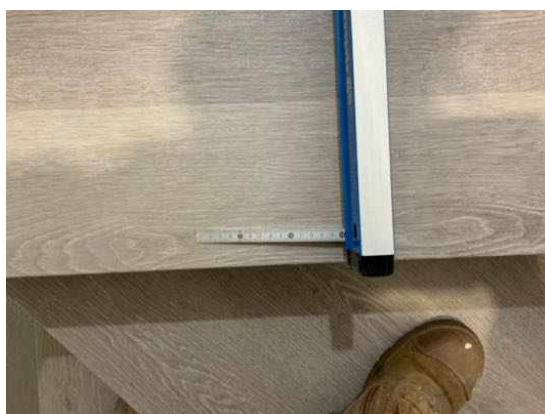
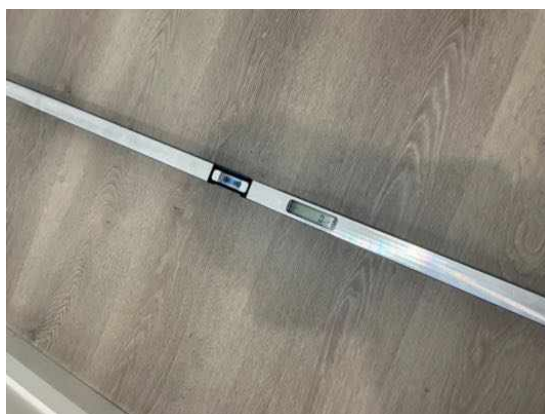
### Finding 3.12

Building:	Main Building
Location:	Stairs - Internal > Centre
Finding:	Flooring - Uneven
Information:	The flooring at the top of the internal staircase was noted to deviate underfoot at the time of inspection. When measured with a 1.8-metre straightedge, the floor was observed to deviate by approximately 15 mm over this length. Information provided by the current owner, who was present at the time of inspection, indicated that new floor coverings had recently been installed and previously laid carpet had been removed. The installation of floating floorboards in this area has accentuated both the visible and physical nature of the deviation.

The condition is most likely the result of incorrect set-out or alignment of the subfloor framing members during the original installation, rather than recent movement. No evidence was observed to suggest subsidence or significant structural movement, with surrounding building elements not displaying associated signs of footing or foundation movement.

While not considered a structural failure, the deviation exceeds typical expectations for floor levelness. It is recommended that a suitably qualified builder or carpenter be engaged to further assess the subfloor framing and determine appropriate rectification options.

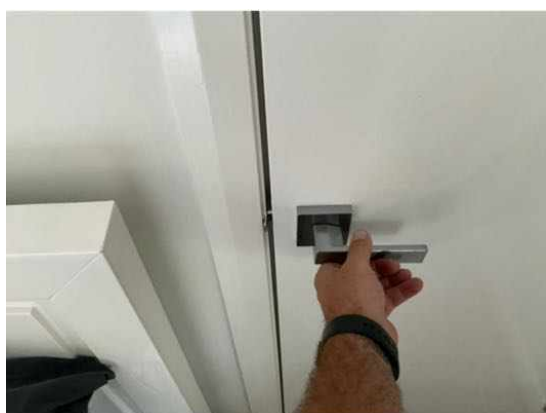
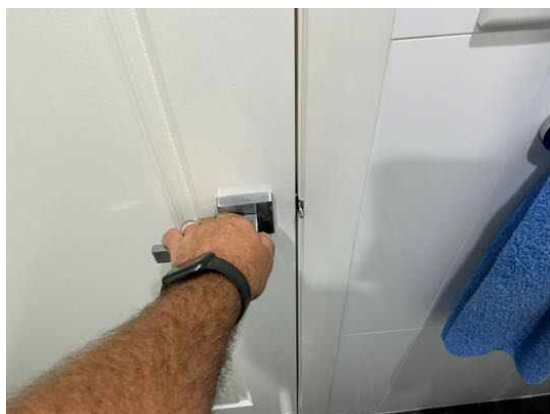
Building:	Main Building
Location:	Bedroom and bathroom. > Upstairs
Finding:	Door handle - Not latching
Information:	It was noted that the rear left bedroom and bathrooms door handles were not latching during operation at the time of inspection. Whilst detracting from the functionality of this building element, this minor defect may also be a security risk, and may therefore have serious implications if left unattended.

It is suspected that this defect has occurred due to minor issues with the associated hinges. Such damage is identified as general wear and tear, which is expected for building elements of this age.

A qualified carpenter or general handyperson may be appointed to perform rectification works as necessary, at client discretion. If left unattended, further functional impairment is likely to occur.

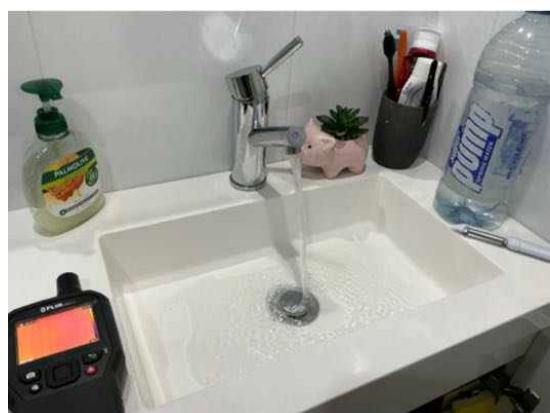
### Finding 3.15

Building:	Main Building
Location:	Ensuite > Upstairs
Finding:	Sealant and grouting - Missing or damaged
Information:	It was noted on inspection that sealant was missing from the back of the vanity in the ensuite bathroom.

Different materials and floor areas move at different rates, generally causing cracking to grout or sealant at this point. A flexible sealant is required to allow for expected expansion and contraction, while keeping the joint water tight and protective of all associated building materials.

Flexible and mould resistant materials should be applied to affected areas to prevent any subsequent water damage that is likely to occur. Regular maintenance and replacement of damage or missing or damaged sealant and grout is highly recommended to the wet areas, as this is a regular wear and tear defect. Sealant and grouting in areas that come into regular contact with water should be maintained for the long term care of your property.

A sealant specialist should be appointed to complete these works as soon as possible

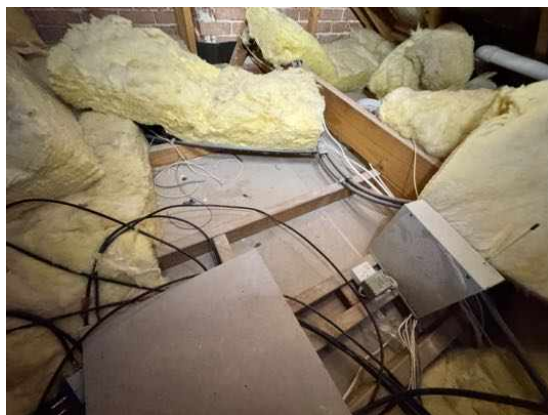
Building: Main Building  
 Location: Roof Void > All Areas  
 Finding: Insulation - Inadequate  
 Information: Upon inspection of the roof void it was noted that insulation had been removed from the intended spacing between the bottom cords of the roof trusses and stock piled within the roof void.

Caution should be exercised when accessing the roof void. Do not attempt to stand on the framework to the underside of the trusses and be aware there is a potential for electric shock if contact is made with exposed or faulty electrical wiring.

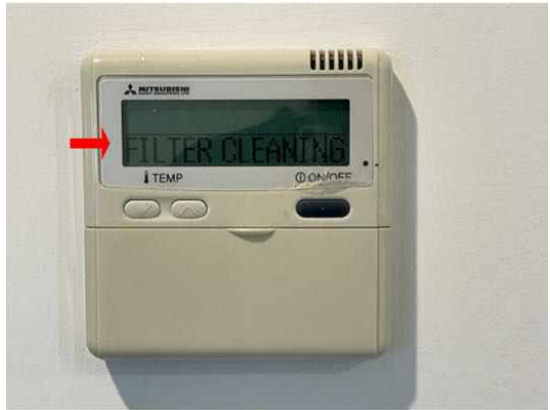
Building: Main Building  
 Location: Hallway > Upstairs  
 Finding: Air conditioning - For your information.  
 Information: The ducted air-conditioning indoor control module was observed to display the message “filters cleaning” during normal operation at the time of inspection. The system appeared to be operating and providing conditioned air as intended at the time. This item is noted for the information of the client only, as no functional fault was identified during the inspection; however, it is recommended that the owner monitor the system and seek further advice from a suitably qualified air-conditioning technician if the message persists or system performance is affected.
