Building Inspection Report

Inspection Date: Thu, 12 Mar 2026

Property Address: 402/6 Gillespie St, Liverpool NSW 2170,
Australia

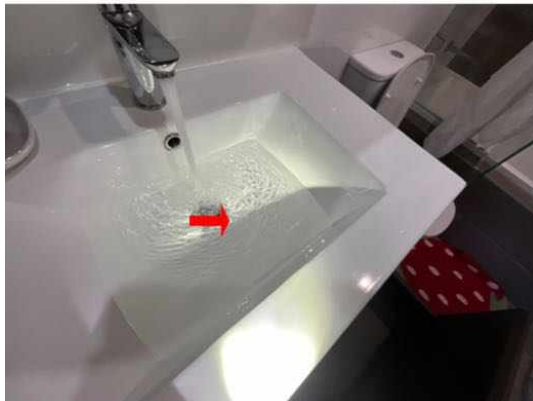
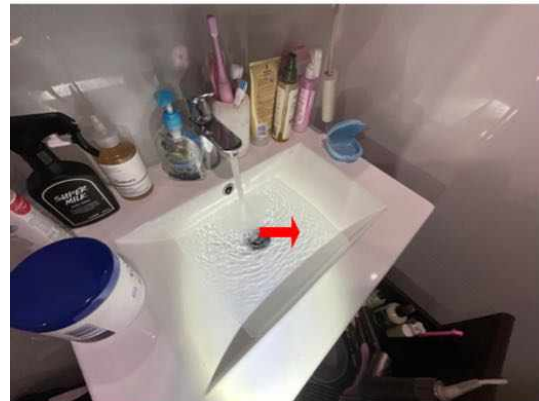
Defects 3.01

Building: Main Building
 Location: Bathroom, ensuite
 Finding: Sink/basin - slow draining
 Information:

The sink/basin drain appeared to be partially blocked at the time of inspection. Blockages here are usually caused by hair and other debris. If left unmanaged, a lack of general maintenance may lead to the development of more significant defects, such as water damage to surrounding building materials.

A licensed plumber should be appointed to remove the blockage at the client discretion.

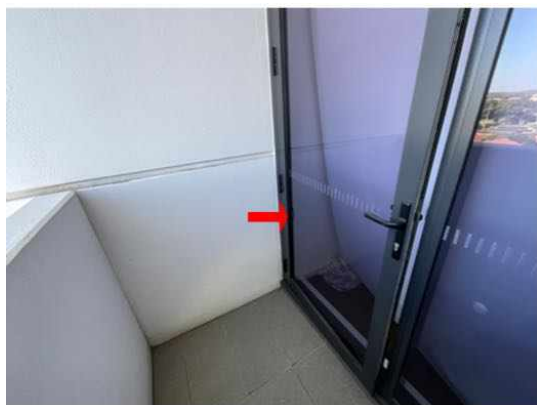
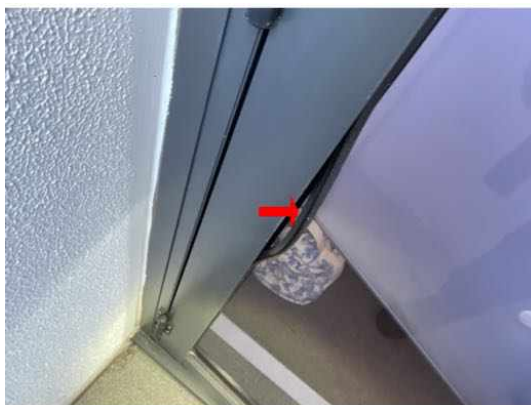
Defects 3.02

Building: Main Building
 Location: Bedroom - Master
 Finding: Window rubber seals - Inadequate
 Information:

This window seal is in a generally poor condition. Poor workmanship during the initial construction phase of the building is suspected to be the cause.

The window is no longer weather-tight; rain penetration and subsequent water damage is therefore likely to ensue. Insulation of the area against external weather conditions will also be compromised.

It is highly recommended these seals be repaired or replaced by a sealant expert to prevent any further damage and to restore the window to a fully functional level.

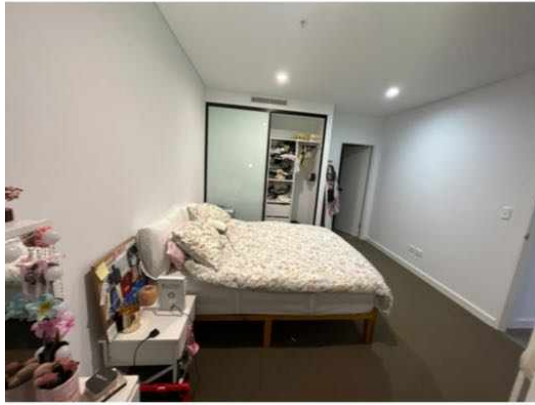
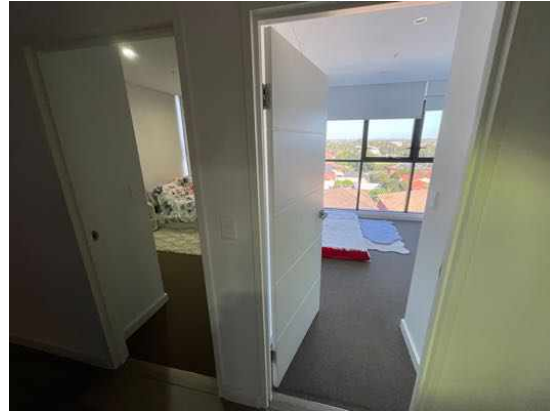
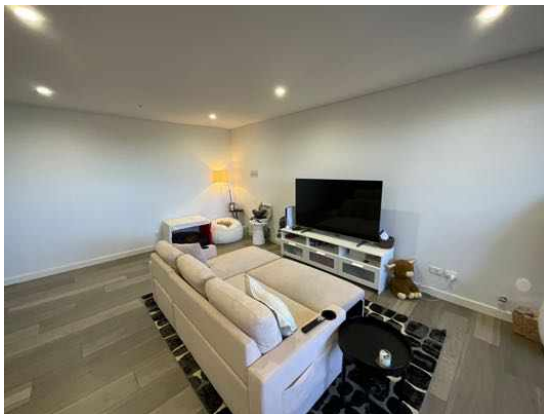
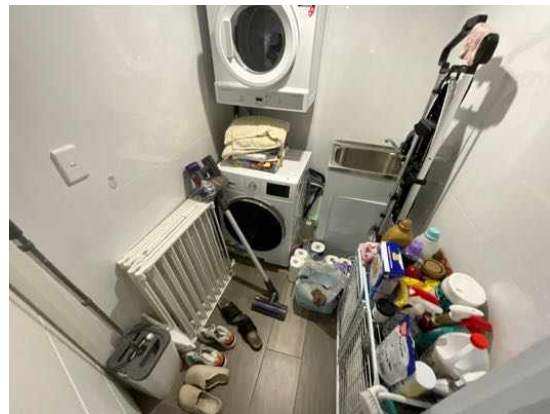
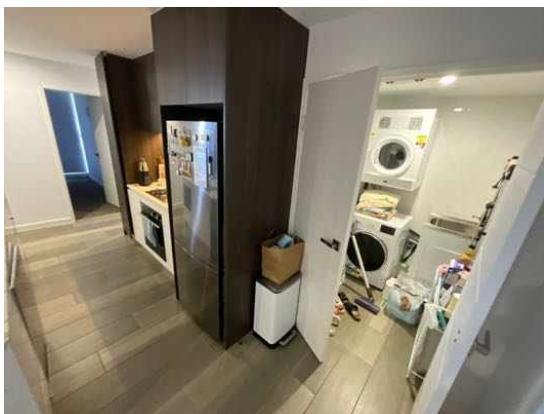
Finding: Additional Photos - Obstructions and Limitations

These photographs are an indication of the obstructions and limitations which impeded full inspection of the property at the time of inspection. These obstructions can hide an array of defects and should be removed to allow full inspection to be carried out. A re-inspection is recommended once the areas are made accessible.
