Building and Timber Pest Inspection Report

Inspection Date: Fri, 27 Mar 2026

Property Address: 71/17 Piccadilly St, Bellmere QLD 4510,
Australia

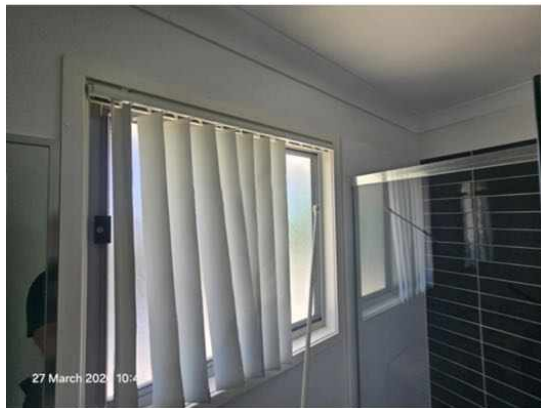
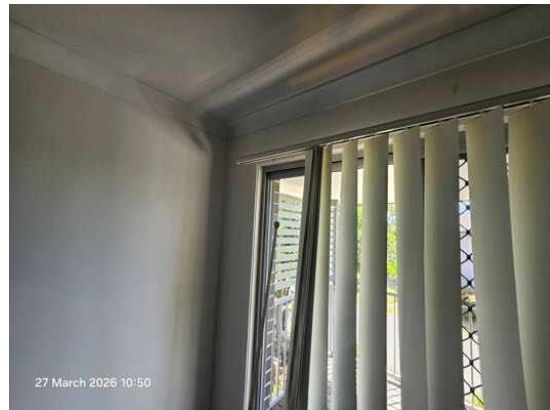
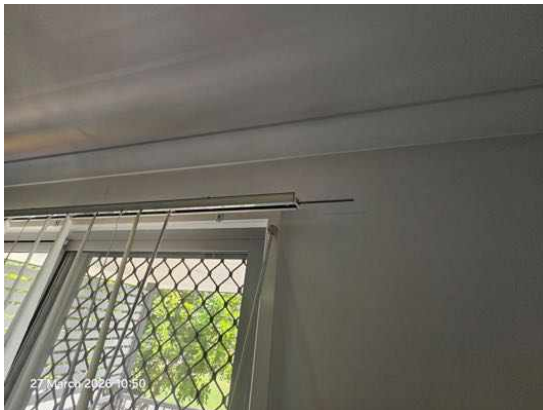
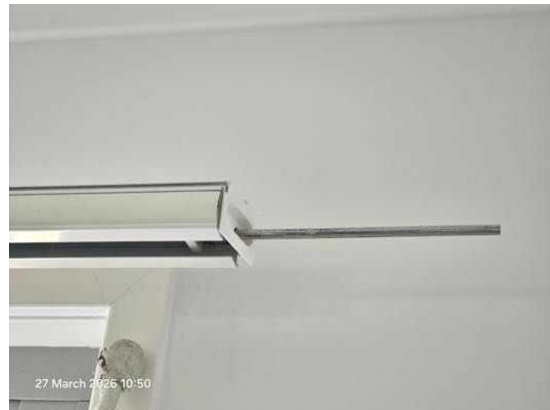
Finding 3.01

Building: Main Building
Location: As shown
Finding: Vertical blinds - broken
Information: During the inspection it was noted that the vertical blinds in the ensuite and master bedroom are broken and not operating as intended.

The client could have this replaced or removed at their discretion.

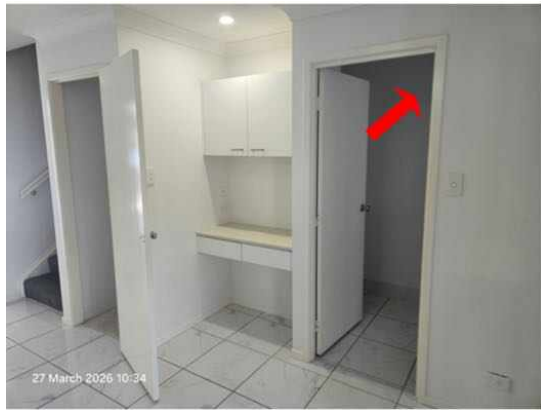
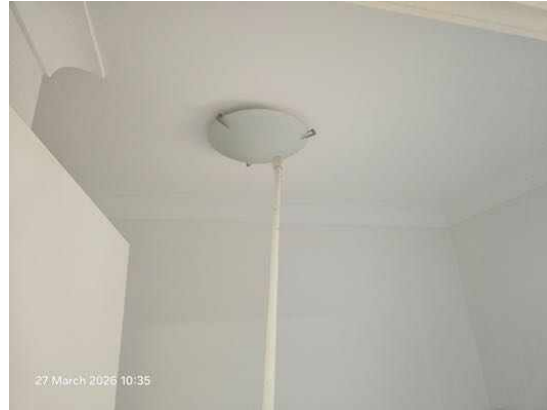
Finding 3.02

Building: Main Building
 Location: Toilet (WC)
 Finding: Light fittings - non operational
 Information: During the inspection, internal light fitting of the WC was noted as being on operational. This may be due to faulty globes or faulty fittings. It is not assessed by the inspector as it is out of scope.

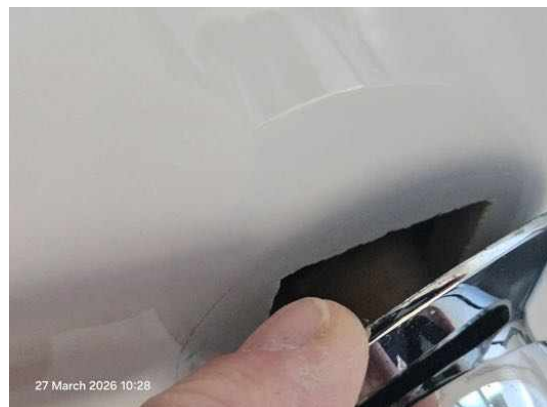
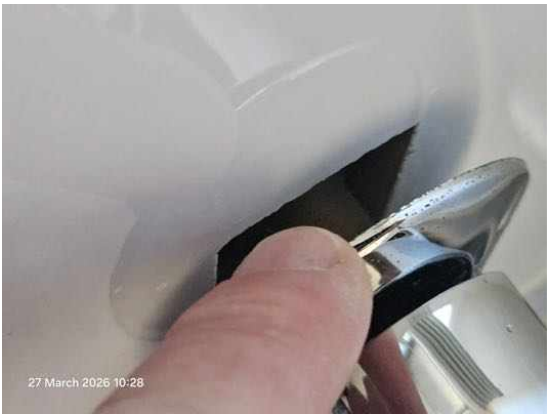
Finding 3.03

Building: Main Building
 Location: Laundry
 Finding: Sealant behind taps
 Information: It was noted on the inspection that the sealant behind the taps of the laundry tub was missing. Sealant in these penetrations is integral to maintaining a waterproof seal and is an important part of the membrane.

A licensed tiler or suitably qualified handy person could be engaged to renew these sealants.

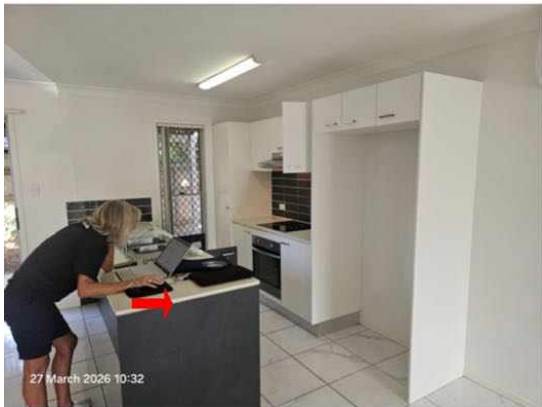
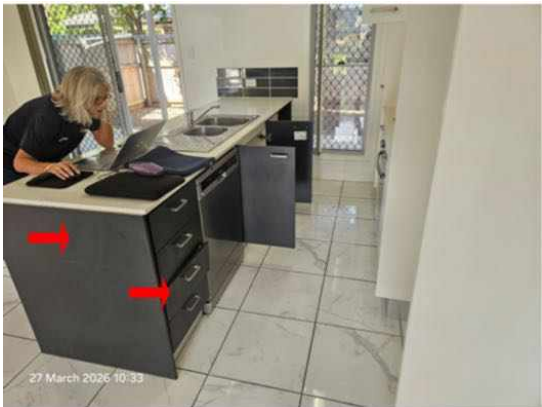
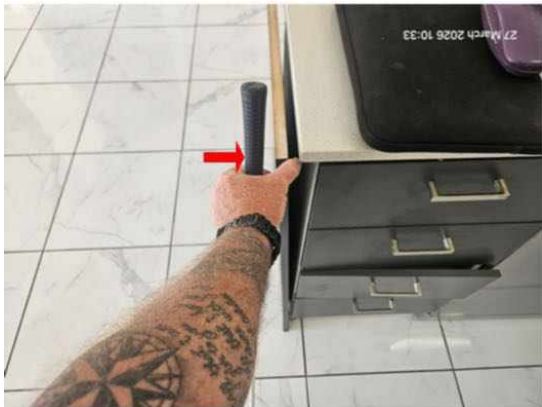
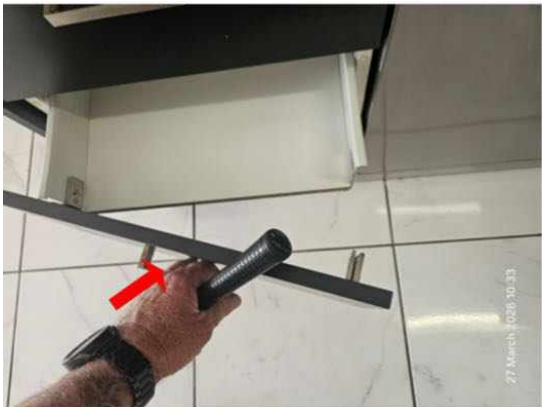
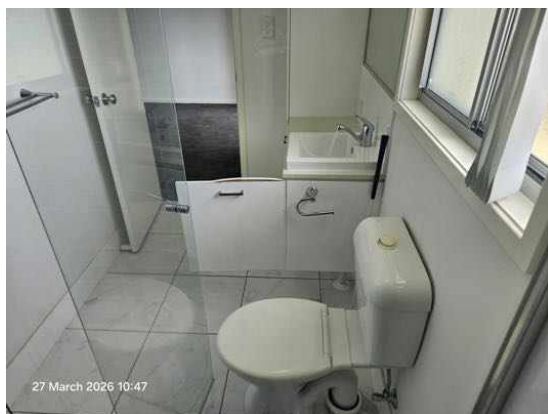
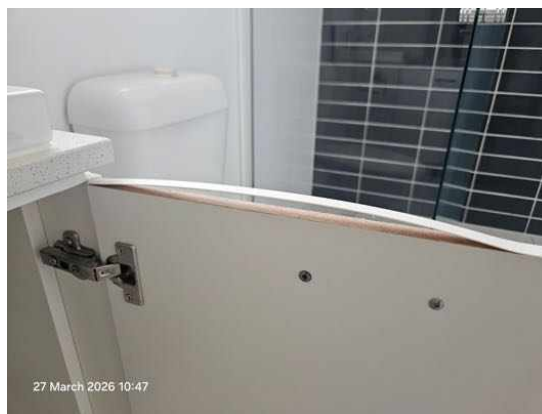
Finding 3.04

Building: Main Building
Location: Kitchen, ensuite
Finding: Kitchen & ensuite cabinetry
Information: Whilst inspecting the kitchen and ensuite, aspects of the cabinetry were noted as requiring minor repairs. The drawer front is loose and the gable end is not fixed into place, and the edge tape has become delaminated from the vanity door.

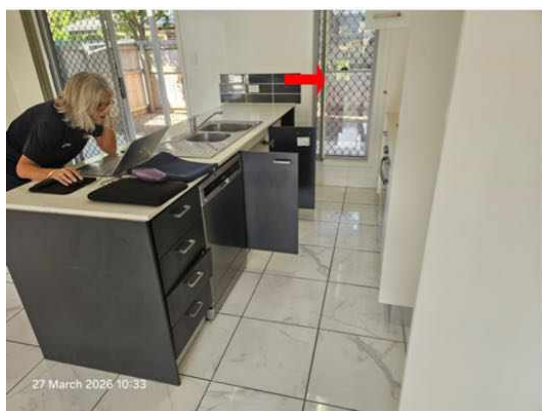
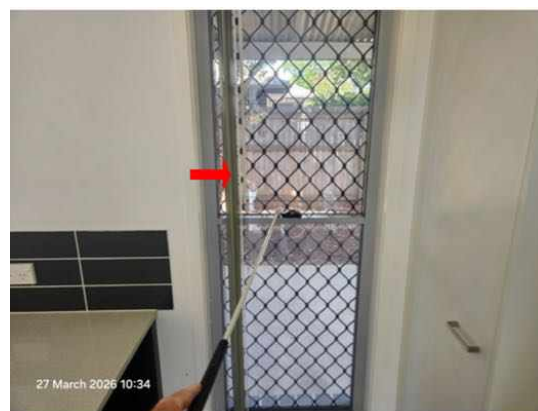
Finding 3.05

Building:	Main Building
Location:	Kitchen
Finding:	Windows - operation
Information:	During the inspection the windows are checked for functionality. The aluminium double hung window in the kitchen is stiff to slide, unable to be opened easily or are heavy to lift, possibly due to the balances around weights being defective.

A suitably qualified trade person could be engaged to service the windows at the clients discretion.

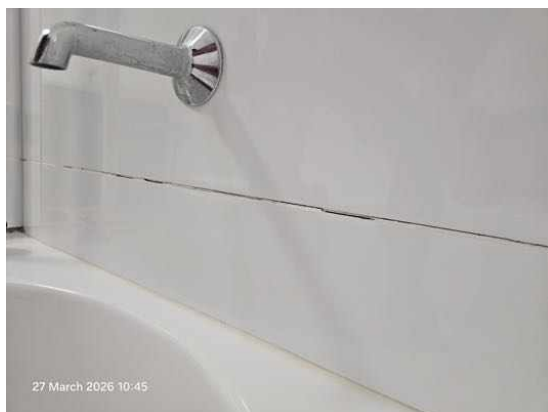
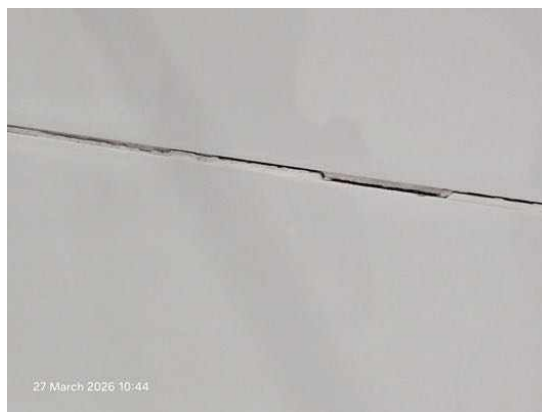
Finding 3.07

Building: Main Building
 Location: Bathroom
 Finding: Grout - degraded
 Information: It was noted on inspection that the grout is degraded to the tiles of the shower recess. There was a noticeable crack above the bath taps in the grout joint.

Although not defective at this time, deterioration is noted and renewal work will be required in the short term.

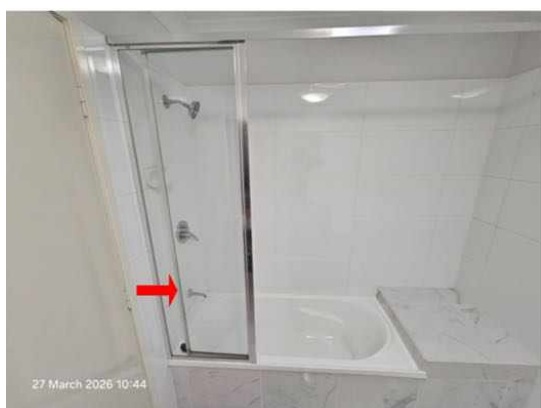
Finding 3.08

Building:	Main Building
Location:	Bathroom
Finding:	Shower screen - Cracked
Information:	Cracking was evident to the shower screen at the time of inspection, which is suspected to be due to accidental impact damage.

While the cracking appears to be minor, any further impact may lead to additional cracking and or shattering of the shower screen, creating a potential safety hazard in the area. Further damage would almost certainly necessitate replacement of the entire shower screen.

A qualified glazier is required to repair the shower screen as soon as possible. Please be advised that any persons coming into contact with the cracked shower screen should do so with due caution to avoid any personal injury that may ensue.

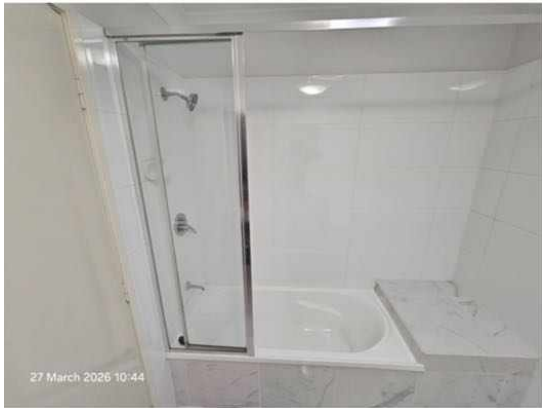
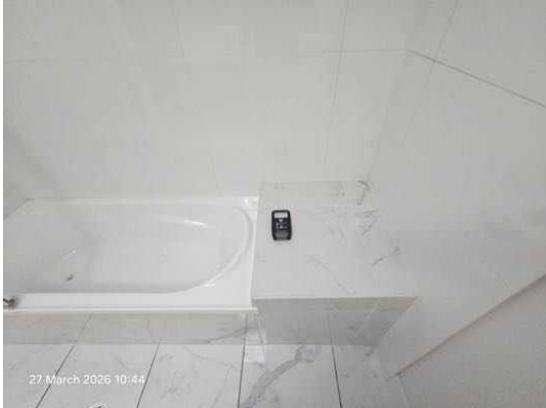
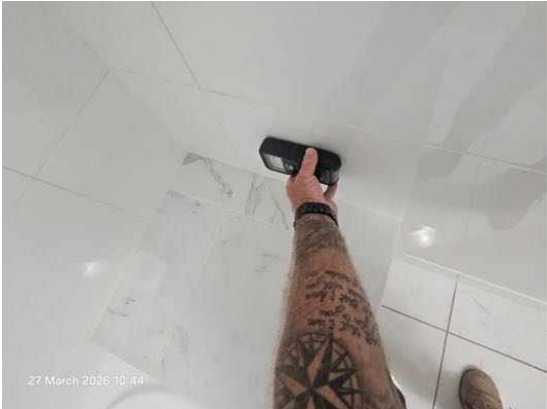
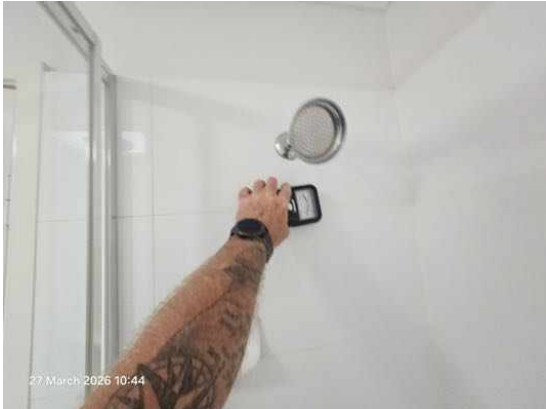
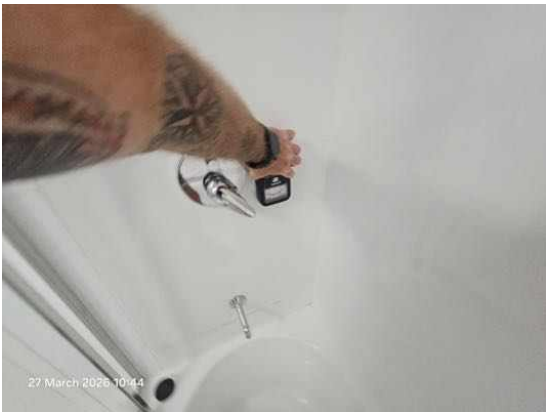
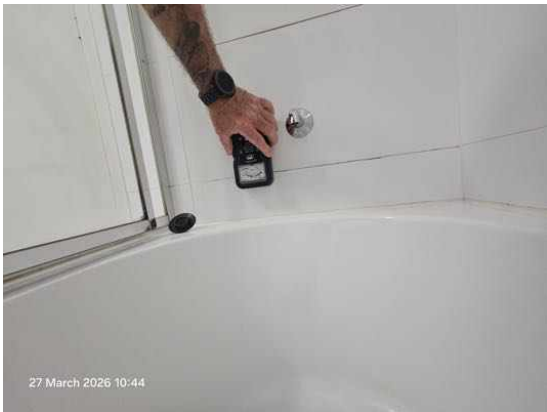
Building: Main Building
Location: Bathroom, ensuite
Finding: No moisture detected in bathroom / ensuite
Information: On the day of inspection the showers in the bathroom/s and ensuite are measure for moisture using a "Tramex" moisture meter. During this inspection no moisture was detected in these areas and the tiled / sheeted surfaces appear to be in good order.

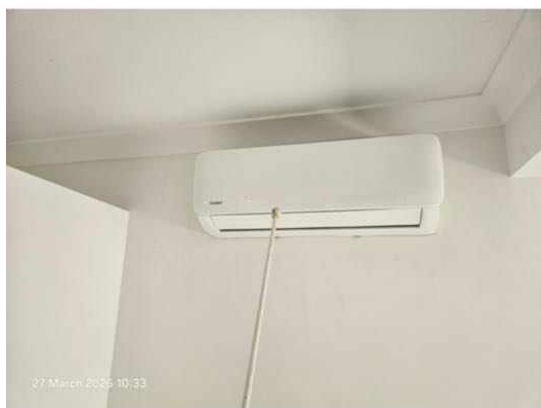
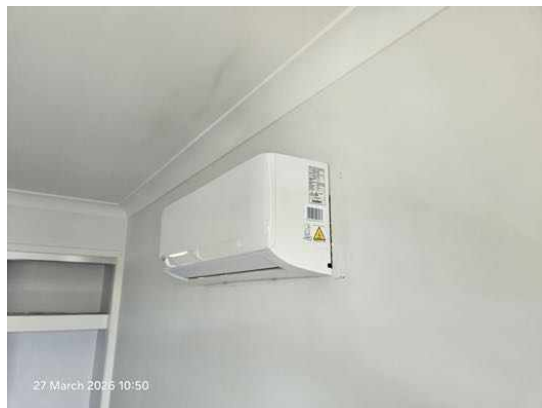
Building: Main Building
 Location: As shown
 Finding: Air conditioner operation
 Information: On the day of inspection the air conditioners in the master bedroom and living area could not be turned on to check the operation. The remotes were not found on the day. It is recommended that the client have the agent test them.

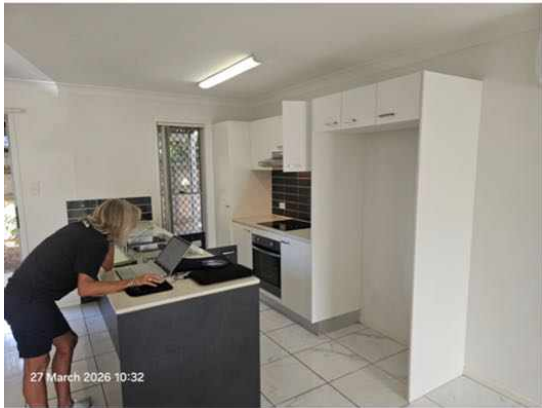
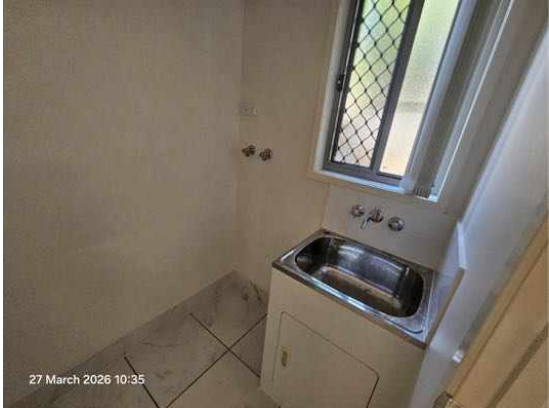
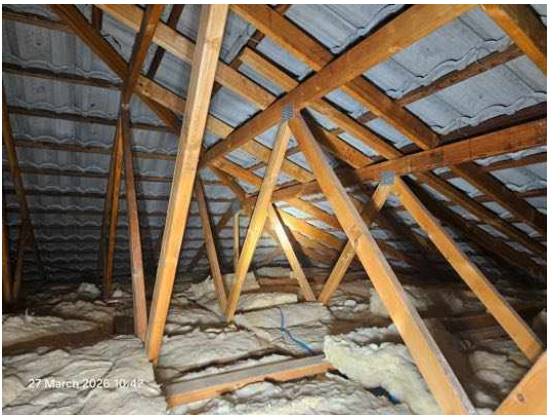
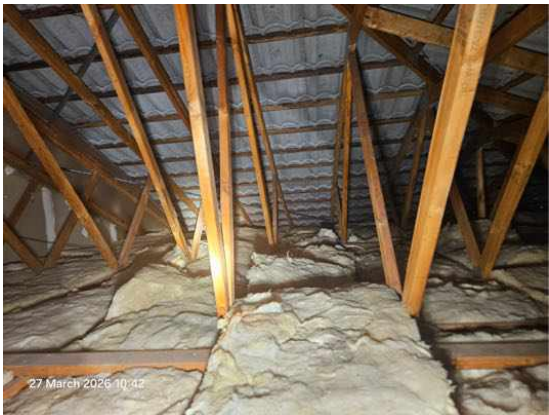
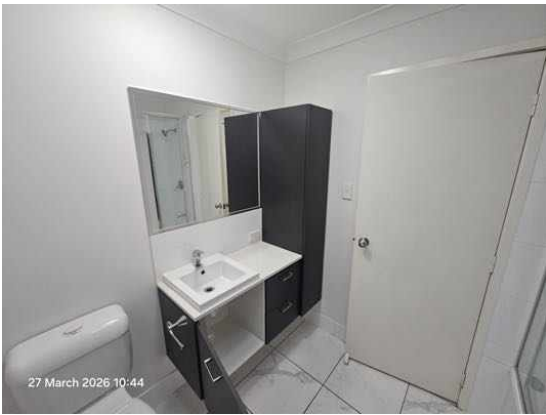
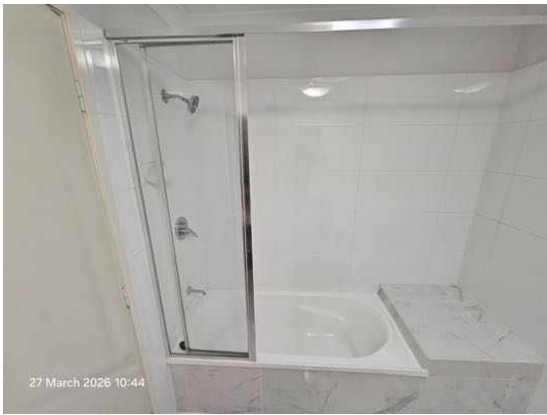
Building: Main Building
Location: All Areas
Finding: Additional Photos - Obstructions and Limitations
Information: These photographs are an indication of the obstructions and limitations which impeded full inspection of the property at the time of inspection. These obstructions can hide an array of defects and should be removed to allow full inspection to be carried out. A re-inspection is recommended once the areas are made accessible.

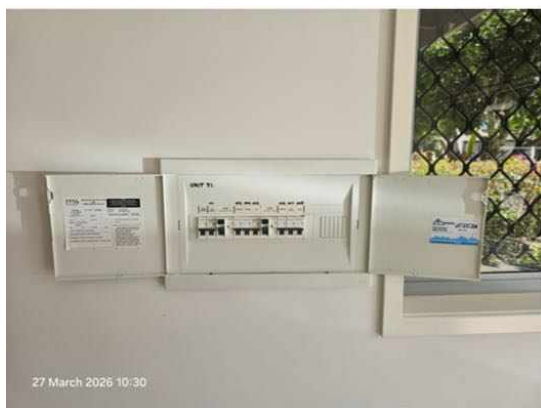
Building: Main Building
 Location: Meter box, kitchen cupboard
 Finding: Durable pest inspection notice
 Information: On the day of inspection it was noted that the durable pest inspection / treatment notice was in place and the most current inspection was notated and in date. These notices / stickers are to verify the timber pest inspection dates, the inspector, and, at times, the currency and type of timber pest system / barrier in place or being used in and around the property.

The client is advised to maintain annual inspections with the company listed or a company of their choosing.

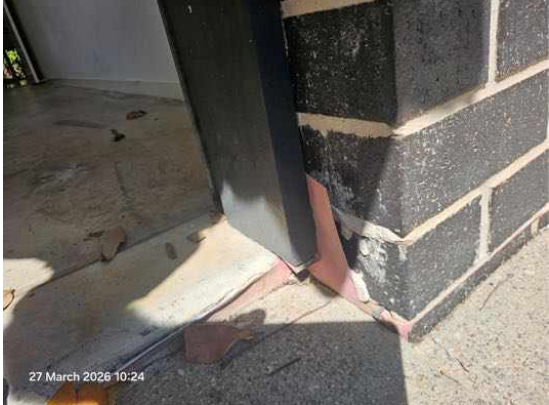
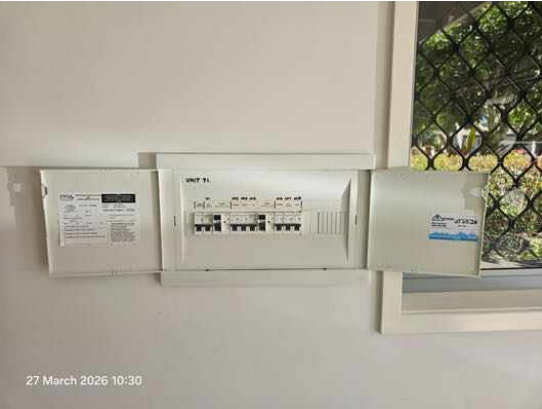
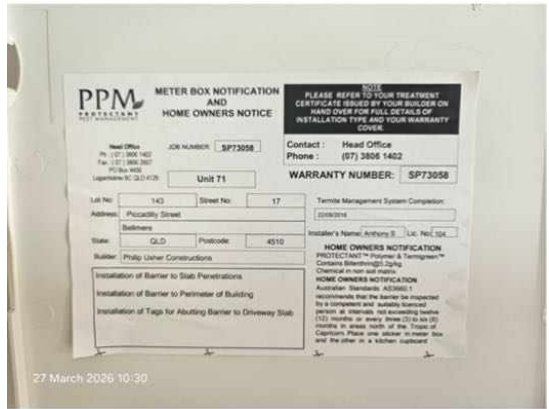
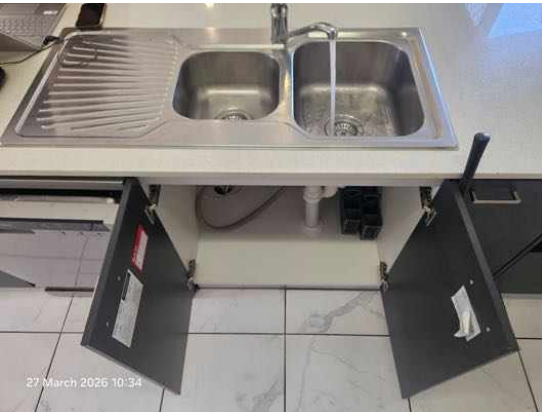
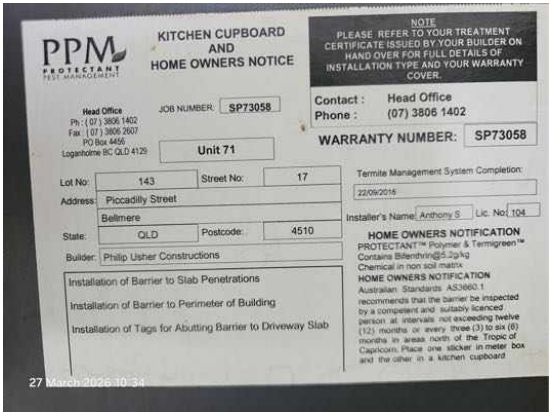
The building employs a "Protectant" physical barrier system to the perimeter and slab penetrations. In order for a barrier system to be effective, the property must have regular inspections at intervals of not greater than 12 months. Depending on the risk profile attributed to the property, these inspections may be recommended at lesser time periods.
