Building and Timber Pest Inspection Report

Inspection Date: Wed, 18 Mar 2026

Property Address: 3 Warrane Rd, Roseville Chase NSW 2069,
Australia

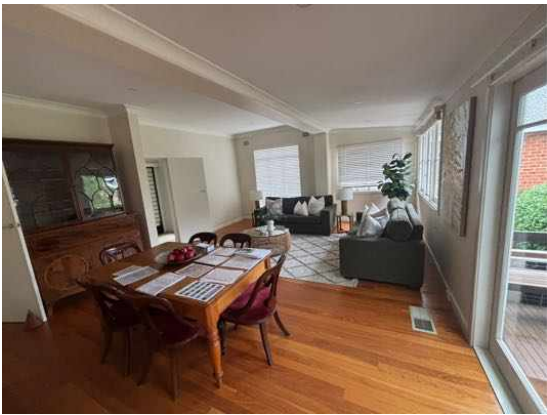
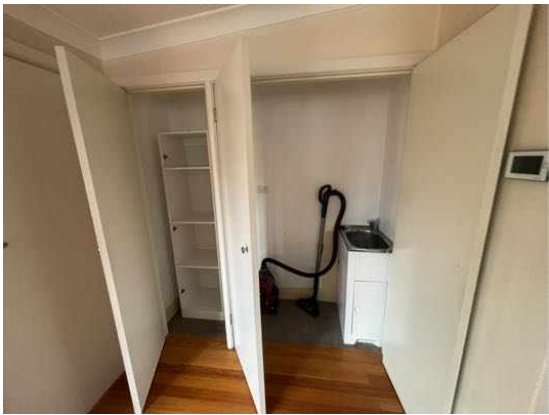
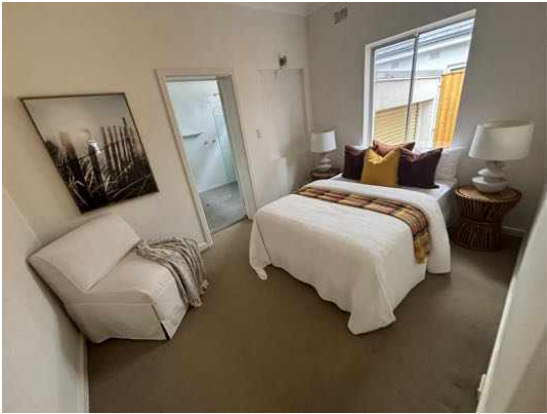
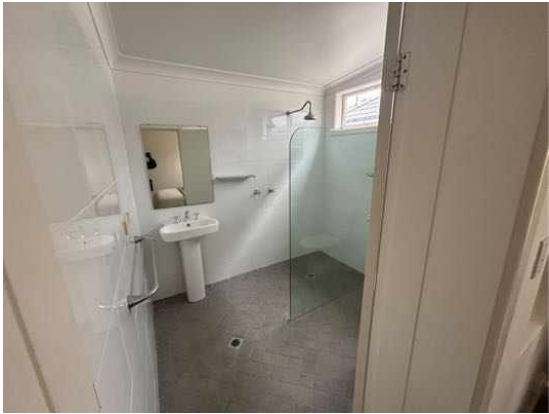
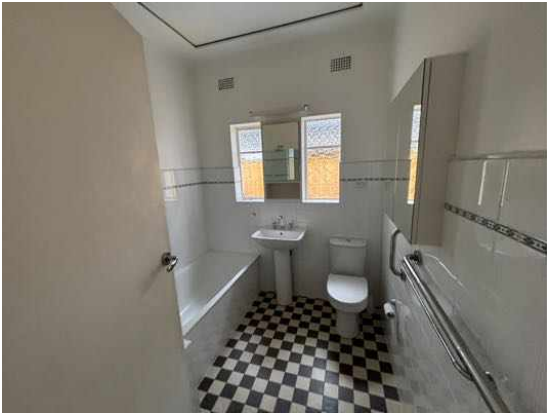
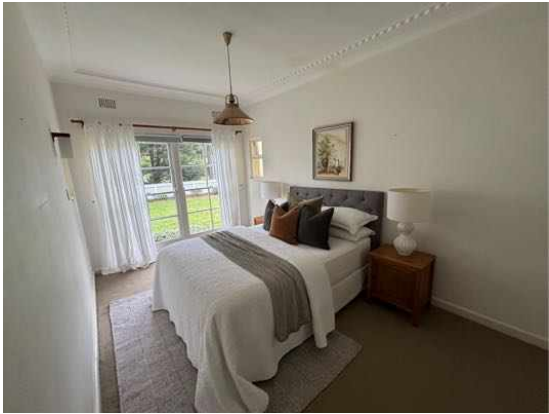
In summary, the limitations encountered during the inspection highlight the importance of ensuring full access to all areas of the property to accurately assess its overall condition. A re-inspection is strongly advised once these areas are made accessible.

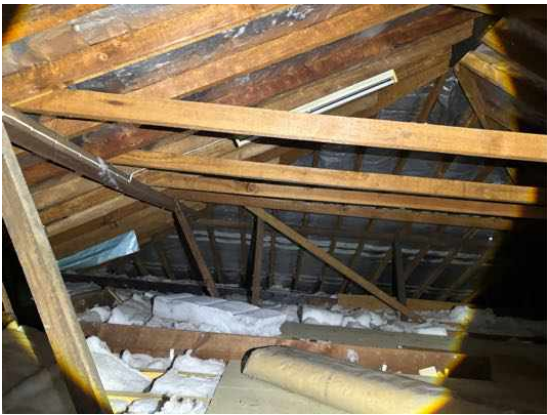
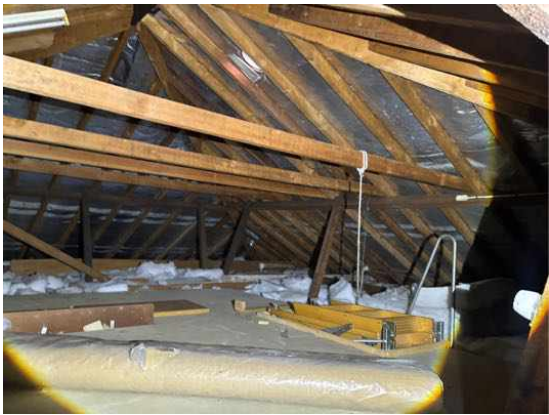
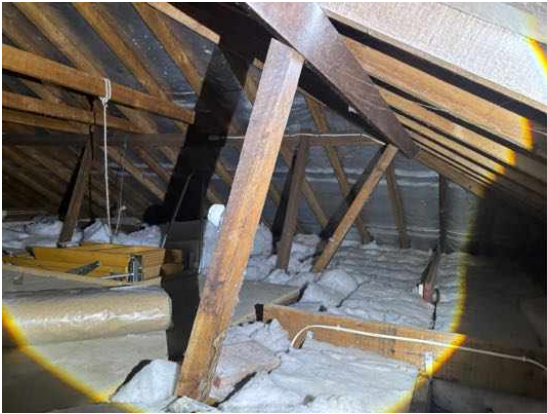
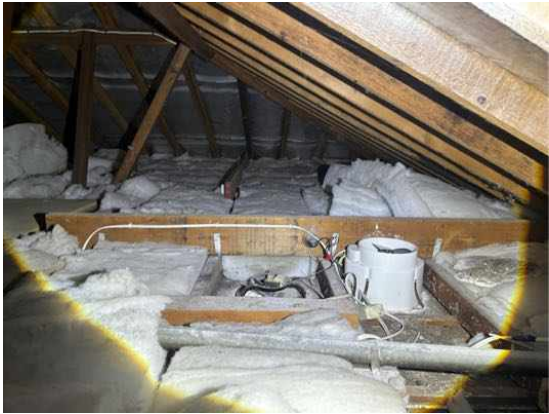
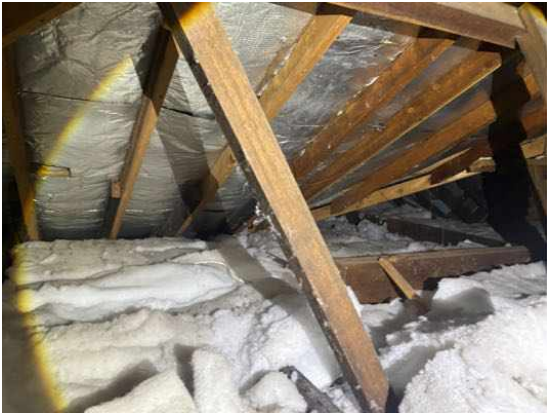
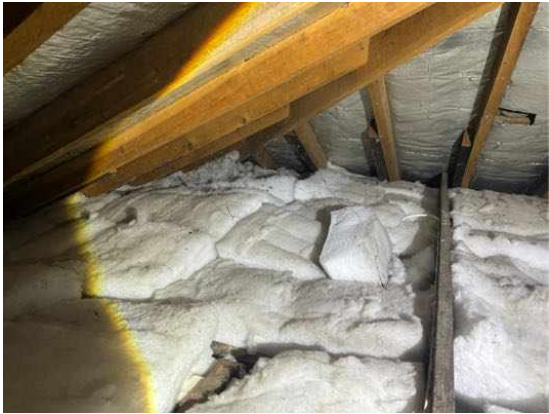
Noted Item

Building: Main Building
 Location: Roof Void
 Finding: Obstructions, Limitations, and General Roof Space Condition
 Information: The photographs provided document both the general condition and the obstructions and limitations that were present in the roof cavity of the main building at the time of inspection. These obstructions—such as insulation materials, stored items, structural elements, or electrical wiring—restricted safe and adequate access to key areas within the roof space. As a result, a comprehensive inspection of all components could not be completed.

It is recommended that these barriers be removed or repositioned to facilitate full and safe access to the roof space. Once clear, a follow-up inspection should be conducted to allow for a thorough assessment of all concealed areas. This will help ensure that the condition of the roof cavity is accurately evaluated and any hidden issues are appropriately identified and addressed.

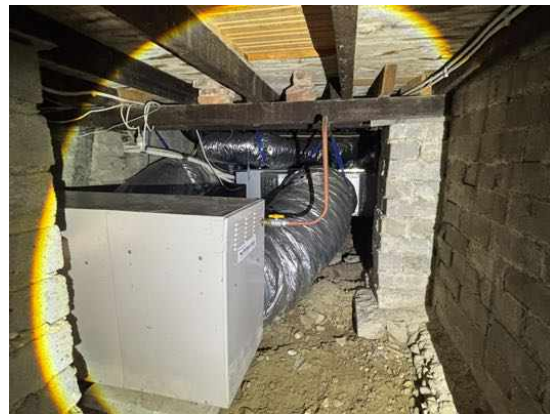
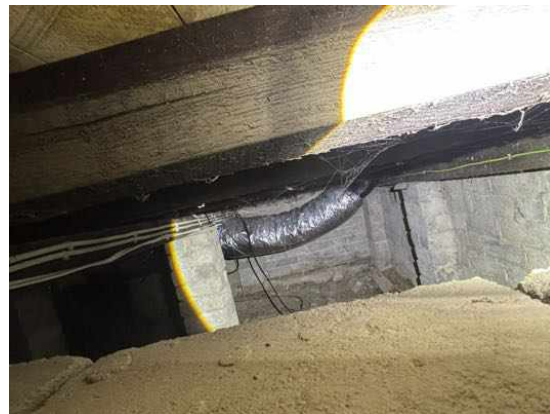
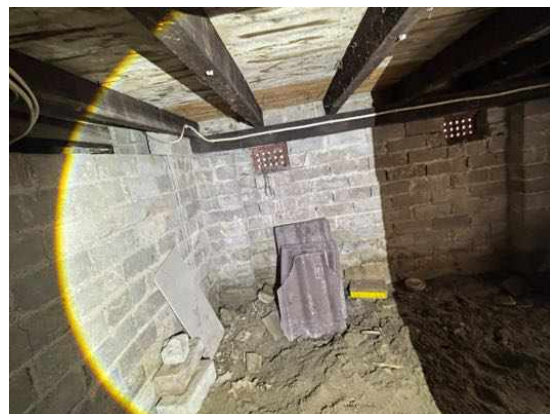
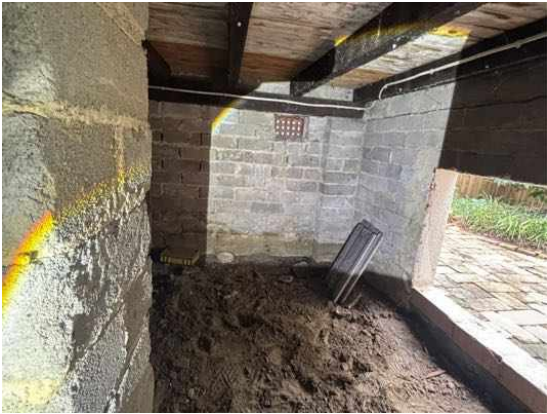
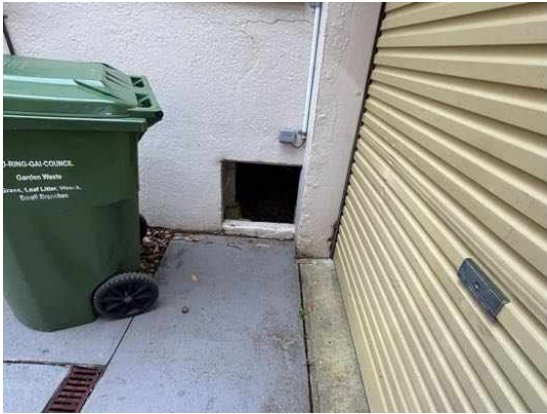
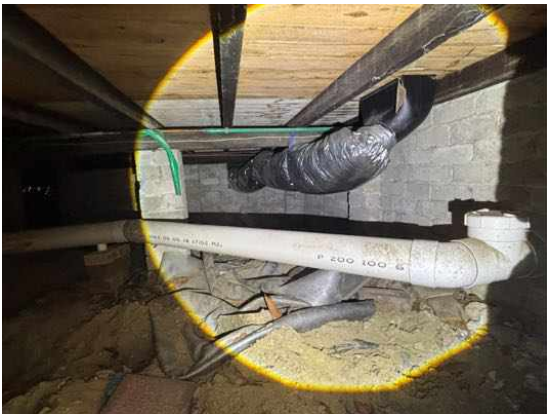
Noted Item

Building: Main Building
Location: Subfloor
Finding: Obstructions, Limitations, and General Subfloor Condition
Information: The attached photographs illustrate the obstructions and access limitations that restricted a full inspection of the subfloor area of the main property at the time of assessment. Items such as stored materials, construction debris, low-hanging services, and insulation impeded movement and visibility within key sections of the subfloor. In addition, the limited crawl height further restricted safe access to inspect critical structural components.

important elements such as floor joists, bearers, stumps, drainage, subfloor ventilation, and signs of moisture or pest activity. These obstructions may also conceal defects such as timber decay, water ingress, termite damage, inadequate support, or ventilation issues that are not immediately visible during a limited inspection.

While no major concerns were identified in the accessible areas, a full and unobstructed inspection is necessary to properly assess the overall condition of the subfloor. It is recommended that obstructions be removed and access improved where possible. Once adequate clearance is provided, a re-inspection should be arranged to ensure that any concealed defects can be identified and addressed accordingly. This will assist in providing a more comprehensive understanding of the subfloor's condition and reduce the risk of unforeseen issues.

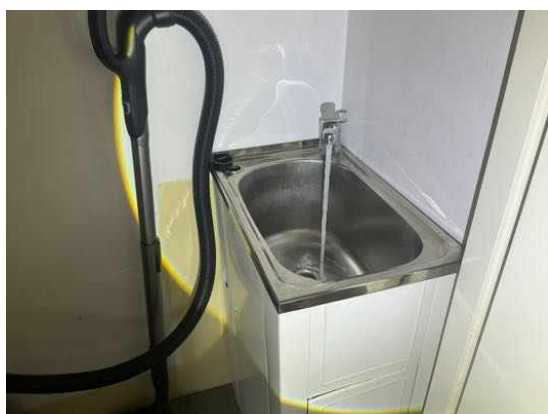
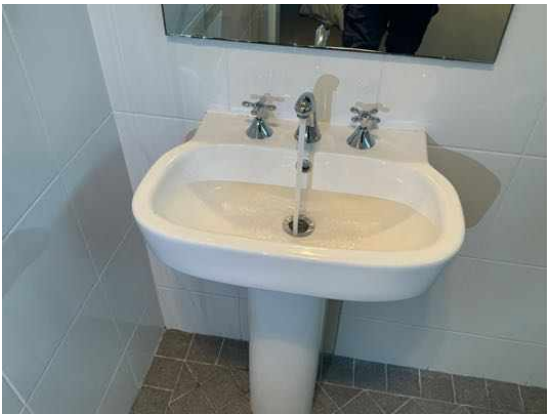
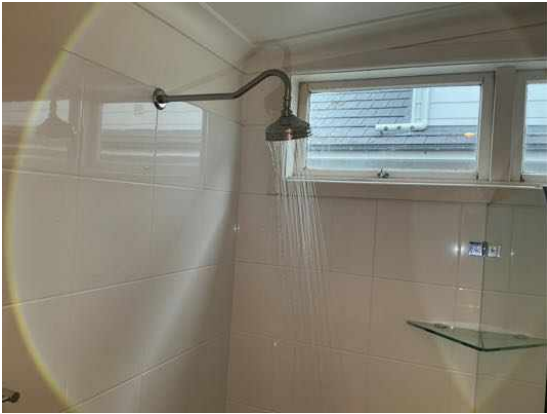
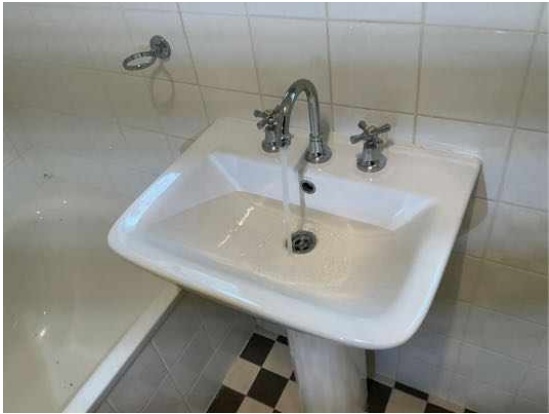
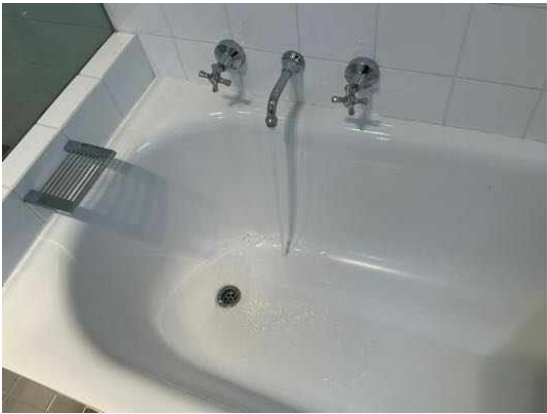
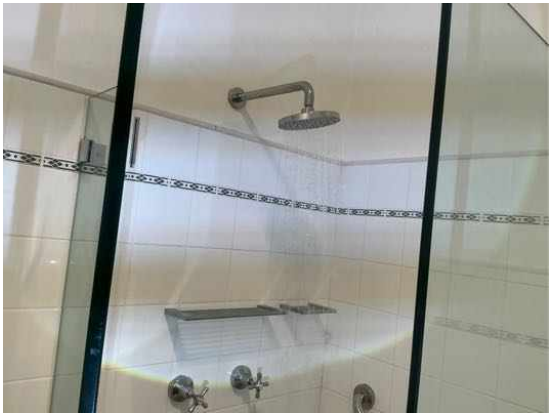
It is important to note that while a visual inspection of cupboards and cabinetry beneath sinks and vanities was undertaken, stored personal items and fixtures presented obstructions that limited full visibility of the internal areas. As per standard inspection practices, inspectors are not permitted to move or disturb personal belongings during the inspection process. Therefore, only visible and accessible sections were inspected, and concealed water damage or plumbing defects may not have been detected.

Given this, a re-inspection is recommended after all obstructions have been cleared to allow for a comprehensive assessment of these areas. Regular maintenance and monitoring of plumbing and drainage systems is also advised to ensure ongoing functionality and early detection of potential issues.

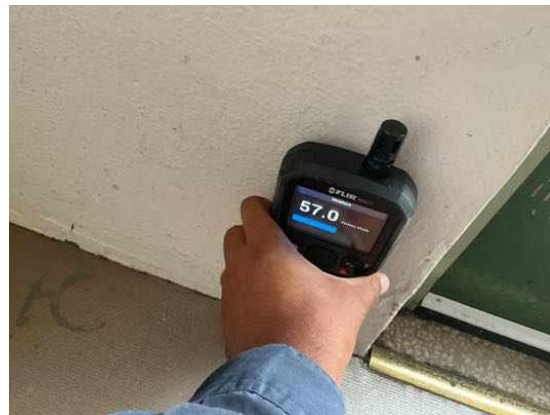
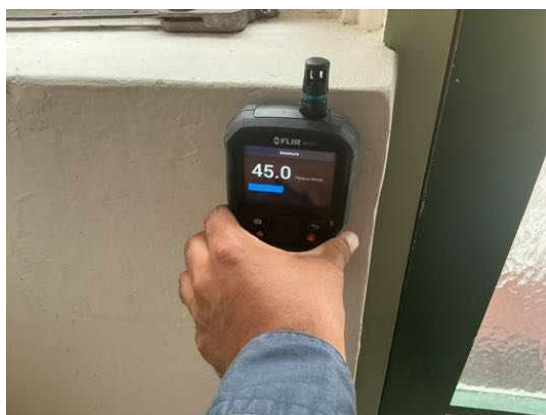
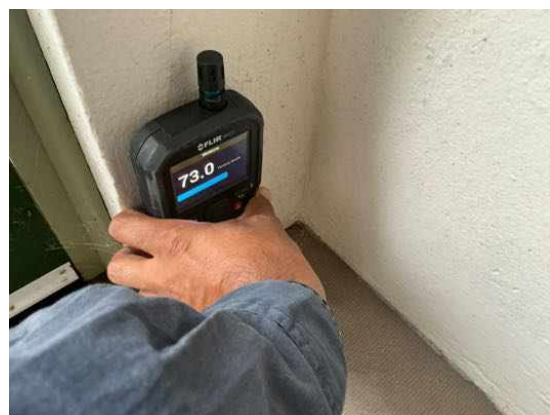
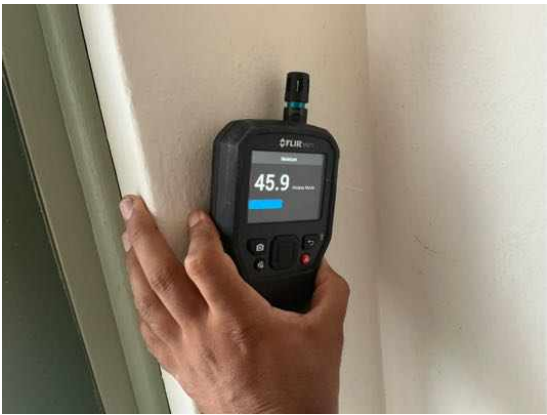
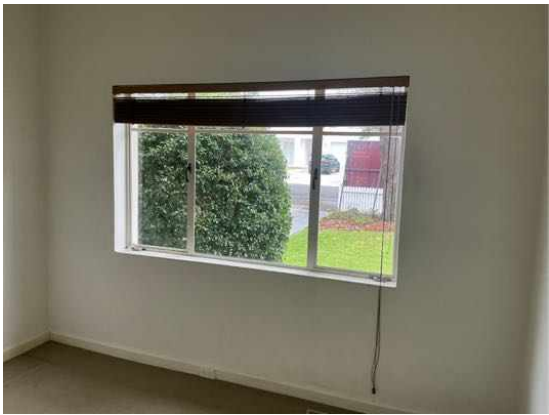
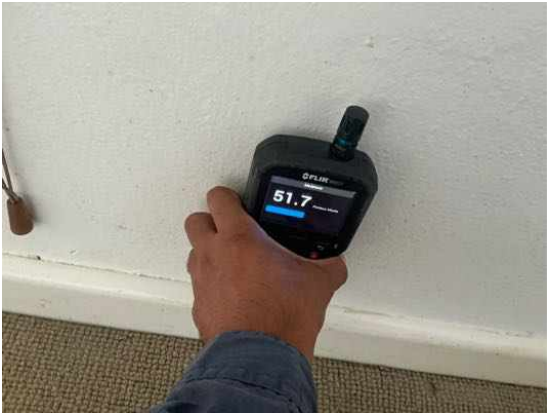
Noted Item

Building: Main Building
Location: All Areas
Finding: Additional Photos - Moisture Meter Readings
Information: Additional moisture meter reading photos have been provided for the property to offer further clarity on areas tested during the inspection. These photos are intended to give a visual reference for the specific locations where moisture levels were measured. These readings were taken at the time of the inspection to assess any potential moisture-related issues within the property. Any defects related to moisture that were identified during the inspection have been separately mentioned in the defect statements within the report.

It is important for the client to understand that moisture levels can fluctuate over time due to various factors, including changes in weather, humidity, and environmental conditions. While the readings reflect the property's moisture levels during the inspection, they may not represent future conditions, and increased moisture could lead to issues such as dampness, mould growth, or deterioration of building materials if left unmonitored.

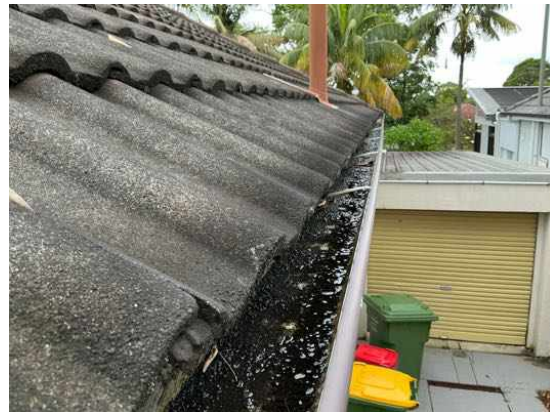
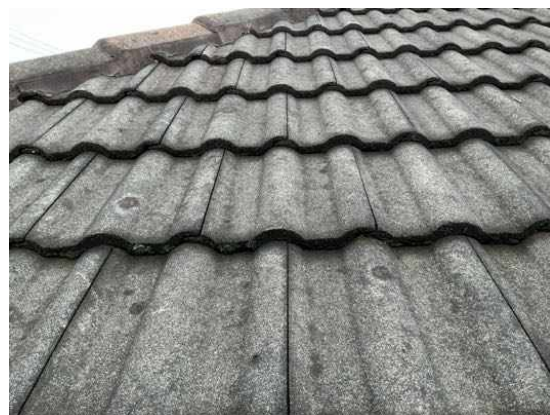
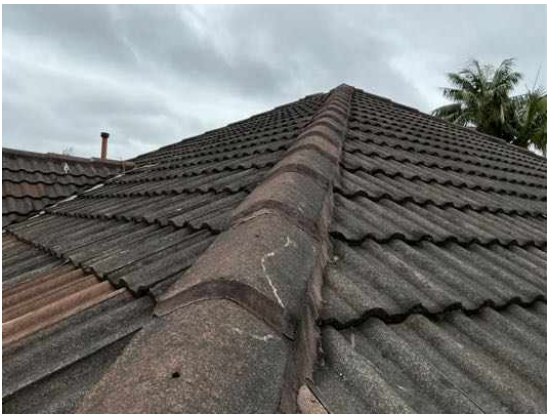
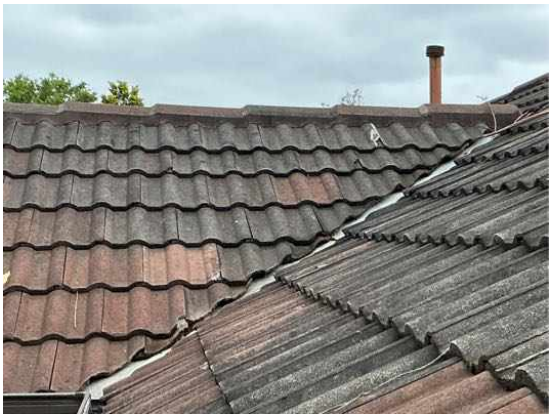
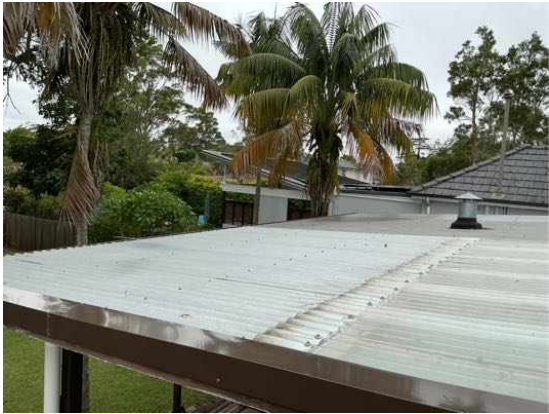
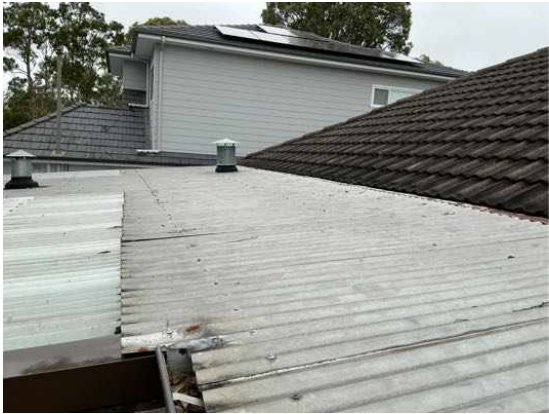
Noted Item

Building: Main Building
Location: Roof Exterior
Finding: Additional Roof Photos
Information:

As part of the information provided, please note that the attached roof photos represent the condition of the roof at the time of inspection. These photos are for visual reference only and do not constitute a detailed roofing assessment. Any defects or issues identified with the roof are mentioned separately in the defect statements. It is strongly recommended that the client engage a qualified roofer to conduct a thorough inspection of the roof, ensuring that any potential issues, such as leaks, structural integrity, or wear and tear, are properly identified and addressed.
