Building and Timber Pest Inspection Report

Inspection Date: Tue, 10 Mar 2026

Property Address: 5/38 McLean St, Liverpool NSW 2170,
Australia

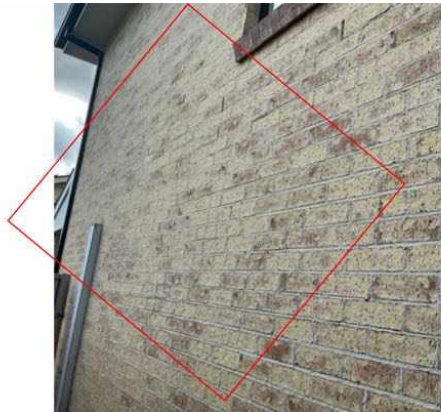
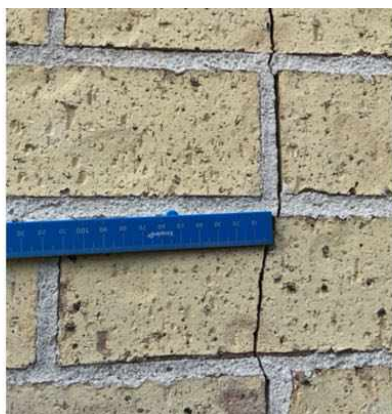
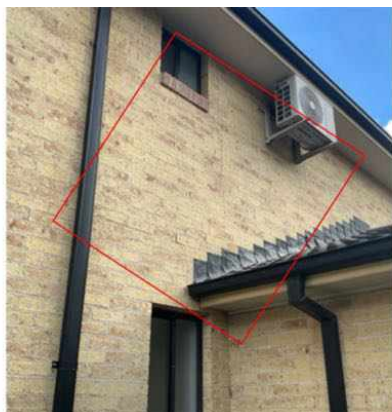
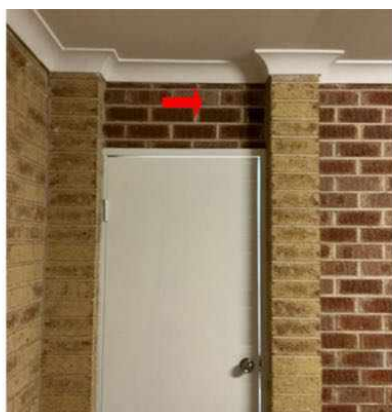
Finding 2.01

Building: Main Building
Location: All External Areas - Right , Left
Finding: Brickwork - Cracking noticeable
Information: Vertical cracking was observed within the external brickwork extending through multiple brick courses. The crack width is moderate and indicative of structural movement within the masonry. The condition may be associated with foundation movement or inadequate articulation within the wall system. Assessment by a suitably qualified structural engineer is recommended to determine the cause and appropriate remedial measures.

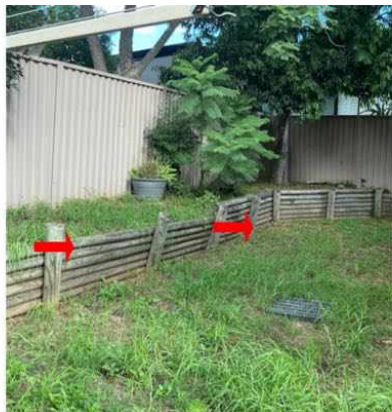
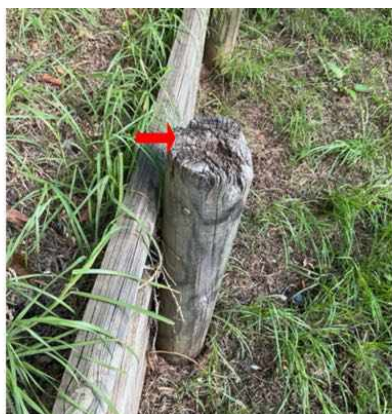
Finding 2.02

| Finding: | Retaining wall - Defective - Bulging, misaligned , wood rot |
| Information: | The retaining wall in this area was found to be defective at the time of inspection. Generally, defective retaining walls are caused by poor original design or material use. However, deteriorated retaining walls may also be a result of substandard construction, poor site drainage or unmanaged stormwater flows. |

If left unmanaged, the retaining wall may become a safety hazard if it continues to destabilise. Where retaining walls further rot and decay, an environment is created that is conducive to termite and pest infestation.

Significant repair and replacement should be expected. Where retaining walls are considered structural walls, a structural engineer / surveyor should be consulted regarding required remedial works. Otherwise, a landscaper or retaining wall installer may be appointed to repair or replace the wall, at the discretion of the client.

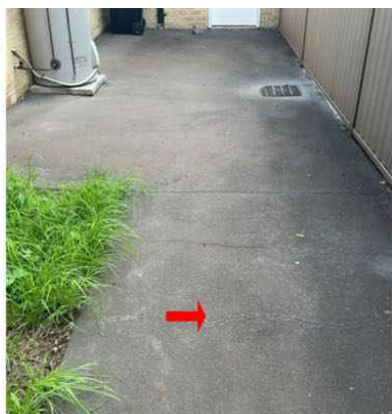
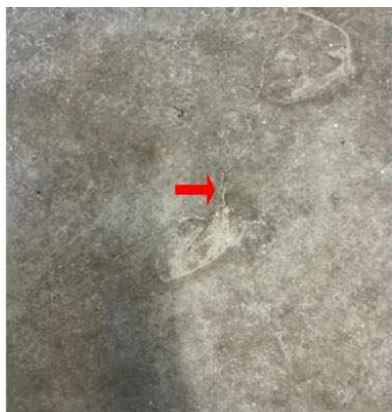
Finding 3.01

| Finding: | Cracking - External Concrete Paving Damage Category 2 - Distinct (less than 3mm) |
| Information: | Distinct cracks were identified in external concrete paving. Distinct cracks are generally found in older concrete paving, and may also present as a trip hazard as consequence of an uneven or curved surface. |

General age and expected deterioration of the paved areas is a common cause of this type of cracking. However, expansion and contraction of the slab may also have occurred due to environmental factors. Such factors include variable moisture and weather conditions, the presence of trees and their roots having a settling or lifting affect on the soil, or the effect of load bearing, e.g. heavy vehicles over a sustained

Cracking to this degree may also be due to poor original installation of the concrete. Factors such as poor compaction of the sub surface and/or inadequate reinforcing of the slab may create cracking and other secondary defects.

Repairs are likely to be required to prevent further cracking and to reduce hazards associated with cracking, such as tripping. Monitoring of all cracking should be conducted frequently. Always contact a building inspector should cracks widen, lengthen, or become more numerous.

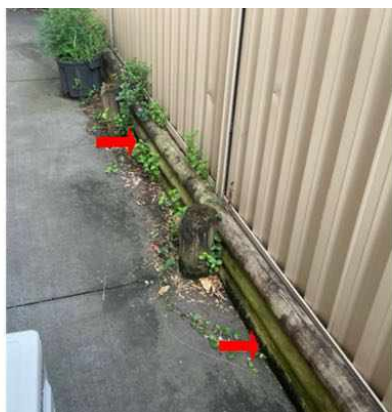
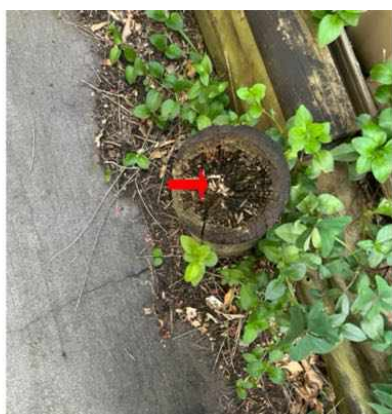
Finding 3.02

| Finding: | Wood rot to some areas |
| Information: | This building element shows evidence of wood rot. Wood rot, also known as Fungal Decay, occurs when timbers and other cellulose building materials are exposed to damp conditions on an ongoing basis. This could be the result of exposure to weathering over a prolonged period of time, or the attraction of excessive moisture from other abutting building materials. Contributing factors also include poor air ventilation in the area. |

Wood rot is often associated with general damp problems and is evidenced by a 'musty' smell or mould and mildew occurring on surfaces. If left unmanaged, damp conditions can lead to further health problems and the decay of timbers will continue.

Early intervention and regular maintenance, particularly of exterior timbers, will prolong the useful life of these building elements. Prior to any works being performed, the cause of the moisture that has created the visible wood rot should be identified and addressed in a suitable manner. Replacement of affected timbers may then be a necessary step in protecting surrounding building elements from such deterioration.

A qualified plumber may be appointed to assess the cause of excessive moisture and to provide advice on any remedial works as required. A qualified carpenter or

registered builder may also be required to replace affected building materials.

An invasive inspection its also recommended by a licensed timber pest technician

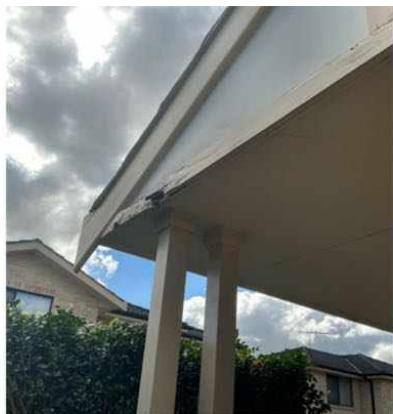
Finding 3.03

| Finding: | Fascias - Wood rot |
| Information: | Wood rot was found to be affecting fascias and barges in this area, evidenced by the presence of mould on the surface in some areas. Wood rot, also known as Fungal Decay, occurs when timbers and other cellulose building materials are exposed to damp conditions on an ongoing basis. |

It is likely that this wood rot has developed as a result of faults in the roof plumbing, creating excessive moisture in this areas. Frequent exposure to rain and other weather conditions also make fascias and barges susceptible to accelerated deterioration.

Early intervention and regular maintenance will prolong the useful life of these building elements. Prior to any works being performed, the cause of the moisture that has created the visible wood rot should be identified and addressed in a suitable manner.

It is advised that a roof plumber be appointed to inspect all roof plumbing and subsequently identify the cause of the wood rot. Replacement of affected fascias and

barges may then be a necessary step in protecting surrounding building elements from such deterioration.

A qualified plumber may be appointed to assess the cause of excessive moisture and to provide advice on any remedial works as required. A qualified carpenter or registered builder may also be required to replace affected building materials.

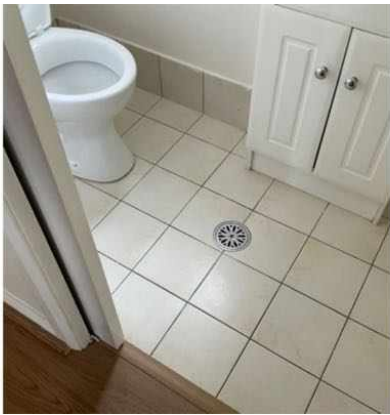
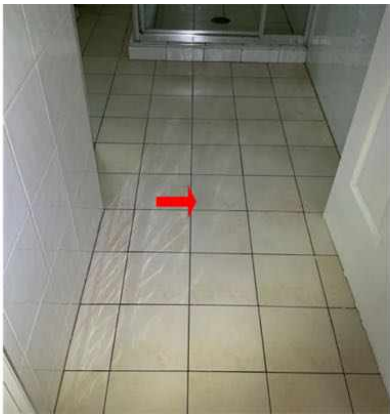
Finding 3.04

| Finding: | Tiles - Cracked or damaged to some areas |
| Information: | Cracking was evident to the tiling in this area at the time of inspection. While the cracking appears to be minor, this area is frequently exposed to water, allowing potential for water penetration into adjoining sections of walls or flooring. |

If left unmanaged, water penetration to these areas may lead to subsequent water damage, which is likely necessitate repair work to affected building elements.

A tiling contractor should be appointed to ensure that no further water damage occurs. The re-application of silicone and grouting throughout remaining tile work is also advised, to further protect the area against water penetration.

Where water penetration has led to water damage, appointment of a relevant tradesperson may be required to repair damaged building elements.

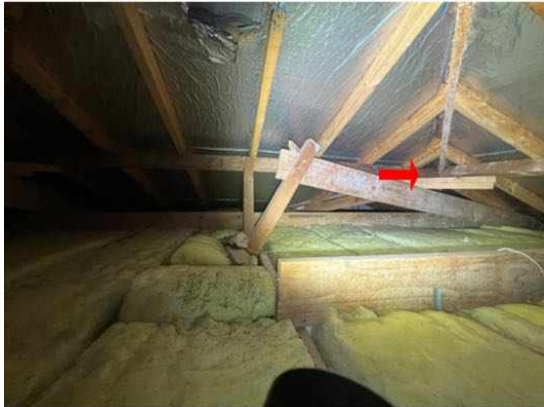
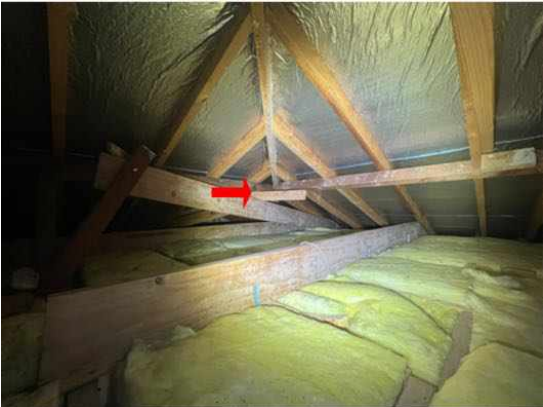
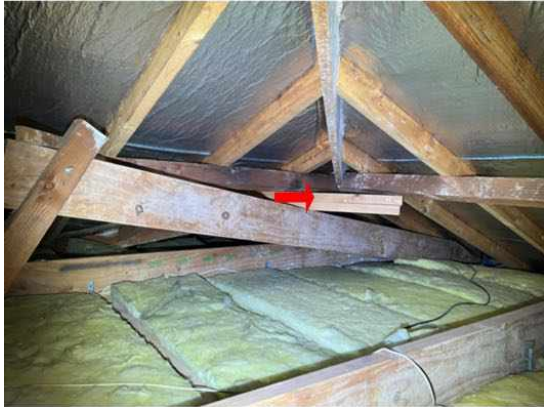
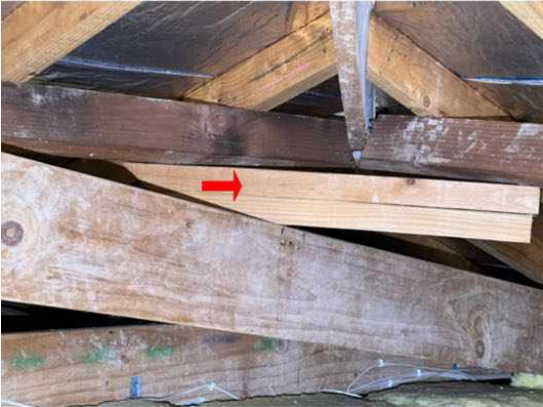
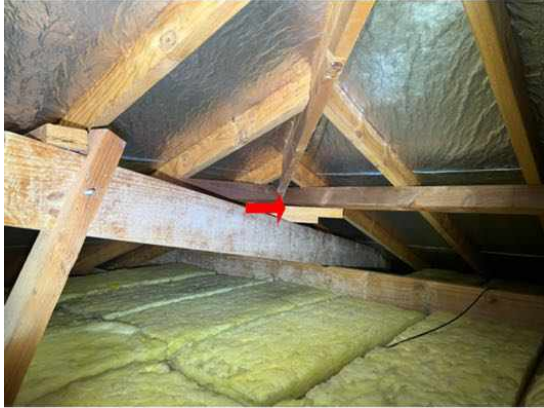
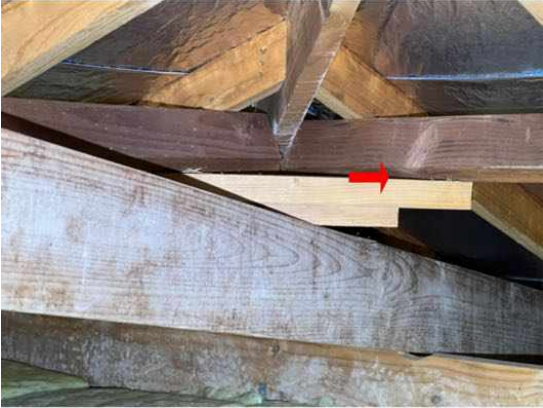
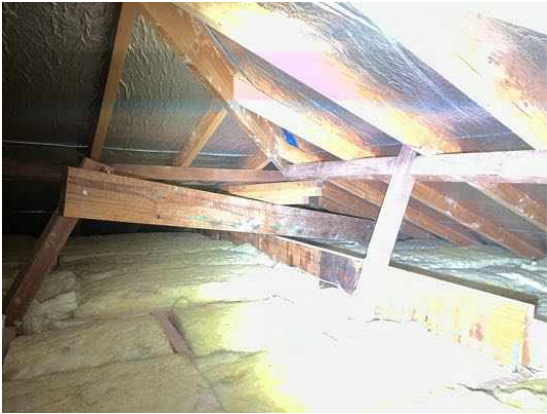
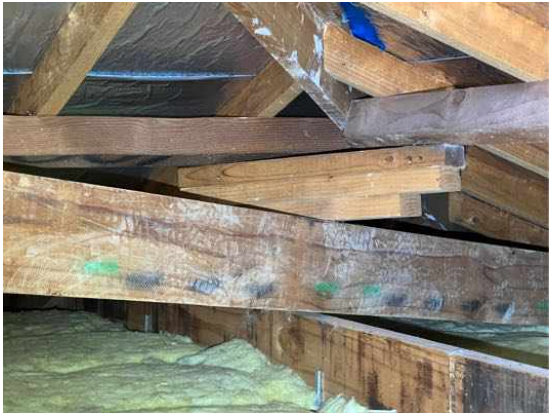
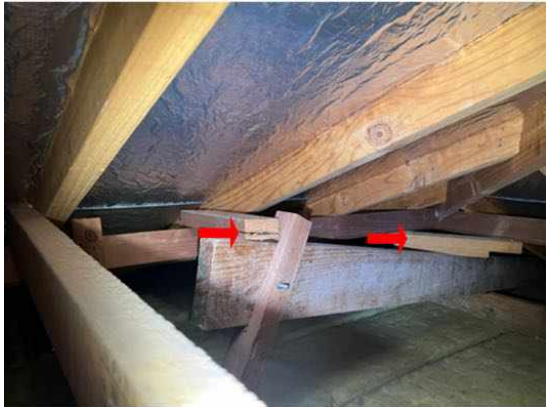
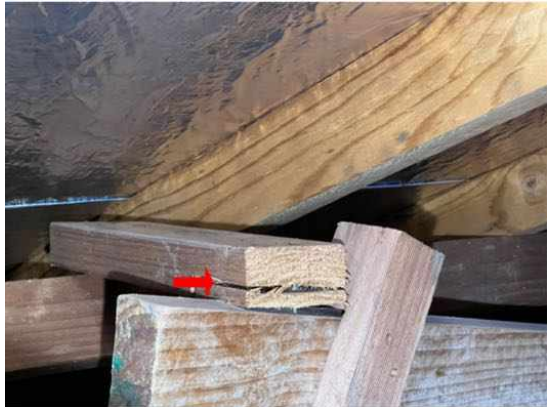
Finding 3.05

Building: Main Building
Location: Roof Void
Finding: Non-Original Roof Support Props
Information: Newer, lighter-coloured timber props and braces have been observed within the roof void. These are not part of the original roof framing and appear to have been retro-fitted to provide supplementary support, possibly due to prior movement, deflection, or remedial works. As their adequacy, structural contribution, and compliance with current standards cannot be confirmed during a visual inspection in accordance with AS 4349.1, further evaluation by a licensed builder or structural engineer is recommended to confirm whether these supports are appropriate and whether additional rectification is required.

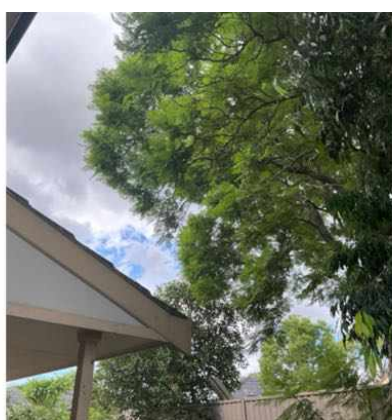
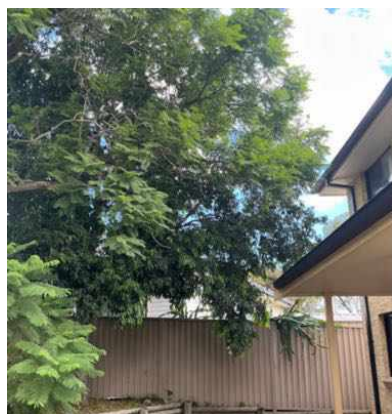
| Finding: | Observation – Vegetation/Tree Proximity to Dwelling |
| Information: | A large tree is located adjacent to the dwelling , this proximity poses risks including potential damage to footings and/or underground services from root activity, increased moisture retention conducive to timber pest activity, and ongoing maintenance issues from falling fronds and debris blocking gutters or drains, while the lean of the tree may also present a future safety risk if it becomes unstable, and further assessment by an arborist is recommended to determine stability and potential impacts, with consideration for trimming, monitoring, or removal if necessary. |

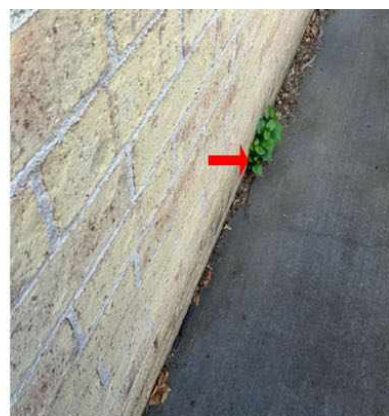
This separation may permit water ingress and contribute to concealed moisture-related damage, pest ingress, or slab movement if left unsealed.

The defect appears consistent with common differential settlement or poor sealant detailing at the slab-to-wall junction. Recommend a licensed contractor seal the gap with an appropriate flexible, UV-stable exterior-grade sealant to prevent moisture entry and pest intrusion.

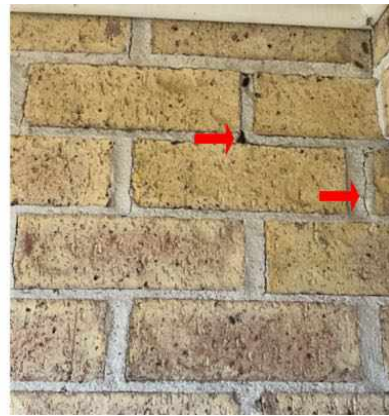
Finding 3.10

Mortar may deteriorate as a result of age of building materials, minor movement of bricks, or frequent exposure to weathering. Mortar should be replaced to ensure that bricks remain in their intended location and to prevent gaps, which would allow water or moisture ingress and secondary damage as a result.

Mortar deterioration can be addressed by a bricklayer where areas of deterioration are localised and easily accessible. Alternatively, appointment of a registered builder is advised, to repoint large areas of decaying mortar. Where secondary structural defects have become evident, consultation with a structural engineer may be required.

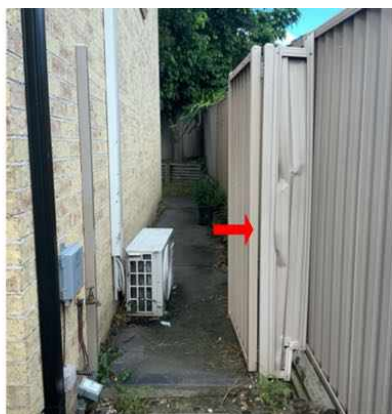
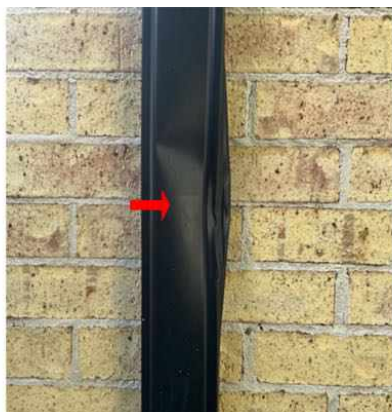
| Finding: | Site drainage - Inadequate |

Repair and/or replacement of broken elements is advised to ensure that additional secondary defects do not arise as a consequence. Such works are necessary, as all building elements play a key role in the operation and function of the overall structure and its performance.

A relevant tradesperson should be appointed to repair or replace the affected building element prior to any subsequent damage being caused.

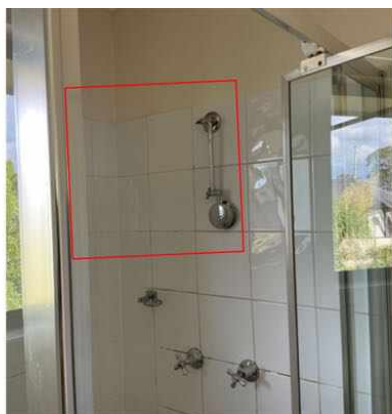
Finding 3.15

Tiled areas may swell and shrink with changes in air humidity if the area has sustained moisture damage. Any exposure to moisture is capable of causing tiled areas to become drummy and/or cracked over a prolonged period of time. Drummy tiled areas generally require removal and replacement of affected tiles, with adequate sealant and grouting.

Specialist trades are available for these types of services. A registered builder may be required to undertake works if damage is extensive or if secondary building defects have resulted. Otherwise, it is advised that a tiling contractor be appointed to perform works as necessary. Immediate action is recommended to ensure that no further damage is sustained in the affected area.

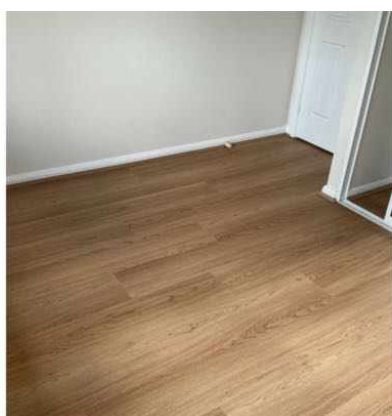
Finding 3.16

Bouncy floors generally indicate that the floorboards or the subfloor structures are coming loose from the joists that they are installed on. Bouncy flooring may also be the result of gaps between flooring and stumps or joist structures, which require packing.

The client is advised to seek quotations for required repairs from a Registered Builder specialising in re-stumping. The potential resolution may range from packing gaps in subfloor structures through to replacement of subfloors stumps and refixing of flooring.

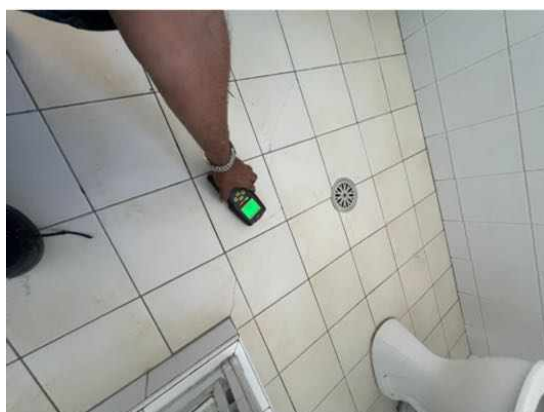
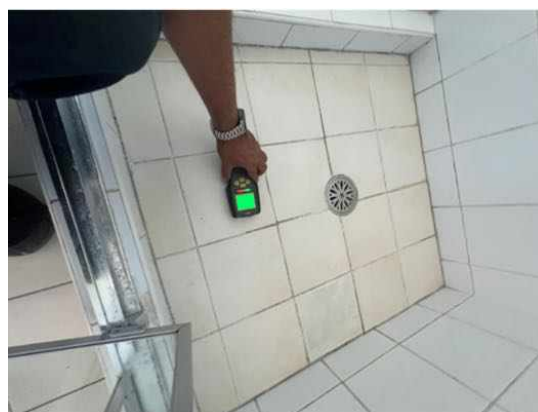
Elevated moisture readings in tiled wet areas can occur from normal shower use, age/deterioration of waterproofing membranes, plumbing leaks or moisture absorption through grout lines. While no damage was visible, elevated readings may indicate moisture retention behind tiles, which can be a conducive condition for future deterioration if not monitored.

No immediate action required. Monitor the area over time for signs of drumming, efflorescence, tile movement, or grout deterioration. If concerns arise, a licensed waterproofing specialist can perform further investigation (e.g., pressure testing, membrane assessment).

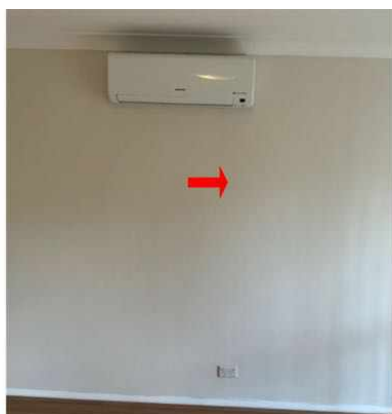
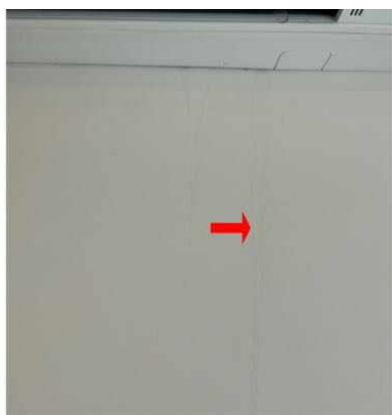
Finding 3.19

Building: Main Building
 Location: All Internal Areas
 Finding: Water staining (Possible aircon)
 Information: Water staining was evident in this area at the time of inspection. Water staining indicates that surfaces have been exposed to excessive moisture over time. The minerals and other elements in the water lead to staining, which may graduate to

corrosion and deterioration if left unmanaged.

Where water staining is active, a licensed plumber must be consulted to identify the cause of the staining and to provide advice on any reparation works that may be required. Replacement of any broken or damaged structures is advised.

Conversely, where water staining is old and inactive, affected building materials may be repaired or replaced at client discretion. A qualified carpenter or registered builder may be appointed to perform these works.

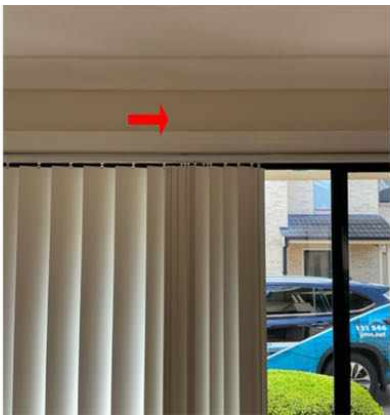
Finding 3.20

If left unmanaged, the wall sheets may become loose and unstable, increasing the rate of deterioration of the wall sheeting and creating potential for the development of secondary defects.

Re-fastening of popped nails will help to maintain the stability of the internal walls and associated building elements. Such minor works will also help to improve the appearance of the affected area and secure the wall sheets. These works should be performed by a qualified carpenter or plasterer at client discretion.

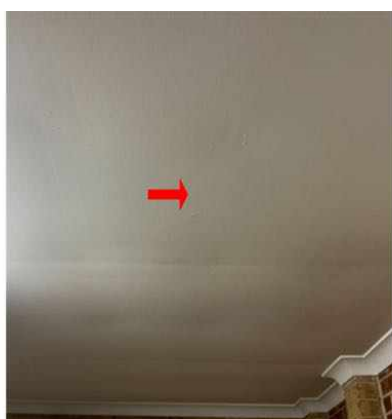
Finding 3.22

If left unmanaged, the ceiling sheets may become loose and unstable, increasing the rate of deterioration of the internal ceiling and creating potential for the development of secondary defects.

Re-fastening of popped nails will help to maintain the stability of the internal ceiling and associated building elements. Such minor works will also help to improve the appearance of the affected area and secure the ceiling sheets, so as to prevent the onset of ceiling sagging. These works should be performed by a qualified carpenter or plasterer at client discretion.

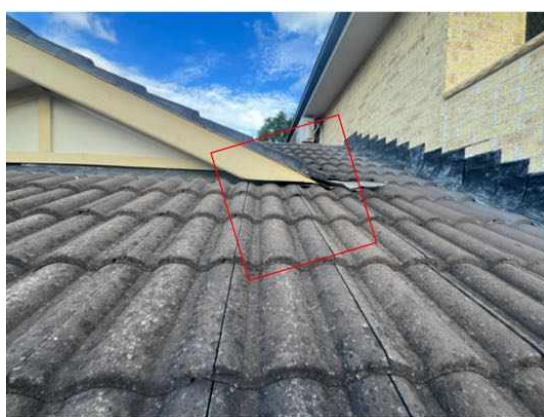
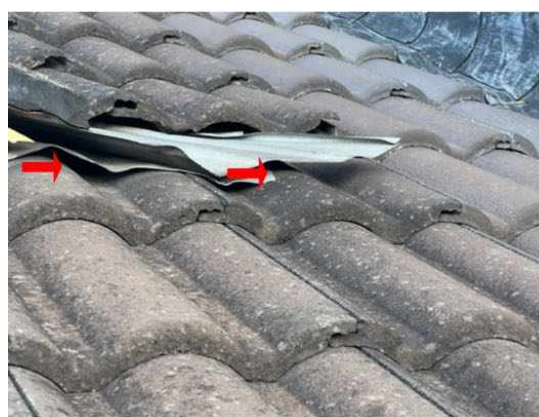
| Information: | The metal flashing at the wall junction appears inadequately installed, with visible gaps and lifting and reliance on surface sealant rather than a properly chased and continuous detail. The junction does not appear fully weather-tight, increasing the risk of moisture ingress into the wall cavity or roof structure over time. Defective flashing installation can lead to concealed deterioration if not addressed. Recommend assessment and rectification by a qualified roofing contractor to ensure compliant and effective weatherproofing. |
