Building and Timber Pest Inspection Report

Inspection Date: Thu, 12 Feb 2026

Property Address: 18 Old Bamarang Rd, Mundamia NSW
2540, Australia

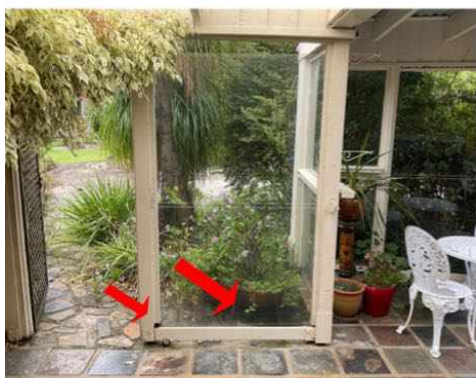
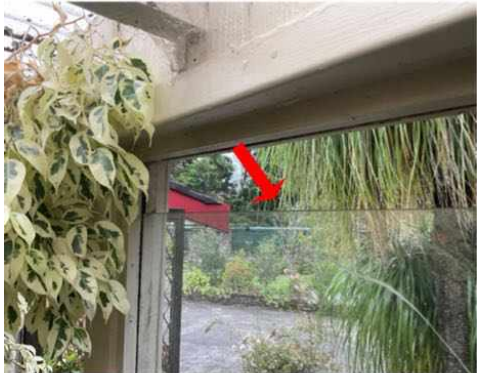
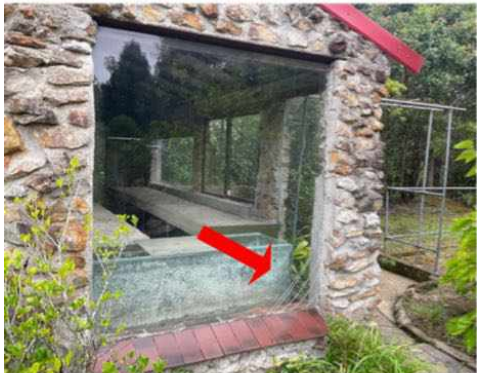
Building:	Building 1
Location:	Pictured pergola and shed areas
Finding:	Wood rot to posts etc and loose glass panes.
Information:	The attached pergola shows evidence of wood rot to some timbers including supportive posts. Two glass panes are now loose due to wood rot.

The shed also has a damaged door and cracked window. These areas of damaged and loose glass need urgent repair to stop potential injury.

Wood rot, also known as Fungal Decay, occurs when timbers and other cellulose building materials are exposed to damp conditions on an ongoing basis. This could be the result of exposure to weathering over a prolonged period of time, or the attraction of excessive moisture from other abutting building materials. Contributing factors also include poor air ventilation in the area.

Early intervention and regular maintenance, particularly of exterior timbers, will prolong the useful life of these building elements. Prior to any works being performed, the cause of the moisture that has created the visible wood rot should be identified and addressed in a suitable manner. Replacement of affected timbers may then be a necessary step in protecting surrounding building elements from such deterioration.

A qualified carpenter or registered builder will be required to make safe the loose and damaged glass urgently.

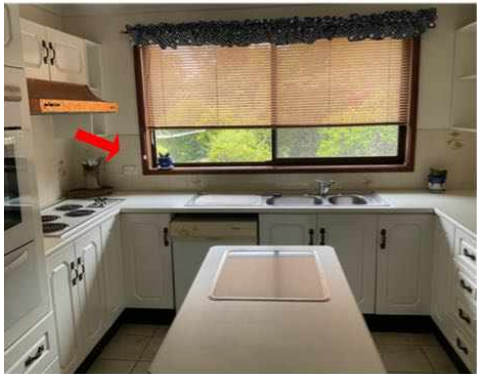
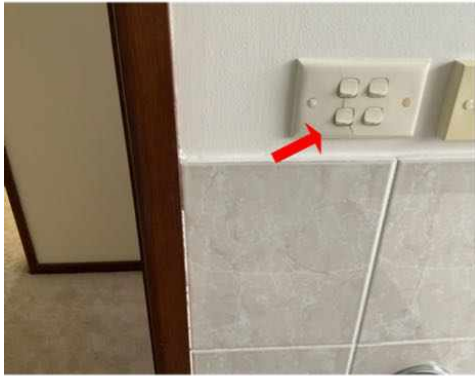
Finding 1.02

Building: Building 1
 Location: Kitchen, bathroom
 Finding: Broken light switches
 Information: The light switches in these areas was found to be cracked at the time of inspection. Breakage occurs generally when the building materials have aged and decayed, but may also be indicative of impact damage to the building element (accidental or deliberate).

Repair and/or replacement of this light switch is advised. A Licensed electrician should be appointed to repair or replace the fitting immediately.

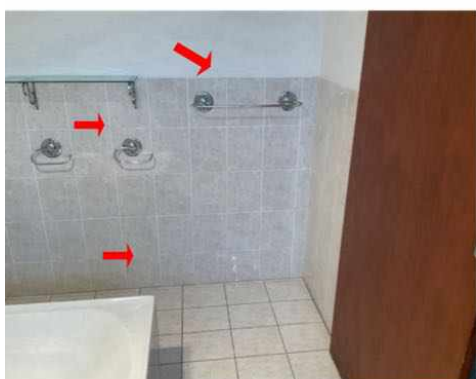
Building: Building 1
 Location: Bathroom behind door
 Finding: Tiles loose
 Information: The tiles behind the bathroom door were found to be loose at the time of inspection. These tiles need to be removed and refixed to the wall to prevent the breakages.

A tiling contractor is required to perform these works.

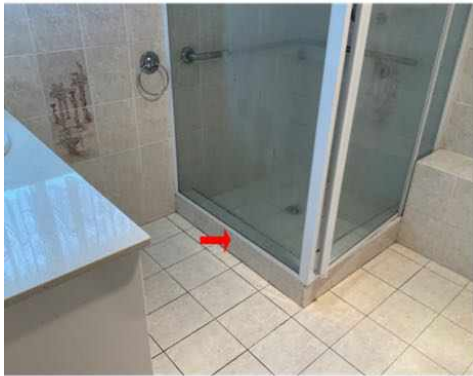
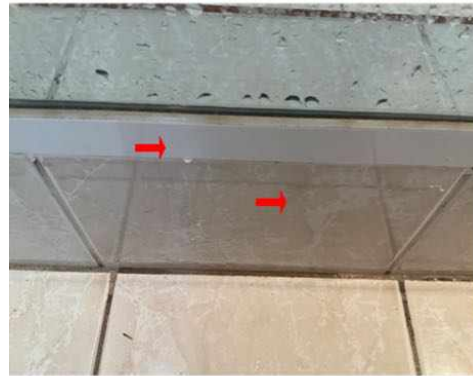
Finding 3.02

Building: Building 1
 Location: Bathroom
 Finding: Shower screen - Leaking
 Information: Leaking was evident to the shower screening at the time of inspection. It is suspected that the leaking has occurred as a result missing sealant. Leaking from the shower , where left unattended, is likely to lead to water damage to adjoining flooring and walls. Such damage can lead to water damage and necessitate extensive remedial works being required. Active water leaks may also create an environment that is susceptible to the formation and development of mould.

Appointment of a sealant expert is required to repair or replace this missing sealant. Such works should be performed as soon as possible to ensure that no further damage occurs.

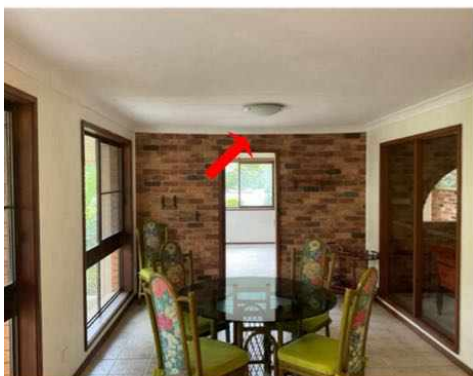
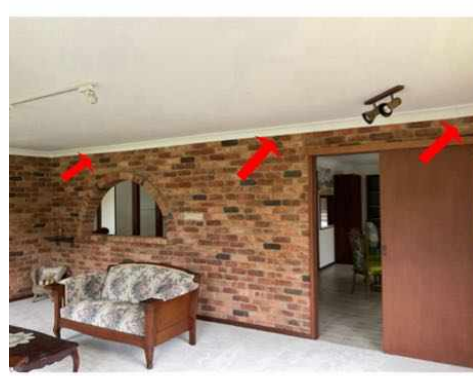
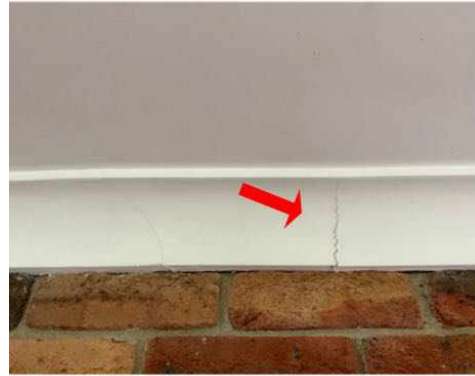
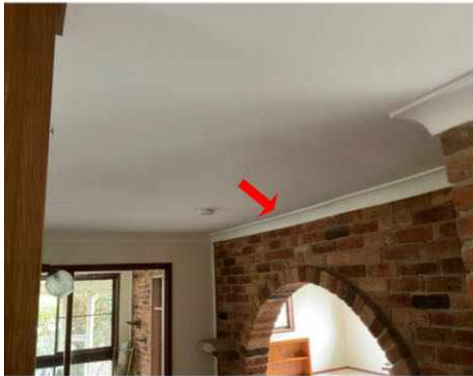
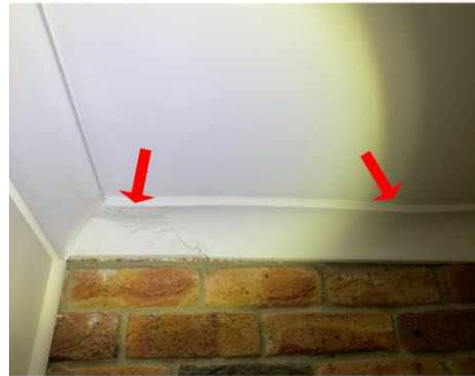
Finding 3.03

Building: Building 1
 Location: Dining and loungerooms
 Finding: Ceilings - Sagging and minor cracks to cornice
 Information: Sections of these ceilings were found to be sagging at the time of inspection. Sagging to the fixed ceiling structure generally indicates that the building materials have swollen, due to contact with water, or that fixings (e.g. nails or glue) have become loose and require reattachment. No moisture was found in these areas.

In some rare cases, sagging ceiling linings may also indicate that there are structural issues, causing surfaces to warp, twist or sag or there can be deflection in roof timbers from termite damage causing sagging. In these cases, removing roof tiles to inspect these areas of external walls is required to rule out these issues.

In most cases, repair works may be performed by relevant tradespeople, such as plasterers and carpenters.

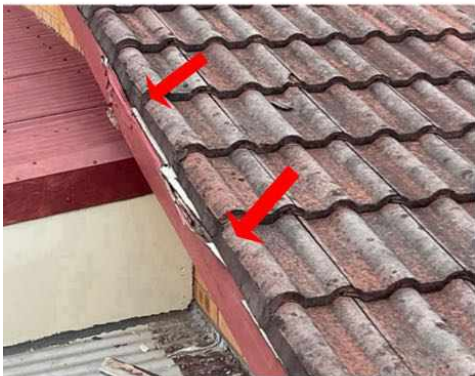
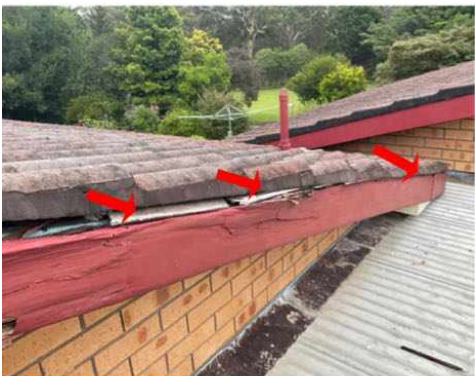
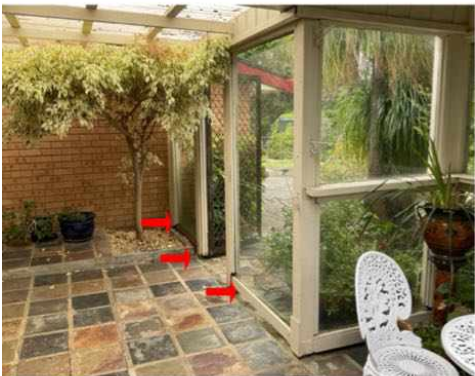
Finding 3.04

Building:	Building 1
Location:	Mostly pergola areas
Finding:	Wood rot
Information:	The pergola and above barge boards show evidence of wood rot. Some right pergola timbers and the above fascia require urgent replacement.

A qualified carpenter or registered builder may also be required to replace affected building materials. This area is the same area as described in the safety defect in the start of this report.

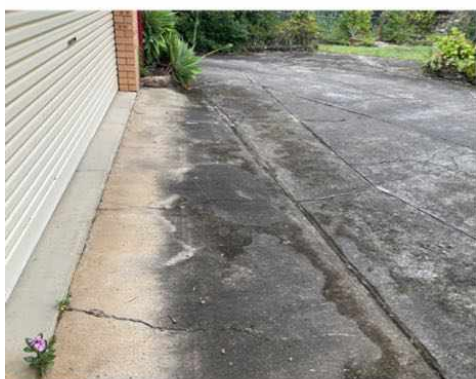
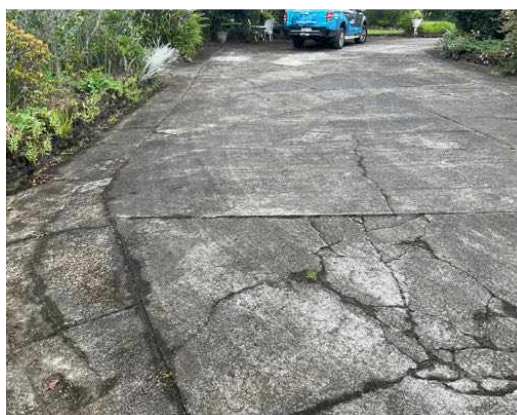
Finding 3.05

Building:	Building 1
Location:	Rear slabs
Finding:	Cracks in concrete slabs - Category 2
Information:	Numerous crack coded as Category 2 was identified in the pictured slabs. A Category 2 crack is described as a distinct crack, with the slab being noticeably curved or changed in level. To be considered Category 2, the approximate width of the crack is less than 2.0mm, or a change in offset of less than 15mm when a 3m straight edge is placed over the defect.

Category 2 cracks to slabs should be monitored for a period of 12 months. At the end of the monitoring period, cracks rated greater than Category 2 are considered defects that require rectification.

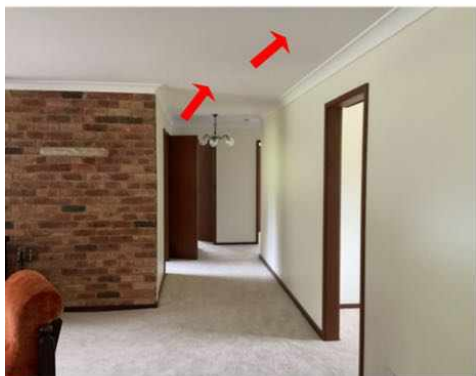
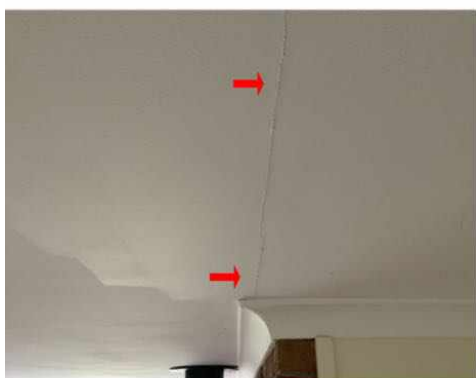
Finding 3.06

Building:	Building 1
Location:	Hall
Finding:	Cracking - Damage Category 1 - Fine (up to 1mm)
Information:	Although fine cracks are quite noticeable, they are often only considered to be an appearance defect, and usually do not indicate any structural damage. Generally, the cause of a fine crack is indicative of a separation between building materials and finishes (e.g. paint, plaster, etc.) along joints. A few ceiling nails also showed minor movement..

Cracking of this nature can generally be repaired with minor sanding, filling and/or repainting. Such works should be performed by a qualified painter or a general handyman.

Monitoring of all cracking should be conducted frequently. See also cracks in the ceiling sagging defect.

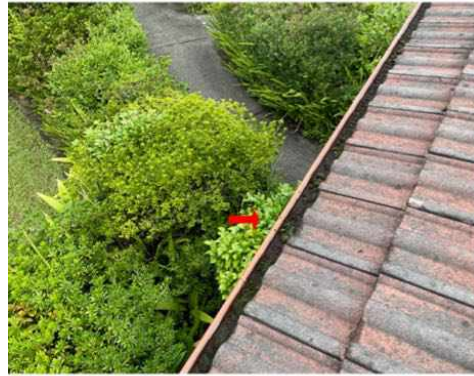
Finding 3.07

Building: Building 1
 Location: Roof exterior
 Finding: Gutters - Full and blocked
 Information: The guttering on around the roof was found to be blocked at the time of the inspection. Roof plumbing structures, such as guttering and downpipes, should be free of all debris to prevent blockages. Blockages of the guttering and downpipes will lead to pooling and accumulated water overflows, which is likely to subsequently flood eaves and exterior walls.

Blocked gutters are likely to lead to high levels of moisture in the affected areas which can cause rust and decay of the gutters and downpipes and wood rot to adjoining timber areas. Blockages in gutters should therefore be removed immediately to ensure dry conditions are maintained.

It is highly advised that gutters be cleaned by the homeowner or a general handyperson as a matter of urgency.

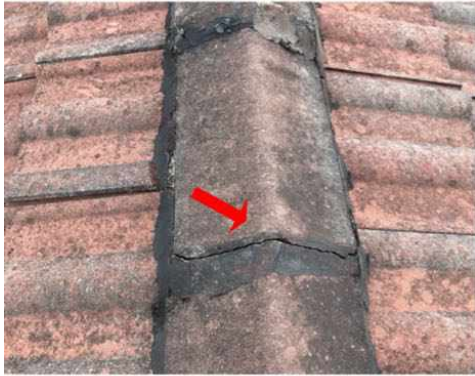
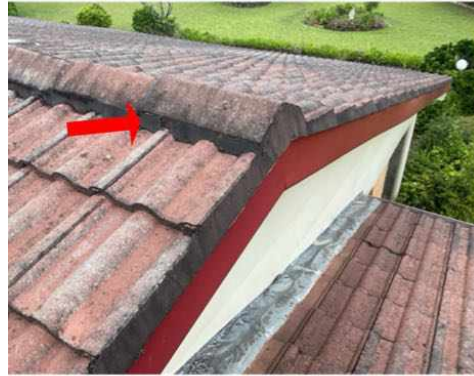
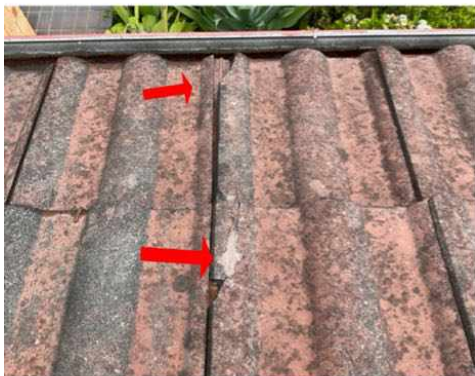
Finding 3.08

Building:	Building 1
Location:	Roof Exterior
Finding:	Roofing areas - Weathered
Information:	Upon inspection of the exterior roofing, the majority of the roof areas were considered to be in a good condition. While weathering of these pictured areas is consistent with the age of the property, maintenance works are required.

Re-sealing and replacing small areas of gaps, damage or rust that may be considered as an interim solution by the client to help preserve and extend the life span of these roofing areas. Where left unmanaged, deteriorating roofing materials are likely to lead to a number of secondary defects, including minor water leaks and weather exposure to internal roofing structures.

Remedial works are likely to increase the longevity of the exterior roofing structure.

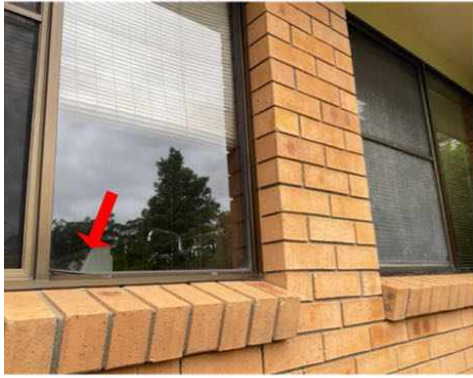
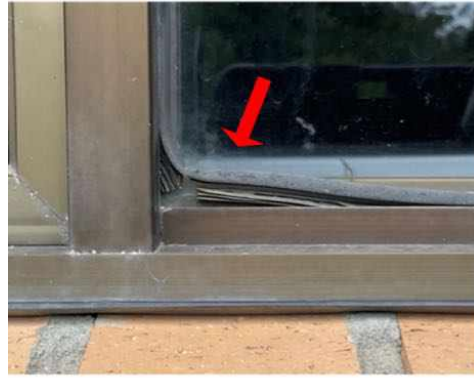
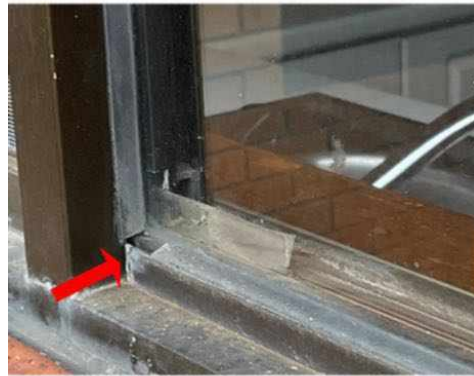
Finding 3.09

Building:	Building 1
Location:	Many window areas
Finding:	Window seals - deteriorated
Information:	Some window seals have deteriorated and are in a generally poor condition. Due to frequent exposure to weather conditions and subsequent moisture, deterioration of window seals is expected in a property of this condition and age.

Where window seals have deteriorated, the window is no longer weather-tight; rain penetration and subsequent water damage is therefore likely to ensue. Insulation of the area against external weather conditions will also be compromised.

It is recommended that all deteriorated window seals be replaced by a general handyman or sealant expert to prevent any further damage and to restore the window to a fully functional level.

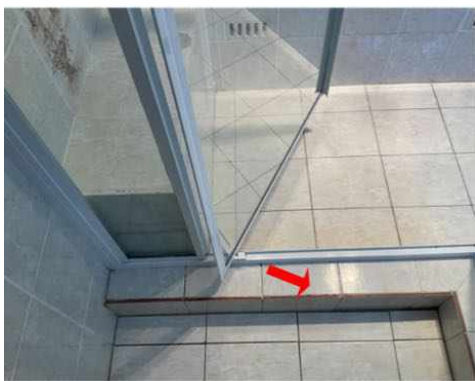
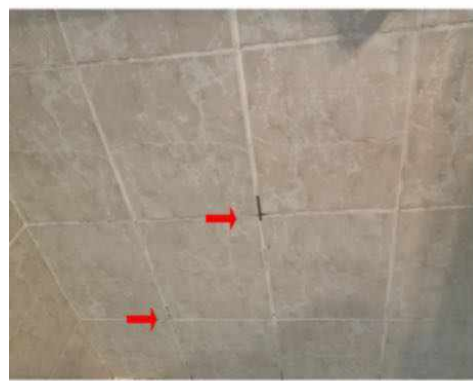
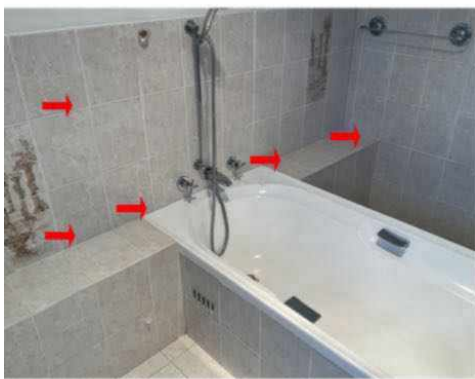
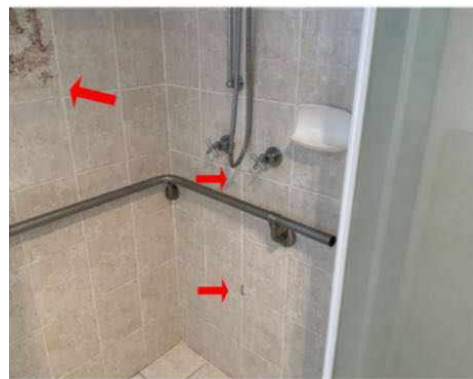
Building: Building 1
Location: Kitchen, laundry and bathroom
Finding: Sealant and grouting - Missing or damaged
Information: It was noted on inspection that sealant or grout is degraded to these pictured wet areas.

Different materials and floor areas move at different rates, generally causing cracking

Flexible and mould resistant materials should be applied to affected areas to prevent any subsequent water damage that is likely to occur. Regular maintenance and replacement of damage or missing or damaged sealant and grout is highly recommended to the wet areas, as this is a regular wear and tear defect. Sealant and grouting in areas that come into regular contact with water should be maintained for the long term care of your property.

A sealant specialist or tiling contractor should be appointed to complete these works as soon as possible

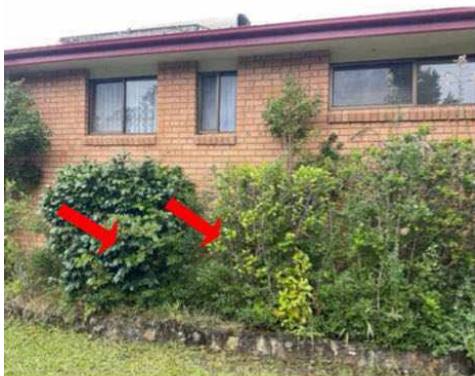
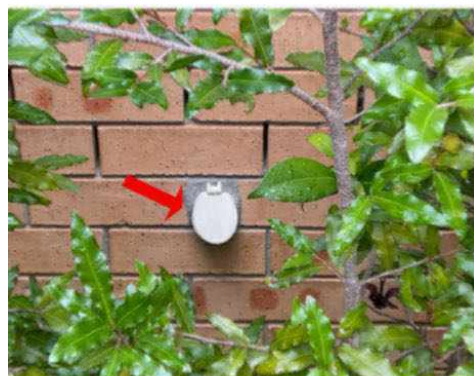
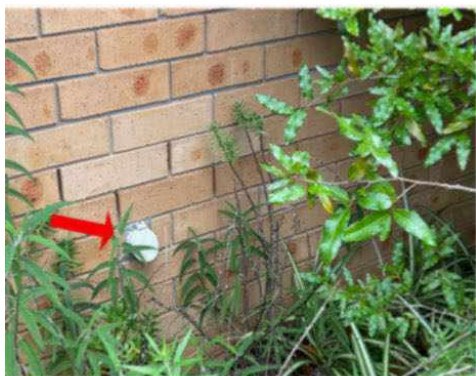
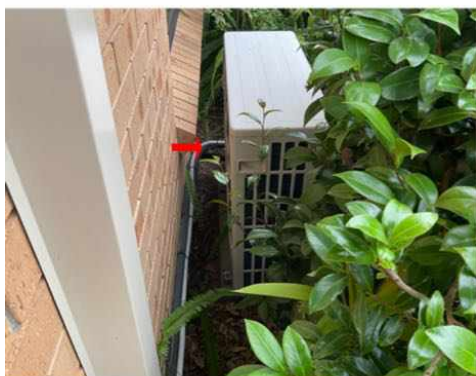
Finding 3.12

Building:	Building 1
Location:	Exterior Walls
Finding:	Site drainage - Inadequate
Information:	The site drainage in this area was found to be inadequate at the time of inspection, creating potential for subsequent water damage to associated building elements.

Three floor wastes empties onto the rear wall. Some pergola areas have no gutters. The Air Conditioner overflows appears to run against the front external wall.

It is important that water does not lie against the base of walls; surrounding paths and ground levels should be sloped to drain water away from walls. Downpipes should not discharge stormwater onto lower walls or plinths. Stormwater should be carried away by large, regularly cleaned drains. Ground levels may need to be lowered to expose a buried DPC.

Where site drainage is inadequate, installation of an Agricultural (Aggie) Drain may be required. A qualified plumber should be appointed to further inspect the property and perform any remedial works as necessary. Secondary defects are likely to occur if left unmanaged.

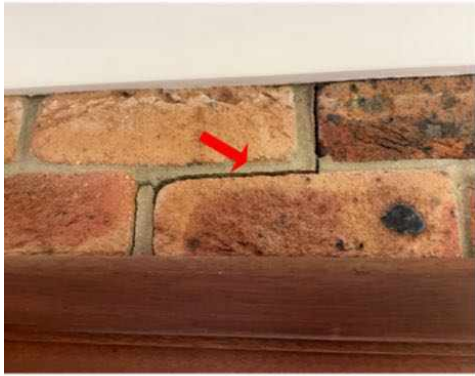
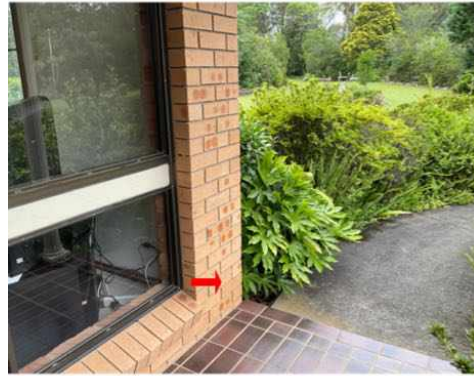
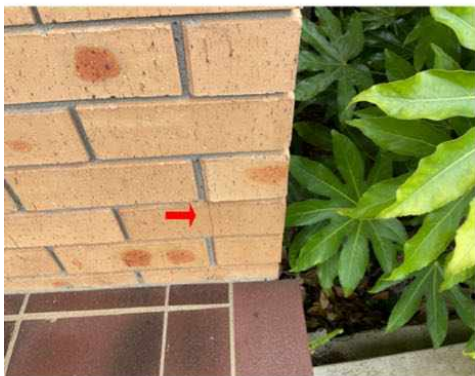
Finding 3.13

Building:	Building 1
Location:	Exterior wall areas
Finding:	Step cracking to brickwork (minor - most under 1mm)
Information:	Step cracking was identified to the brickwork in these pictures areas at the time of inspection. Step cracking, which is similar to other forms of cracking, has a variety of possible causes. However, the most common is the subsidence of adjacent footings.

Step cracking is a relatively common defect, and is most likely to occur adjacent to windows, doors and other openings. Mortar failure in the gaps between affected bricks indicates the stresses and tensions affecting the wall.

Where step cracking is extensive or severe, the client is advised to consult a structural engineer. Minor step cracking can be used as a warning sign to address factors causing stress to the wall, which can include the effect of surrounding trees, water leaks, soil erosion, or even the presence of reactive soils in the surrounding area.

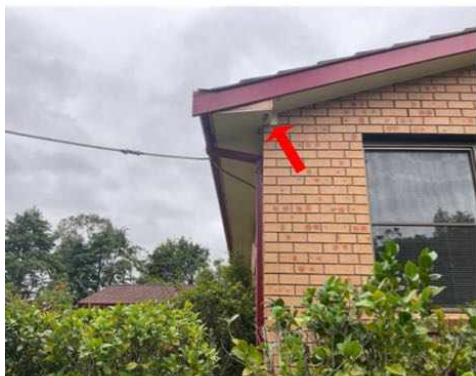
Information: Mould growth was noted in the subfloor and small eave areas. Subfloor mould is generally caused by moisture ingress, lack of external drainage, lack of adequate ventilation and subfloor debris present. These issues need rectification. In this case, it is thought the large amount of vegetation around the house perimeter is restricting ventilation and often keeping the lower brick walls damp.

It is highly recommended to remove much of the perimeter vegetation (or move away from walls) and install more ventilation to reduce the subfloor mould.

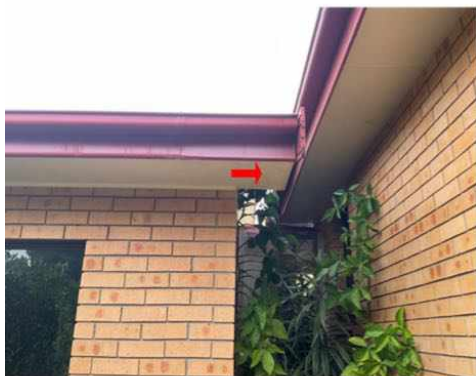
Finding 3.18

Building: Building 1
 Location: Garage
 Finding: Eaves - Sagging & cracking (minor)
 Information: Sagging to the eaves was evident in this area at the time of inspection. This type of defect is generally consistent with older properties, where the eave sheeting has worn over time.

Eaves are important in preventing water ingress to associated walls by promoting adequate water run-off from roofing structures. Their secondary function is to prevent shelter to adjoining structures from excessive moisture and hence prevent water damage to these areas.

Sagging eaves are susceptible to the attraction of excessive moisture, and are therefore considered non-functional. This defect also detracts from the overall appearance and condition of the roofing structure and any associated structures.

A roofing plumber or general handyman is recommended to perform rectification works.

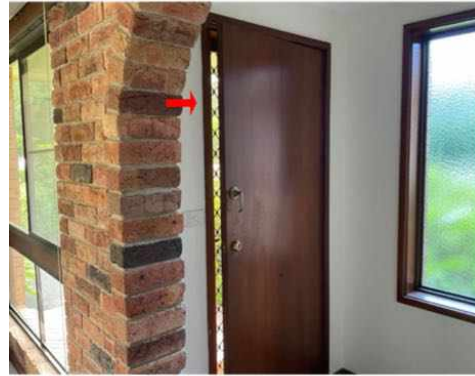
Finding 3.19

Building:	Building 1
Location:	Garage & front doors
Finding:	Doors - Binding/jamming
Information:	Binding and/or jamming of these 2 doors was evident during standard operation. This defect inhibits the functionality of the affected doors as well as creating potential for secondary defects to associated building elements, such as damage to the floor covering.

A door that binds to flooring or to the associated door frame may have several causes, ranging from minor defects, such as poor installation of the door or deteriorated hinges, through to major structural issues, such as damage to subfloor structures.

Where door binding/jamming appears to indicate major structural issues, a registered builder specialising in re-stumping should be appointed to provide an estimate on the cost of rectification.

For minor causes, a qualified carpenter or general handyperson should be appointed to perform minor rectification works at client discretion.

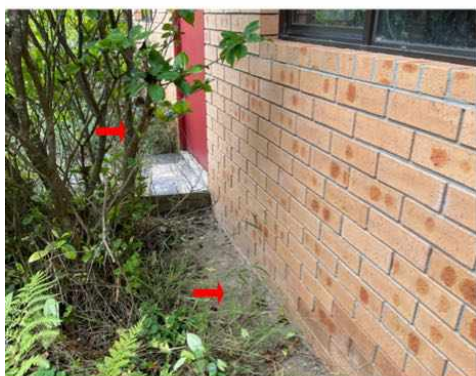
If the slab edge is not properly exposed there is a high risk of termite attack. Sometimes, in order to determine the type of slab, a suitably qualified person such as an architect or builder may be required to consult the construction plans.

Where the slab edge cannot be properly inspected, it is highly recommended that termite or timber pest inspections be carried out every 6-12 months to aid protection of the property against infestation.
