## Building Inspection Report

Inspection Date: Mon, 2 Mar 2026

Property Address: 18 Bowser Cres, Wangaratta VIC 3677,  
Australia

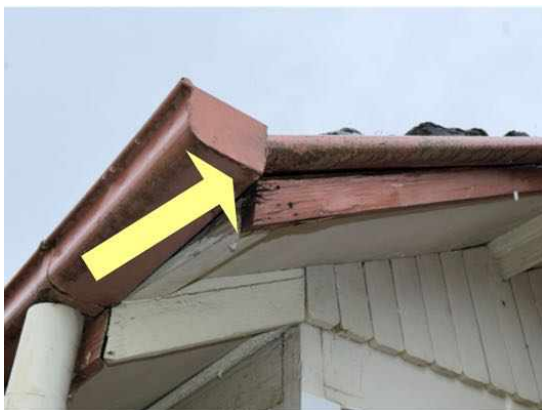
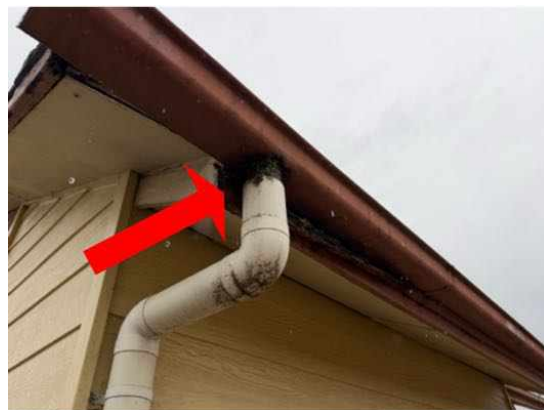
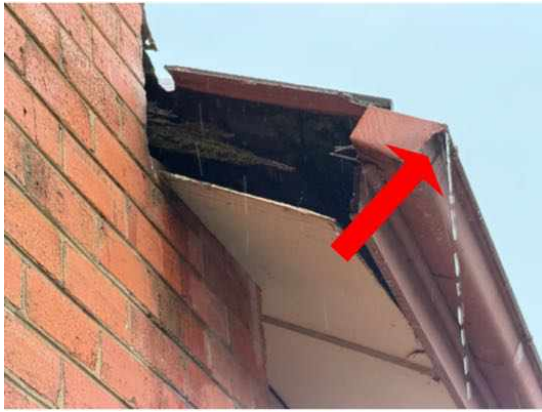
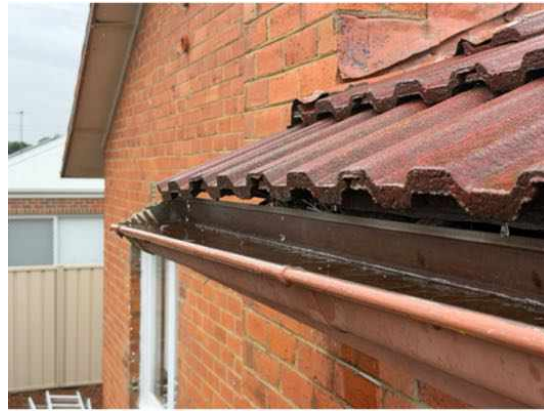
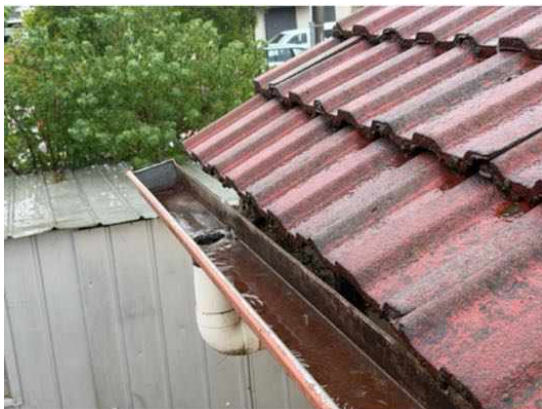
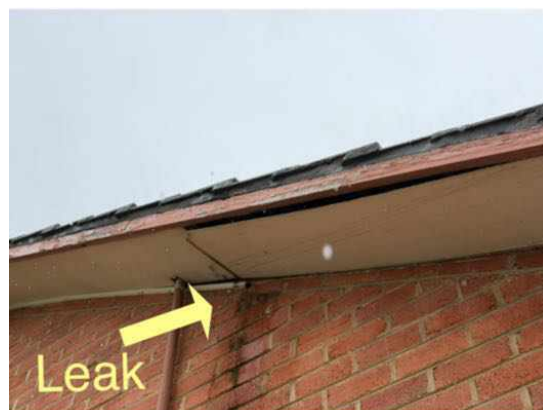
#### Defects 3.01

Building: Main Building  
Location: Roof Plumbing  
Finding: Roof Plumbing - Water pooling & Leaking  
Information: Areas of water pooling & leaking were identified to areas of the gutters & down-pipes. Water pooling of the gutters can lead to deterioration of the roof plumbing over time, if neglected. Water was found to be overflowing from the gutters, and areas of the gutters have pulled away from the roof & were sagging.

A licensed roof plumber should be engaged promptly, to provide further advice & remedial works where necessary.

Areas of water pooling, leaking and sagging/separation of the gutters & down-pipes were identified. Recommend engaging a licensed roof plumber promptly, to provide further advice & remedial works where necessary, to avoid further water damage to surrounding materials.

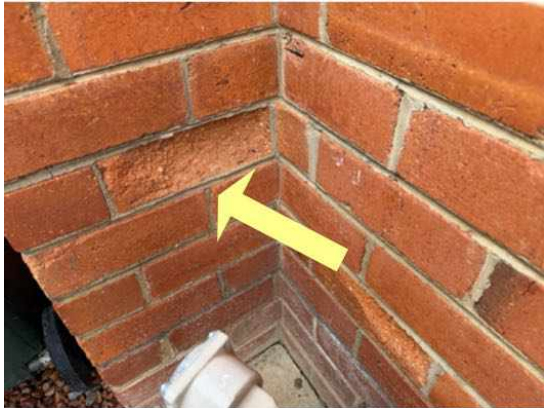
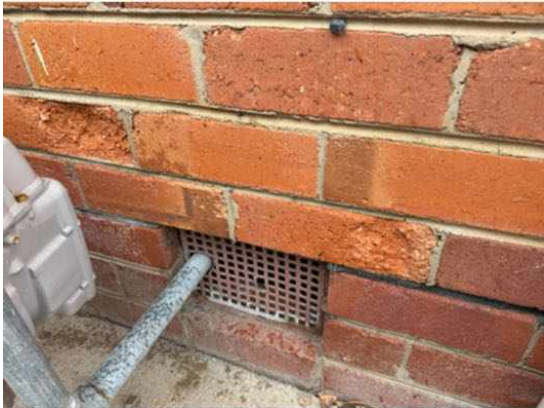
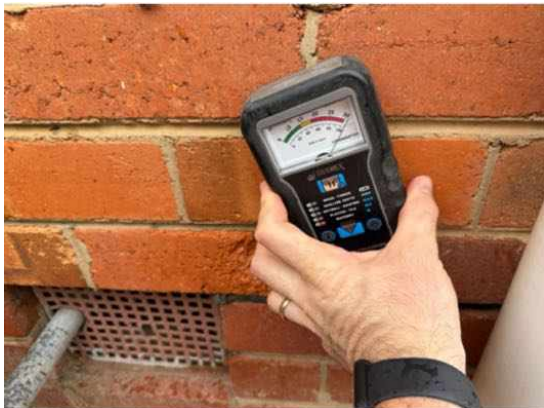
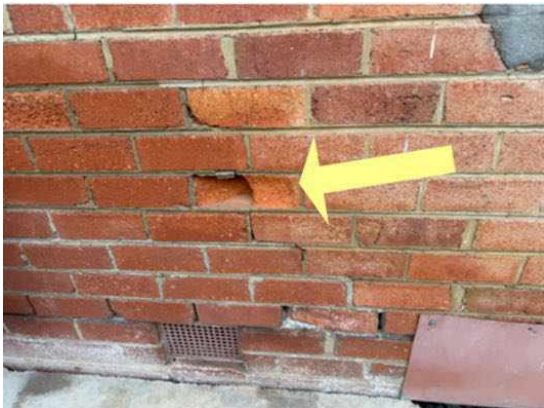
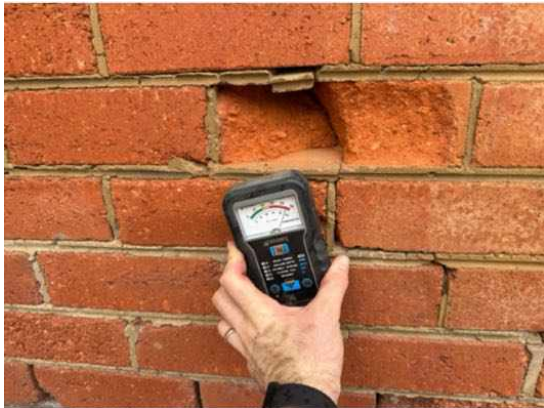
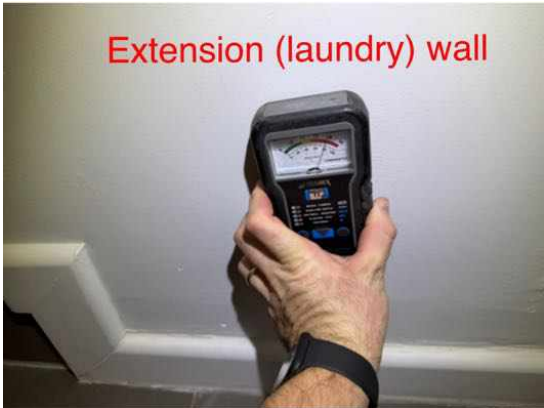
### Defects 3.02

Building:	Main Building
Location:	External Brickwork, Extension wall
Finding:	Brickwork - Deterioration (Fretting) & Rising Damp
Information:	Deterioration also known as fretting, was evident in some areas of the brickwork. Rising damp (high moisture reading above the damp-proof course) was also evident in some areas of the brickwork, and to the wall of the extension, (likely due to moisture transfer from the brickwork to the plaster)

Overtime, general aging and contact with moisture can cause the bricks to become brittle & eroded. Recommend consulting with a damp proofing specialist in the short term to provide further advice & remedial works where necessary to avoid further

deterioration.

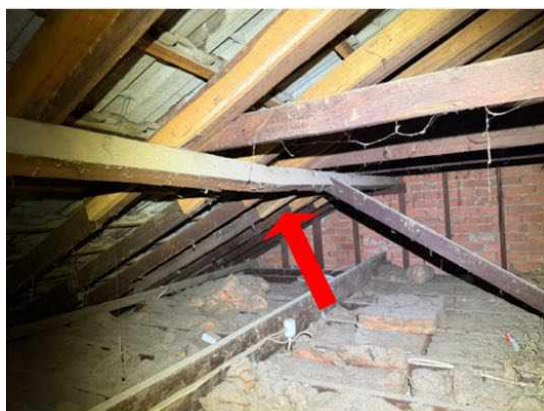
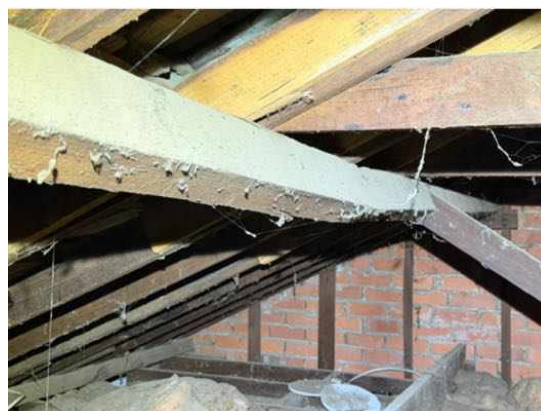
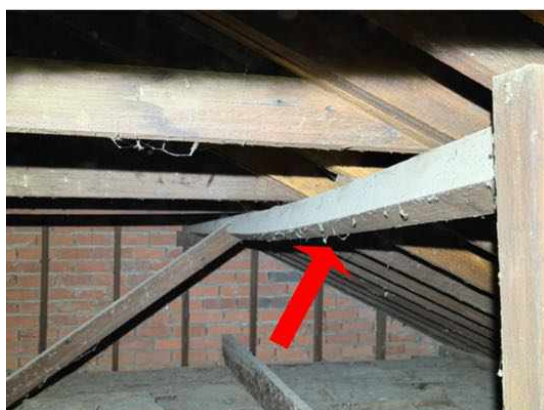
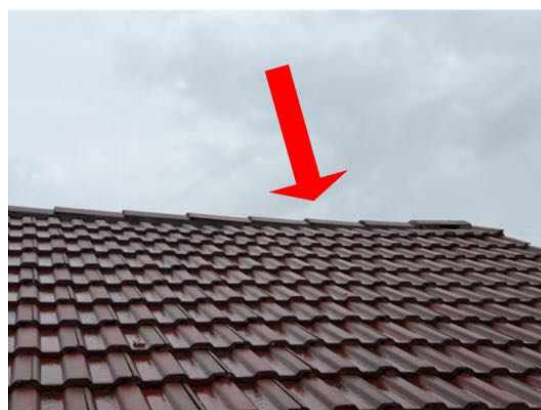
**Defects 3.03**

Building: Main Building  
 Location: Roof Exterior  
 Finding: Sagging Under-purlins  
 Information: Some under purlins in the roof appear to be sagging at the time of inspection, a relatively common finding in buildings of a similar age.

While this type of construction is common for the era of building, additional support may be required.

While it would appear that this defect has been present for an extended period of time, it is recommended that the client engage a registered builder, in the short term, to further assess and provide additional support where necessary, to ensure the longevity of the roof framing & avoid further sagging.

Some areas of the roof framing were found to be sagging. Recommend consulting with a registered builder in the short term, to provide further advice & remedial works, to ensure the longevity of the roof structure & avoid further sagging.

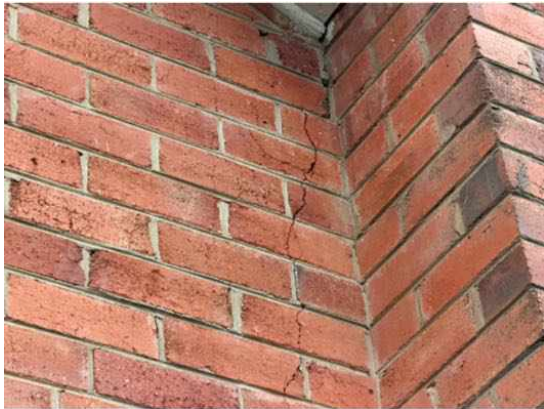
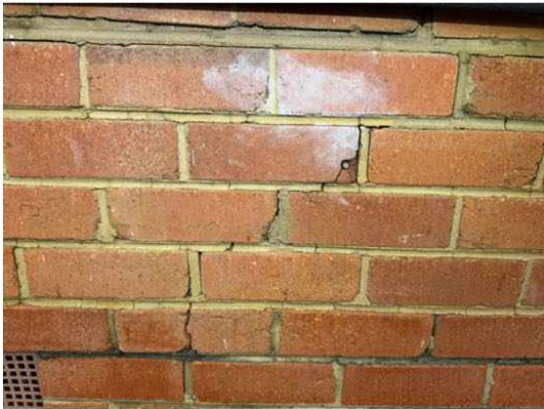
### Defects 3.04

Building:	Main Building
Location:	External Brickwork
Finding:	Brickwork - Step cracking
Information:	Step cracking was identified to areas of the brickwork at the time of inspection. Step cracking, has a variety of possible causes. However, the most common is movement of adjacent footings. Step cracking is a relatively common defect, and is most likely to occur adjacent to windows, doors and other openings.

The client should monitor the cracking. Should the step cracking lengthen, widen or become more numerous, the client should contact a structural engineer promptly, to provide further advice.

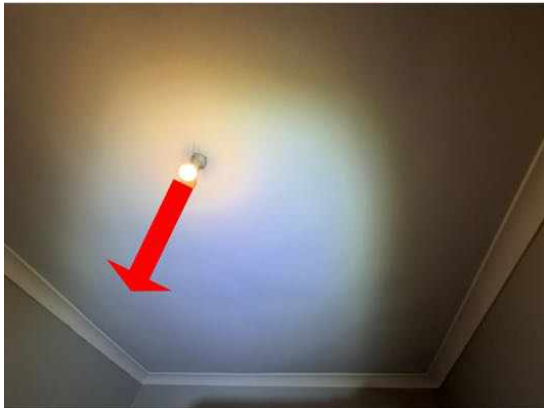
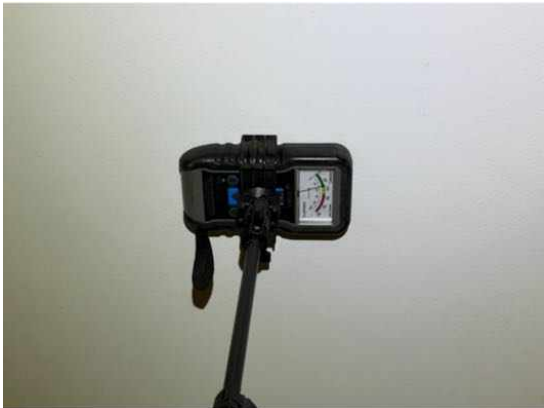
**Defects 3.05**

Building: Main Building  
Location: Bedroom Ceiling  
Finding: Elevated moisture - Ceiling  
Information: Elevated moisture readings were identified at, but not limited to the ceiling of the rear bedroom. Potential causes of moisture include damaged plumbing fittings and fixtures, or deterioration of the roof plumbing and cladding.

Recommend engaging a licensed roof plumber and/or roofing contractor promptly to identify the cause of the moisture & provide remedial works.

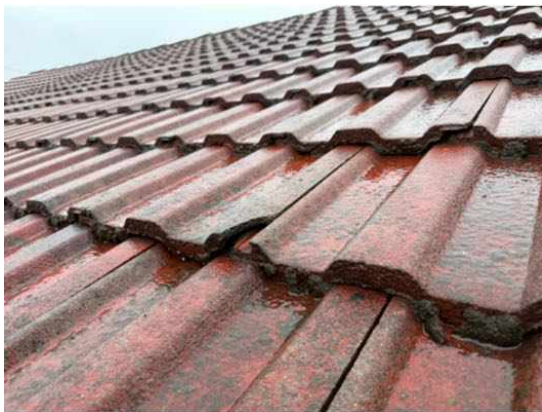
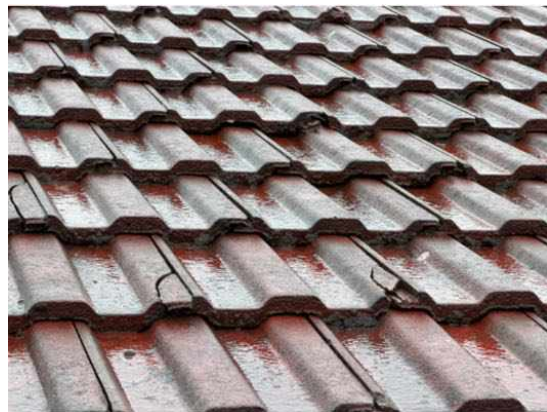
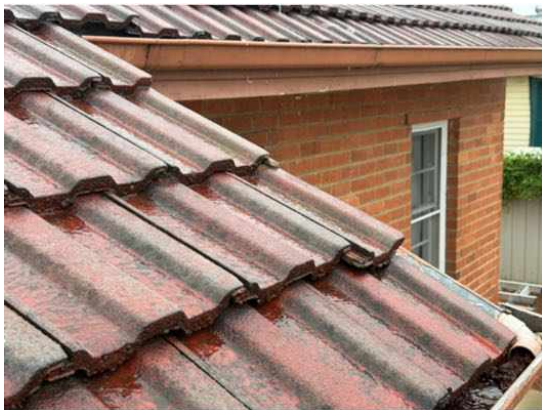
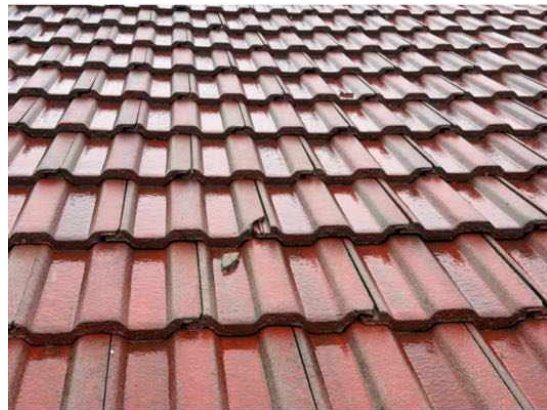
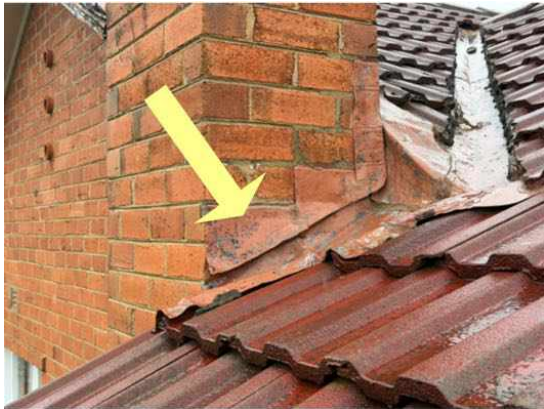
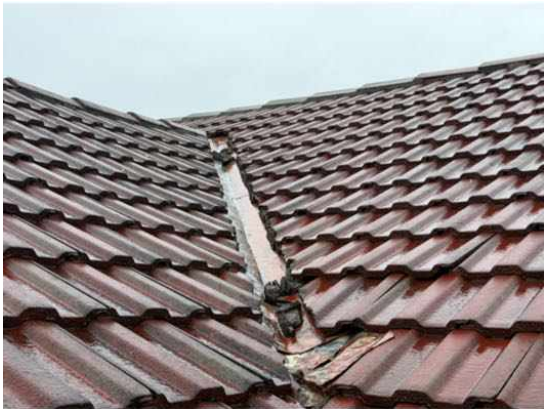
## Defects 3.06

Building: Main Building

Location: Roof Exterior

Finding: Roof Exterior & Flashings - Weathered, Cracking

Information: Areas of general weathering & cracking/chipping of the roof exterior & tile pointing were noted. Some flashings were also found to be weathered and lifted. While weathering of the roof exterior and flashings is consistent with the age of the property, maintenance works are advised, to ensure the longevity of the roof exterior.

Recommend consulting with a licensed roofing contractor in the short term, to provide further advice on maintenance works required.

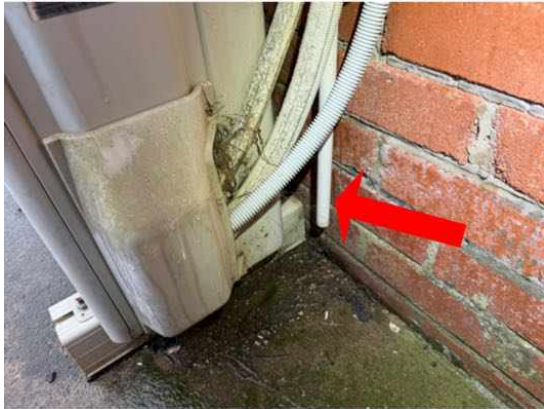
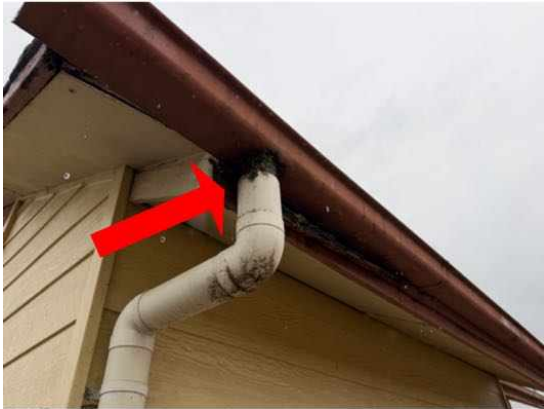
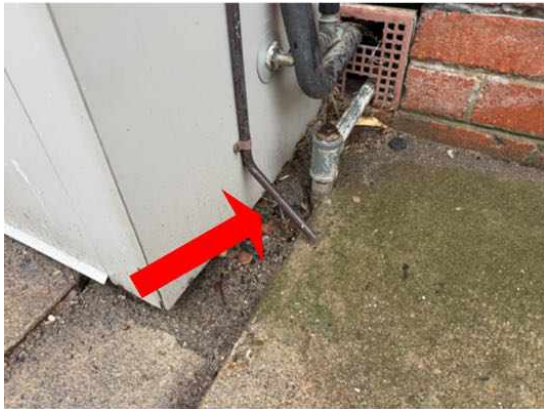
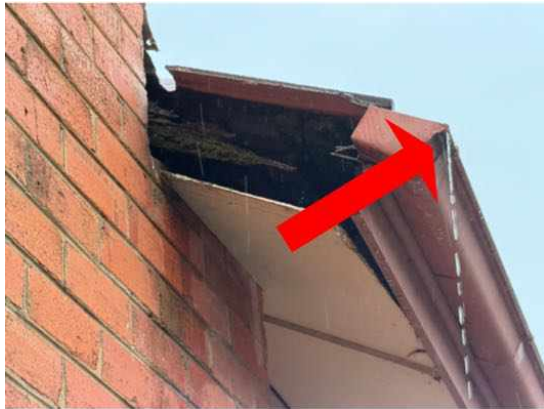
**Defects 3.07**

Building: Main Building  
Location: All external areas, HWS, Aircon, Gutters & Down-pipes  
Finding: Potential Water pooling - against property  
Information: It appears that there are potential areas around the perimeter of the property that could be susceptible to water pooling.

Where insufficient drainage of taps, hot water system & aircon overflows, and overflowing / leaking of roof plumbing is present, water pooling is likely to occur, and can create areas conducive to timber pests and potential damage to the subfloor structure overtime, if neglected.

Recommend consulting with a licensed plumber in the short term to further assess and provide remedial works.

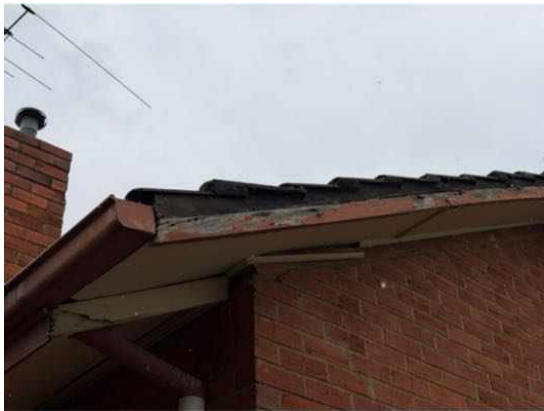
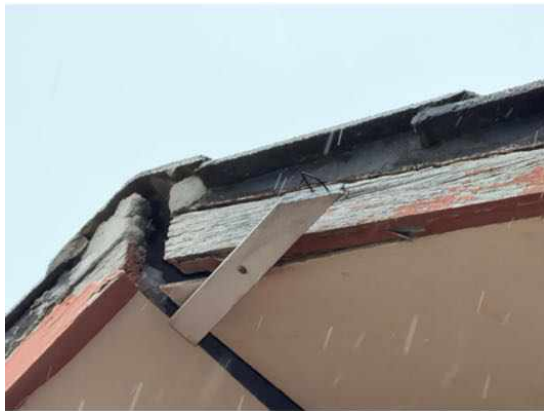
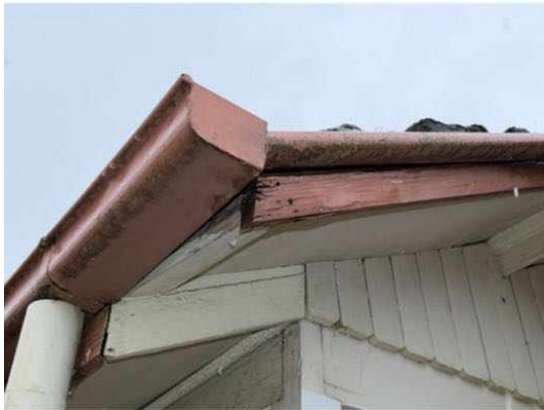
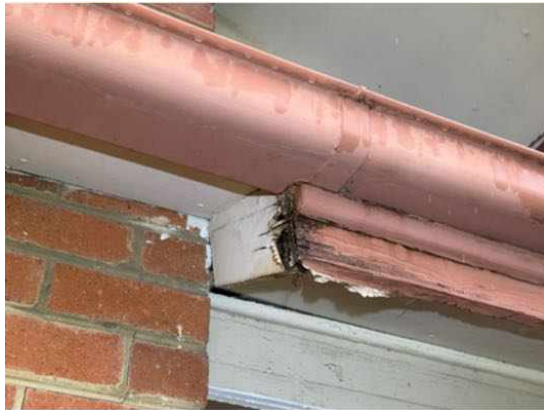
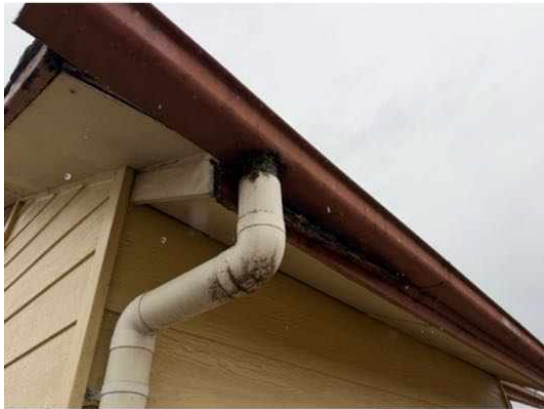
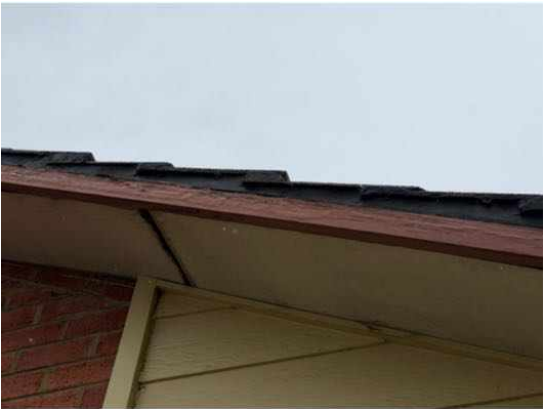
**Defects 3.08**

Building: Main Building  
Location: Fascia's, External Trims, Roof Framing, Stumps  
Finding: Fungal decay & weathering  
Information: Areas of fungal decay (wood rot) & weathering were identified at but not limited to areas of the fascia's, roof framing, timber stumps, and external trims.

For areas of fungal decay, the client should engage a licensed carpenter in the short term, to replace affected materials. For areas of general weathering, it is advised the client engage a licensed painter to apply protective sealant or coating to these areas.

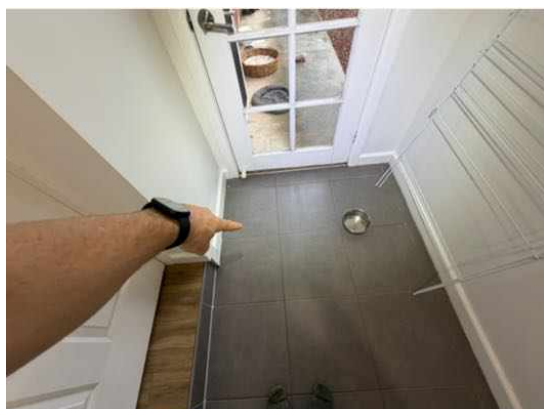
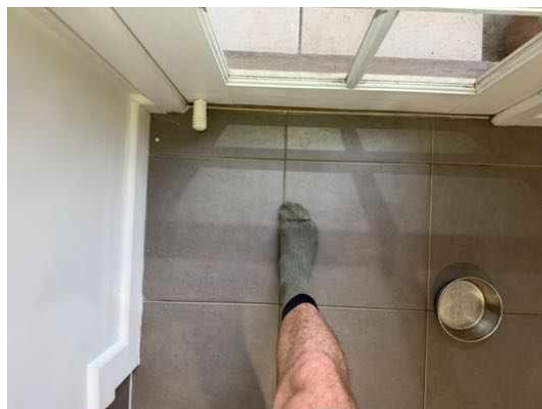
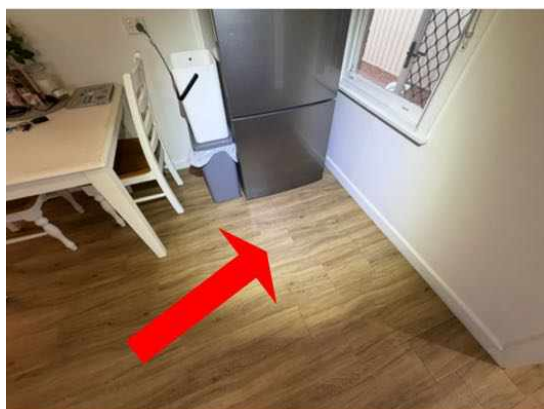
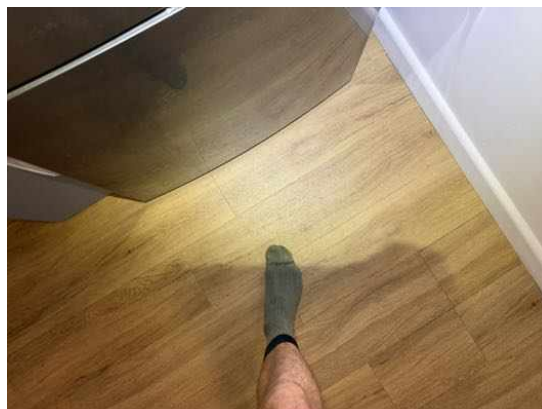
Defects 3.09

Building: Main Building  
 Location: Kitchen, Extension  
 Finding: Flooring - Uneven  
 Information: Some areas, of the flooring throughout the building appear to be slightly uneven.

It is advised that the client monitor the flooring to identify any further movement. Where flooring remains relatively unchanged for an extended period of time, it is likely that this defect has been caused by expected movement of the foundations of the property.

However, where further movement and unevenness occurs, a structural engineer should be engaged promptly for further evaluation.

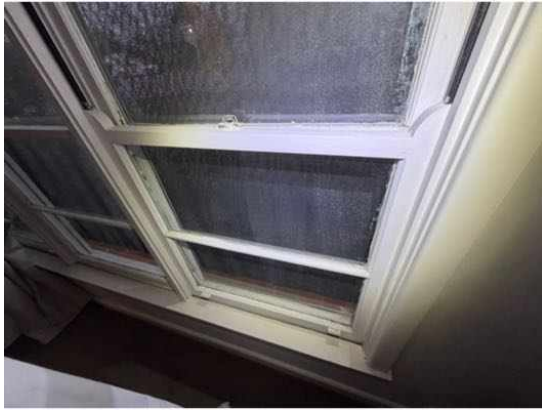
### Defects 3.10

Building: Main Building  
 Location: Windows  
 Finding: Windows - Stiff to slide  
 Information: Some windows were found to be stiff to slide at the time of inspection. General maintenance works ie; cleaning of the tracks or adjustment of the frame may be required to return the windows to a fully operational level. These minor works can be conducted by a general handyman, at clients discretion.

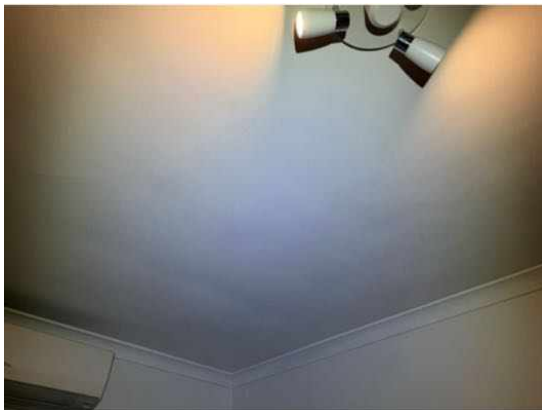
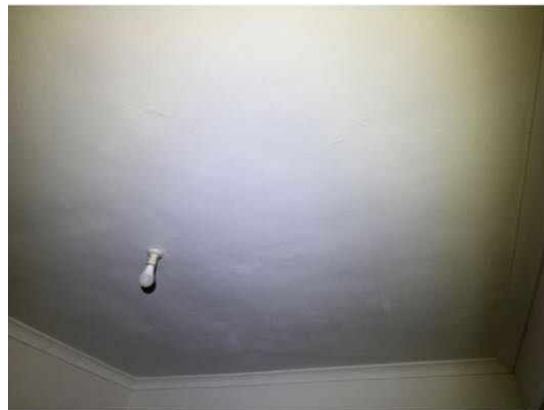
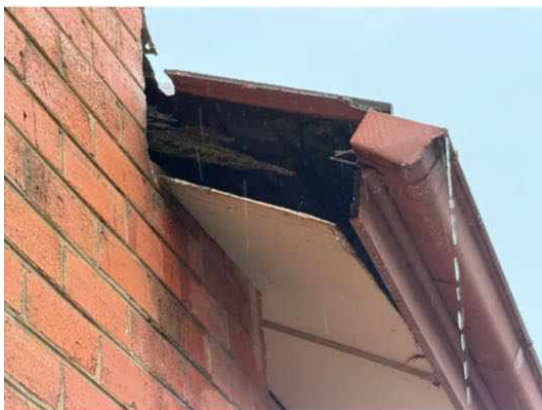
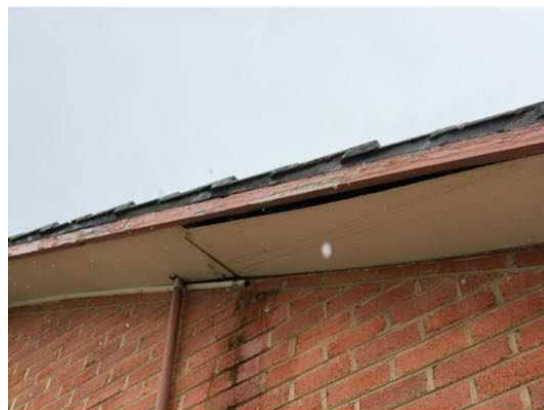
### Defects 3.11

Building:	Main Building
Location:	Interior Ceilings, Eaves
Finding:	Ceiling & Eaves - Sagging
Information:	Sections of the internal ceilings & eaves were found to be sagging at the time of inspection. Causes of ceiling and eaves sagging include fixings (e.g. nails or glue) that have become loose and require re-fixing.

Where sagging has occurred, works such as re-gluing of ceiling sheets and installing additional fixings may be required. Such works may be performed by relevant tradespeople, such as plasterers or licensed carpenters.

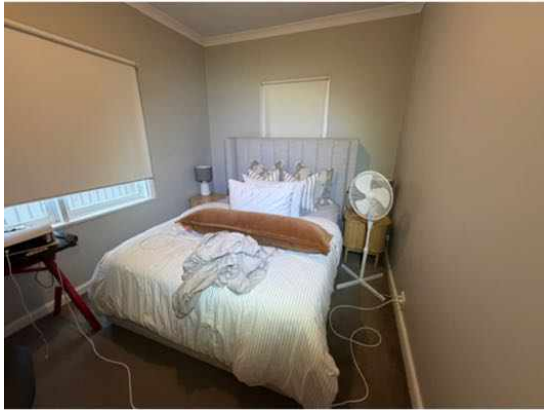
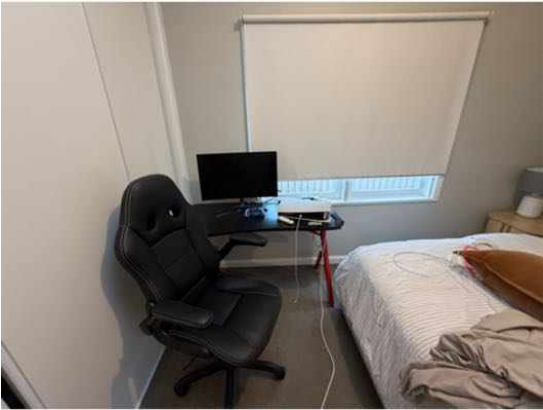
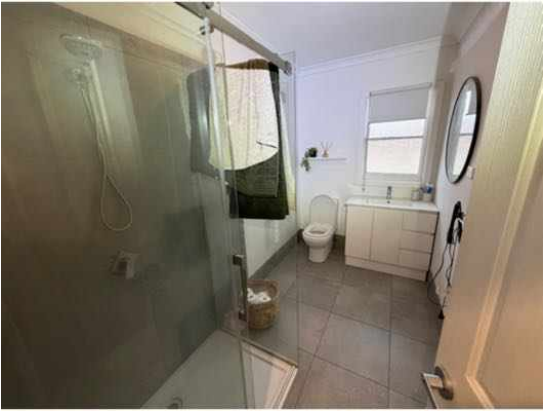
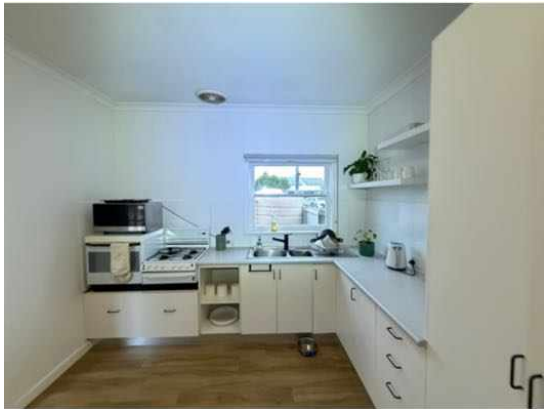
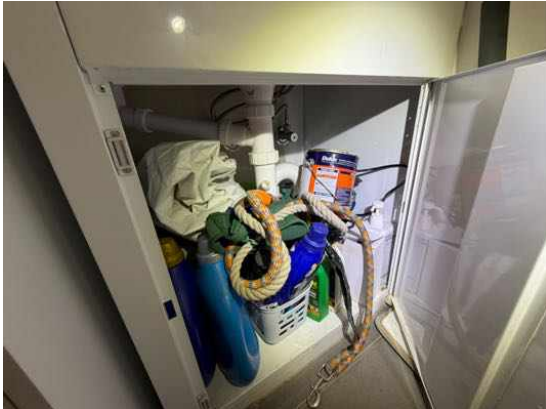
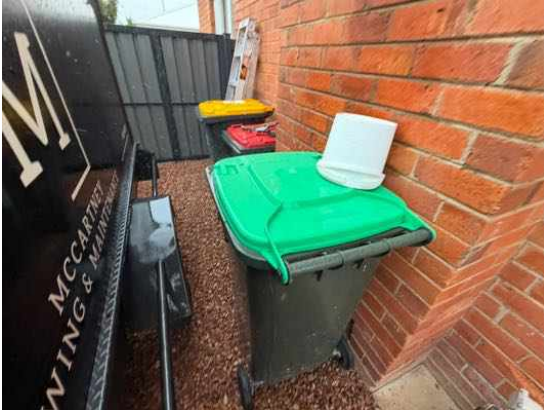
Building: Main Building  
Location: All Areas  
Finding: Additional Photos - Obstructions and Limitations  
Information: These photographs are an indication of the obstructions and limitations which impeded full inspection of the property at the time of inspection. These obstructions can hide an array of defects and should be removed to allow full inspection to be carried out. A re-inspection is recommended once the areas are made accessible.

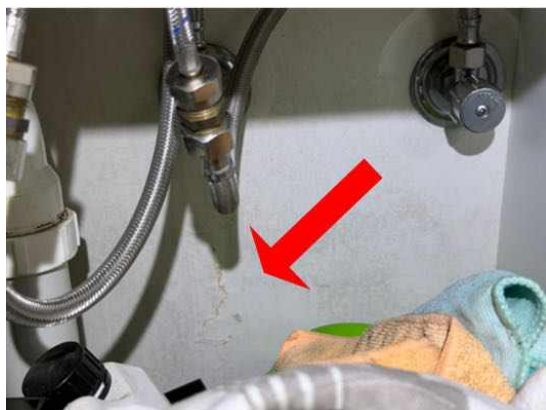
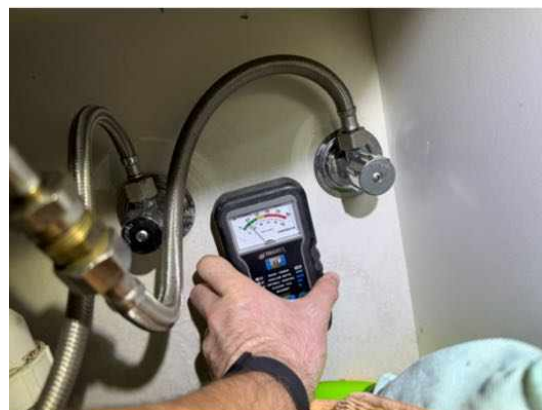
Building: Main Building  
 Location: Kitchen Sink  
 Finding: Water Staining Present  
 Information: It appears water staining was present at, but not limited to beneath the kitchen sink. No high moisture was evident in this area at the time of inspection.

Recommend that the client monitor the area. Should leaking persist or return, a licensed plumber should be engaged promptly to provide remedial works.

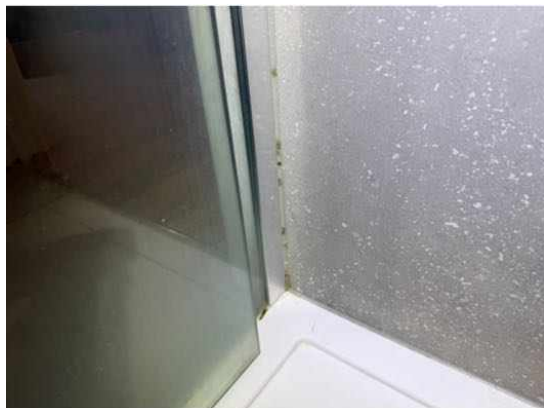
Building: Main Building  
 Location: Bathroom  
 Finding: Sealant and grouting - Monitor & General Maintenance  
 Information: It appears that the sealant and grouting in the tiled areas are slightly weathered, a common defect in houses of a similar age.

It is noted for the clients information that sealant and grouting in areas that come into regular contact with water should be maintained.

Should the sealant deteriorate further, a tiling contractor should be engaged to provide maintenance works where necessary to ensure all wet areas are sufficiently sealed.

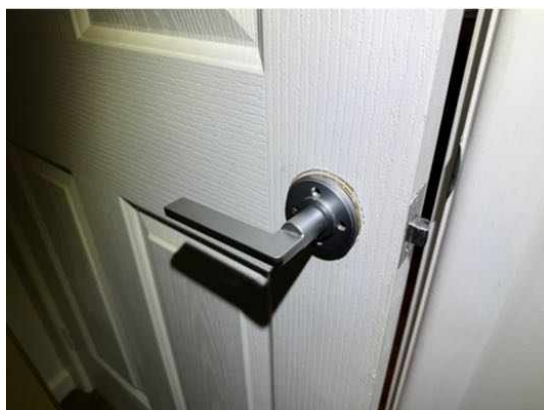
Building:	Main Building
Location:	Bedroom Doors
Finding:	Door Handles - Loose
Information:	It appears that some door handles are loose and require adjustment to tighten. A general handyman may be appointed to perform these minor works at the clients discretion.

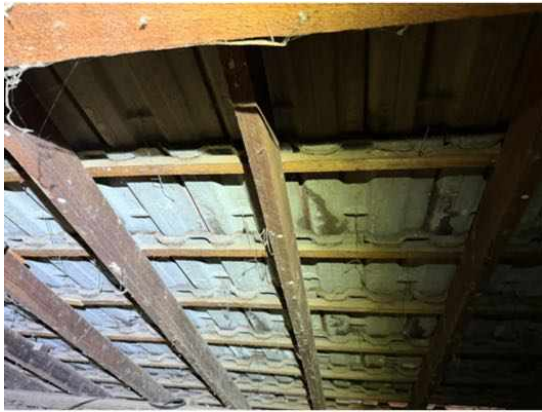
Building:	Main Building
Location:	Roof void
Finding:	Sarking - Not Present
Information:	It is noted for your information that sarking has not been installed on the roof, a common finding in buildings of a similar age. Sarking is a laminated aluminium foil applied to the interior of the roof covering, assists in insulating the property and acting as a vapour-barrier to the roof void.
	The client can consult with a licensed roofing contractor at their discretion, to provide further advice.

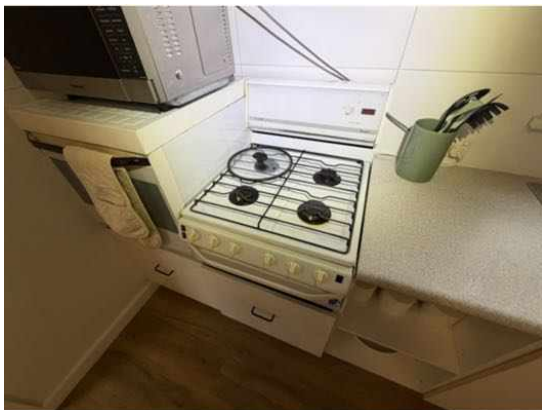
Building: Main Building  
Location: Stove  
Finding: Stove - Not Igniting  
Information: It appears that the stove was not igniting at the time of inspection. Recommend engaging a licensed electrician at clients convenience to provide maintenance works.

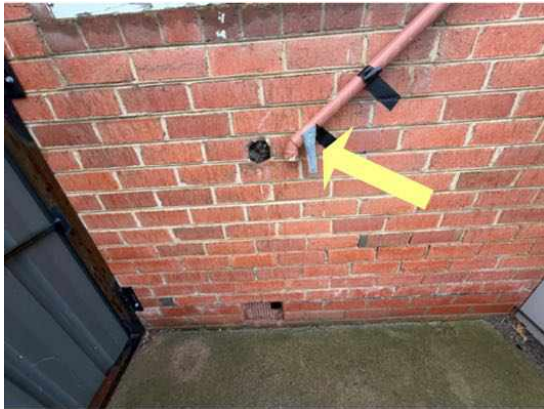
Building: Main Building  
Location: Right Side  
Finding: Vent Pipe - Disconnected  
Information: It appears that a vent pipe was disconnected at the time of inspection. Recommend consulting with a licensed plumber at clients discretion, to provide further advice and remedial works.
